**Antler Energy LLC
Federal-Chamberlin 22-1
Location ID: 312863**

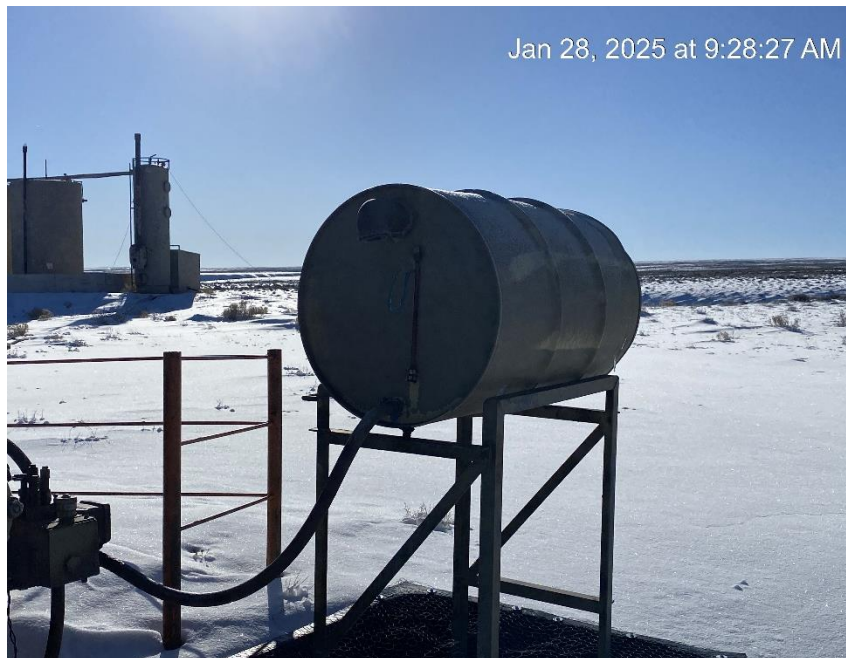
Unlabeled container

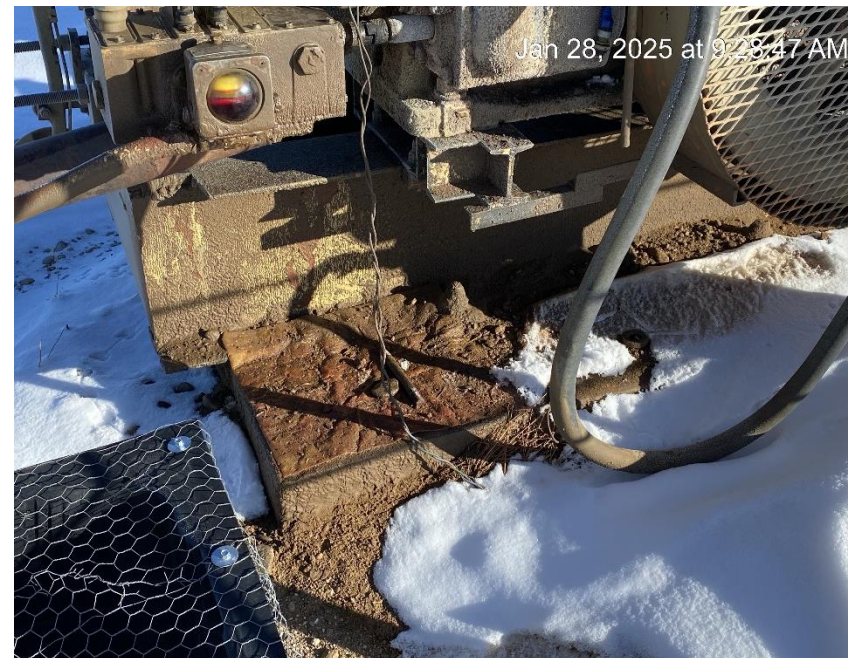
Oily waste and stained soil

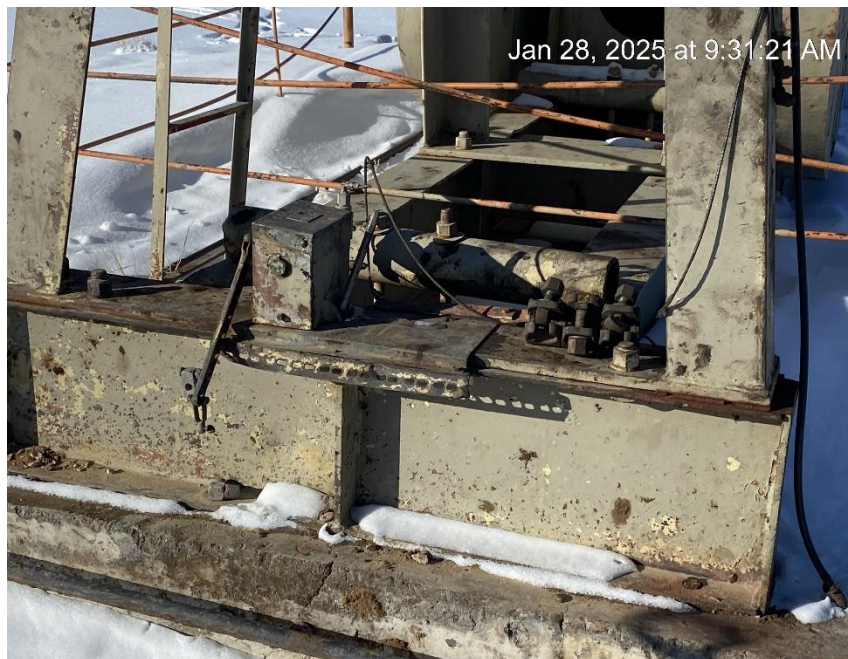
Debris

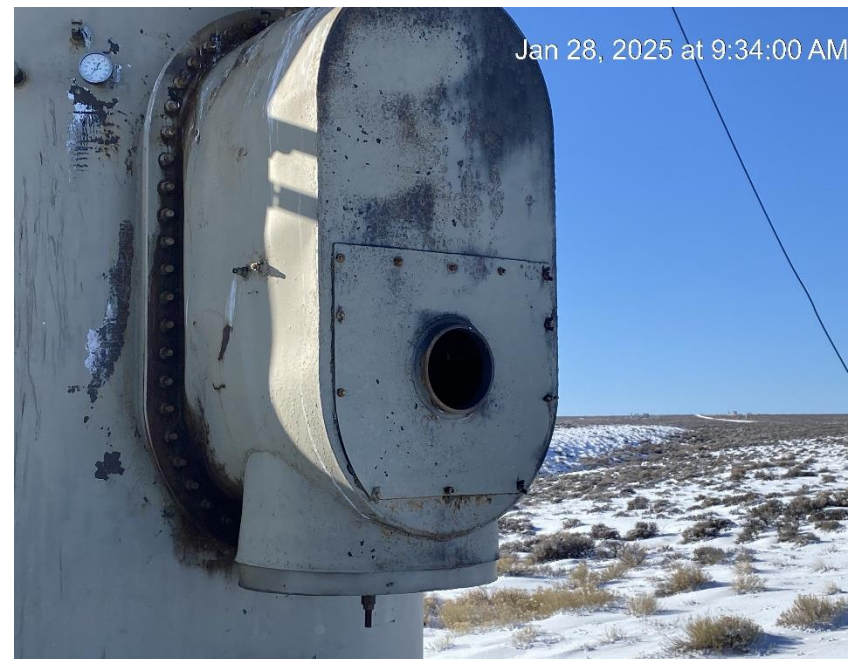
Open to wildlife

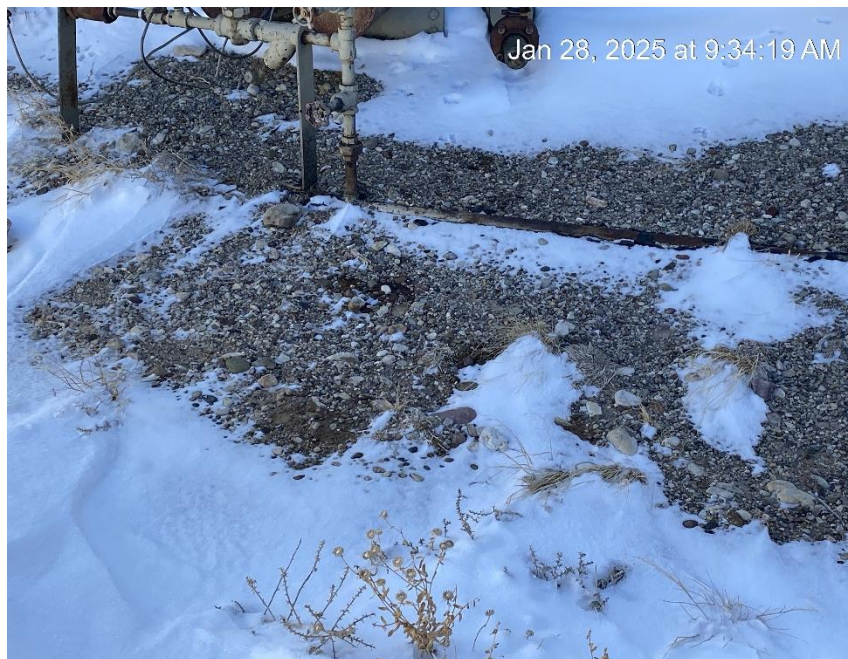
Stained soil

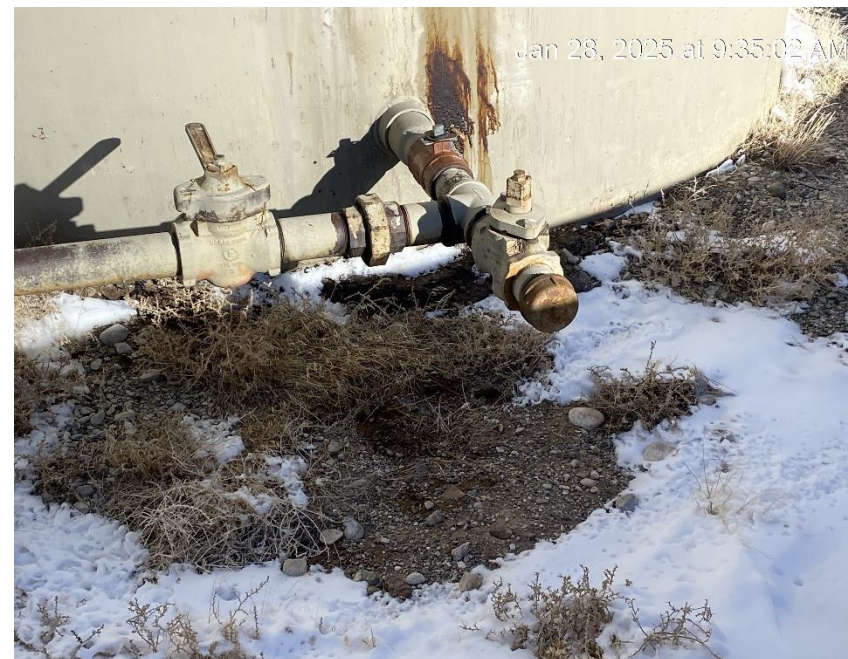
Stained soil

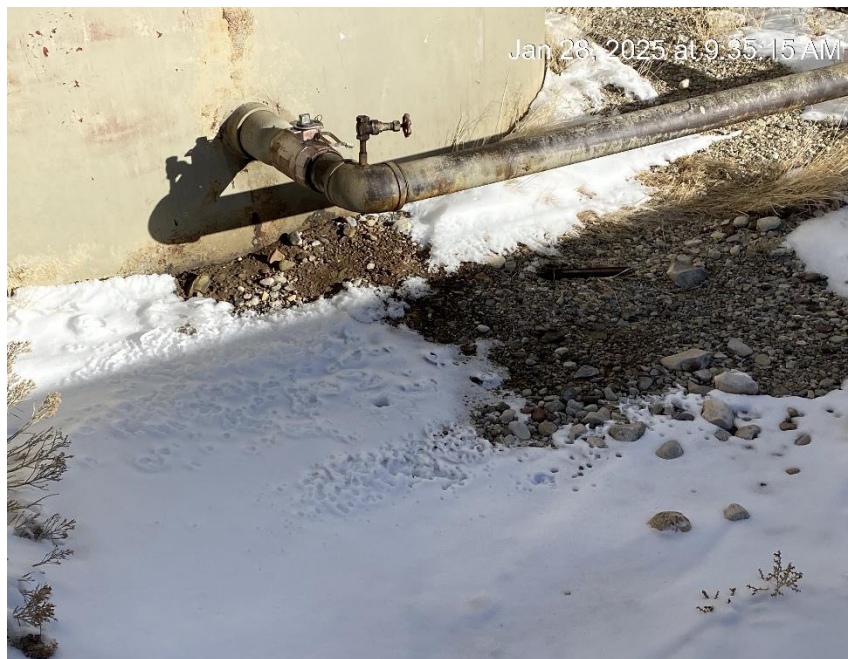
Stained soil
