**Antler Energy LLC**  
**Amoco Federal 21-1**  
**Location ID: 312970**

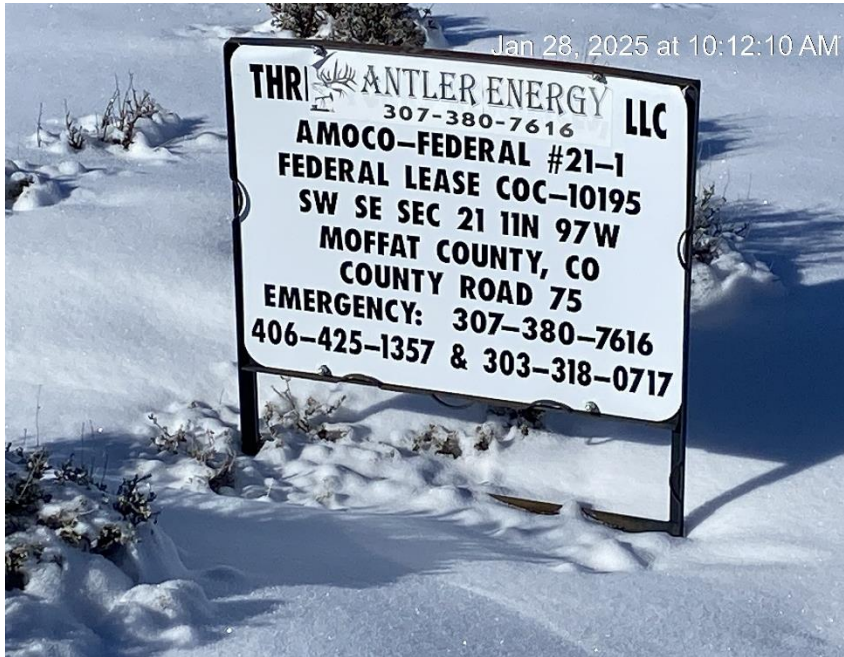
**When replaced additional information is required**

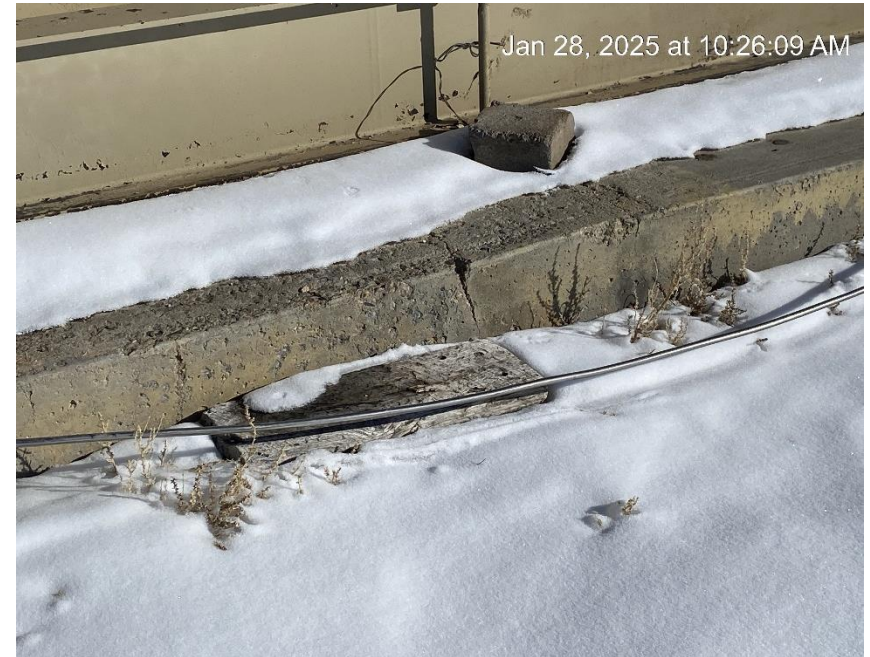
**Debris**

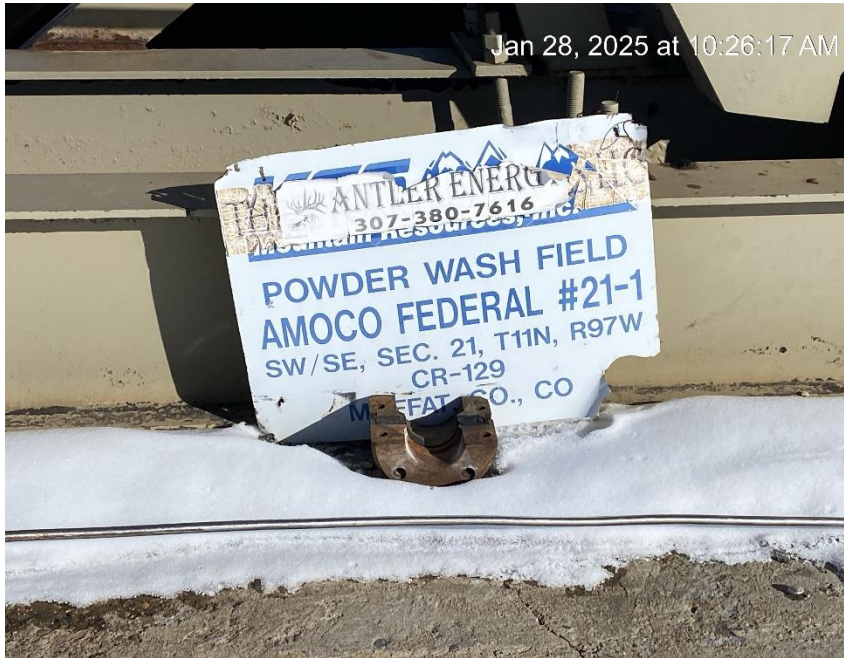
**Well sign missing required information**

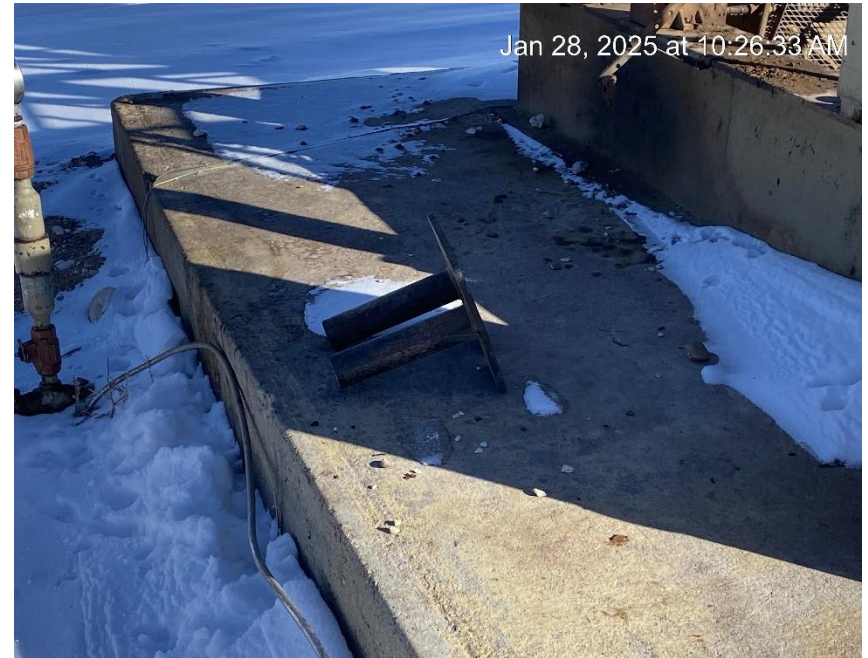
**Debris**

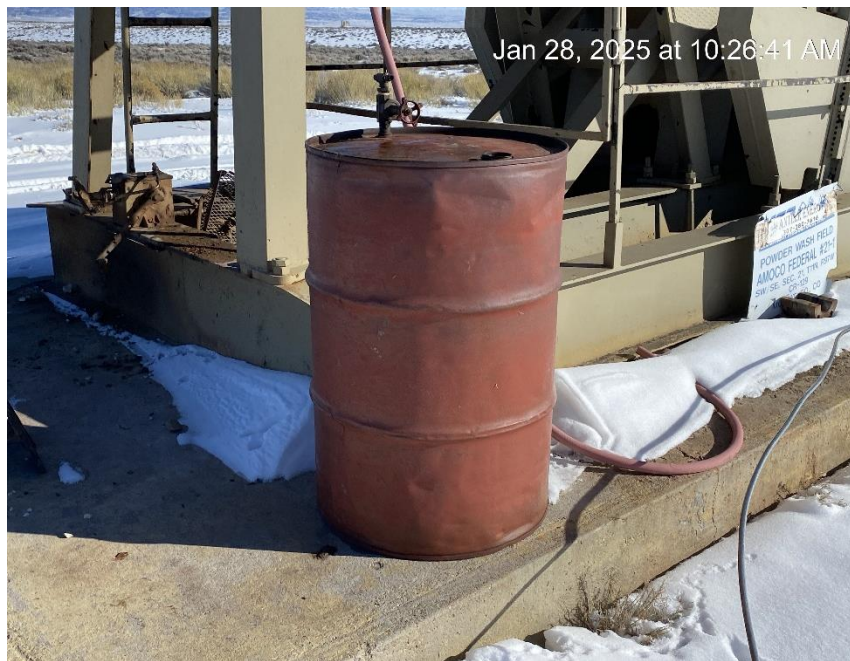
**Debris. Unlabeled container.**

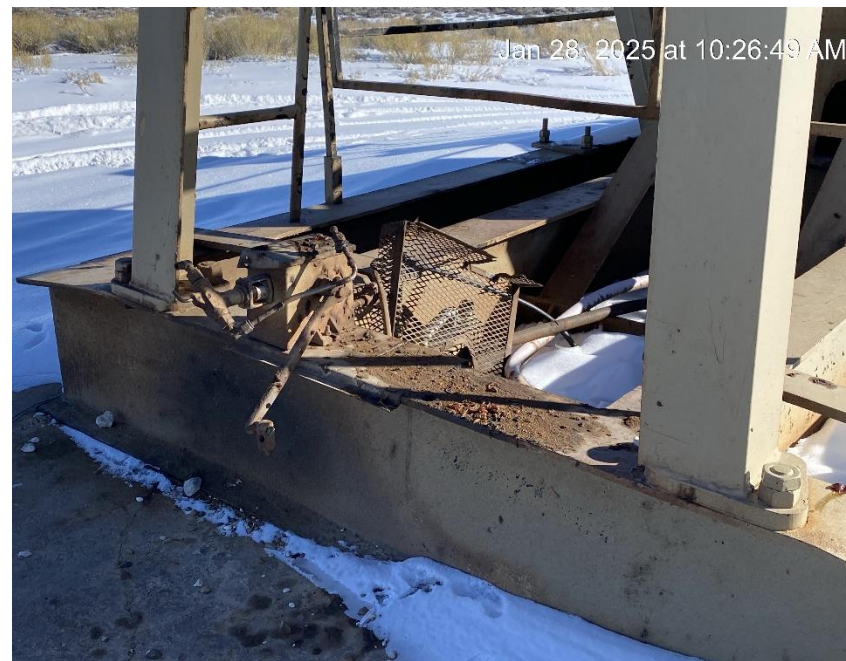
**Debris**

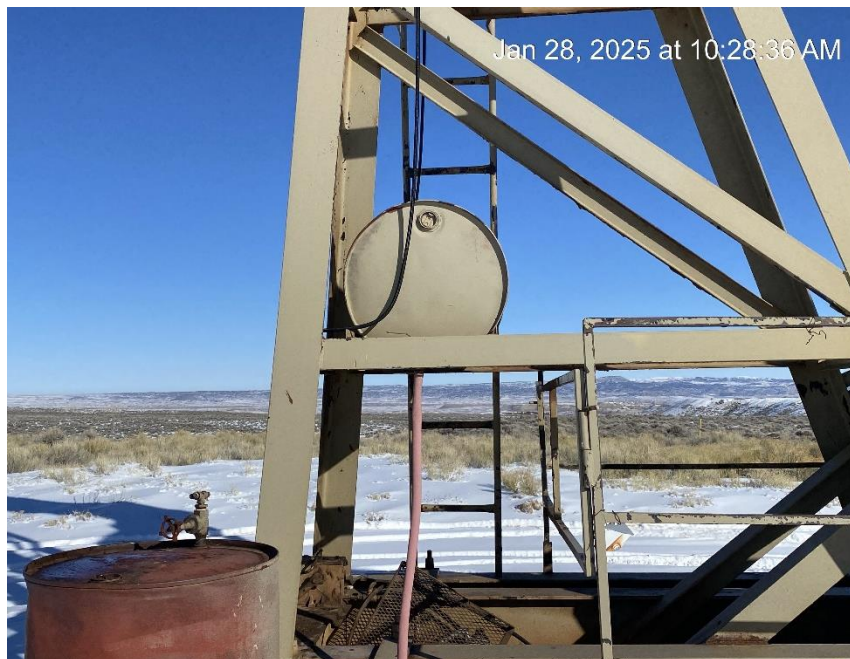
**Debris. Unlabeled container.**

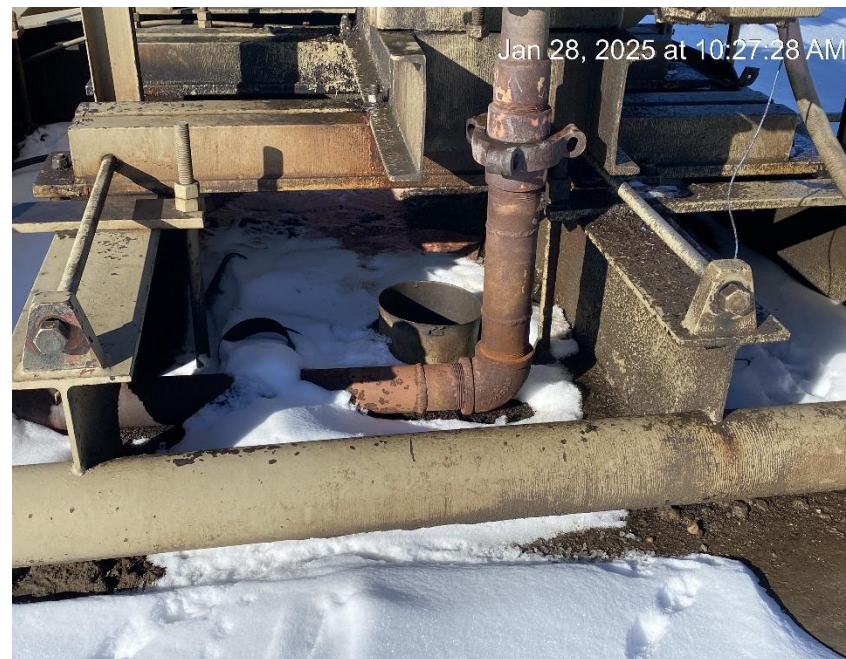
**Oily waste and debris**

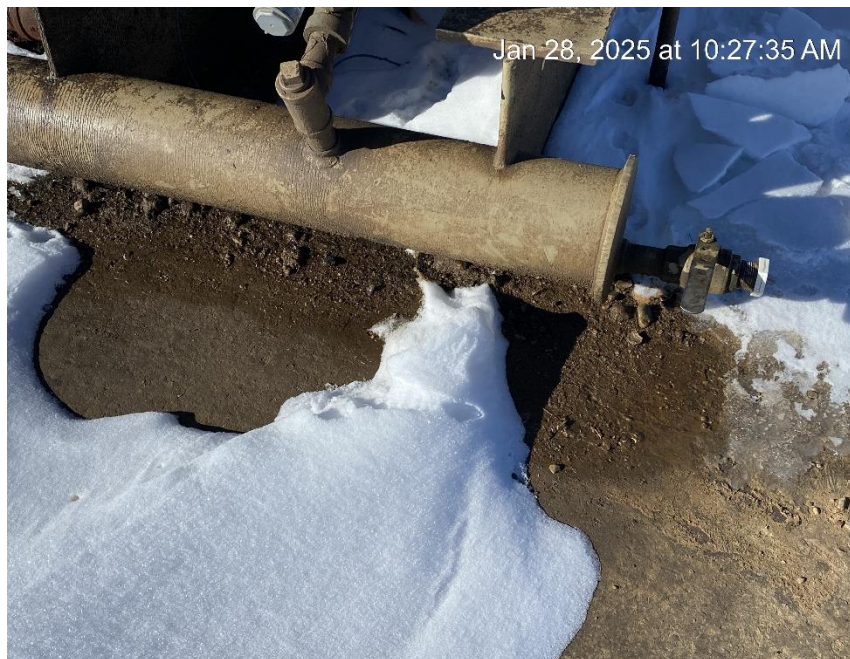
**Oily waste**

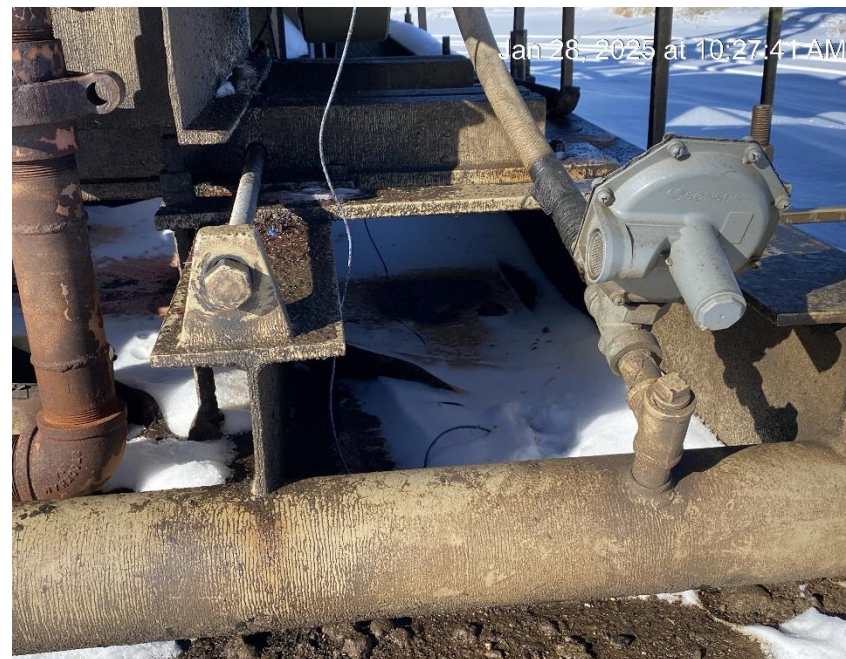
**Oily waste and debris**

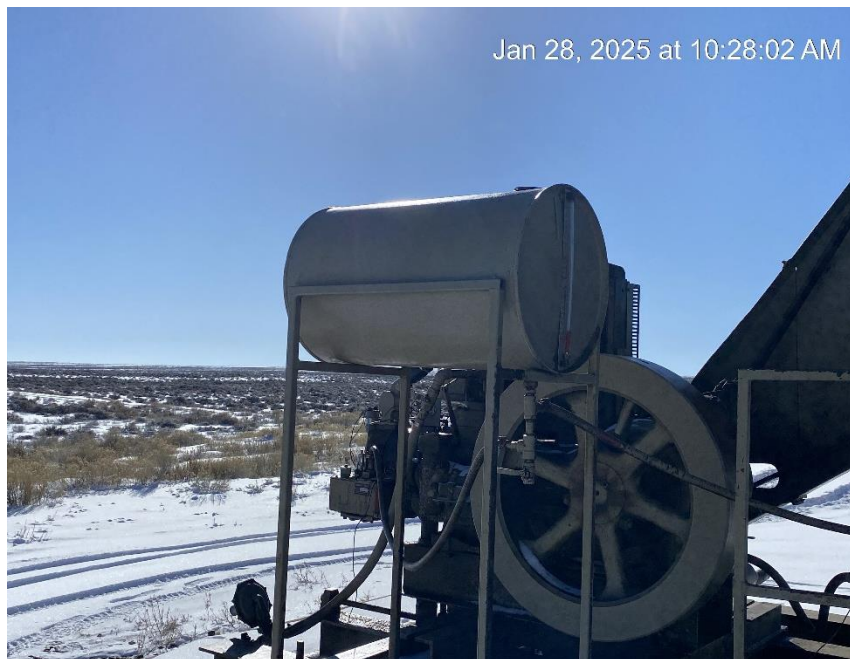
**Unidentified container**

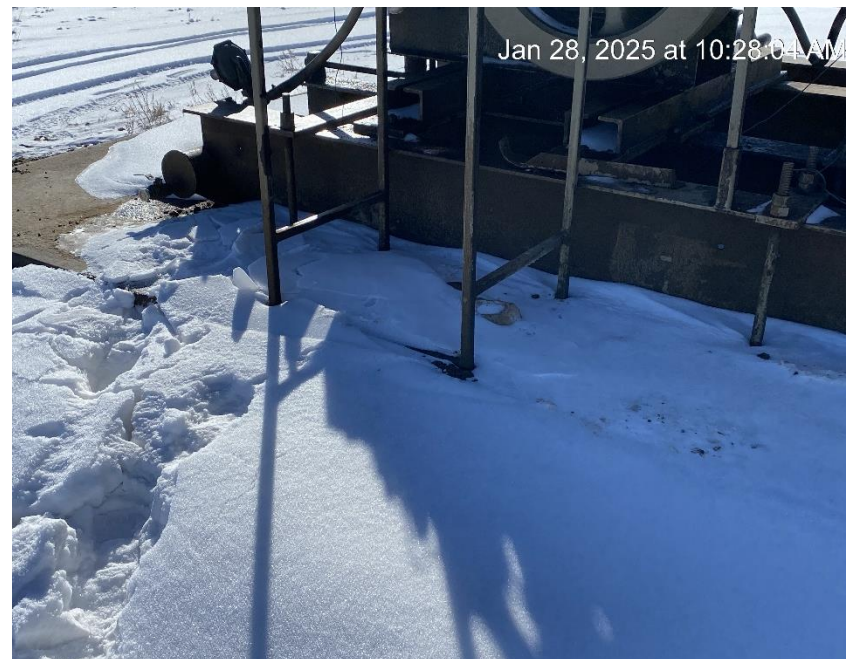
**No spill containment**

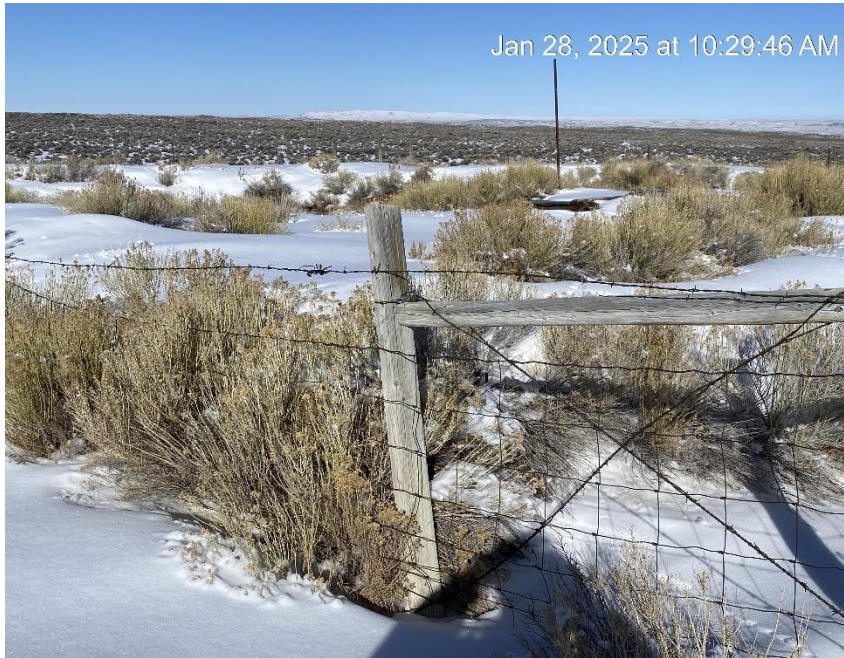
**Unregistered pit**

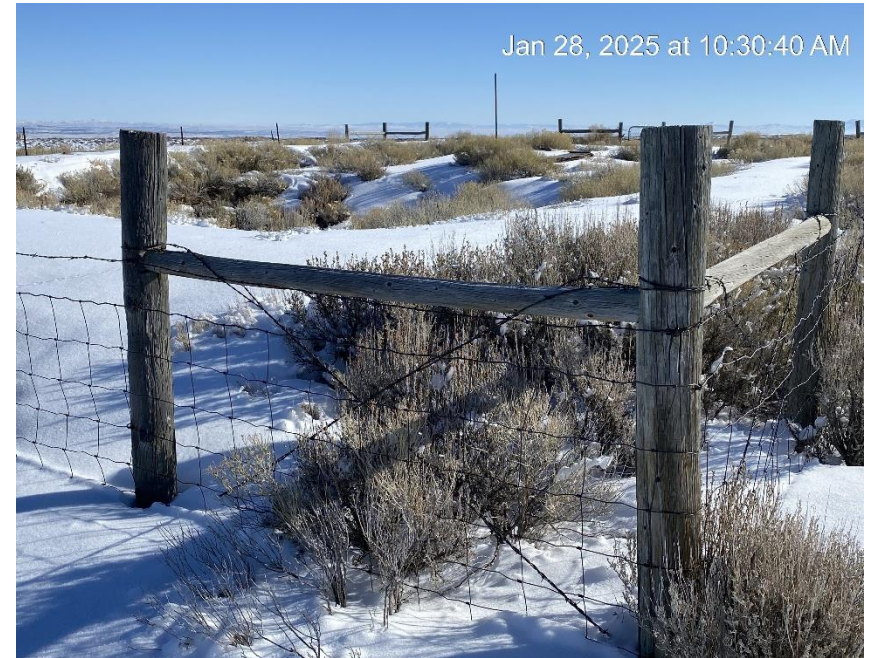
**Unregistered pit**

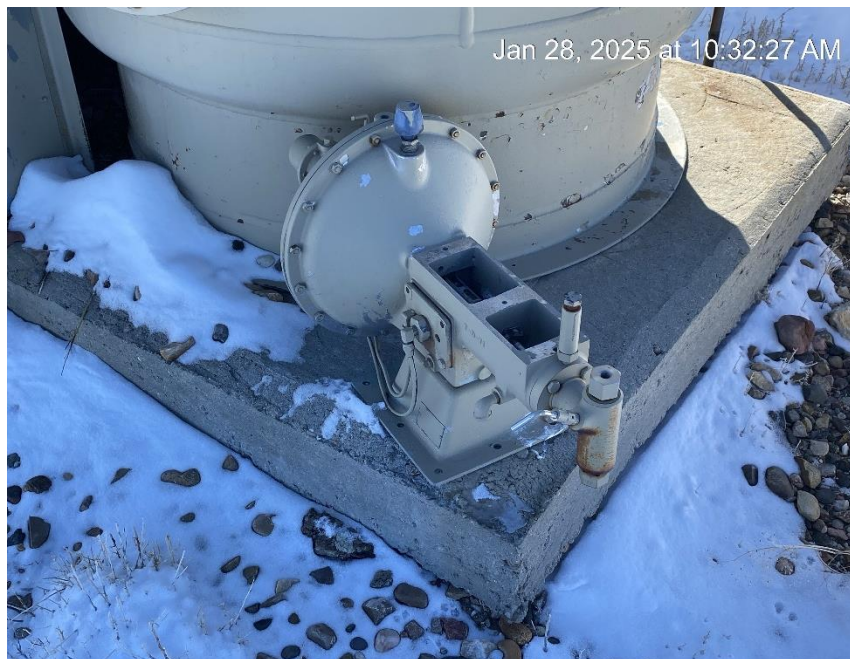
**Unused equipment**

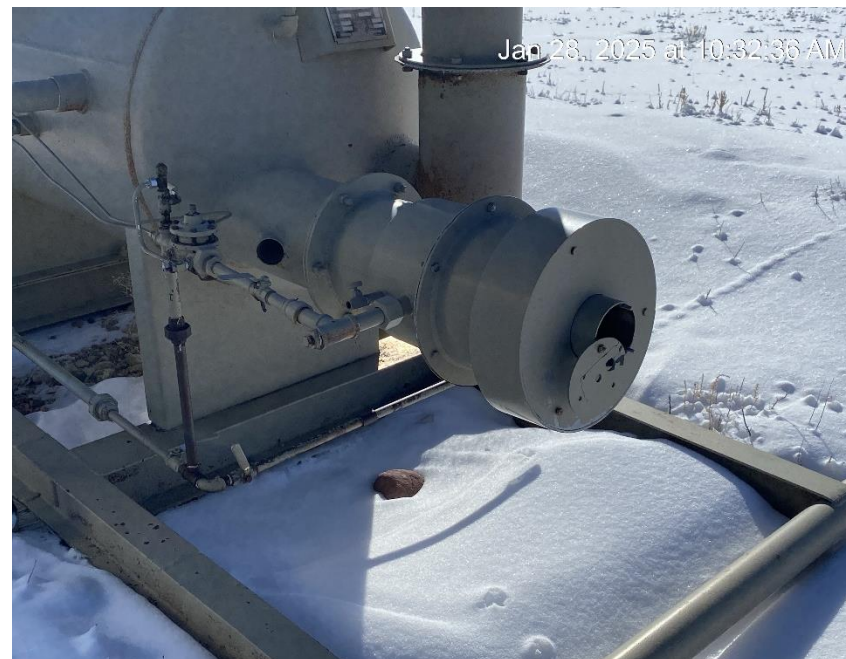
**Open to wildlife**

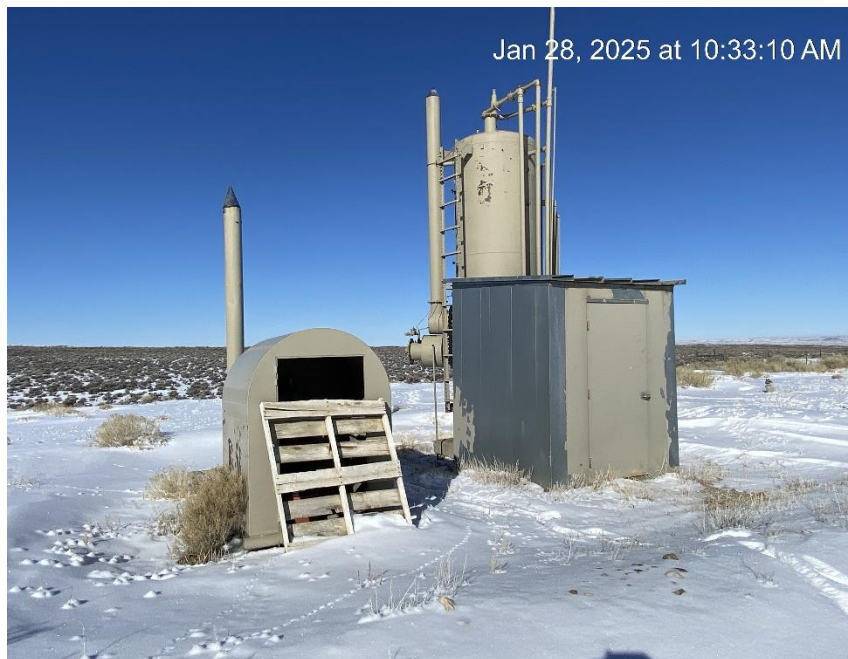
**Unused equipment**

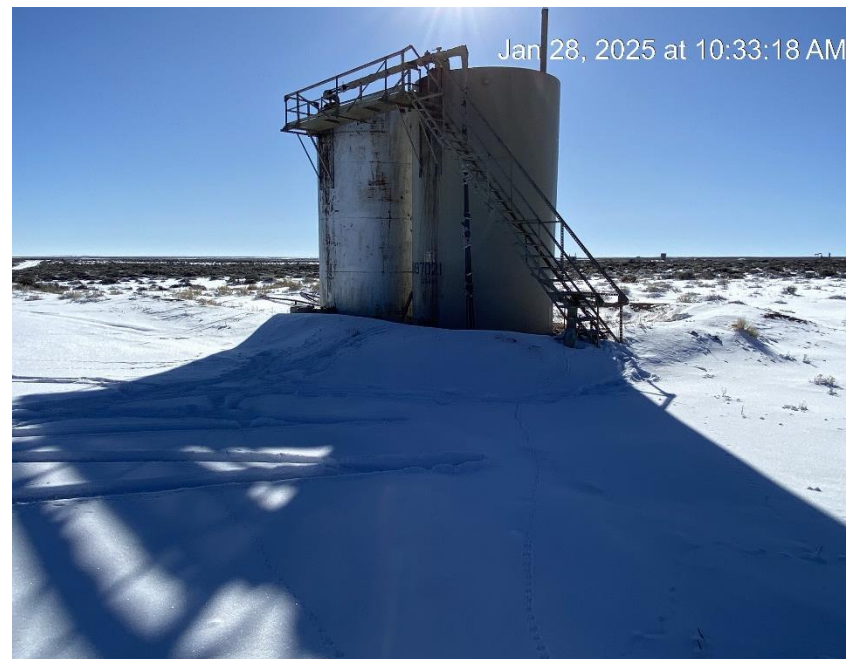
**No sign at tank battery**

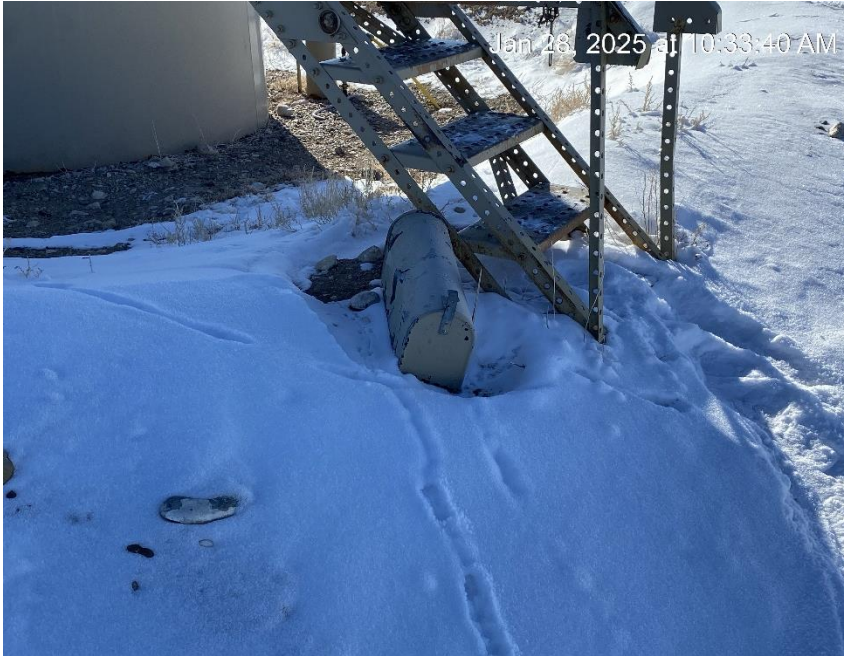
**Debris**

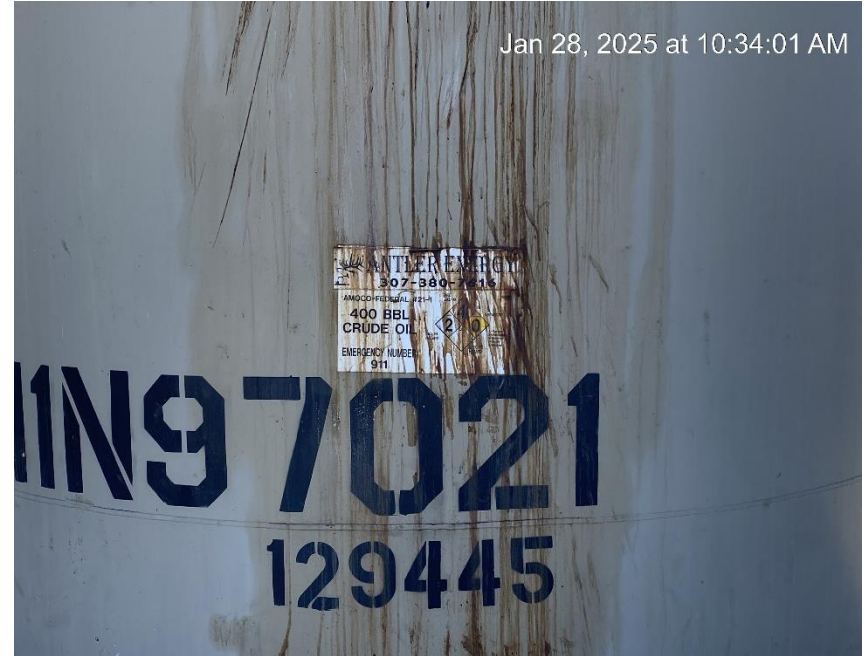
**Illegible label**

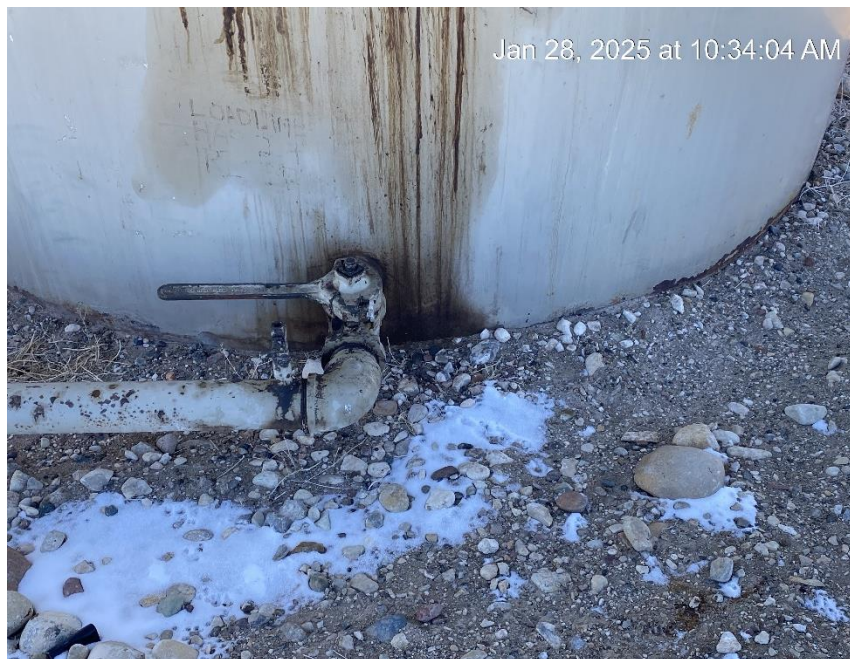
**Stained soil**

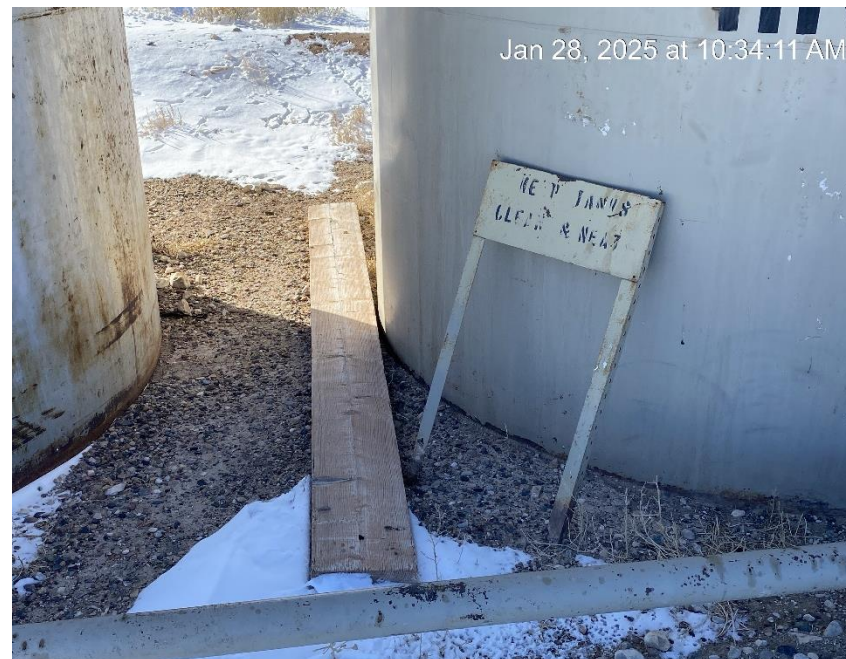
**Debris**

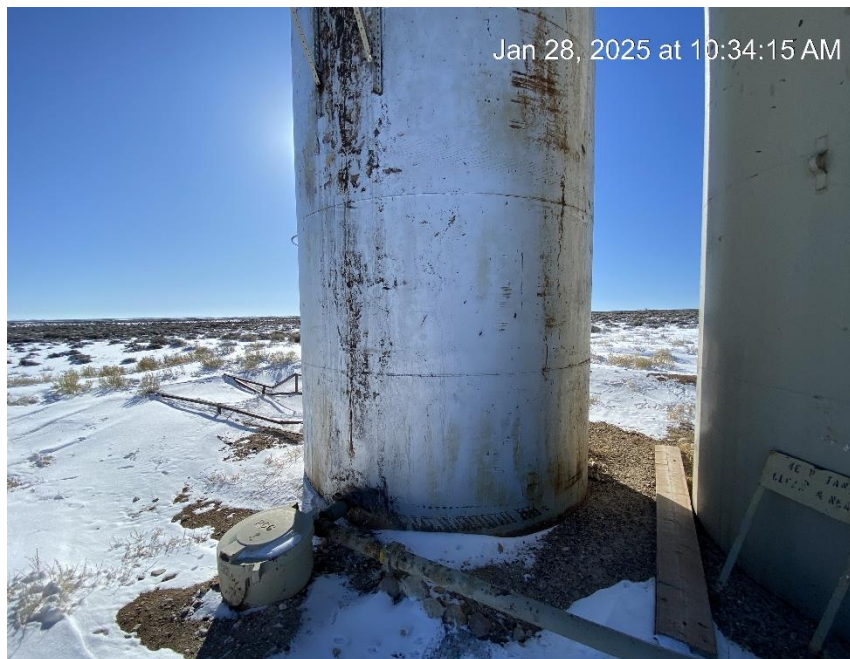
**Unlabeled tank**

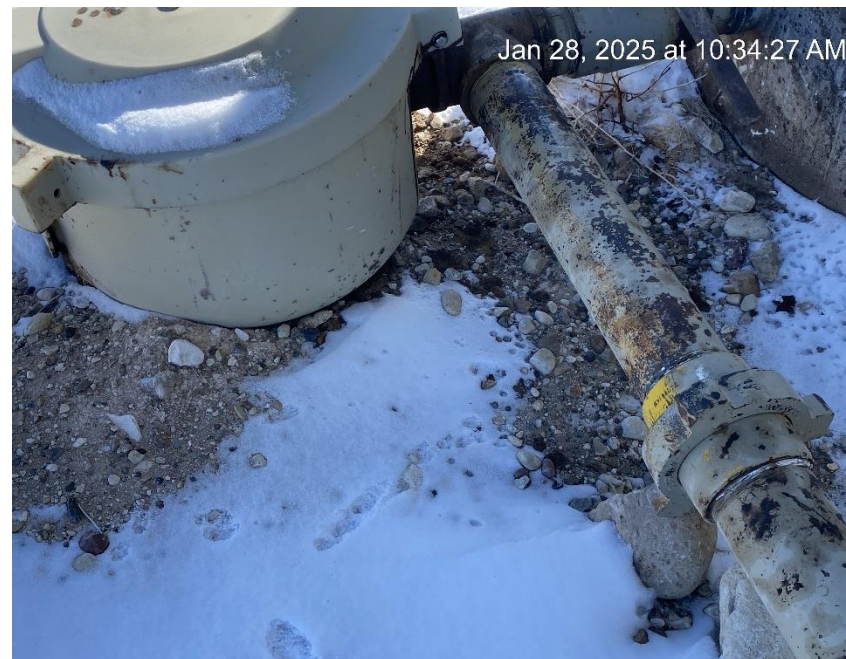
**Oily waste and stained soil**

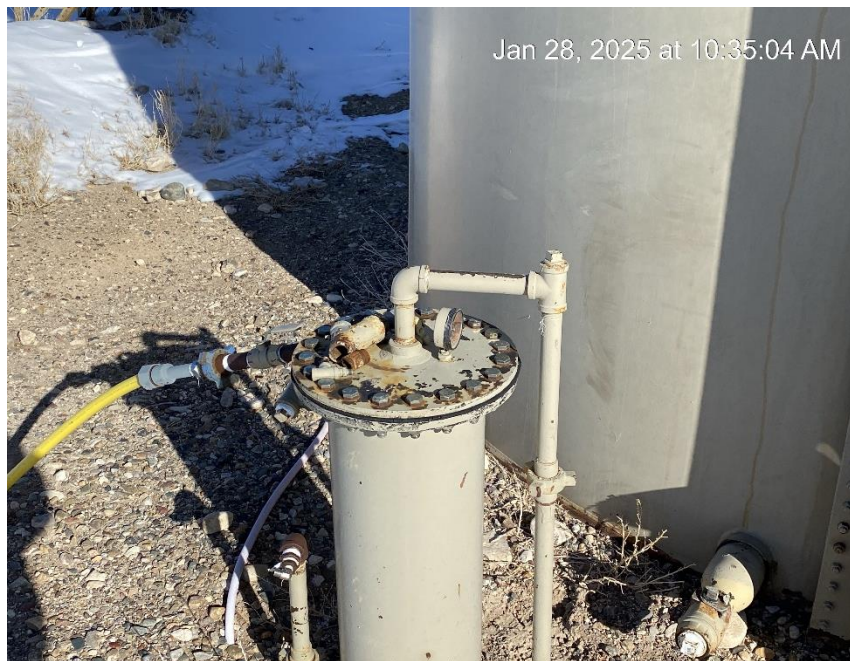
**Debris**

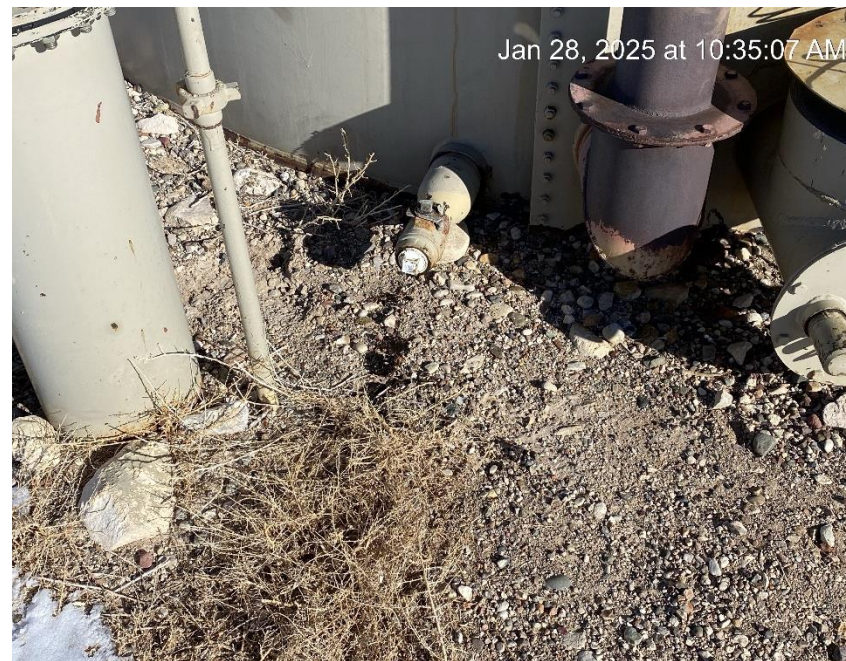
**Oily waste**

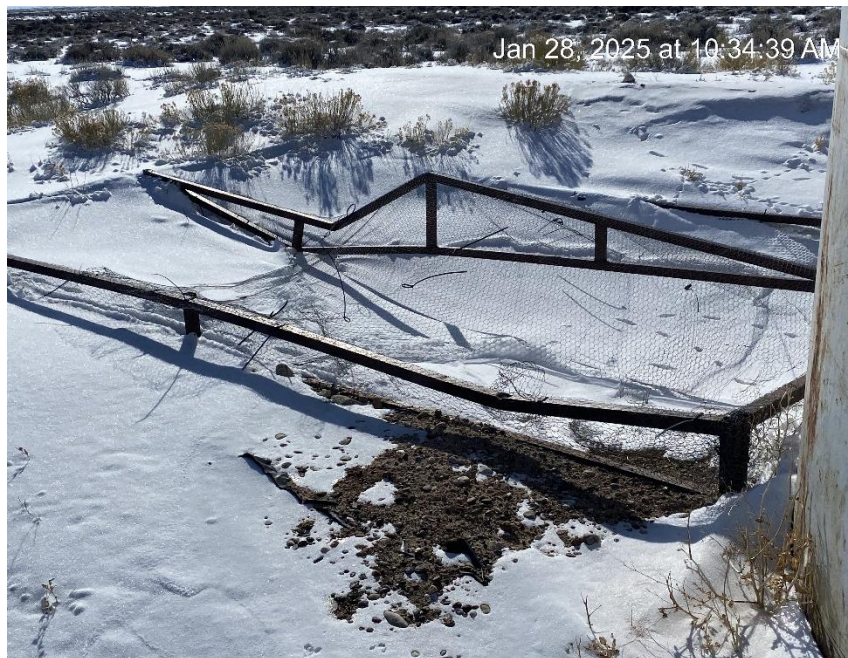
**Production pit inside tank berm**

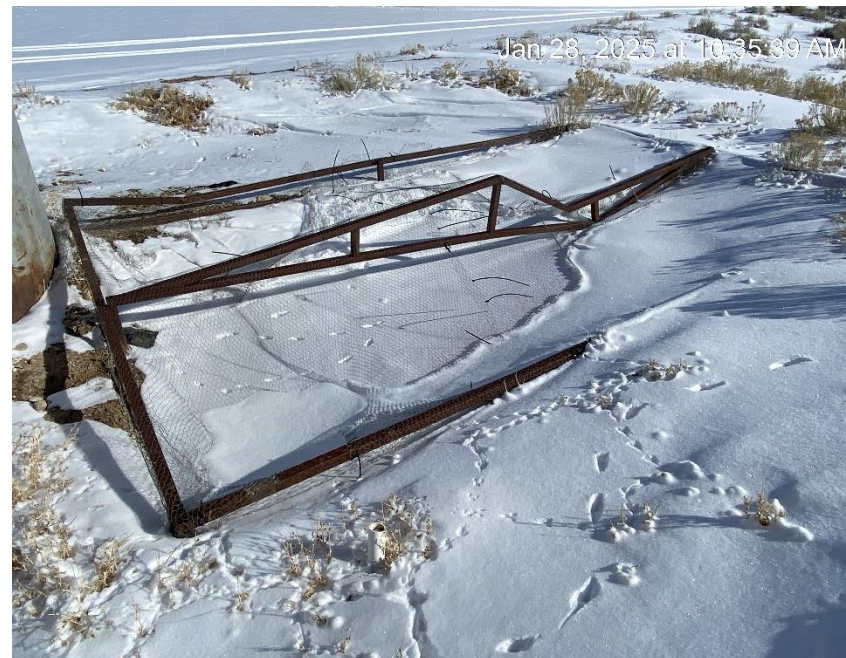
**Production pit inside tank berm**
