Inspection Photos

Location Name: McCall 42-09 1N46W

API Number: 125-12103

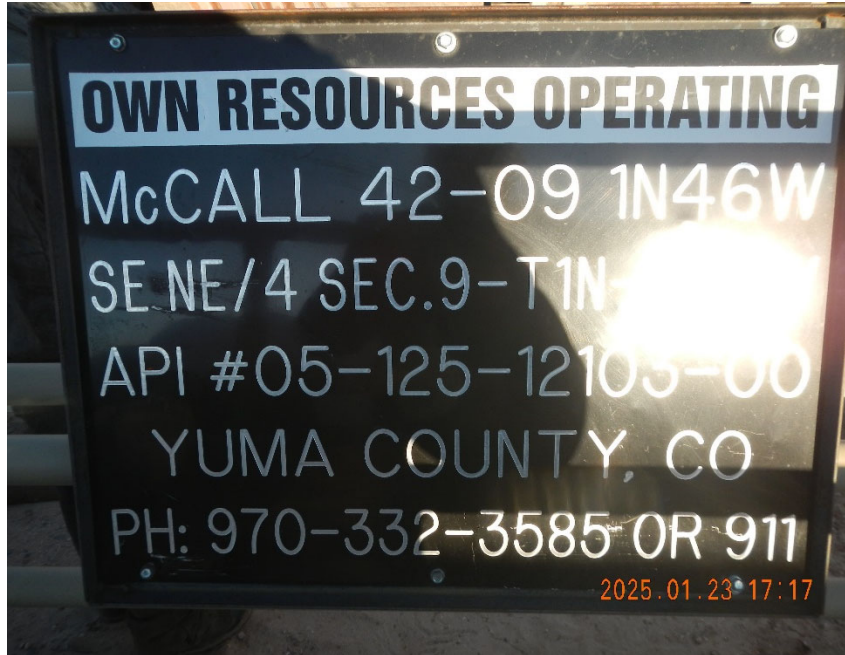
1. Lease sign at well location.

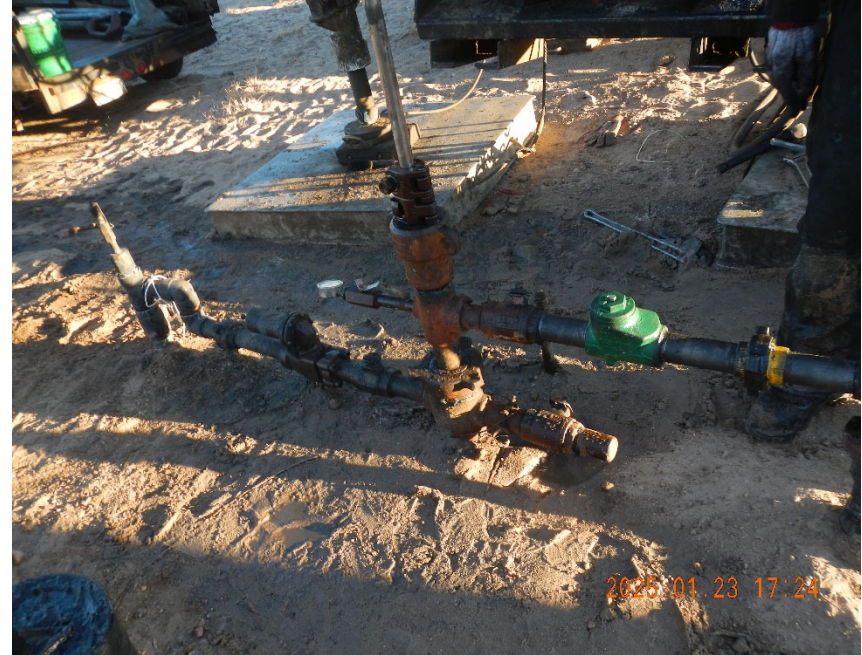
2. View of wellhead. Rods and Tubing are back in wellbore.

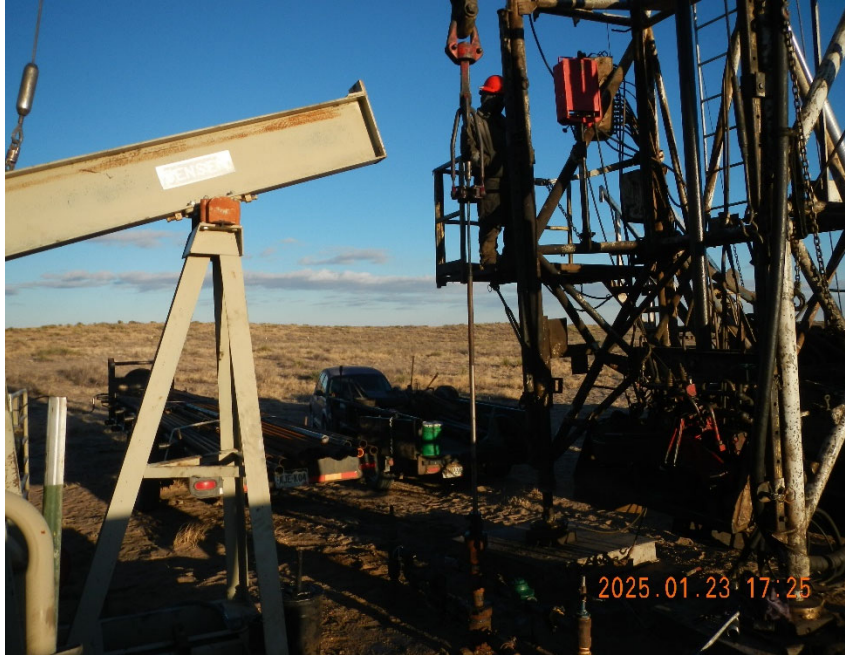
4. View of pump jack with horse head removed, Crew will be getting well set up to return to production.

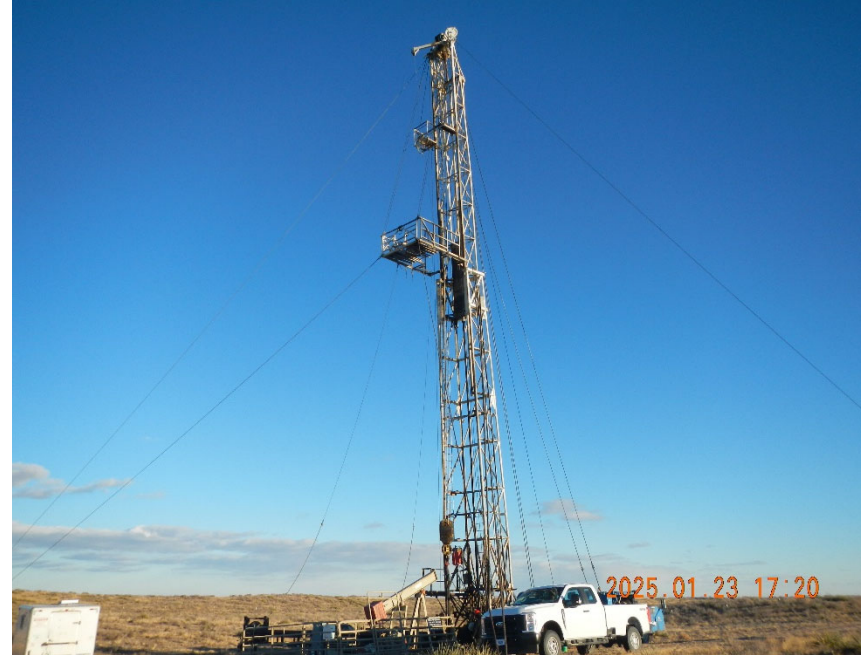
5. View of rig at well location.
