ECMC
Environmental
Field Inspection

Highum, Norden, Clark Facility
© 24-Jan-25 01:01:41 PM
ECMC Environmental Inspection

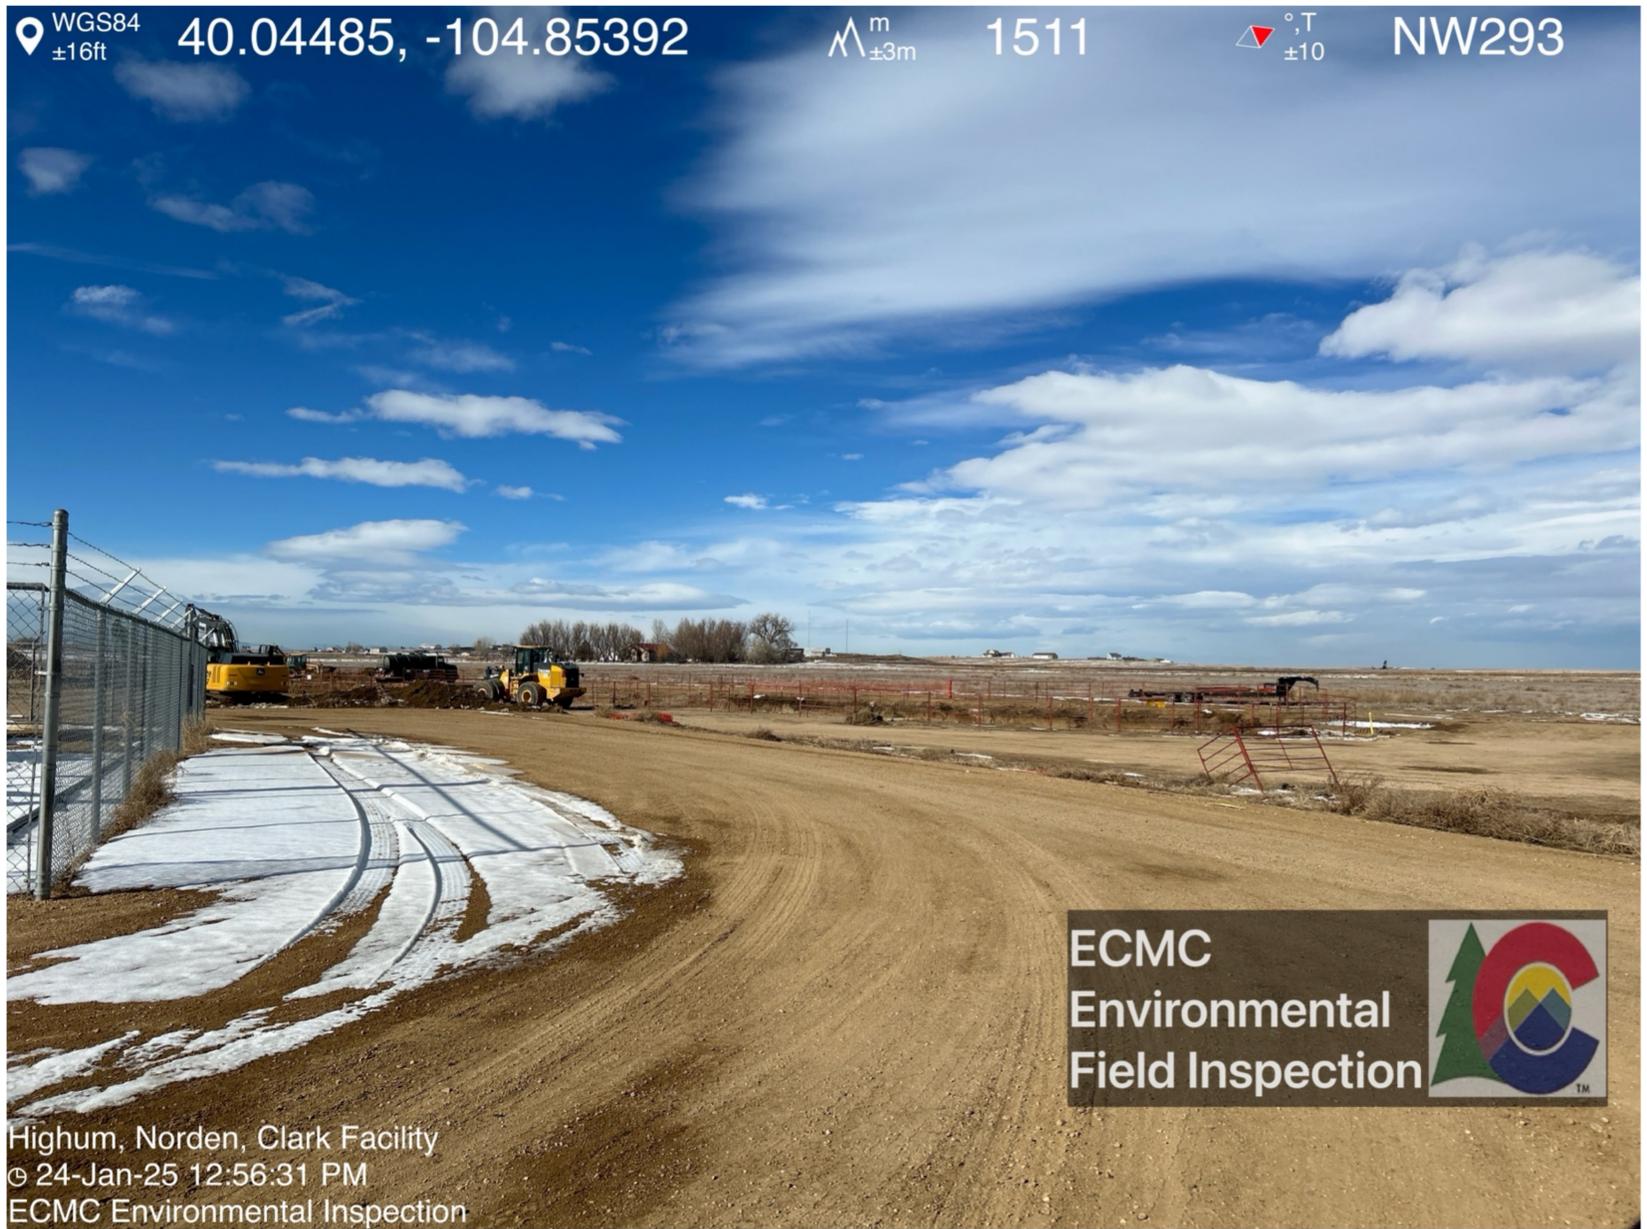
Soil stockpile marked as "Topsoil Storage" on location; BMPs are adequate.

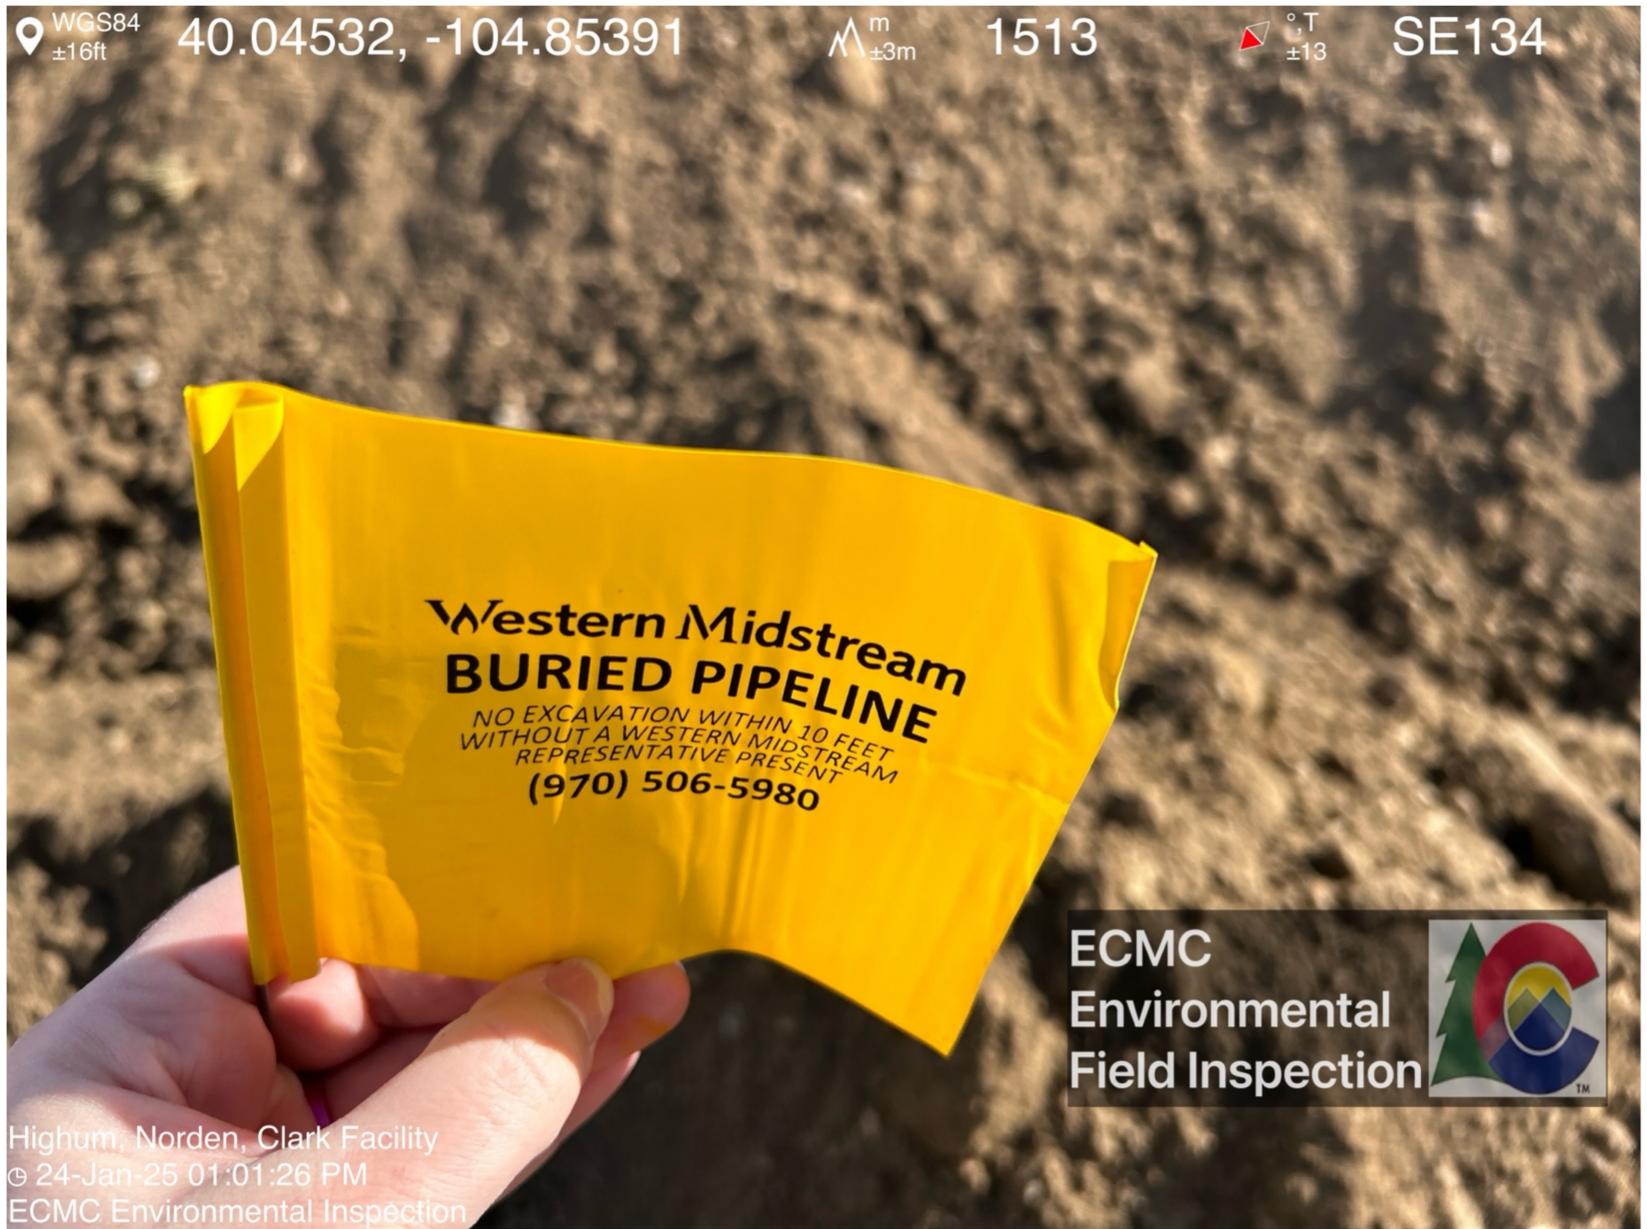
Metal fencing has been installed around the excavation. A pipeline marker is visible.

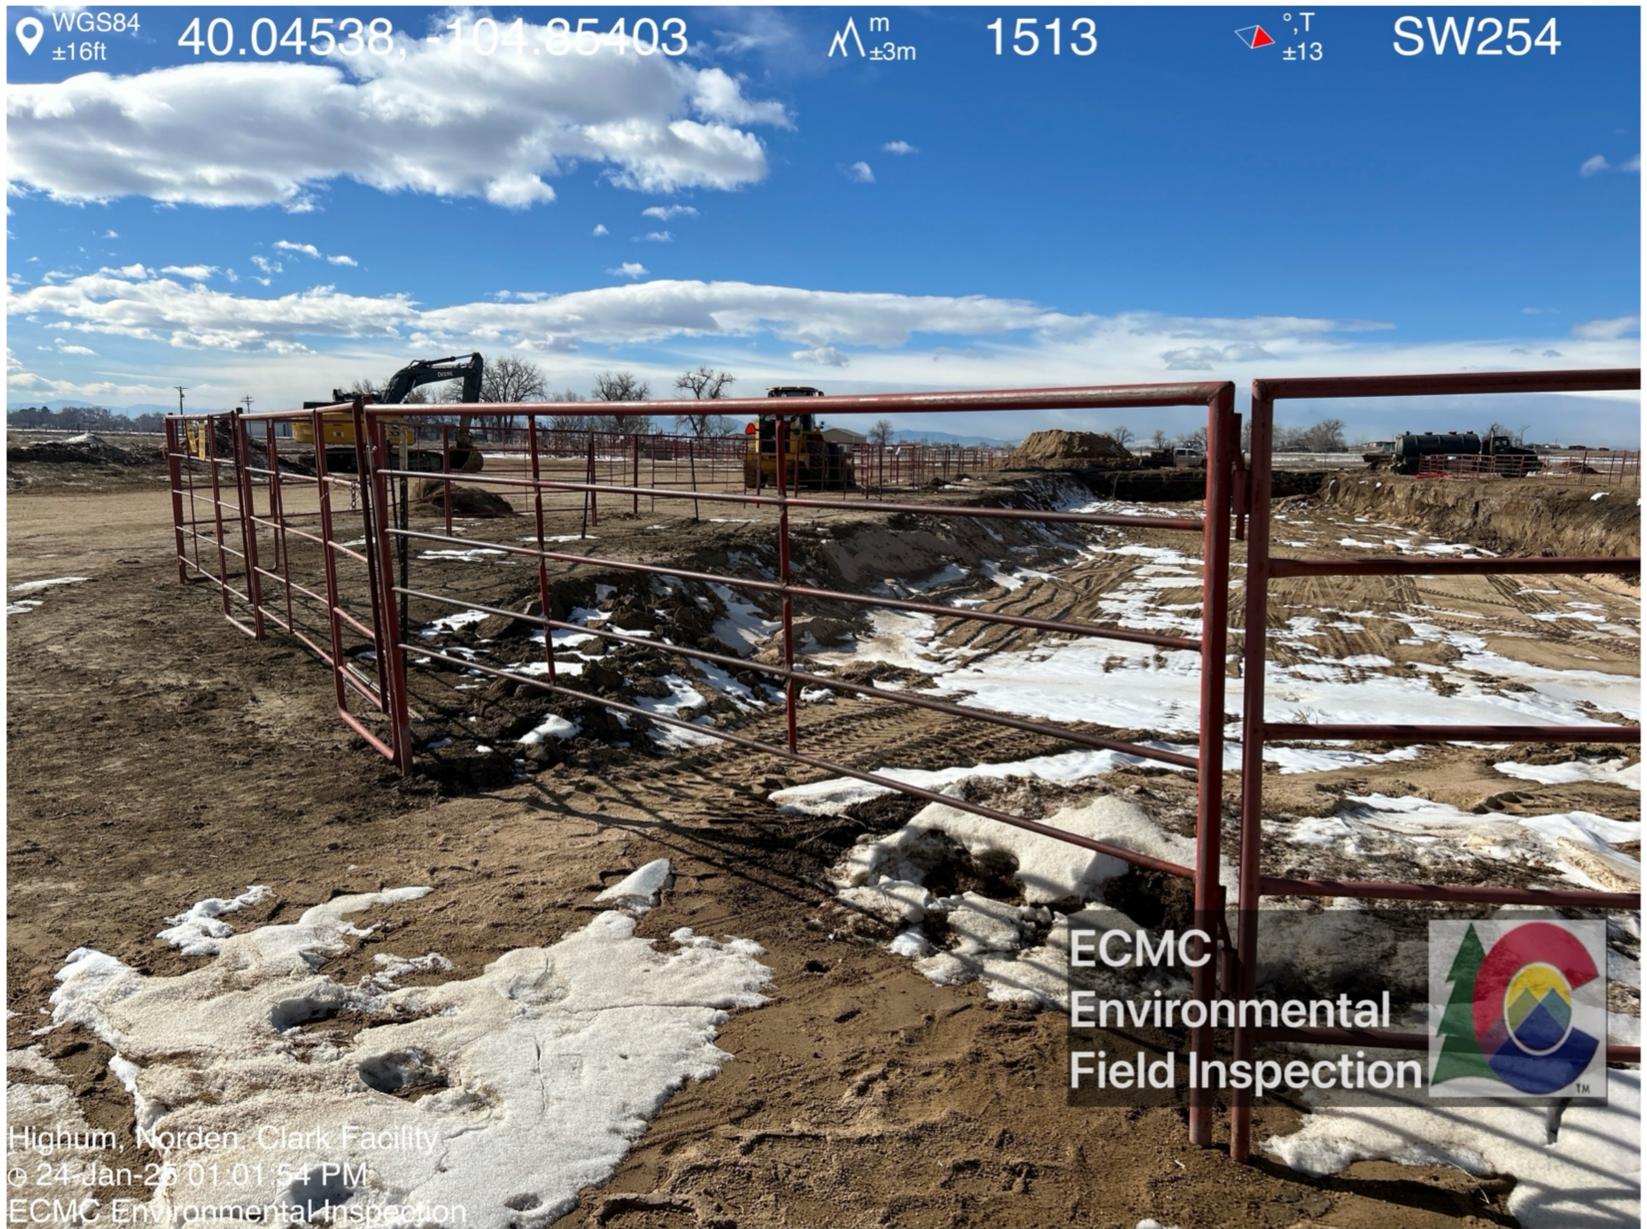
Gray staining is visible on the excavation sidewalls in-situ.

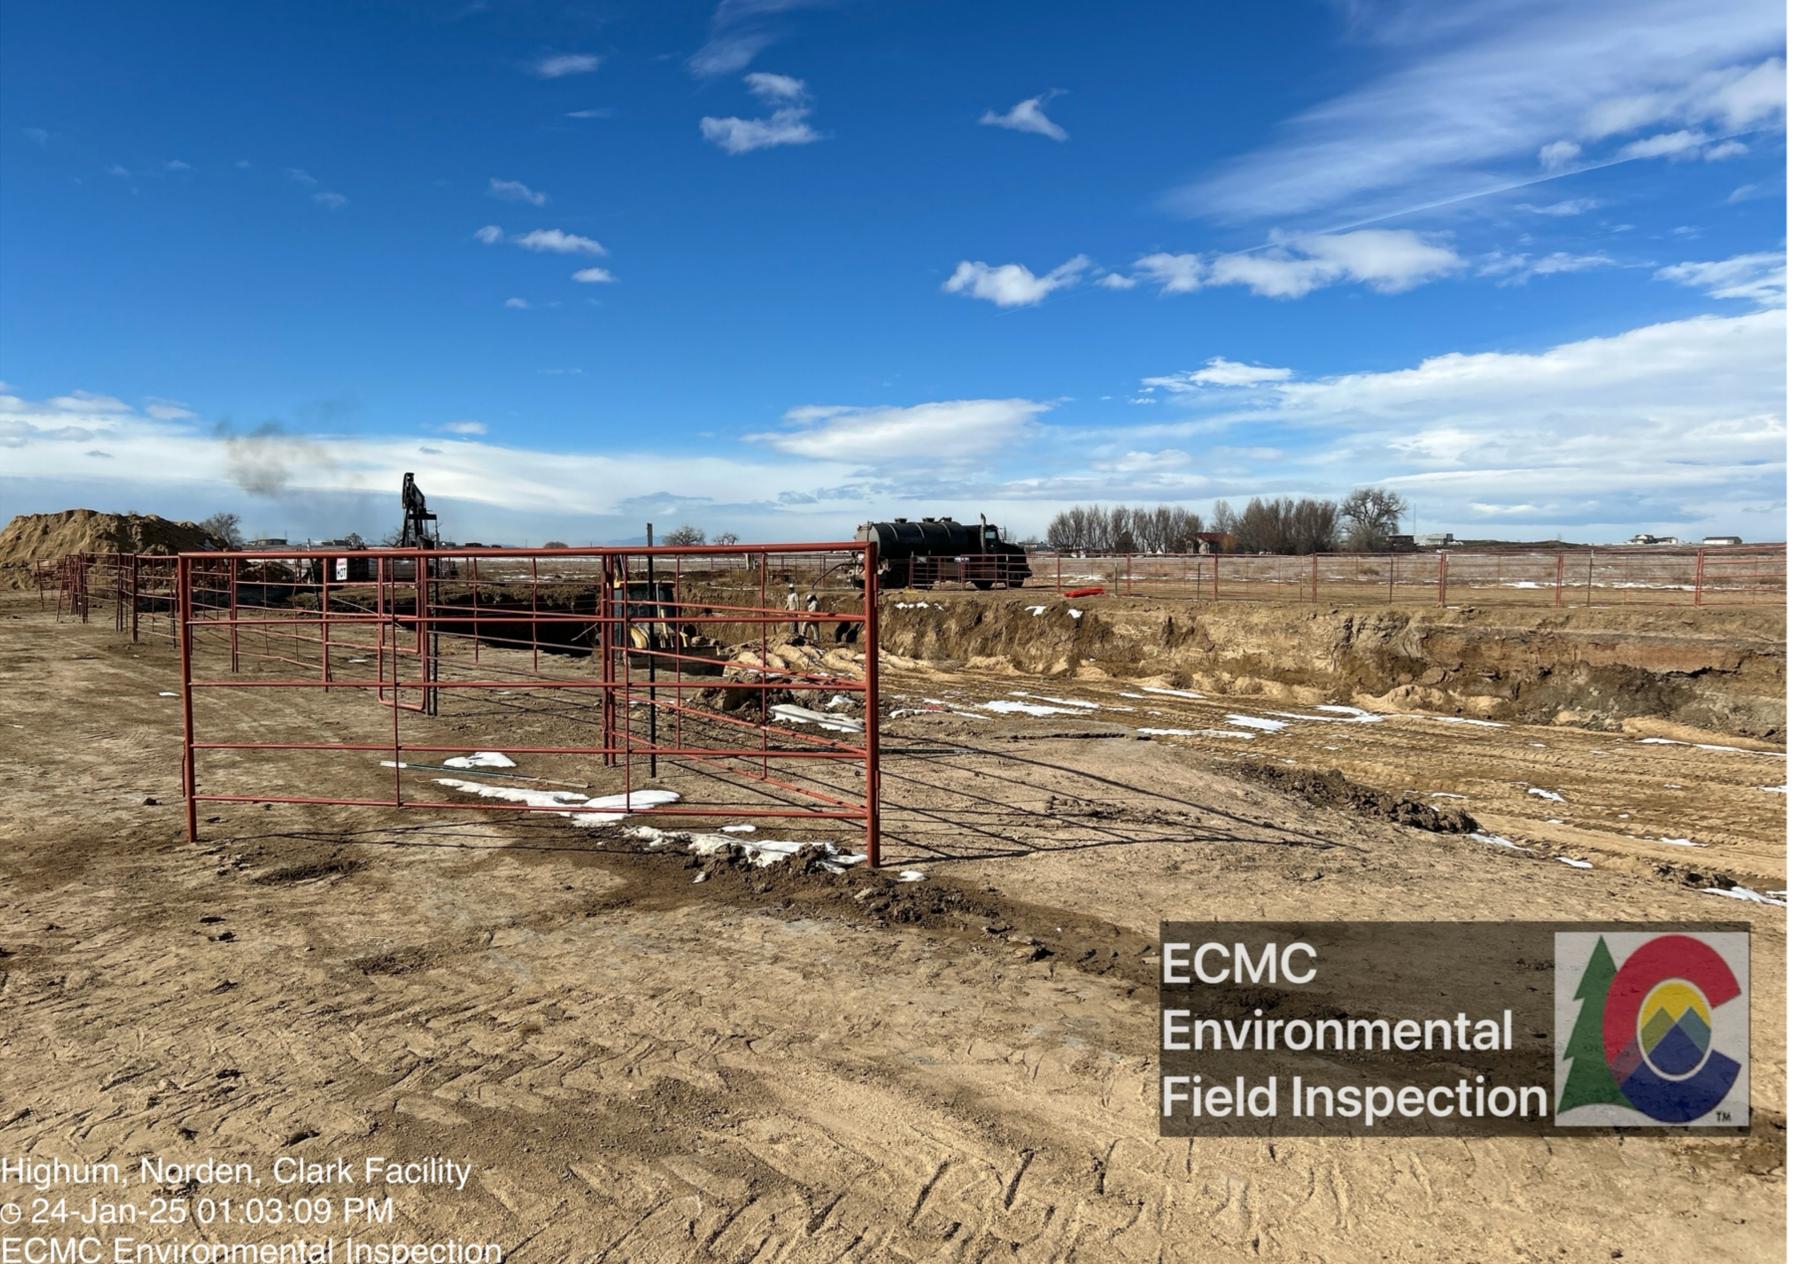
The western portion of the excavation was deepened in the area of recent Spill ID 489119 and will be addressed on a separate inspection.

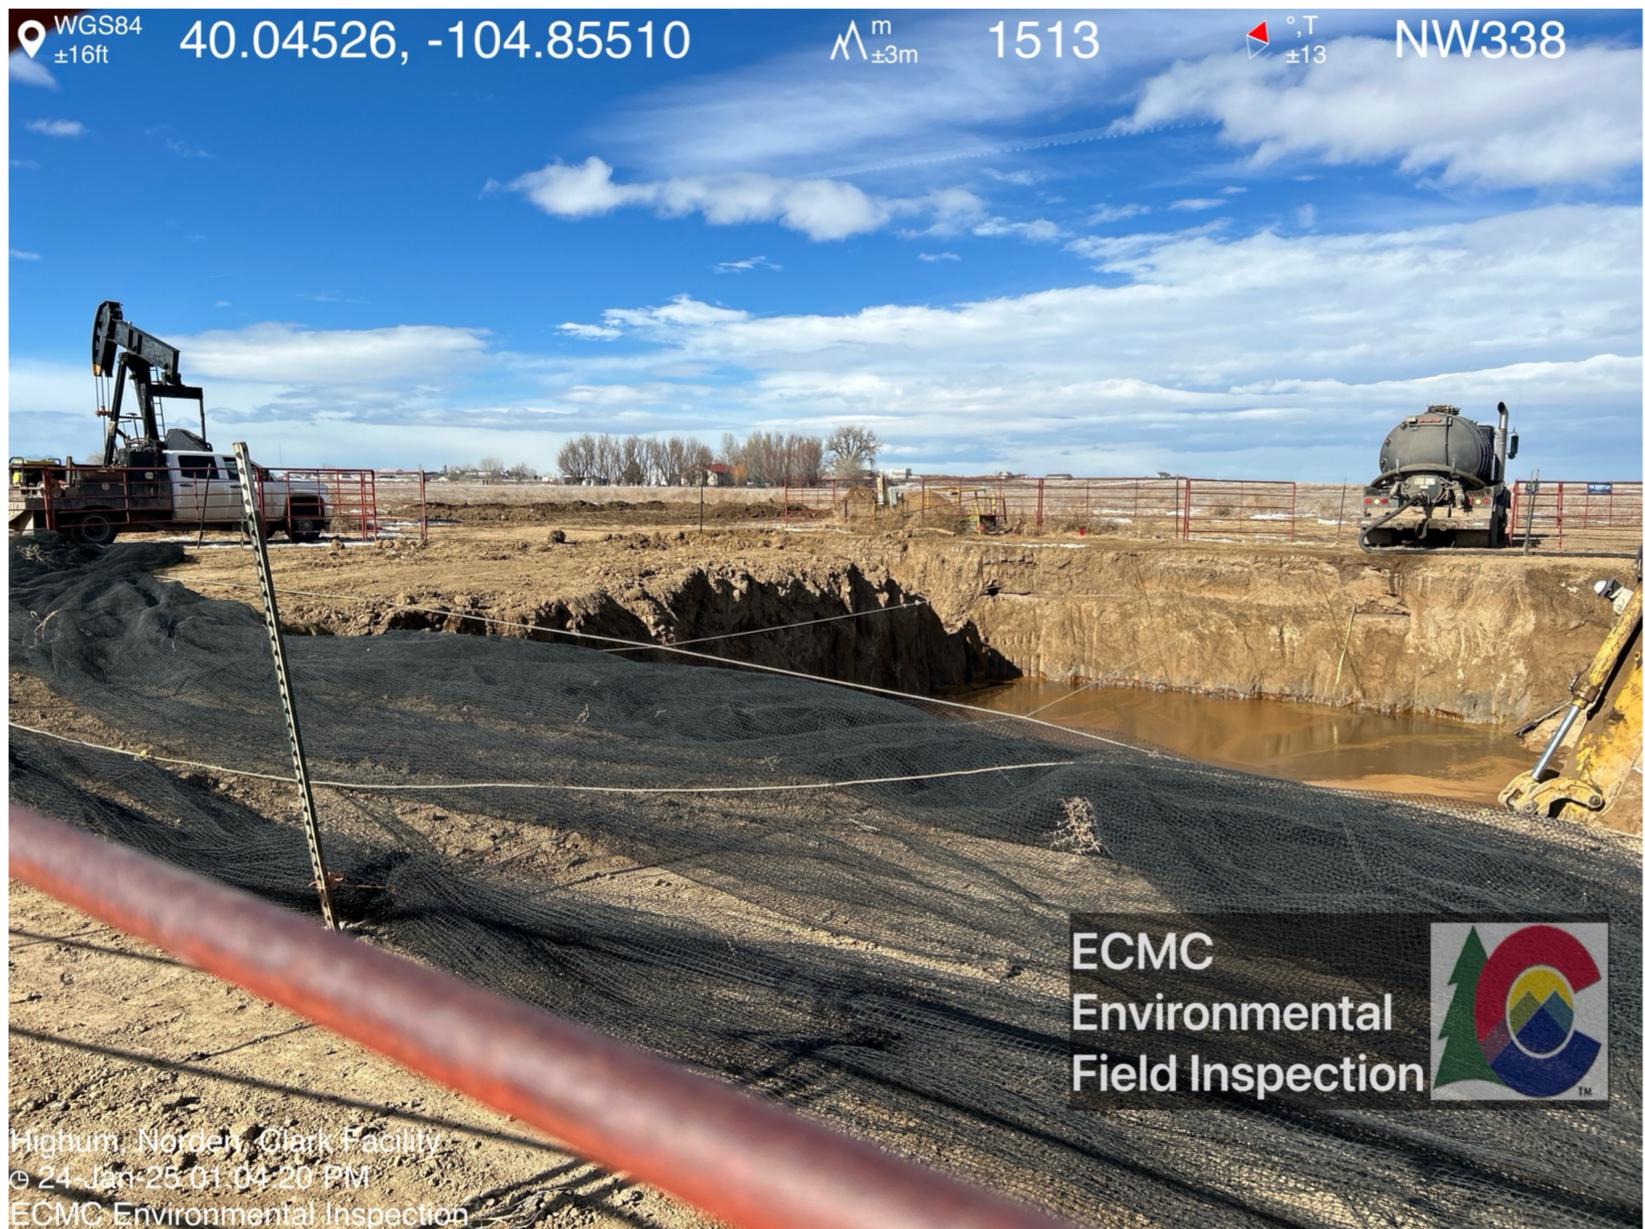
An unmarked stockpile was visible west of the spill location; BMPs are adequate.
