Inspection Photos

API: 017-06622

Operator: **WILLIFORD ENERGY COMPANY**

Inspection Date: 1/28/2025

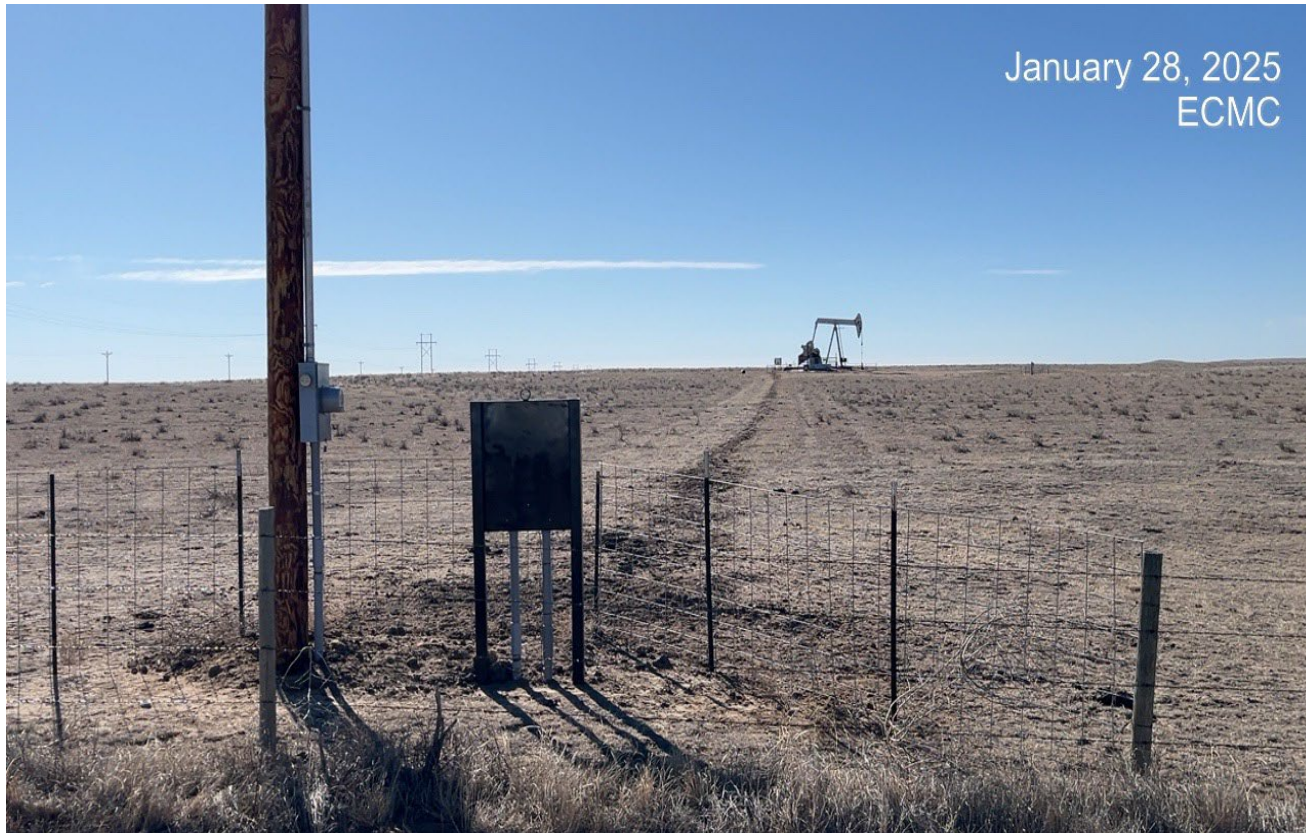
Photo 1. The cattleguard at the beginning of the access road has been cleaned out and the material was removed.

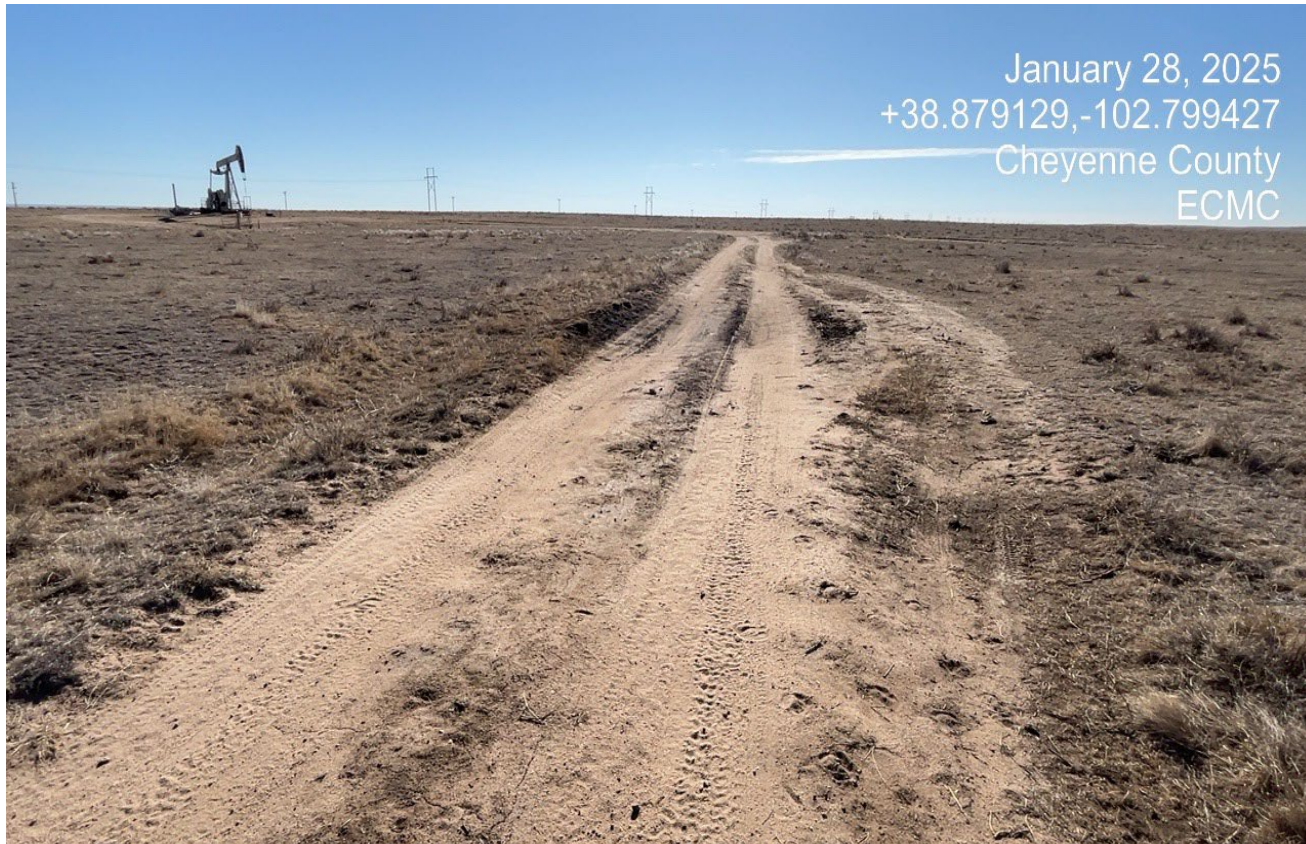
Photo 2. Facing southeast along the access road. Vehicles are causing unnecessary disturbance driving outside of the access road due to stormwater pooling on the road. The access road must be maintained and shall not drive outside of the access road boundary.

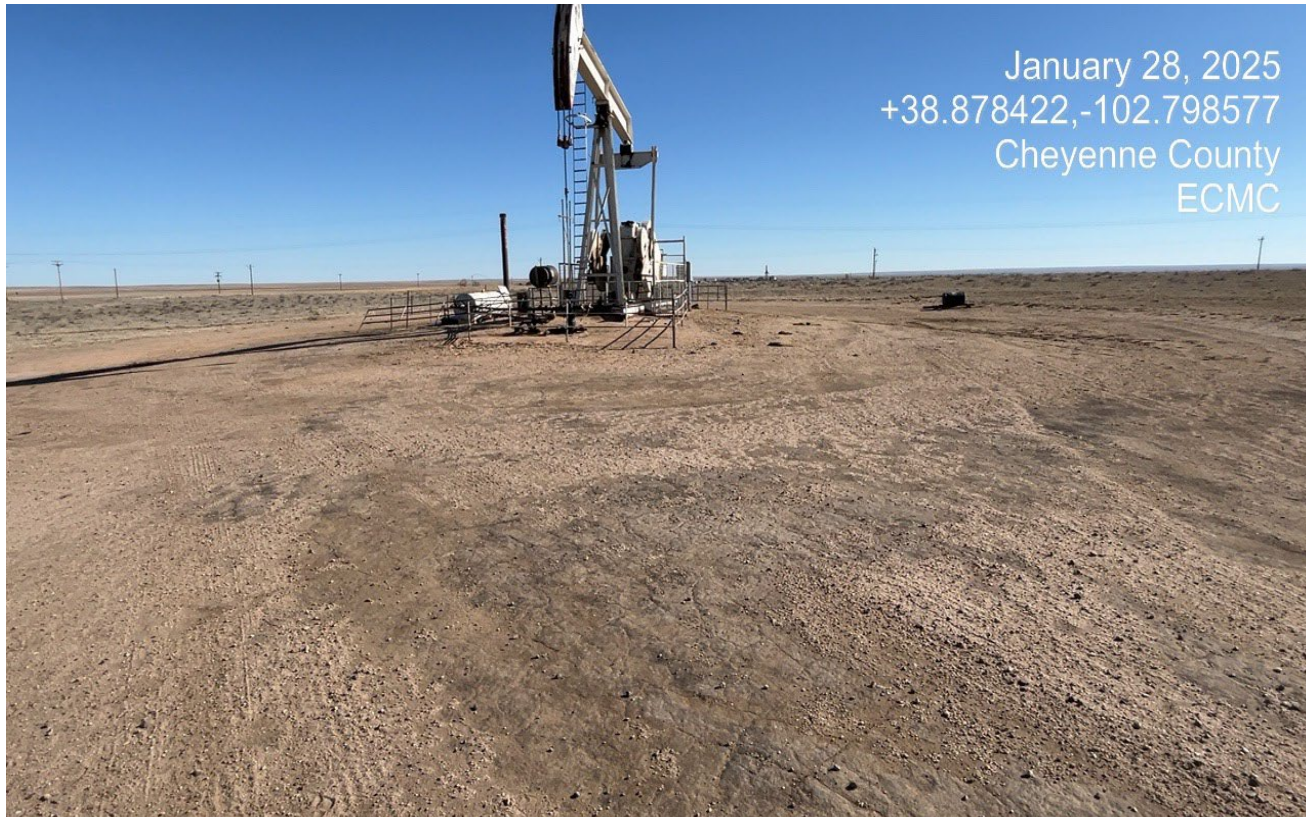
Photo 4. Facing east toward the wellsite.

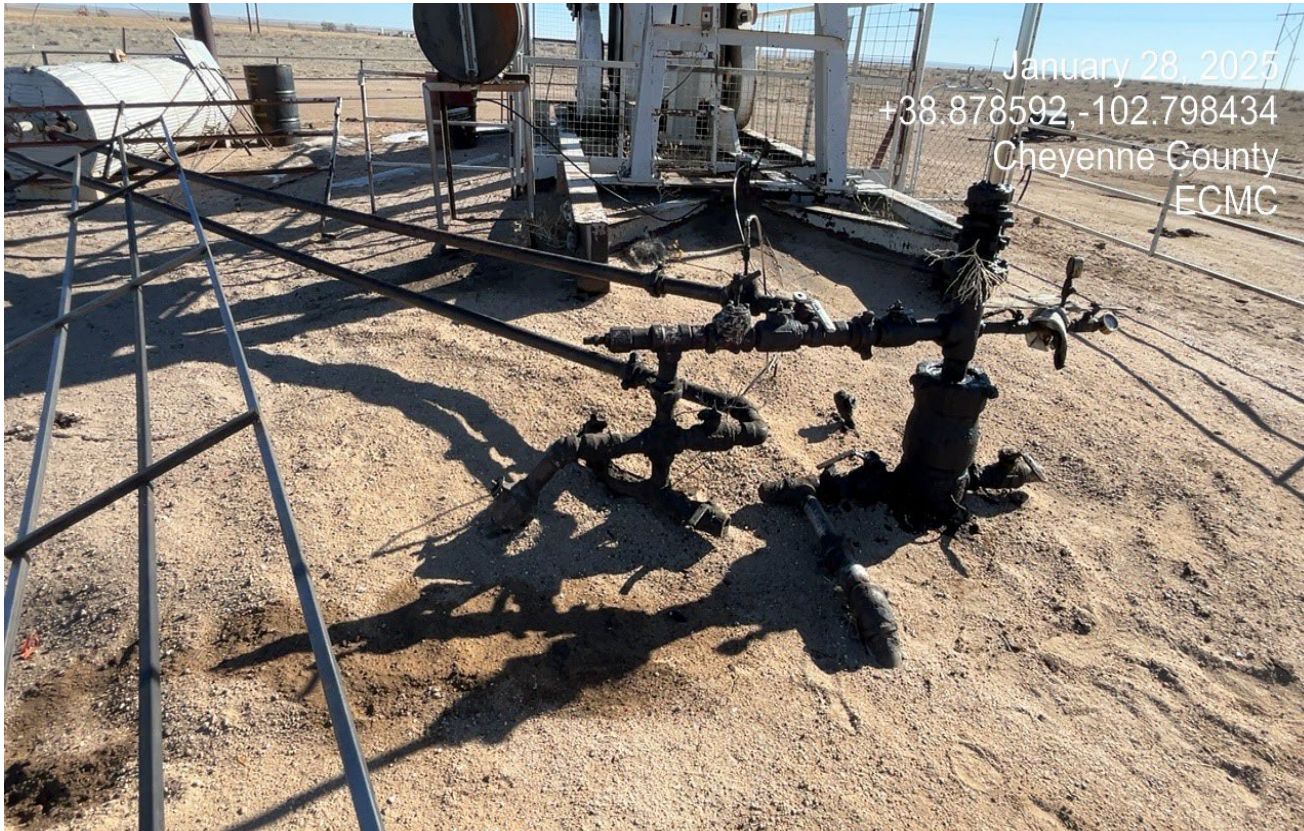
Photo 5. There is still stained soils around the wellhead from a E&P waste spill. It appears there was sand spread on top of the spill which was not cleaned up per the rules. Previous corrective action was not completed.

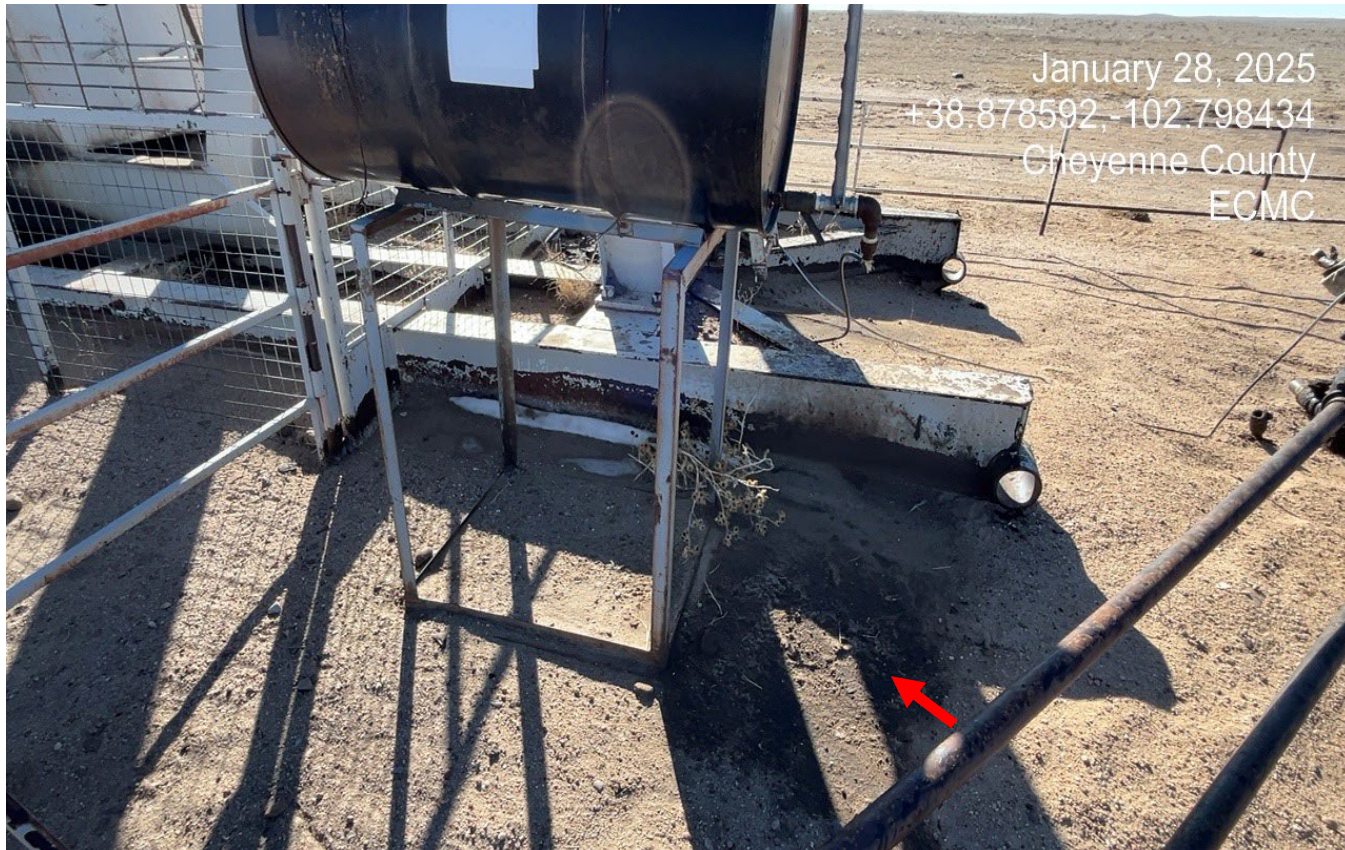
Photo 6. This chemical drum has no secondary containment and has been leaking fluids onto the soils which are stained.

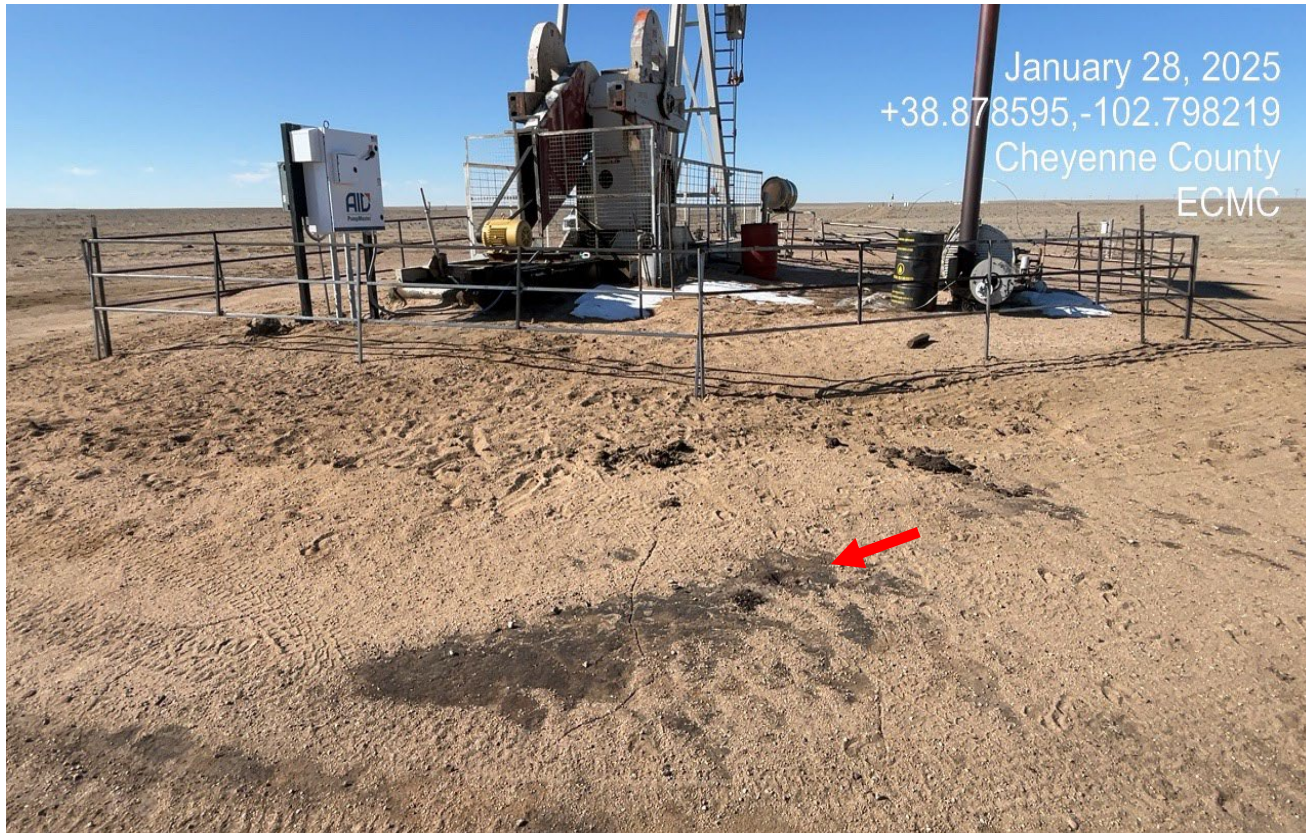
Photo 8. East side of the location facing west. There are black stained soils shown at red arrow.

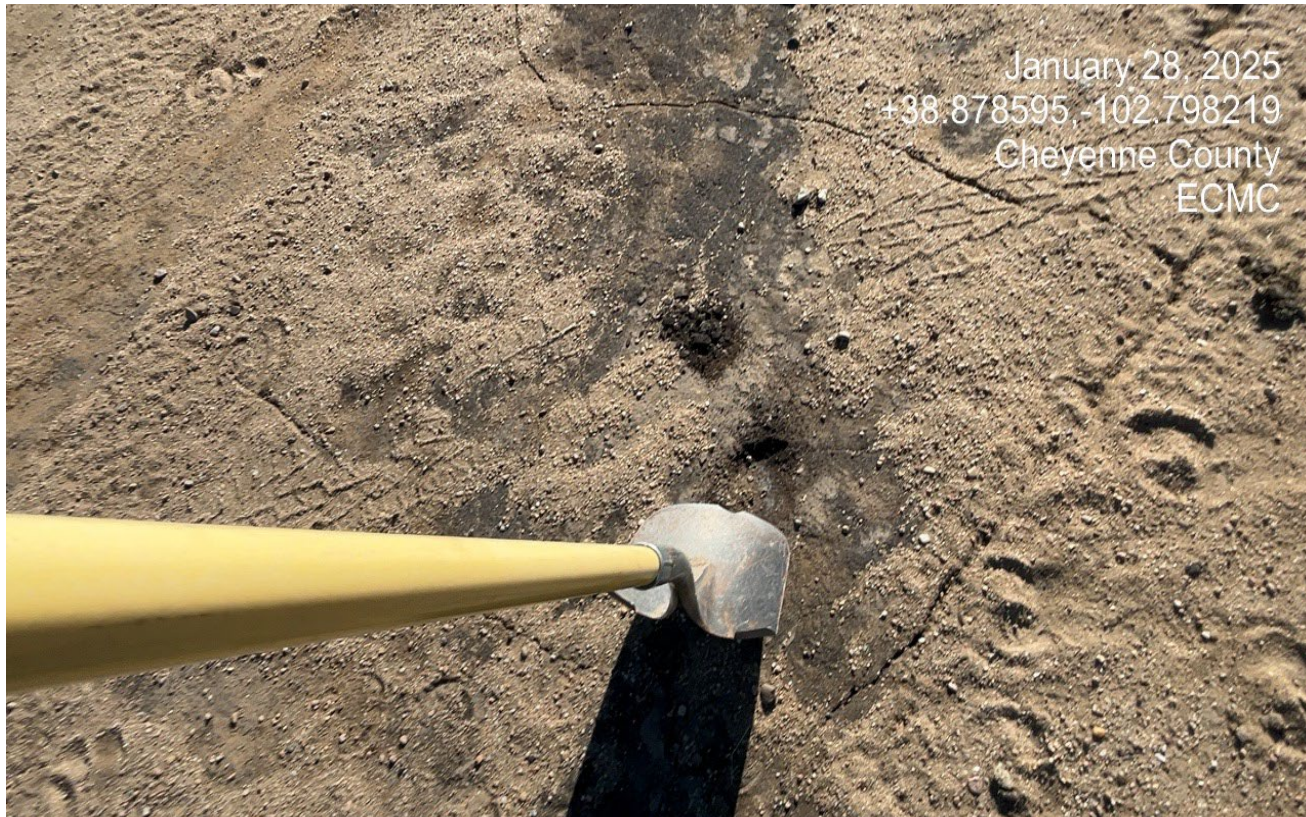
Photo 7. View of black hardened material shown at previous photo. All impacted soils must be cleaned up and removed.

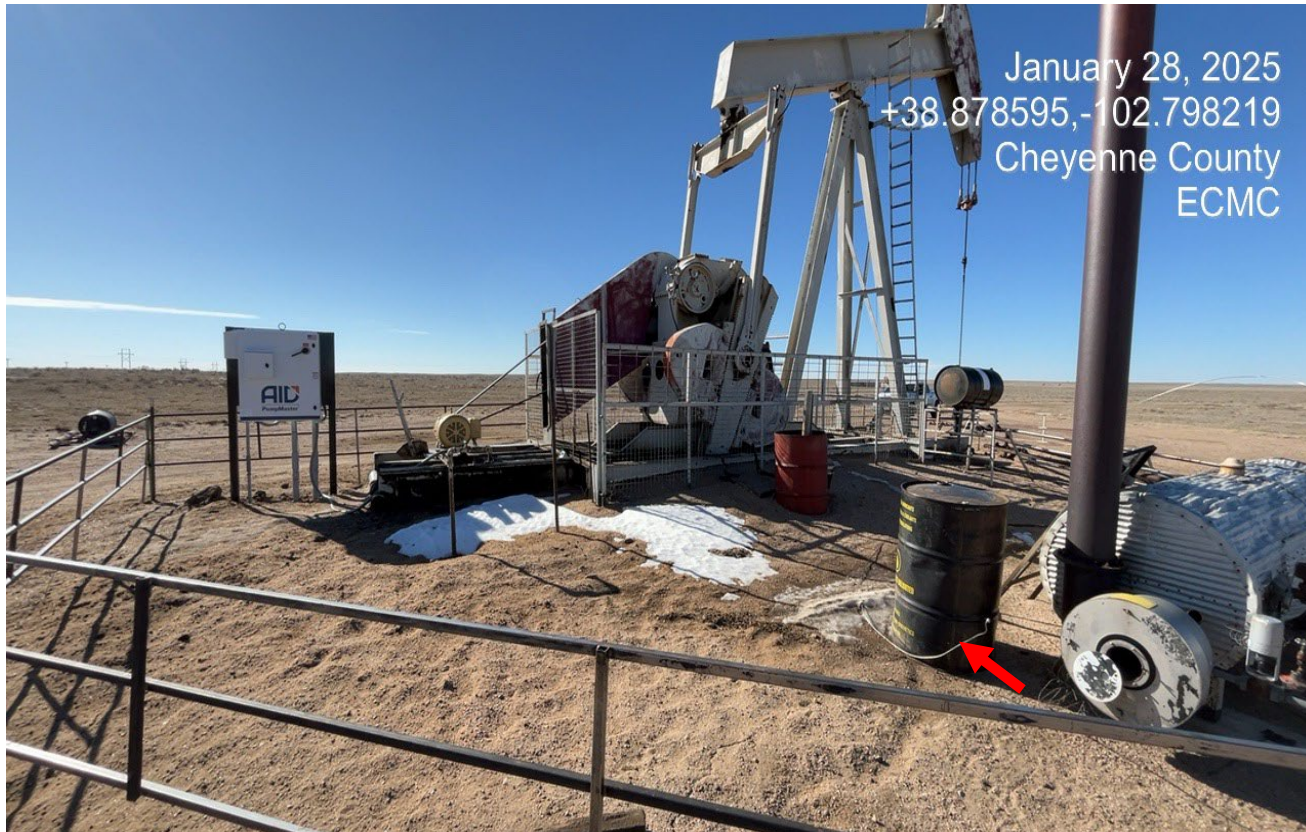
Photo 8. There are chemical barrels with no secondary containment. There is fresh sand spread around the pumpjack where oil staining was previously observed. It is unknown if stained soils were cleaned up.

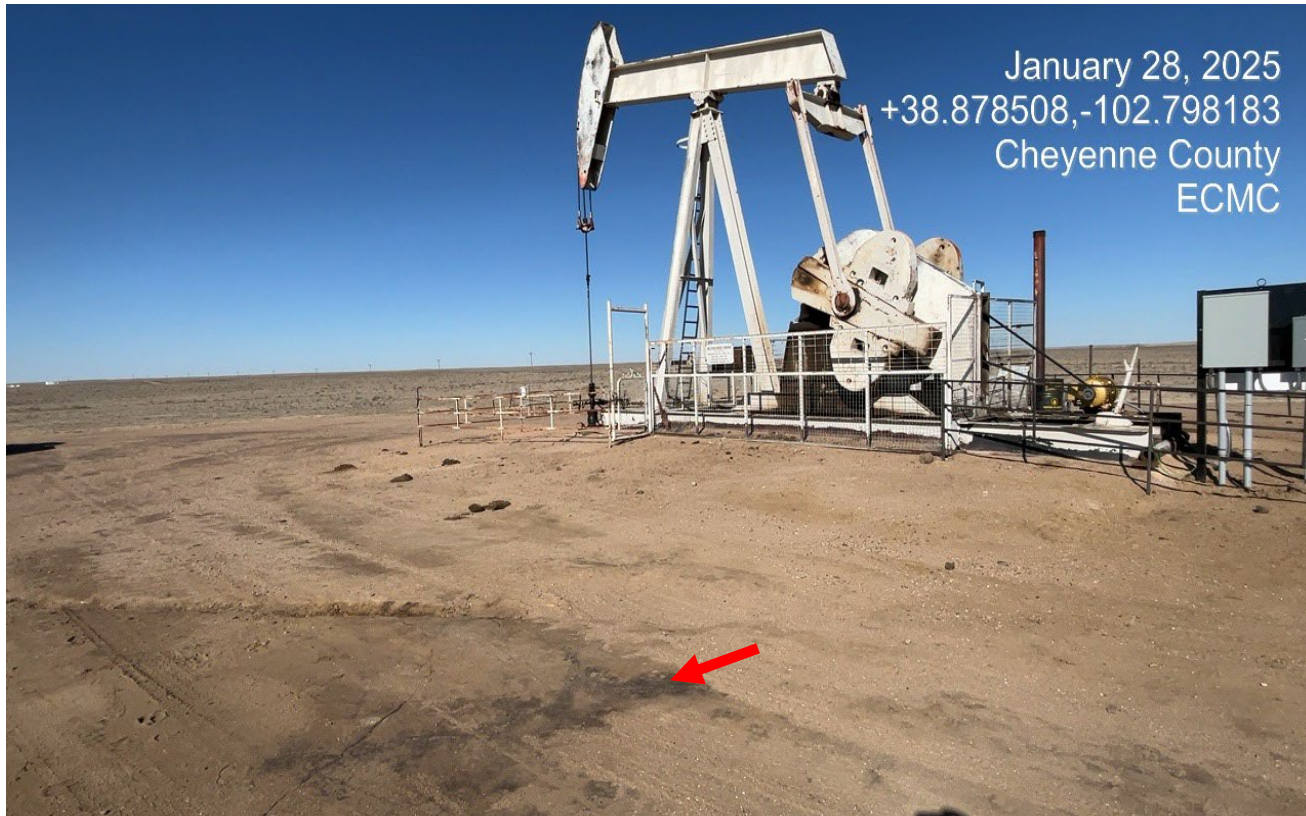
Photo 9. South side of the pumpjack facing northwest. There is black stained soil shown at red arrow.

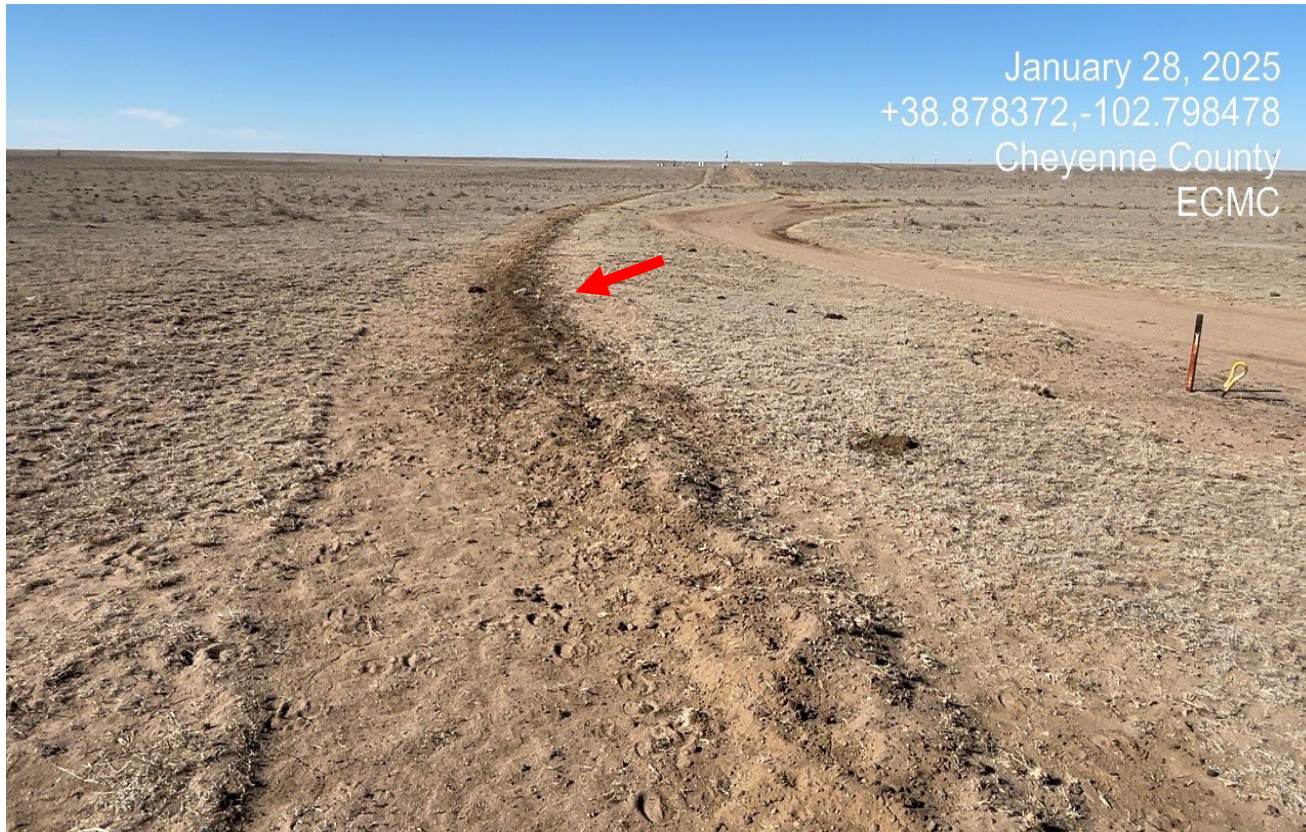
Photo 10. There has been a new electric line trenched which goes to the Rhoades Unit 5-5. The disturbed soils must be seeded and stabilized.

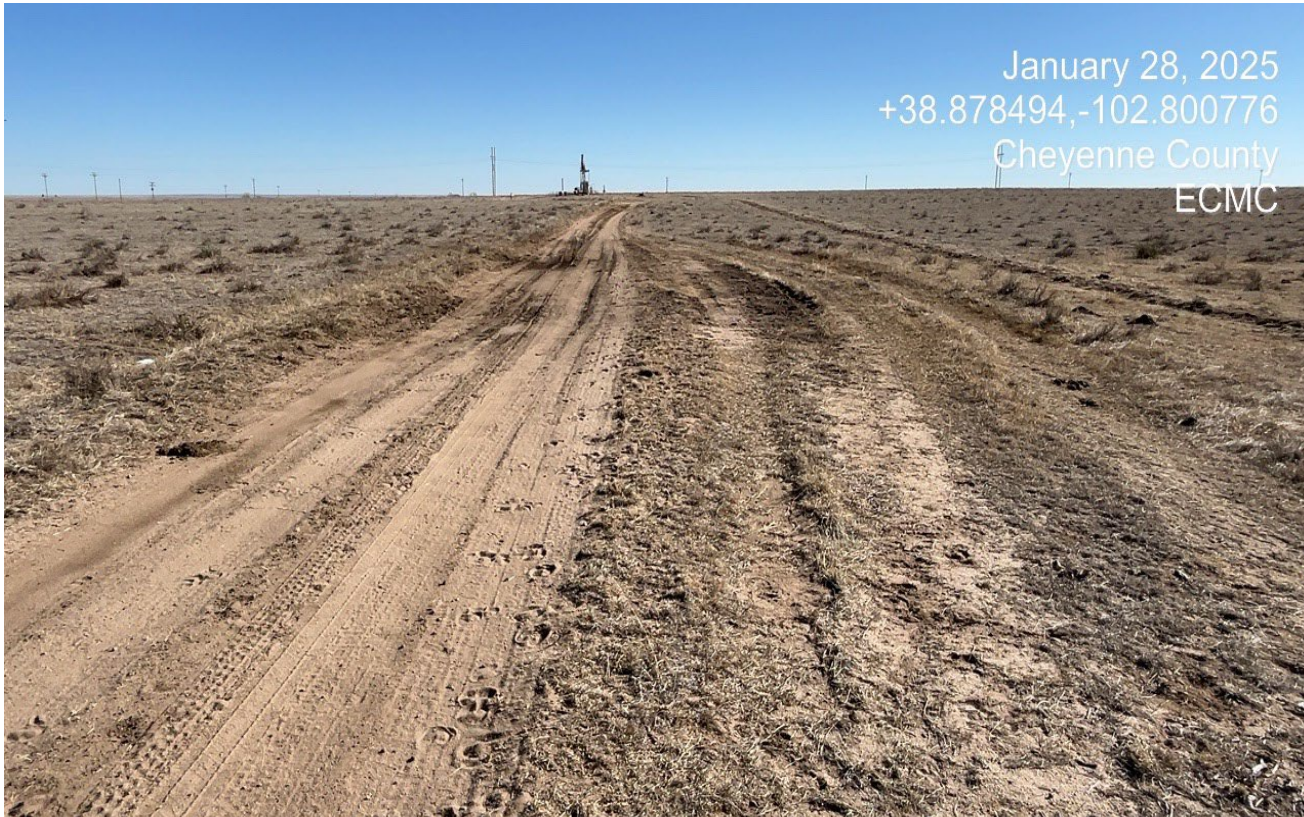
Photo 11. Facing east along the access road. Vehicles are causing unnecessary disturbance driving outside of the access road due to stormwater pooling on the road. The access road must be maintained and shall not drive outside of the access road boundary.
