Inspection Photos

API: 017-06632

Operator: **WILLIFORD ENERGY COMPANY**

Inspection Date: 1/28/2025

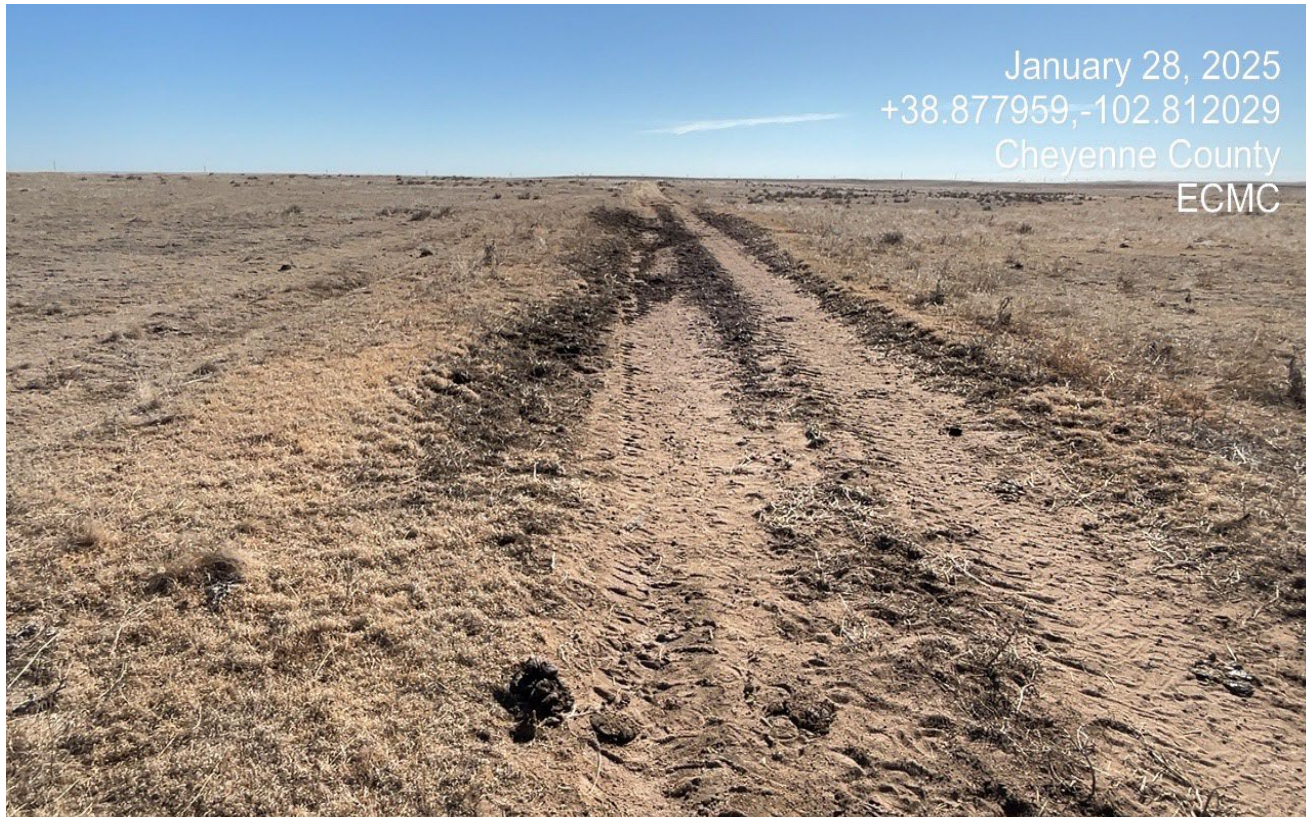
Photo 1. Facing southeast toward the access road. The access road is eroded and will need to be regraded to match the surrounding contours which may require imported topsoil.

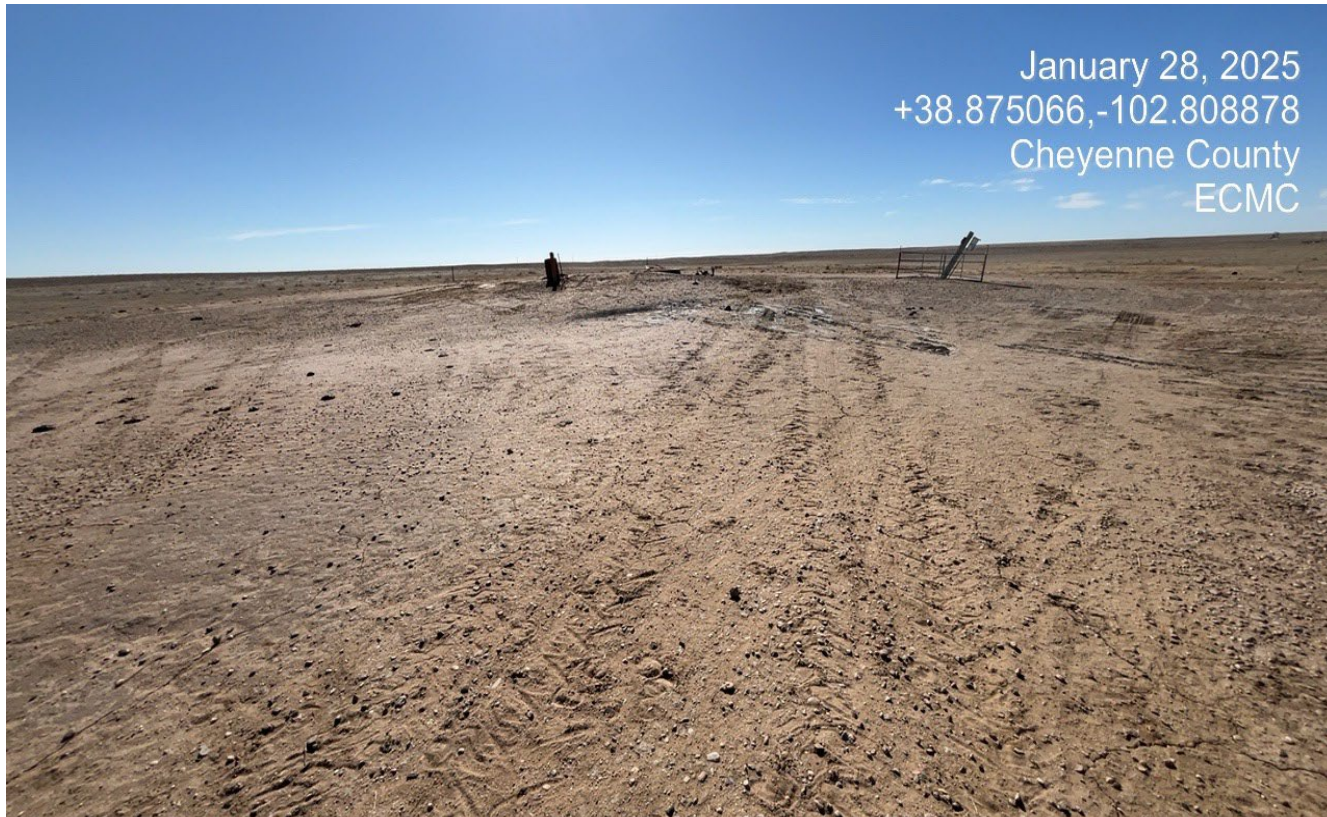
Photo 2. Facing southeast toward the location. It appears the well was recently plugged and abandoned.

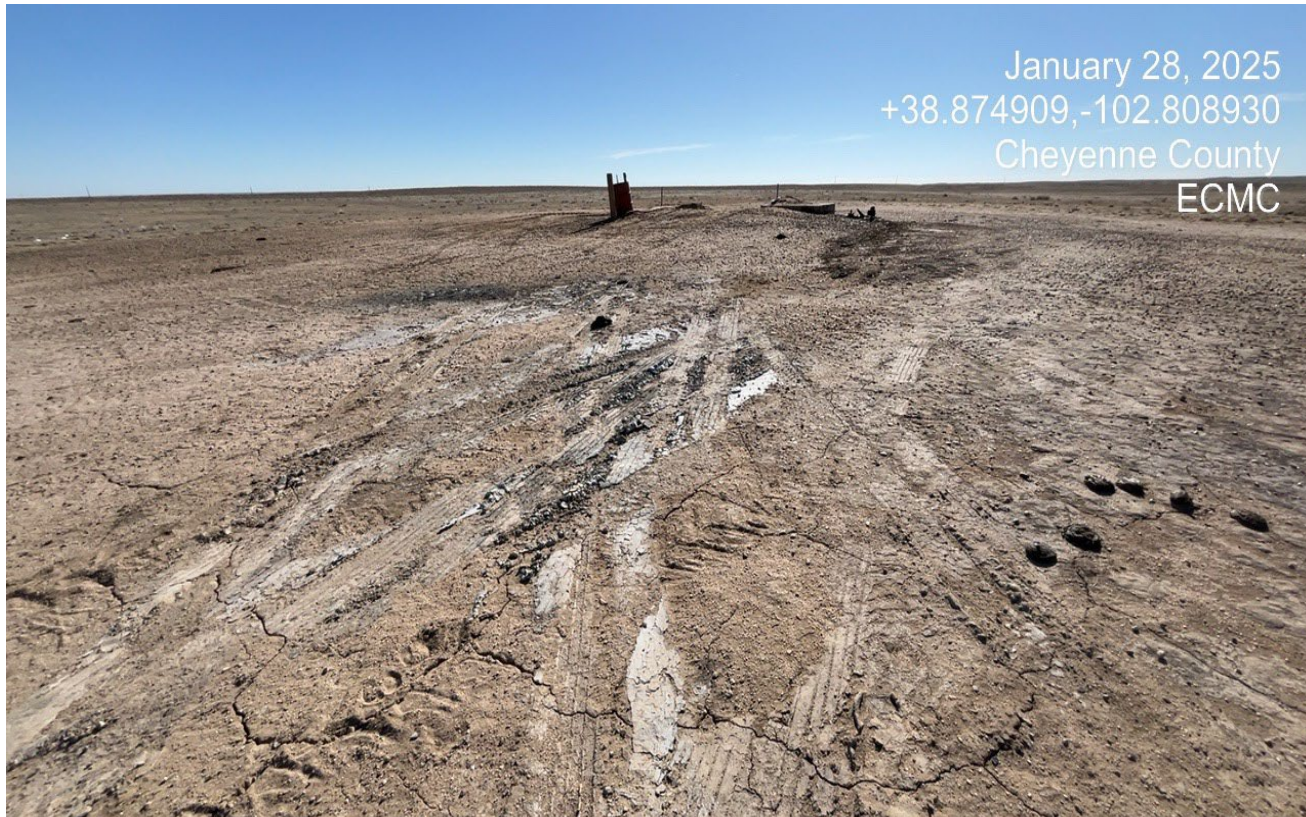
Photo 3. There is stained soils and cement spilled on location that will need to be cleaned up.

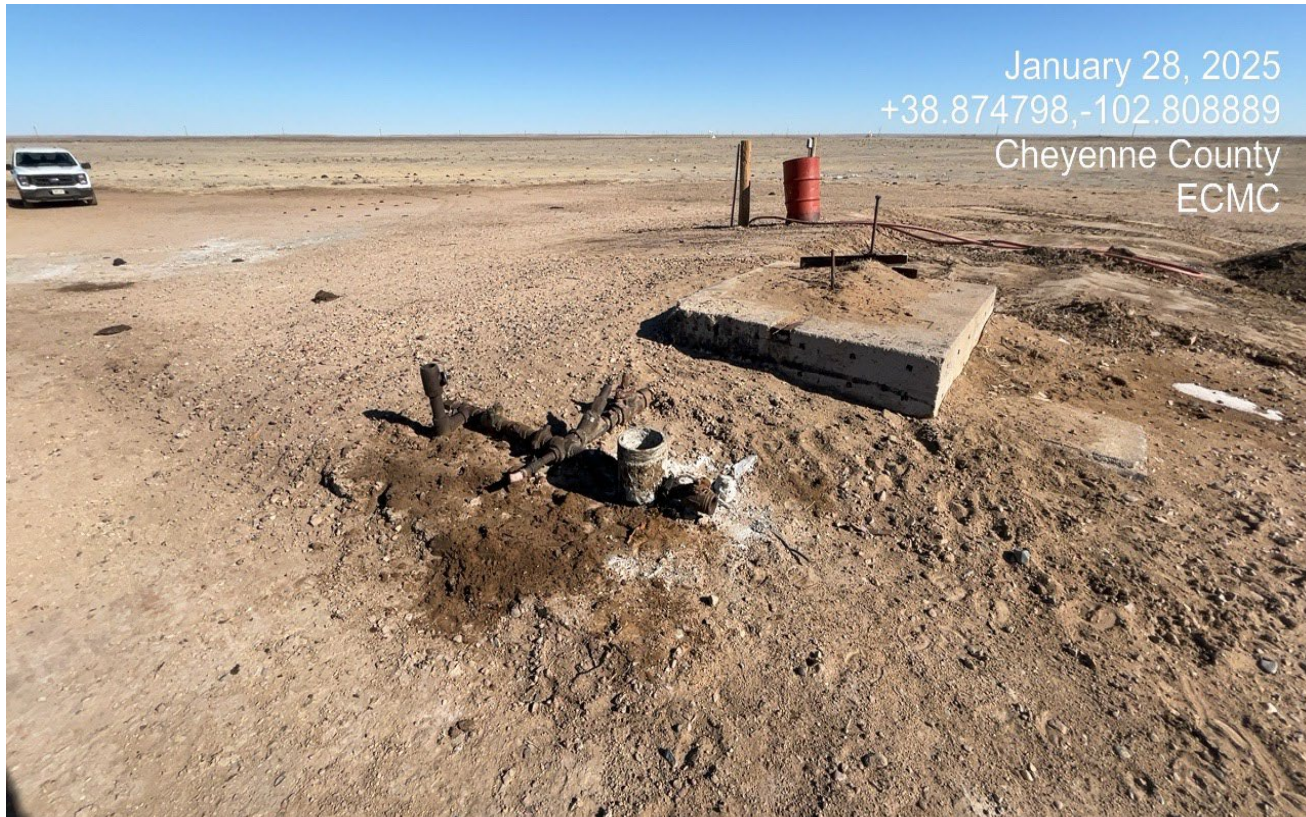
Photo 4. Facing toward the wellhead. There are stained soil at the wellhead. This area will need to be sampled and remediated for decommissioning of the well.

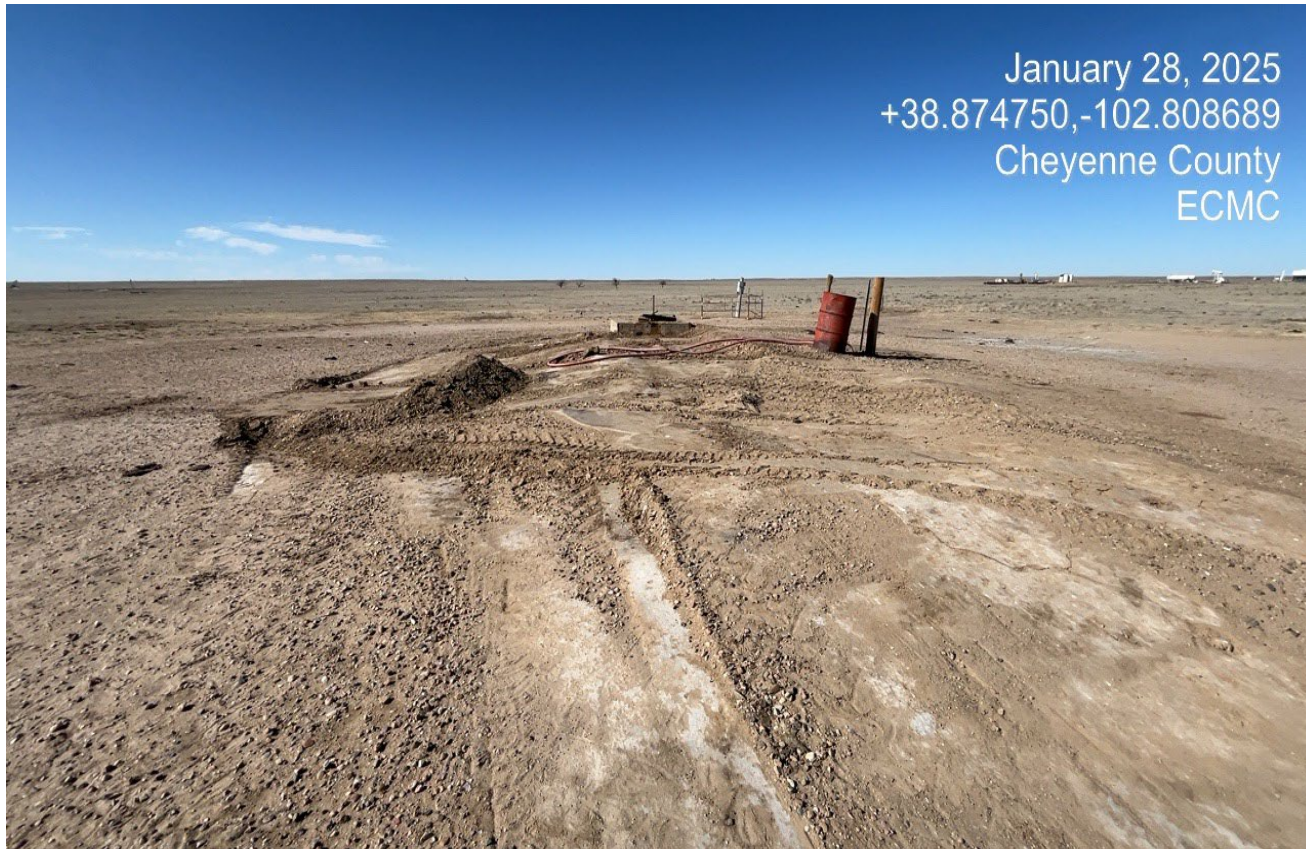
Photo 5. Facing west toward the area where the pumpjack was located. All equipment, risers, and debris must be removed within 3 months of abandonment.

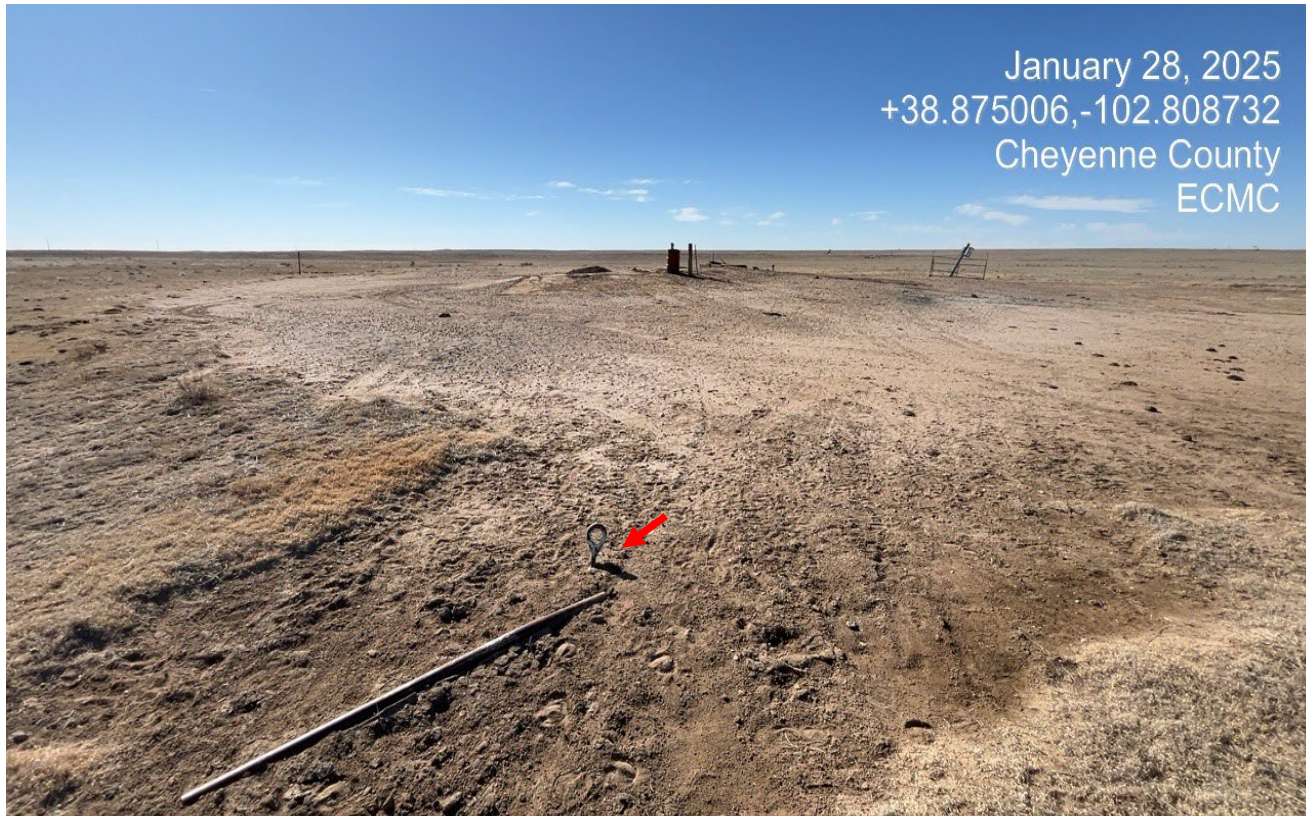
Photo 6 . There are 4 guyline anchors that remain at the location that must be removed within 3 months of abandonment

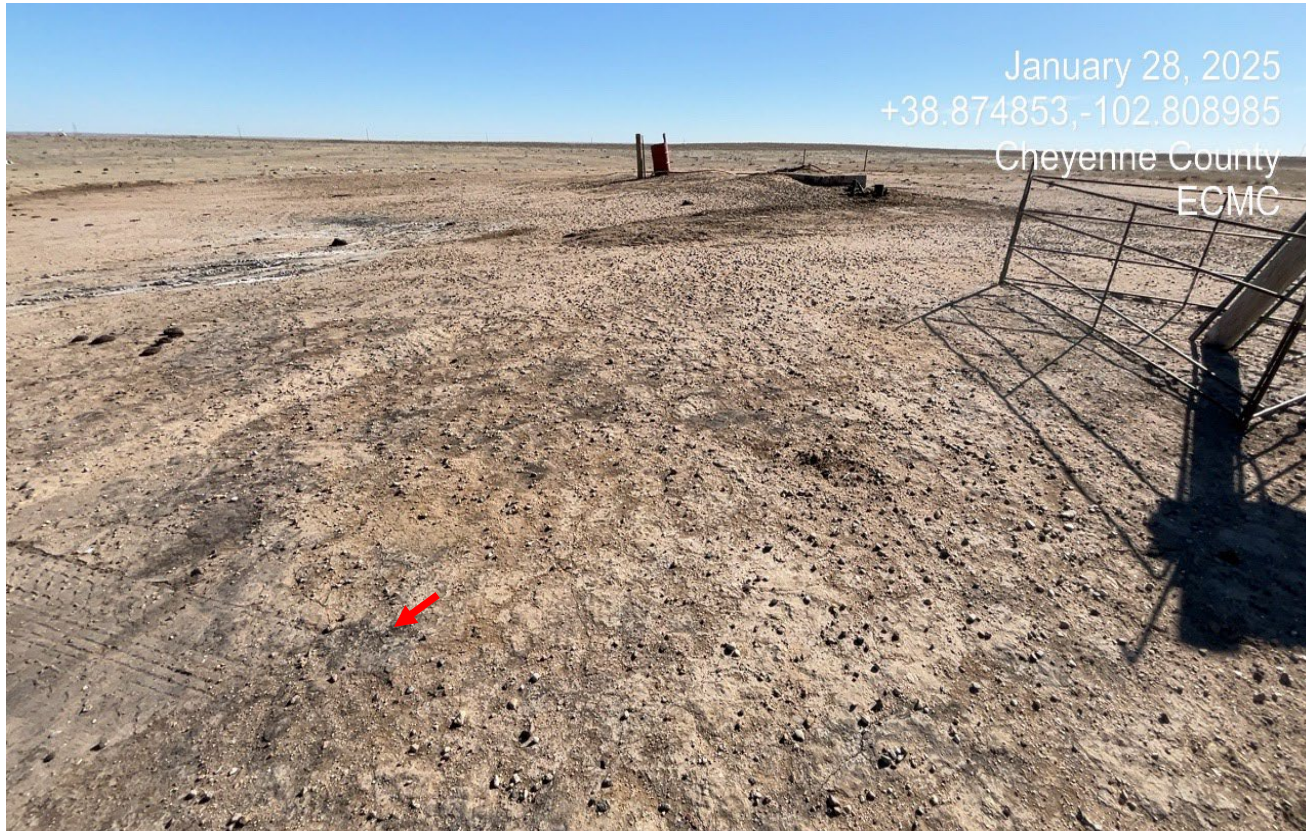
Photo 7. Facing southeast at the location. There are blacked and compacted soils throughout the location which maybe impacts from historic spills.

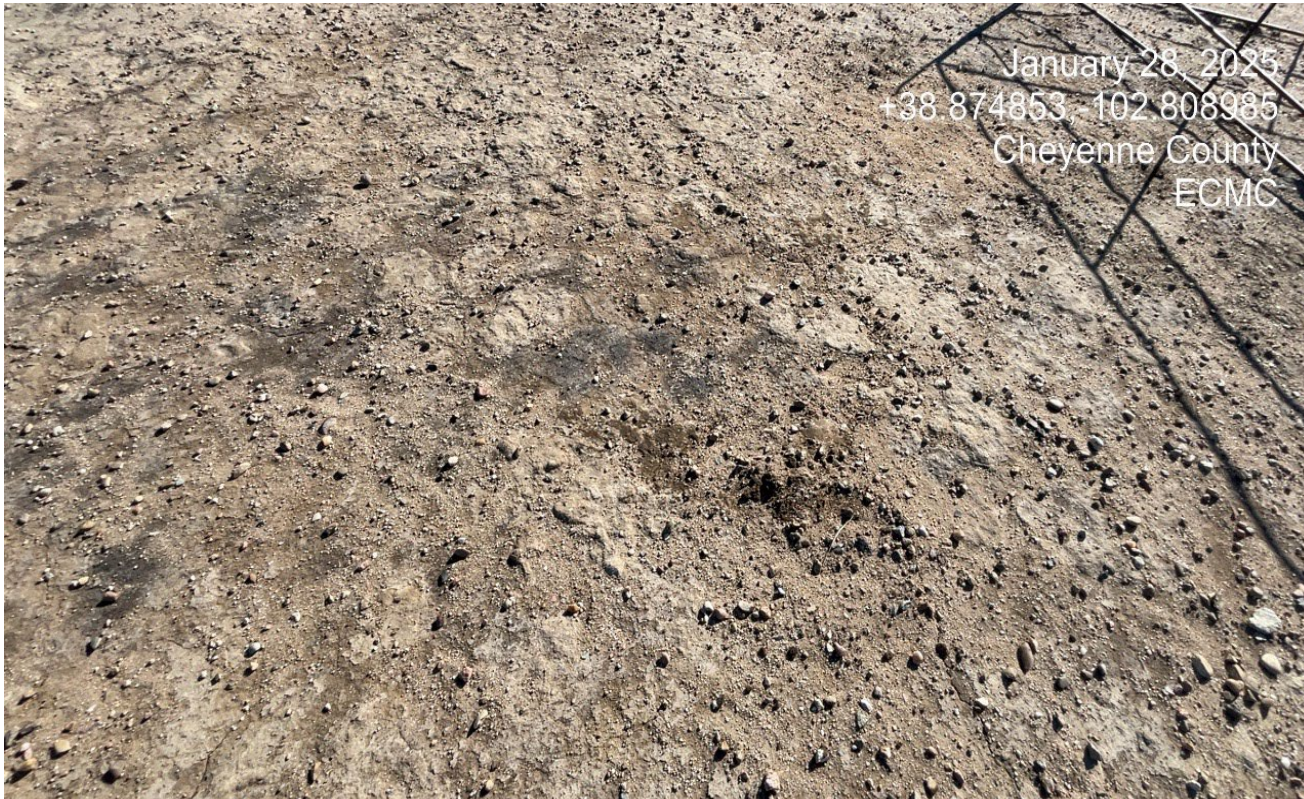
Photo 8. View of blackened hardened soil at the location. Samples will need to be taken to evaluate soil suitability for reclamation.
