Inspection Photos

API: 017-06636

Operator: **WILLIFORD ENERGY COMPANY**

Inspection Date: 1/28/2025

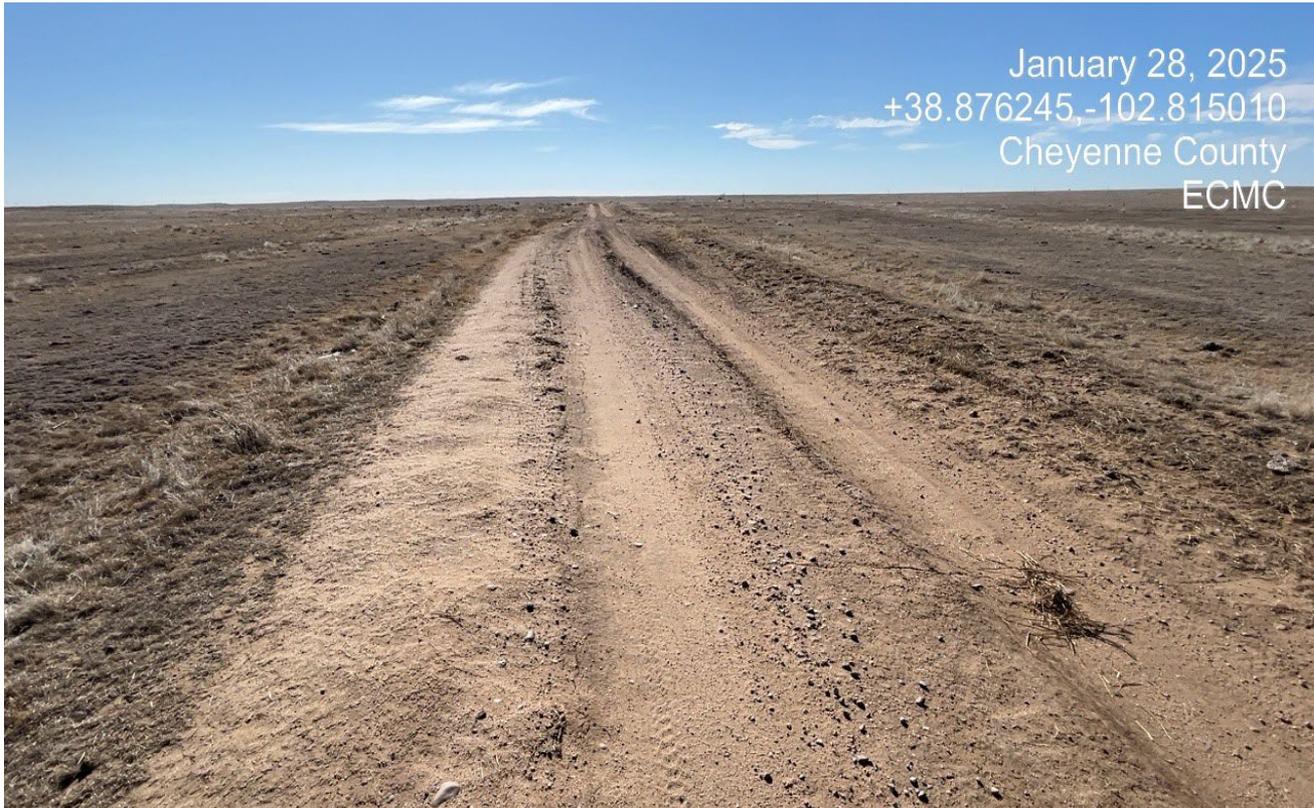
Photo 1. Facing south along the access road. Vehicles are causing unnecessary disturbance driving outside of the access road due to stormwater pooling on the road. The access road must be maintained and vehicles shall not drive outside of the access road boundary. Previous corrective action was not completed.

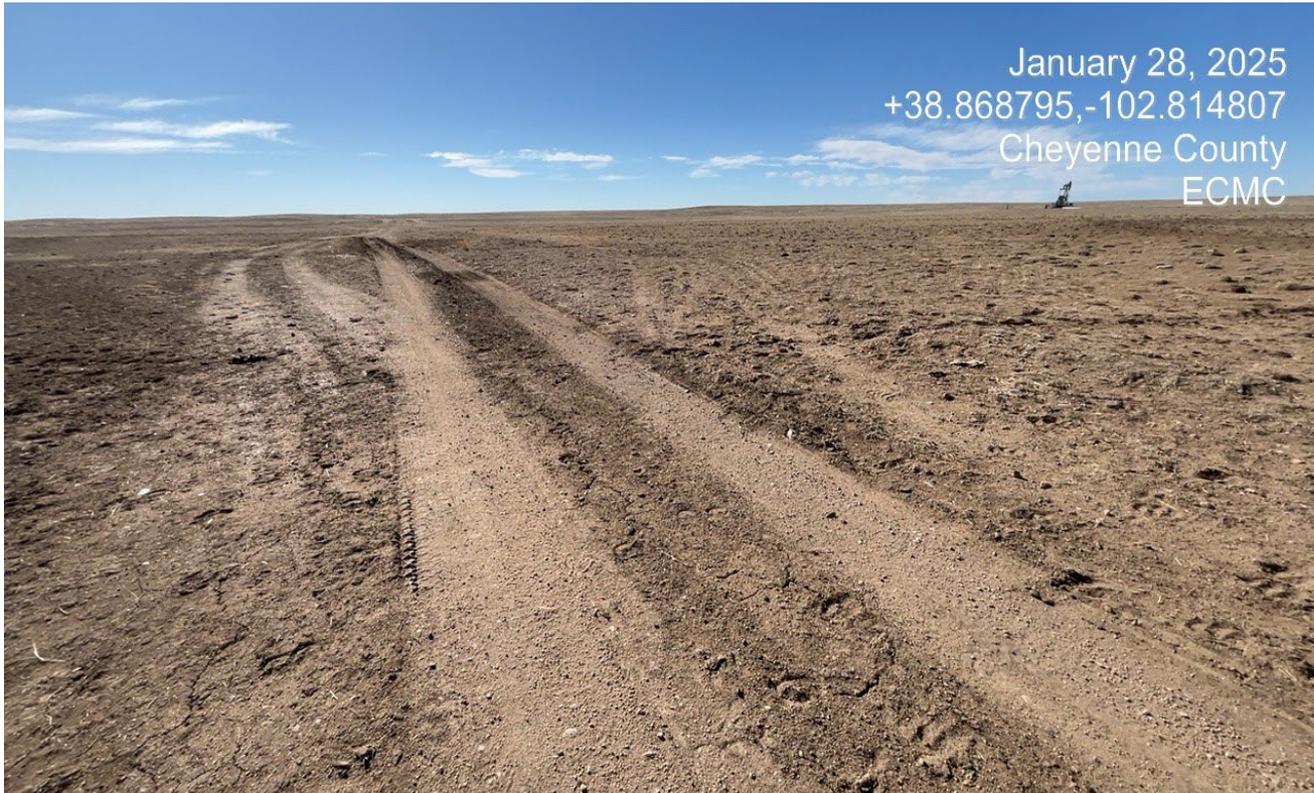
Photo 2. Facing south along the access road. Vehicles are causing unnecessary disturbance driving outside of the access road due to stormwater pooling on the road. The access road must be maintained and vehicles shall not drive outside of the access road boundary. Previous corrective action was not completed.

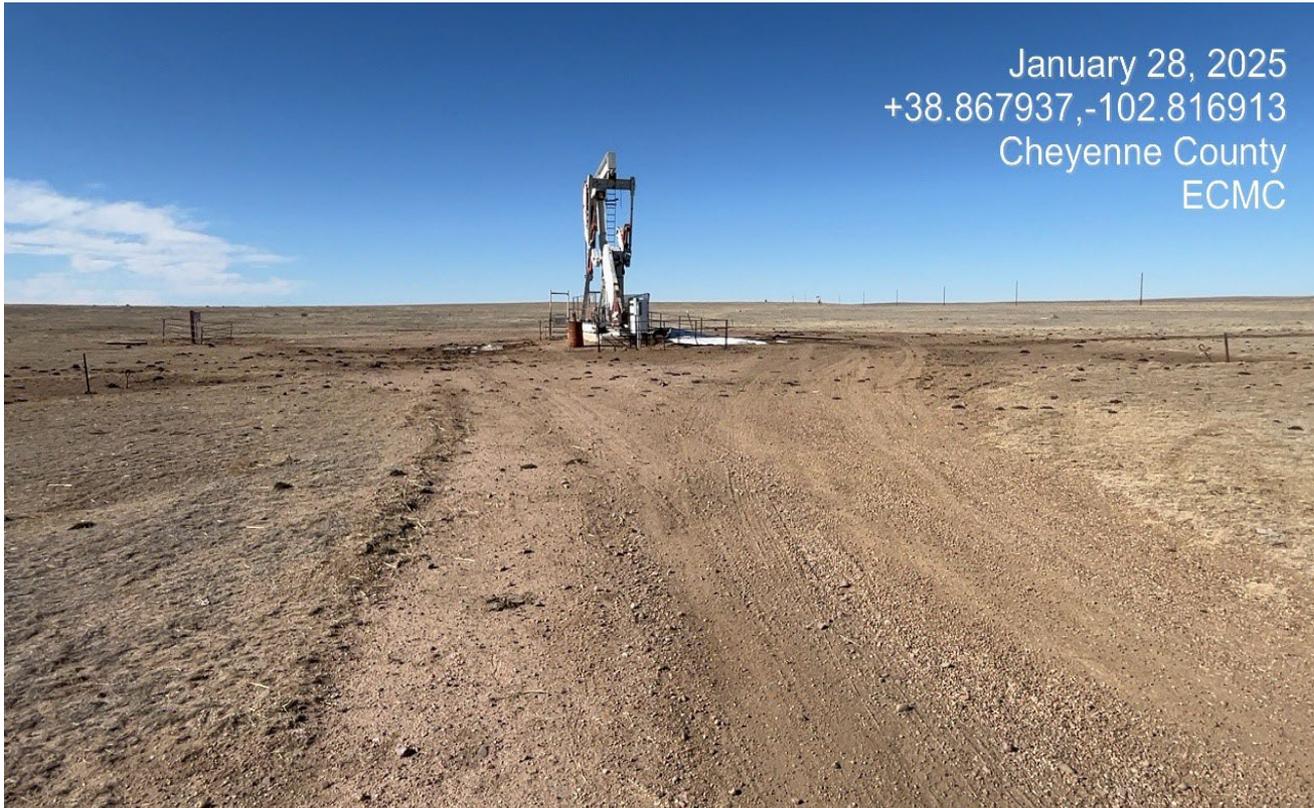
Photo 3. Facing west along the road toward the wellsite. There has been gravel spread along the area where erosion channel was previously observed.

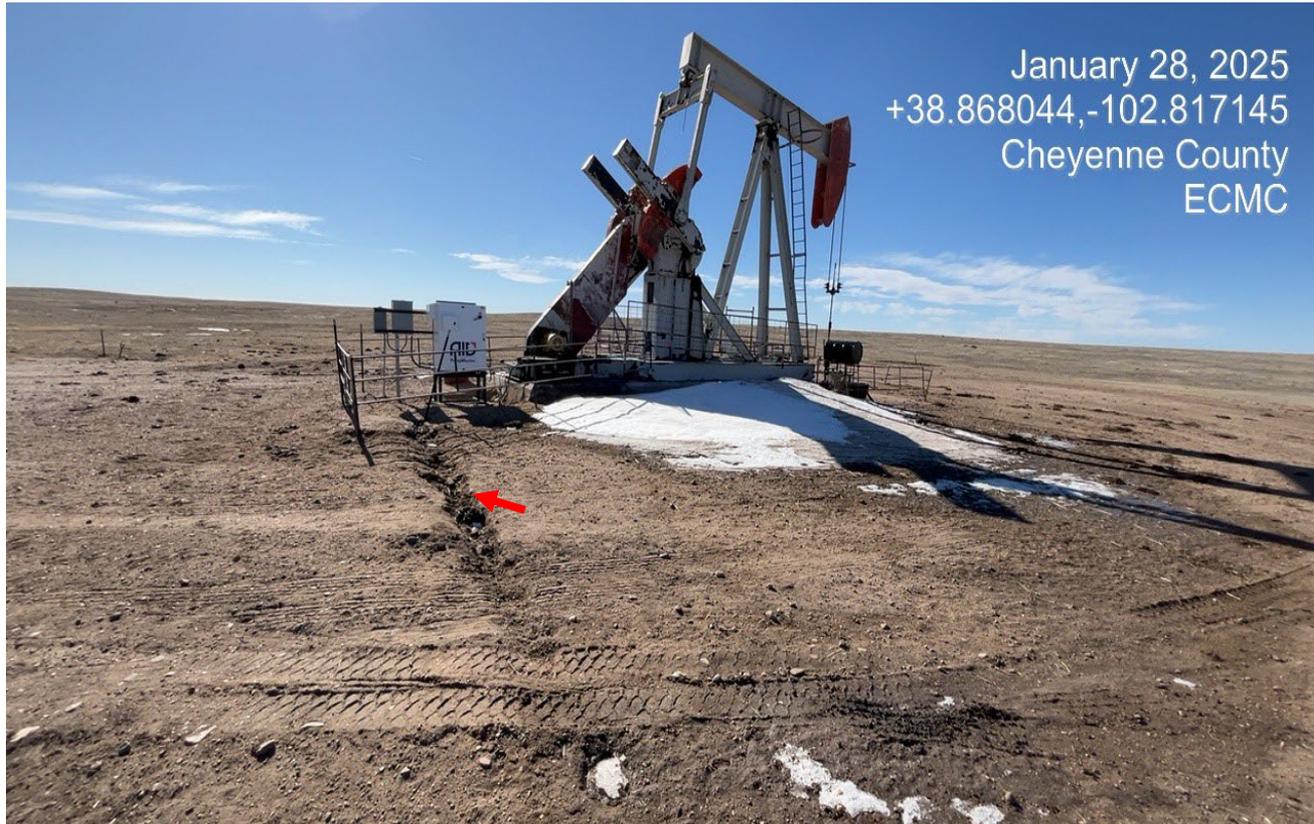
Photo 4. Facing toward the wellsite. The pumpjack engine has been replaced with an electric motor. The trench is shown at red arrow and needs to be filled in. The disturbance to the electric line needs to be reclaimed.

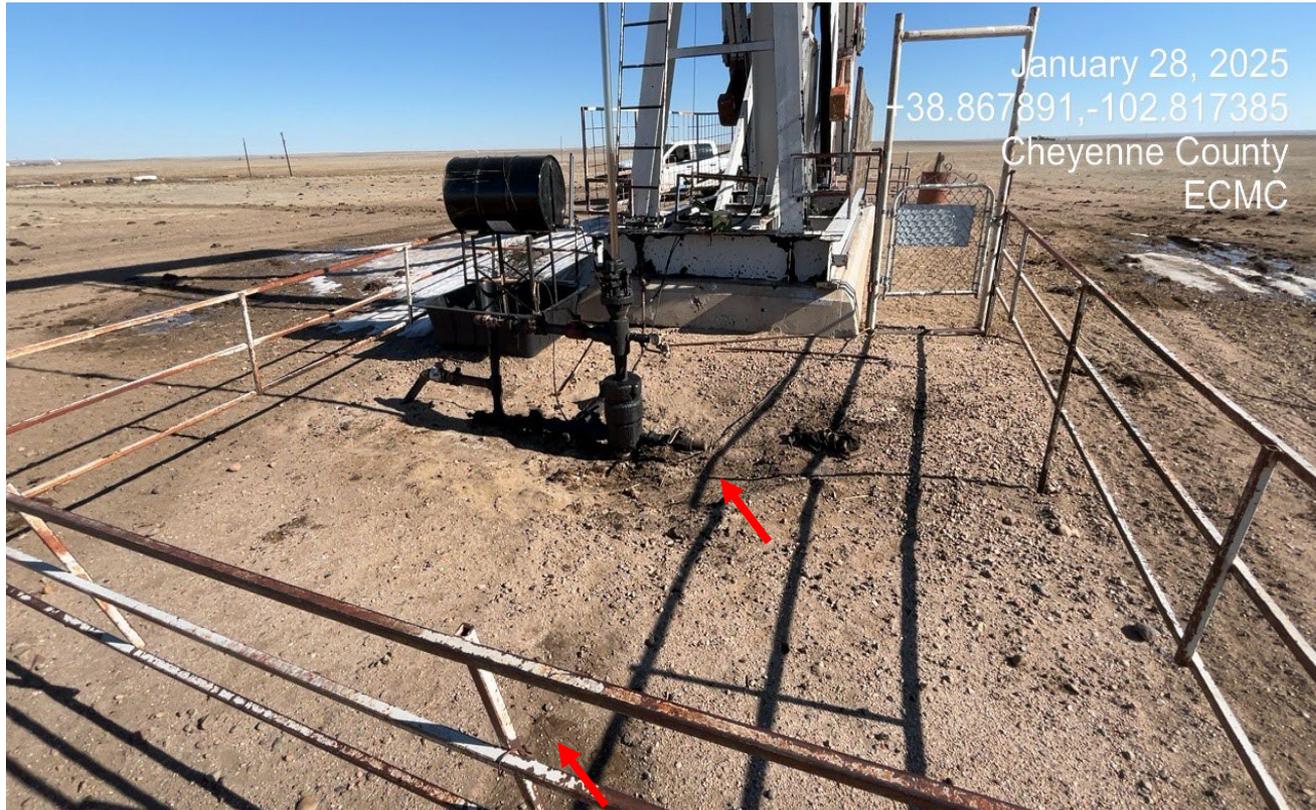
Photo 5. There is oil stained soils at the wellhead that need to be cleaned up and properly disposed.

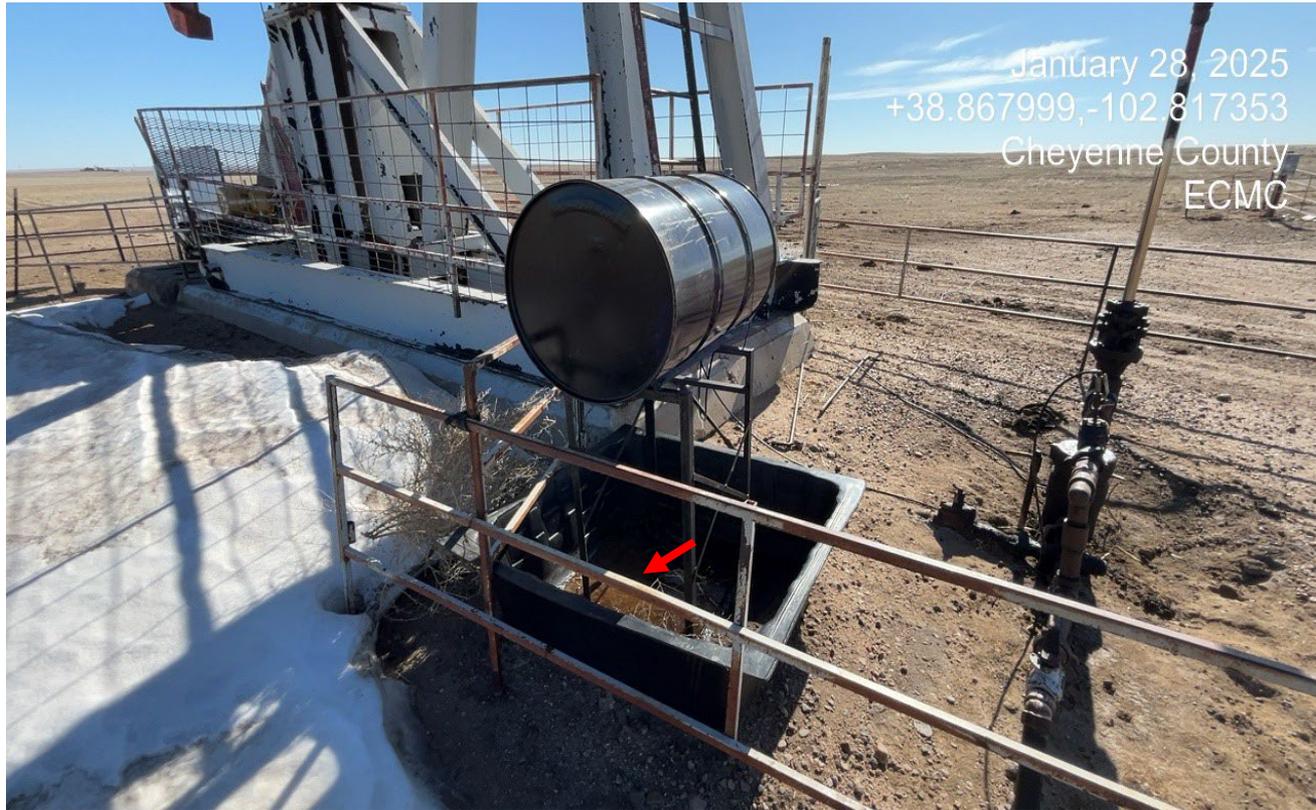
Photo 6. Facing toward the wellhead. The barrel has been repositioned into the secondary containment. There is oily fluids inside the containment and there are no wildlife protections to prevent entry.

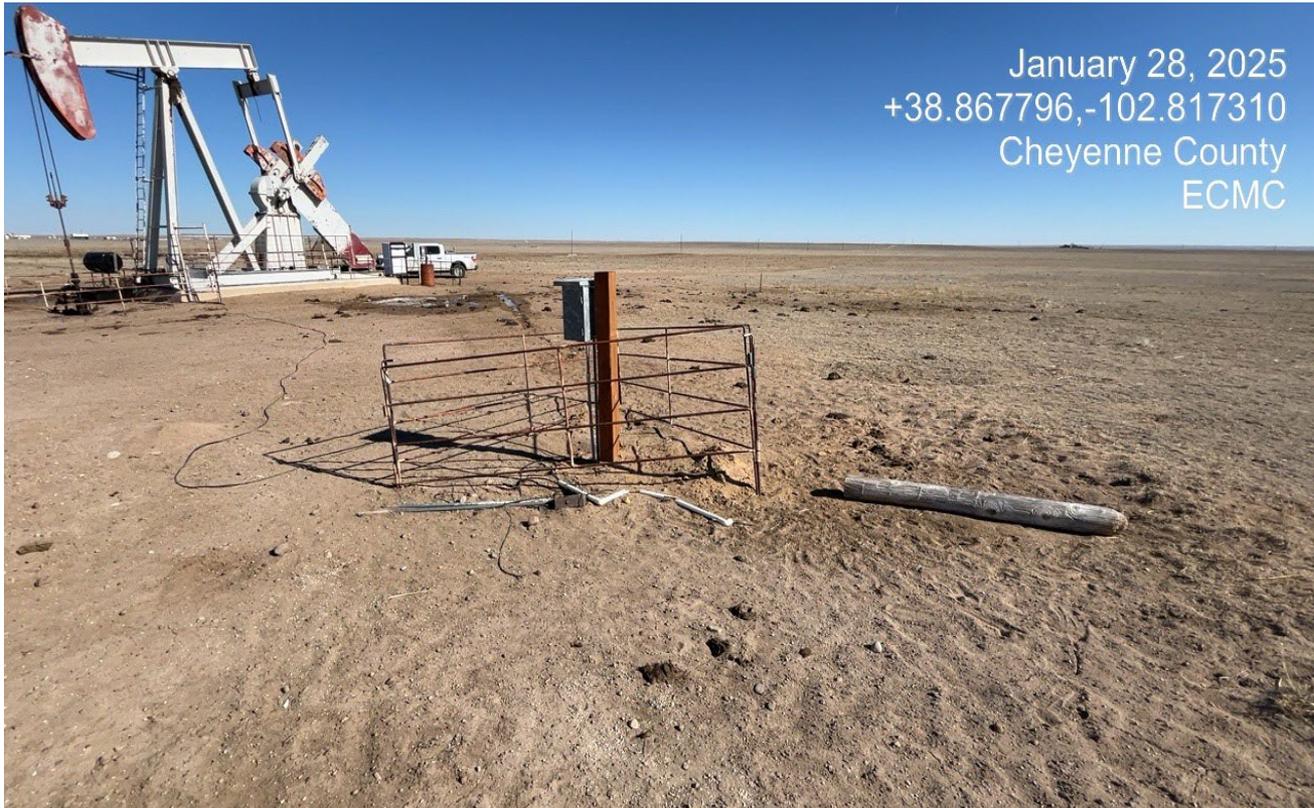
Photo 7. Facing toward the electric utility just south of the well. The electric utility was repaired but the wire and debris on the ground needs to be removed.
