Inspection Photos

ID: 321570

Operator: **MULL DRILLING COMPANY INC**

Inspection Date: 1/28/2025

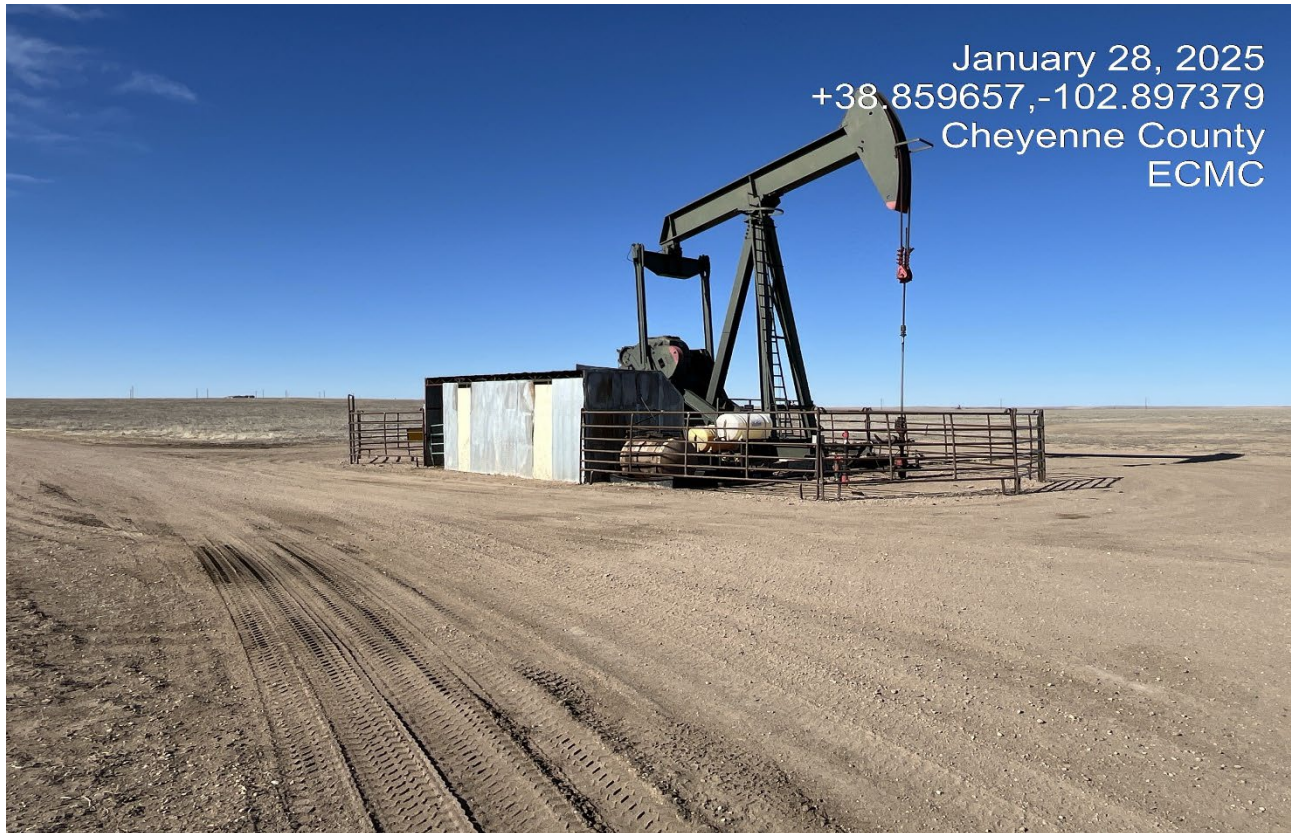
Photo 1. Facing northwest toward the wellsite..

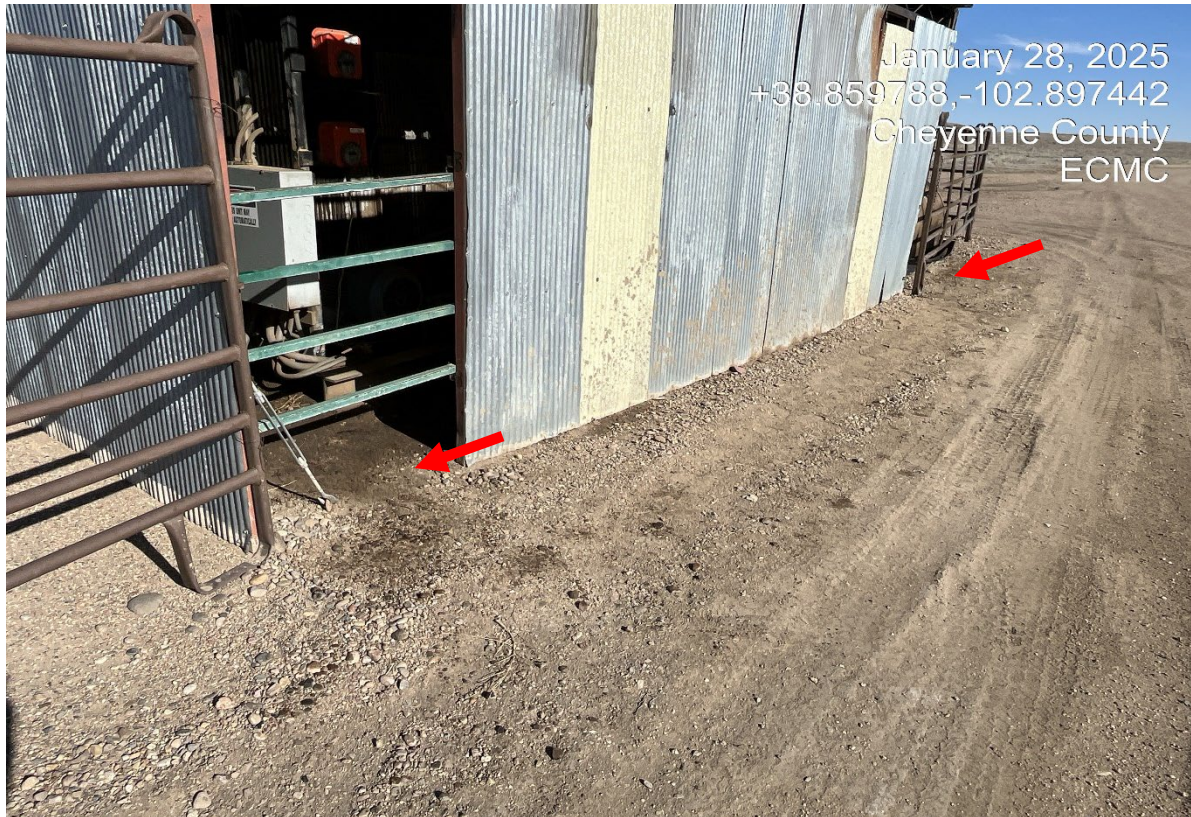
Photo 2. Facing toward the pumpjack engine shed. There are stained soils shown at red arrows that need to be cleaned up..

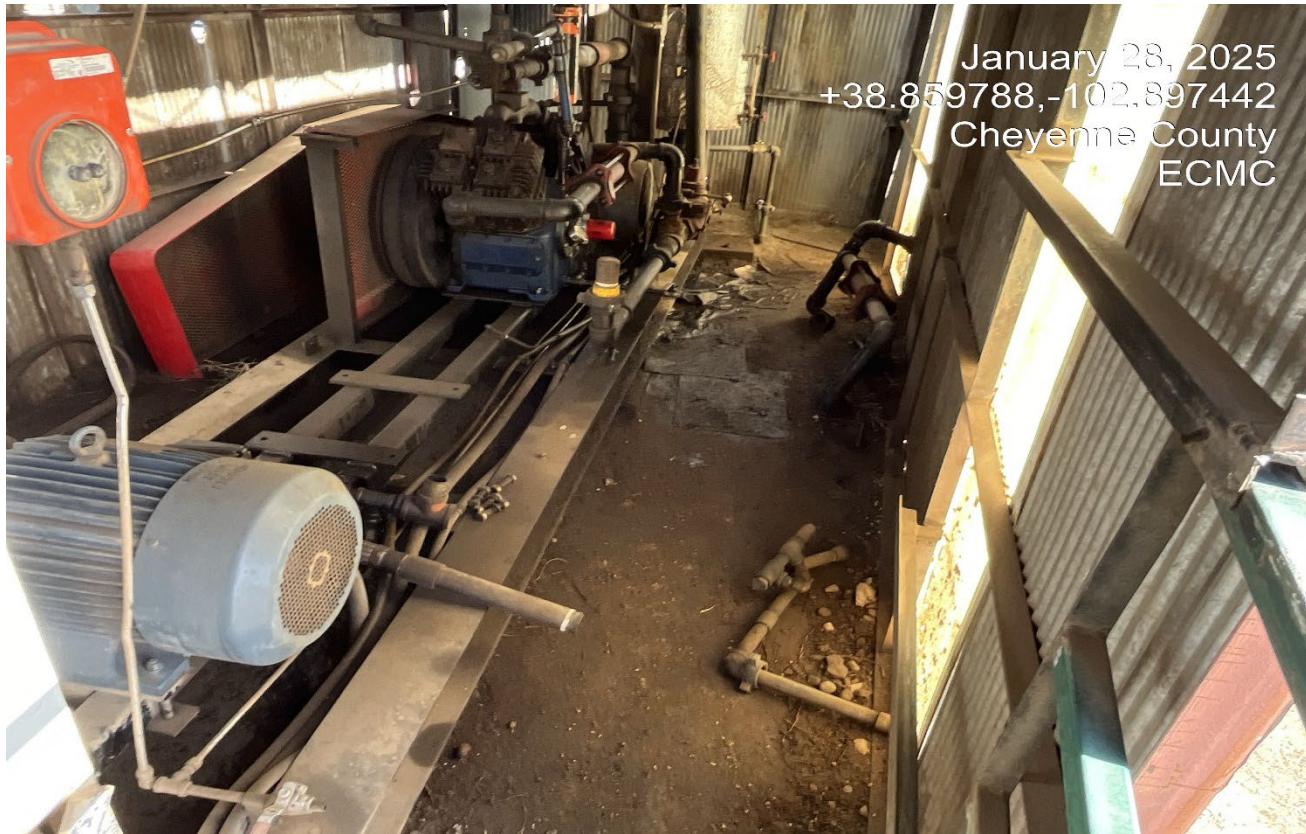
Photo 3. There is oil stained soils inside the shed from the leaking pumpjack engine.
