Inspection/Audit Photos
Location: QB Energy 596-33C Pad
Location ID: 335880
Date: 01/30/2025

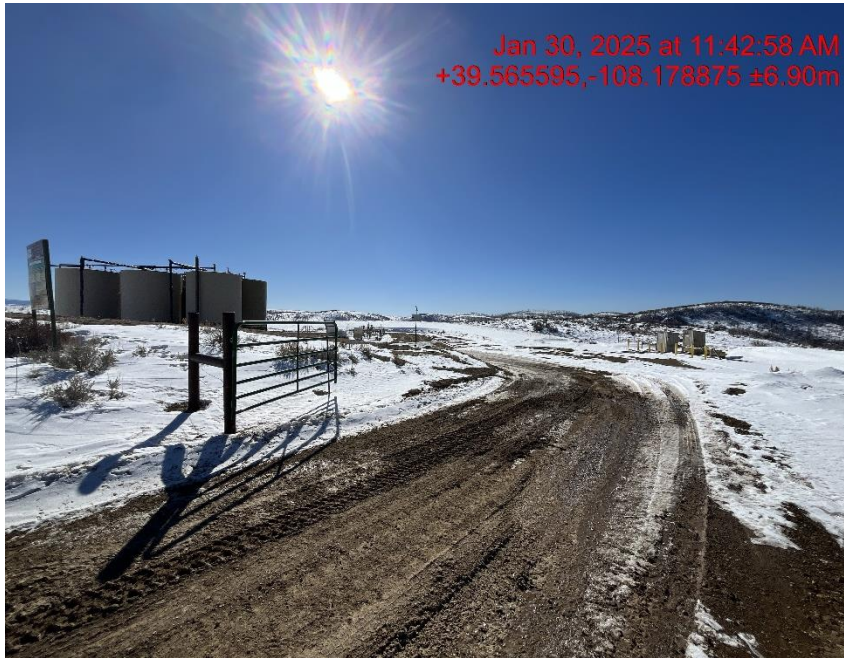
Photo # 3809 Entrance to location

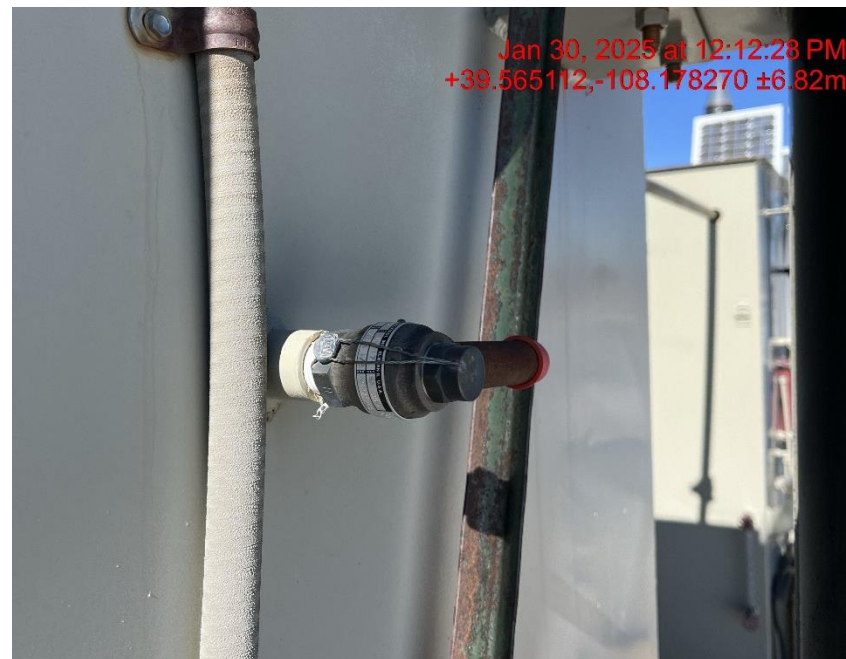
Photo # 3825 PRV vent line does not comply with CECMC pressure safety device rules

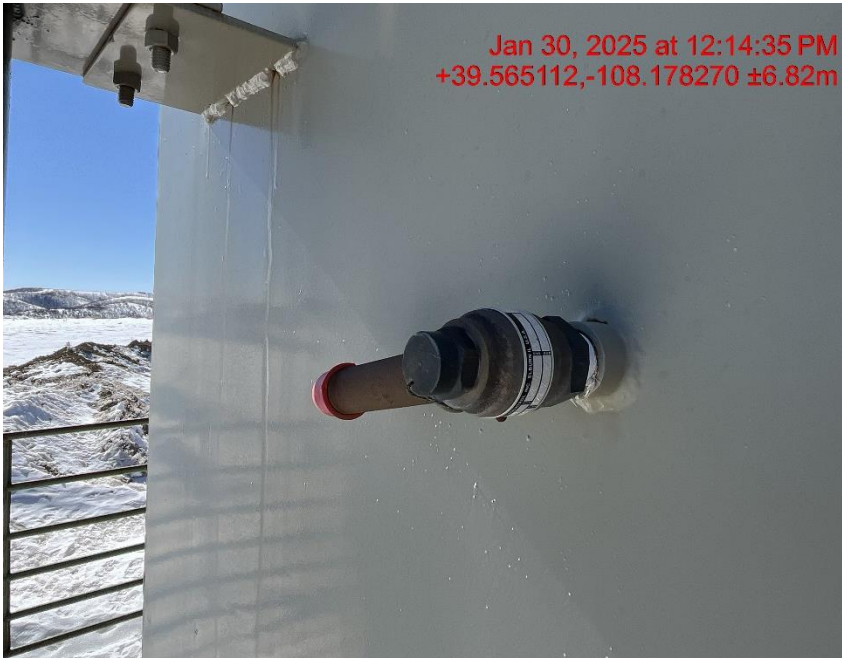
Photo # 3828 PRV vent line does not comply with CECMC pressure safety device rules

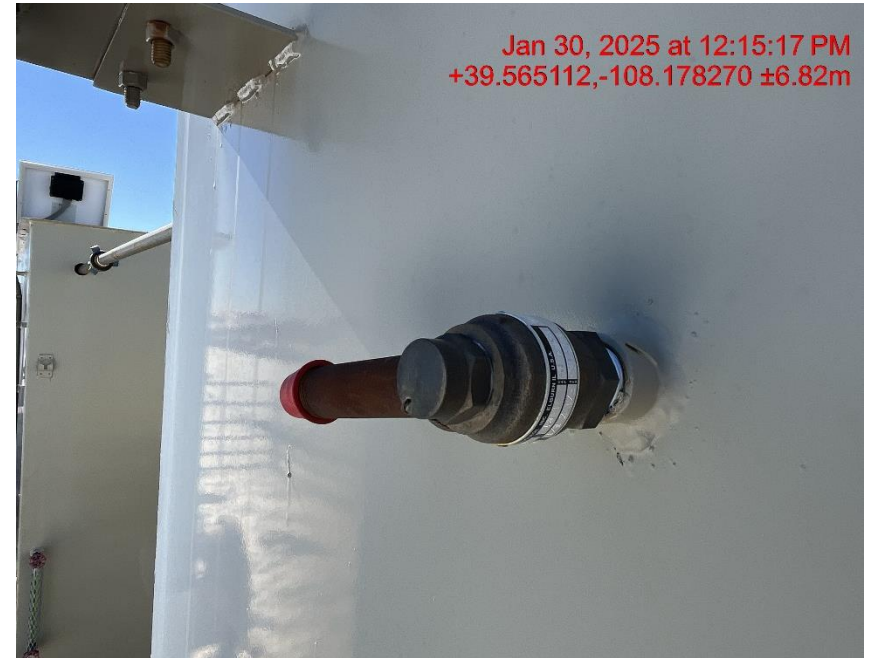
Photo # 3829 PRV vent line does not comply with CECMC pressure safety device rules

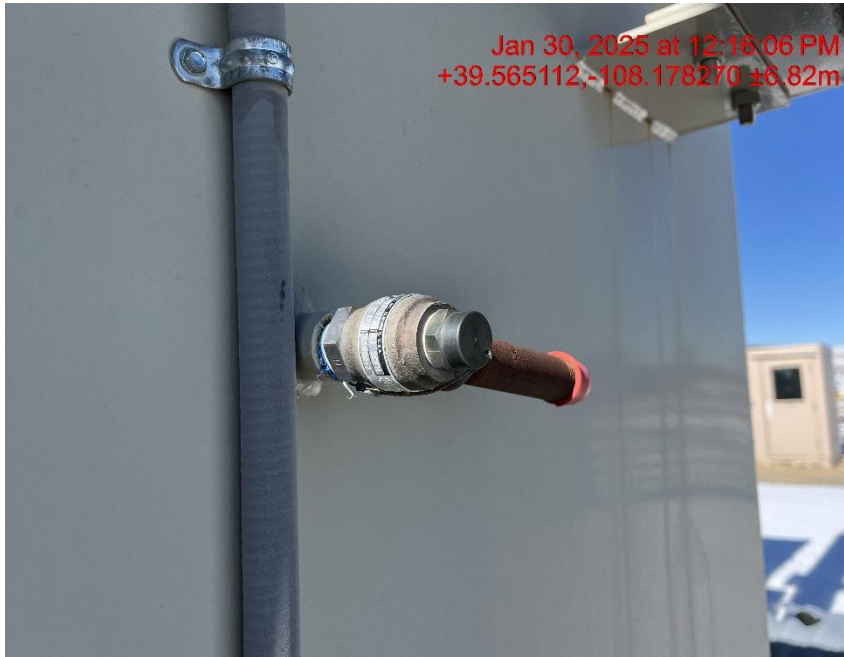
Photo # 3832 PRV vent line does not comply with CECMC pressure safety device rules

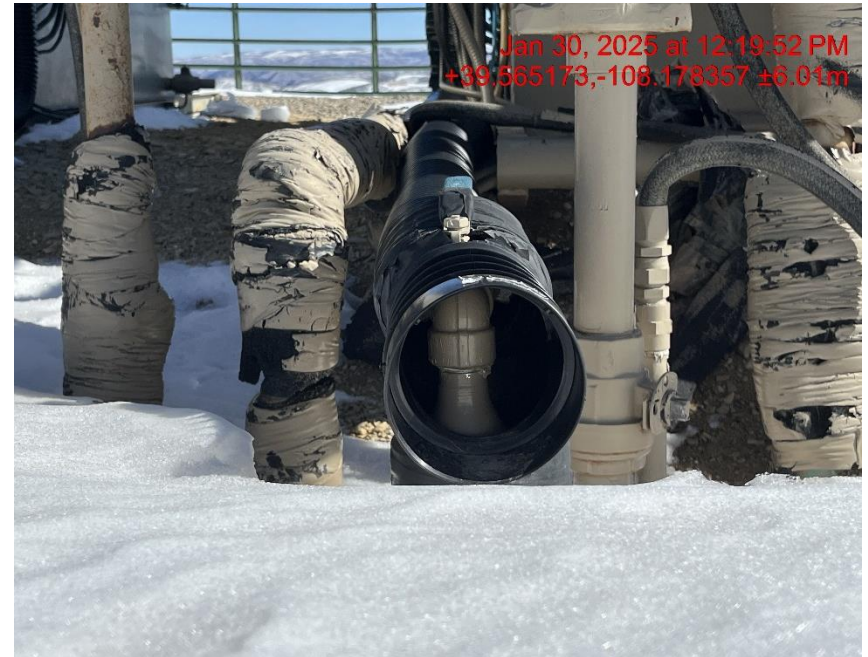
Photo # 3834 Wildlife hazard

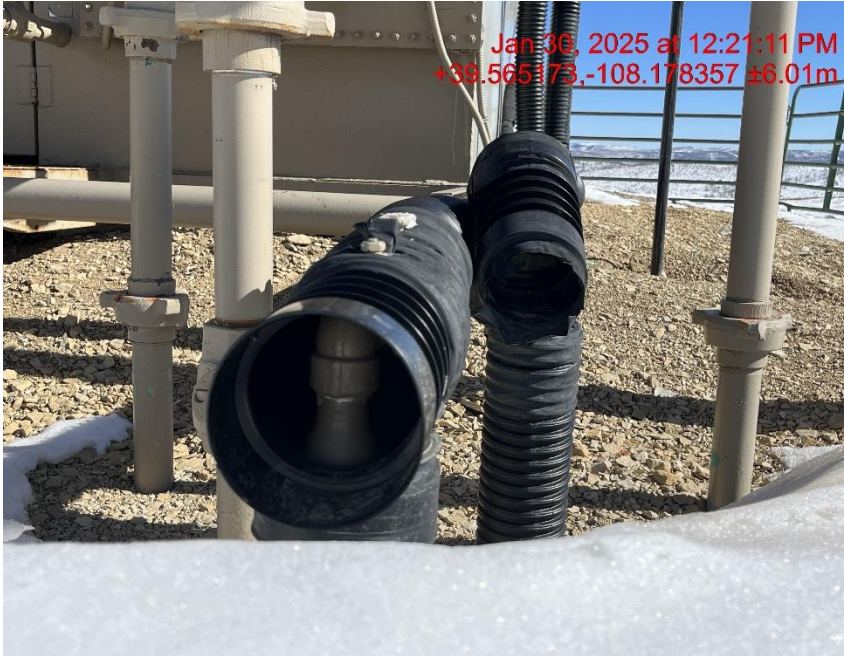
Photo # 3835 Wildlife hazard

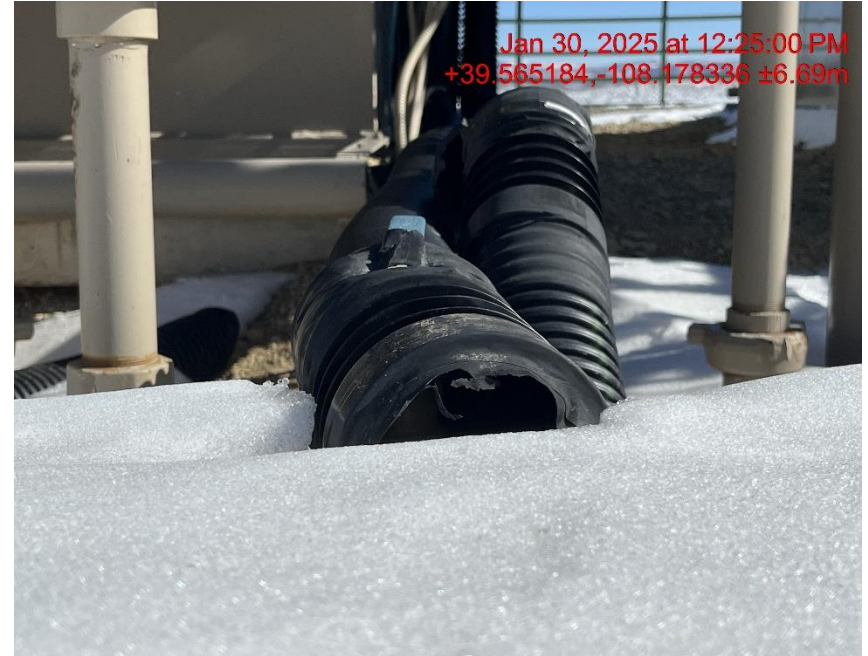
Photo # 3839 Wildlife hazard

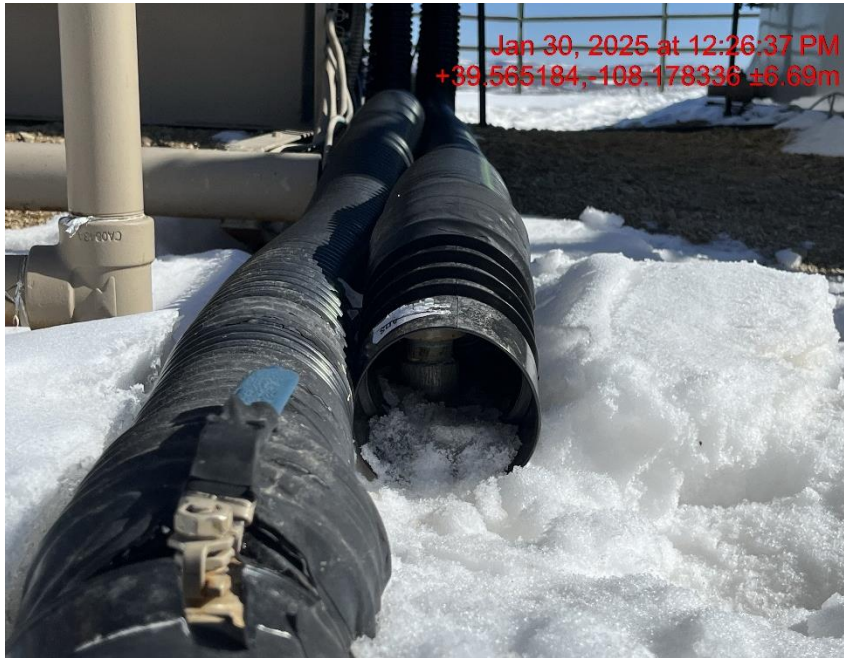
Photo # 3842 Wildlife hazard

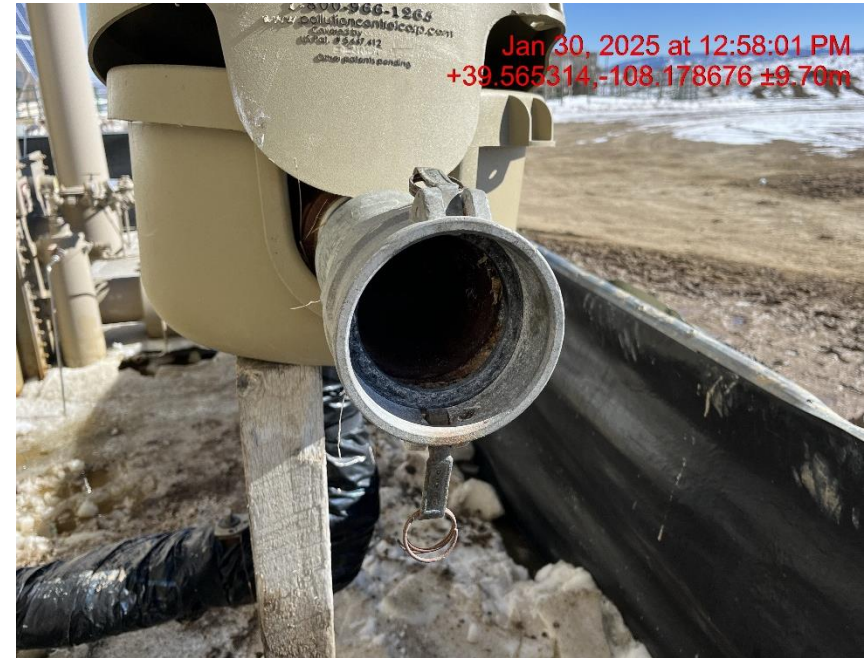
Photo # 3865 Open ended load line

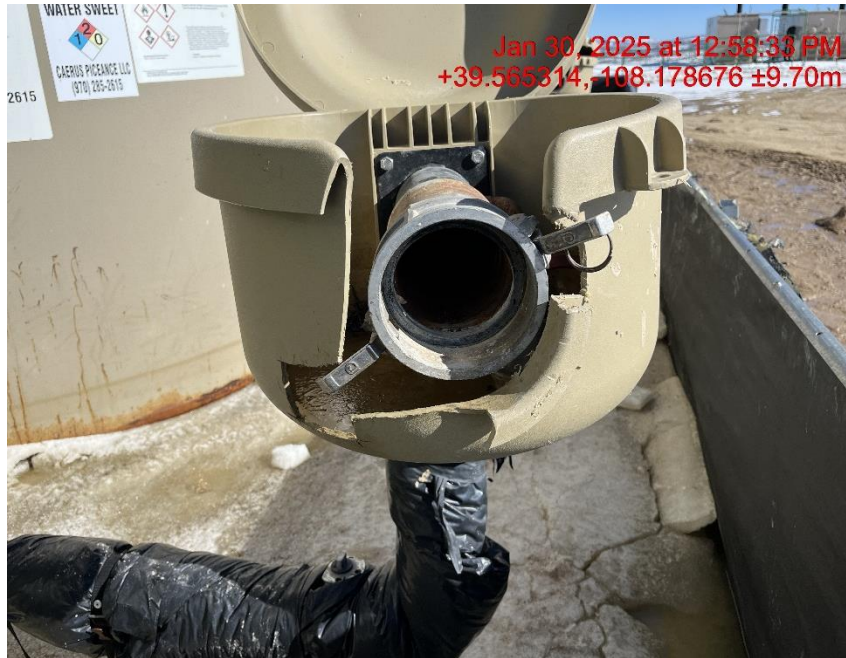
Photo # 3866 Open ended load line

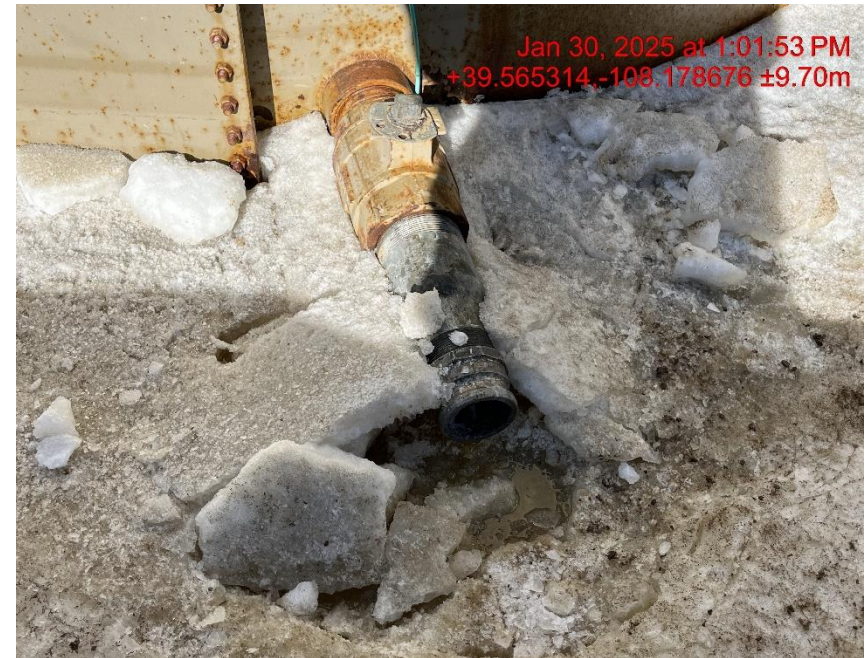
Photo # 3869 Open ended load line

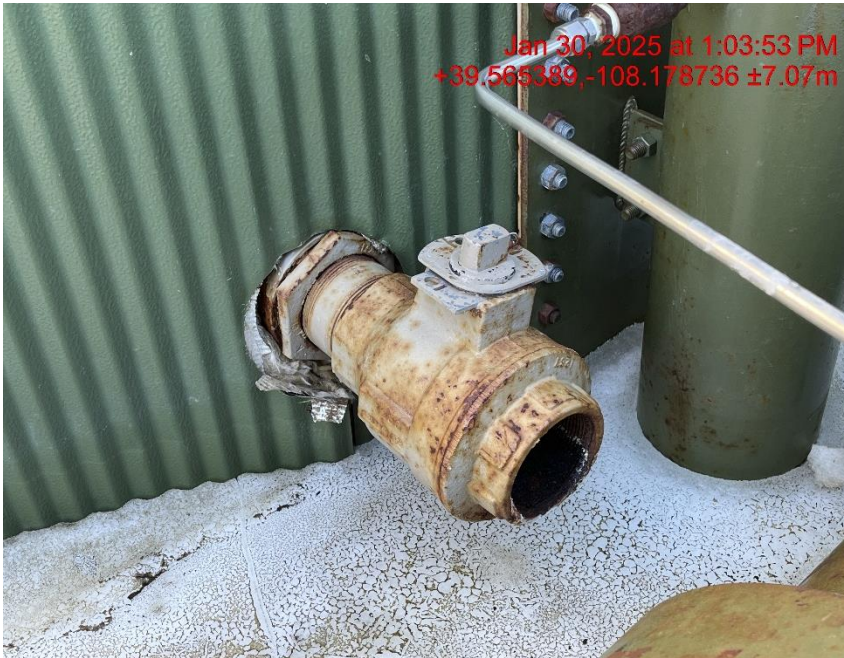
Photo # 3870 Open ended load line

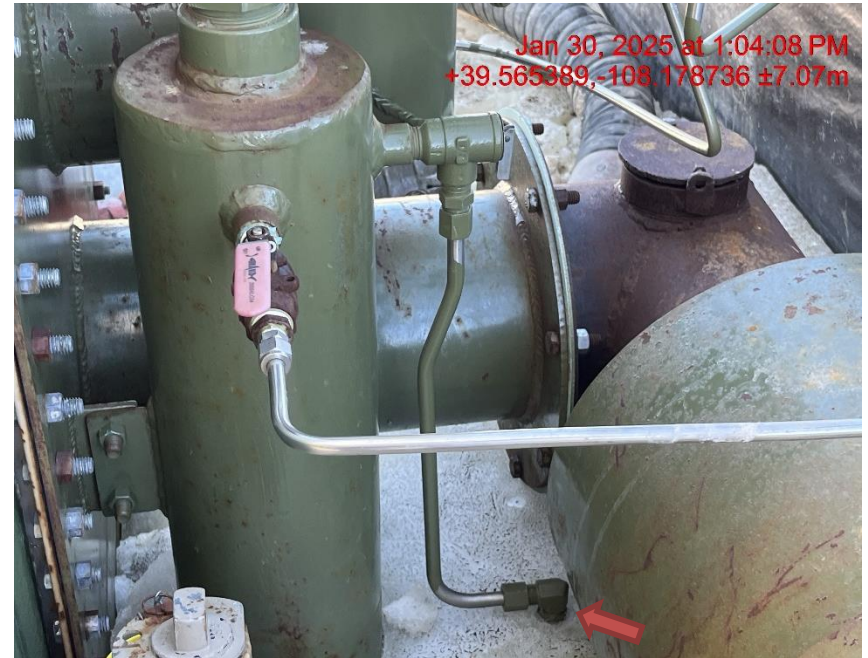
Photo # 3871 PRV vent line does not comply with CECMC pressure safety device rules

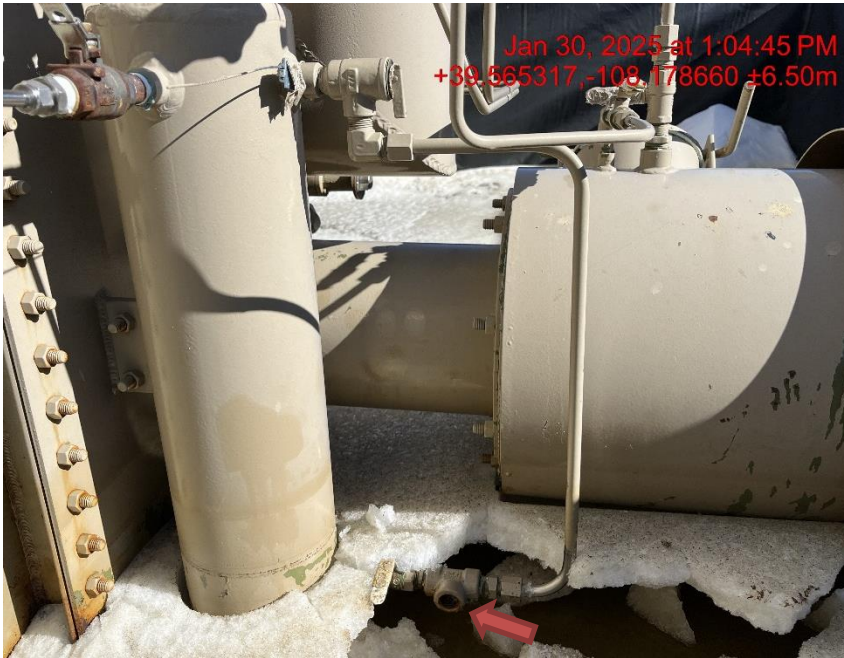
Photo # 3872 PRV vent line does not comply with CECMC pressure safety device rules

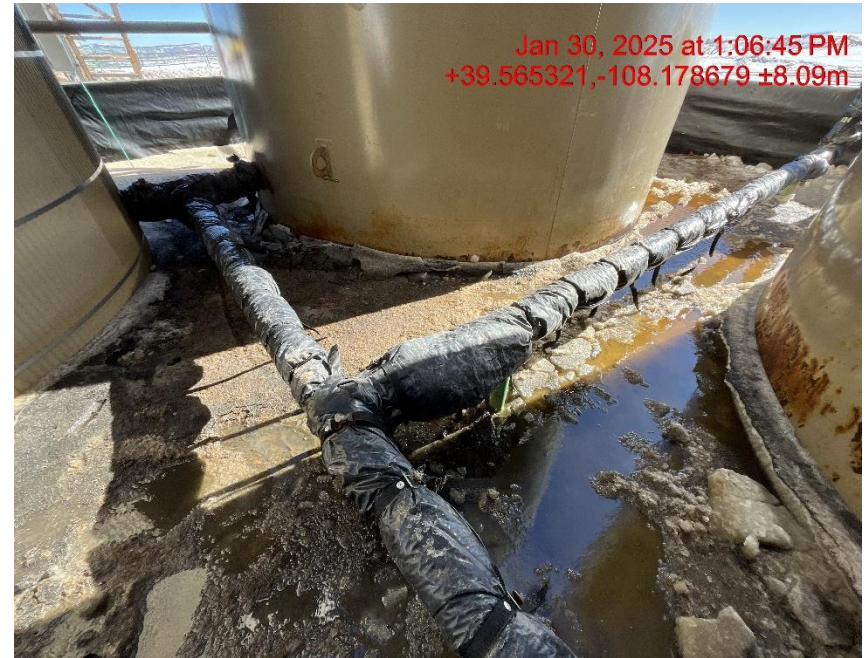
Photo # 3876 Staining in secondary containment

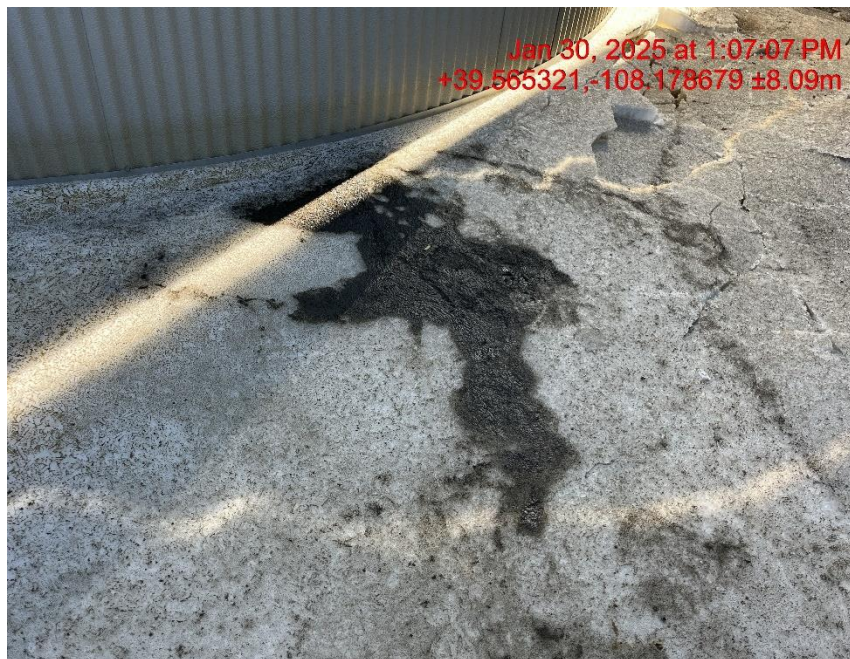
Photo # 3877 Staining in secondary containment

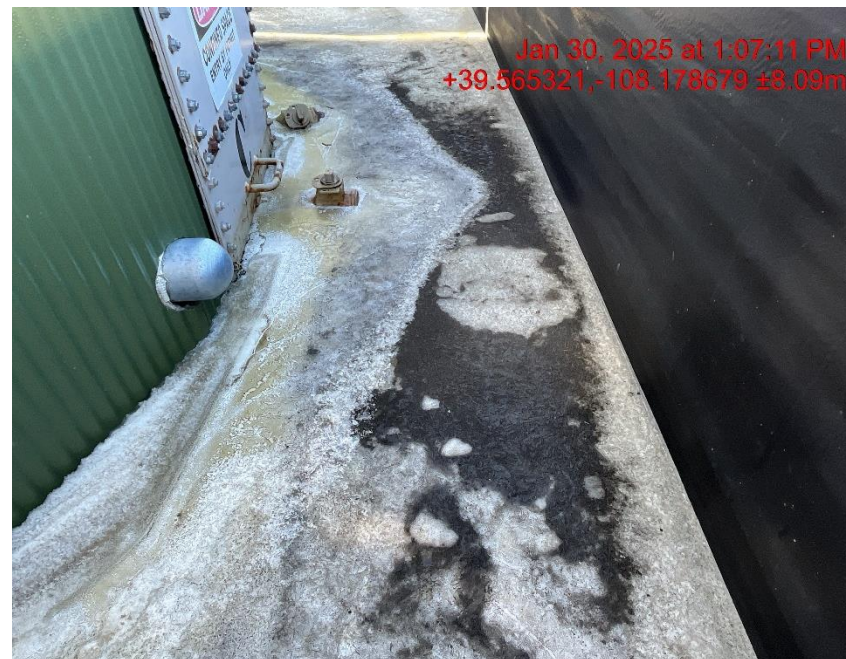
Photo # 3878 Staining in secondary containment

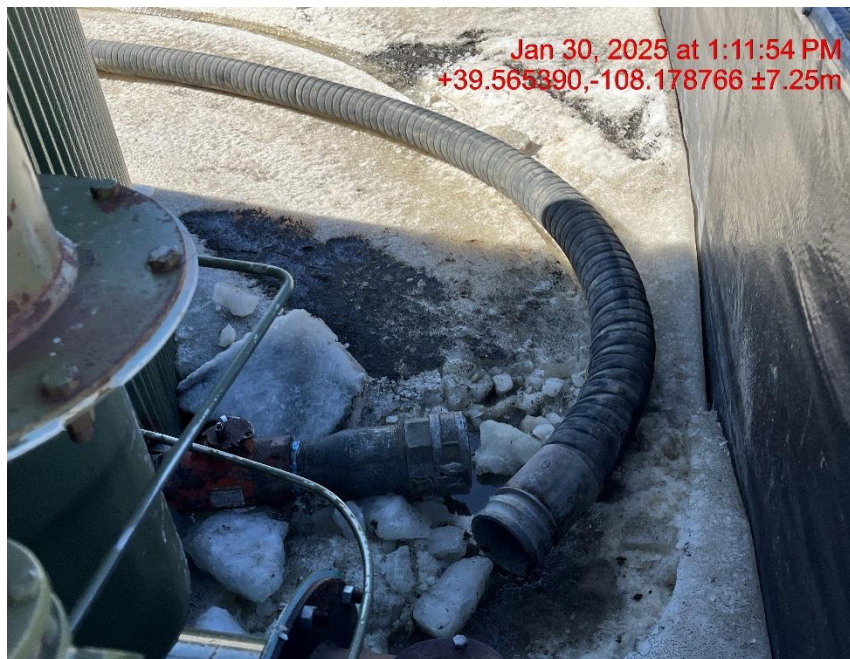
Photo # 3882 Staining in secondary containment

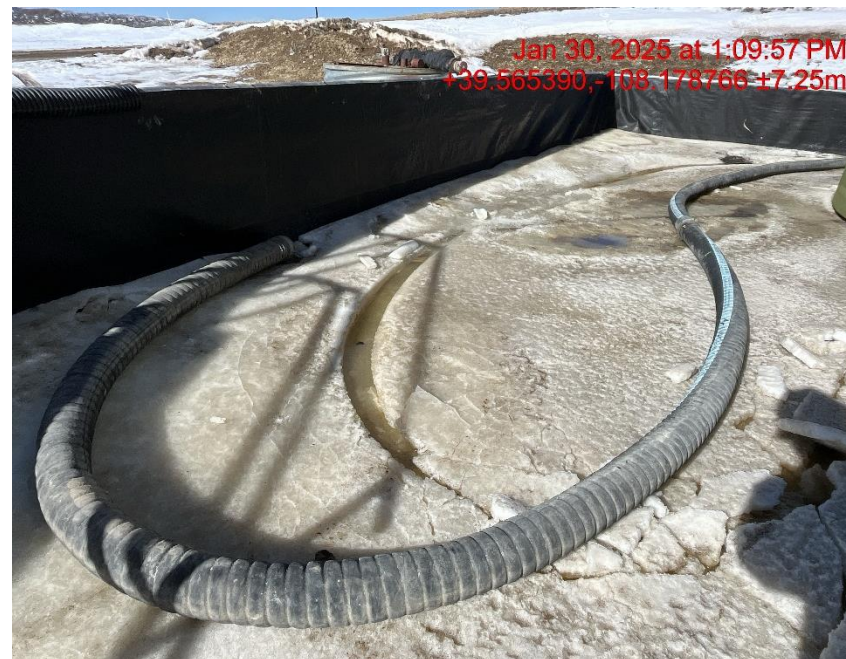
Photo # 3880 Unused hoses
