Interim Reclamation and Stormwater Inspection

Date: 02/03/2025

Operator: MDS ENERGY DEVELOPMENT - 10814

Location ID: 471039

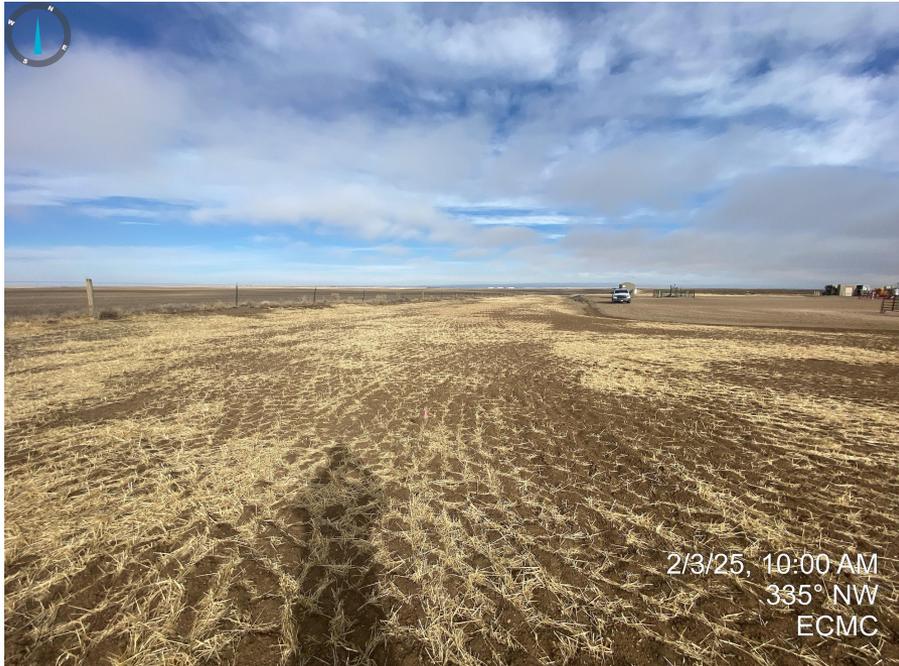
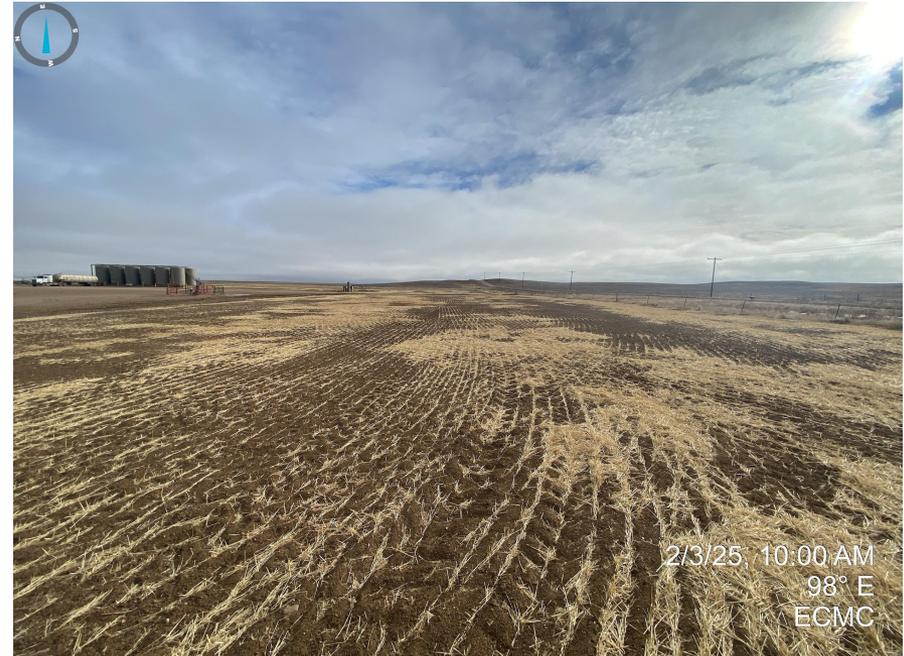
Photos 1 & 2. Taken from the southwest corner of the location. Appears the Operator has performed interim reclamation activities to reduce disturbance areas only needed for production operations, with the evidence of drill rows and straw crimped mulch. Operator shall continue to monitor and manage this site until the location meets Rule 1003 standards, including stormwater and weed management.

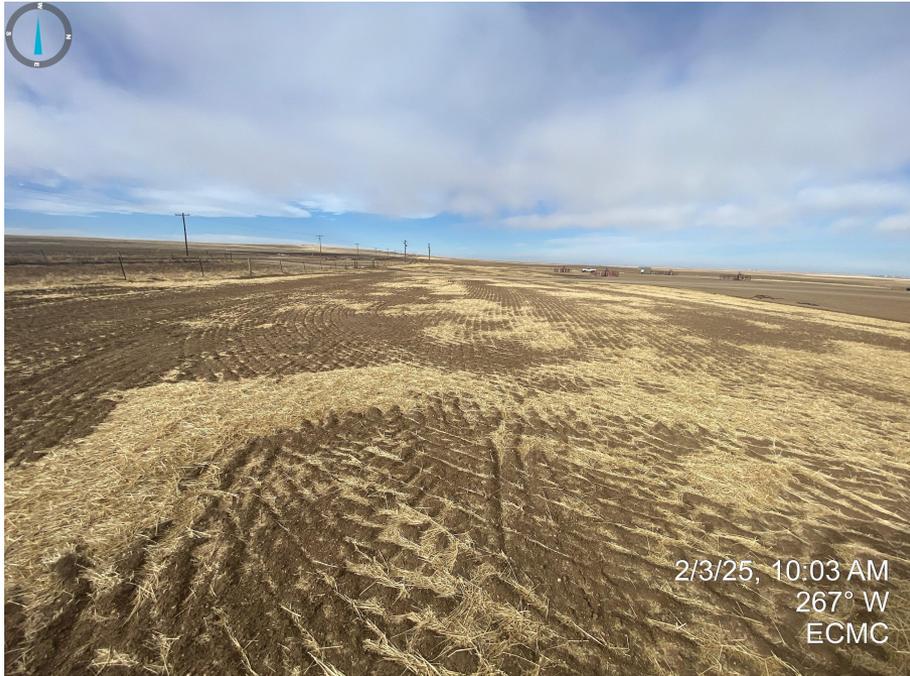
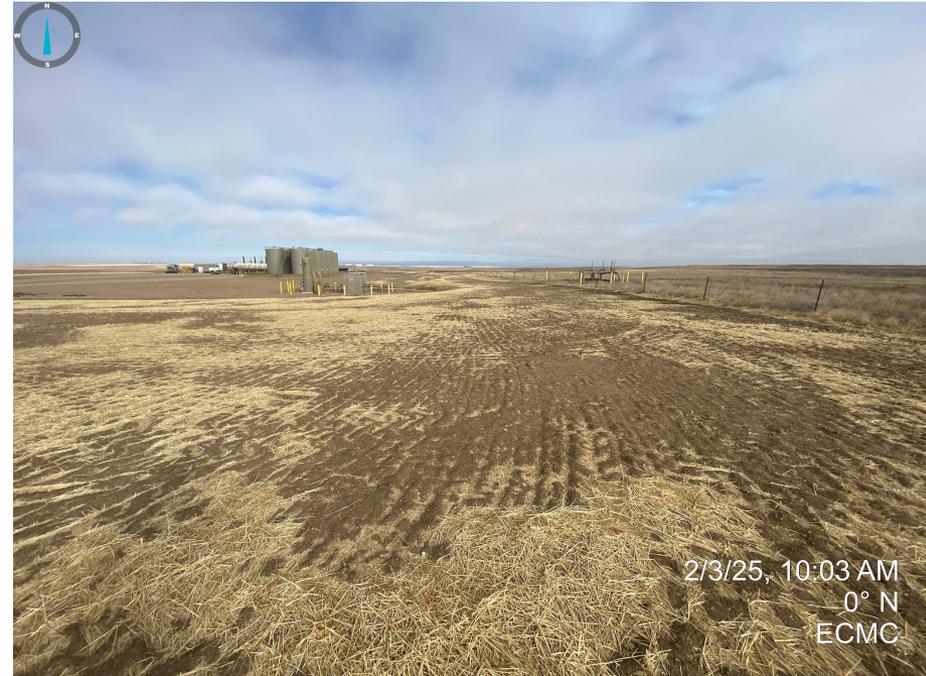
Photos 3 & 4. Taken from the southeast corner of the location. Appears the Operator has performed interim reclamation activities to reduce disturbance areas only needed for production operations, with the evidence of drill rows and straw crimped mulch. Operator shall continue to monitor and manage this site until the location meets Rule 1003 standards, including stormwater and weed management.

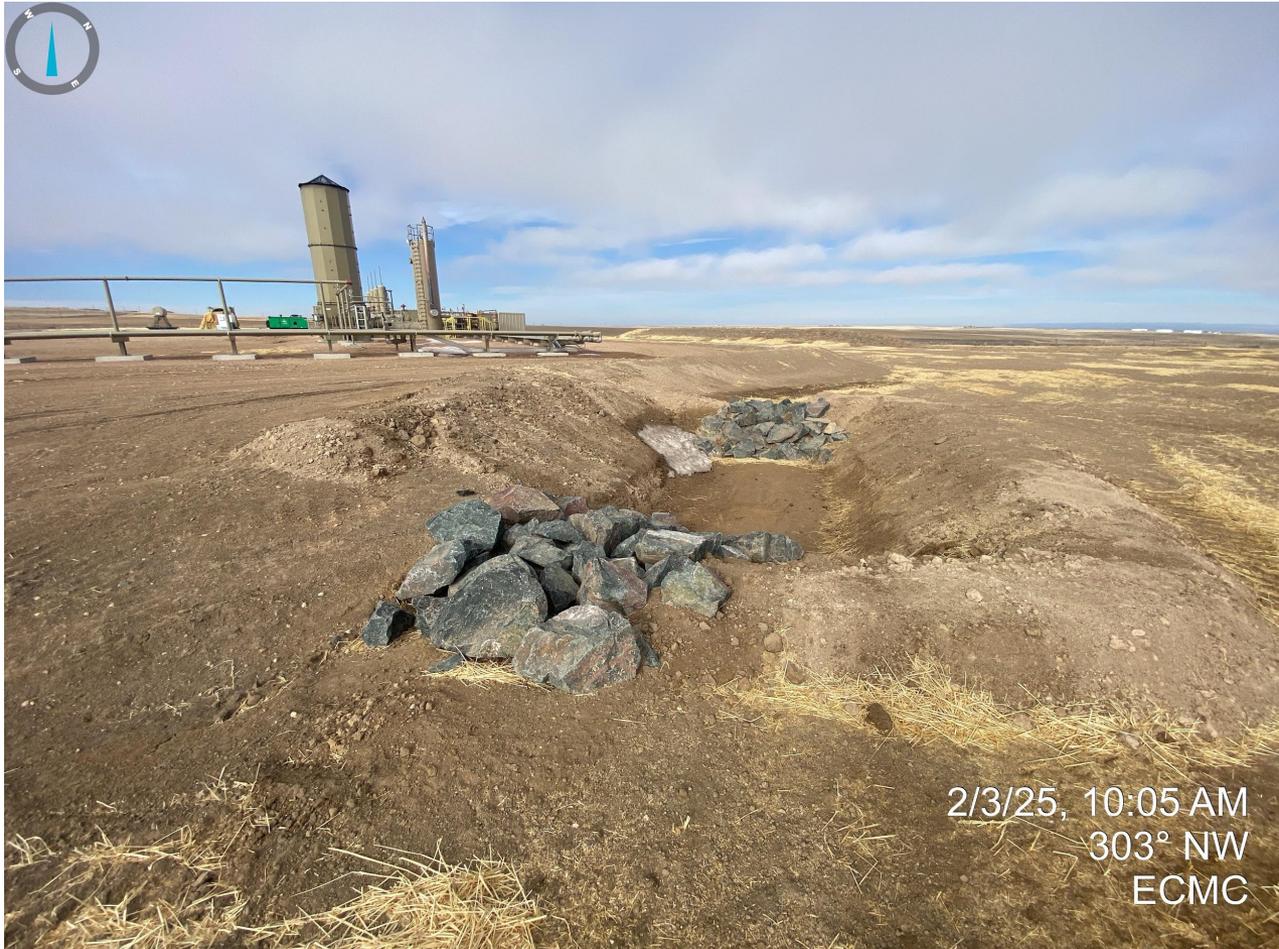
Photo 5. Sediment trap installed along the eastern side of the production facilities.

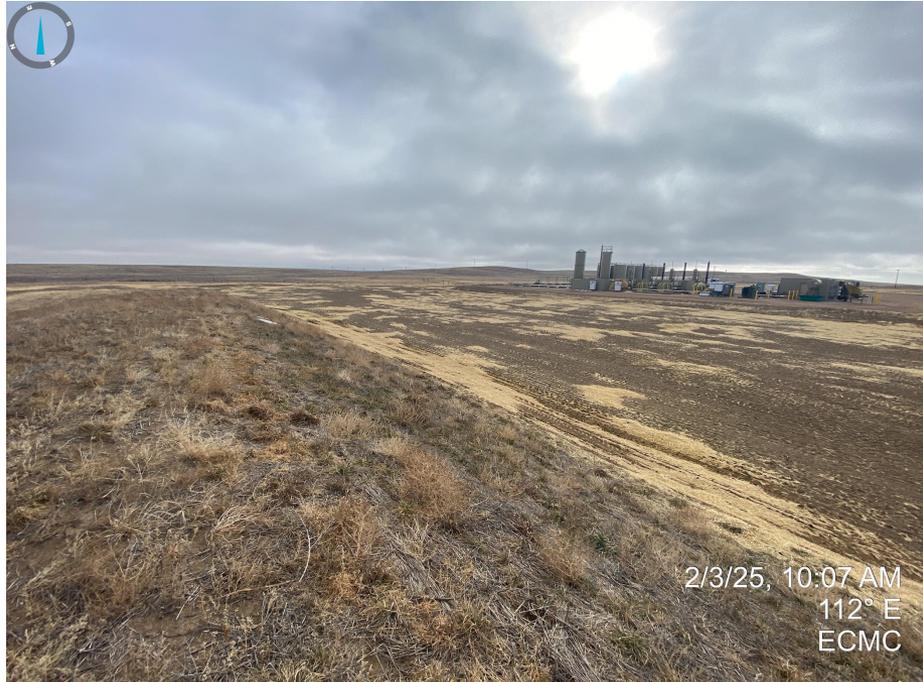
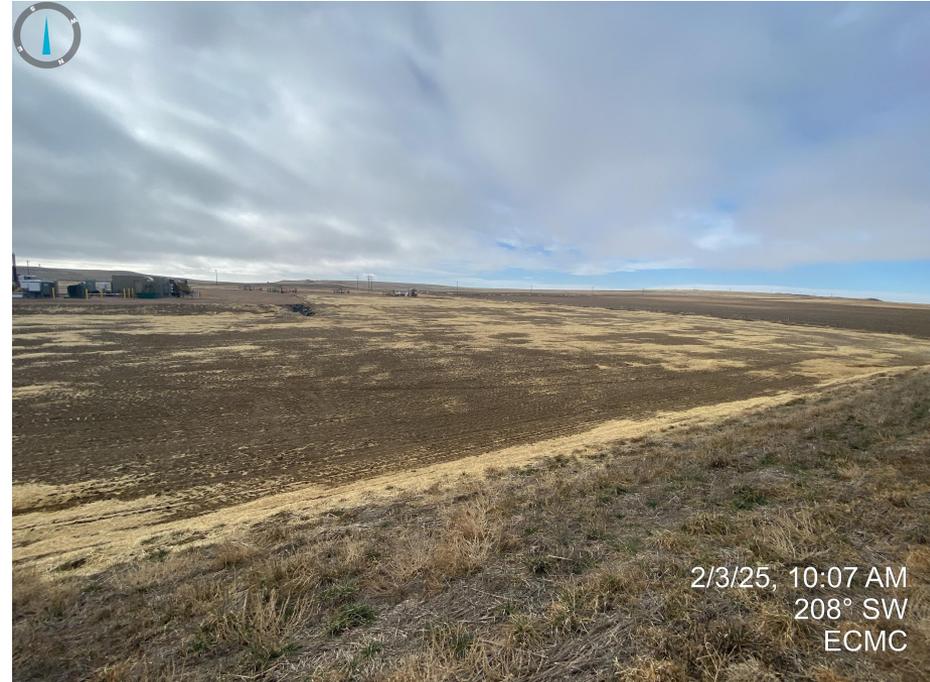
Photos 6 & 7. Taken from the top/center portion of the topsoil stockpile, overlooking the northern interim areas. Interim areas appear to have been drill seeded with evidence of drill rows and crimped mulch. Also pictured, topsoil stockpile has significant weed cover, which is not in compliance with Rule 1002.c.

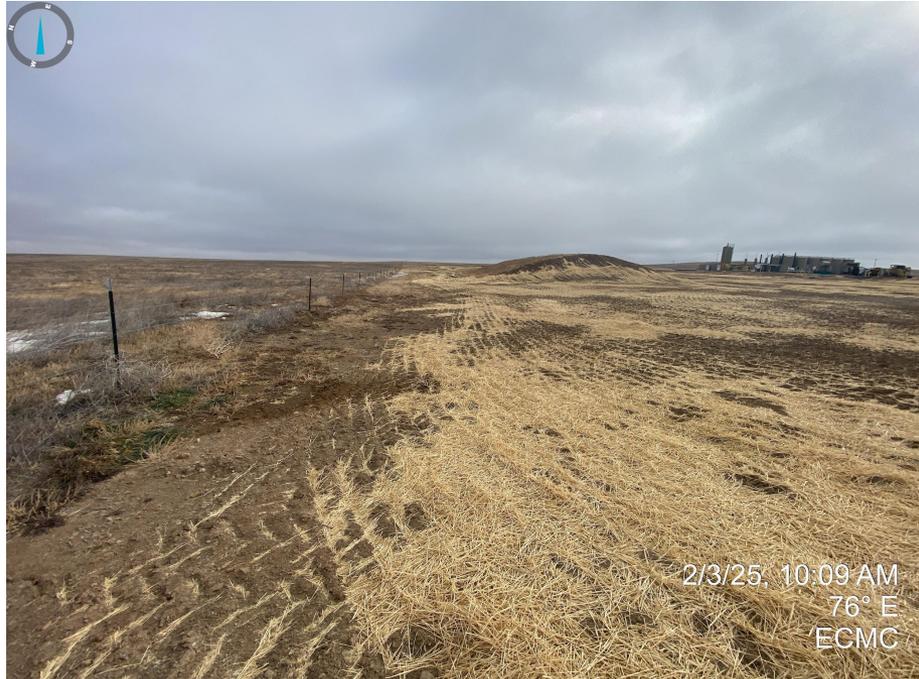
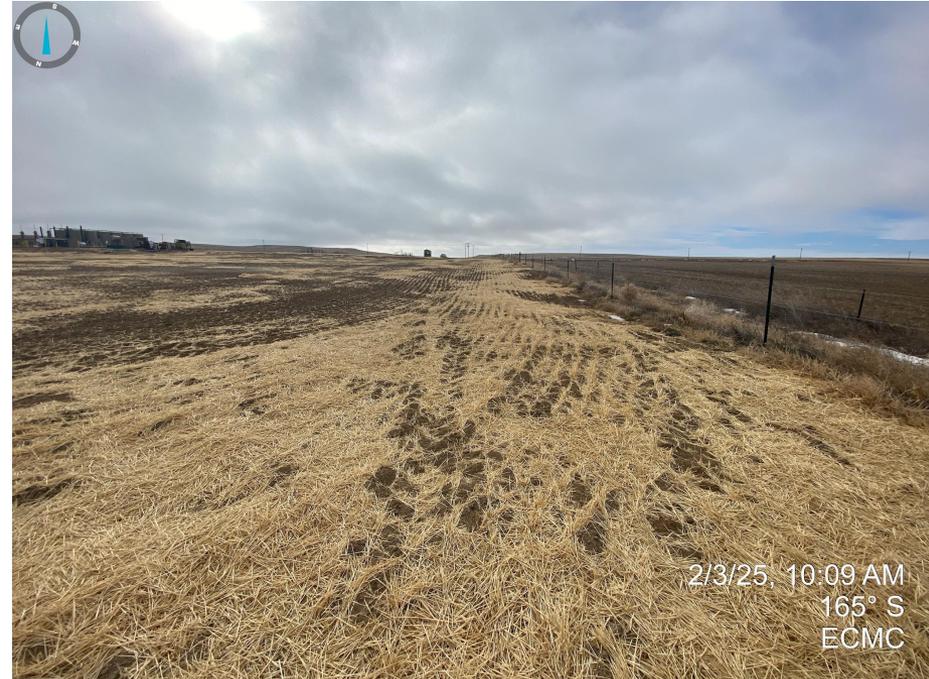
Photos 8 & 9. Taken from the northwest corner of the location. Appears the Operator has performed interim reclamation activities to reduce disturbance areas only needed for production operations, with the evidence of drill rows and straw crimped mulch. Operator shall continue to monitor and manage this site until the location meets Rule 1003 standards, including stormwater and weed management.

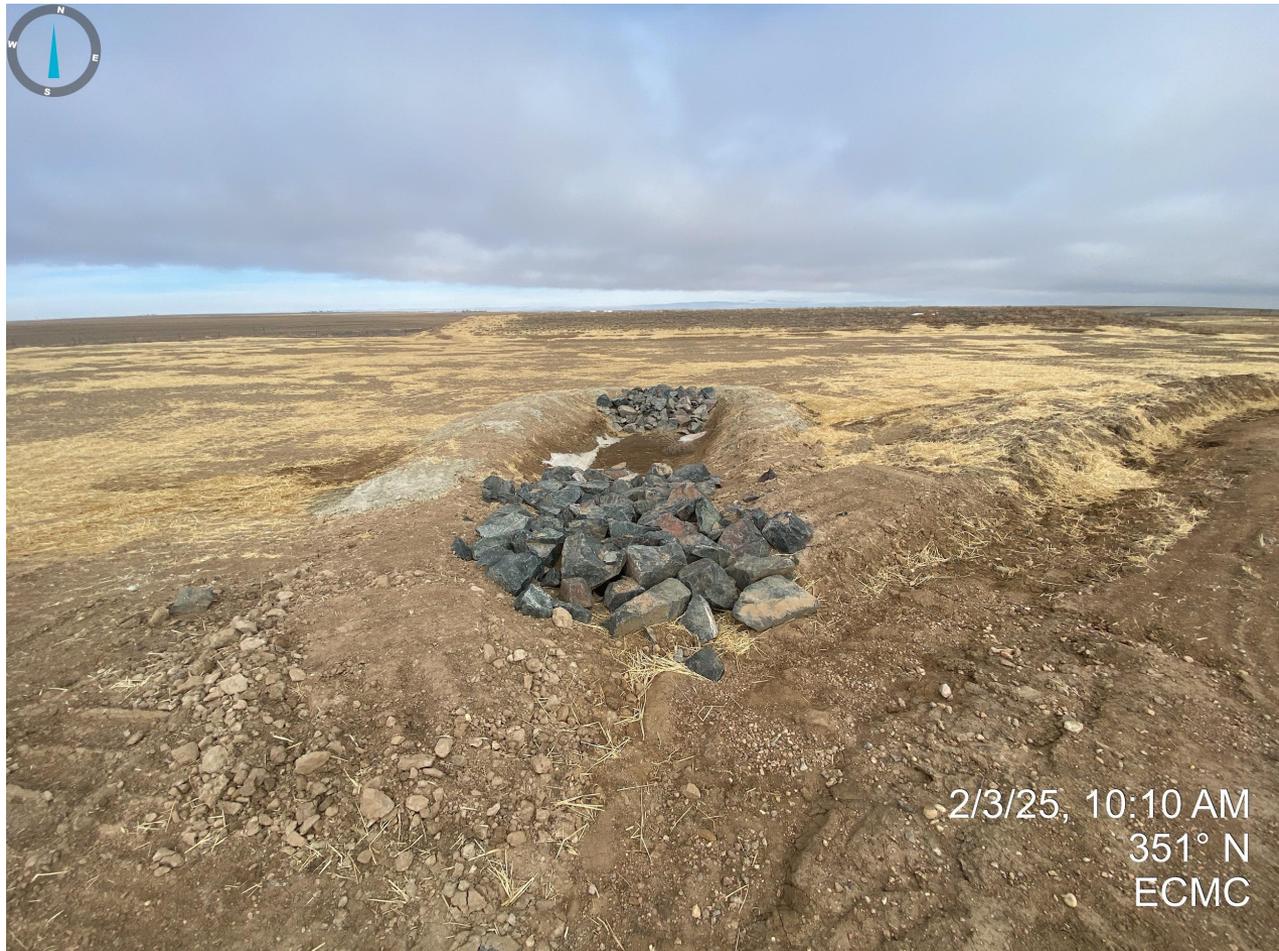
Photo 10. Sediment trap installed along the northern side of the production facilities.

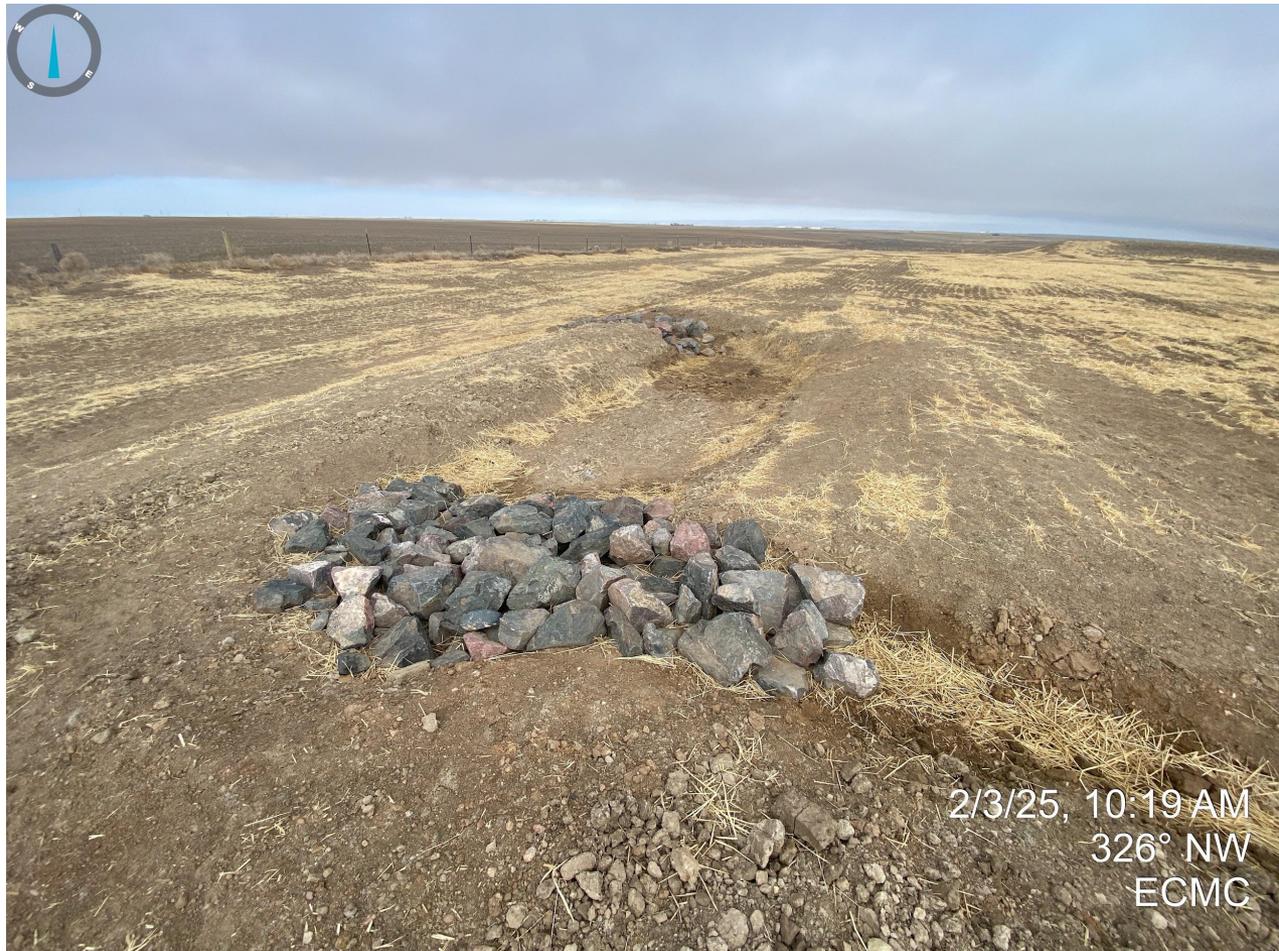
Photo 11. Sediment trap installed along the northwestern side of the production facilities.

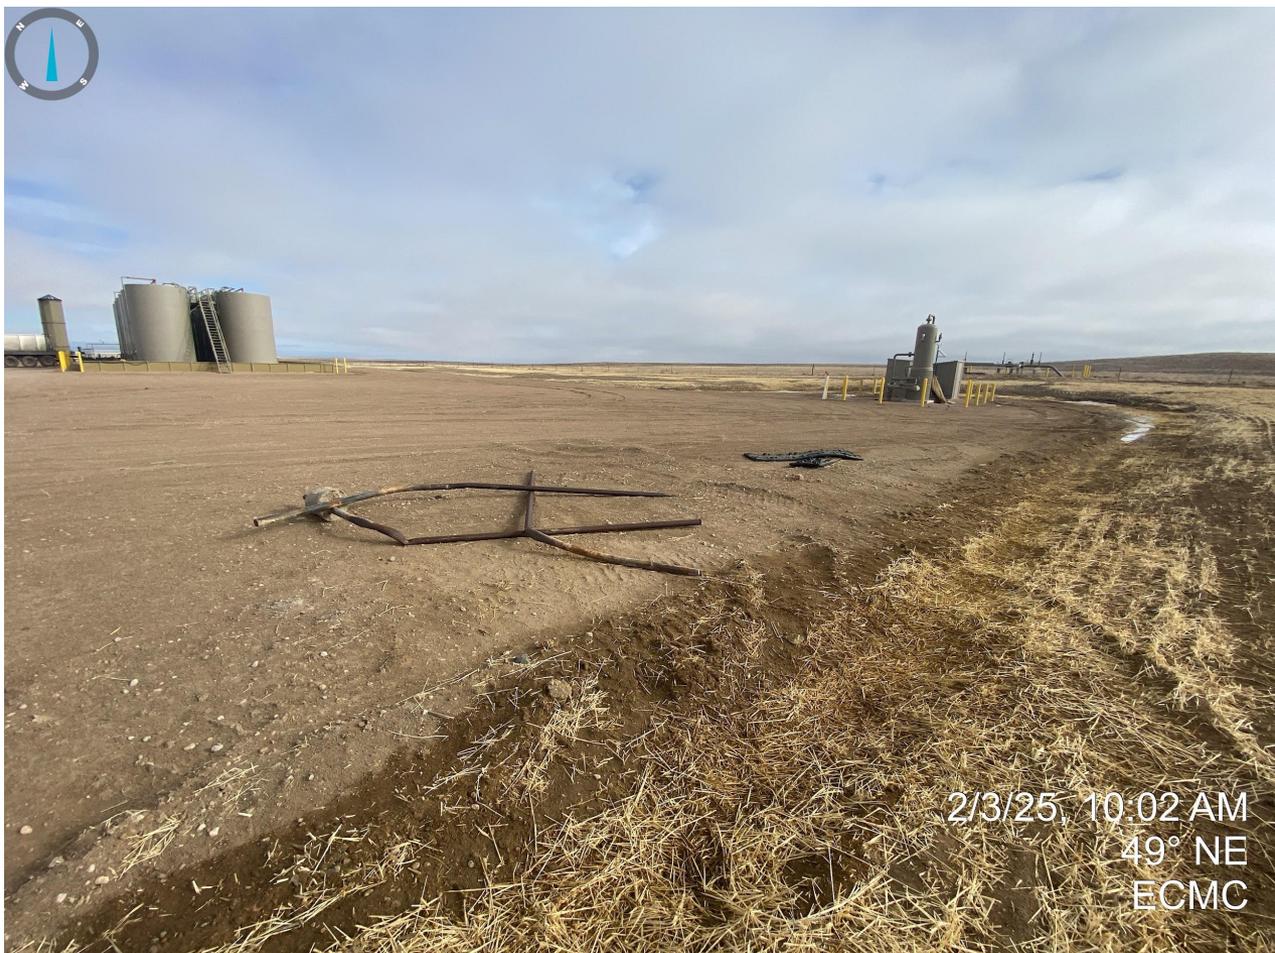
Photo 12. Trash/debris observed on the southeastern portion of the production facilities.

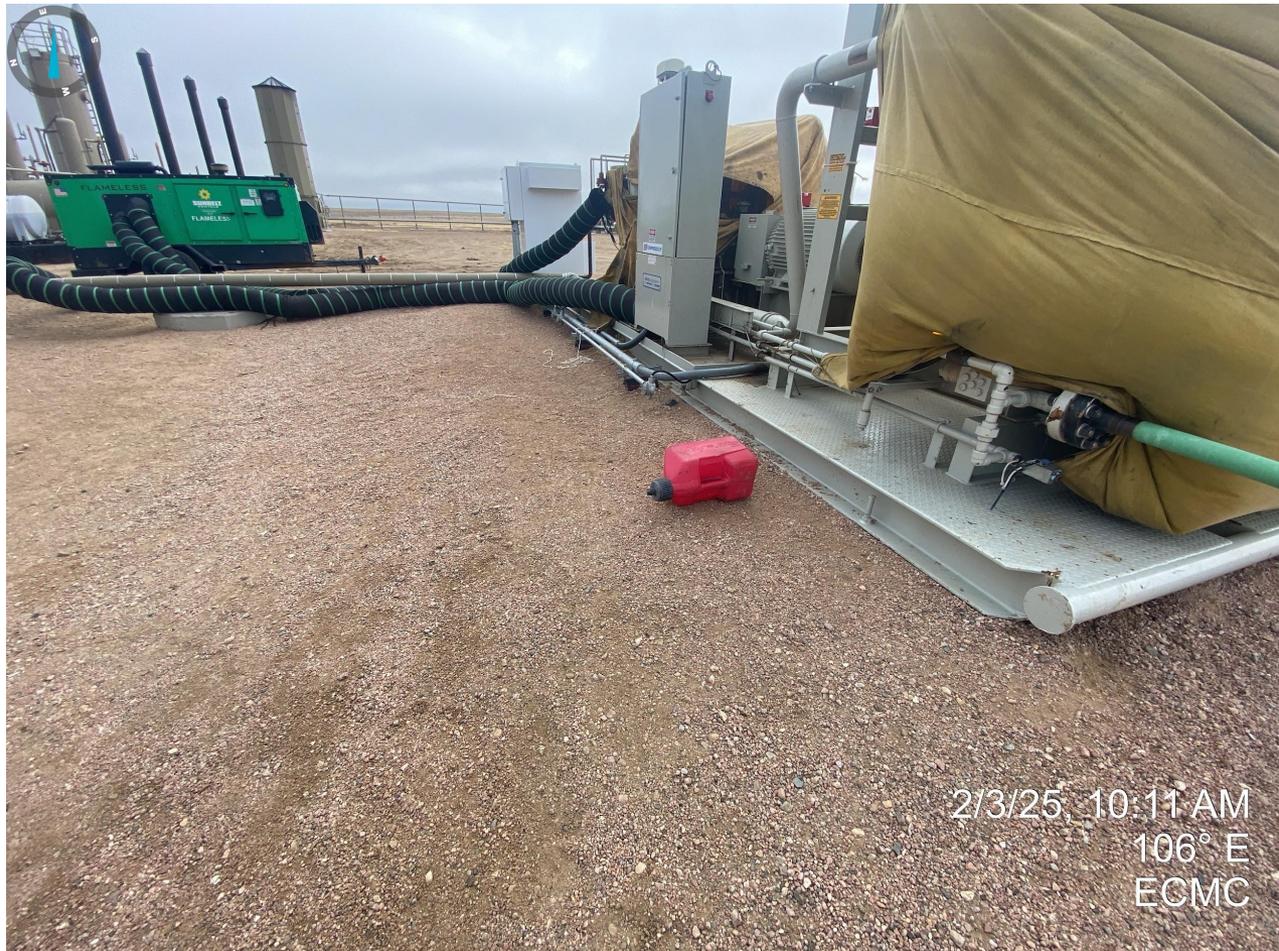
Photo 13. Gas can outside of secondary containment, near compressor.

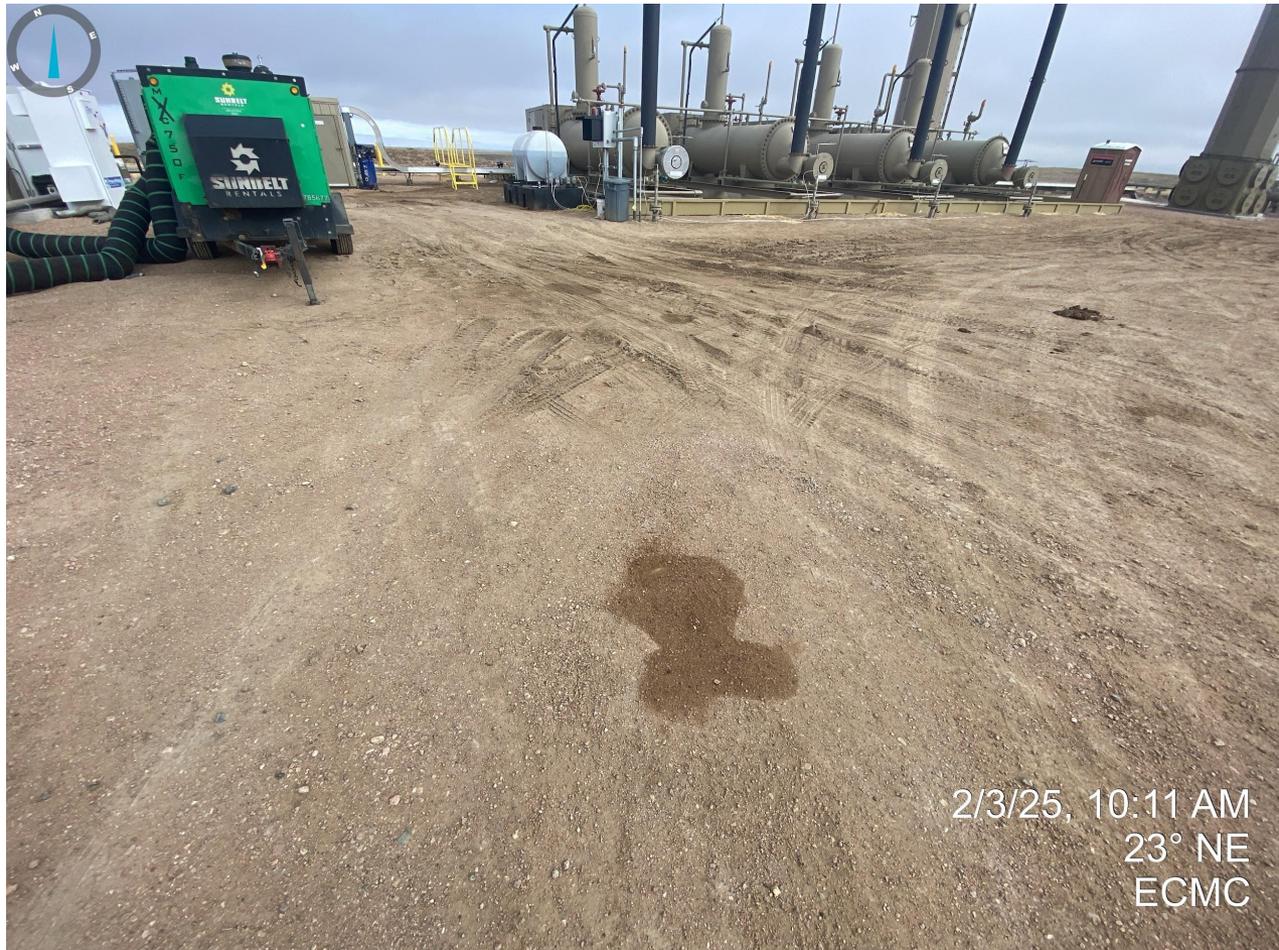
Photo 14. Stained soil east of compressor.

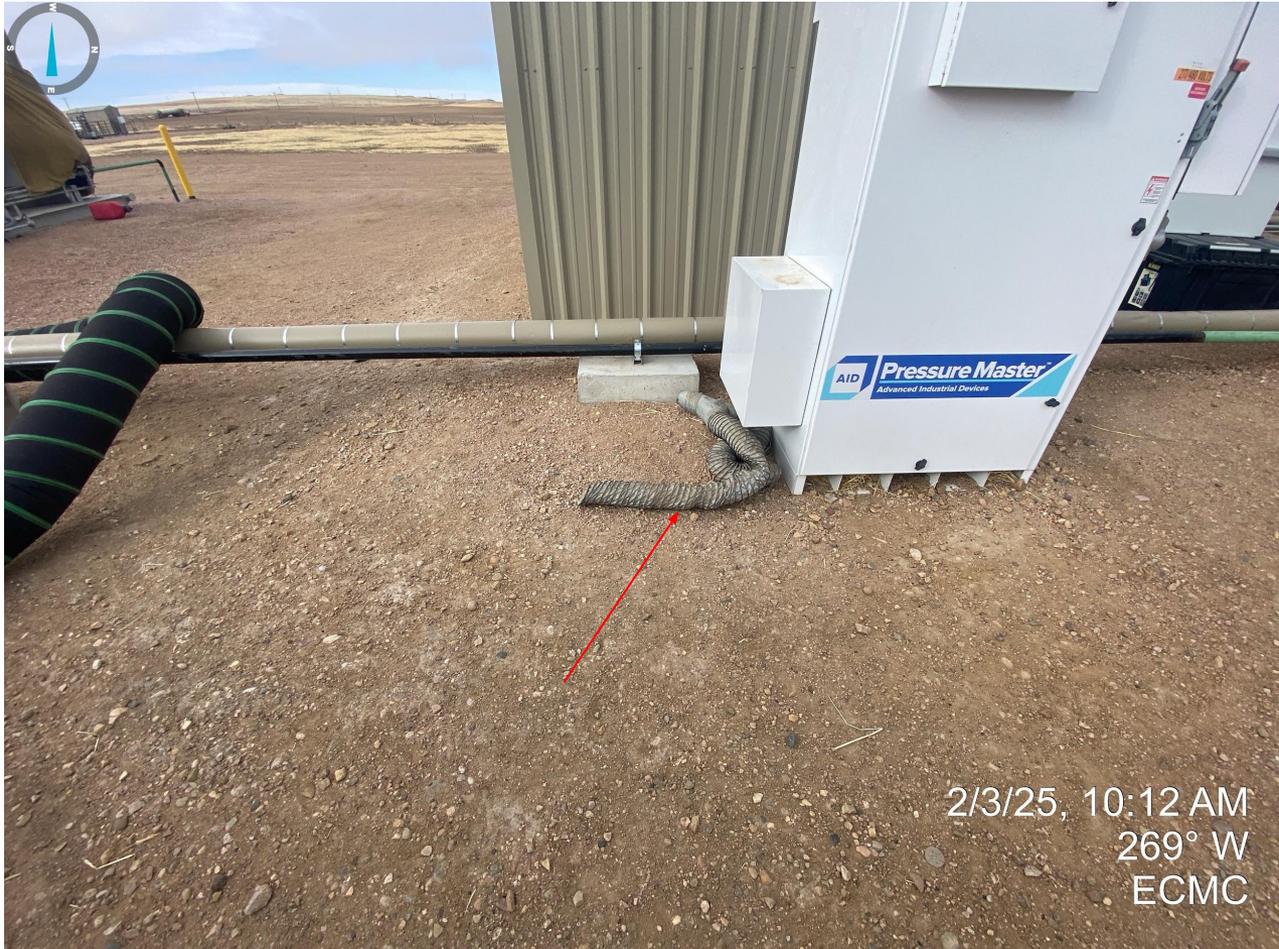
Photo 15. Debris/unused equipment near compressor.

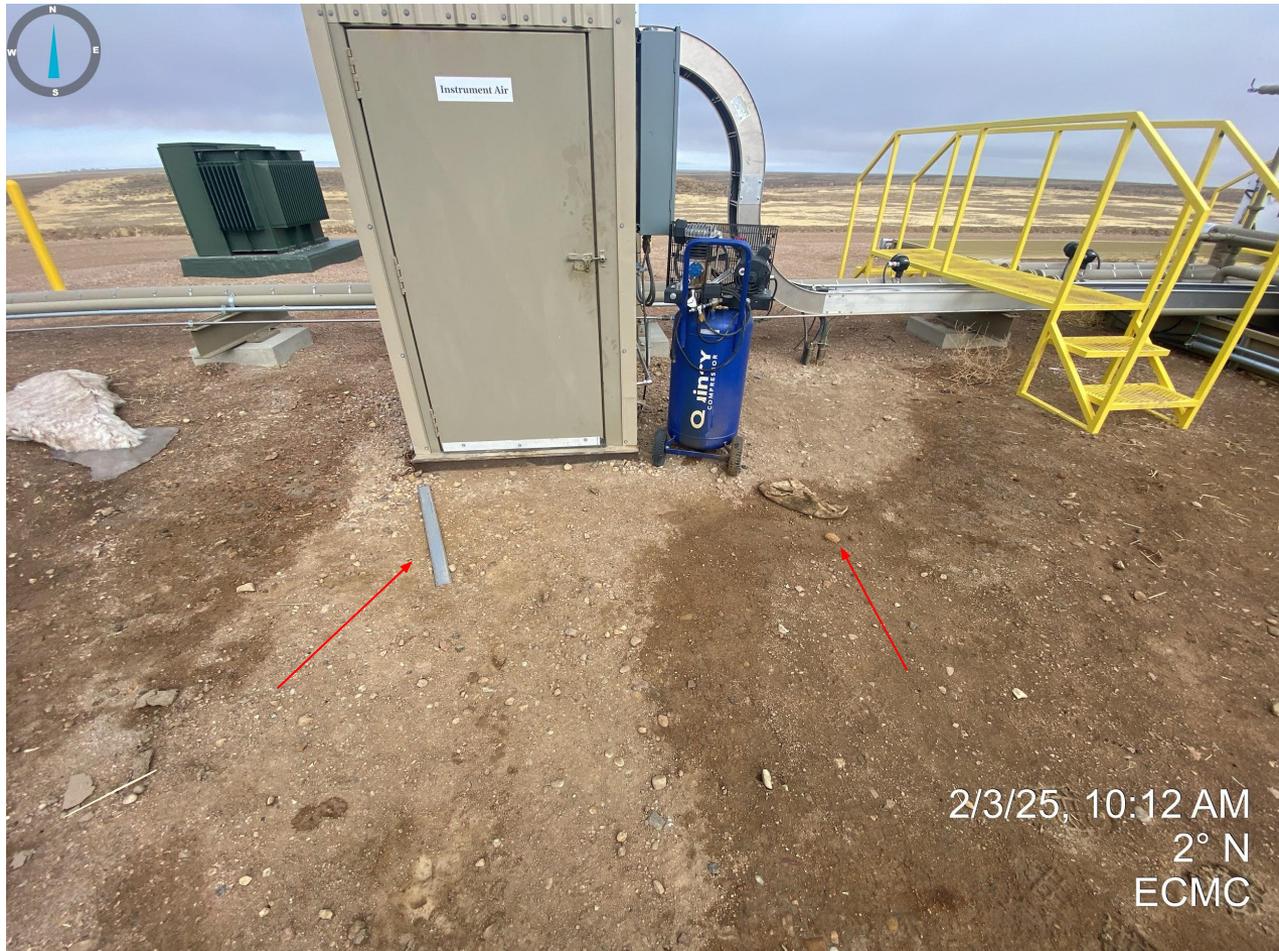
Photo 16. Trash/debris north of compressor station.

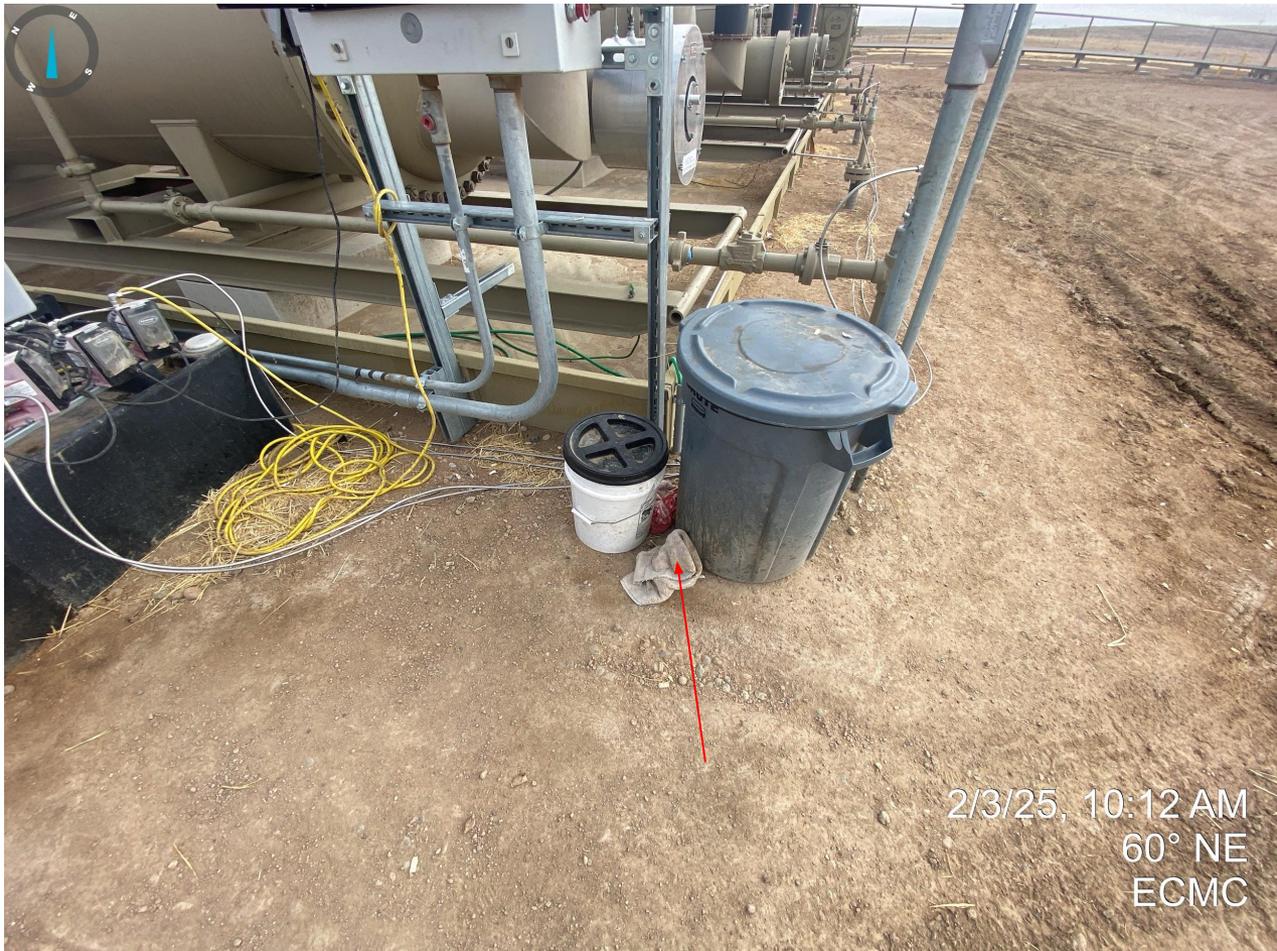
Photo 17. Trash/debris near separators.

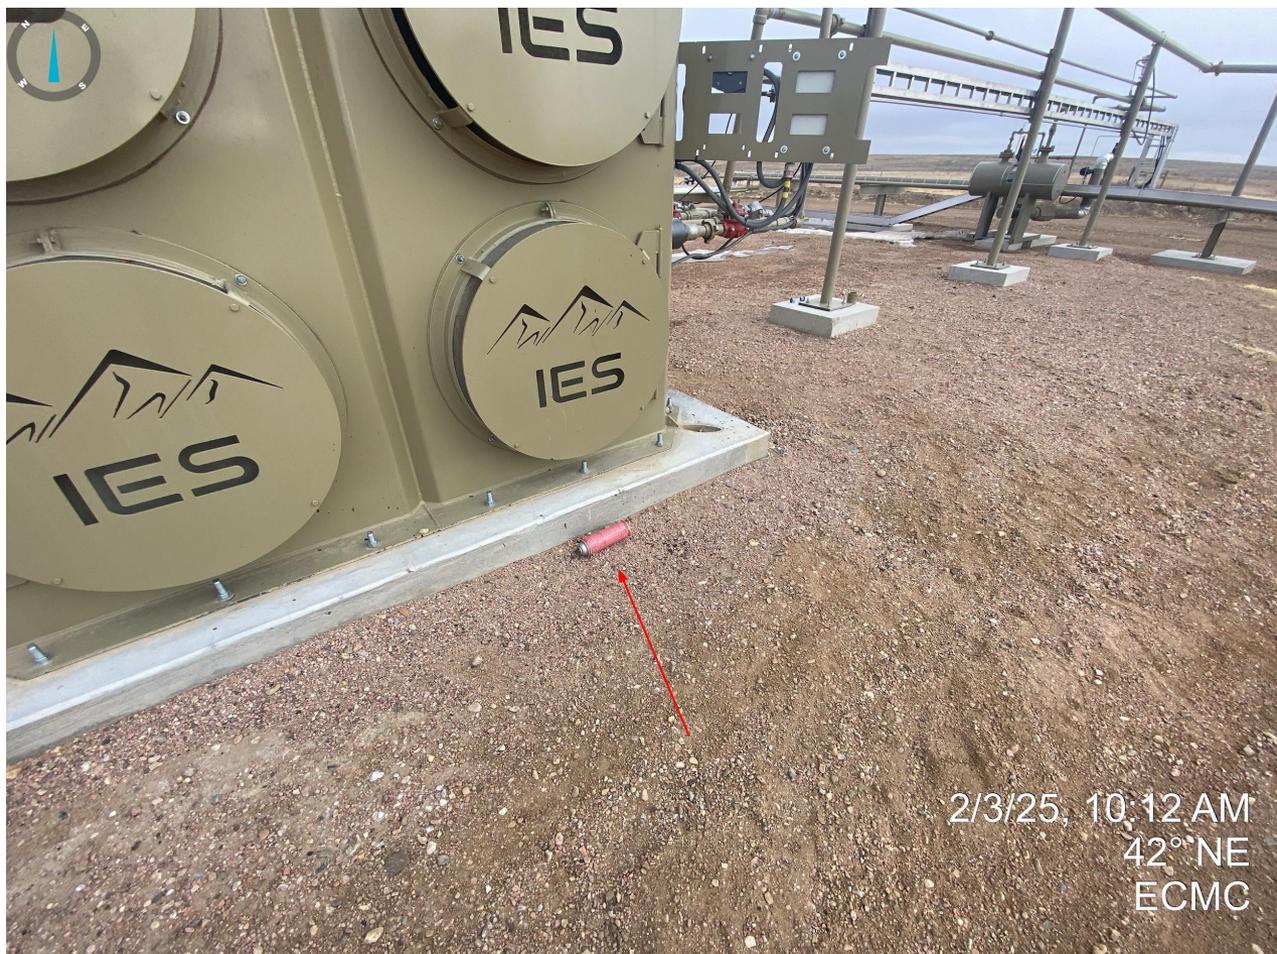
Photo 18. Trash/debris, north of tank battery.

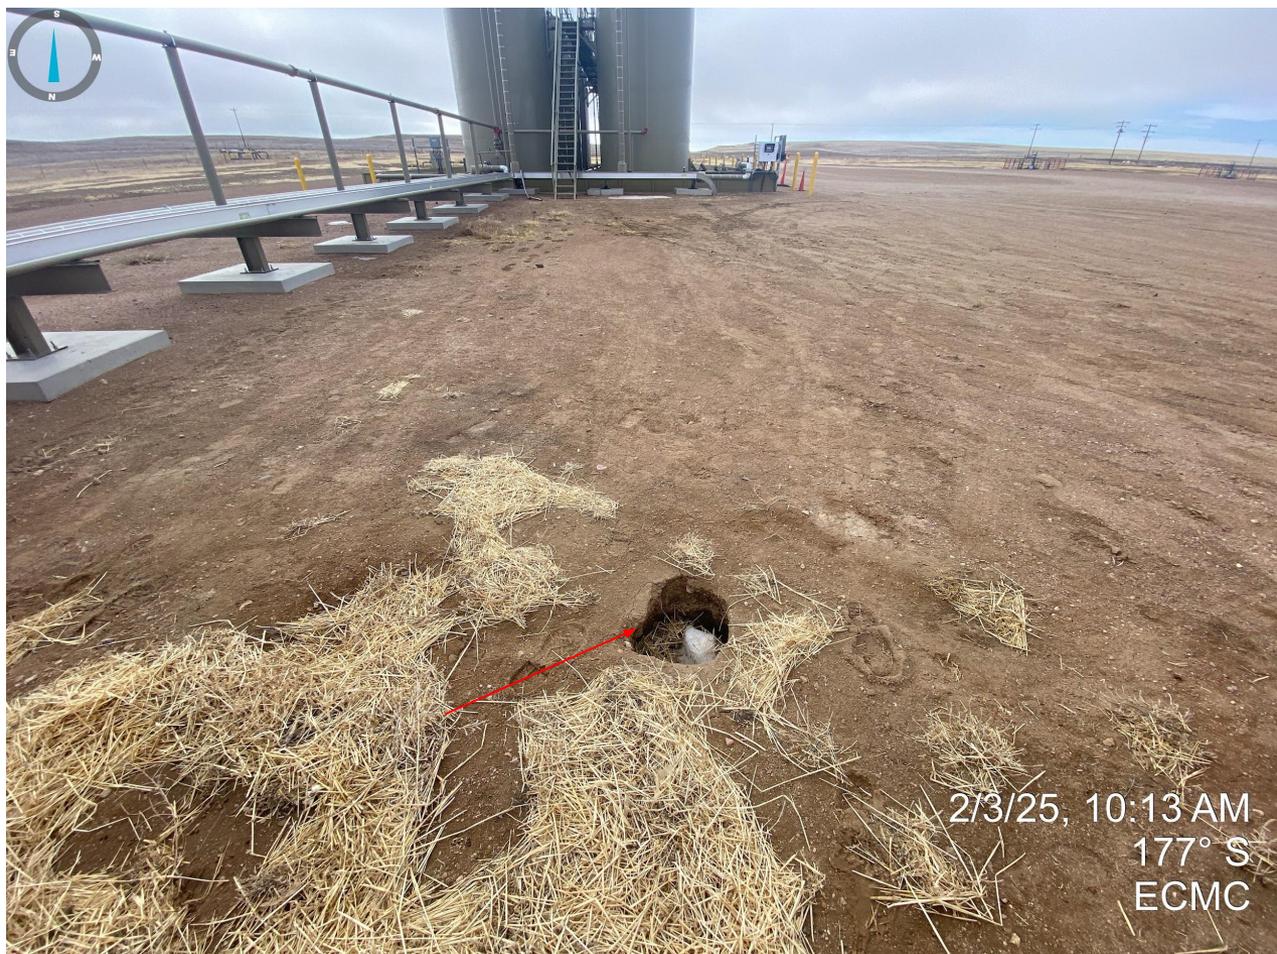
Photo 19. Pothole/subsidence north of tank battery.

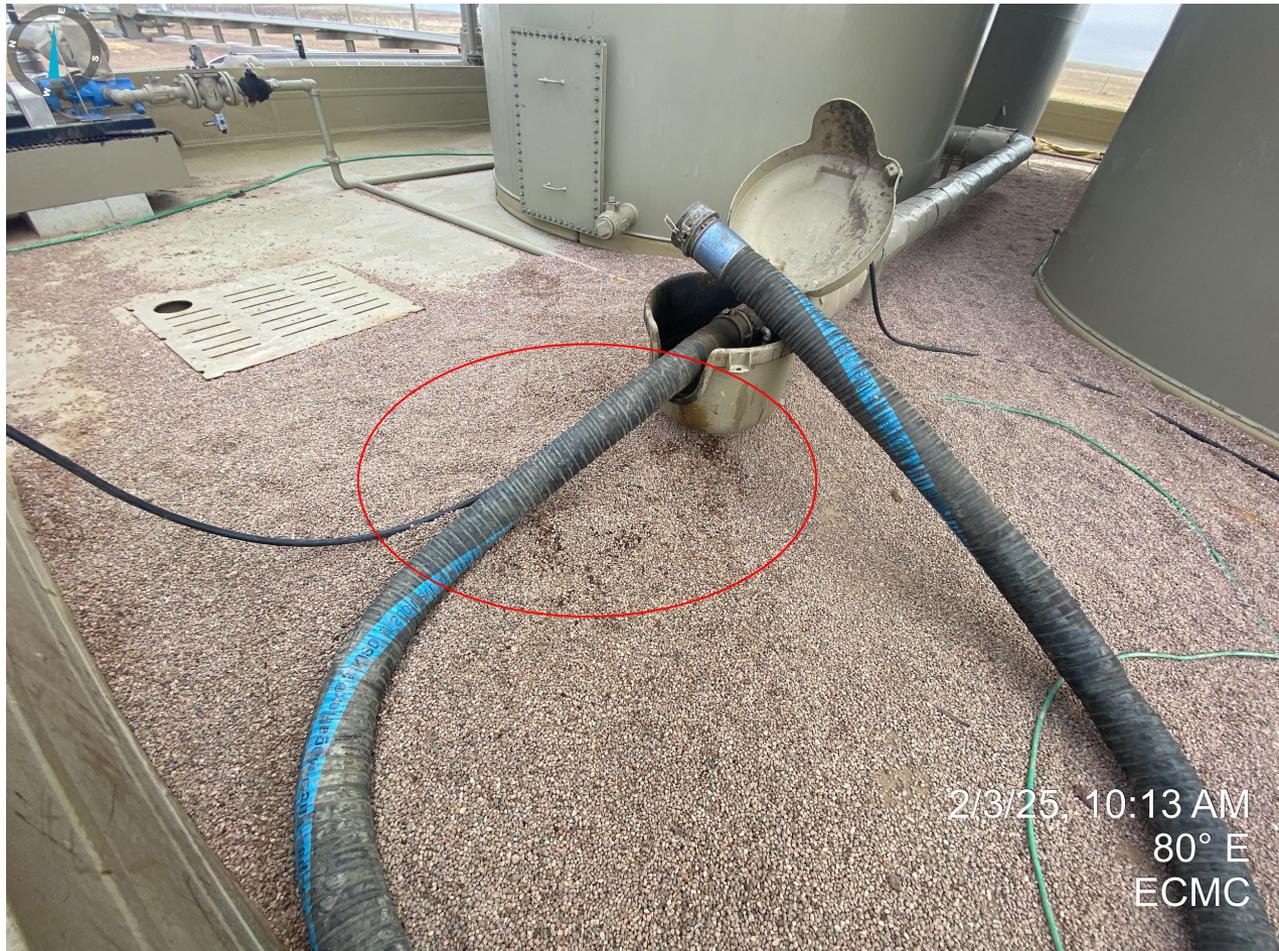
Photo 20. Stained soil observed near loadout lines.

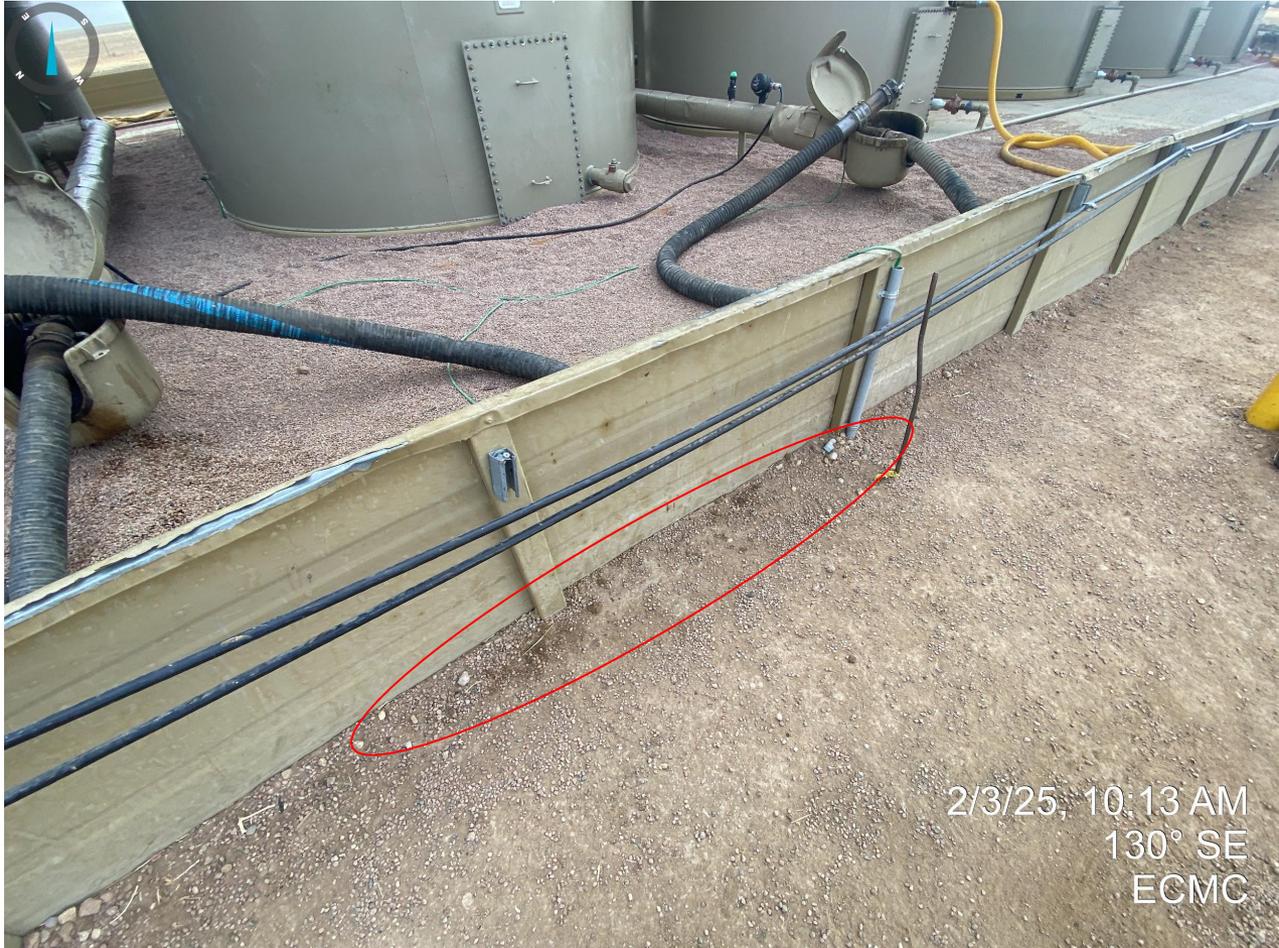
Photo 21. Stained soil observed near loadout lines, outside of secondary containment.

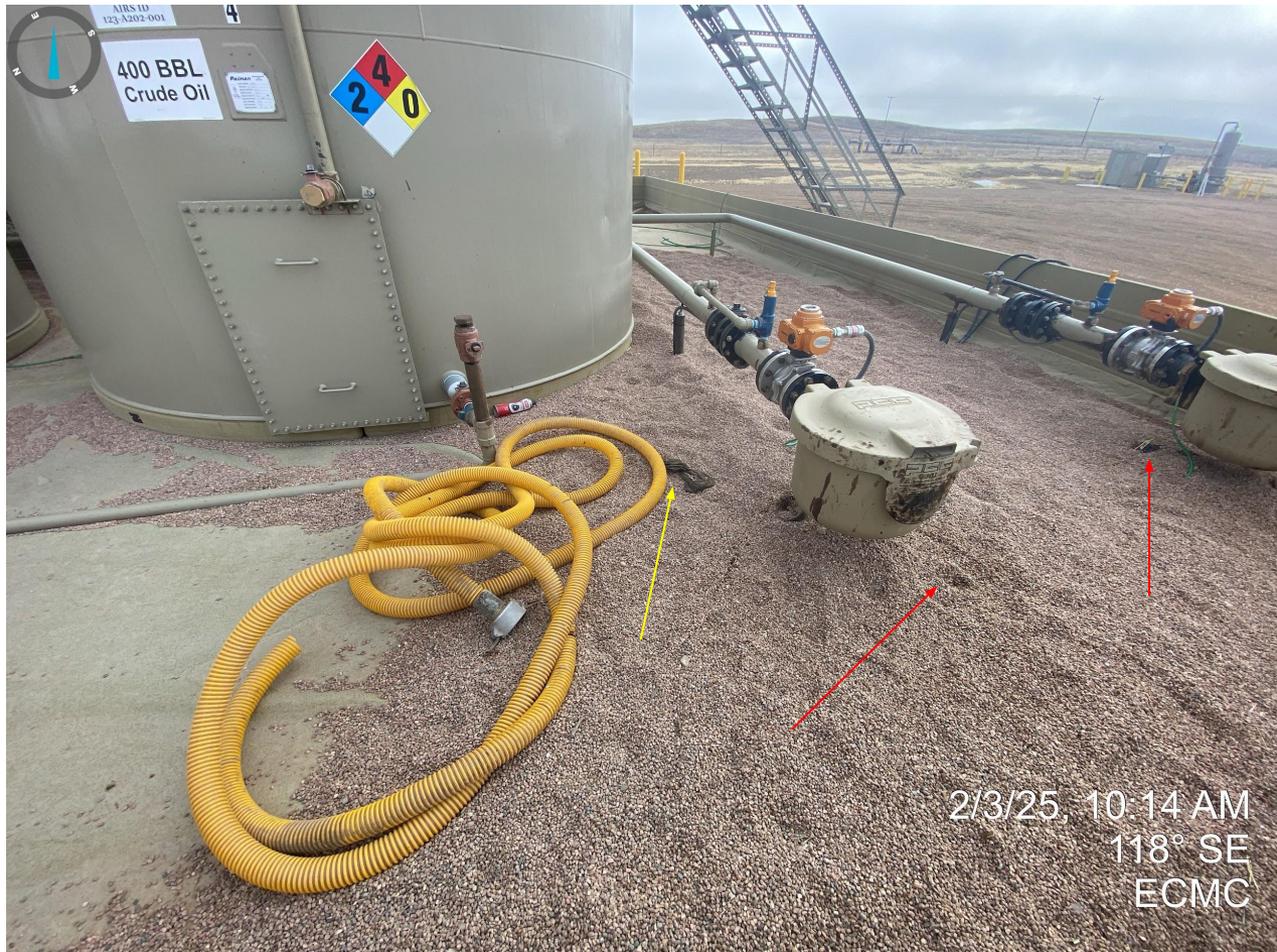
Photo 22. Stained soil observed near loadout lines, and oily rag (yellow arrow).
