Interim Reclamation and Stormwater Inspection

Date: 02/03/2025

Operator: MDS ENERGY DEVELOPMENT - 10814

Location ID: 471039

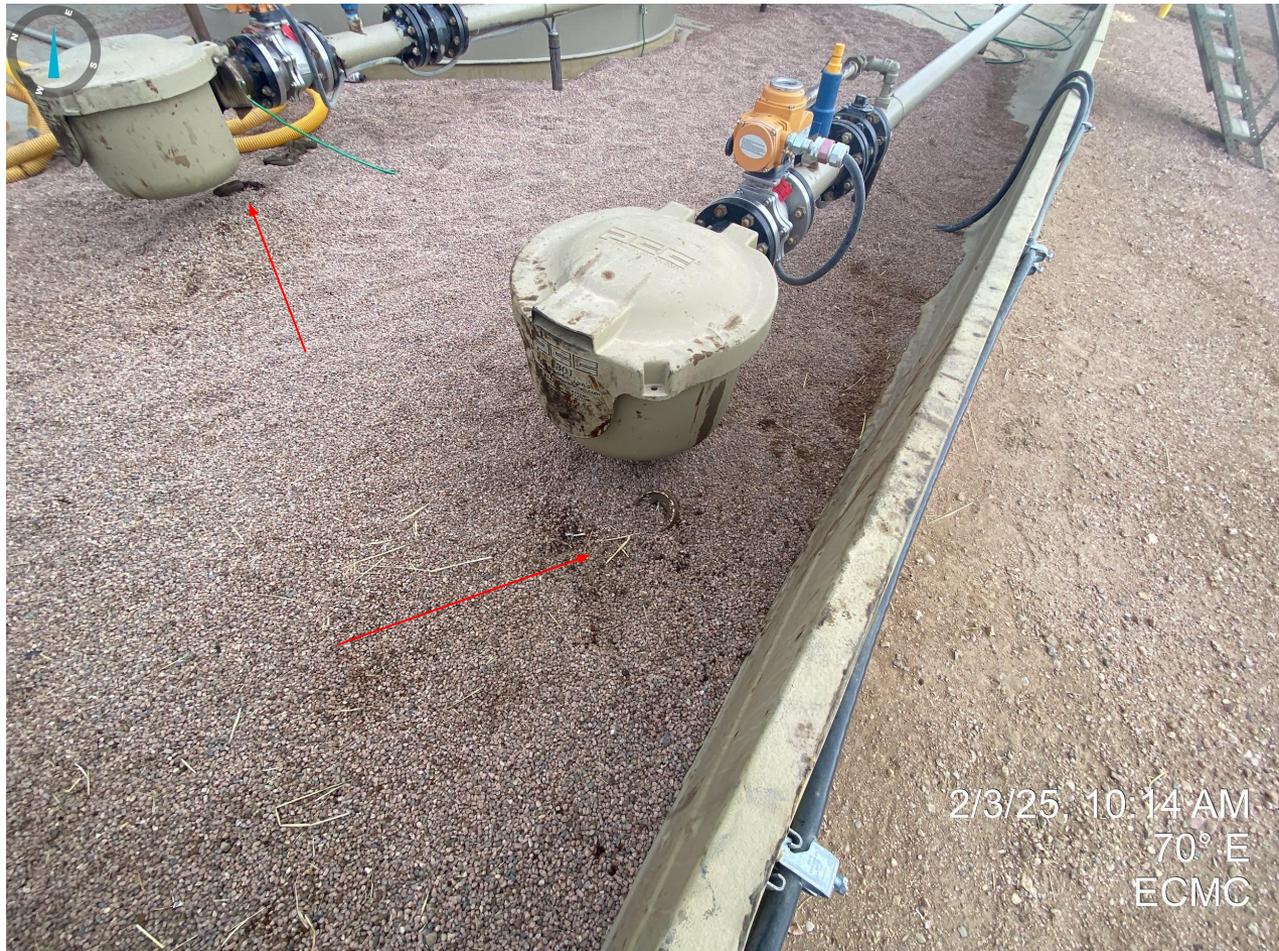
Photo 23. Continued from Photo 22; stained soil observed near loadout lines.

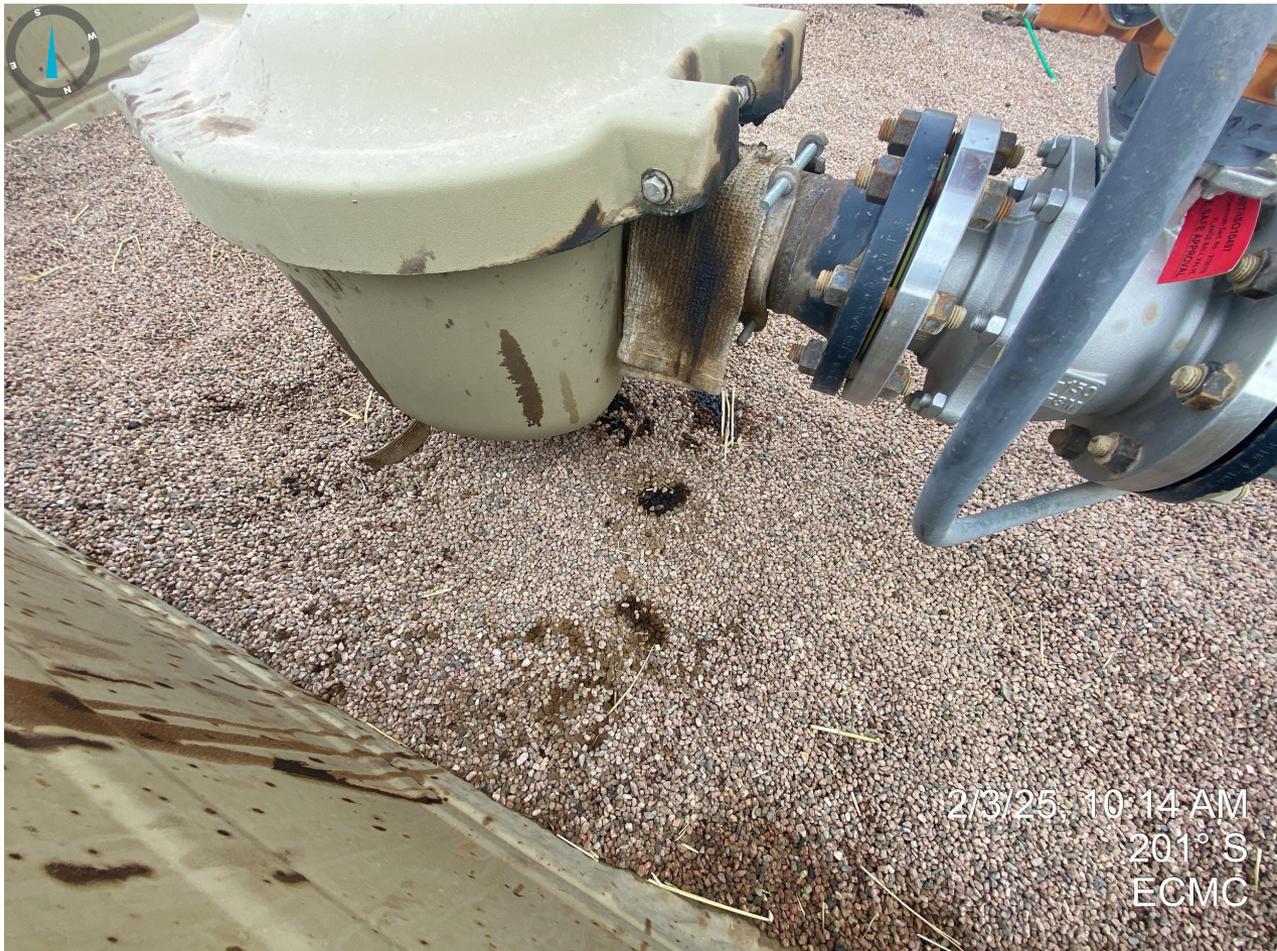
Photo 24. Continued from Photo 23; stained soil observed near loadout lines.

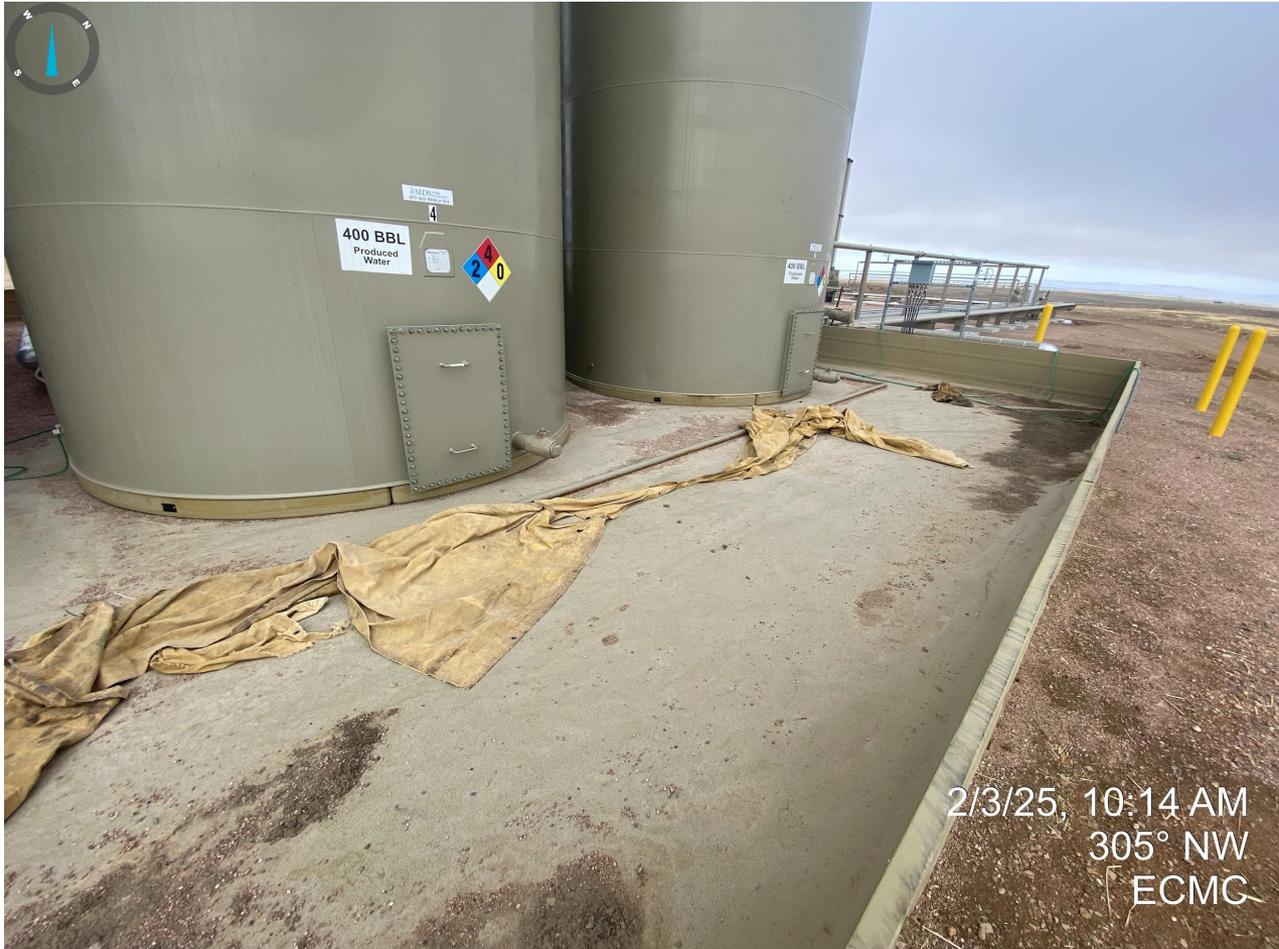
Photo 25. Trash/debris observed within tank battery secondary containment.

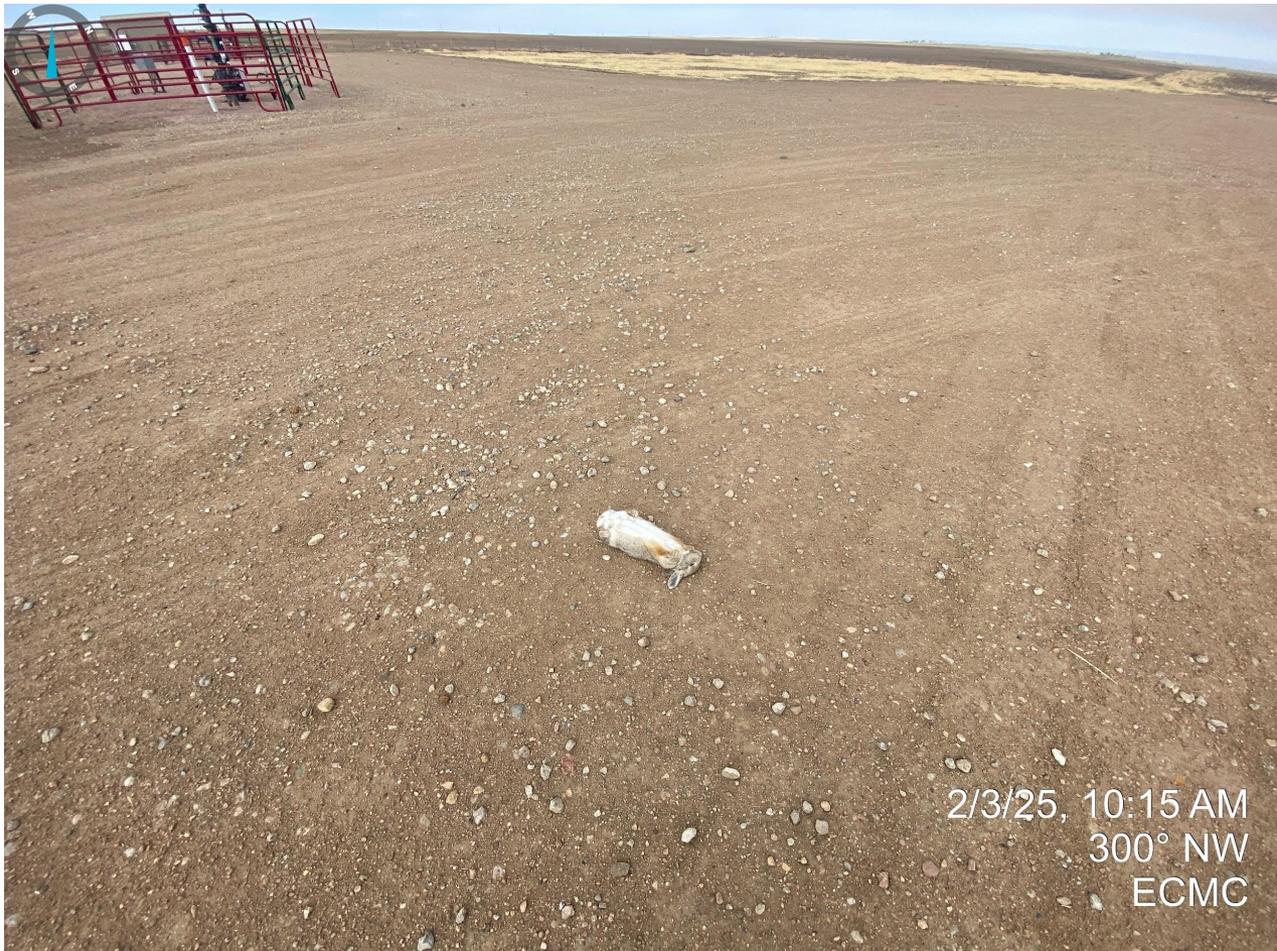
Photo 26. Wildlife mortality observed near well locations. ECMC Staff spoke with on-site Pumper and recommended that the Operator to reach out to CPW to notify of the mortality. This is being entered for documentation purposes.

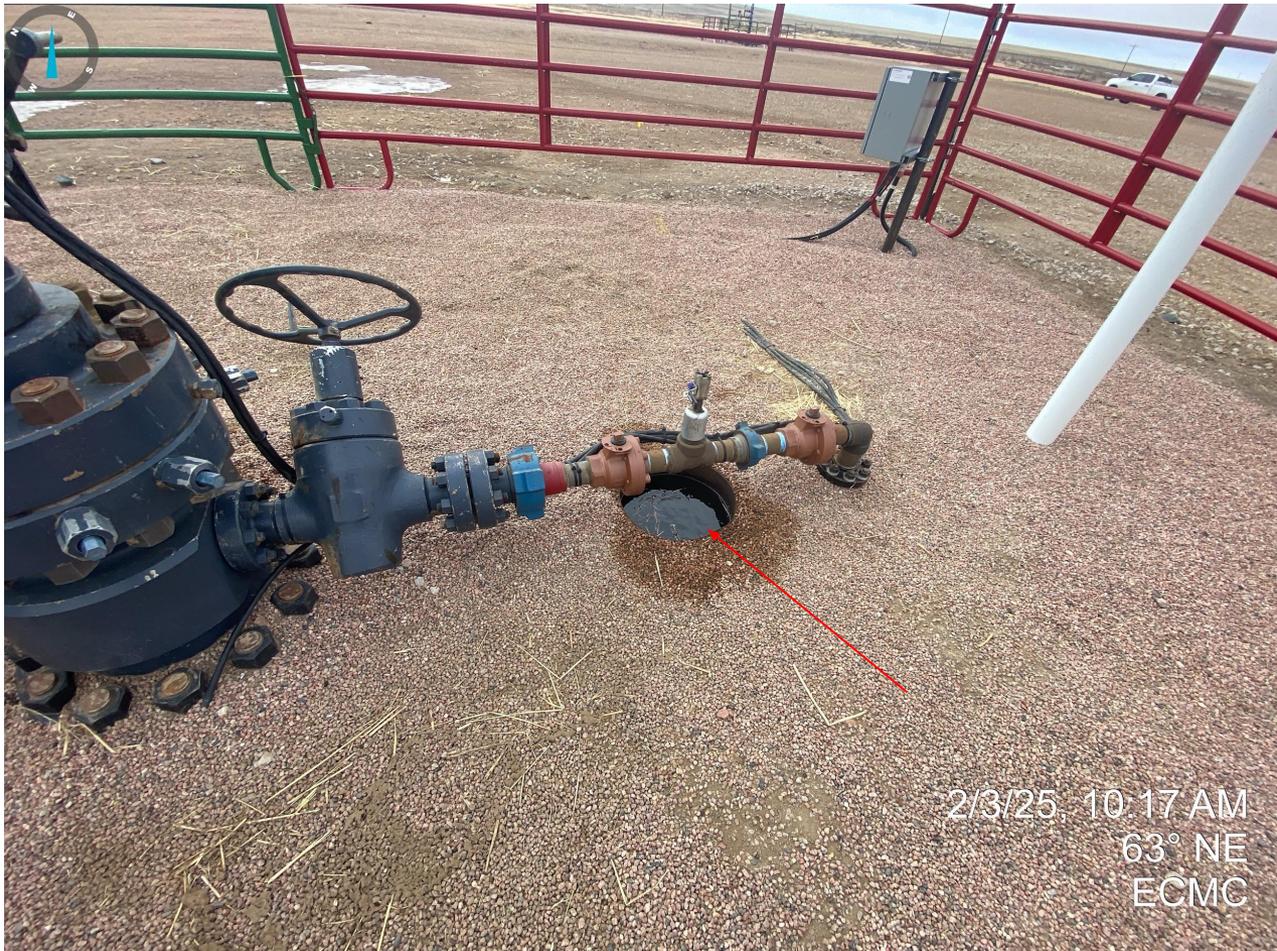
Photo 27. Pooled hydrocarbons were observed next to the wellhead (API #123-50751), inside of the rat/mouse hole area. This was previously documented in FIR (doc #708201524) conducted on 08/19/2024.

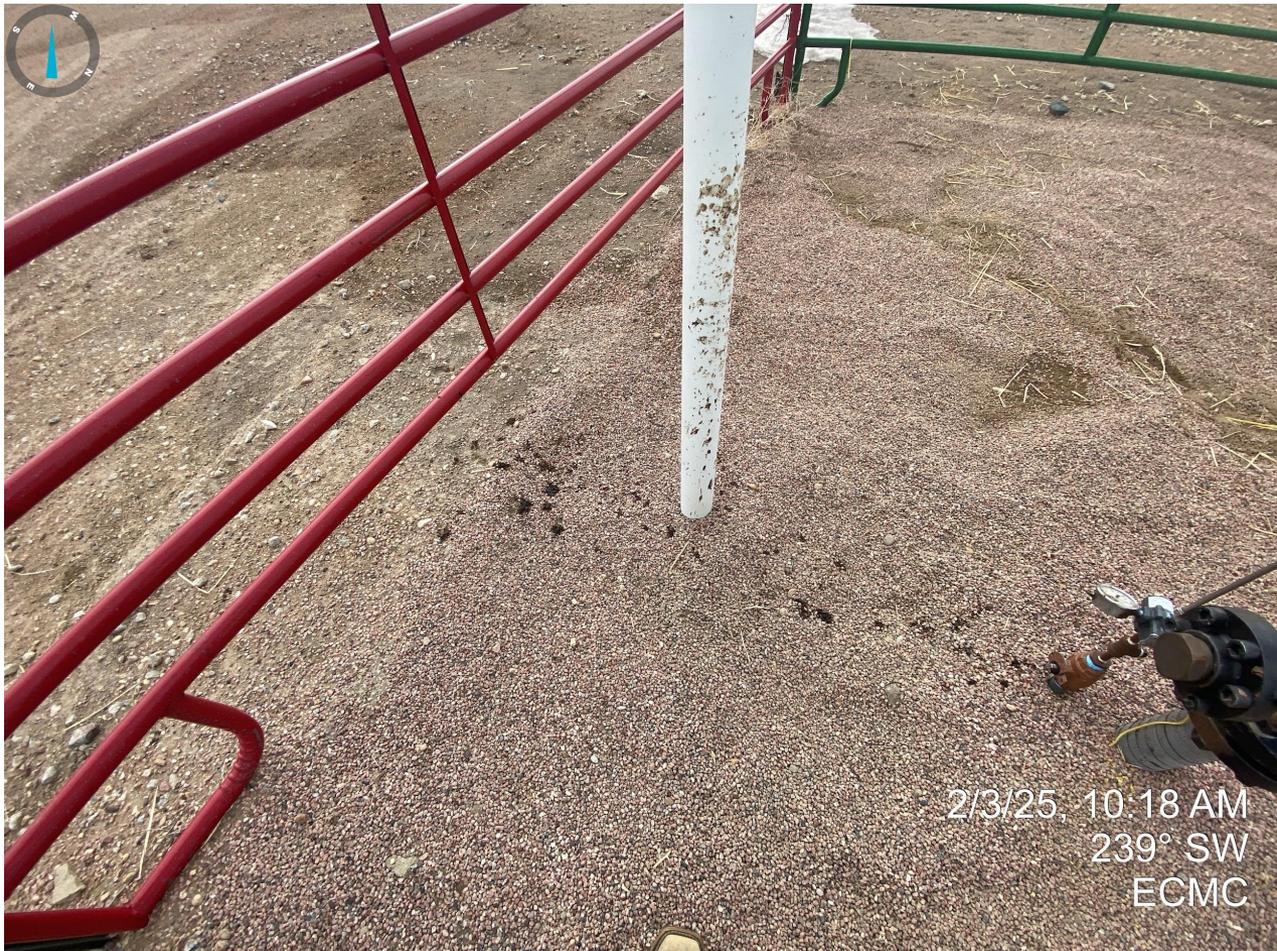
Photo 28. Continued from Photo 27; hydrocarbon staining observed near well head.

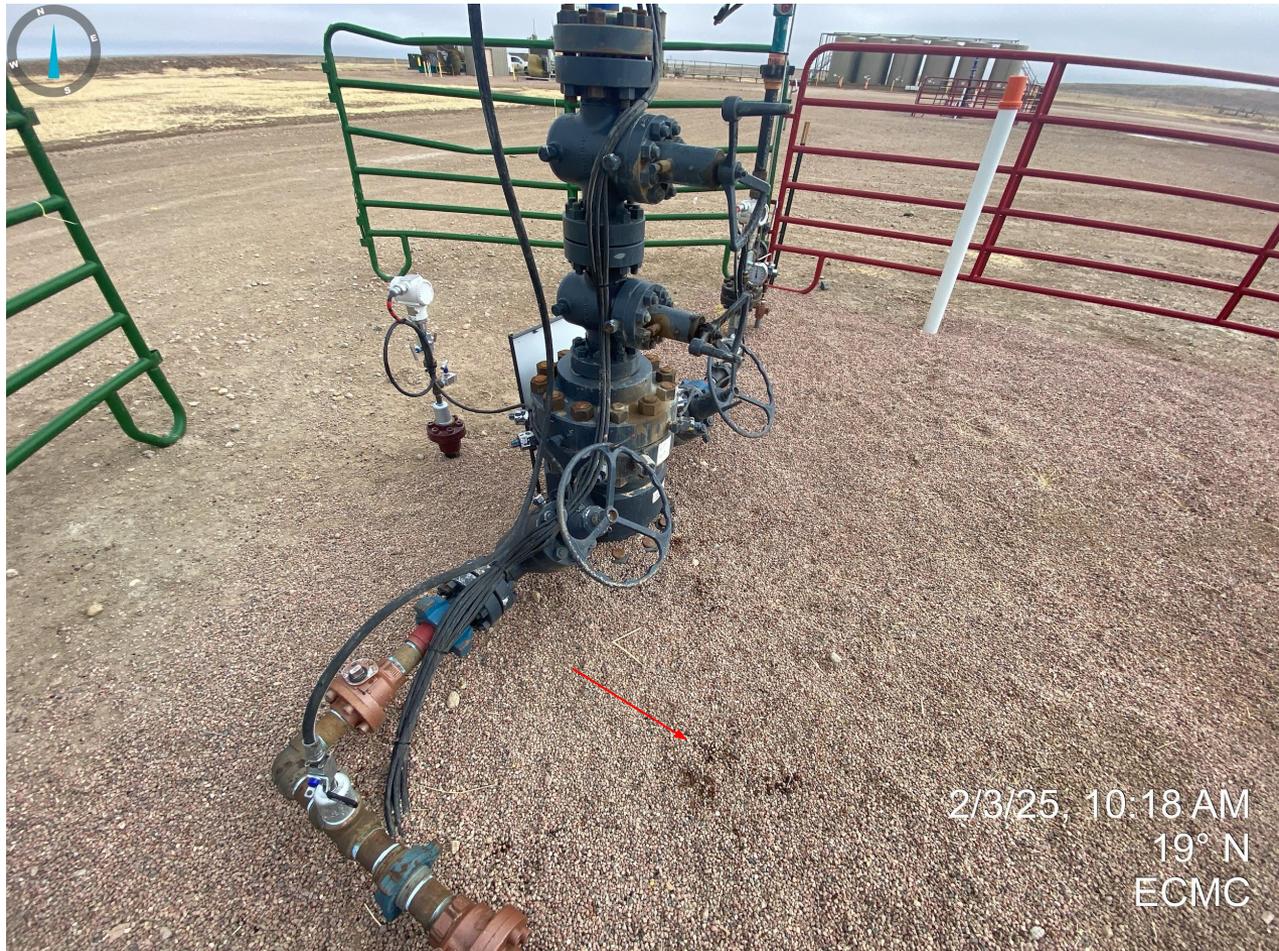
Photo 29. Stained soils observed at API #123- 50750.

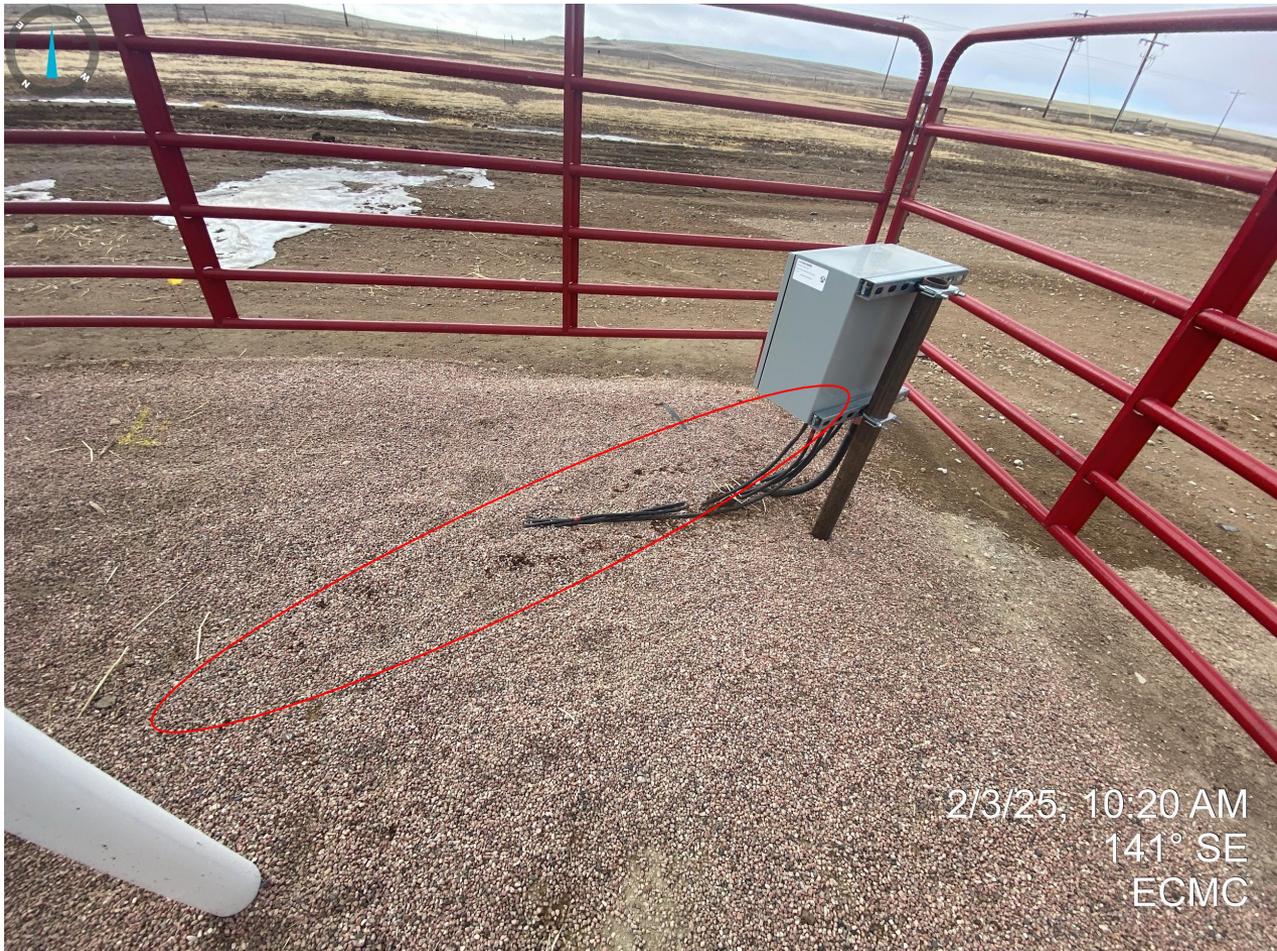
Photo 30. Stained soils observed at API #123- 50755.

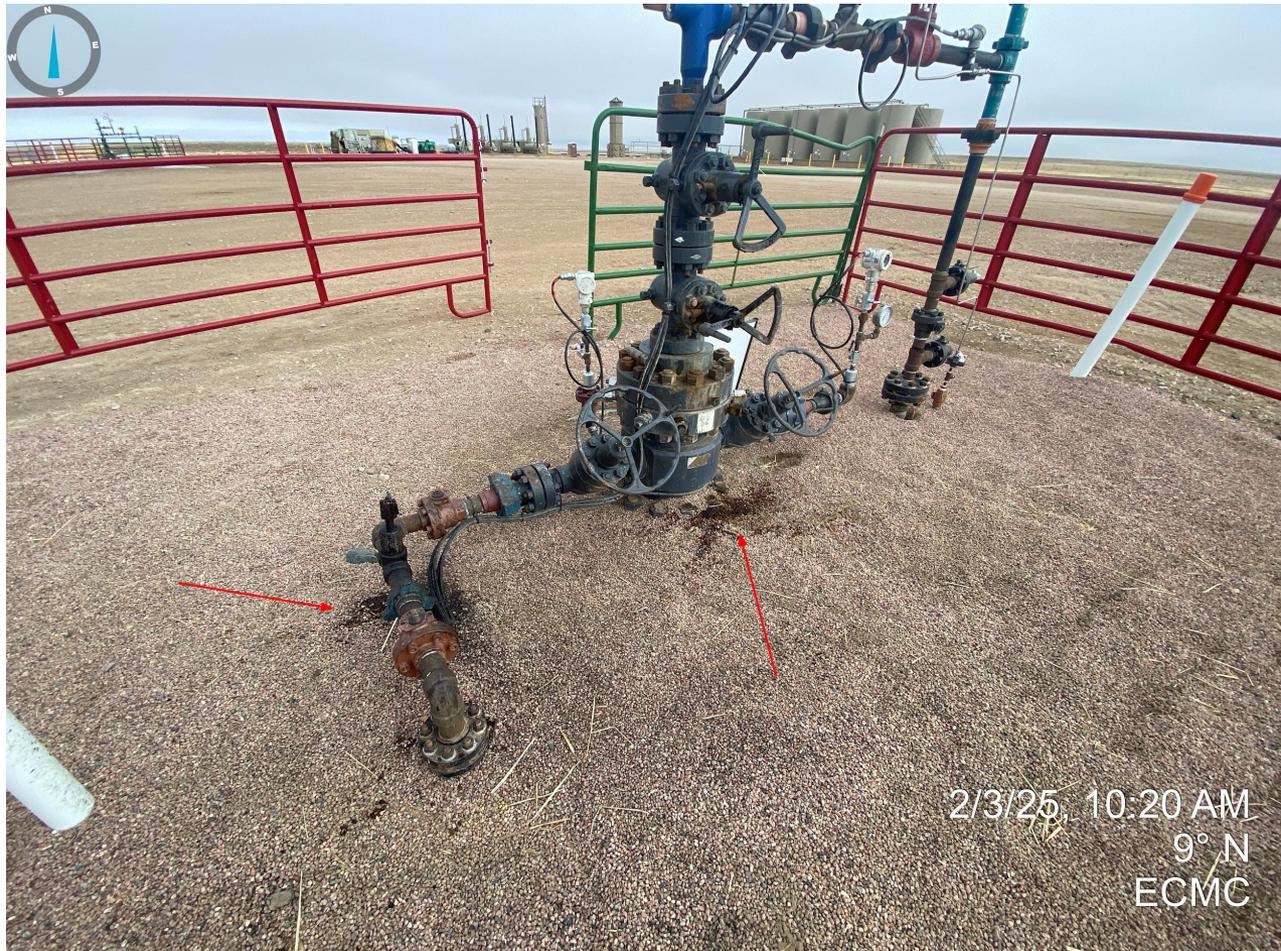
Photo 31. Continued from Photo 30; stain soil observed near wellhead.
