Inspection/Audit Photos
Location: QB ENERGY CHEVRON/O33 596 PAD
Location ID: 335872
Date: 01/30/2025

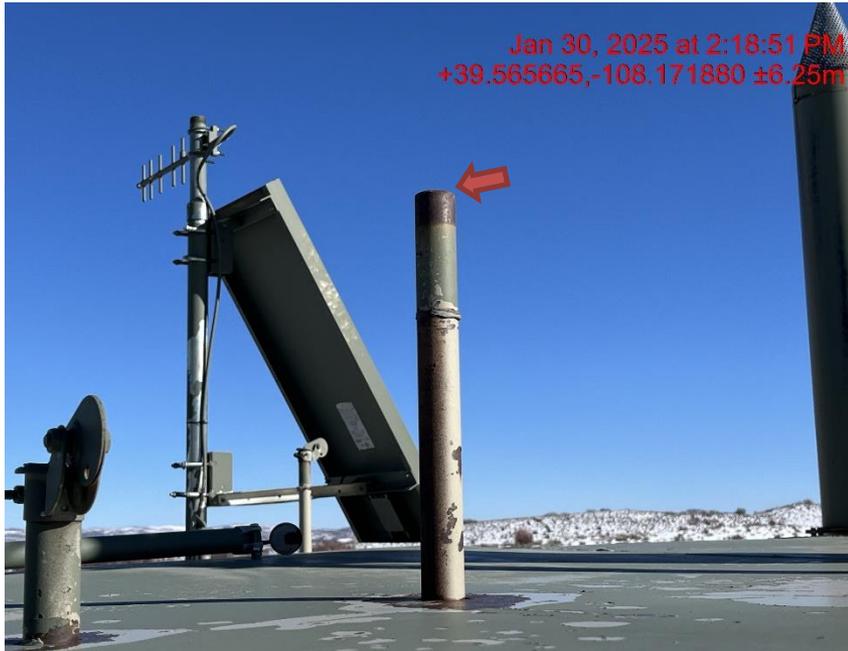
Photo # 3924 PRV vent line does not comply with CECMC pressure safety device rules

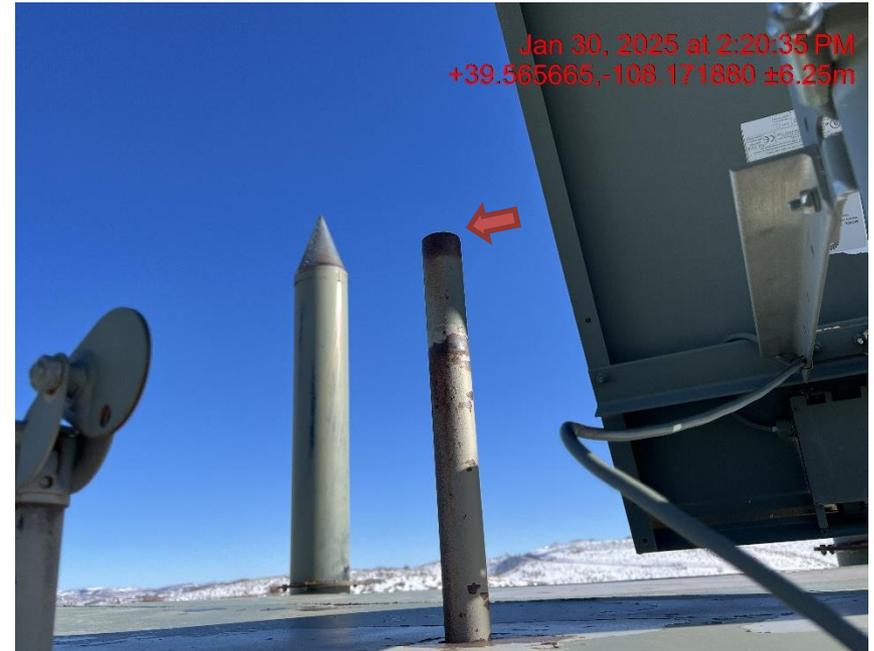
Photo # 3927 PRV vent line does not comply with CECMC pressure safety device rules

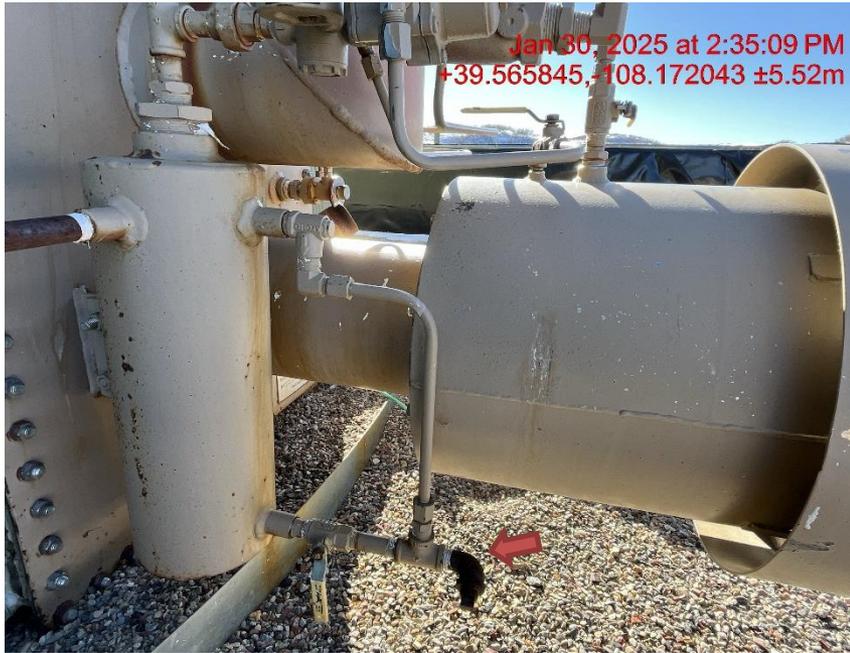
Photo # 3943 PRV vent line does not comply with CECMC pressure safety device rules

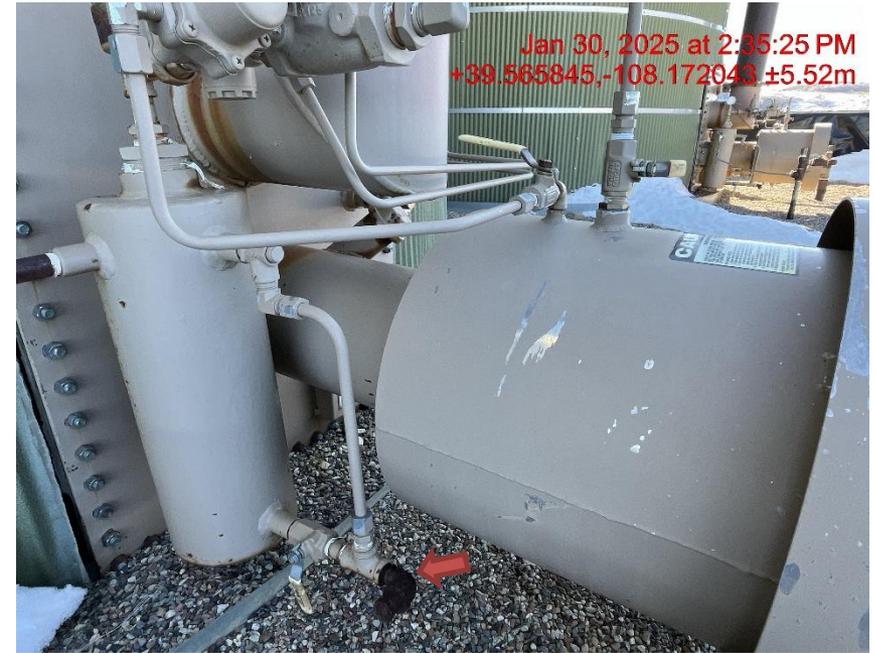
Photo # 3944 PRV vent line does not comply with CECMC pressure safety device rules

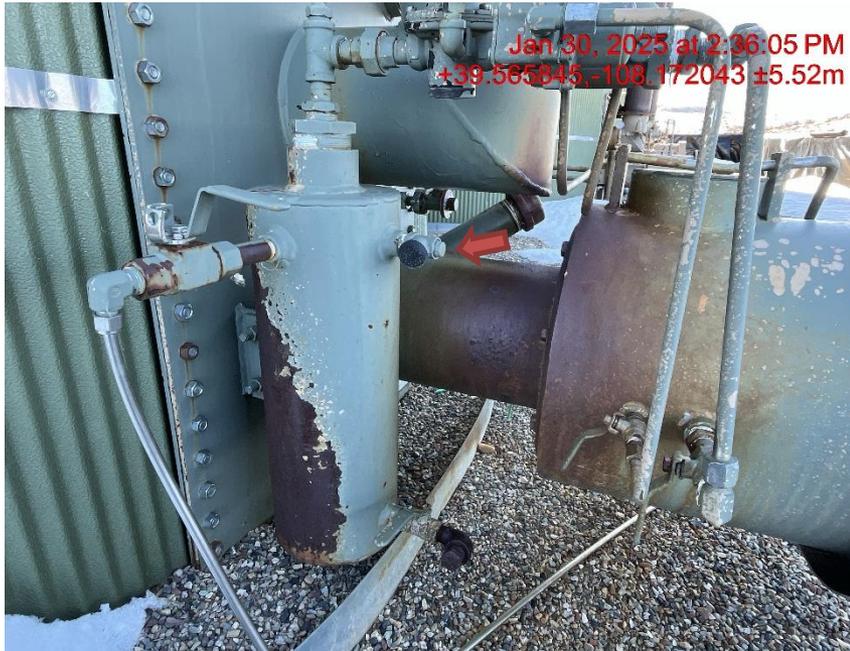
Photo # 3945 PRV vent line does not comply with CECMC pressure safety device rules

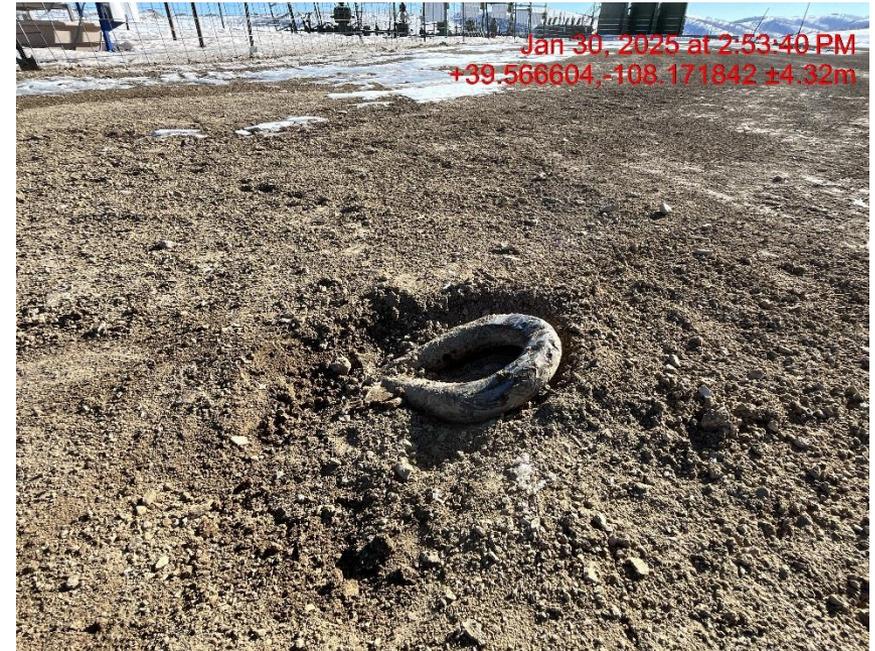
Photo # 3959 Unmarked deadman

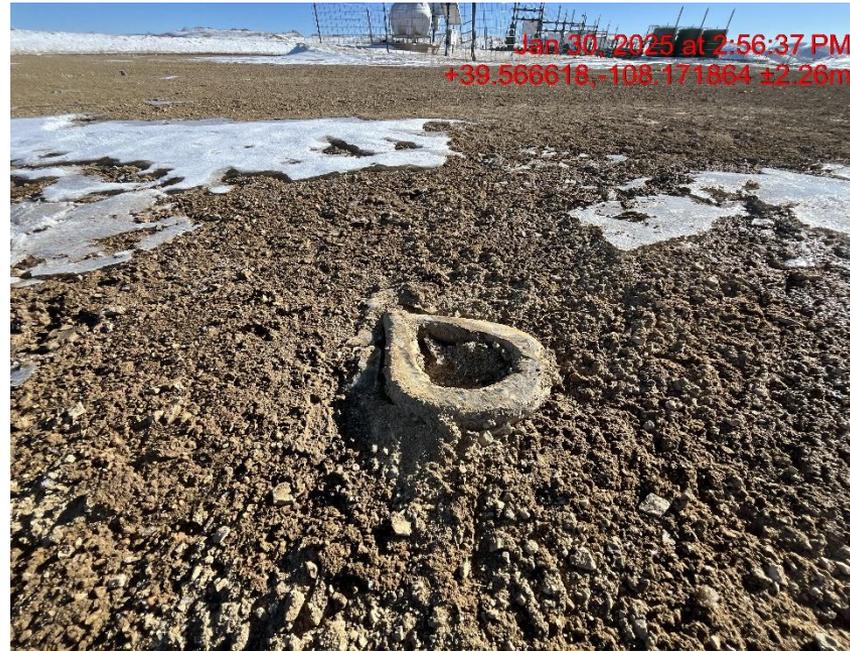
Photo # 3690 Unmarked deadman
