Inspection/Audit Photos

Location: VISION ENERGY LLC USA-67S99W/28SEW (USA 1-28DF)

Location ID: 322450

Date: 02/3/2025

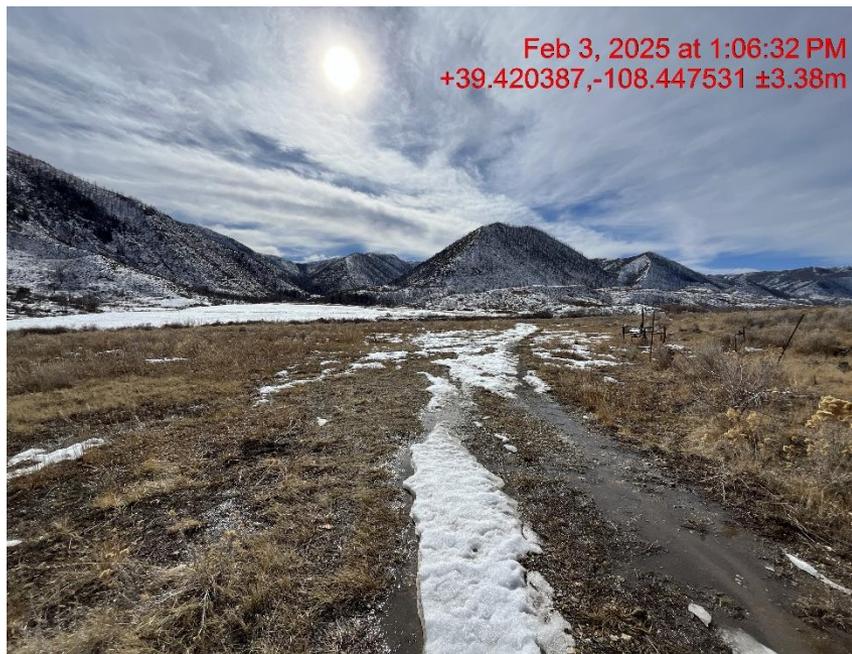
Photo # 3998 Entrance to location

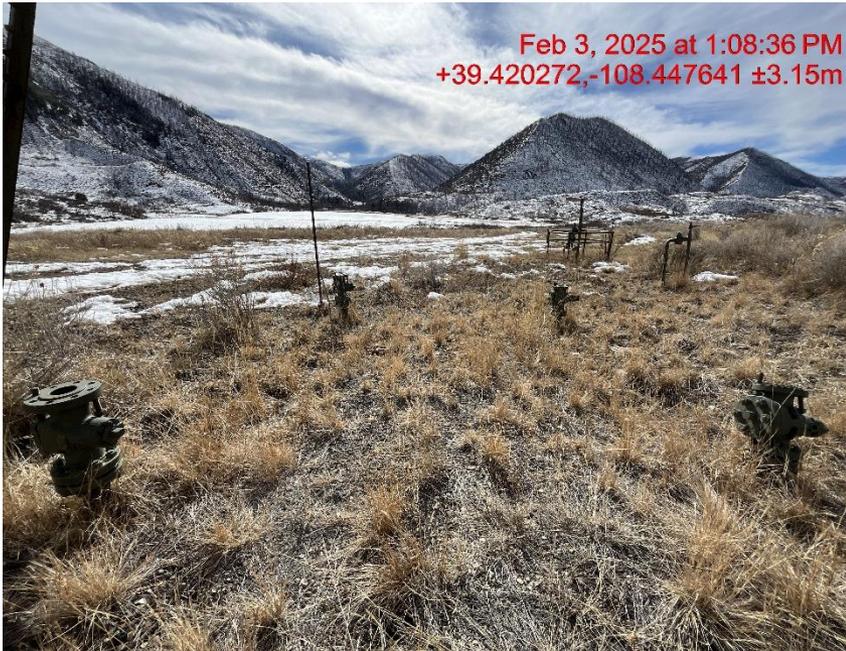
Photo # 4000 Equipment on location is not in compliance with CECMC reclamation rules

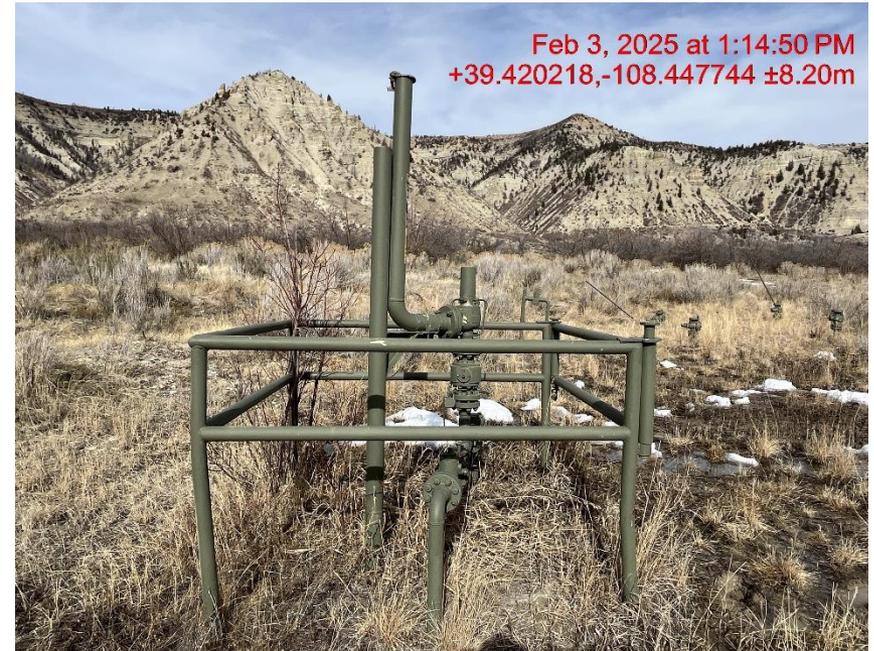
Photo # 4008 Equipment on location is not in compliance with CECMC reclamation rules

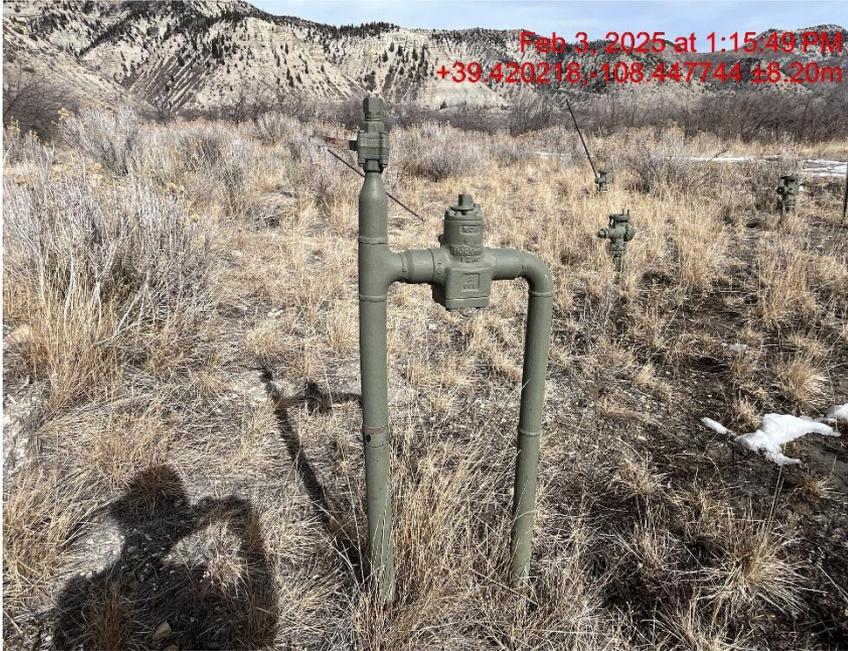
Photo # 4010 Equipment on location is not in compliance with CECMC reclamation rules

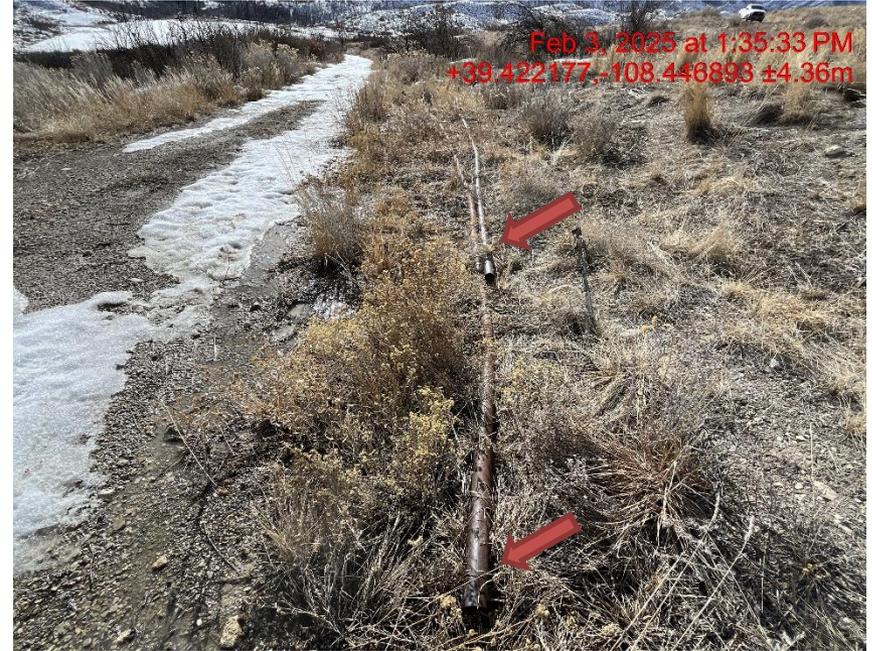
Photo # 4024 Debris
