Herman UPRR 31-31.1  
© 04-Feb-25 11:55:33 AM  
ECMC Environmental Inspection

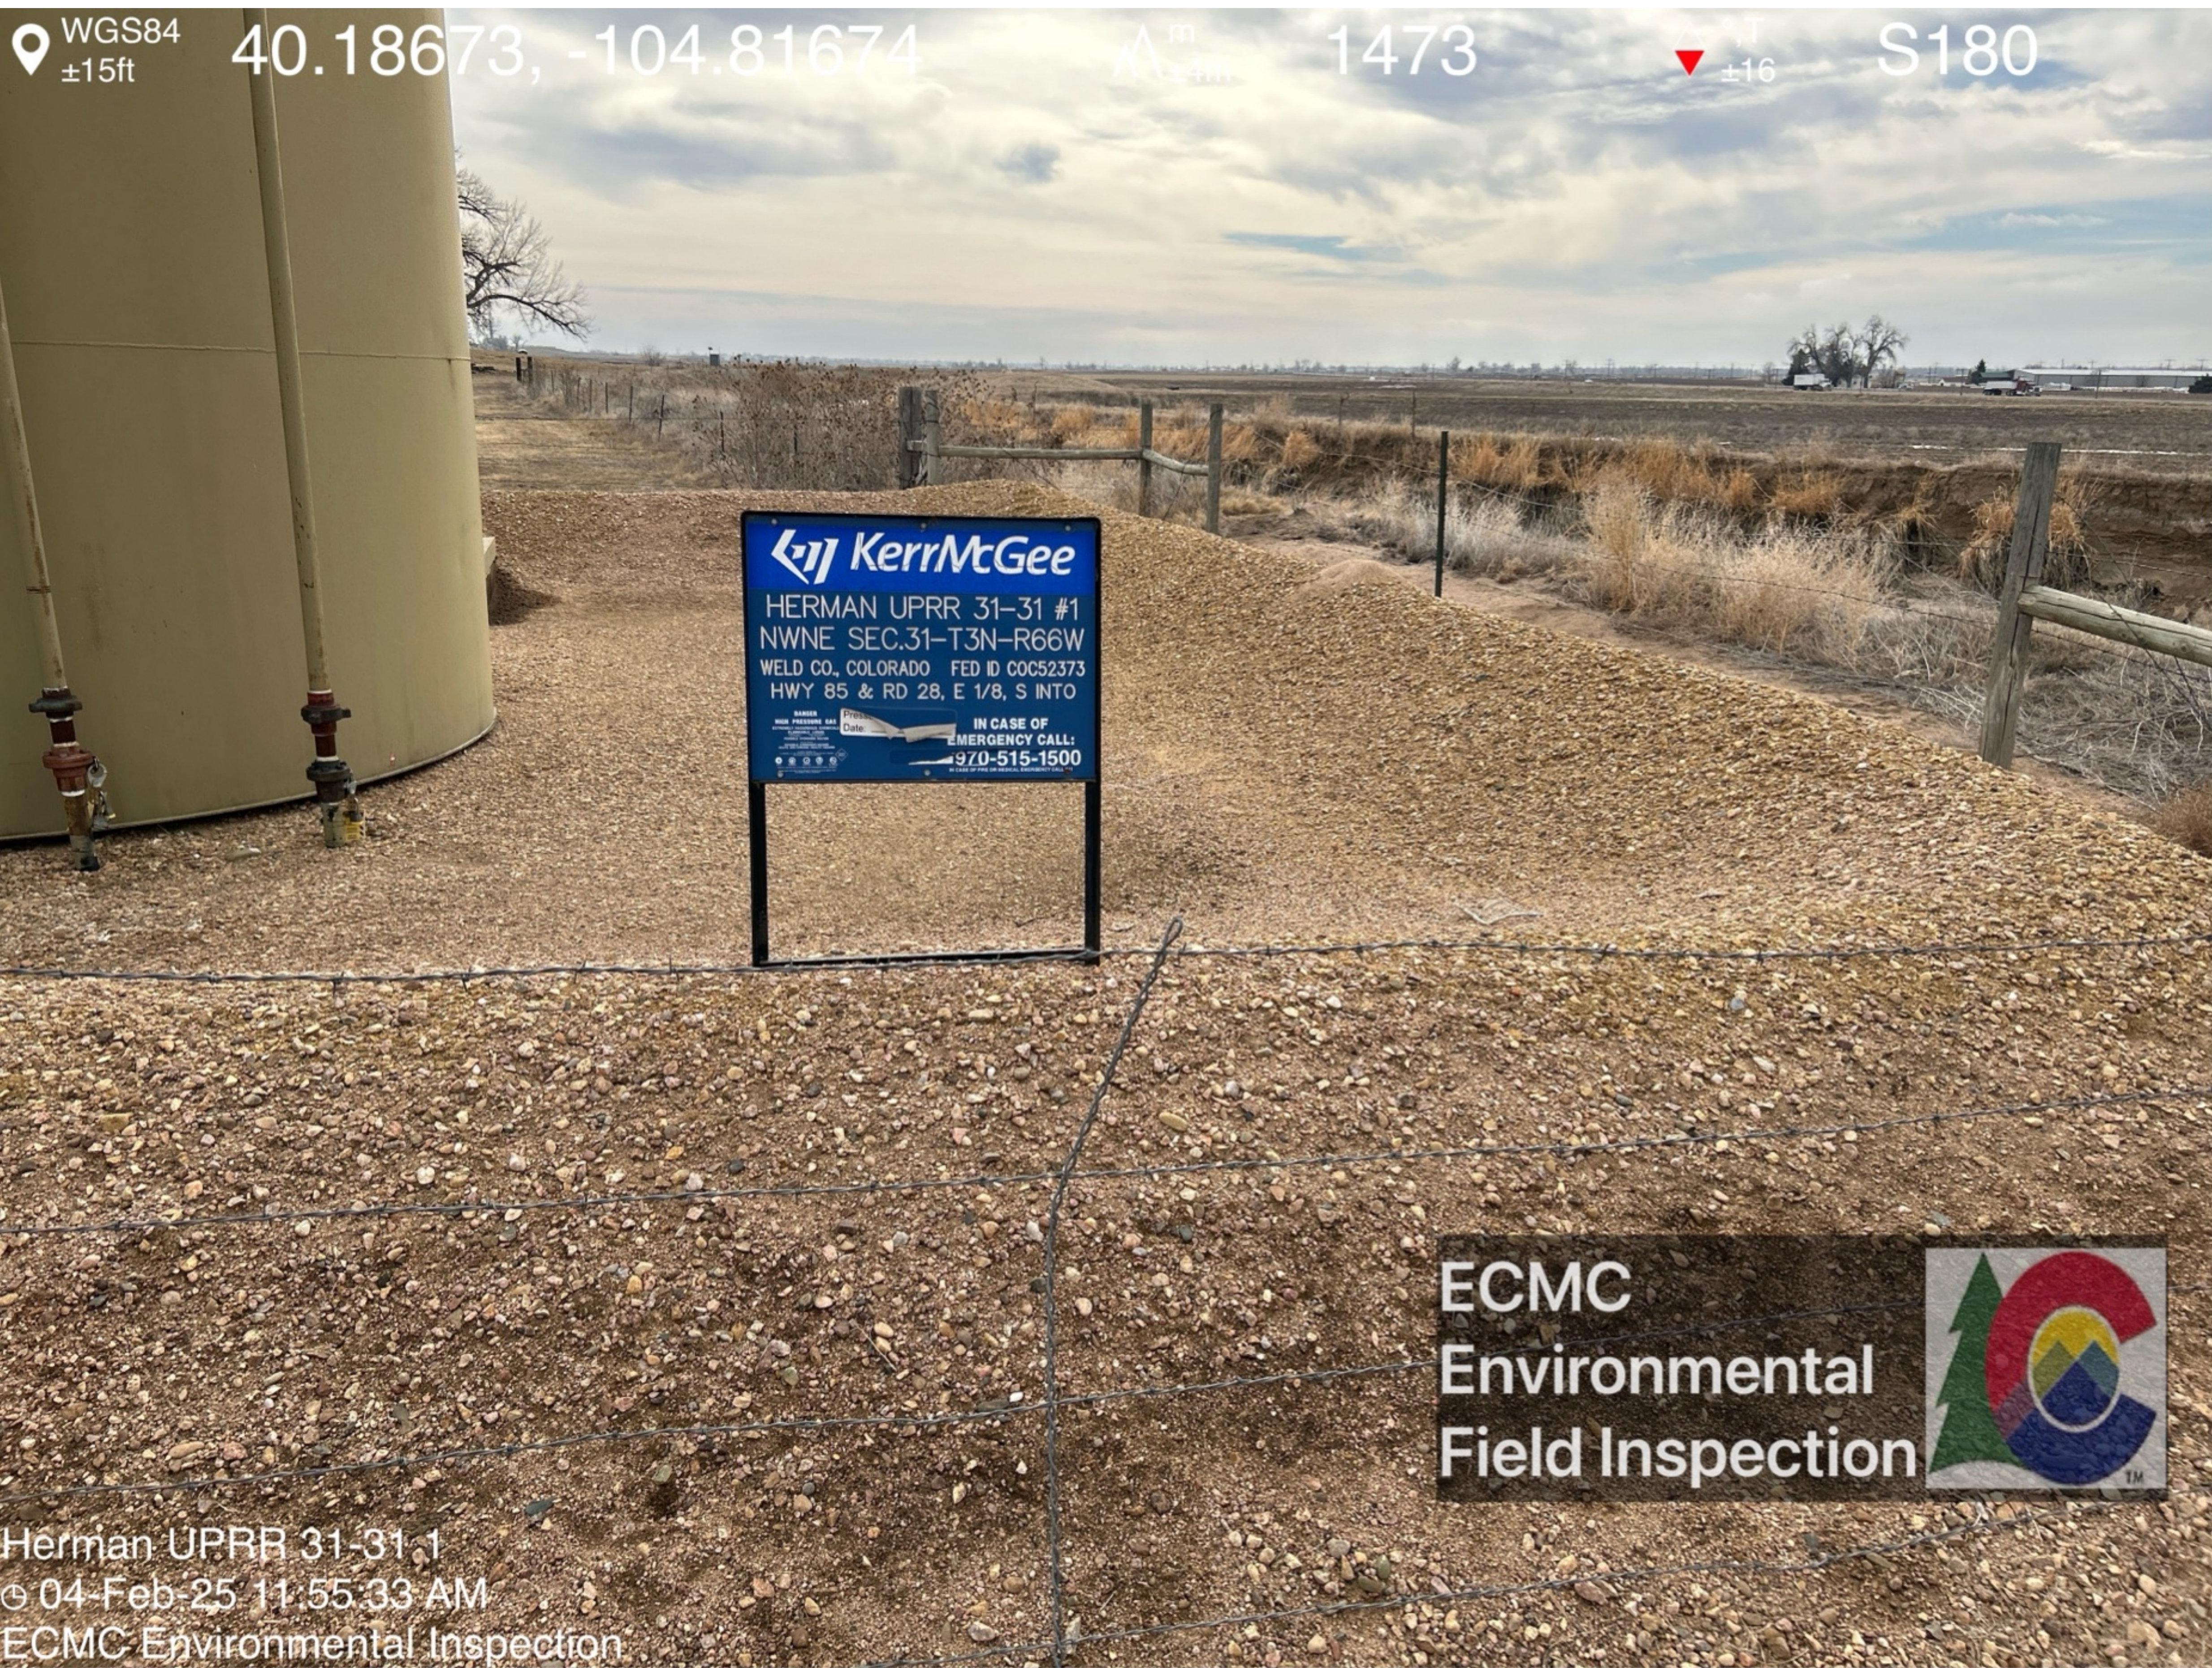
Sign with emergency contact phone number visible.

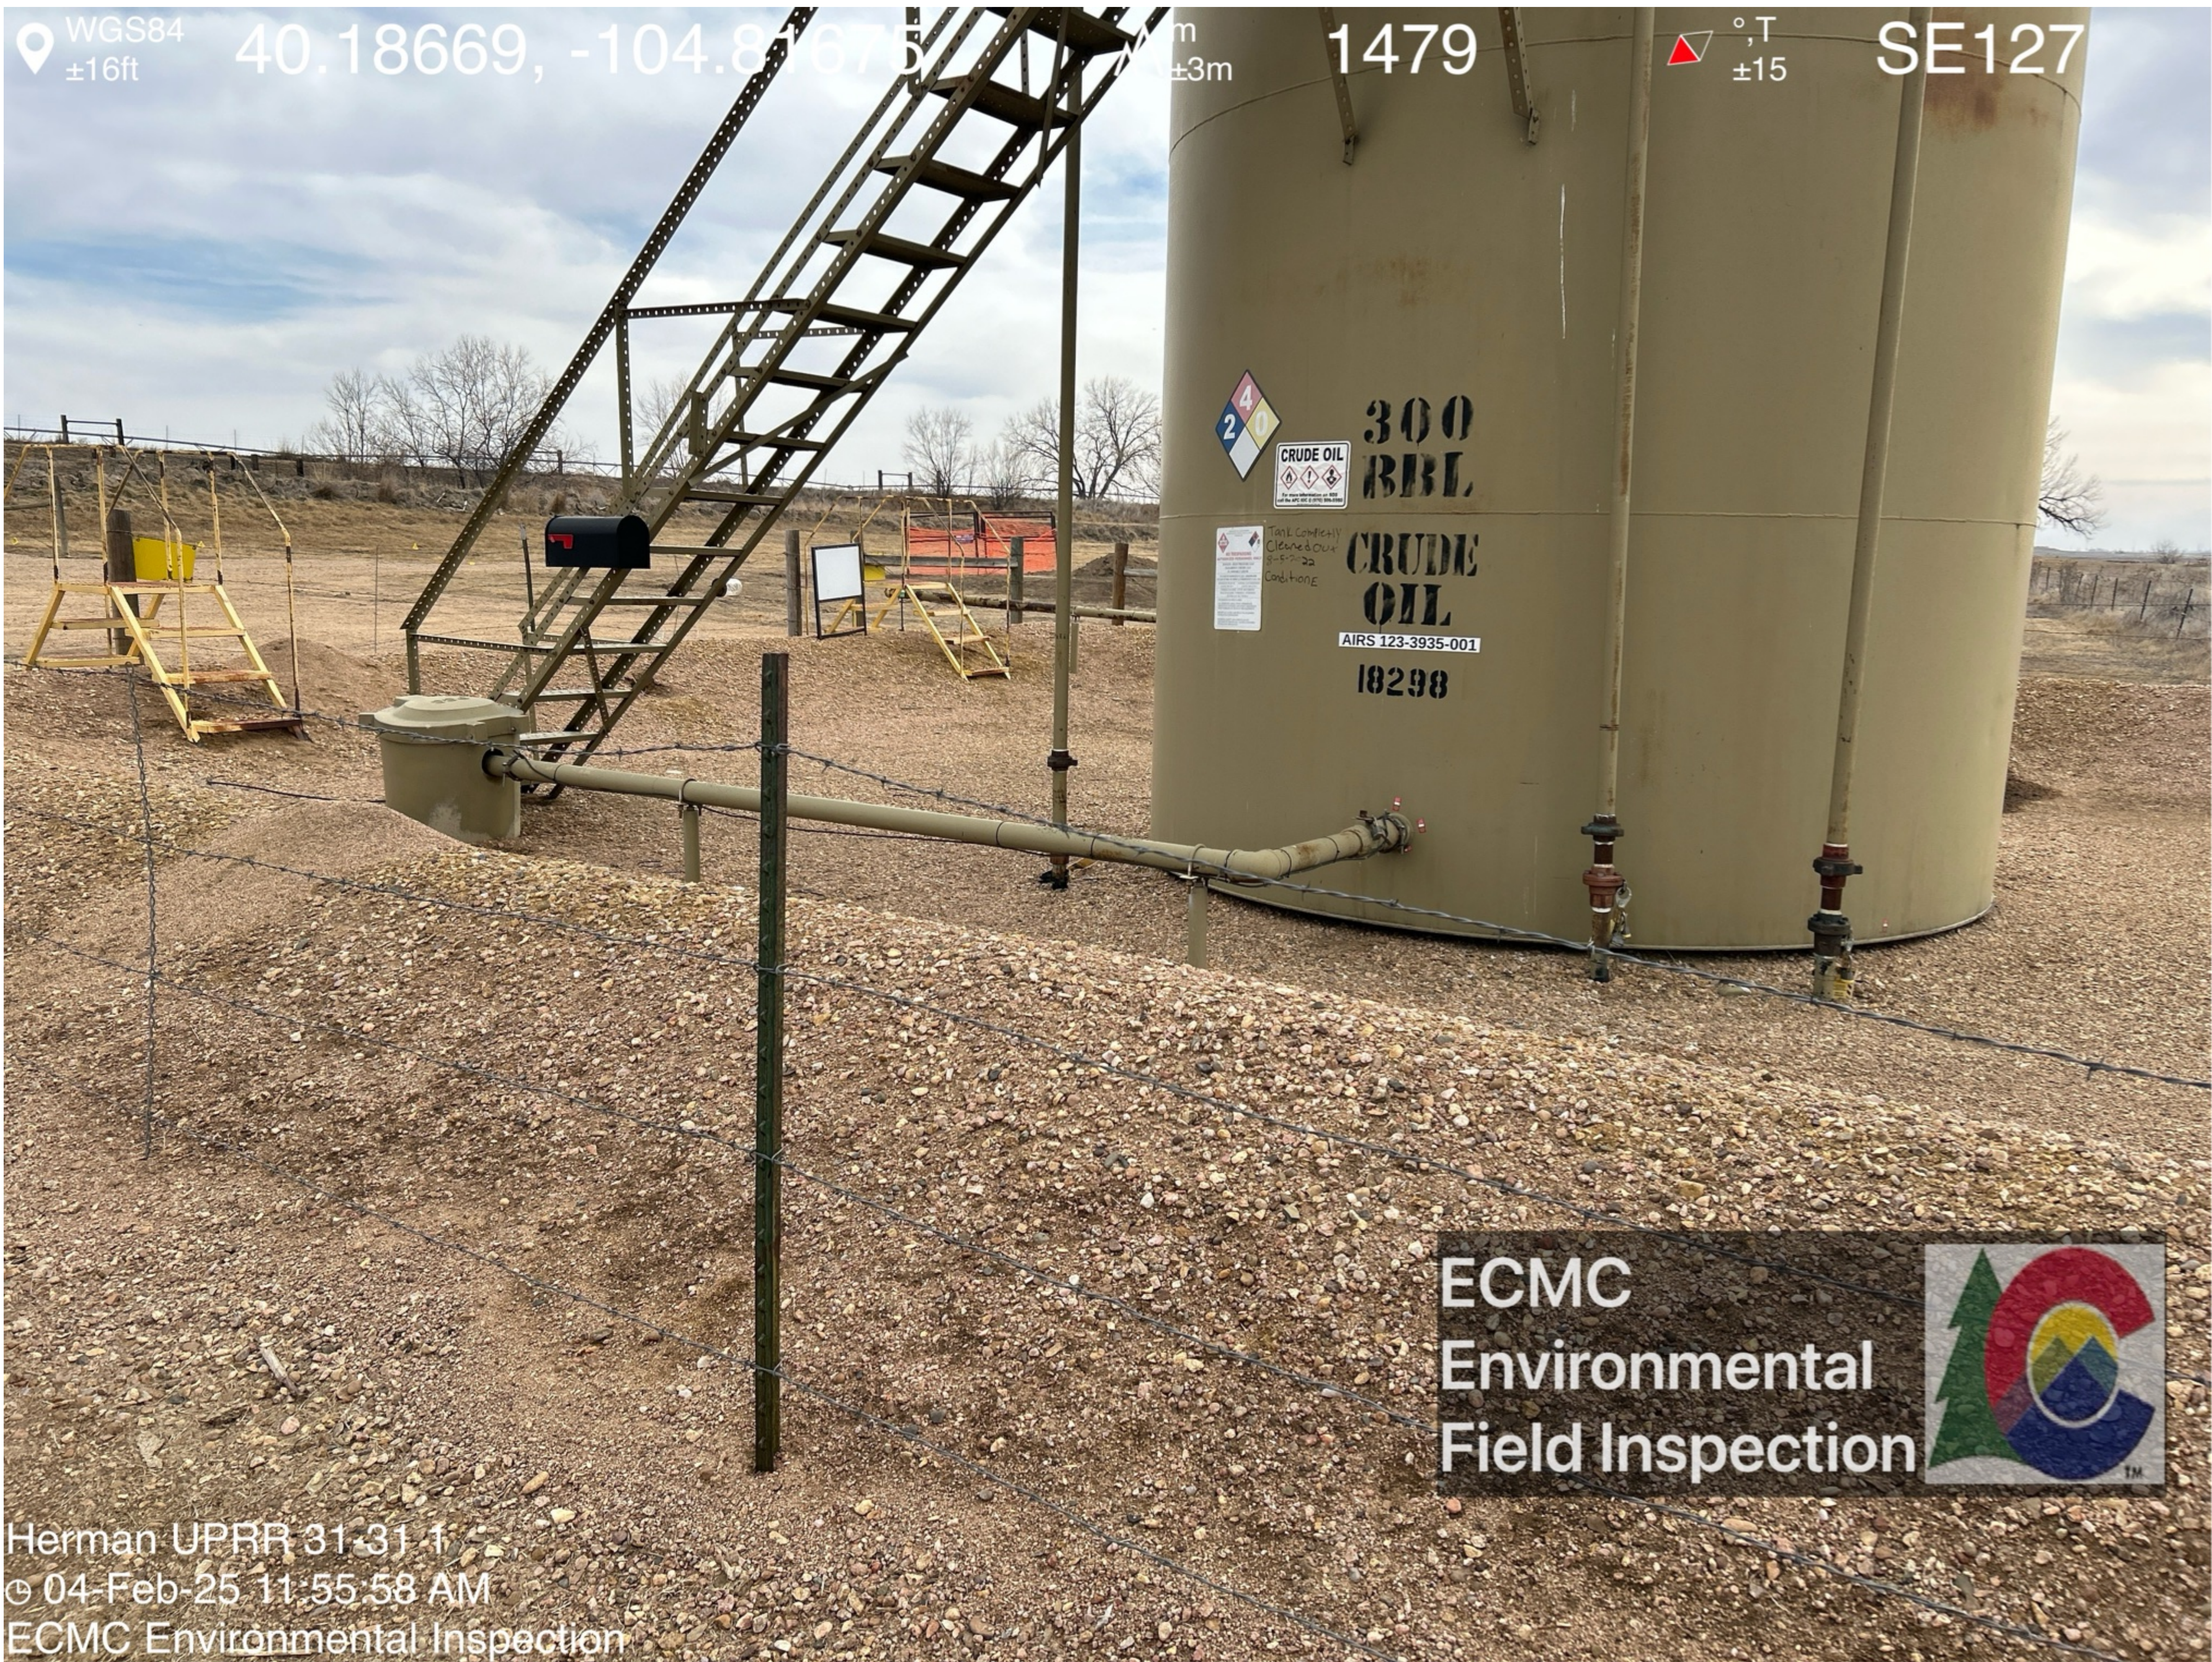
NFPA placard visible on production tank.

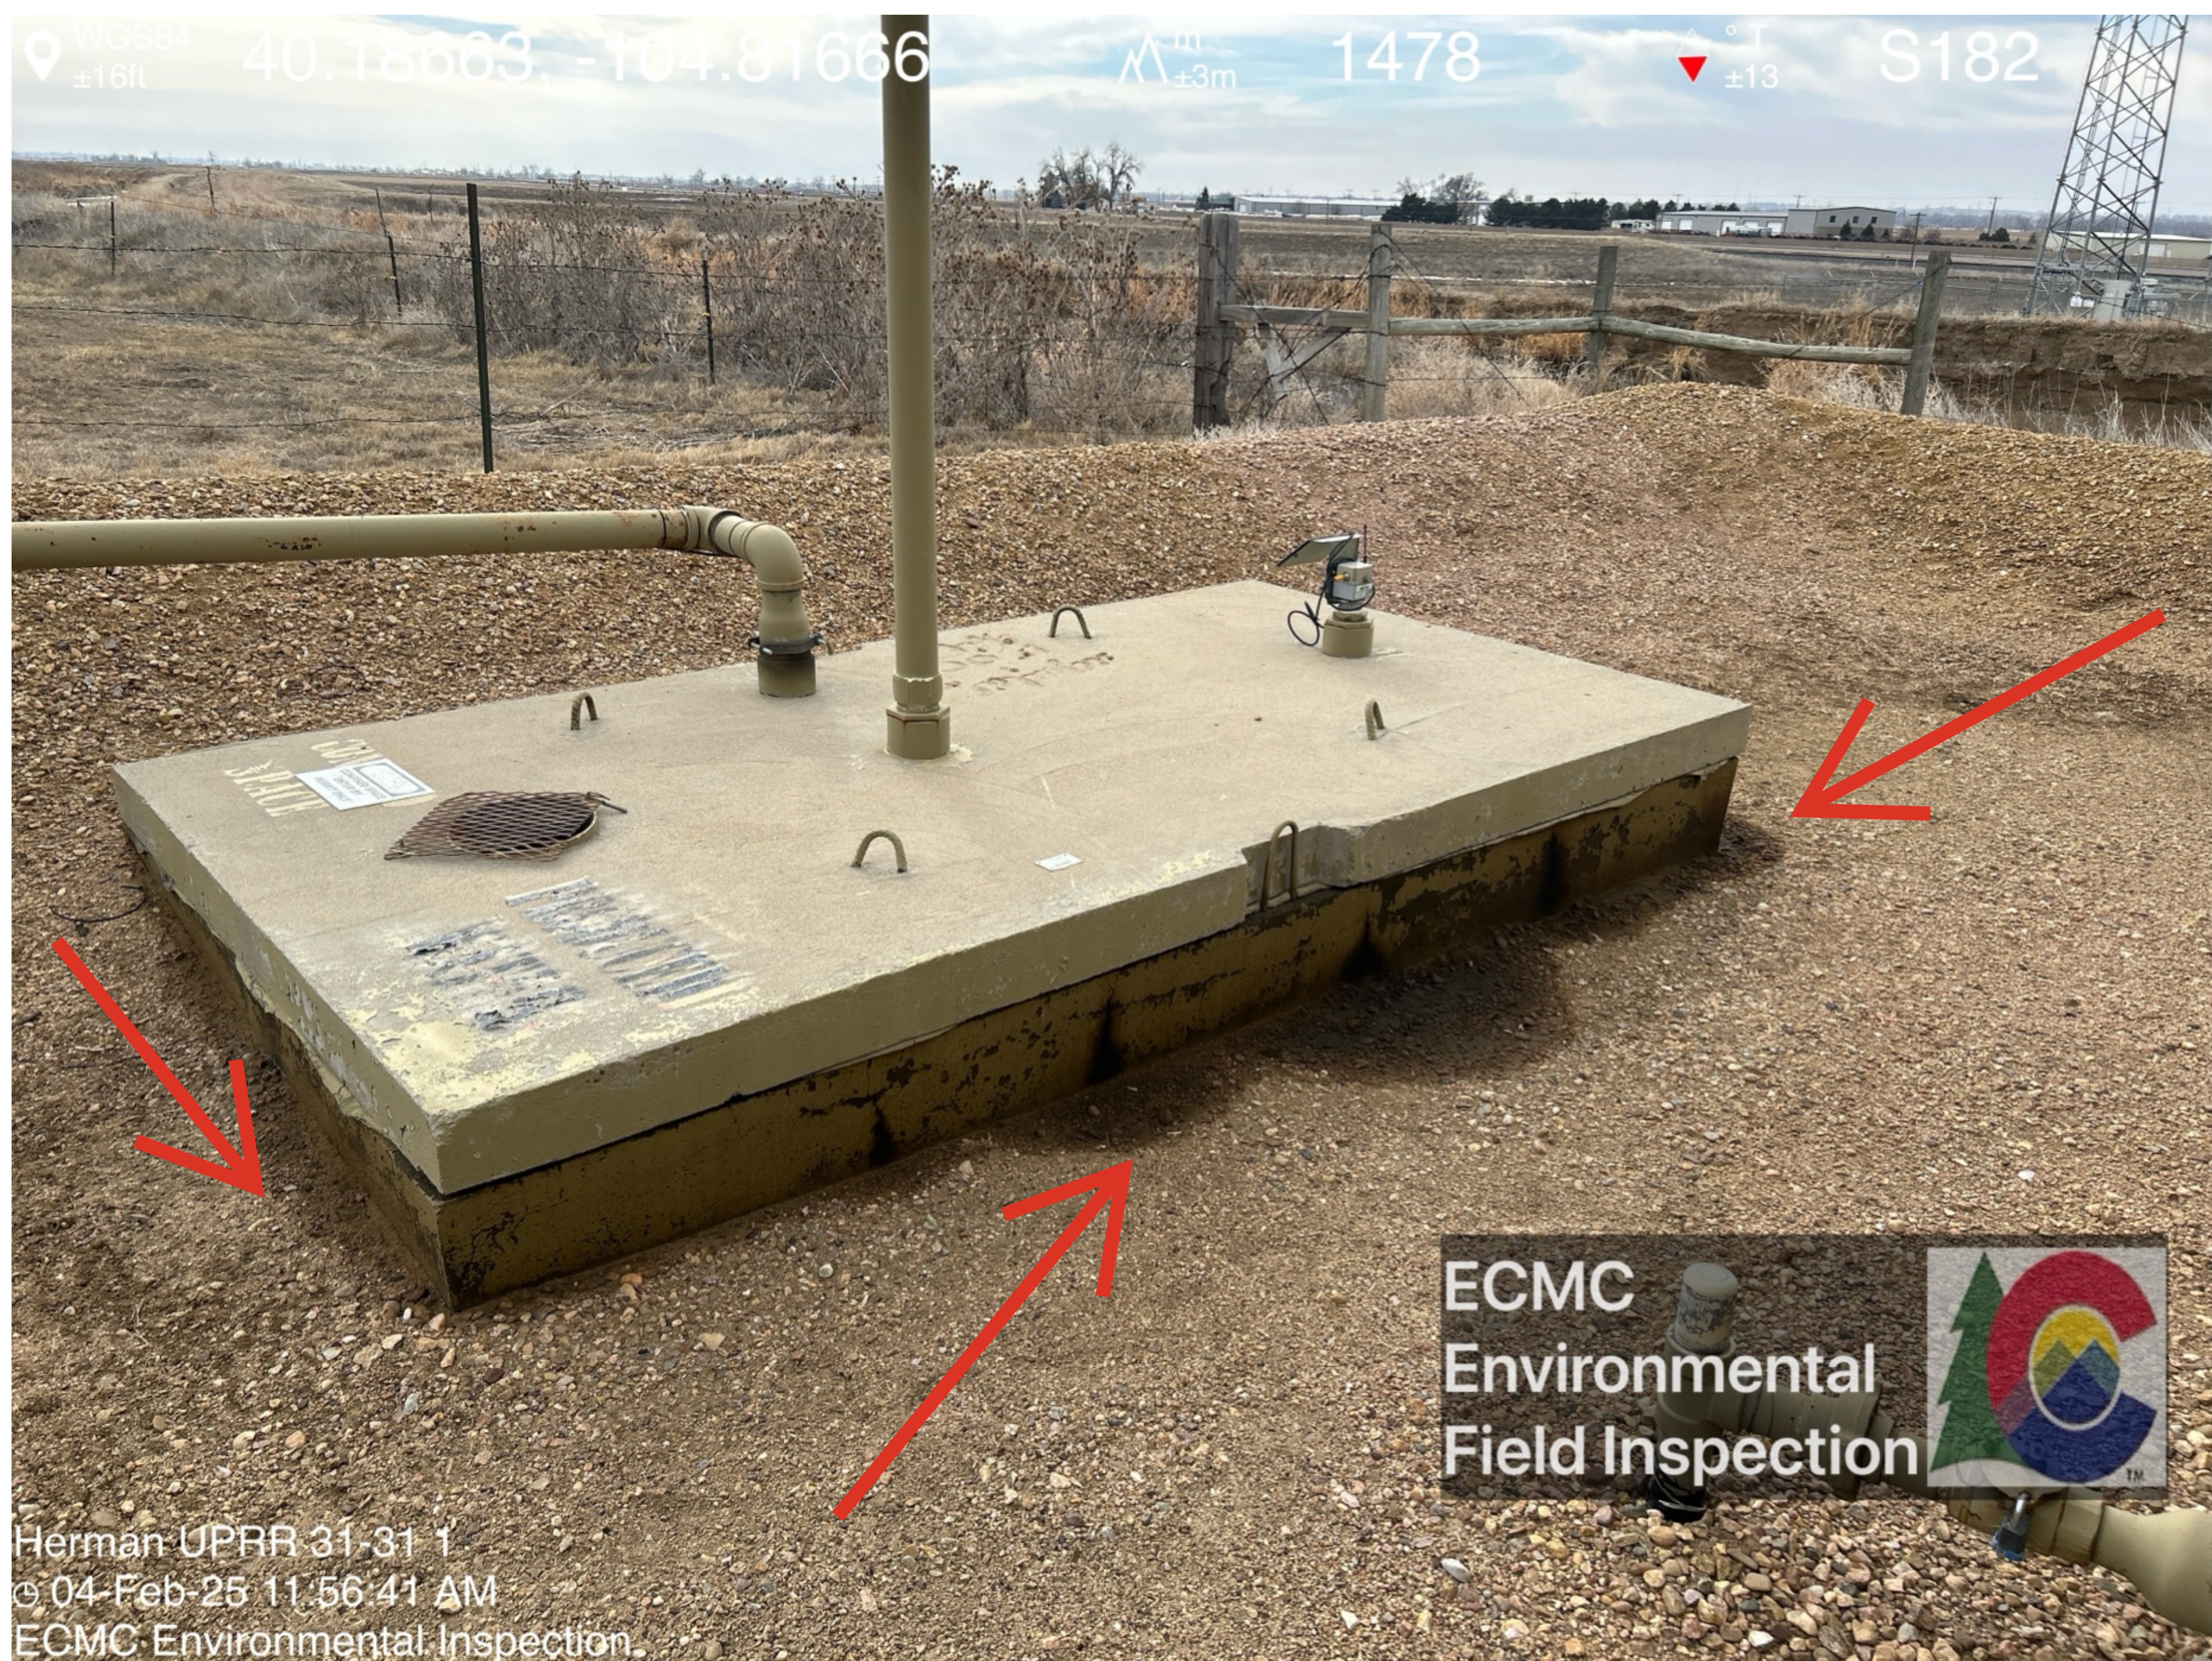
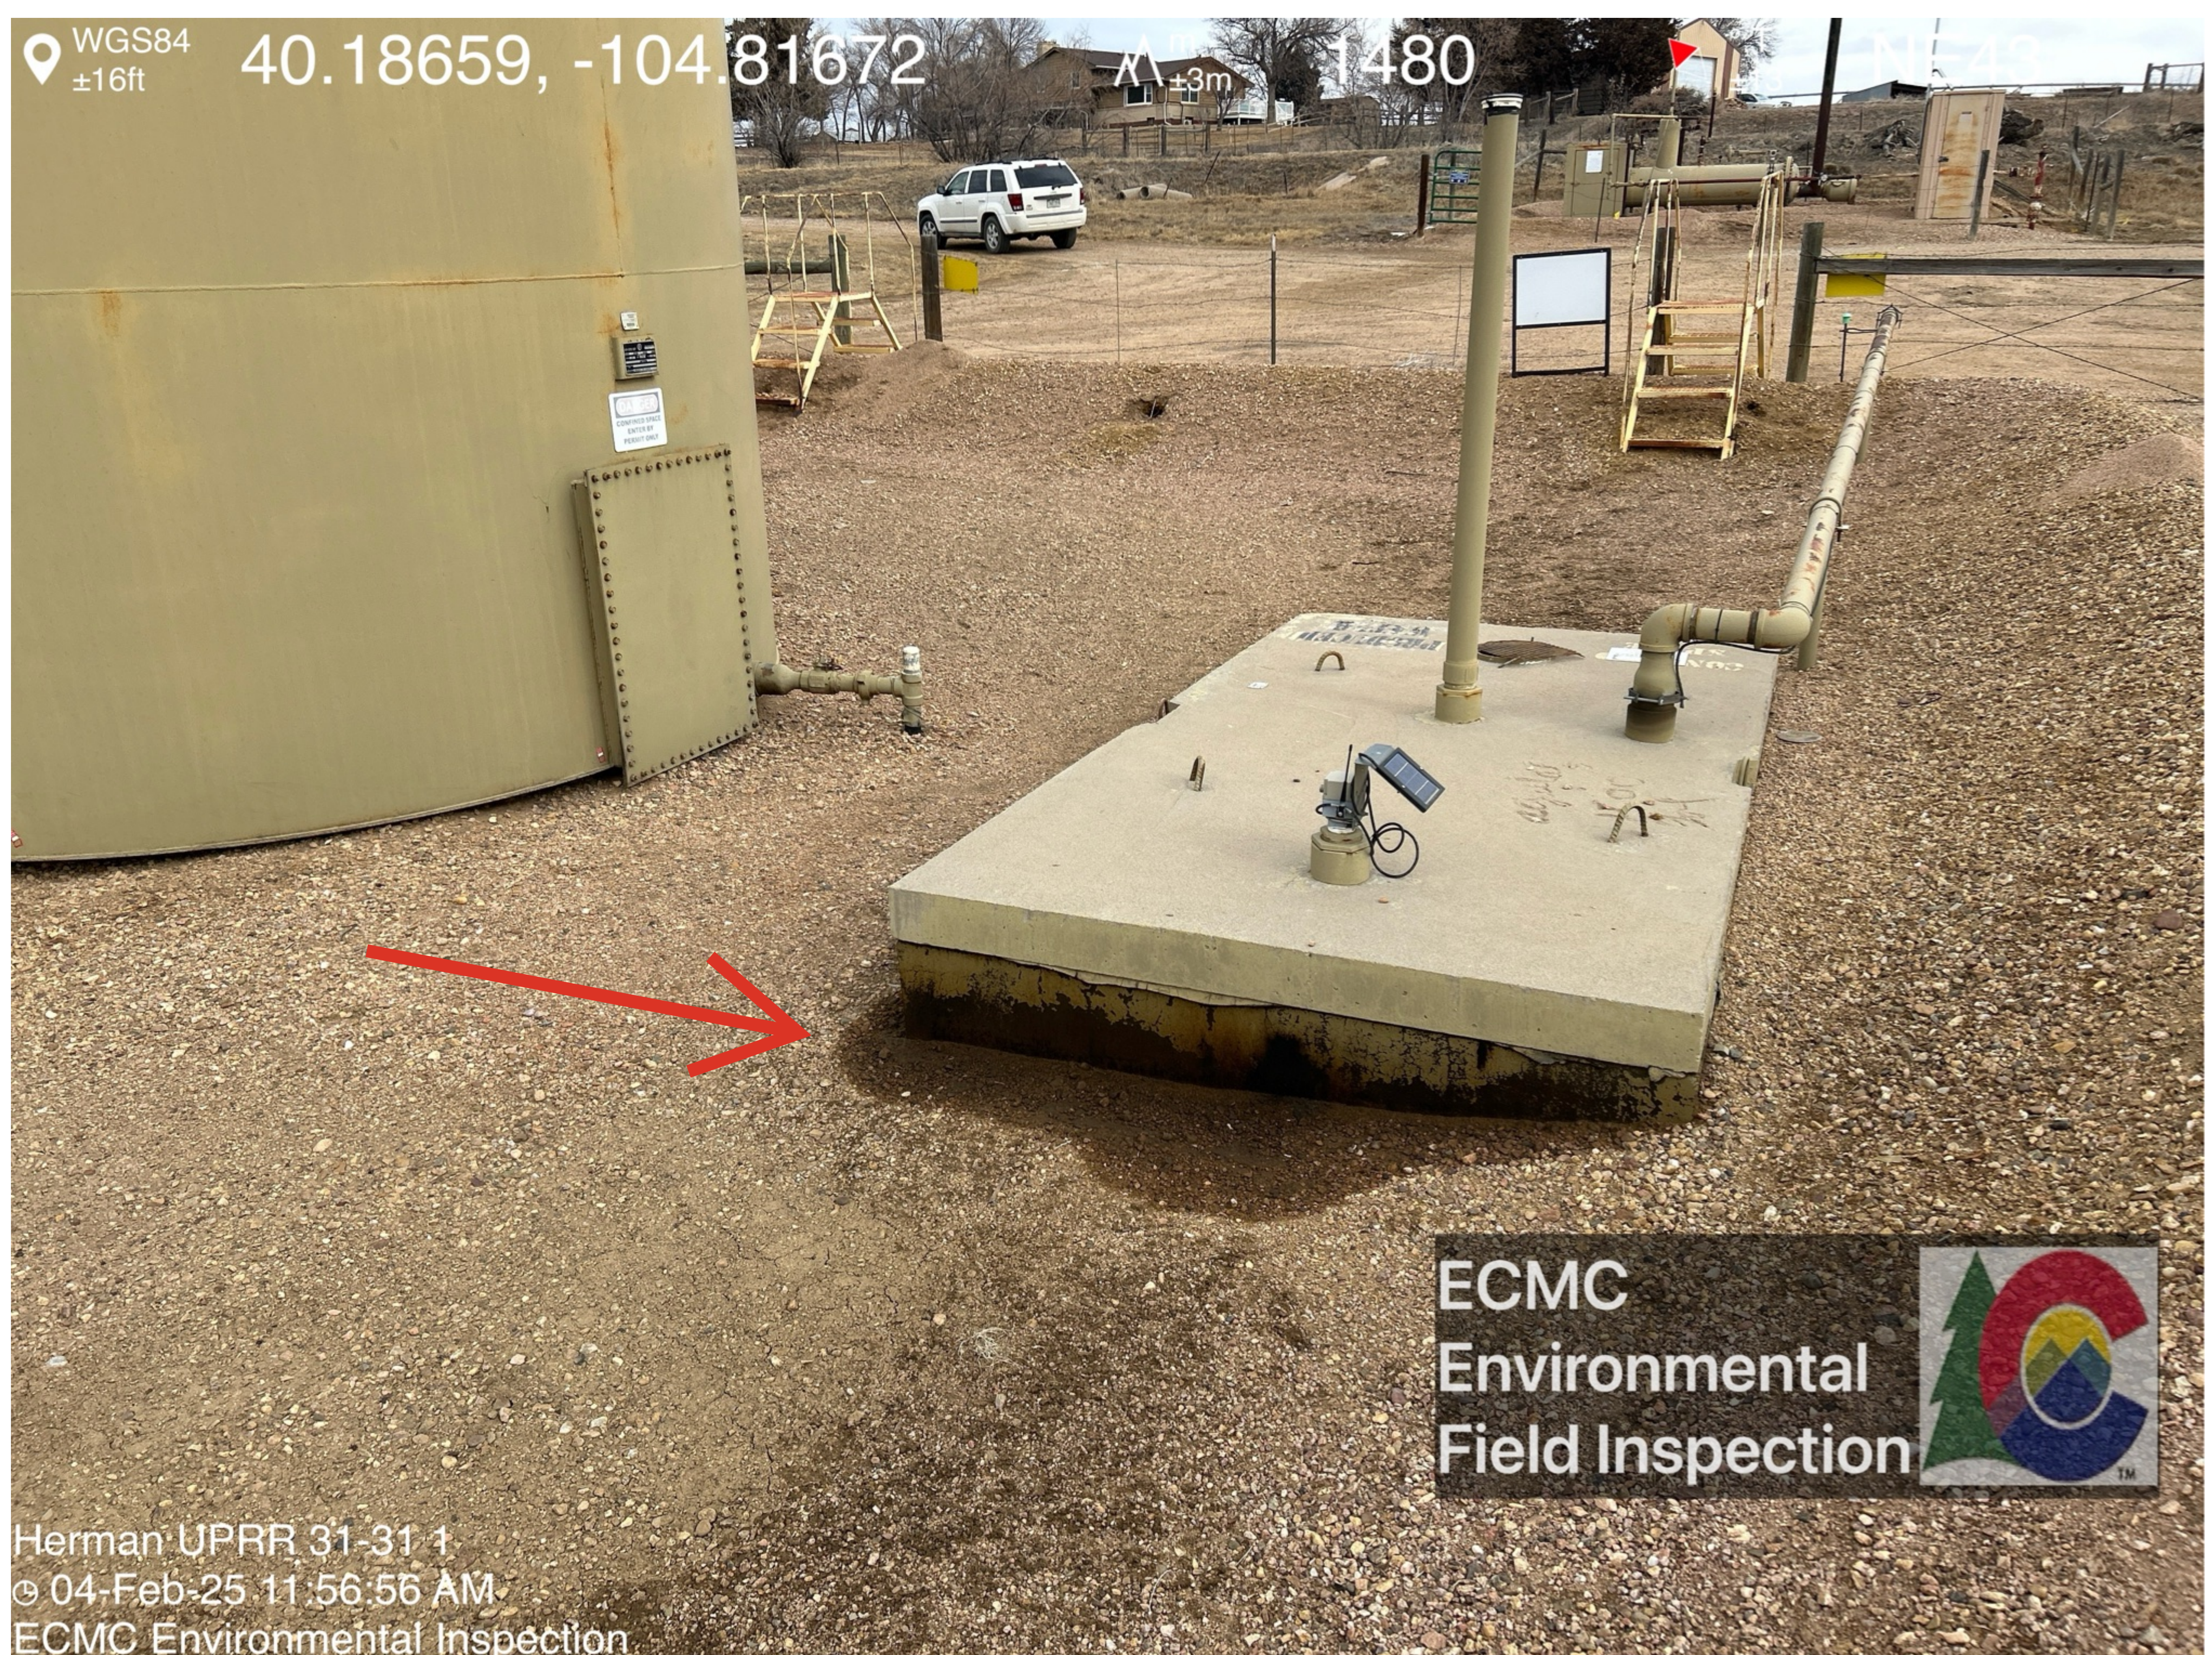
Staining observed around produced water vault. Petroleum hydrocarbon odor observed when soil was disturbed.

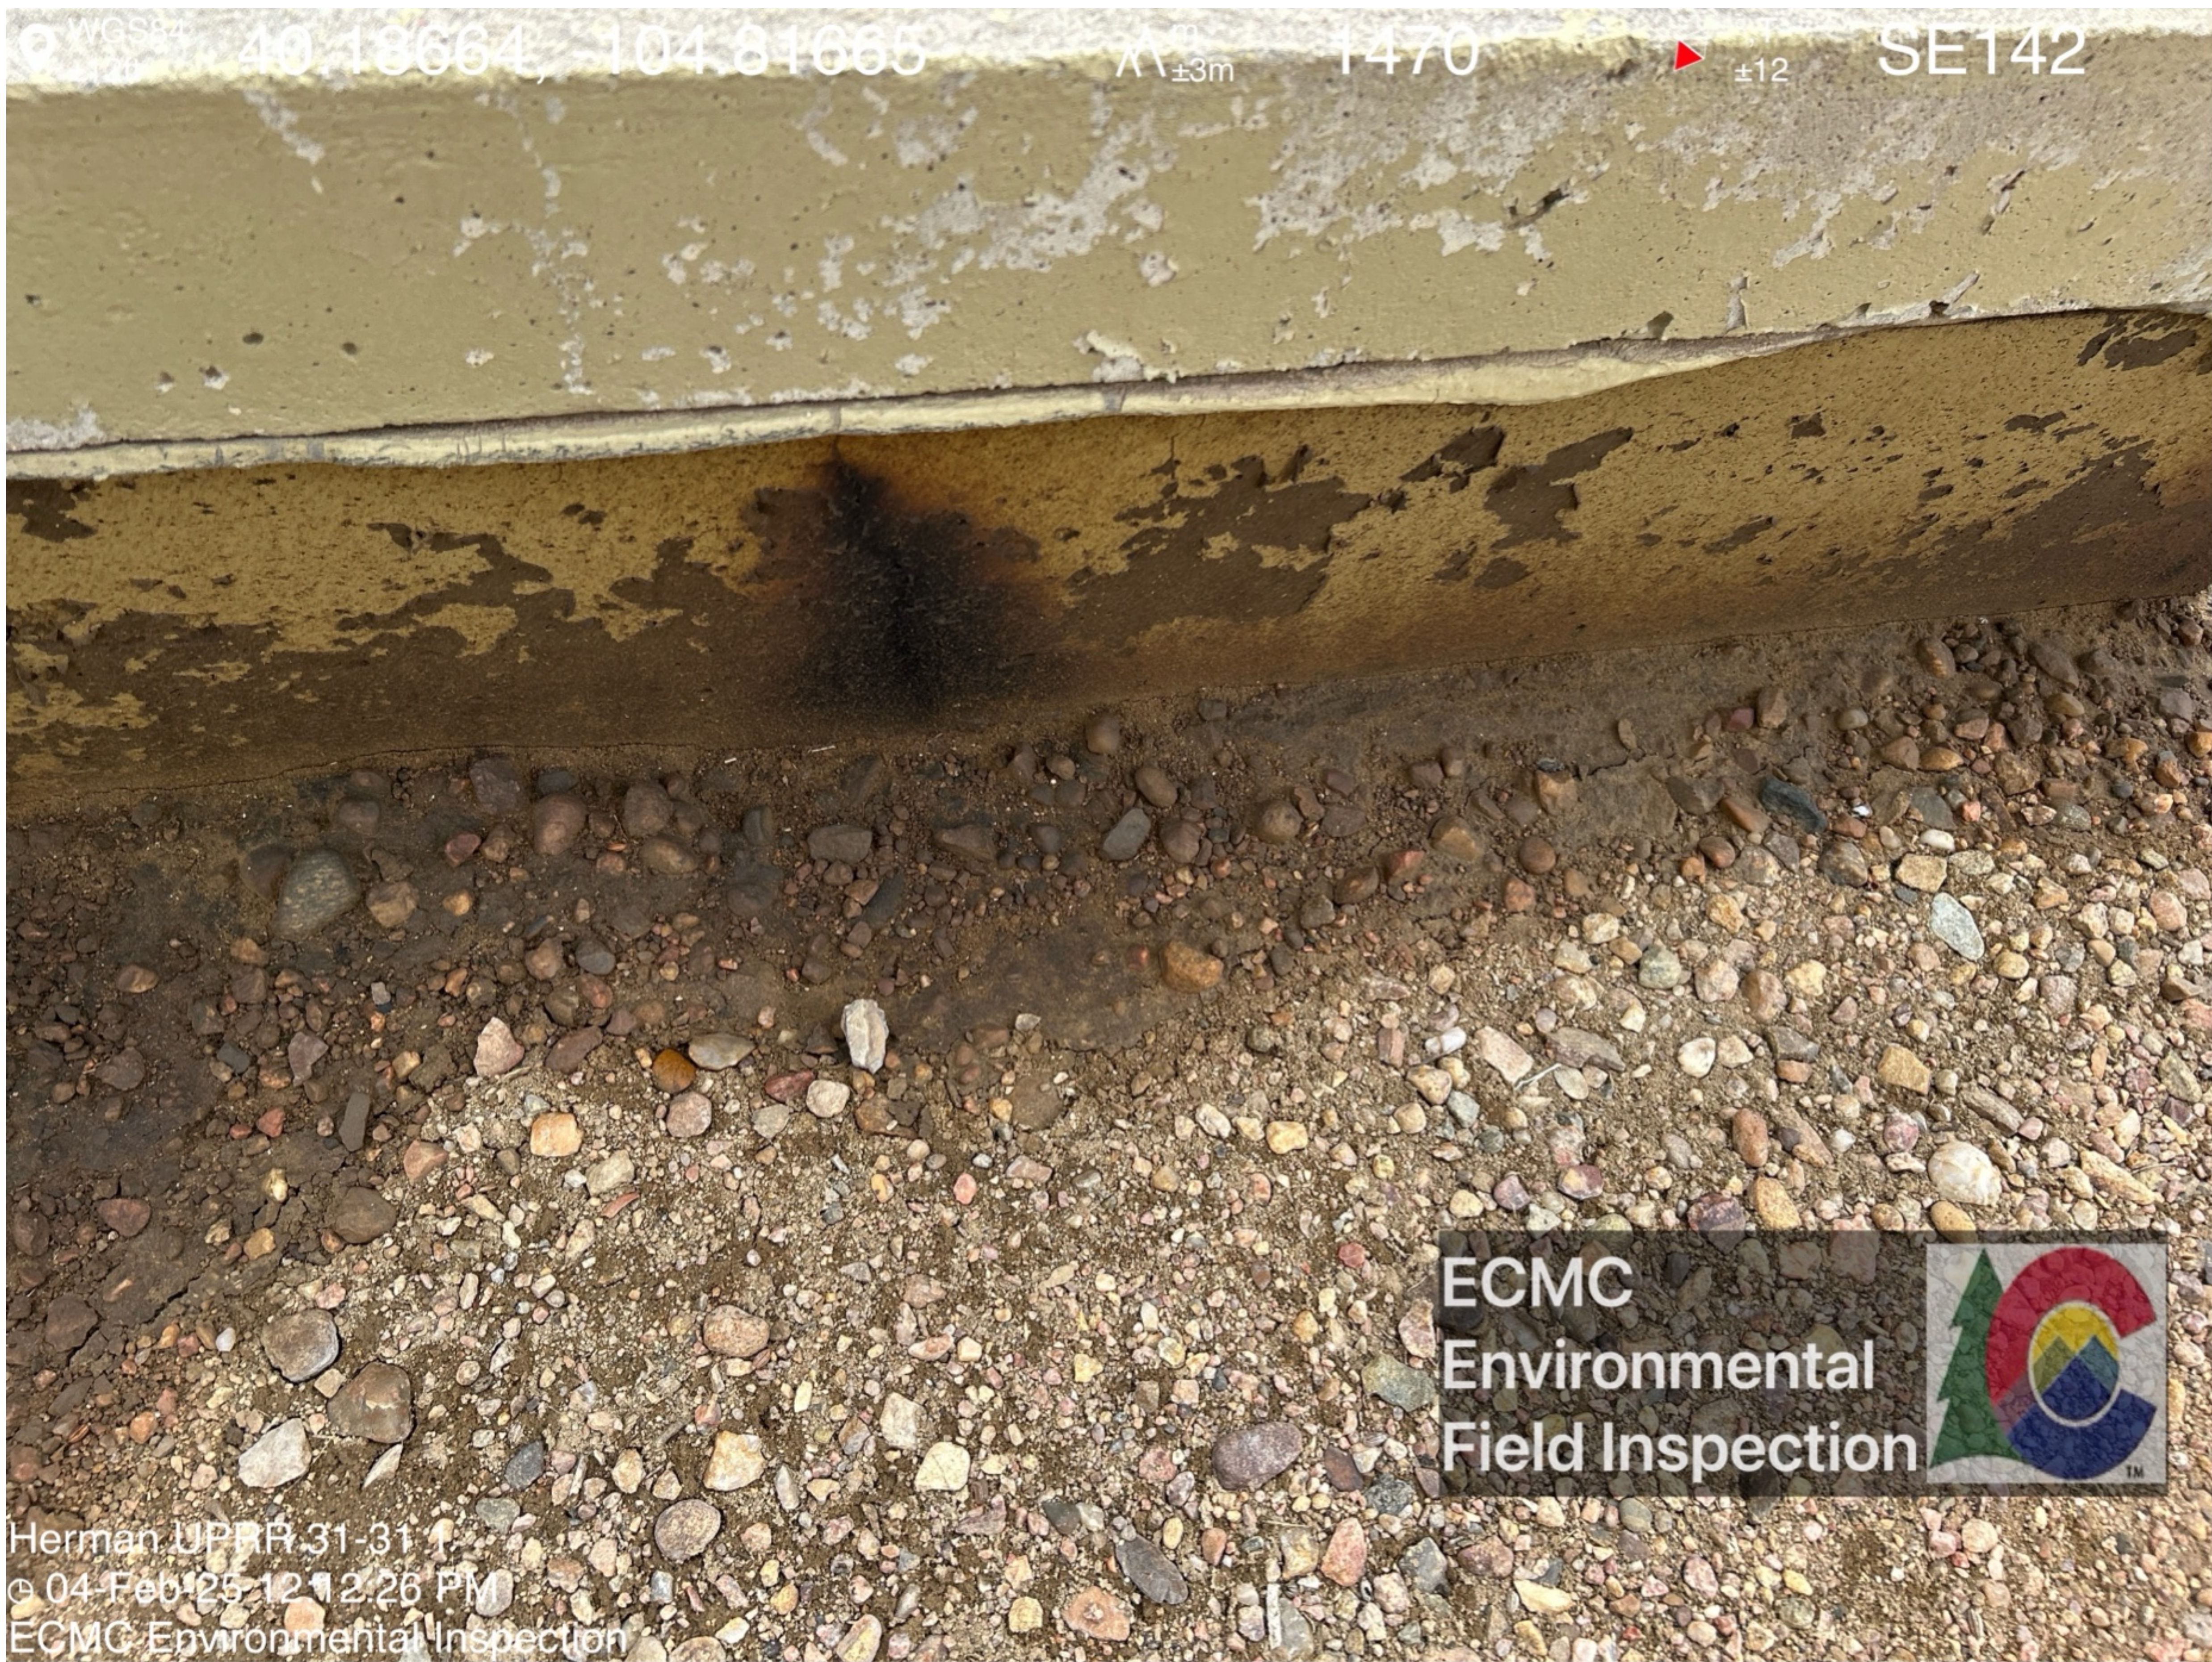
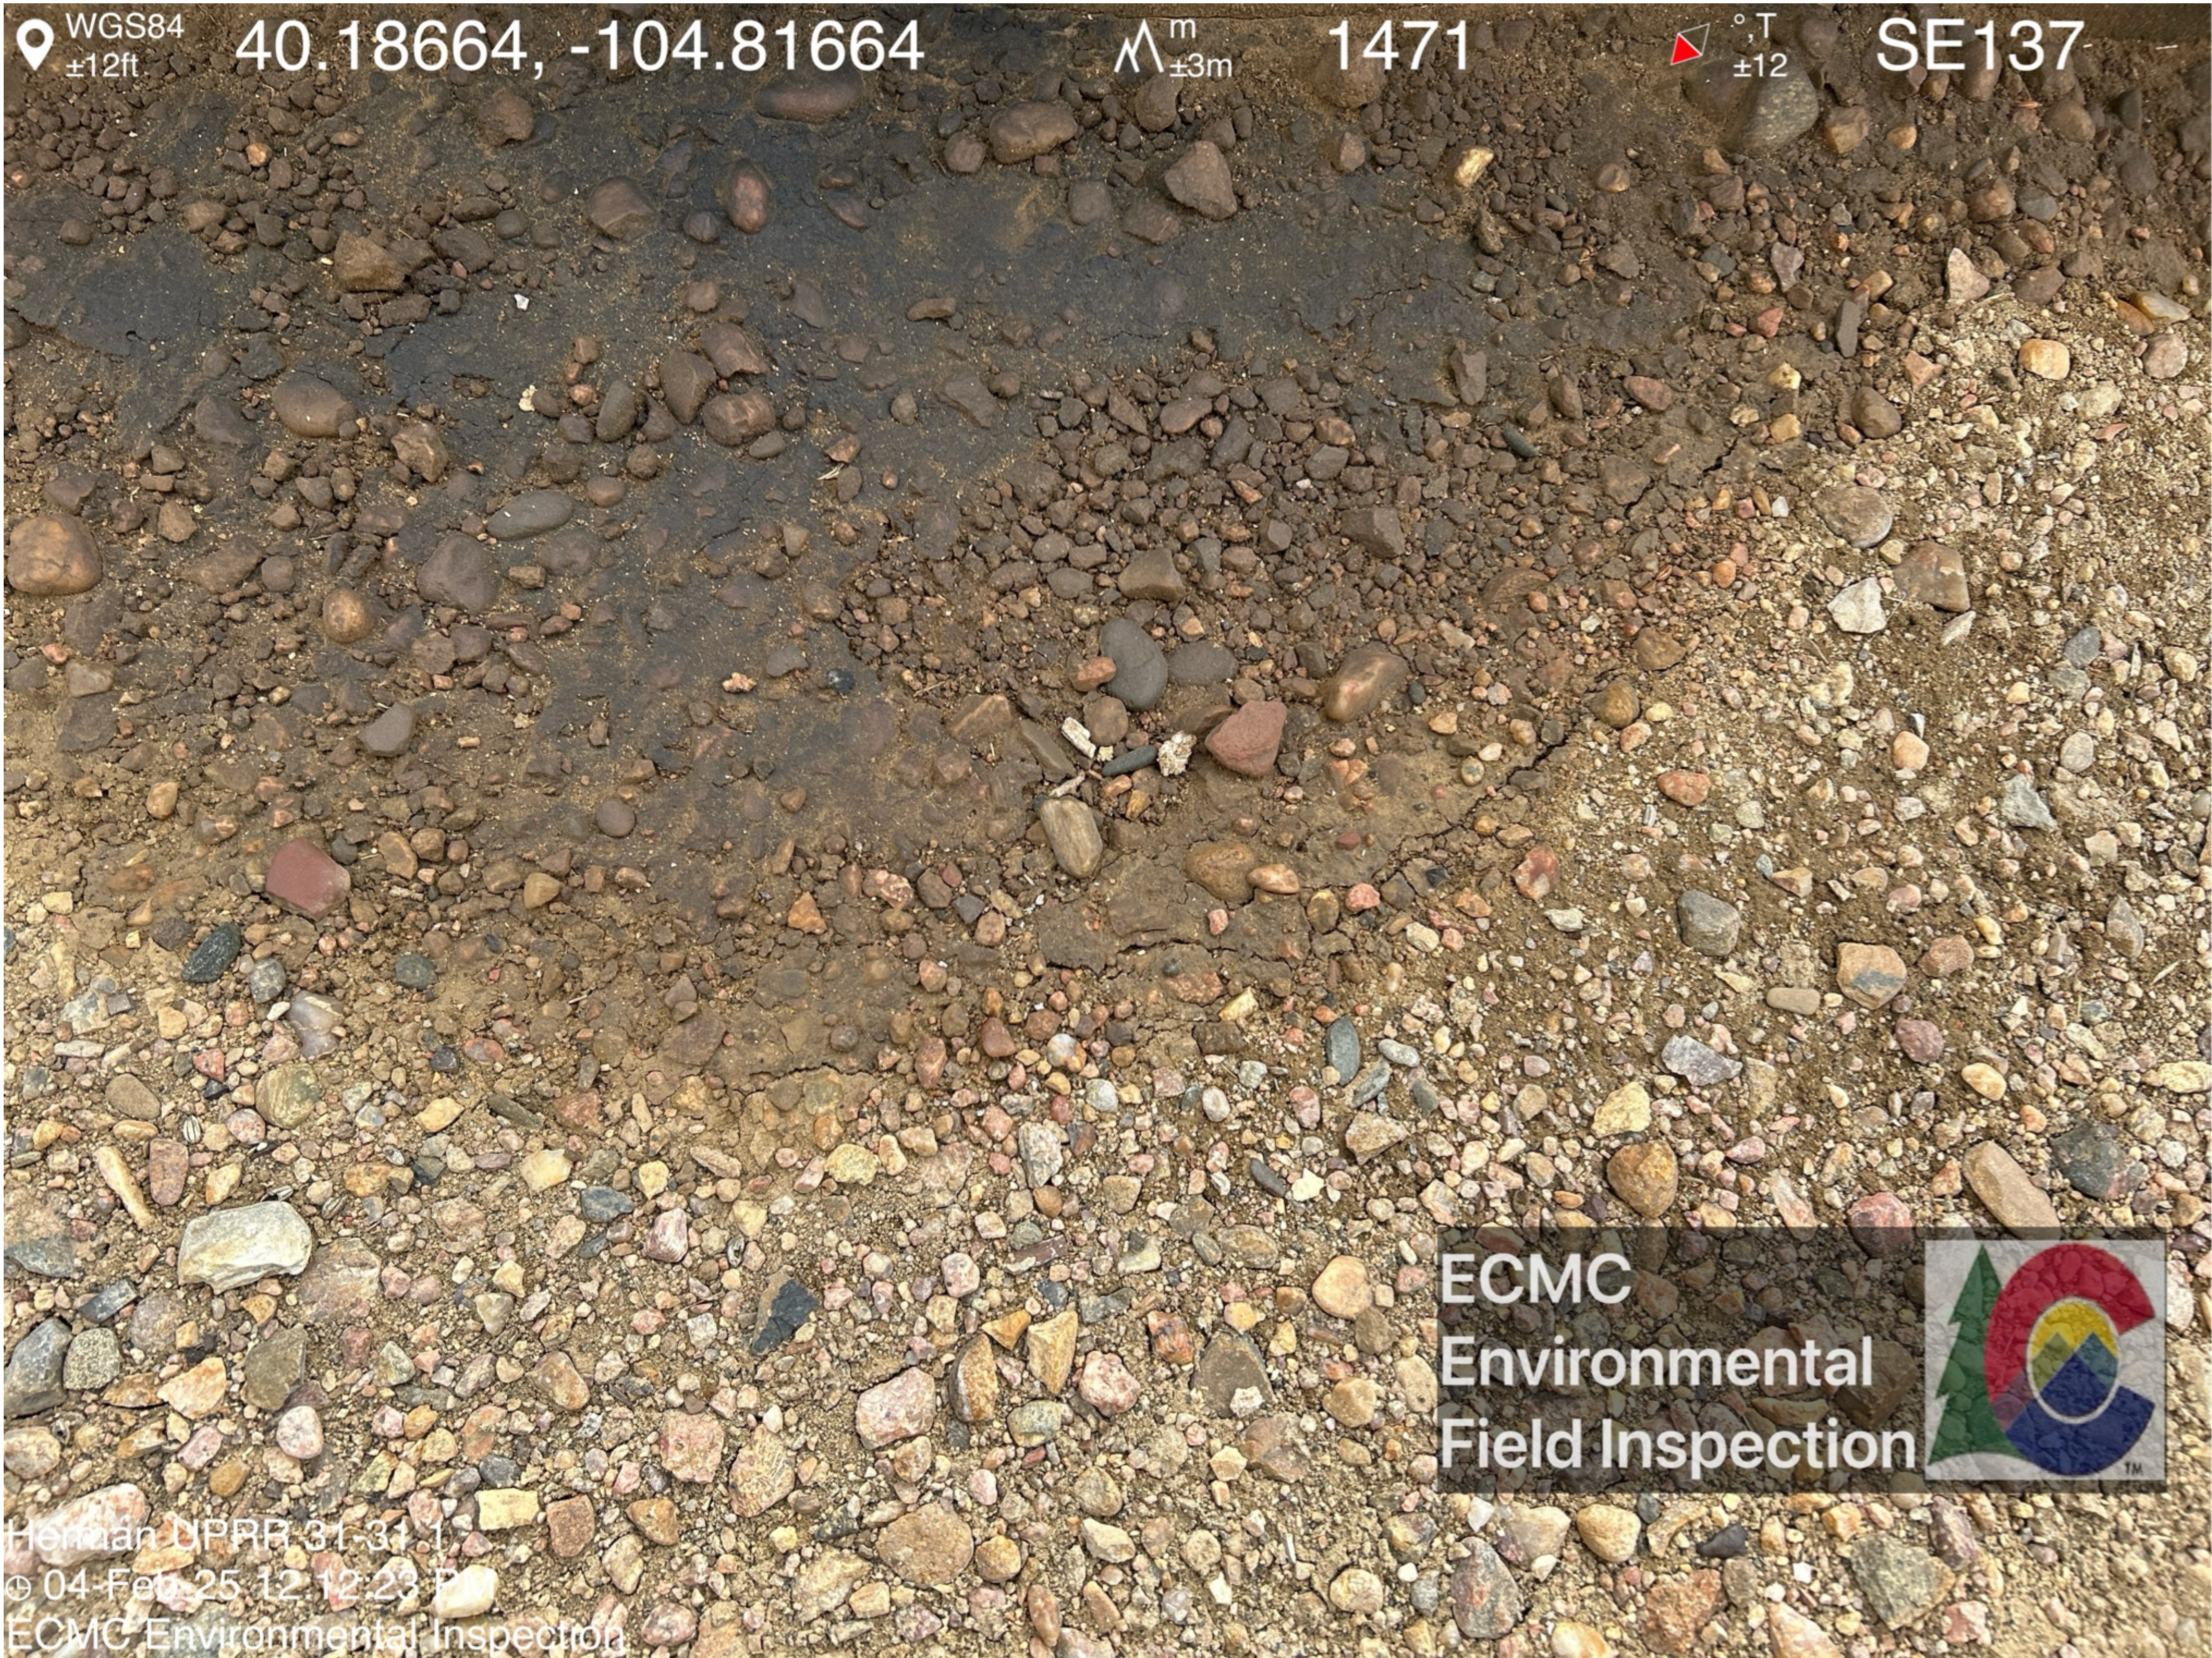
Fluid is not visible on the surface in the area of stained soil; migration to the subsurface is suspected.
