Herman UPRR 31-31.1  
© 04-Feb-25 11:55:33 AM  
ECMC Environmental Inspection

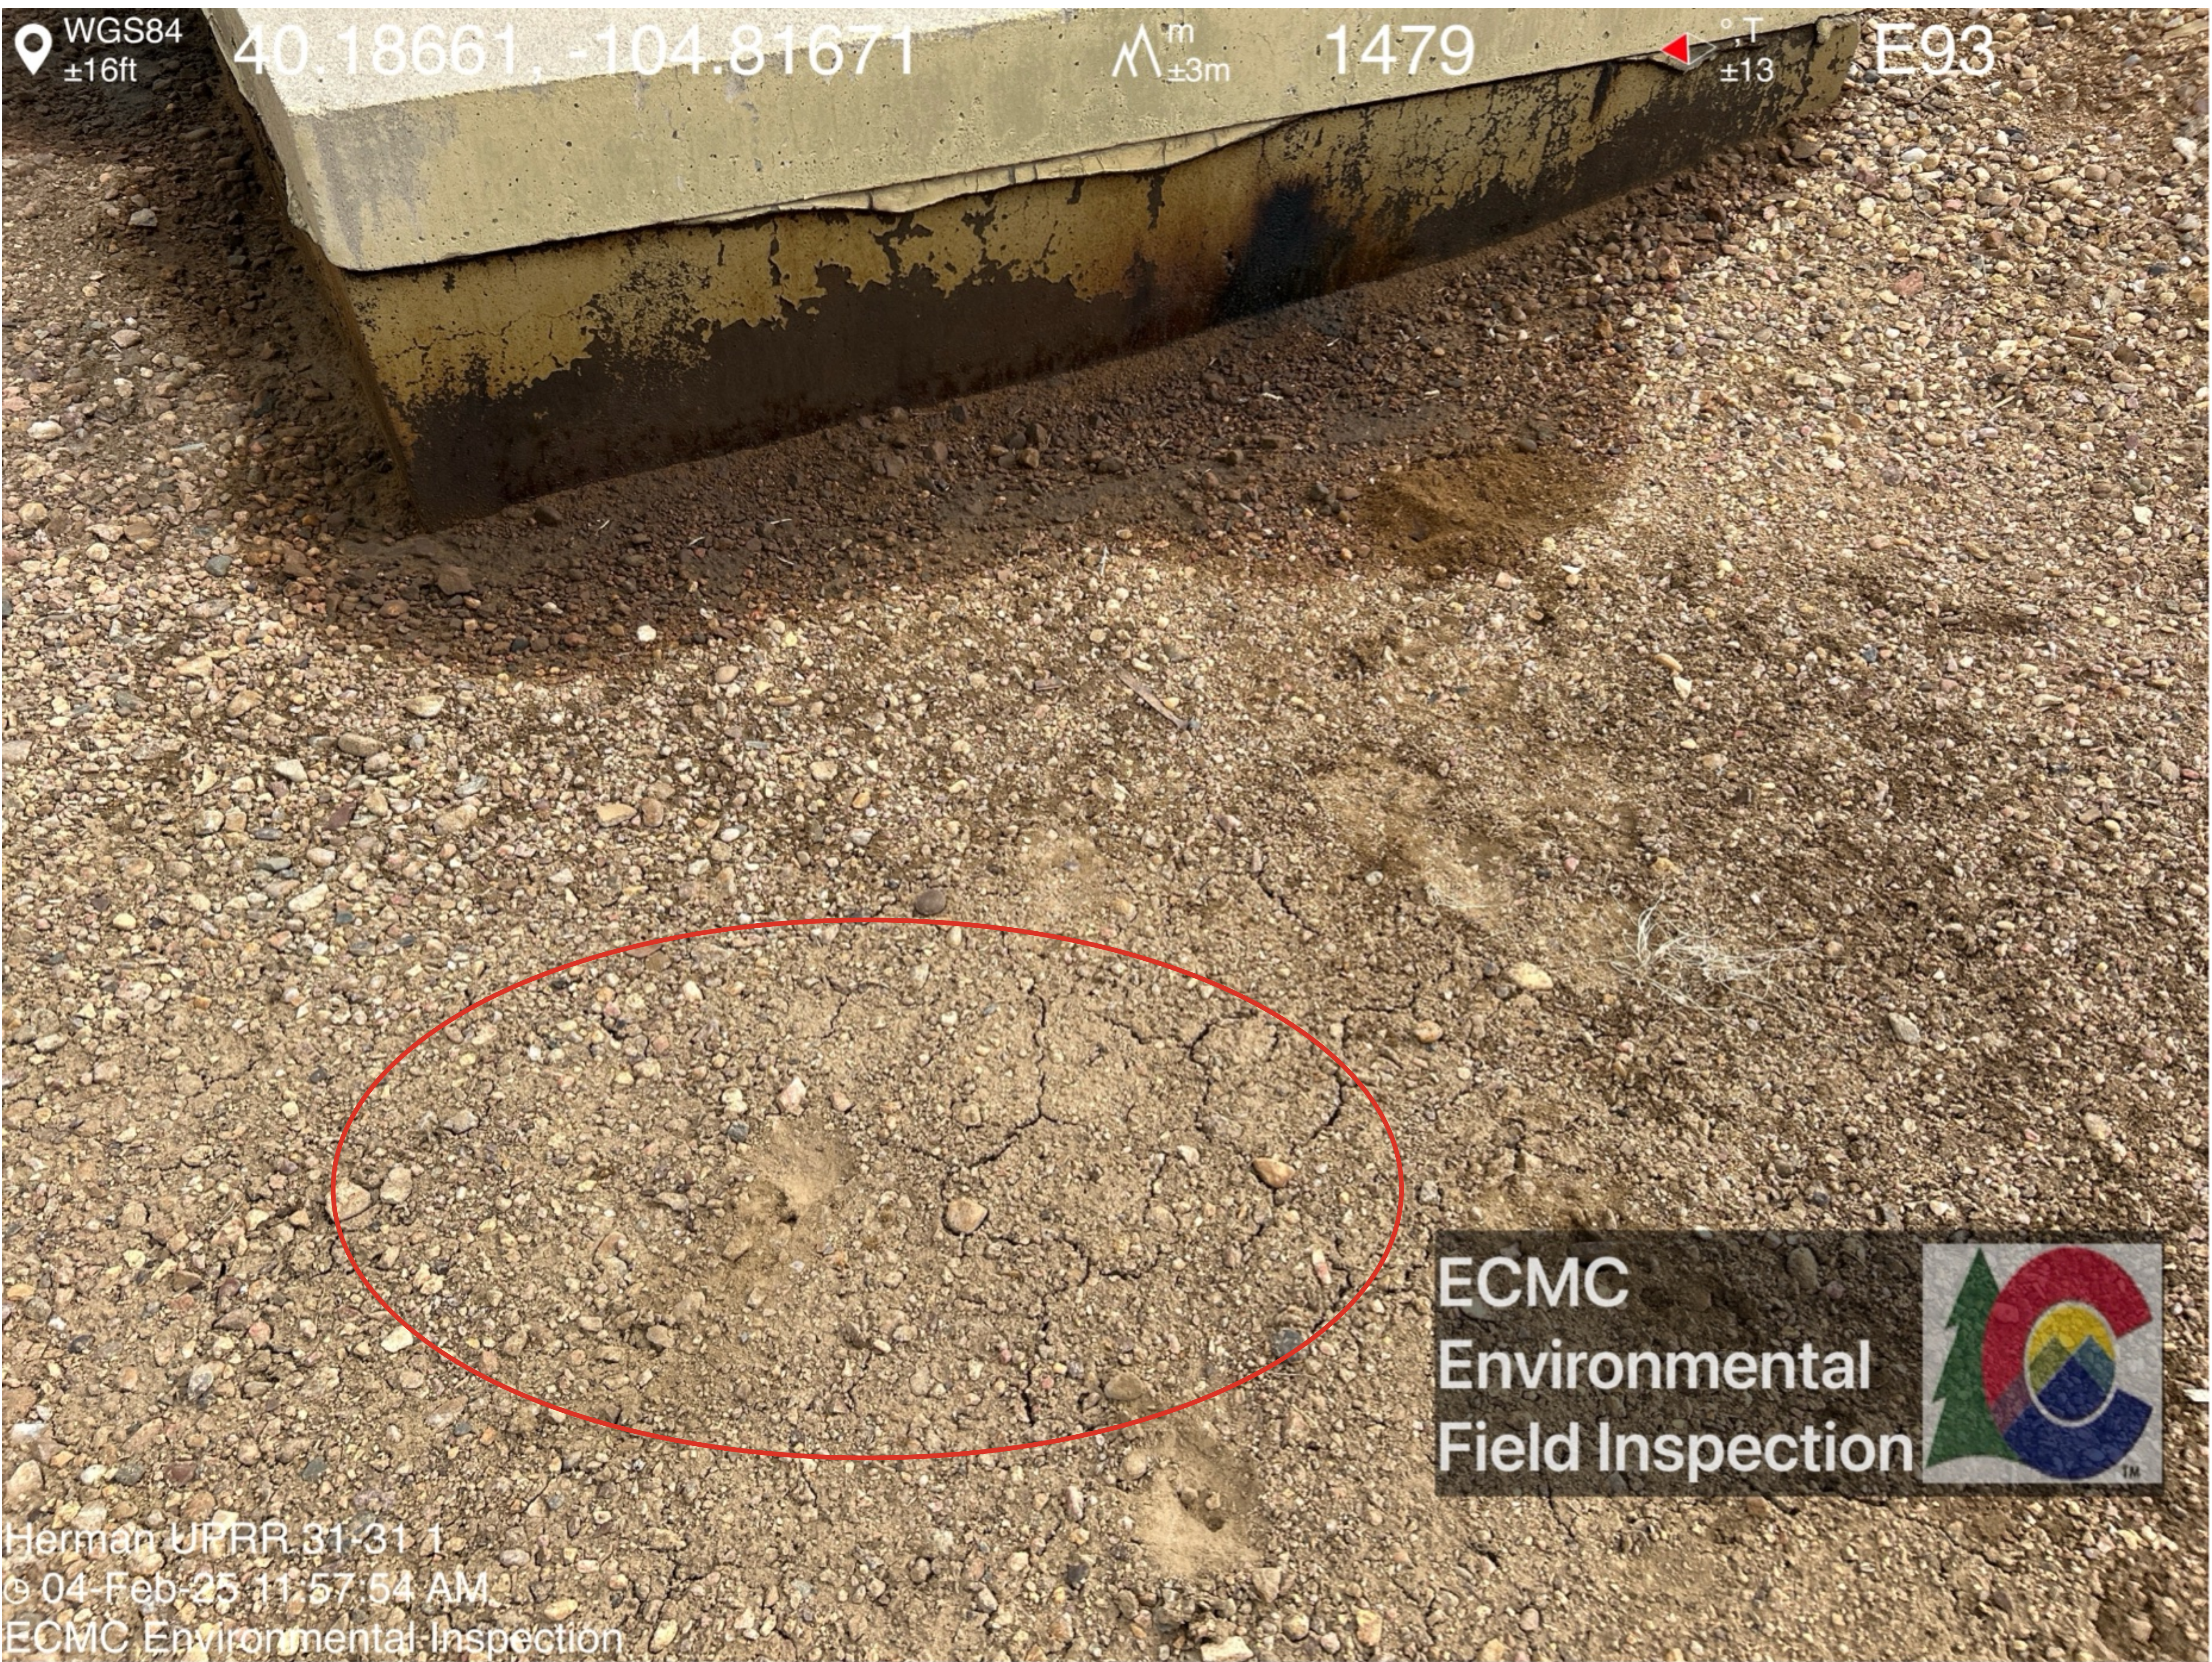
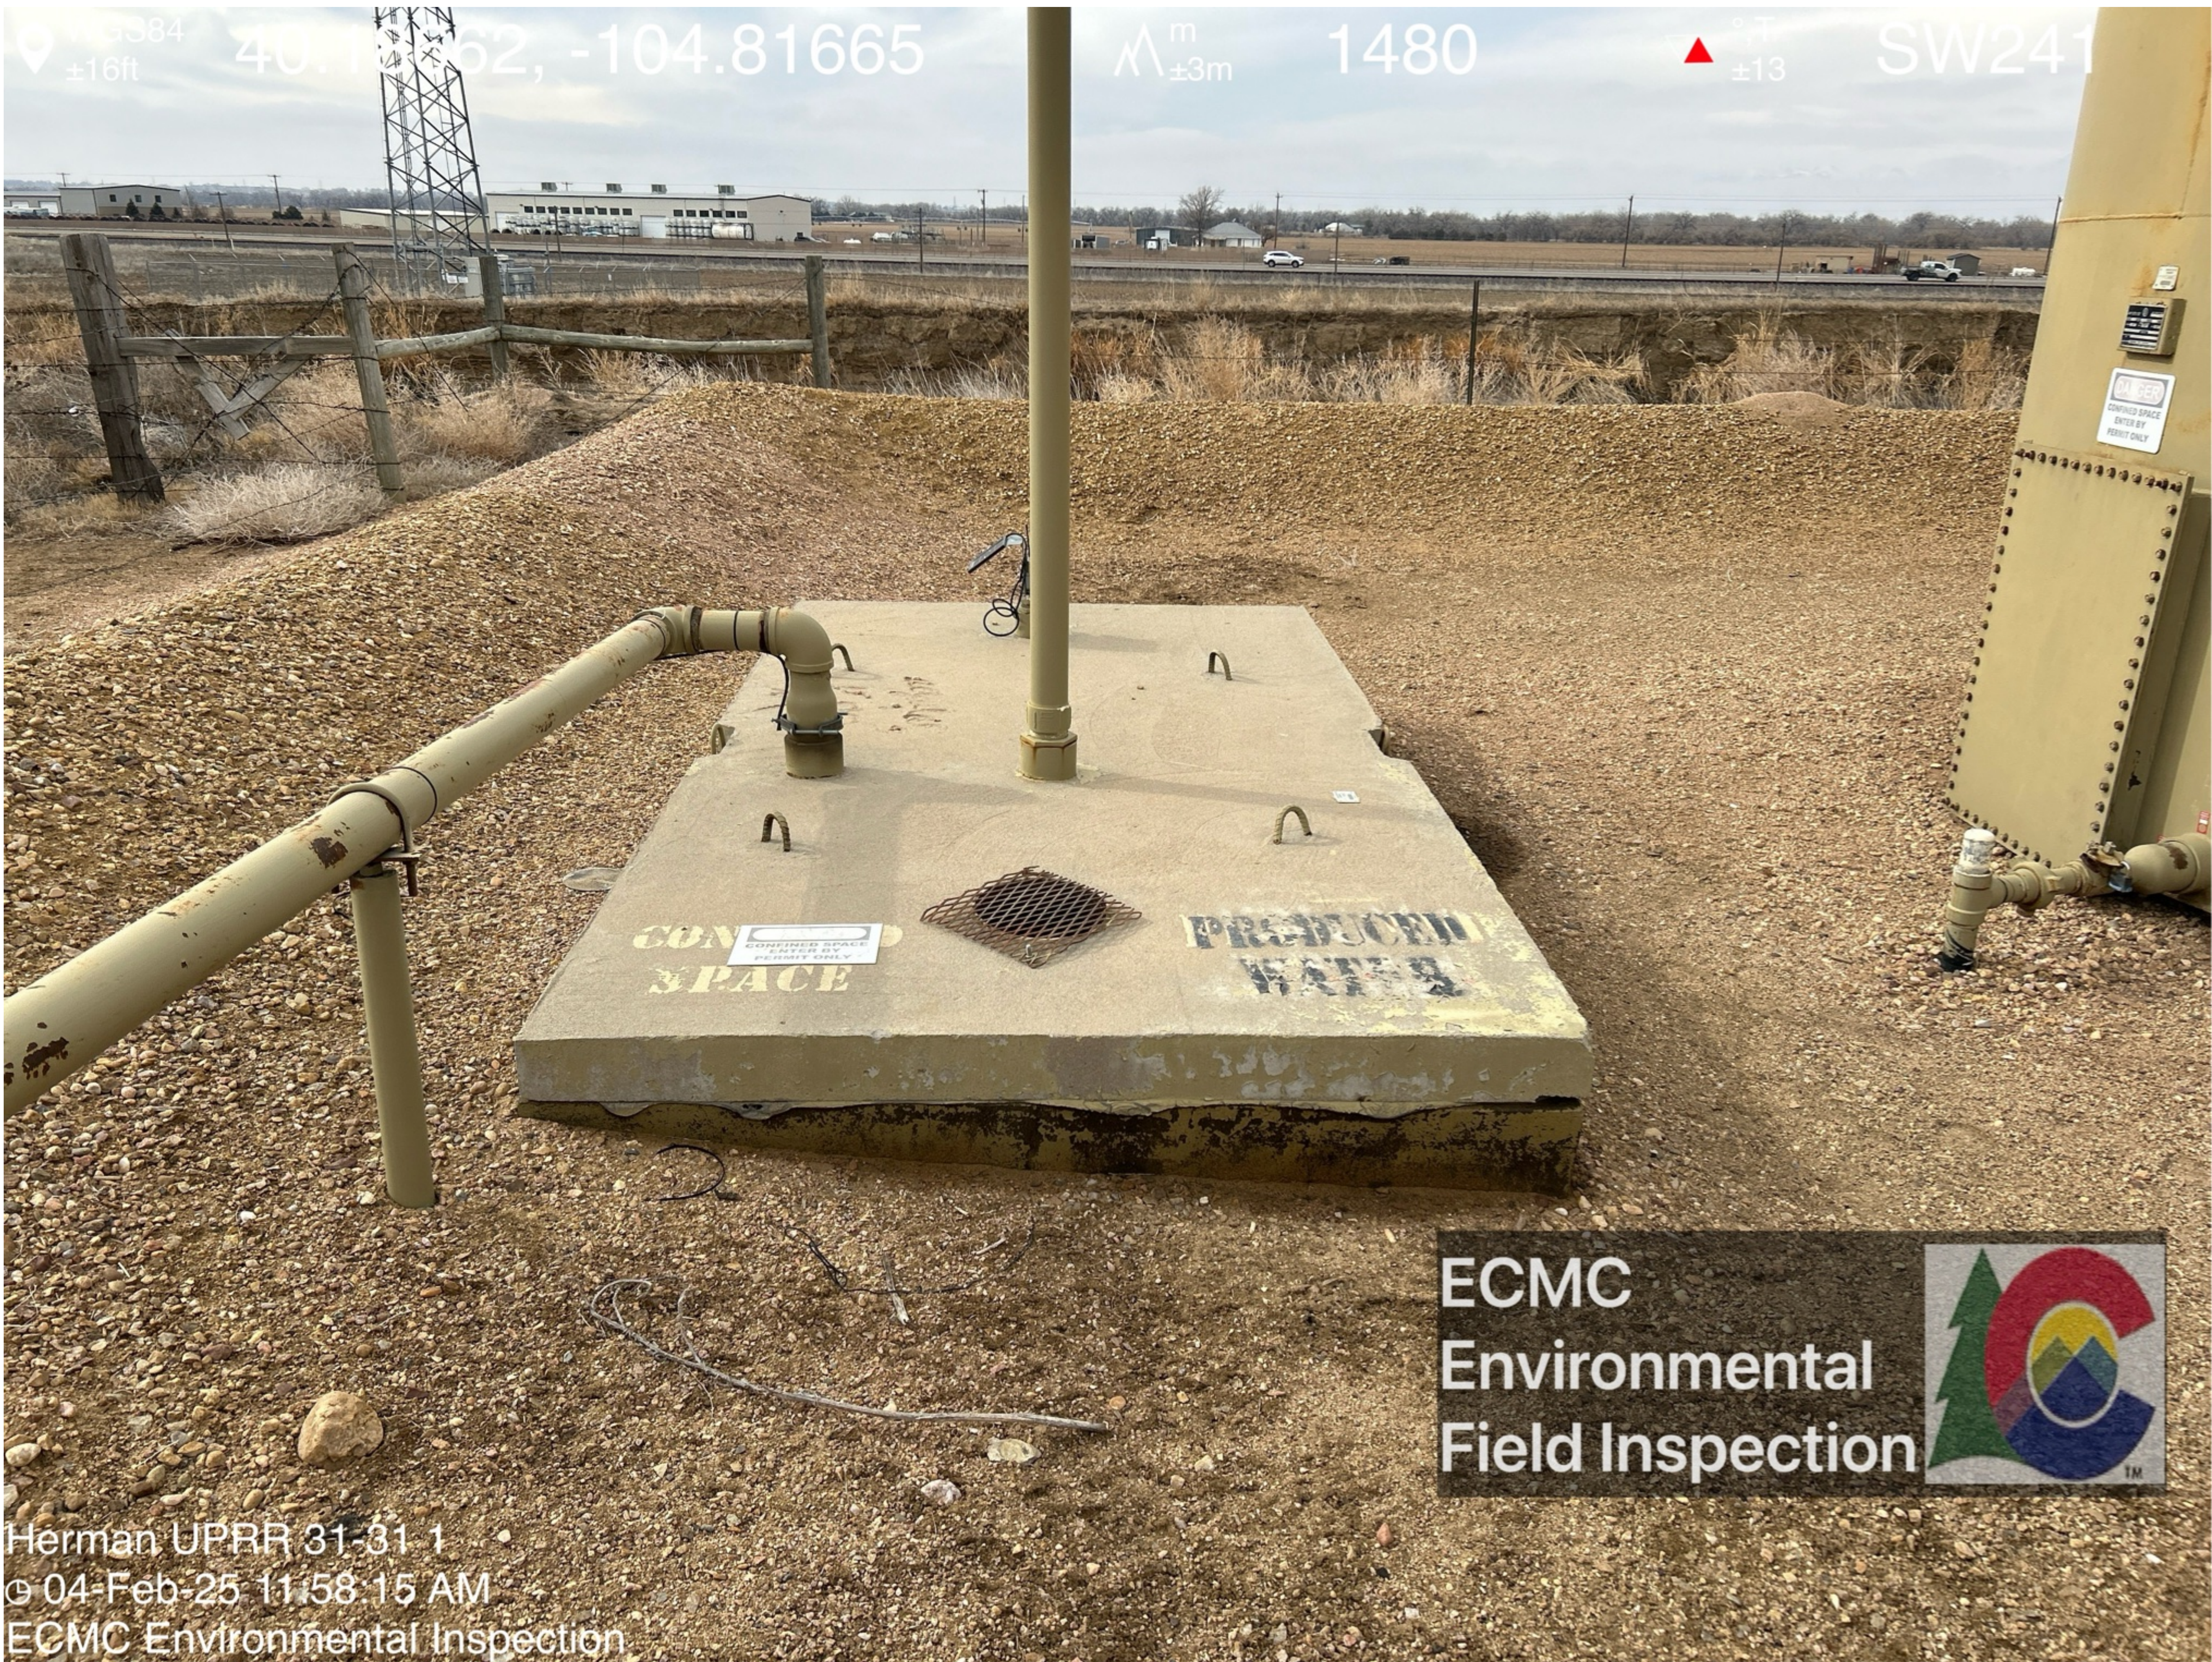
Production tank/produced water vault berm exhibited signs degradation (surface cracks).

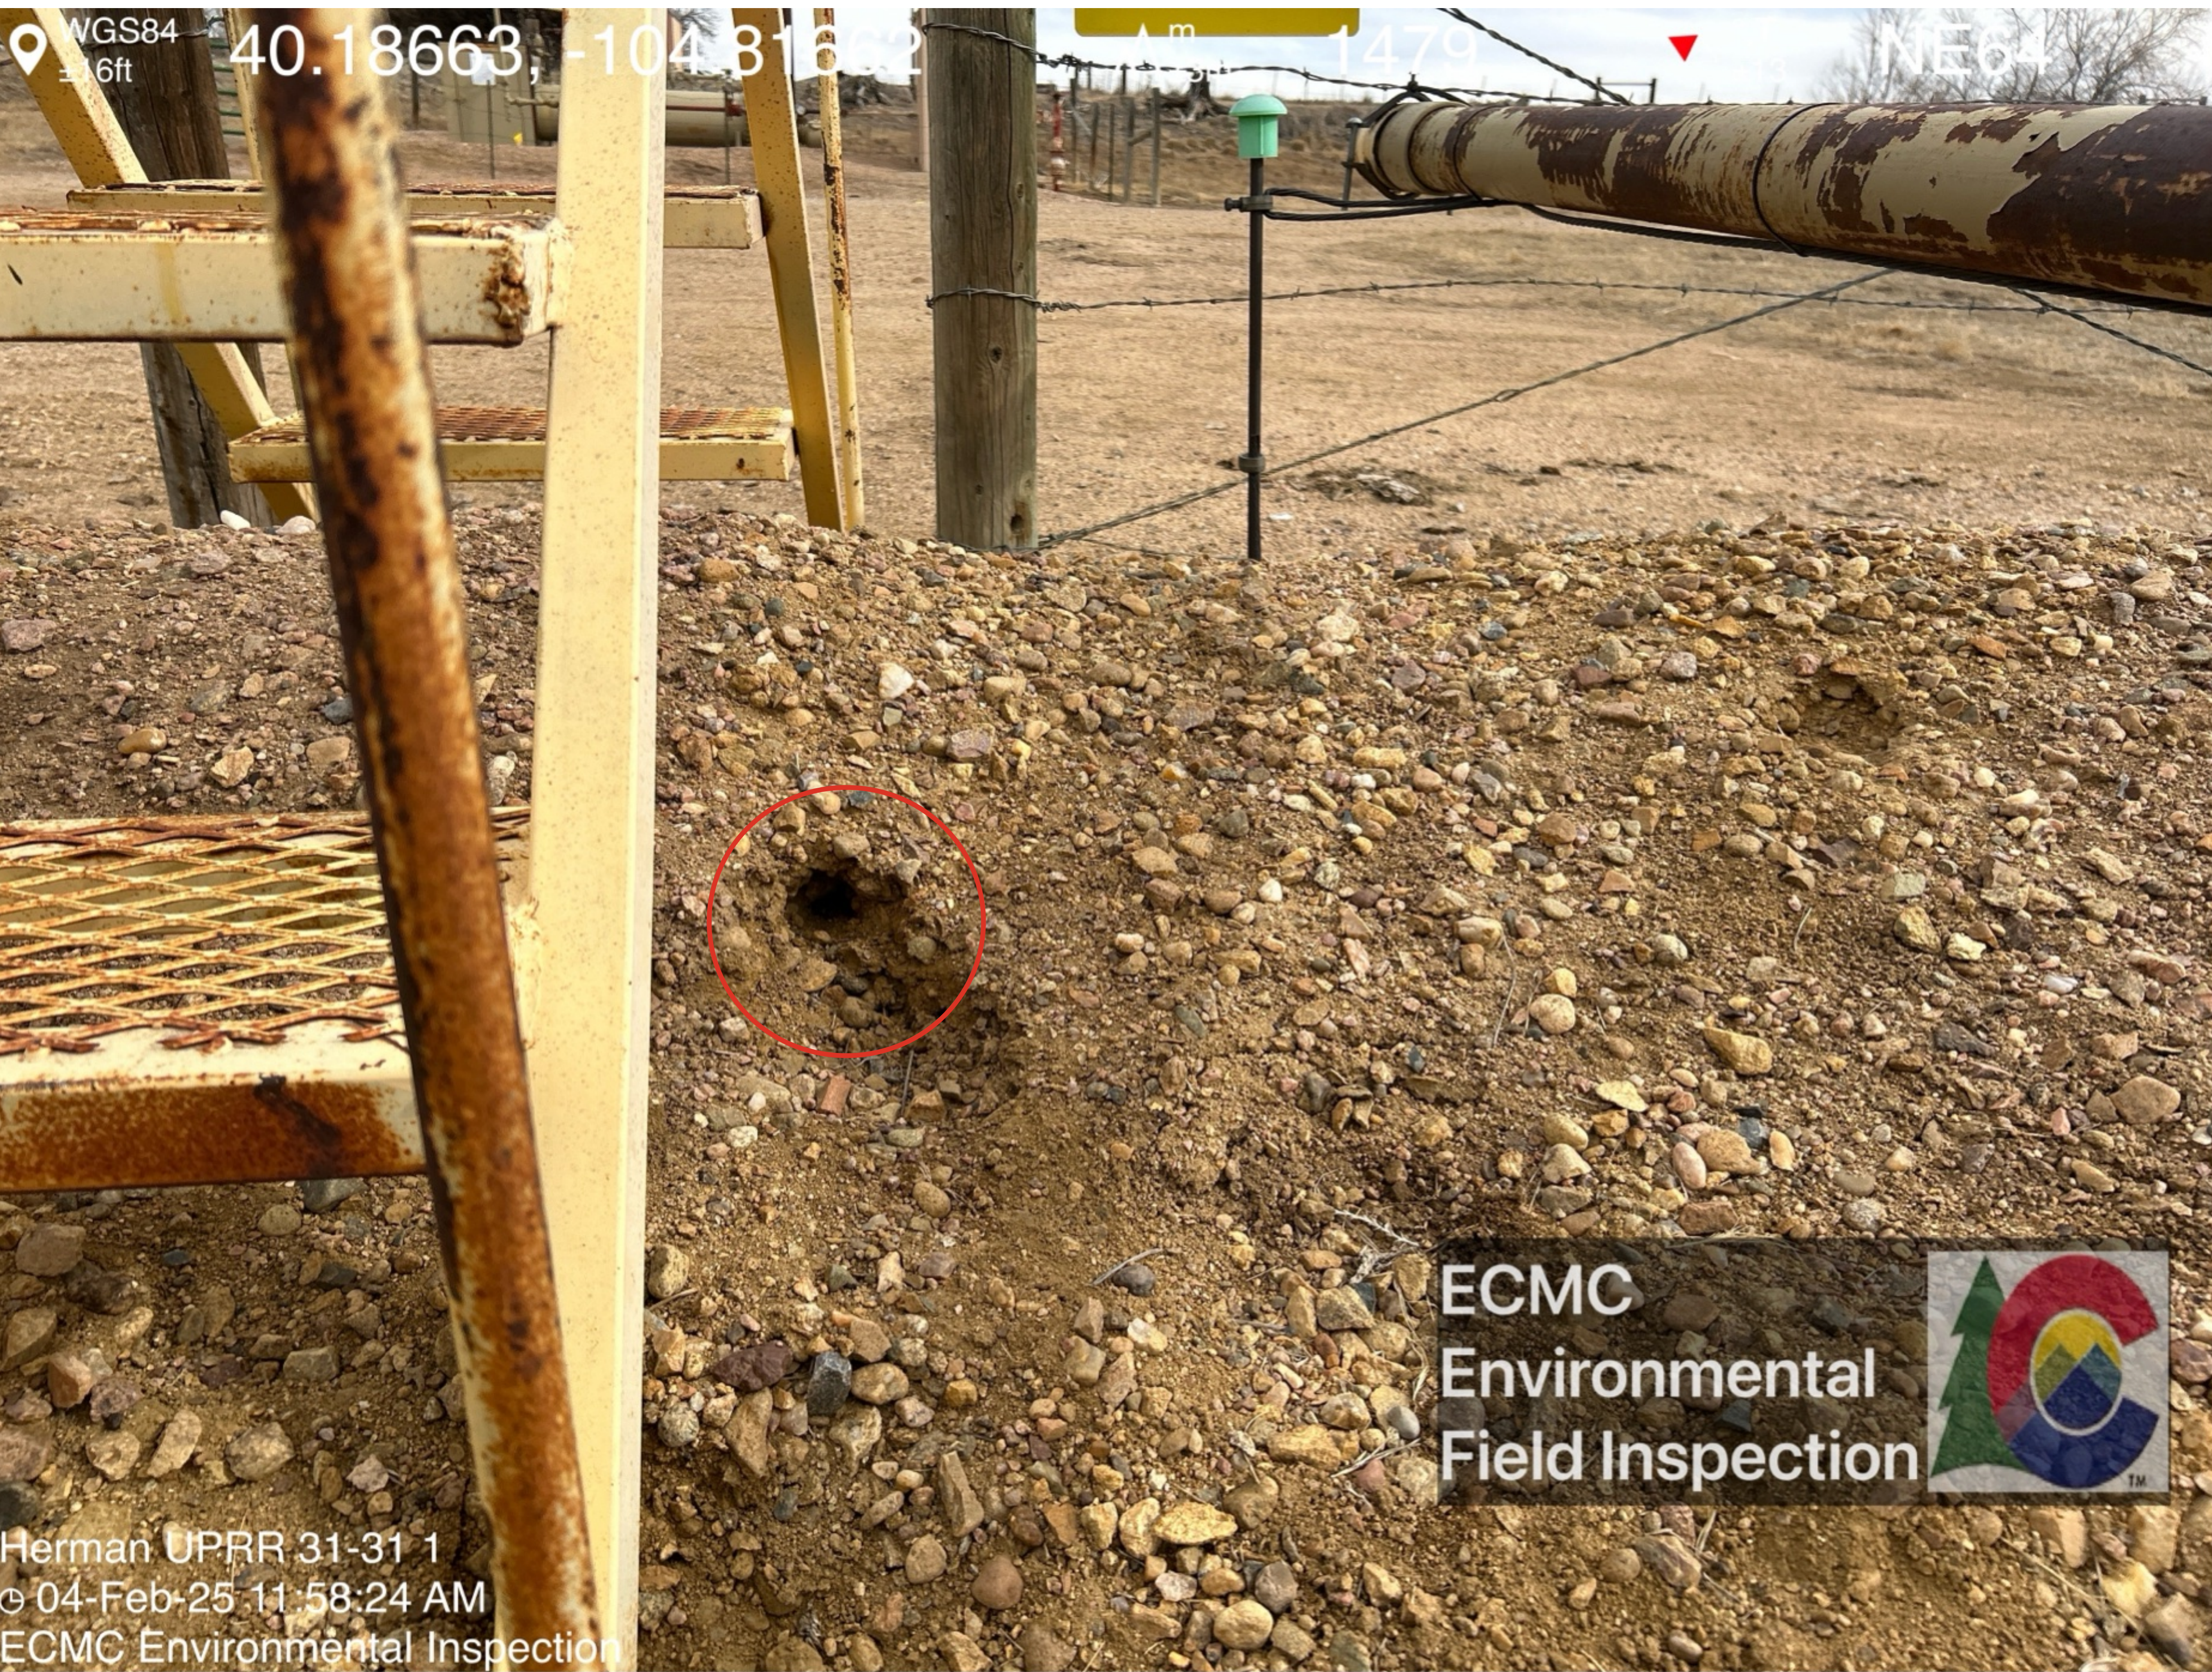
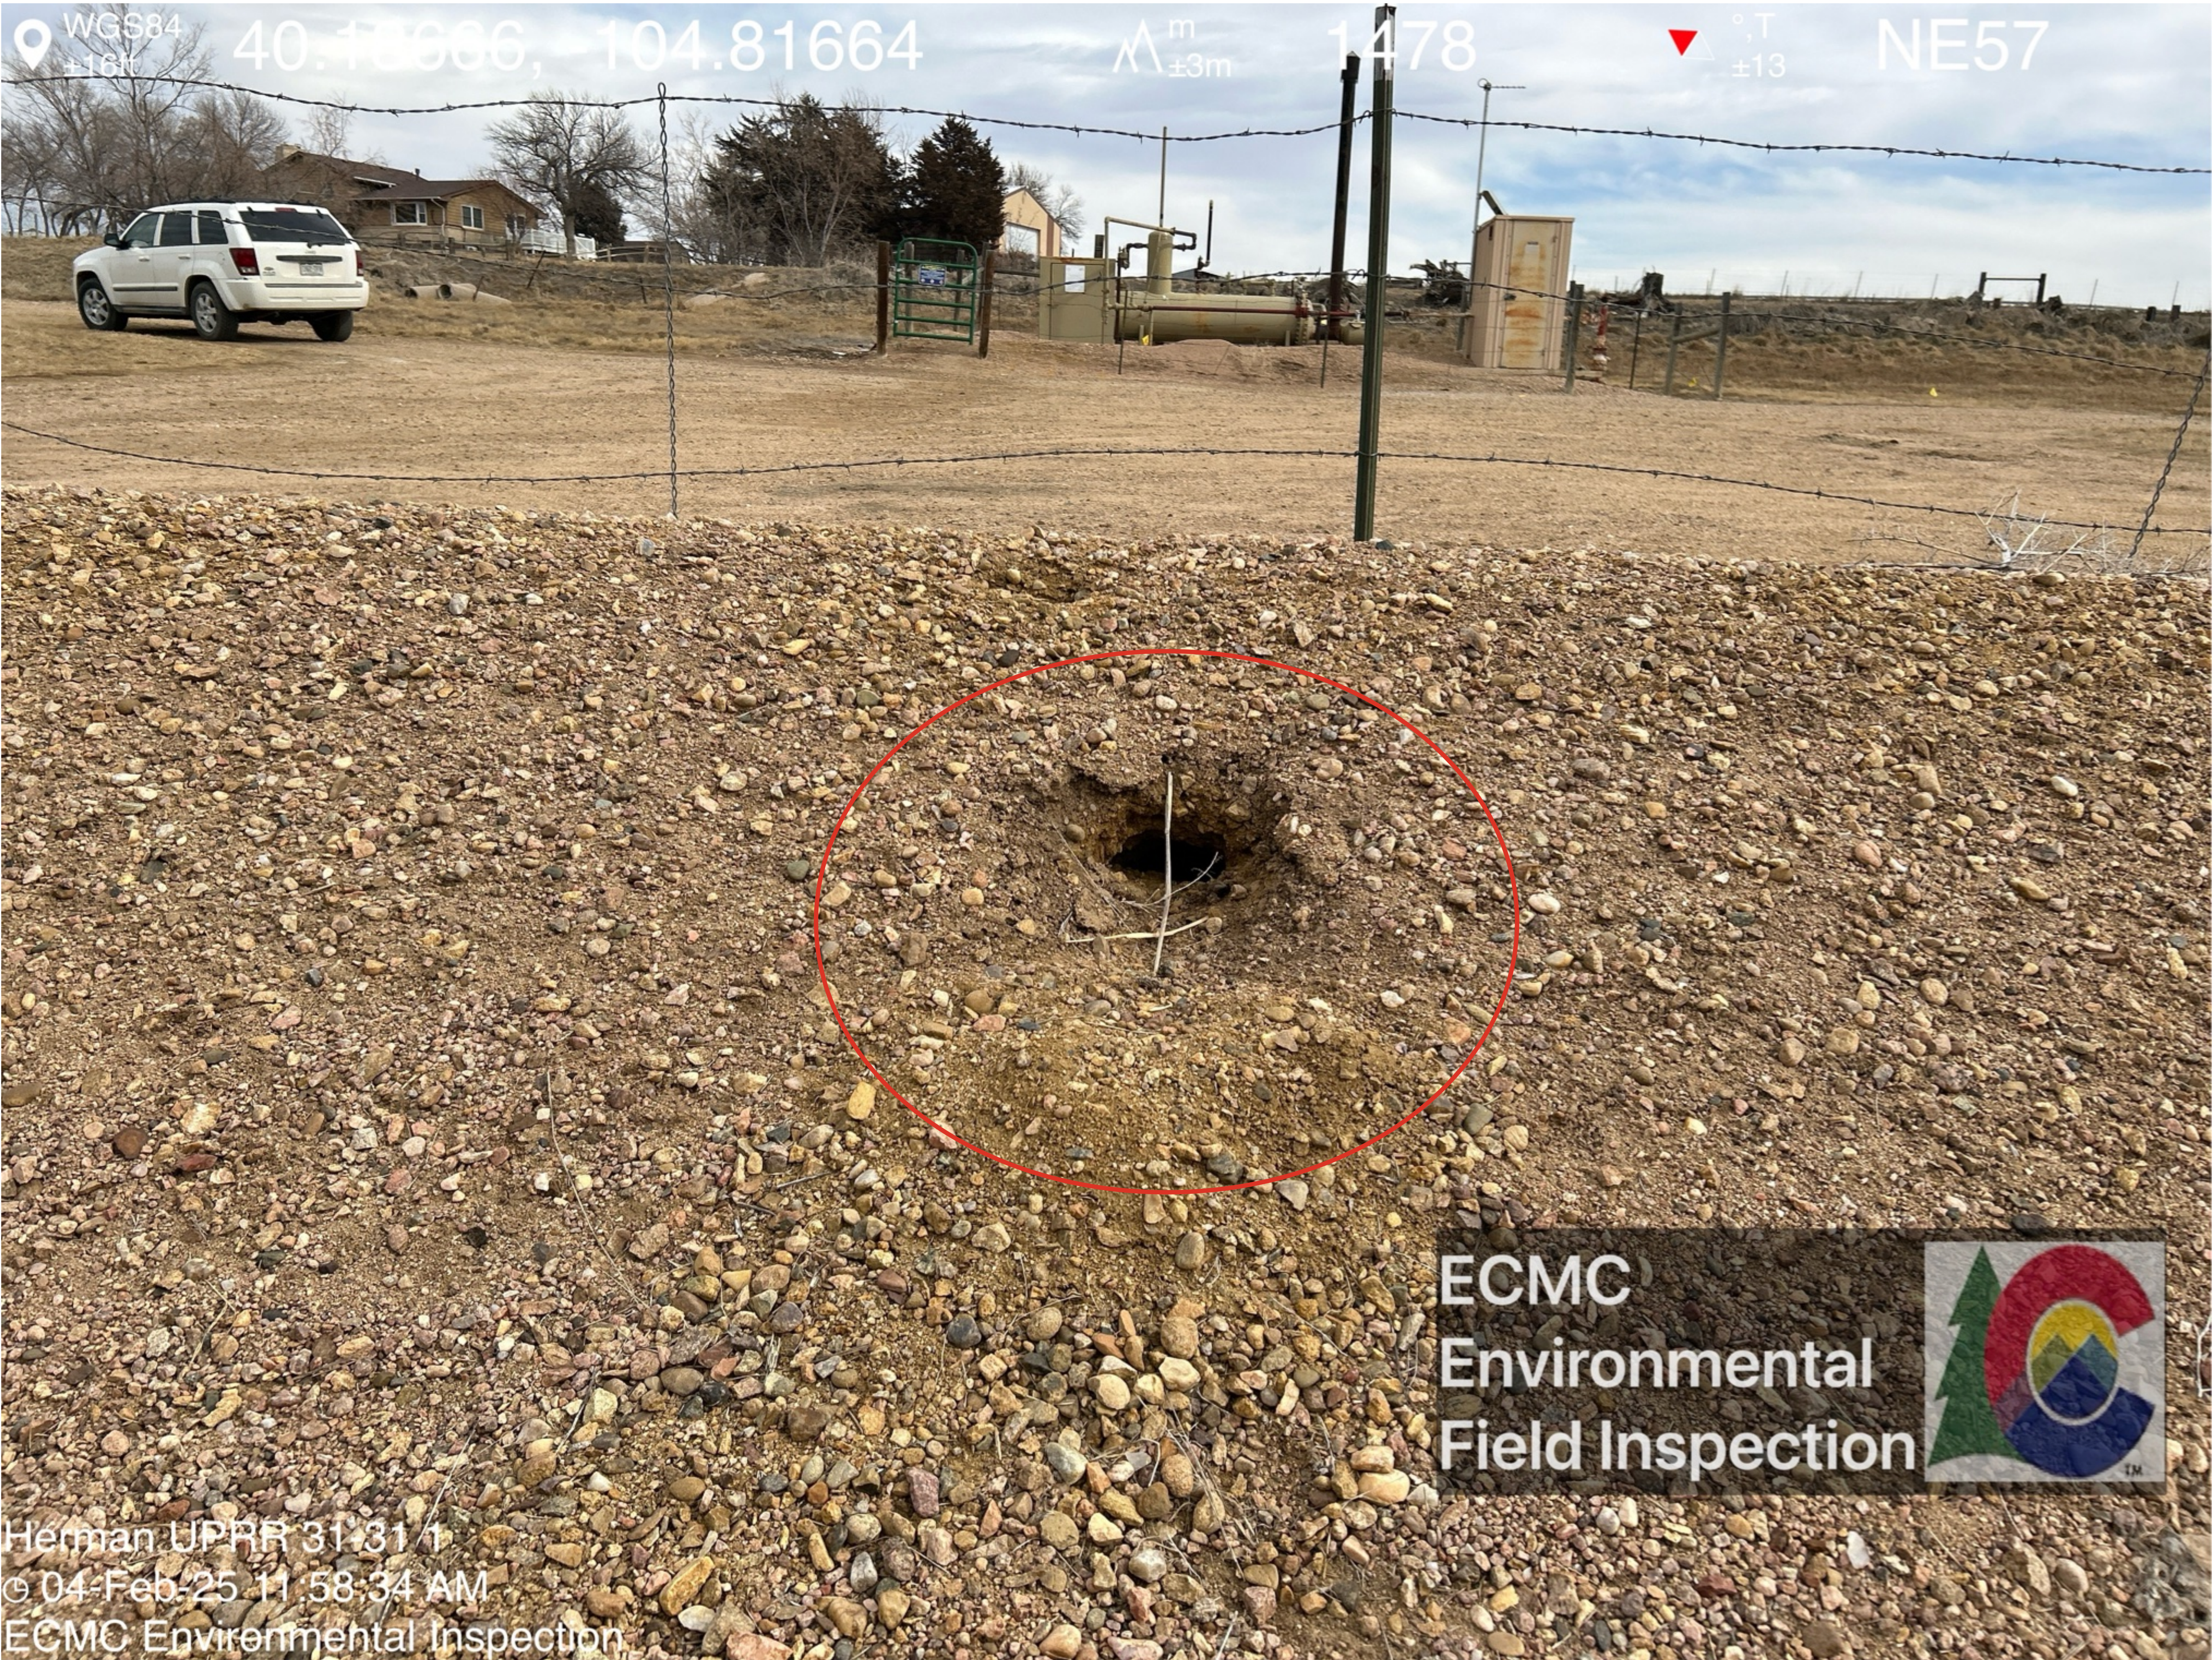
Multiple rodent holes were visible in the production tank/produced water vault berm.

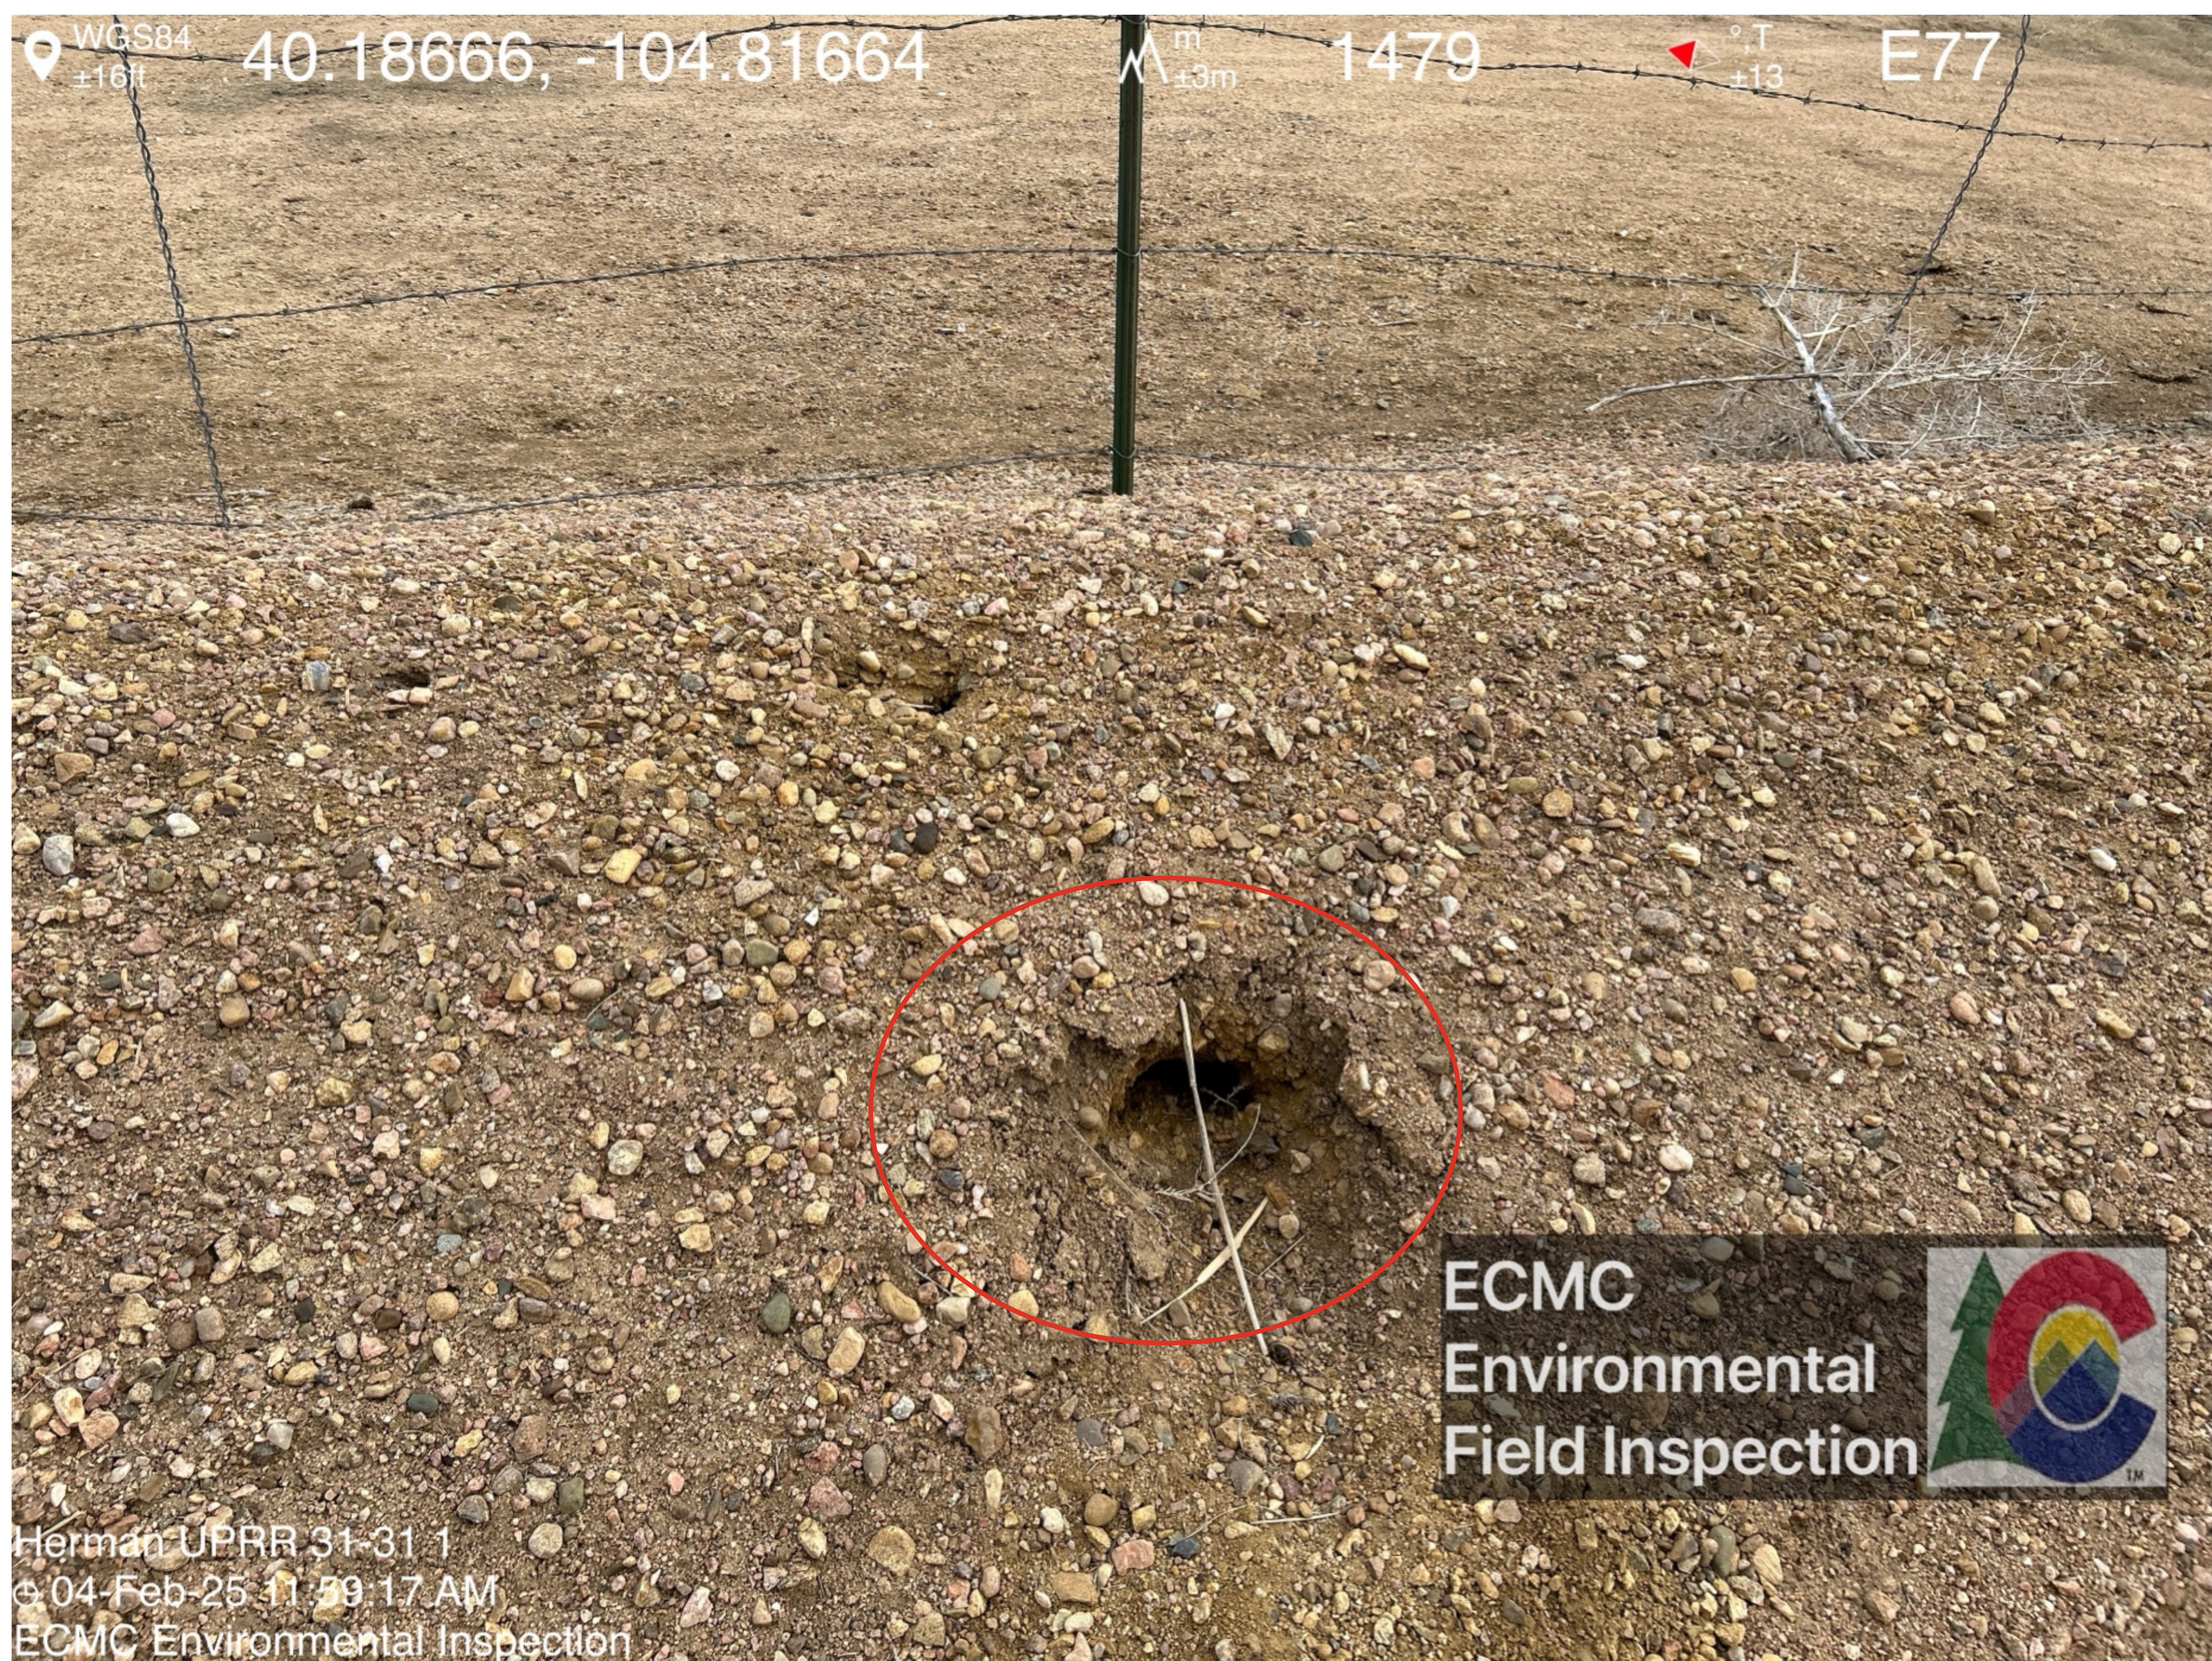
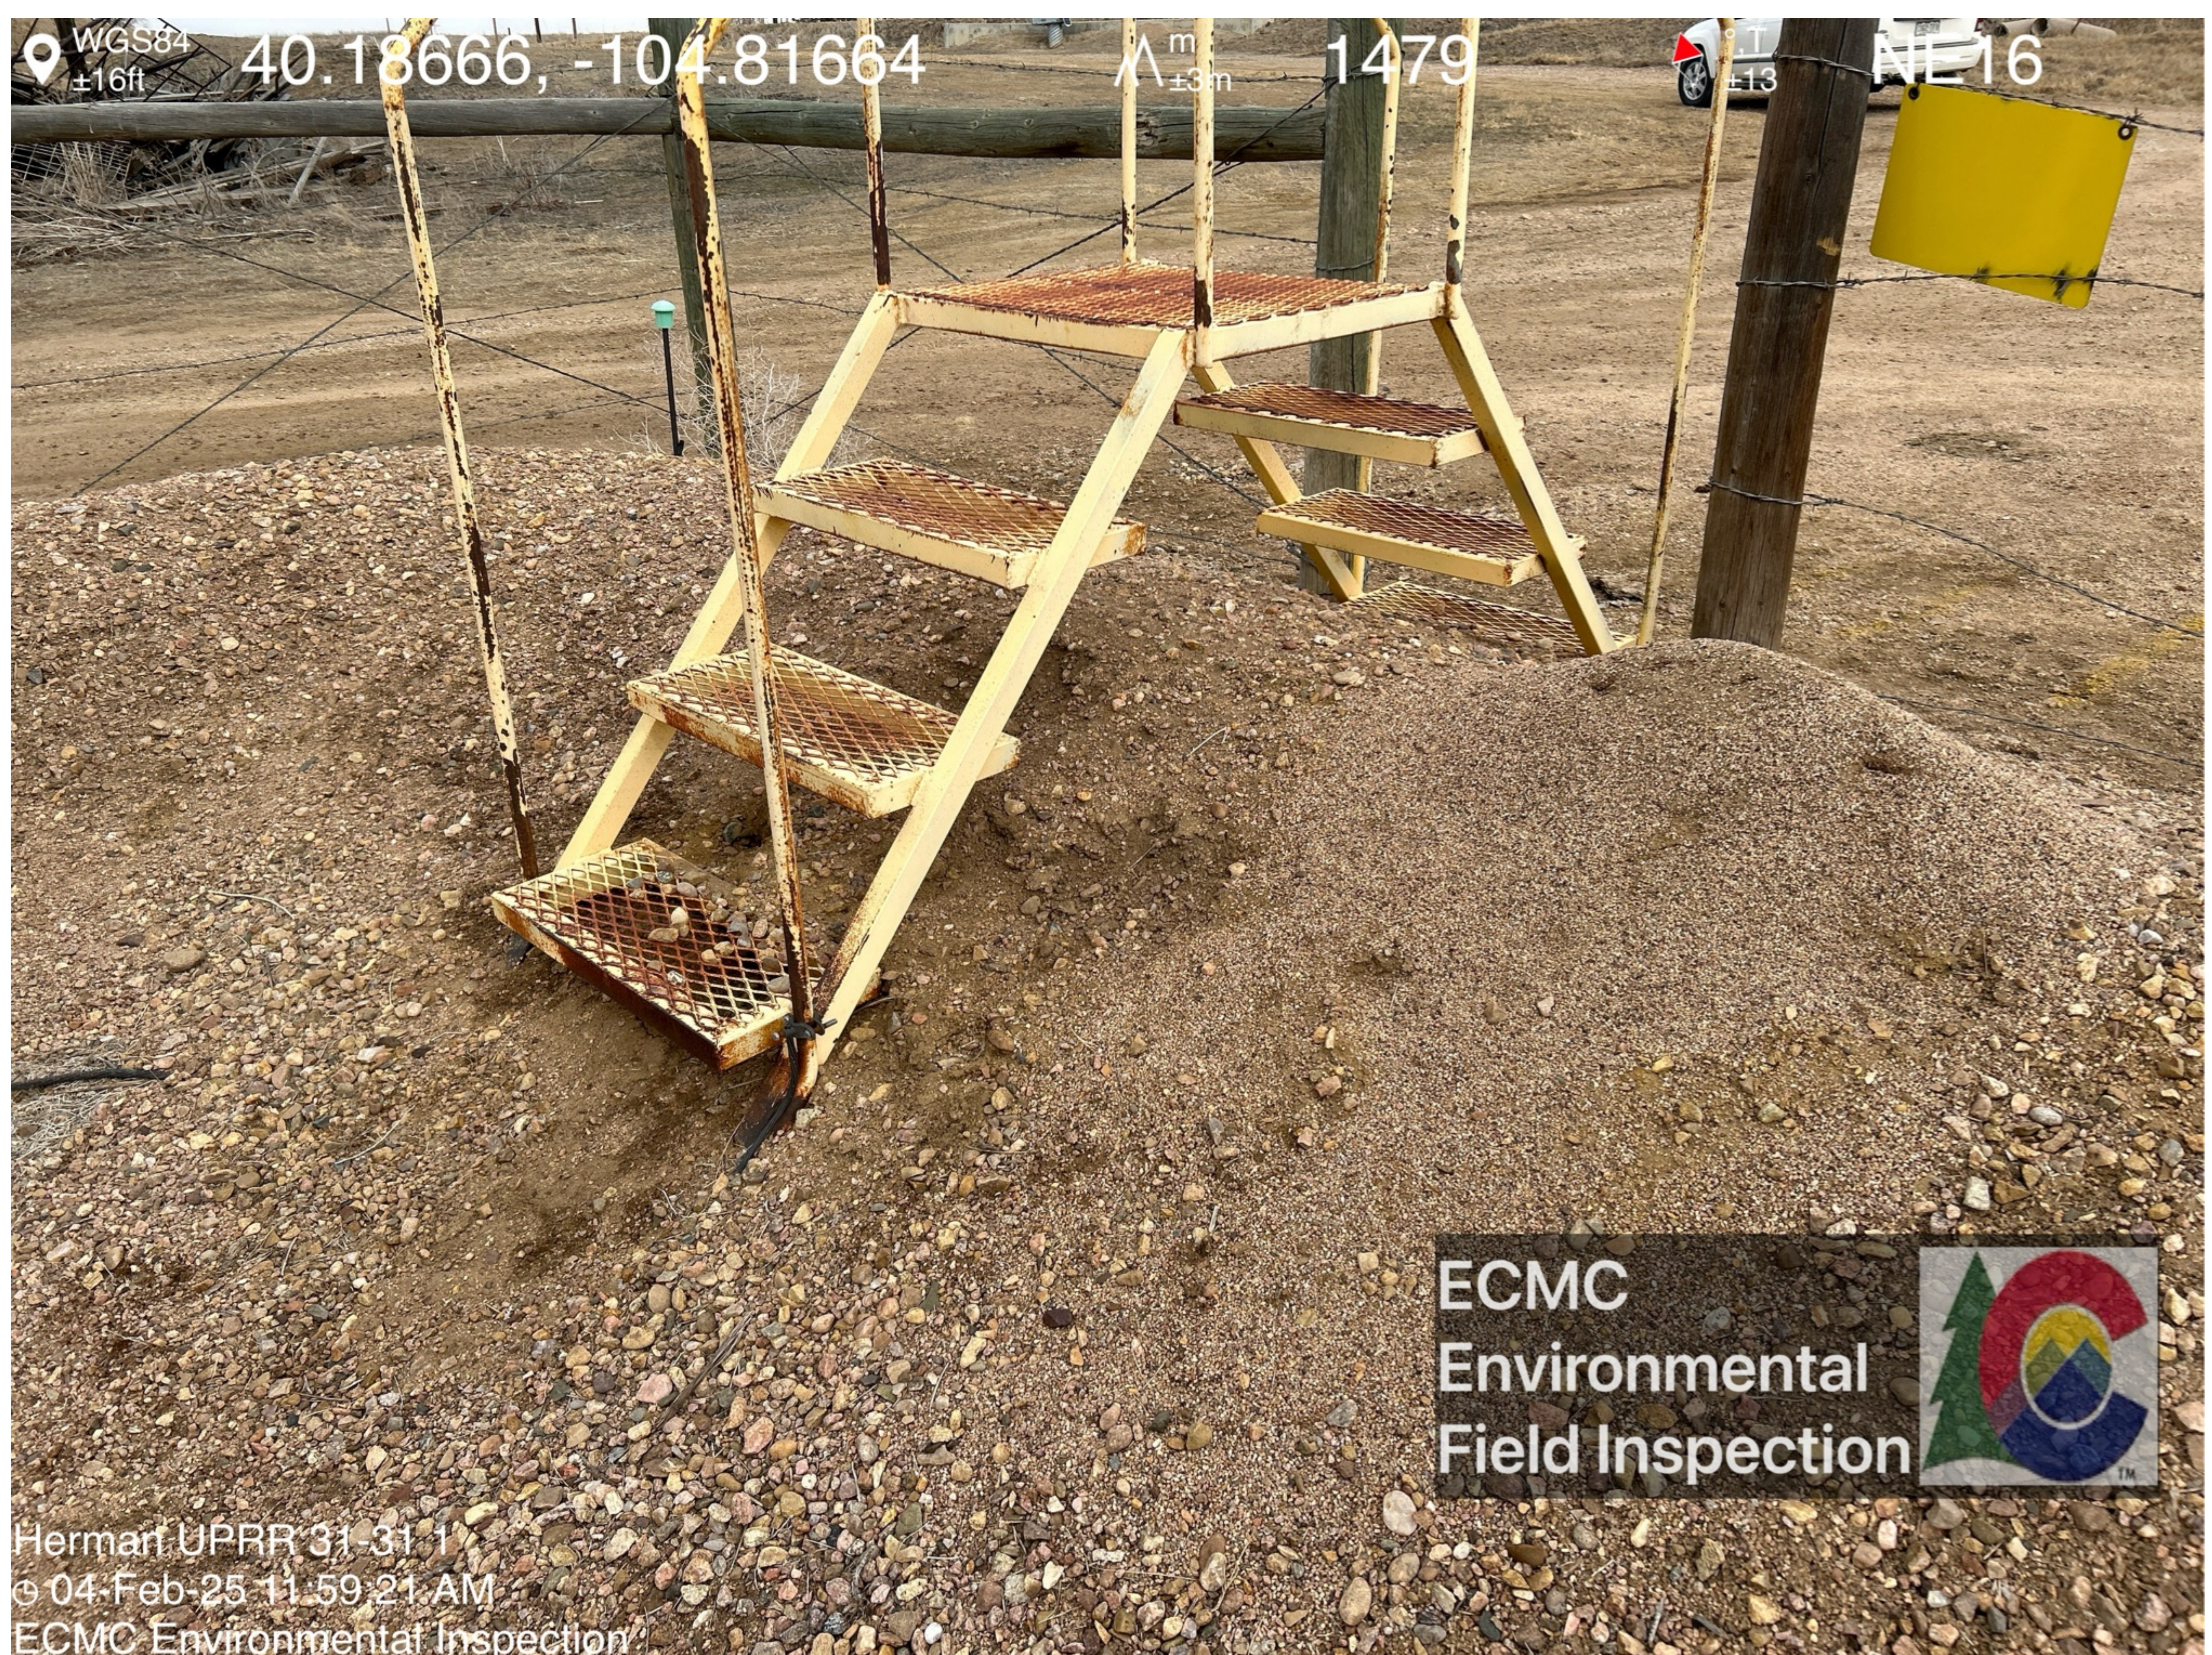
Berm material observed loose and was easily disturbed by walking.
