Herman UPRR 31-31.1  
© 04-Feb-25 11:55:33 AM  
ECMC Environmental Inspection

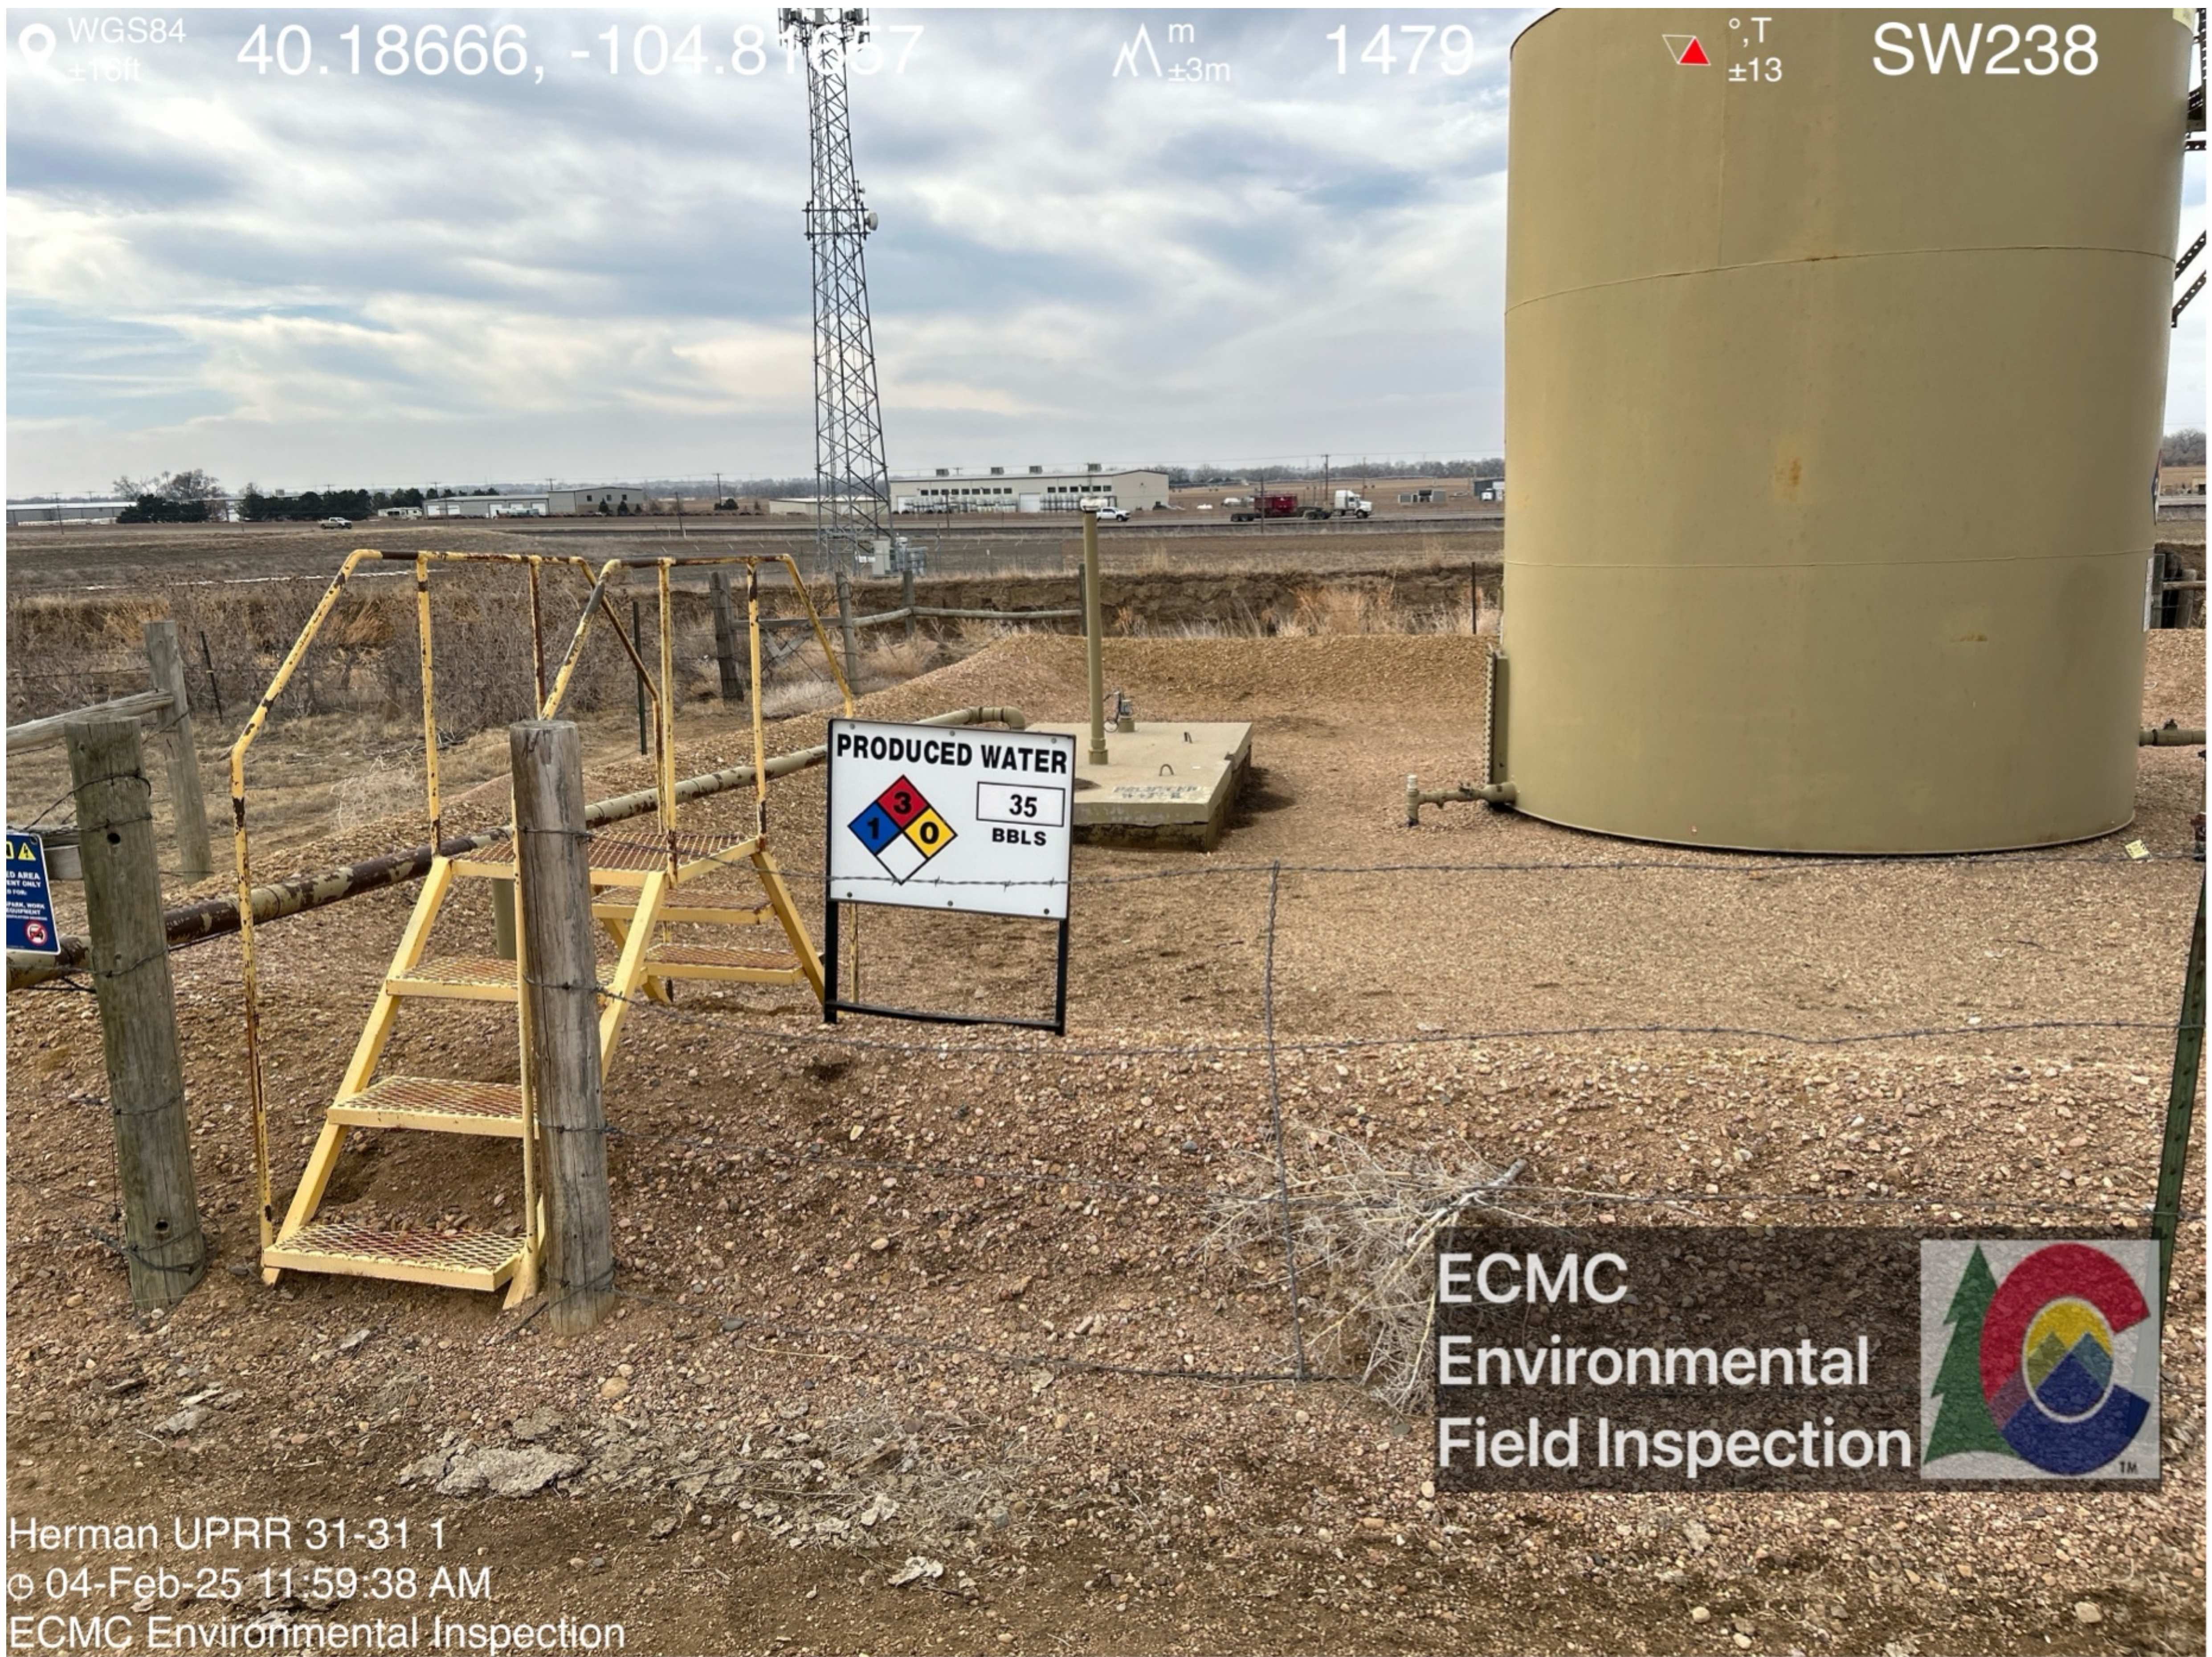
NFPA placard visible.

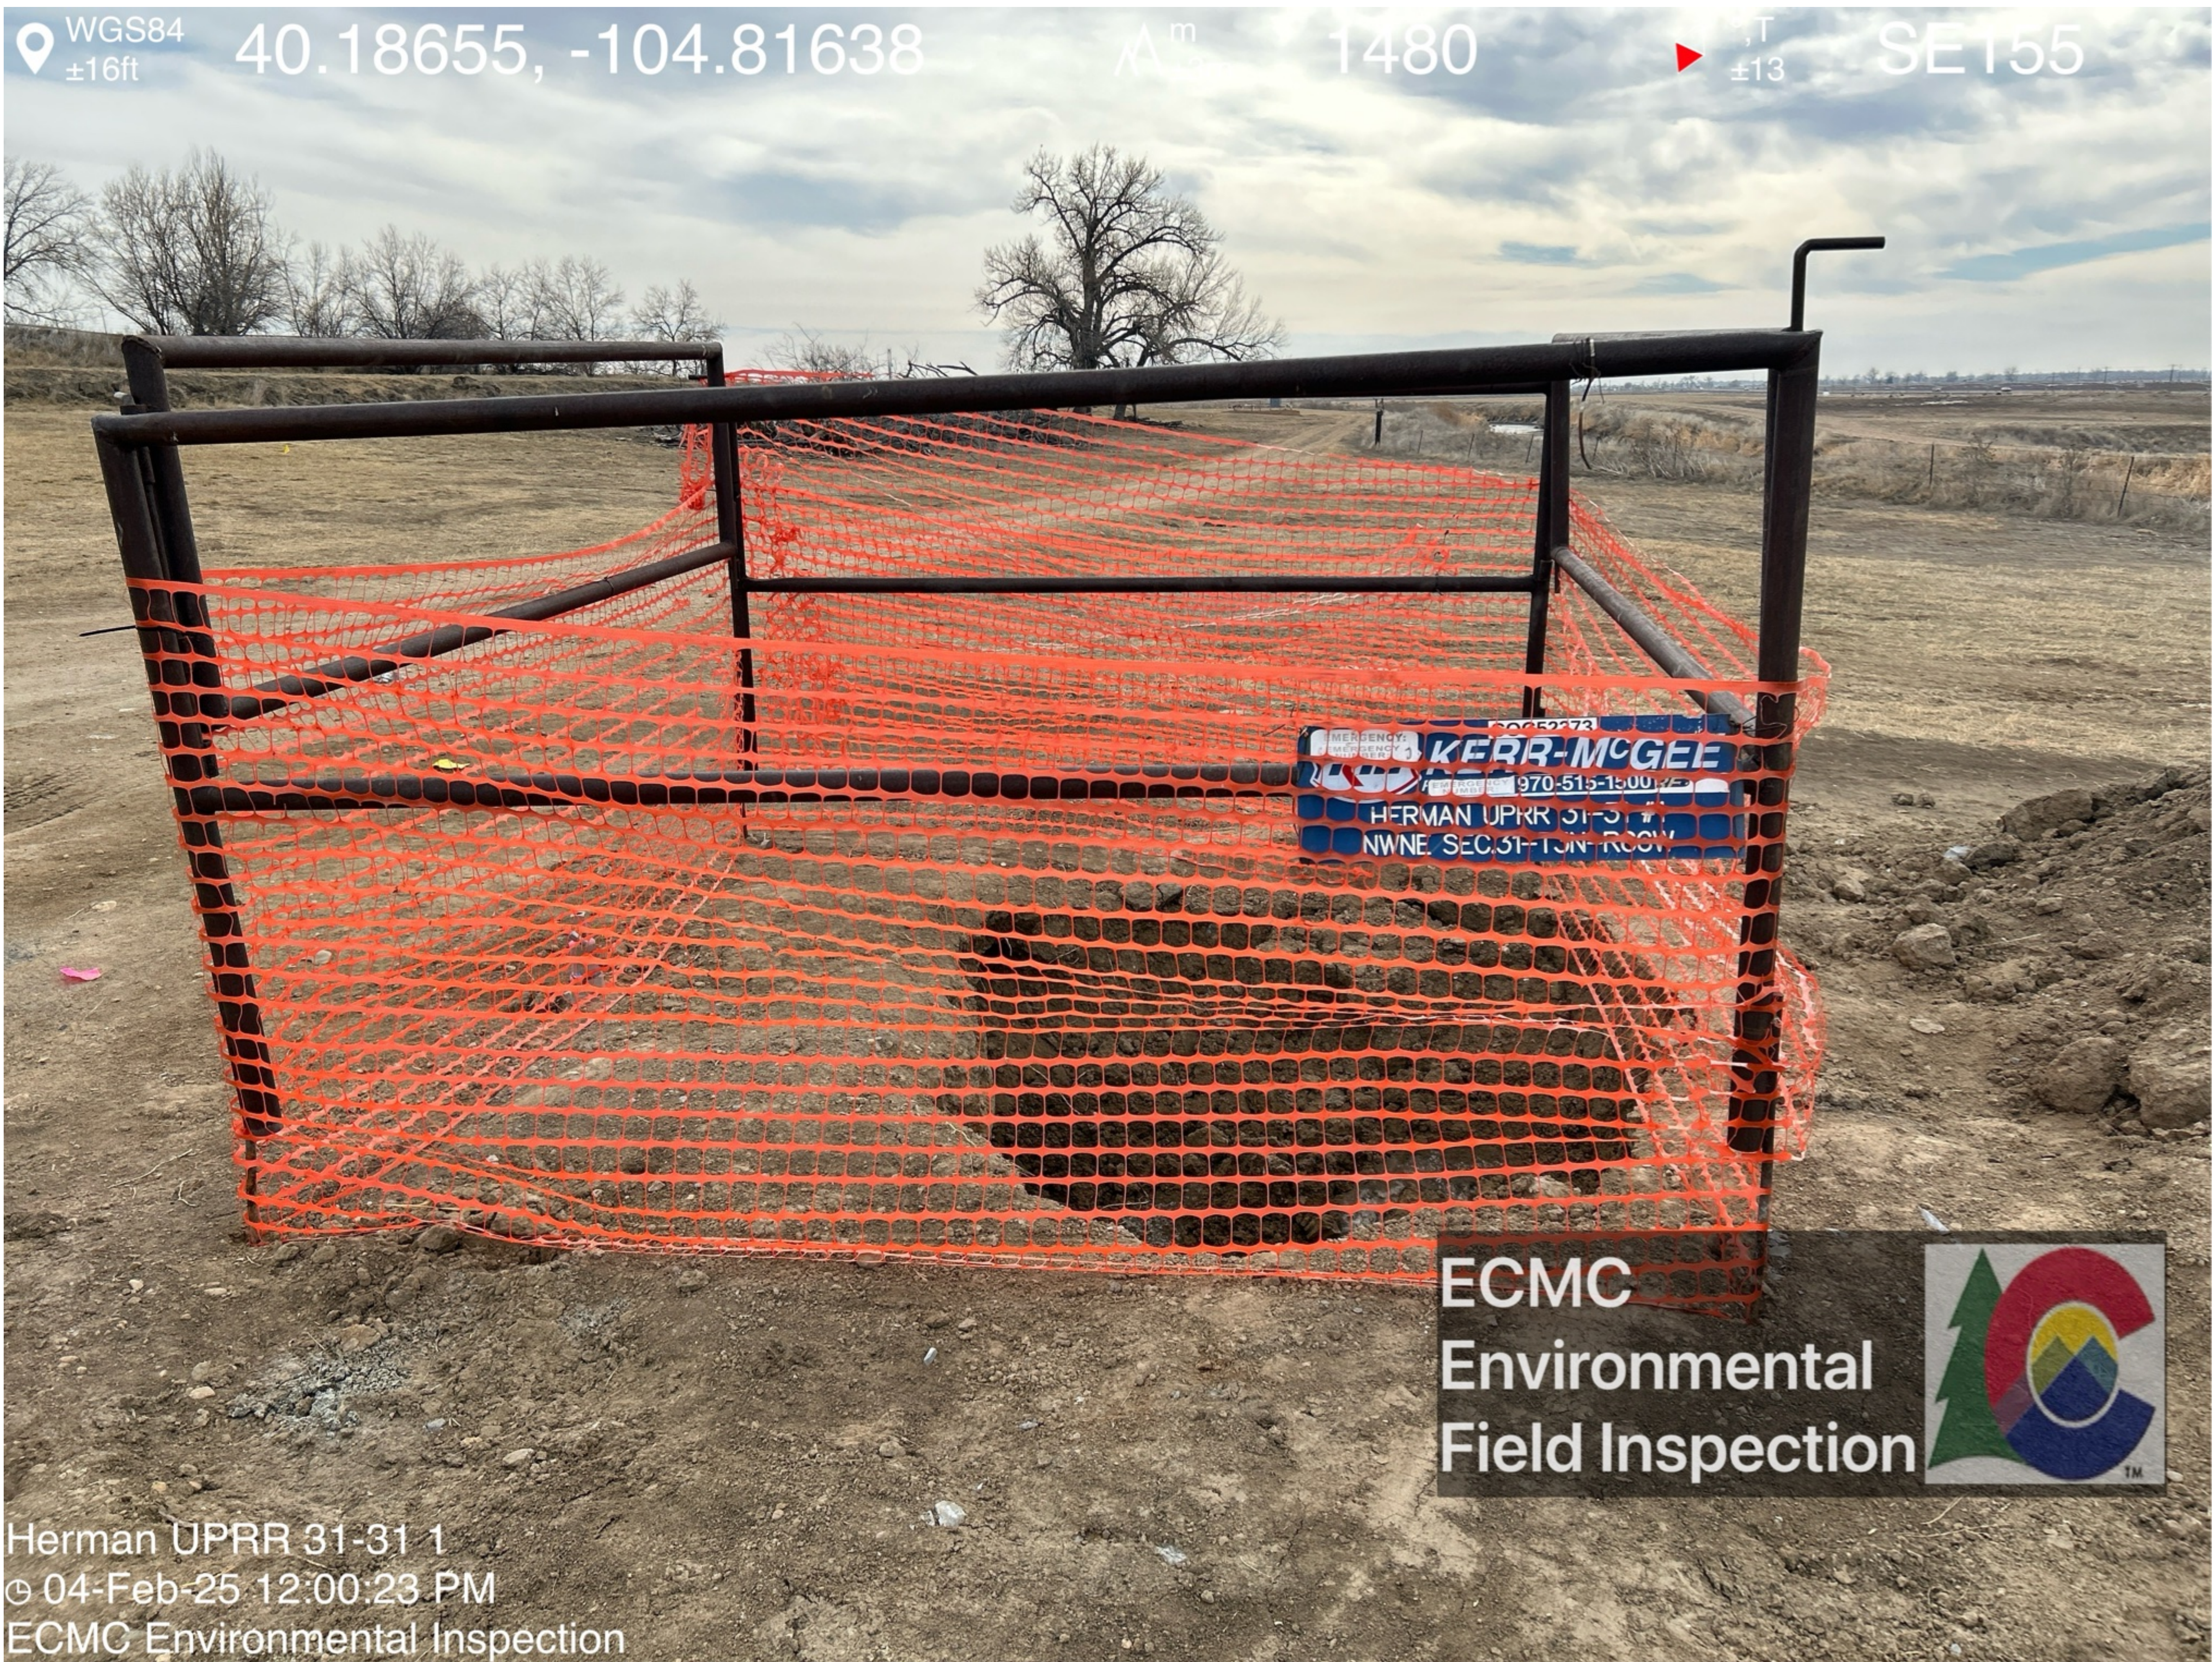
Metal fencing and orange construction fencing observed at former wellhead location.

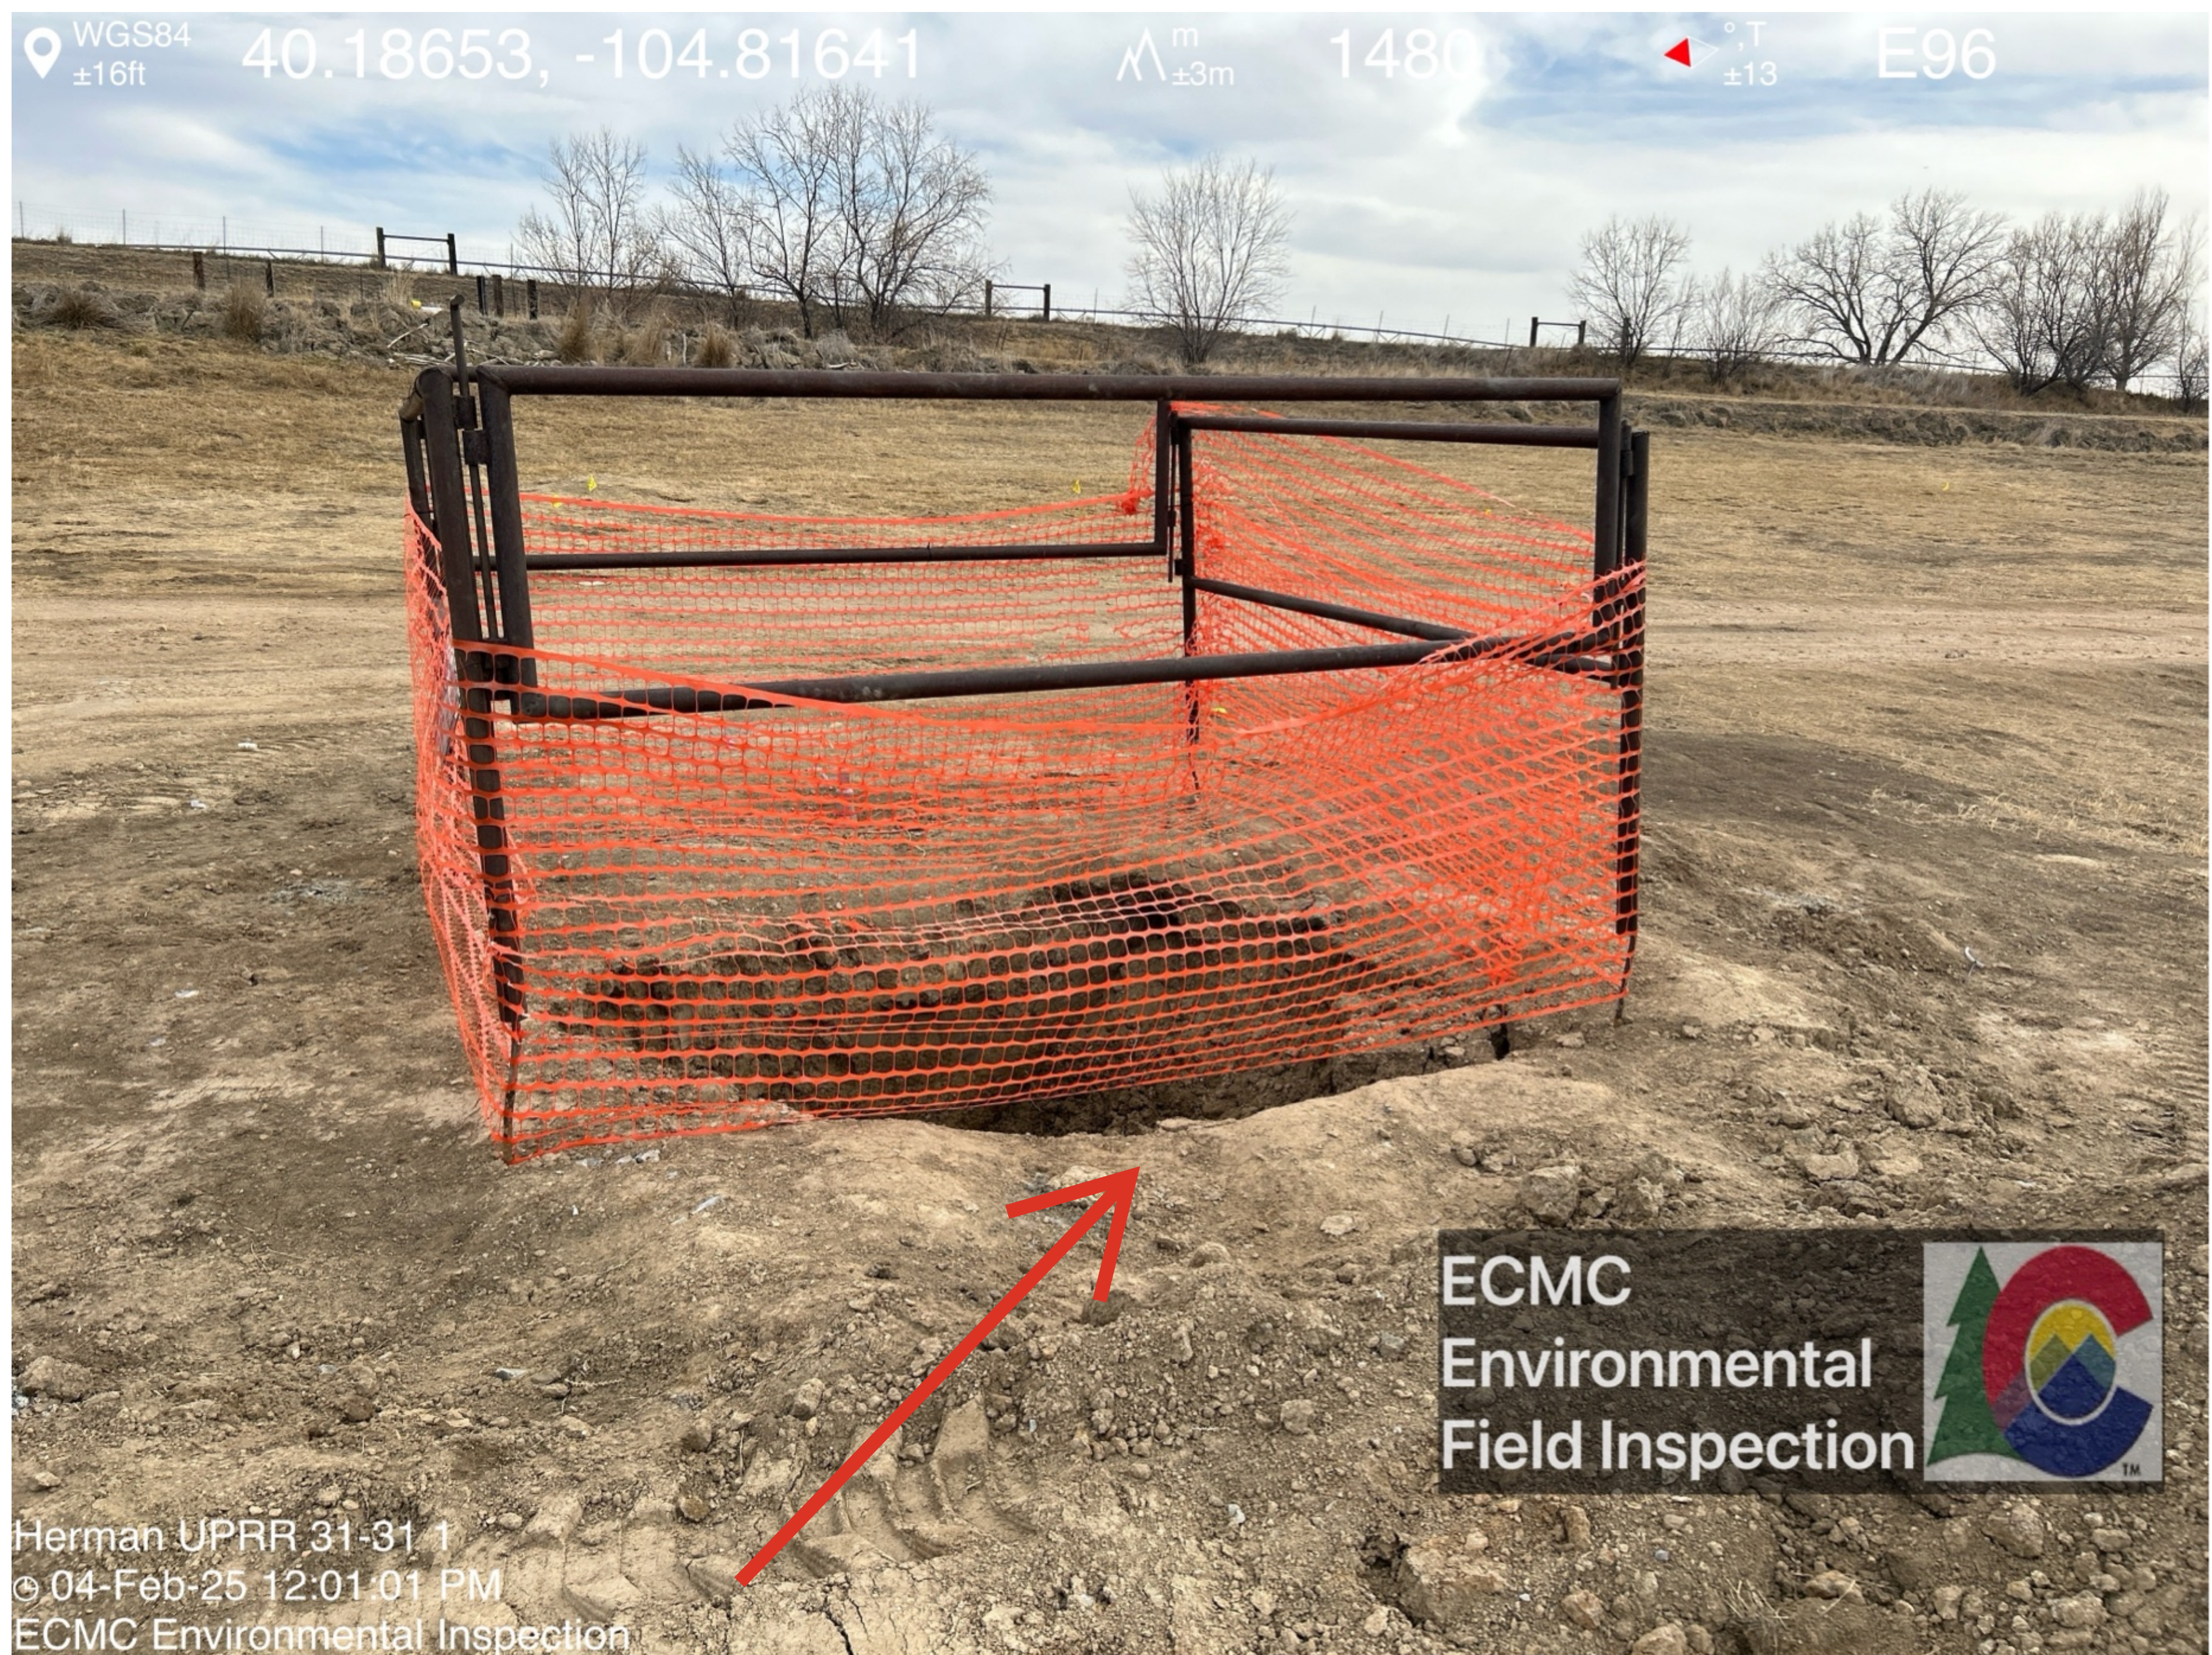
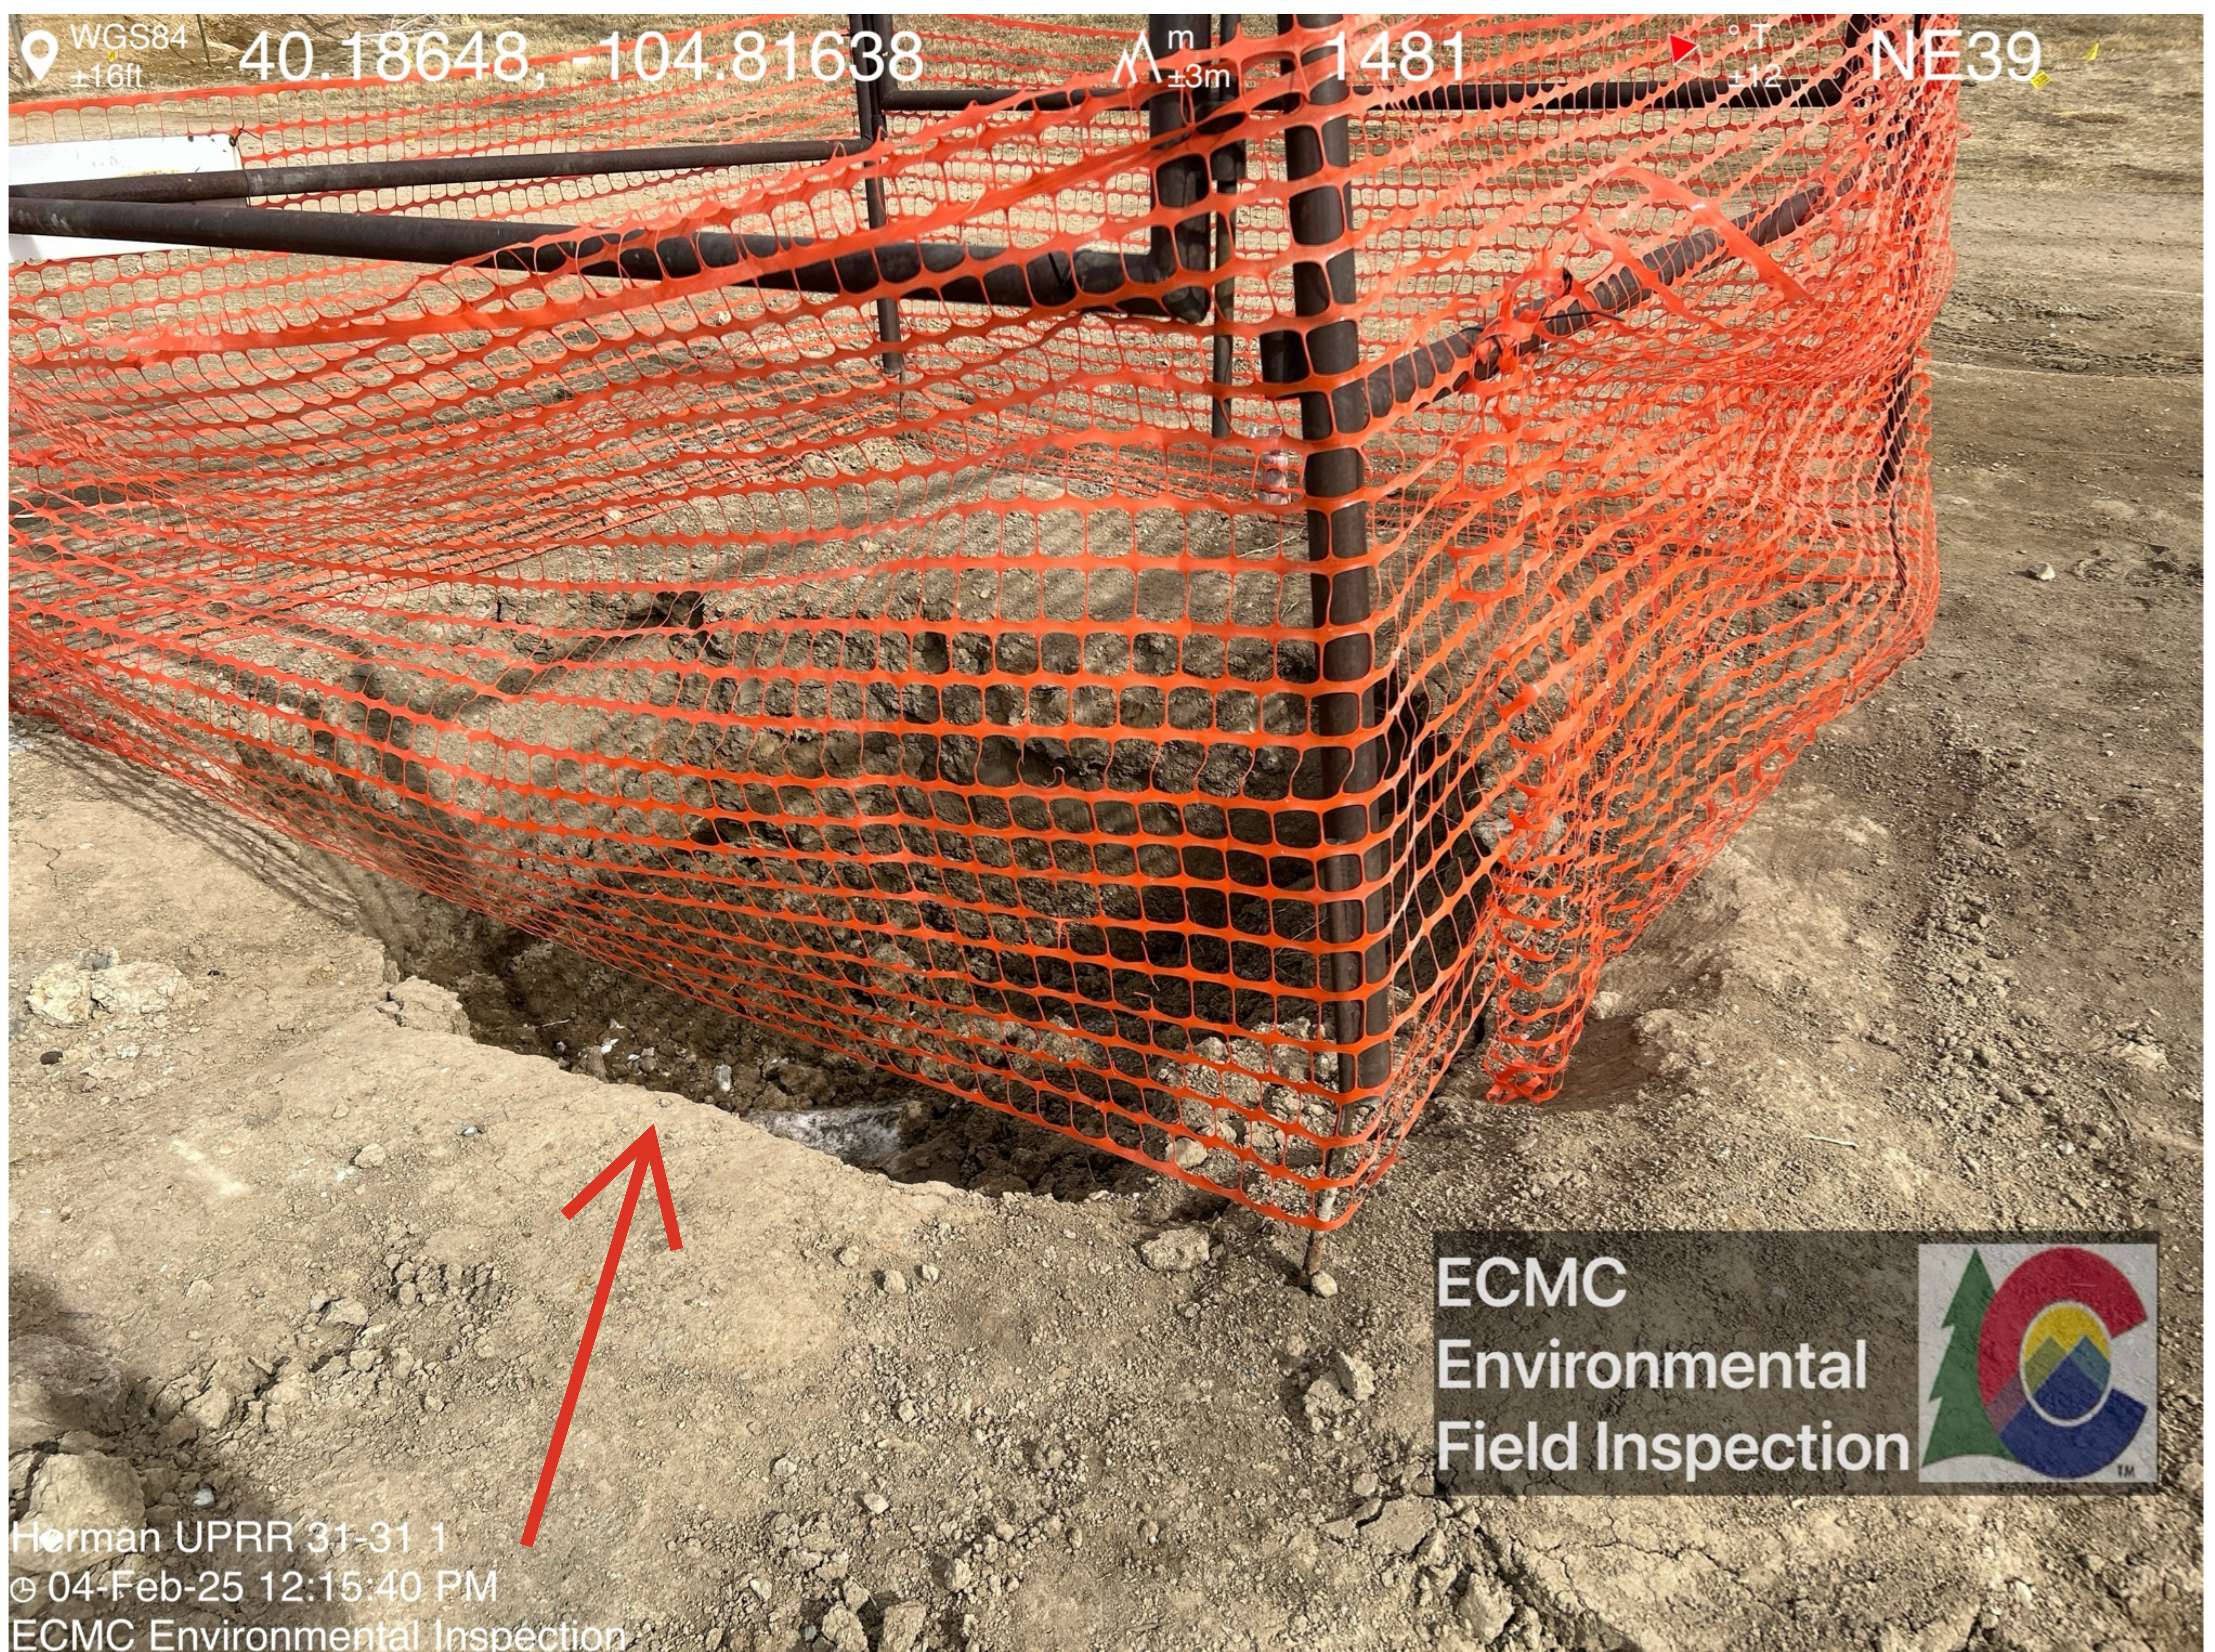
Fencing does not fully encompass excavation.

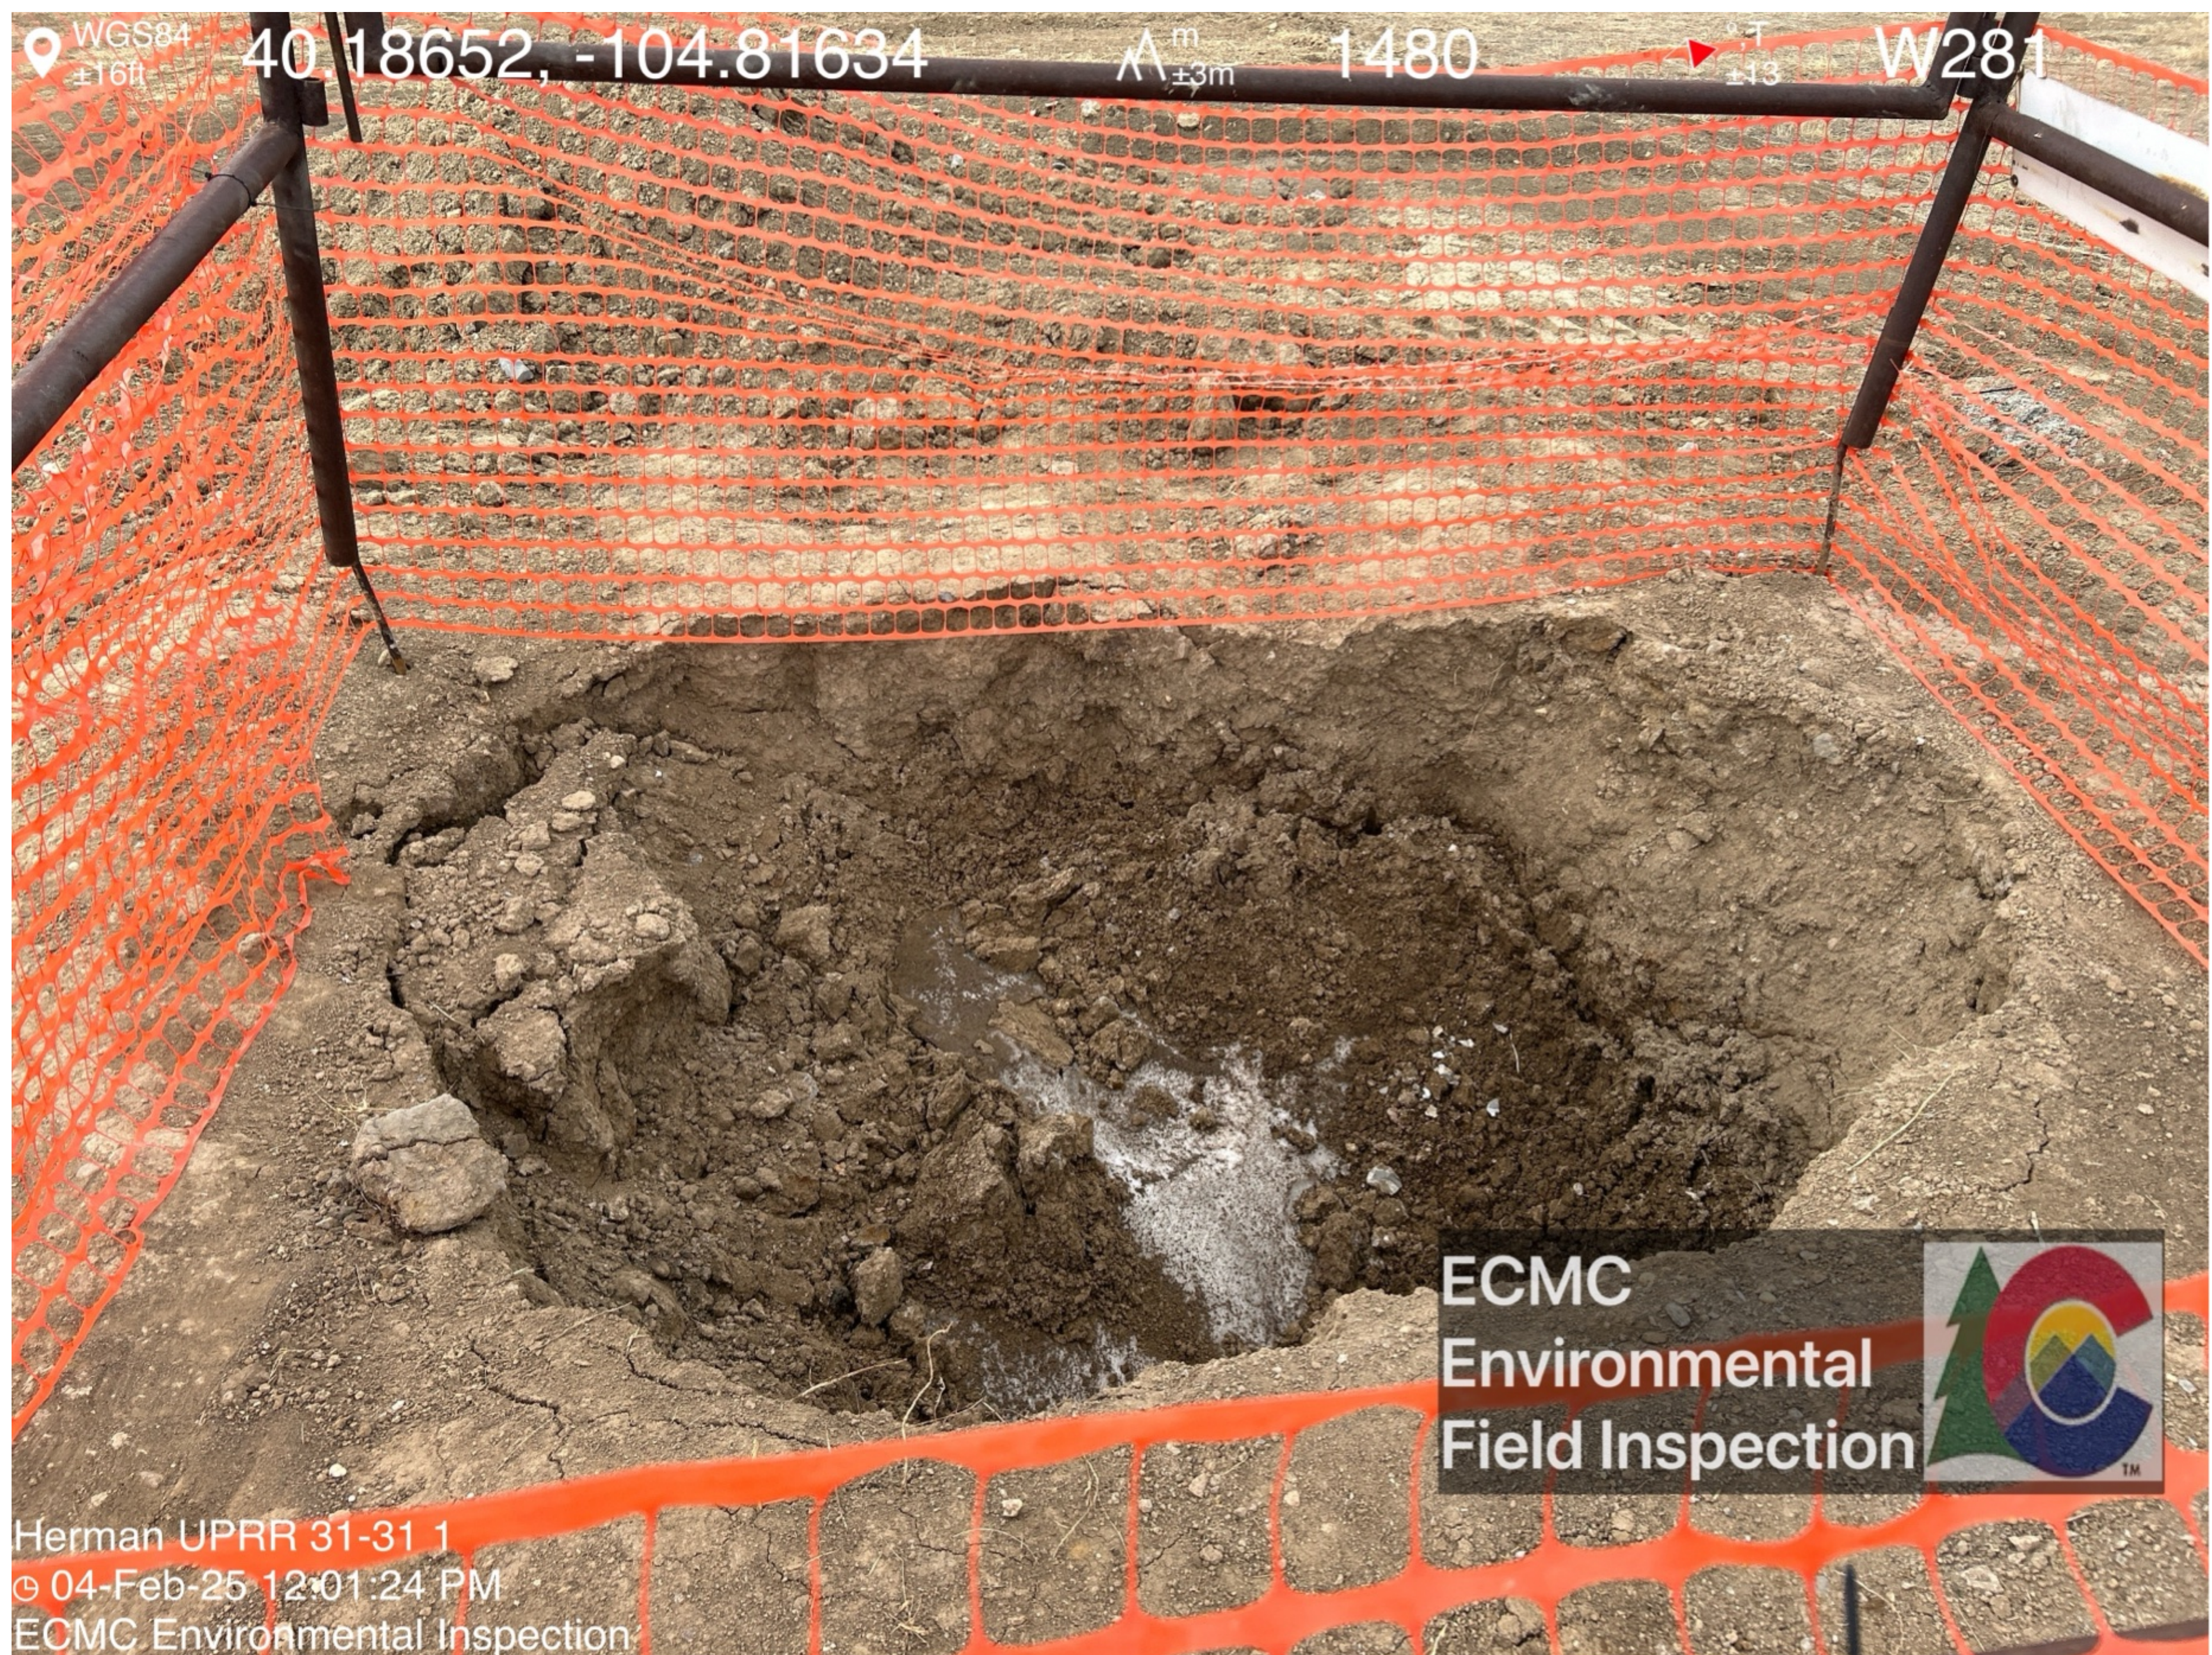
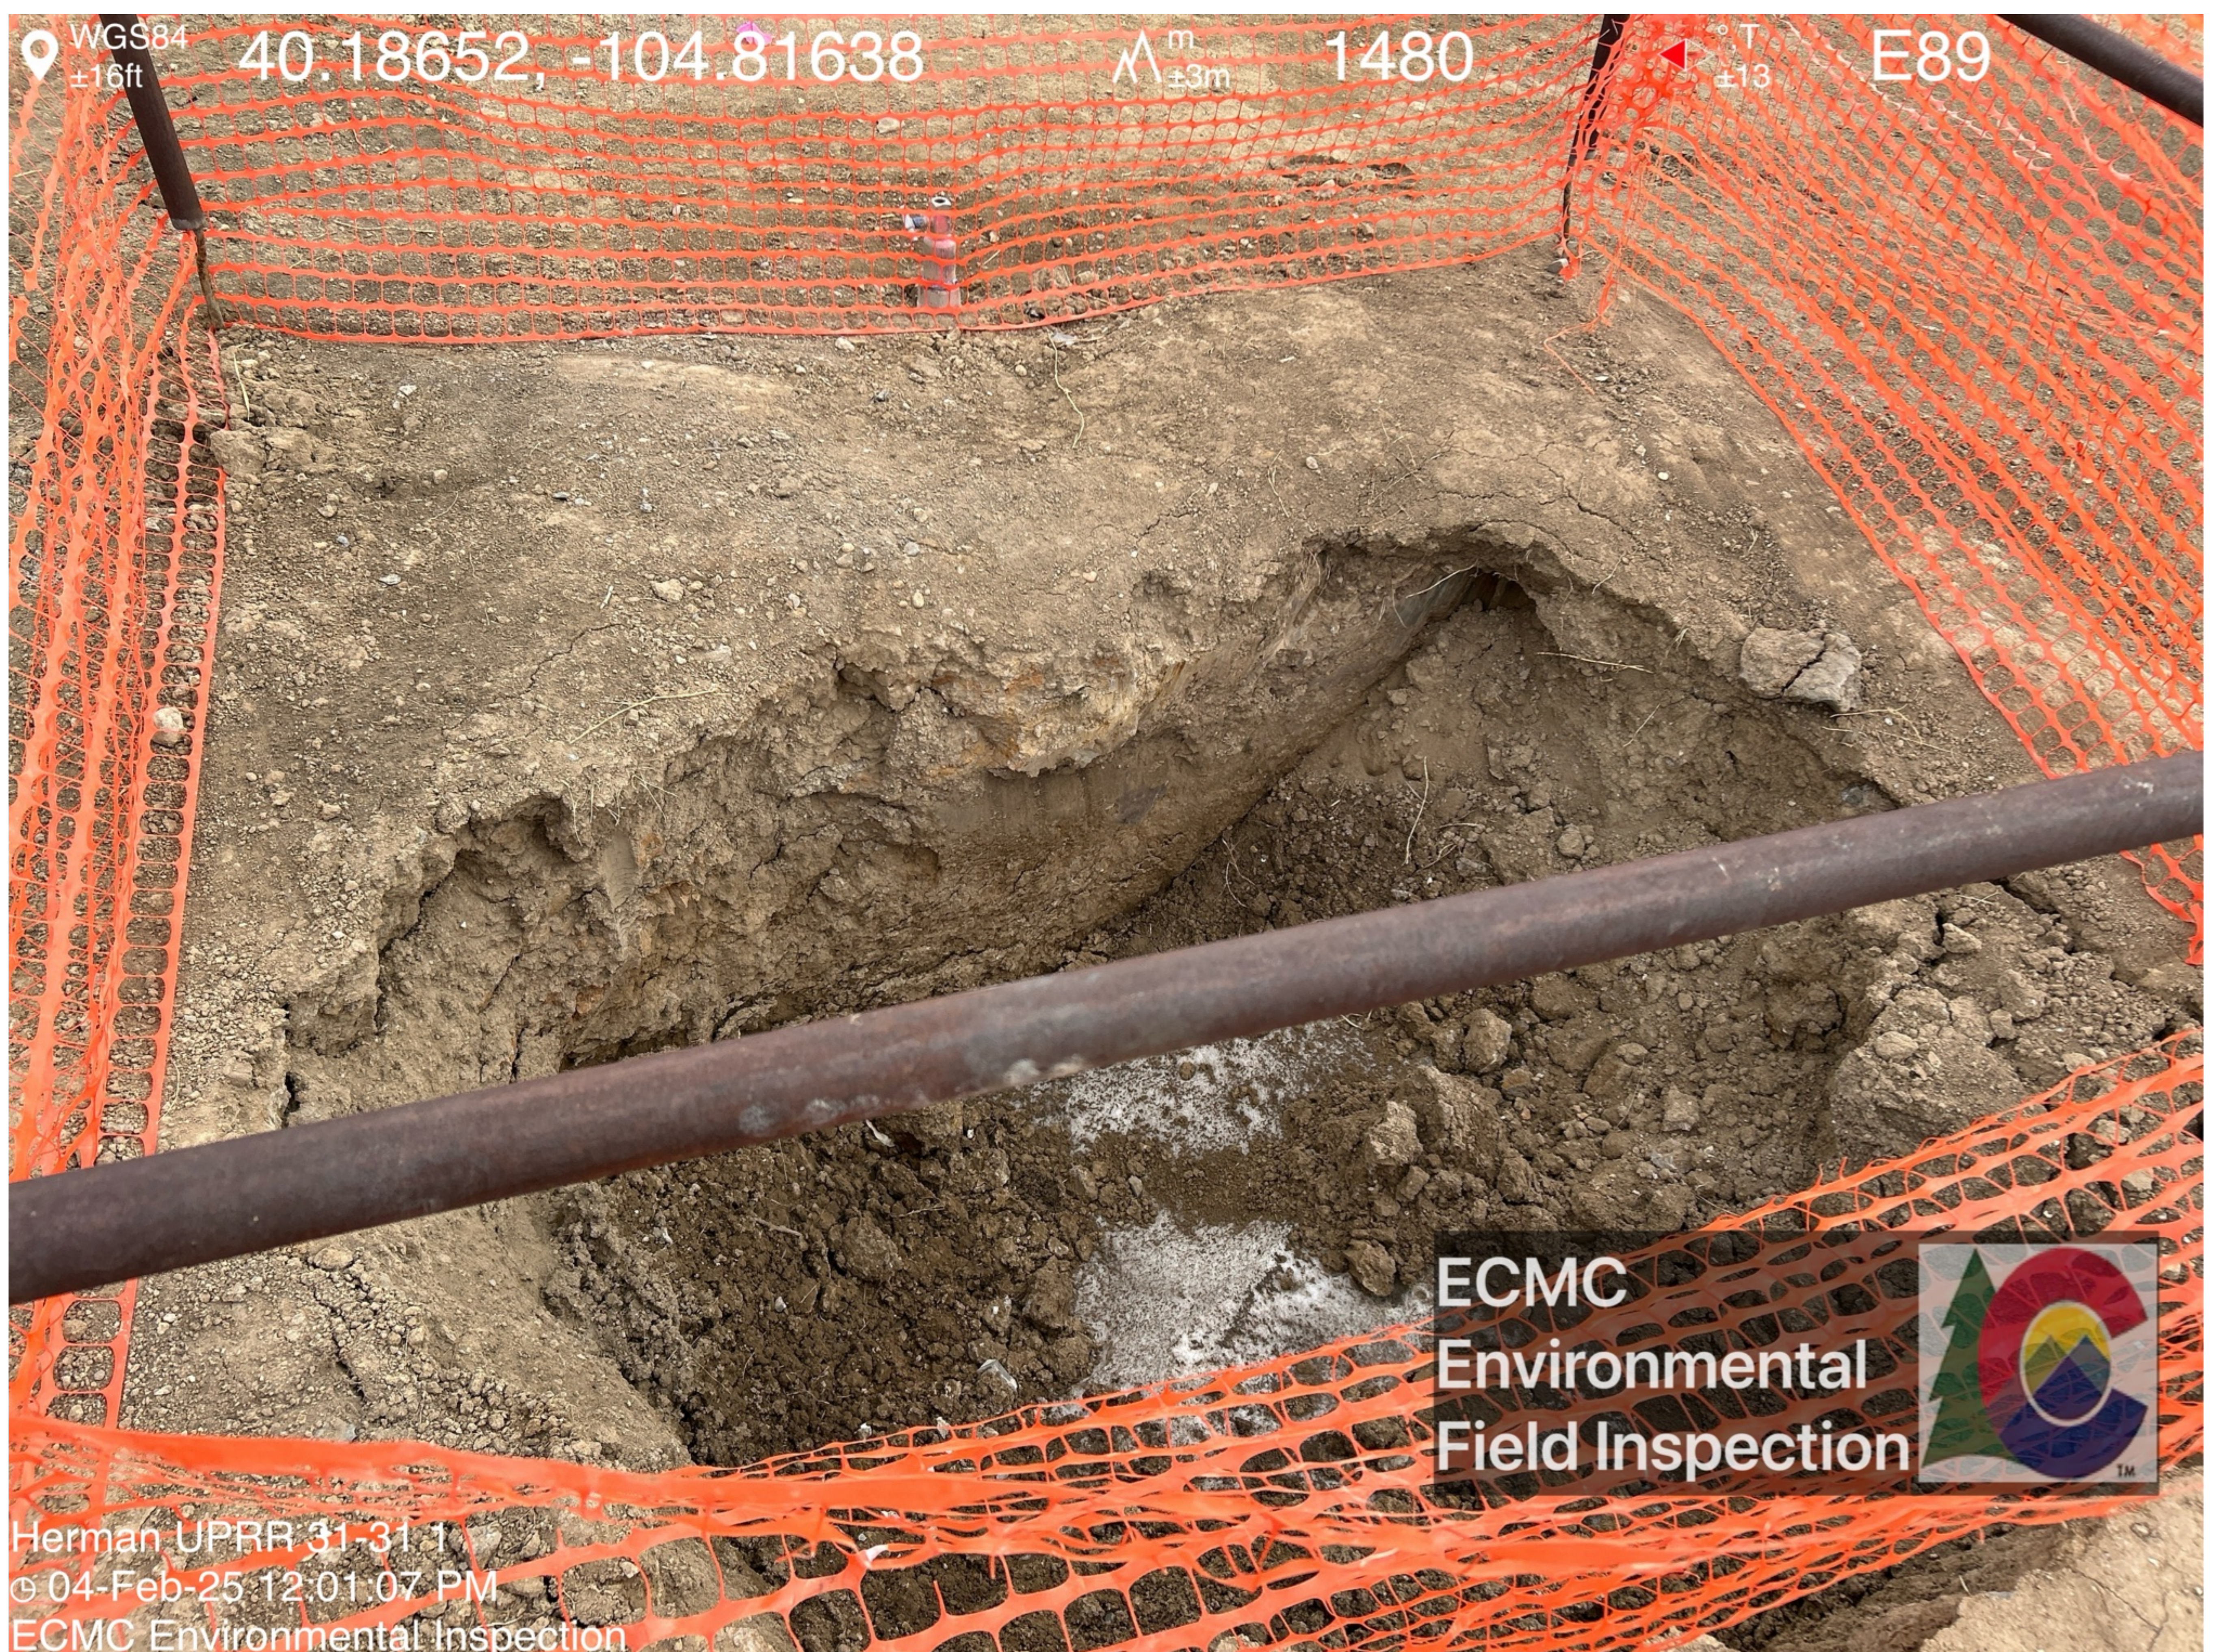
Snow has accumulated at the base of the excavation.
