Herman UPRR 31-31.1  
© 04-Feb-25 11:55:33 AM  
ECMC Environmental Inspection

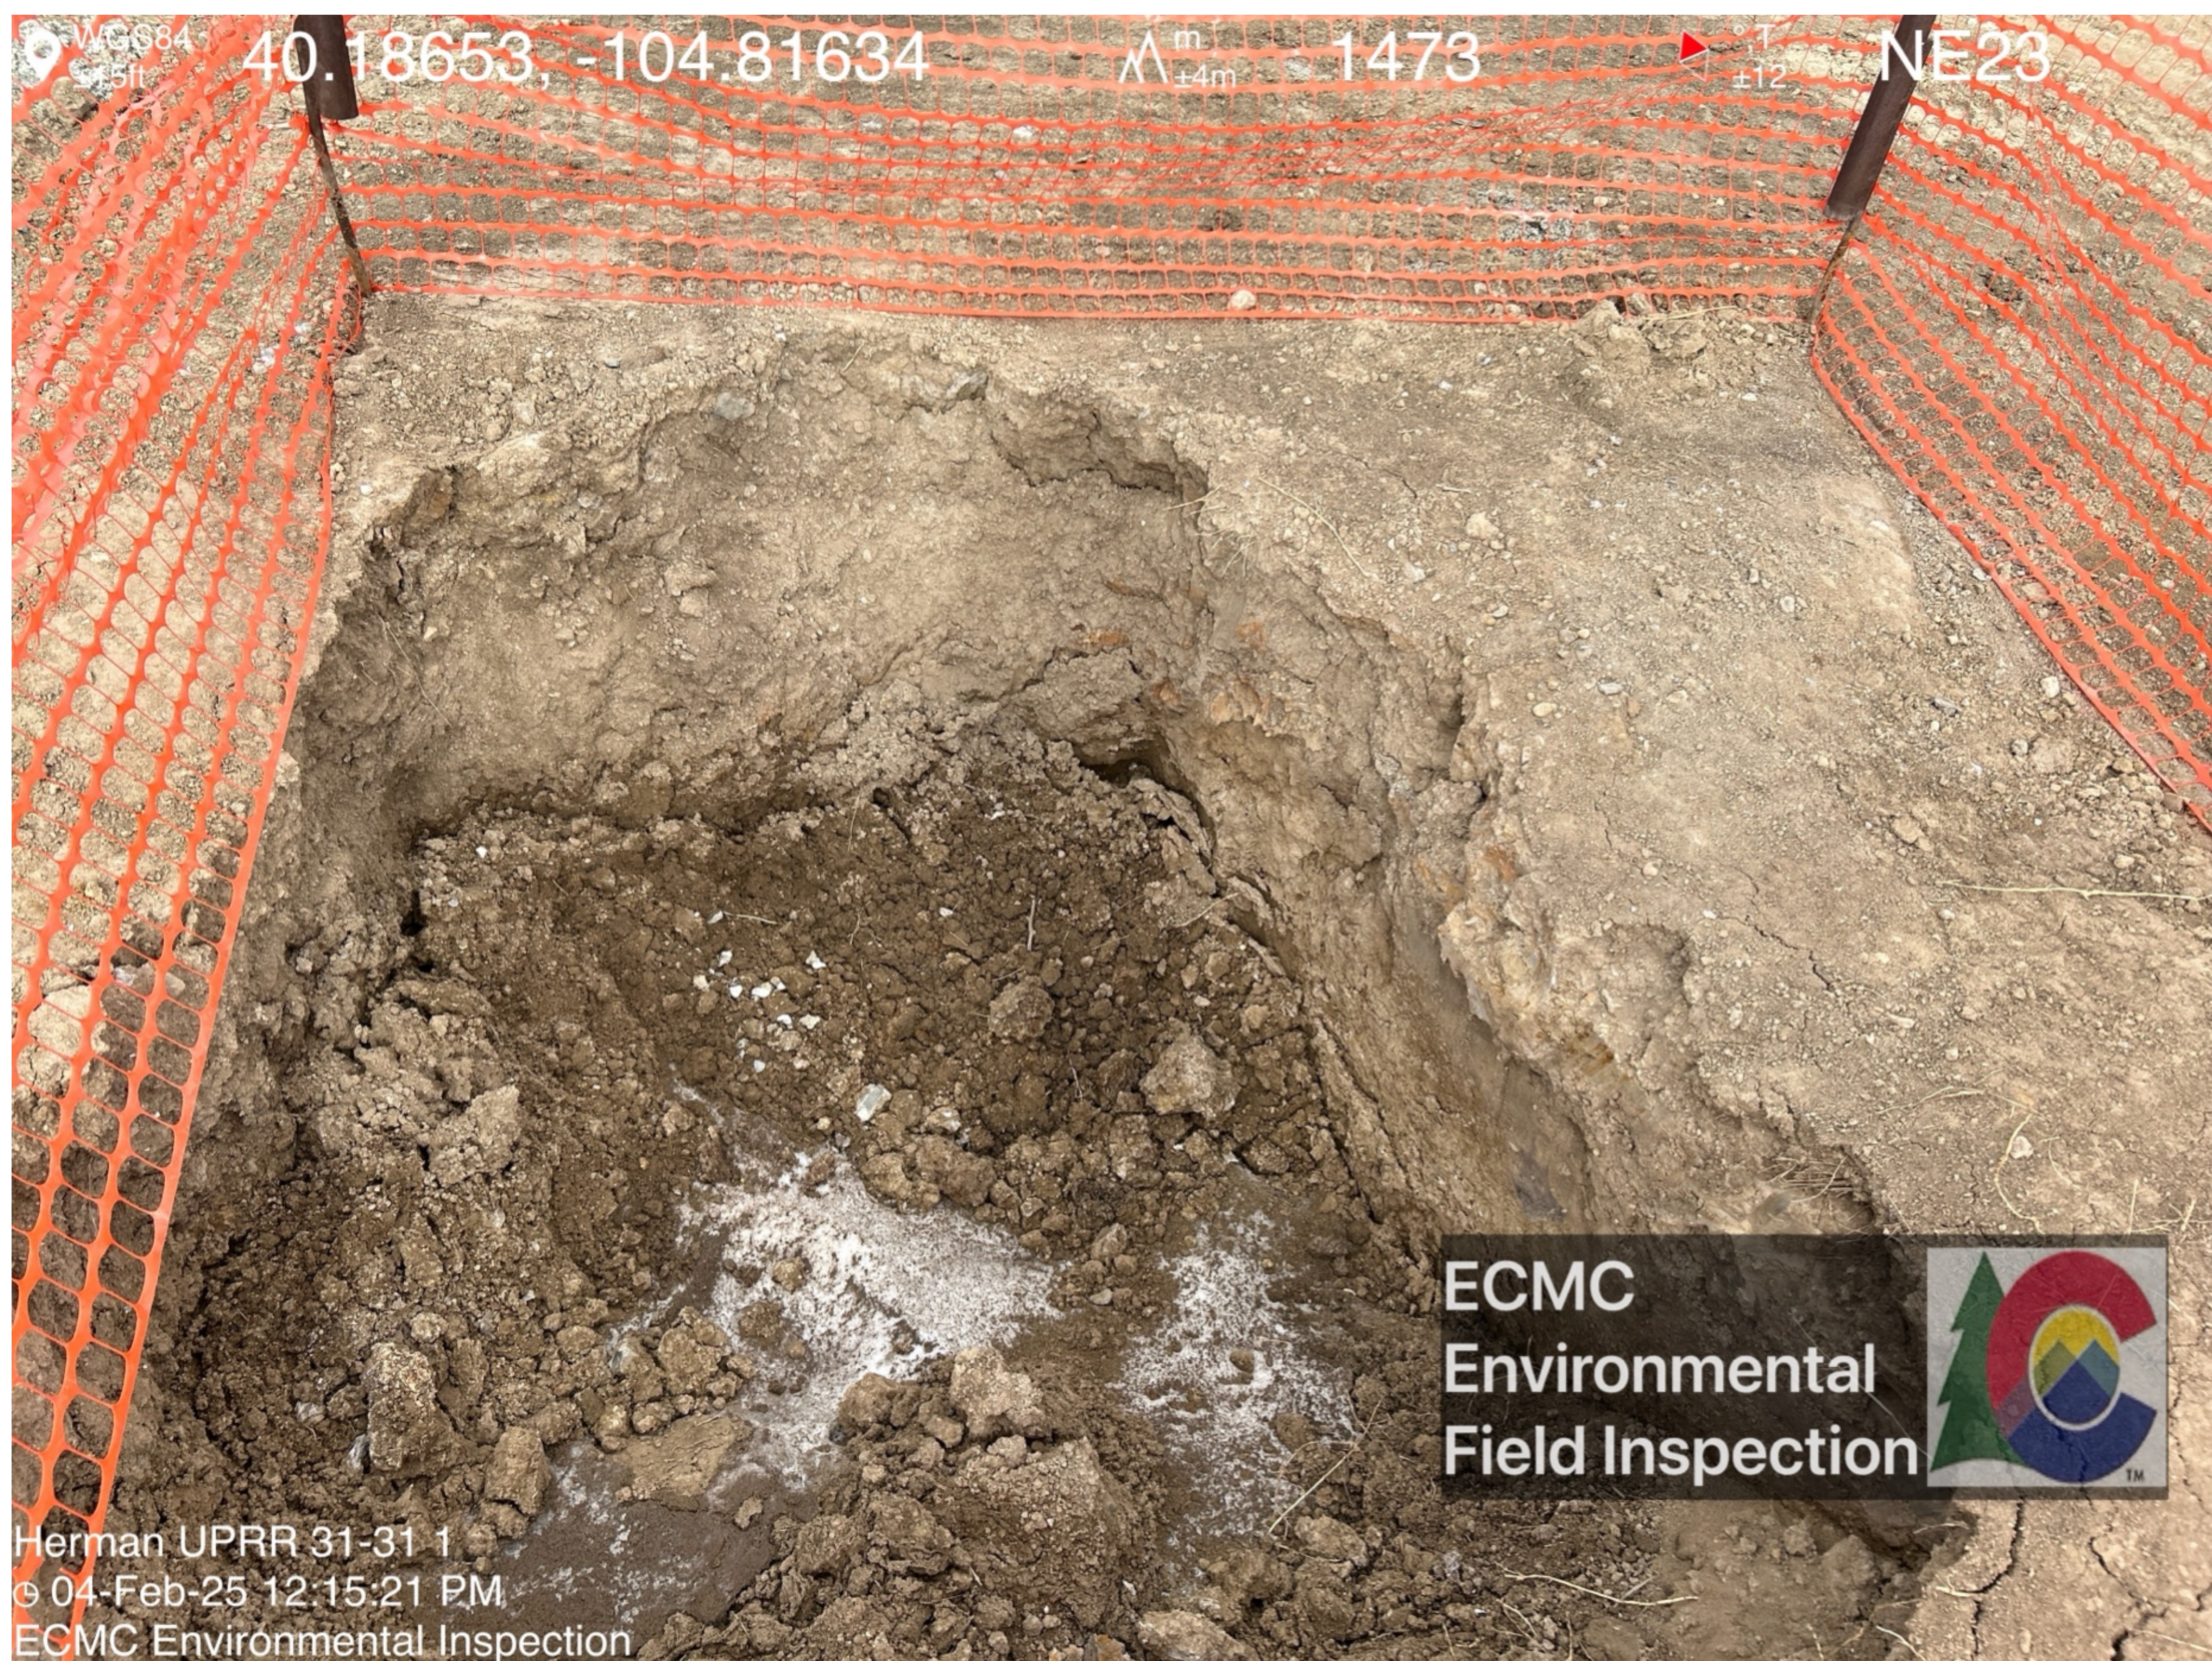
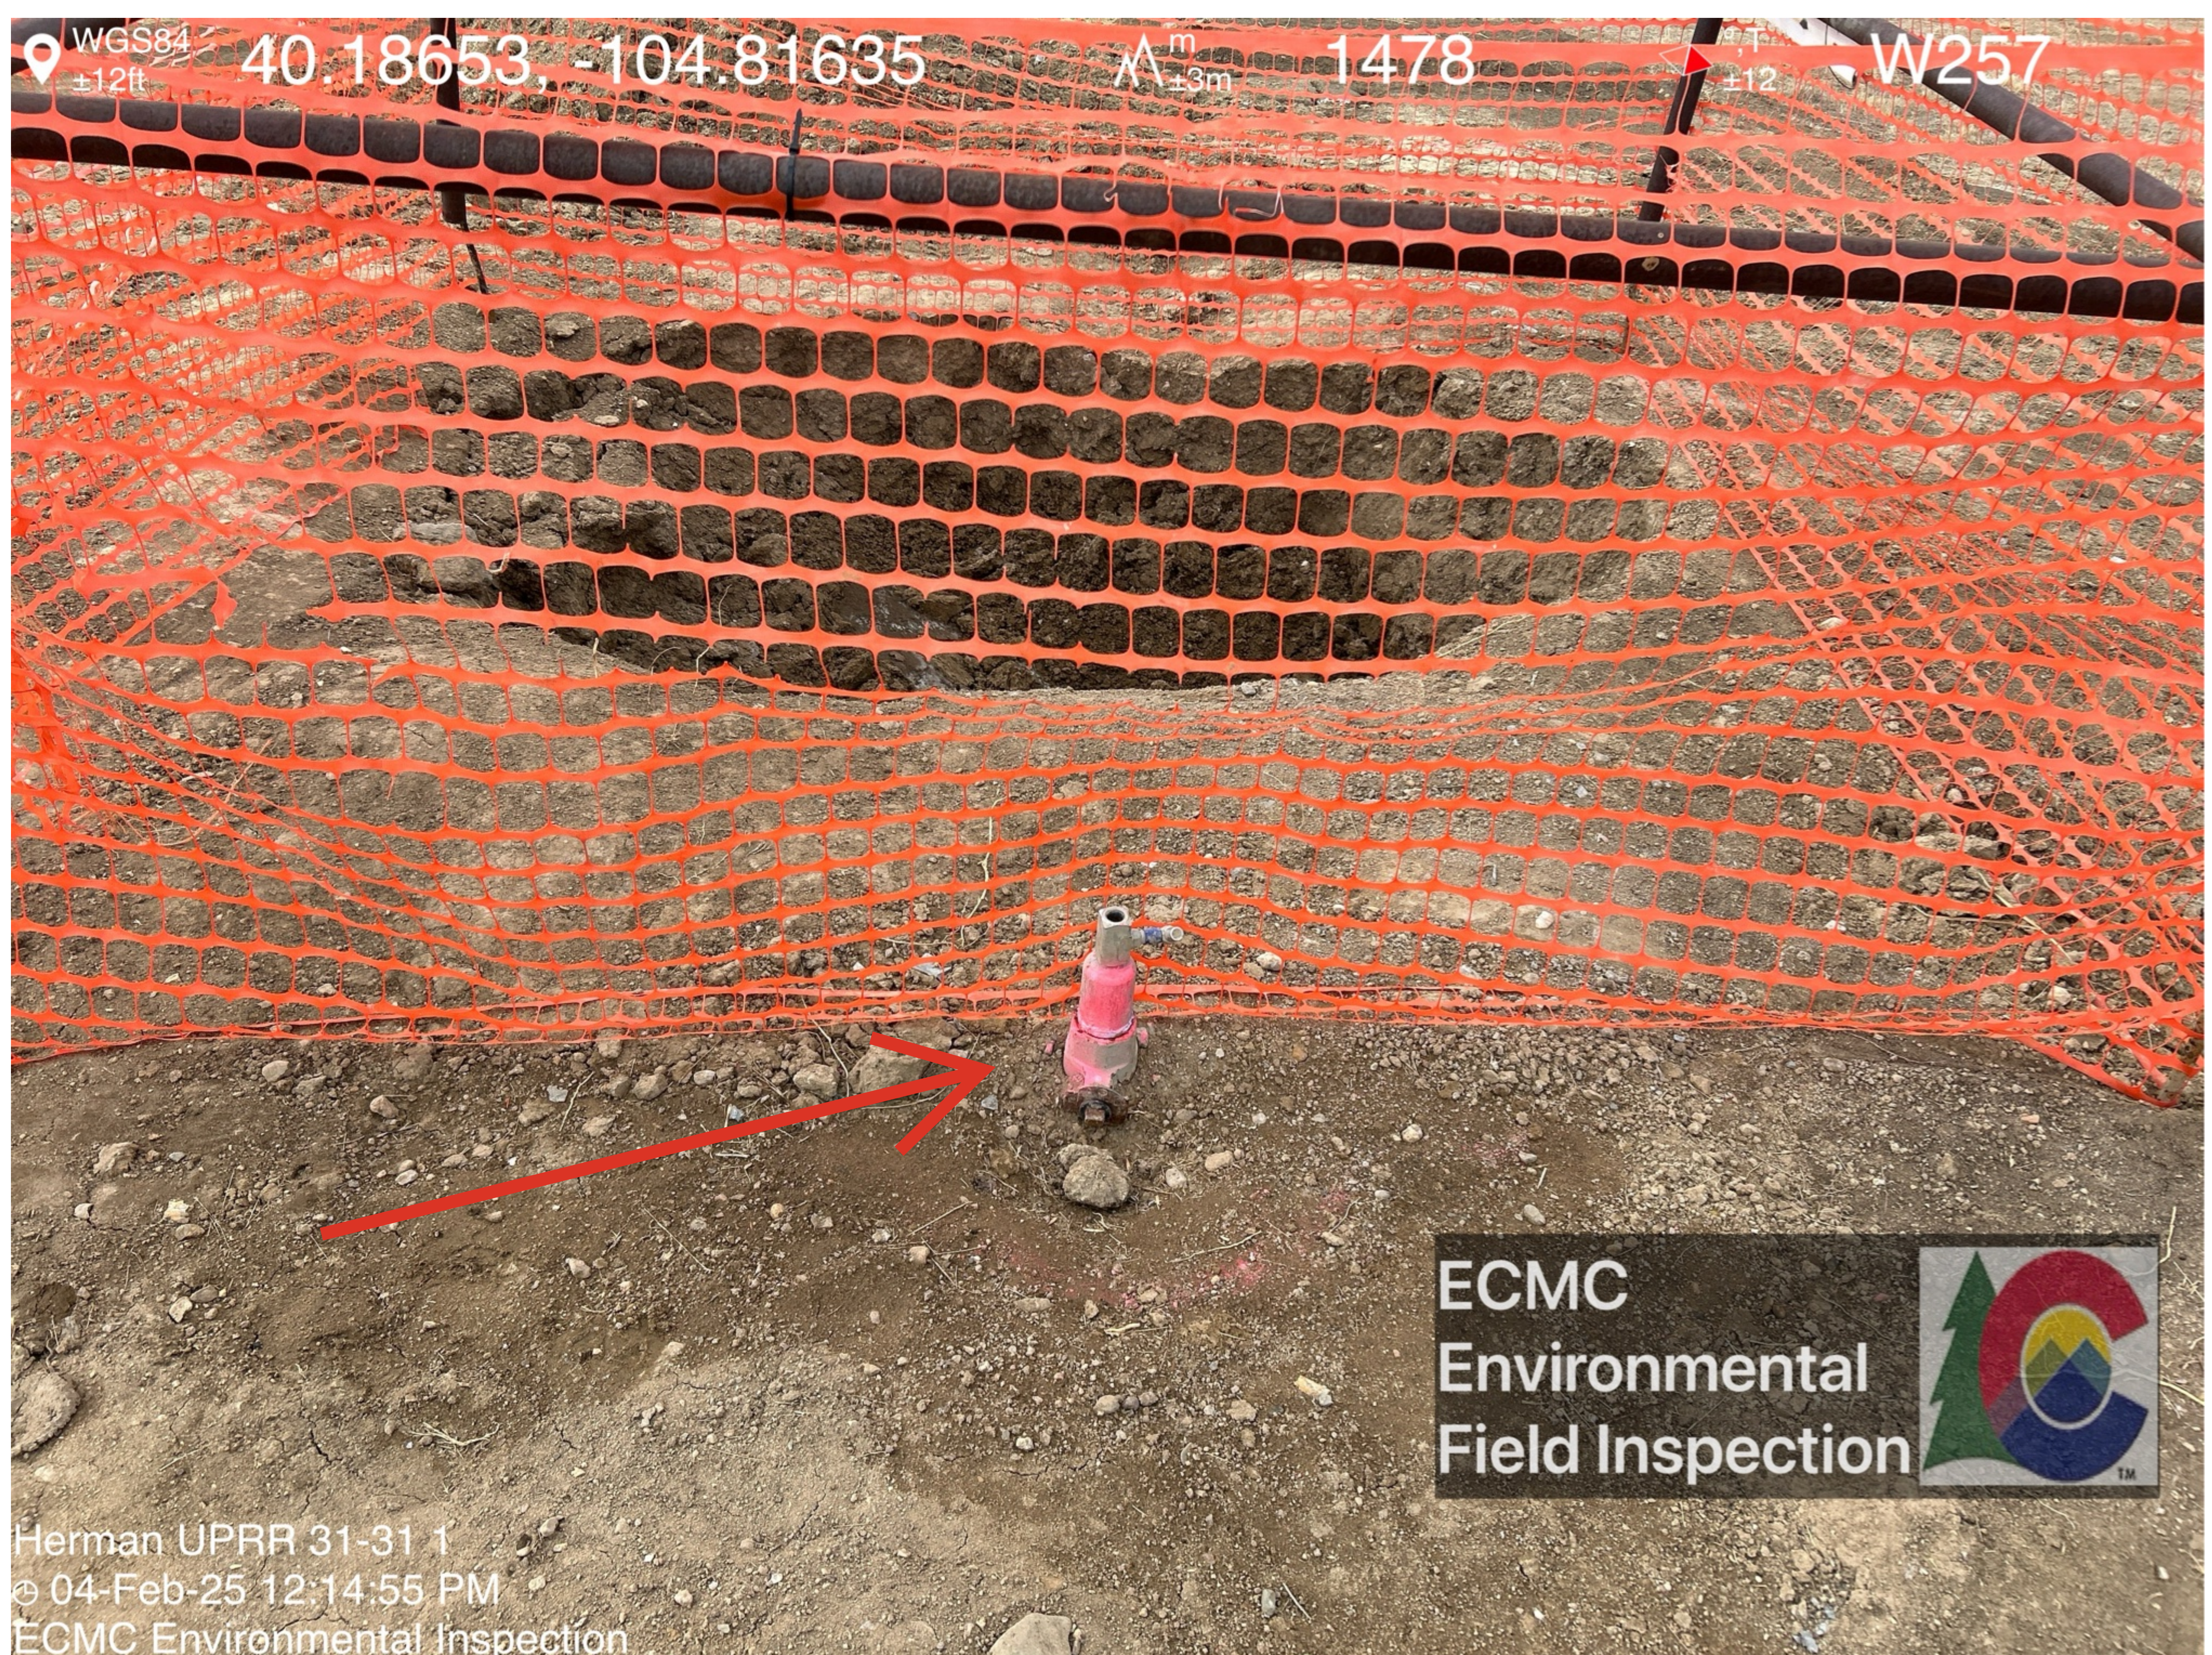
Riser visible adjacent to excavation.

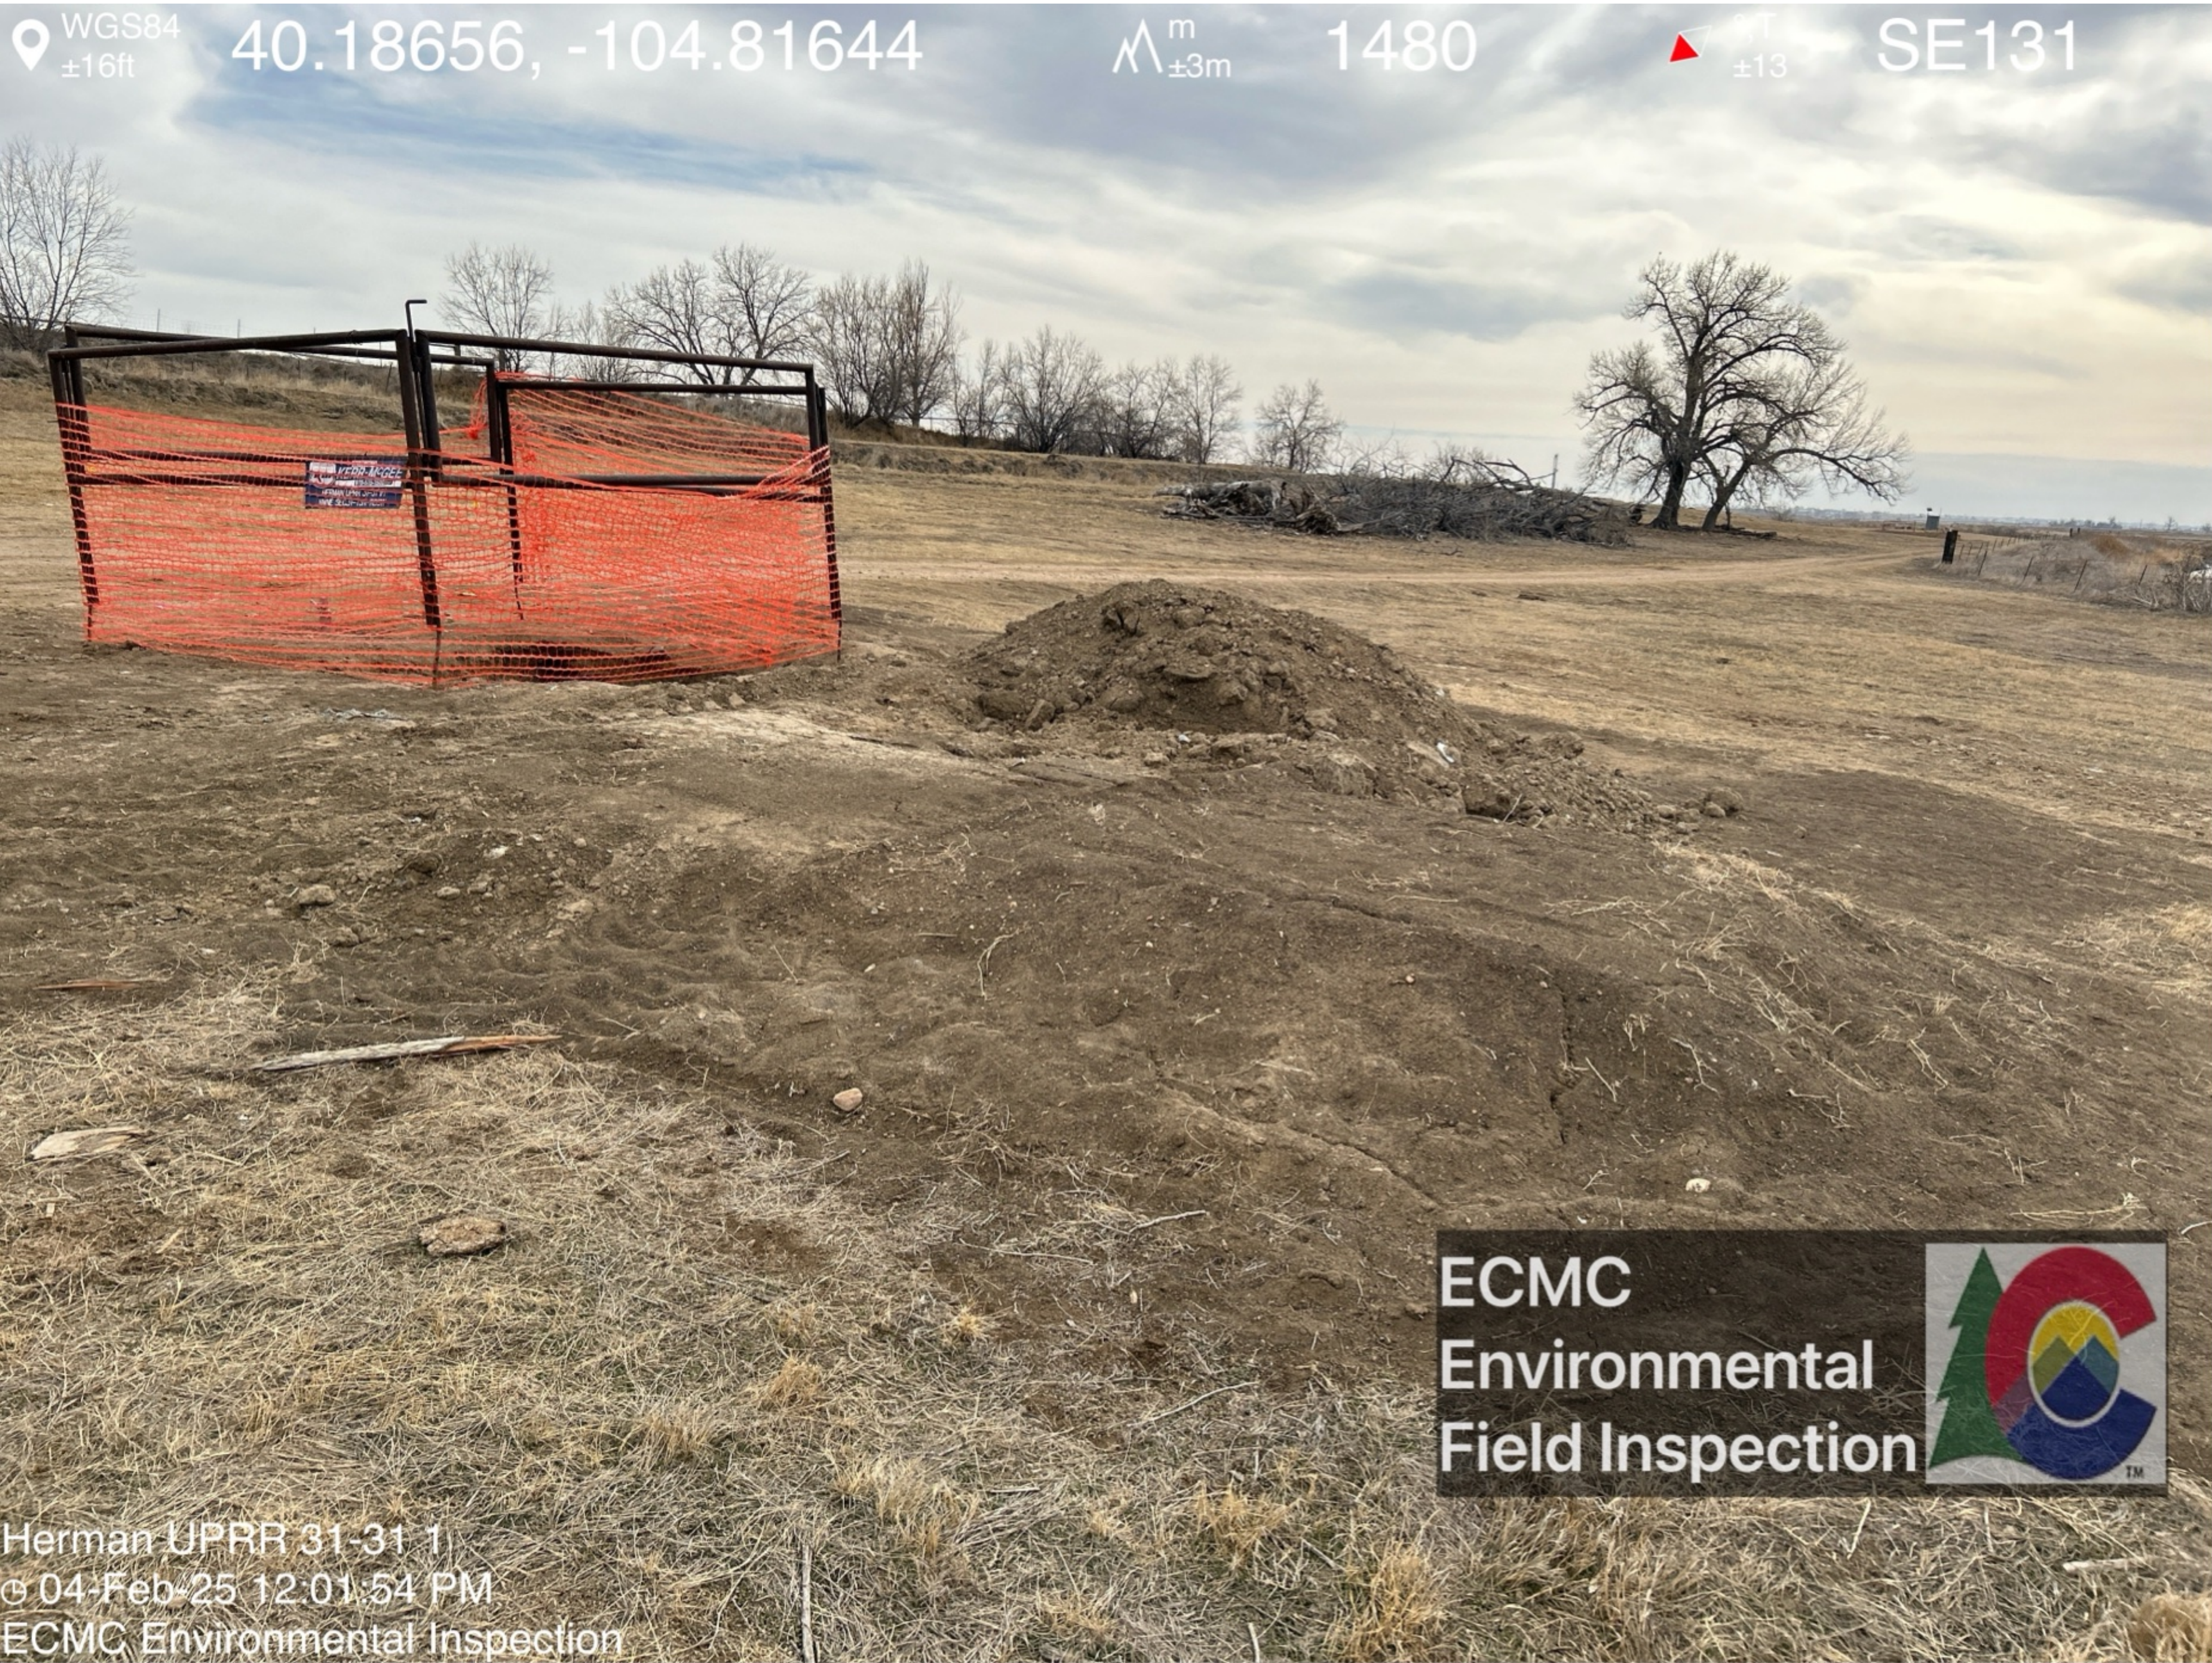
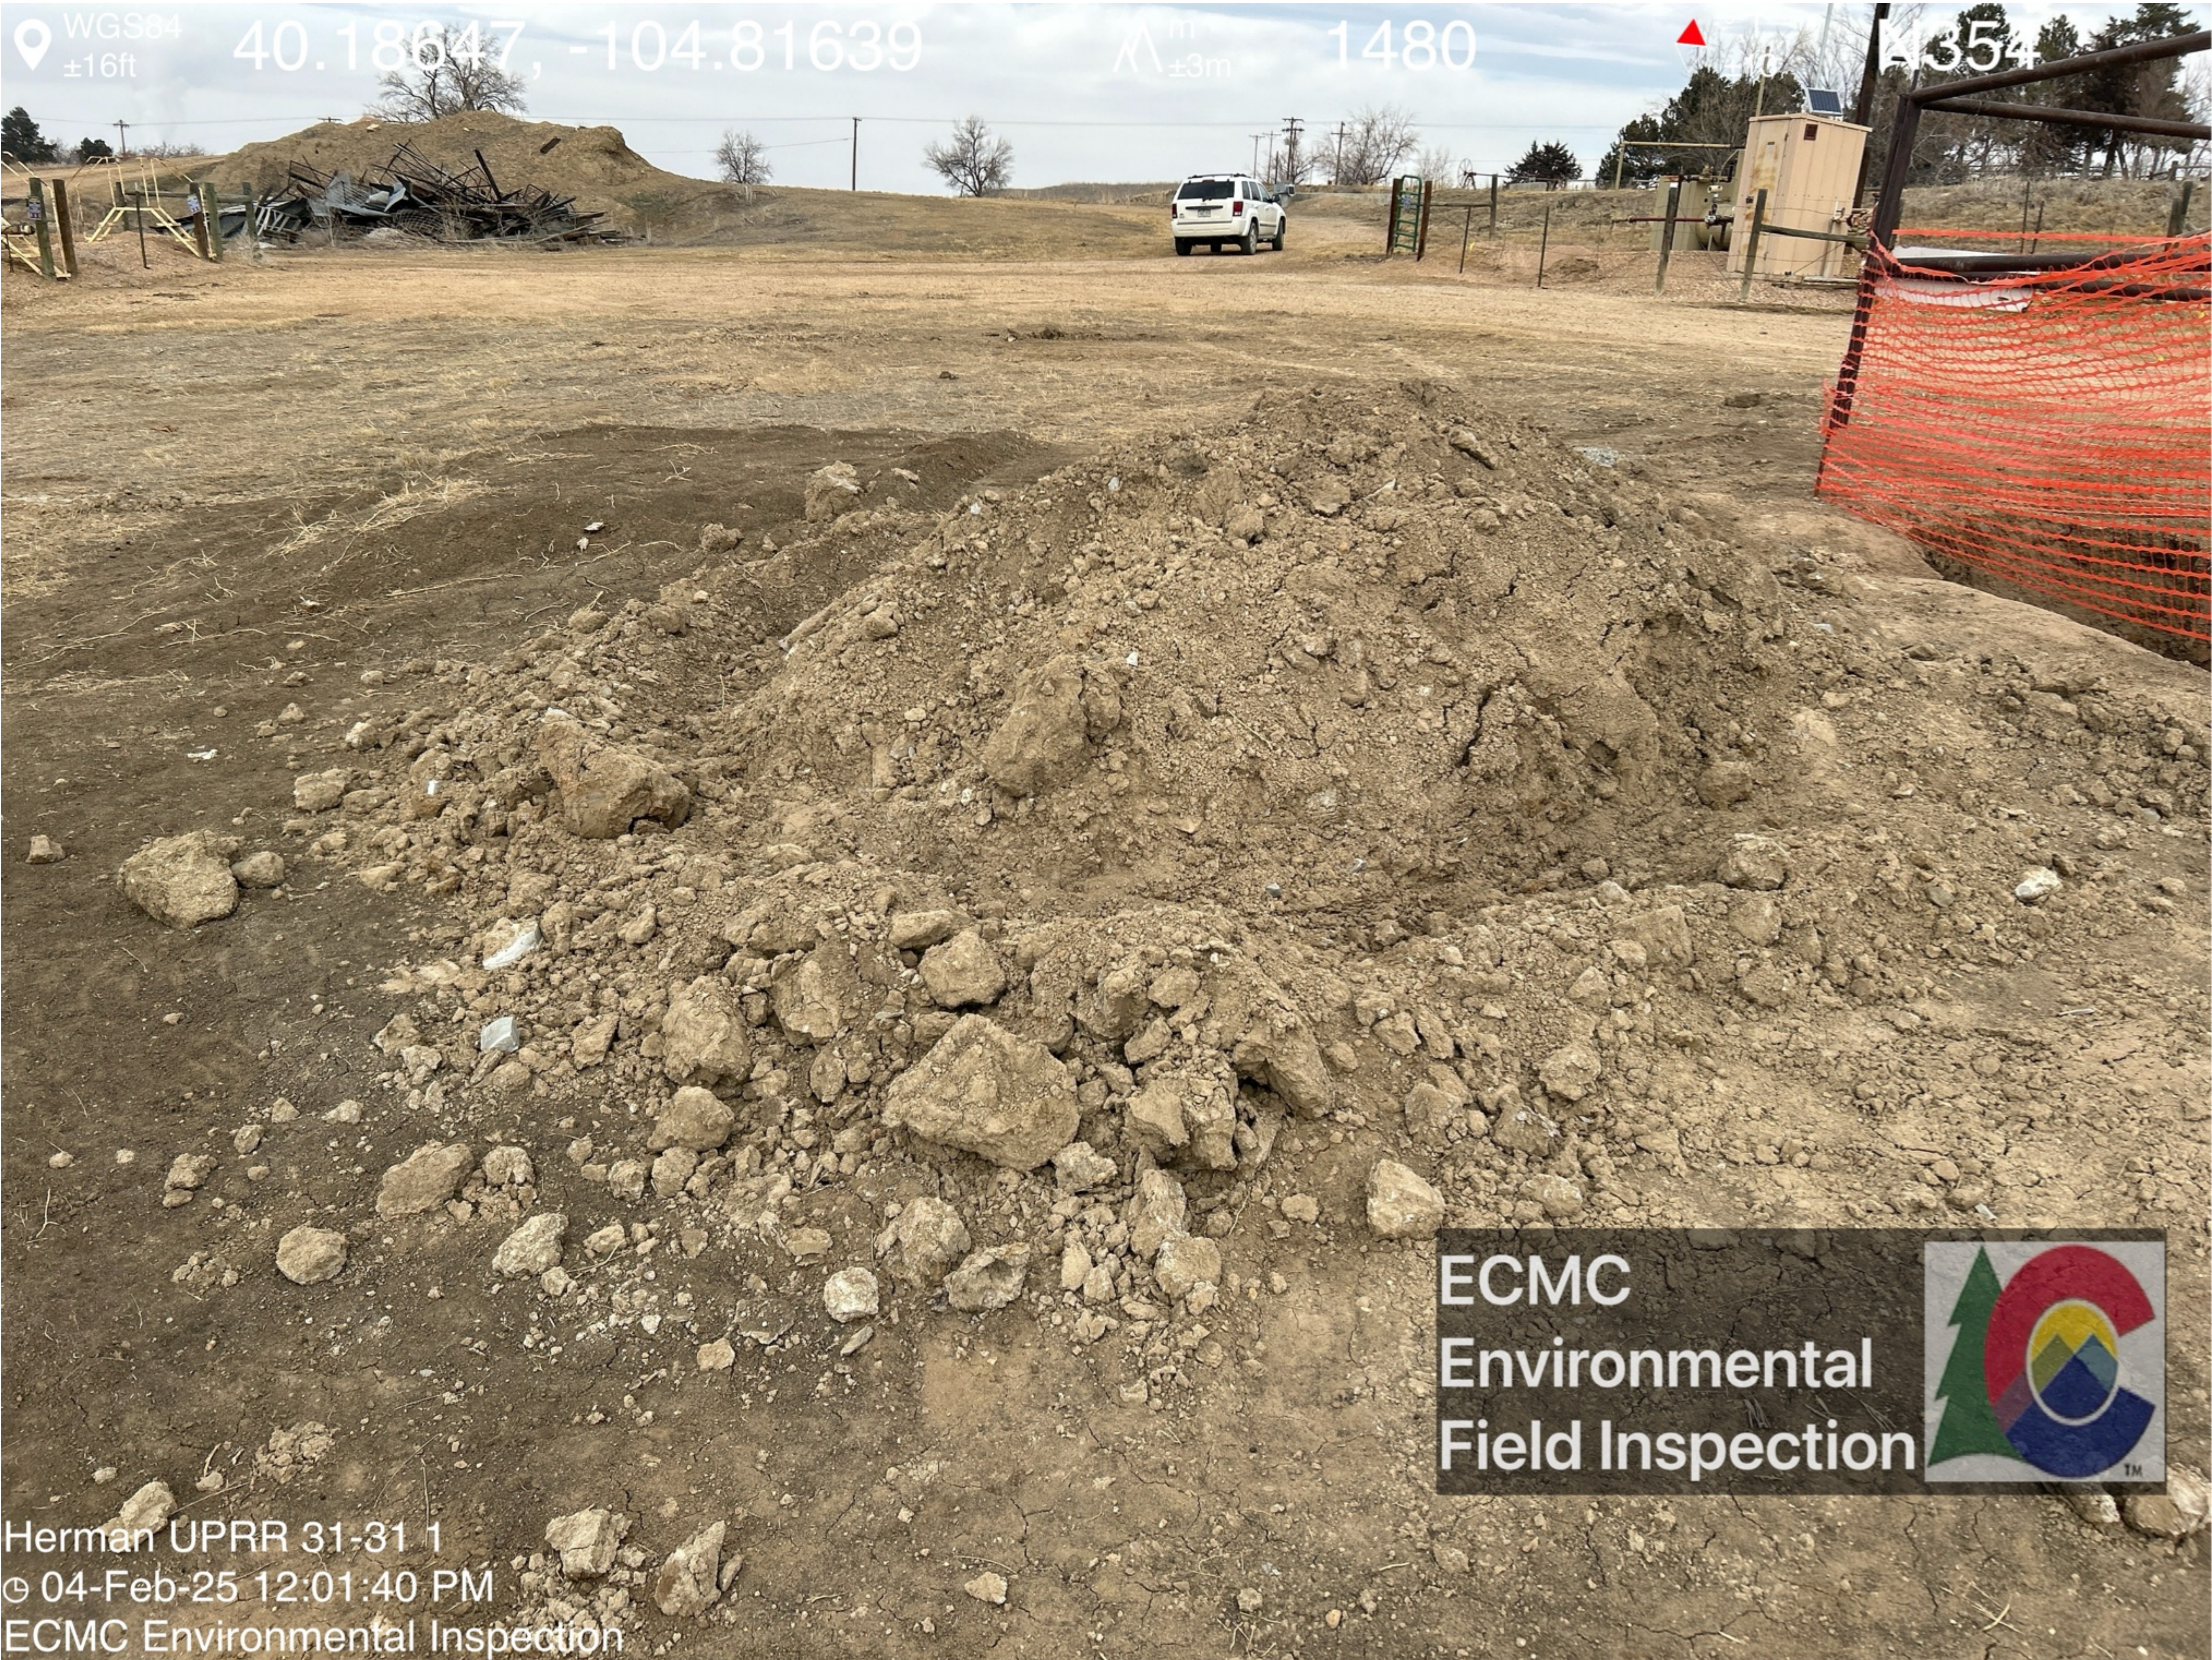
A small stockpile of soil was observed on location; partial BMPs are inadequate.

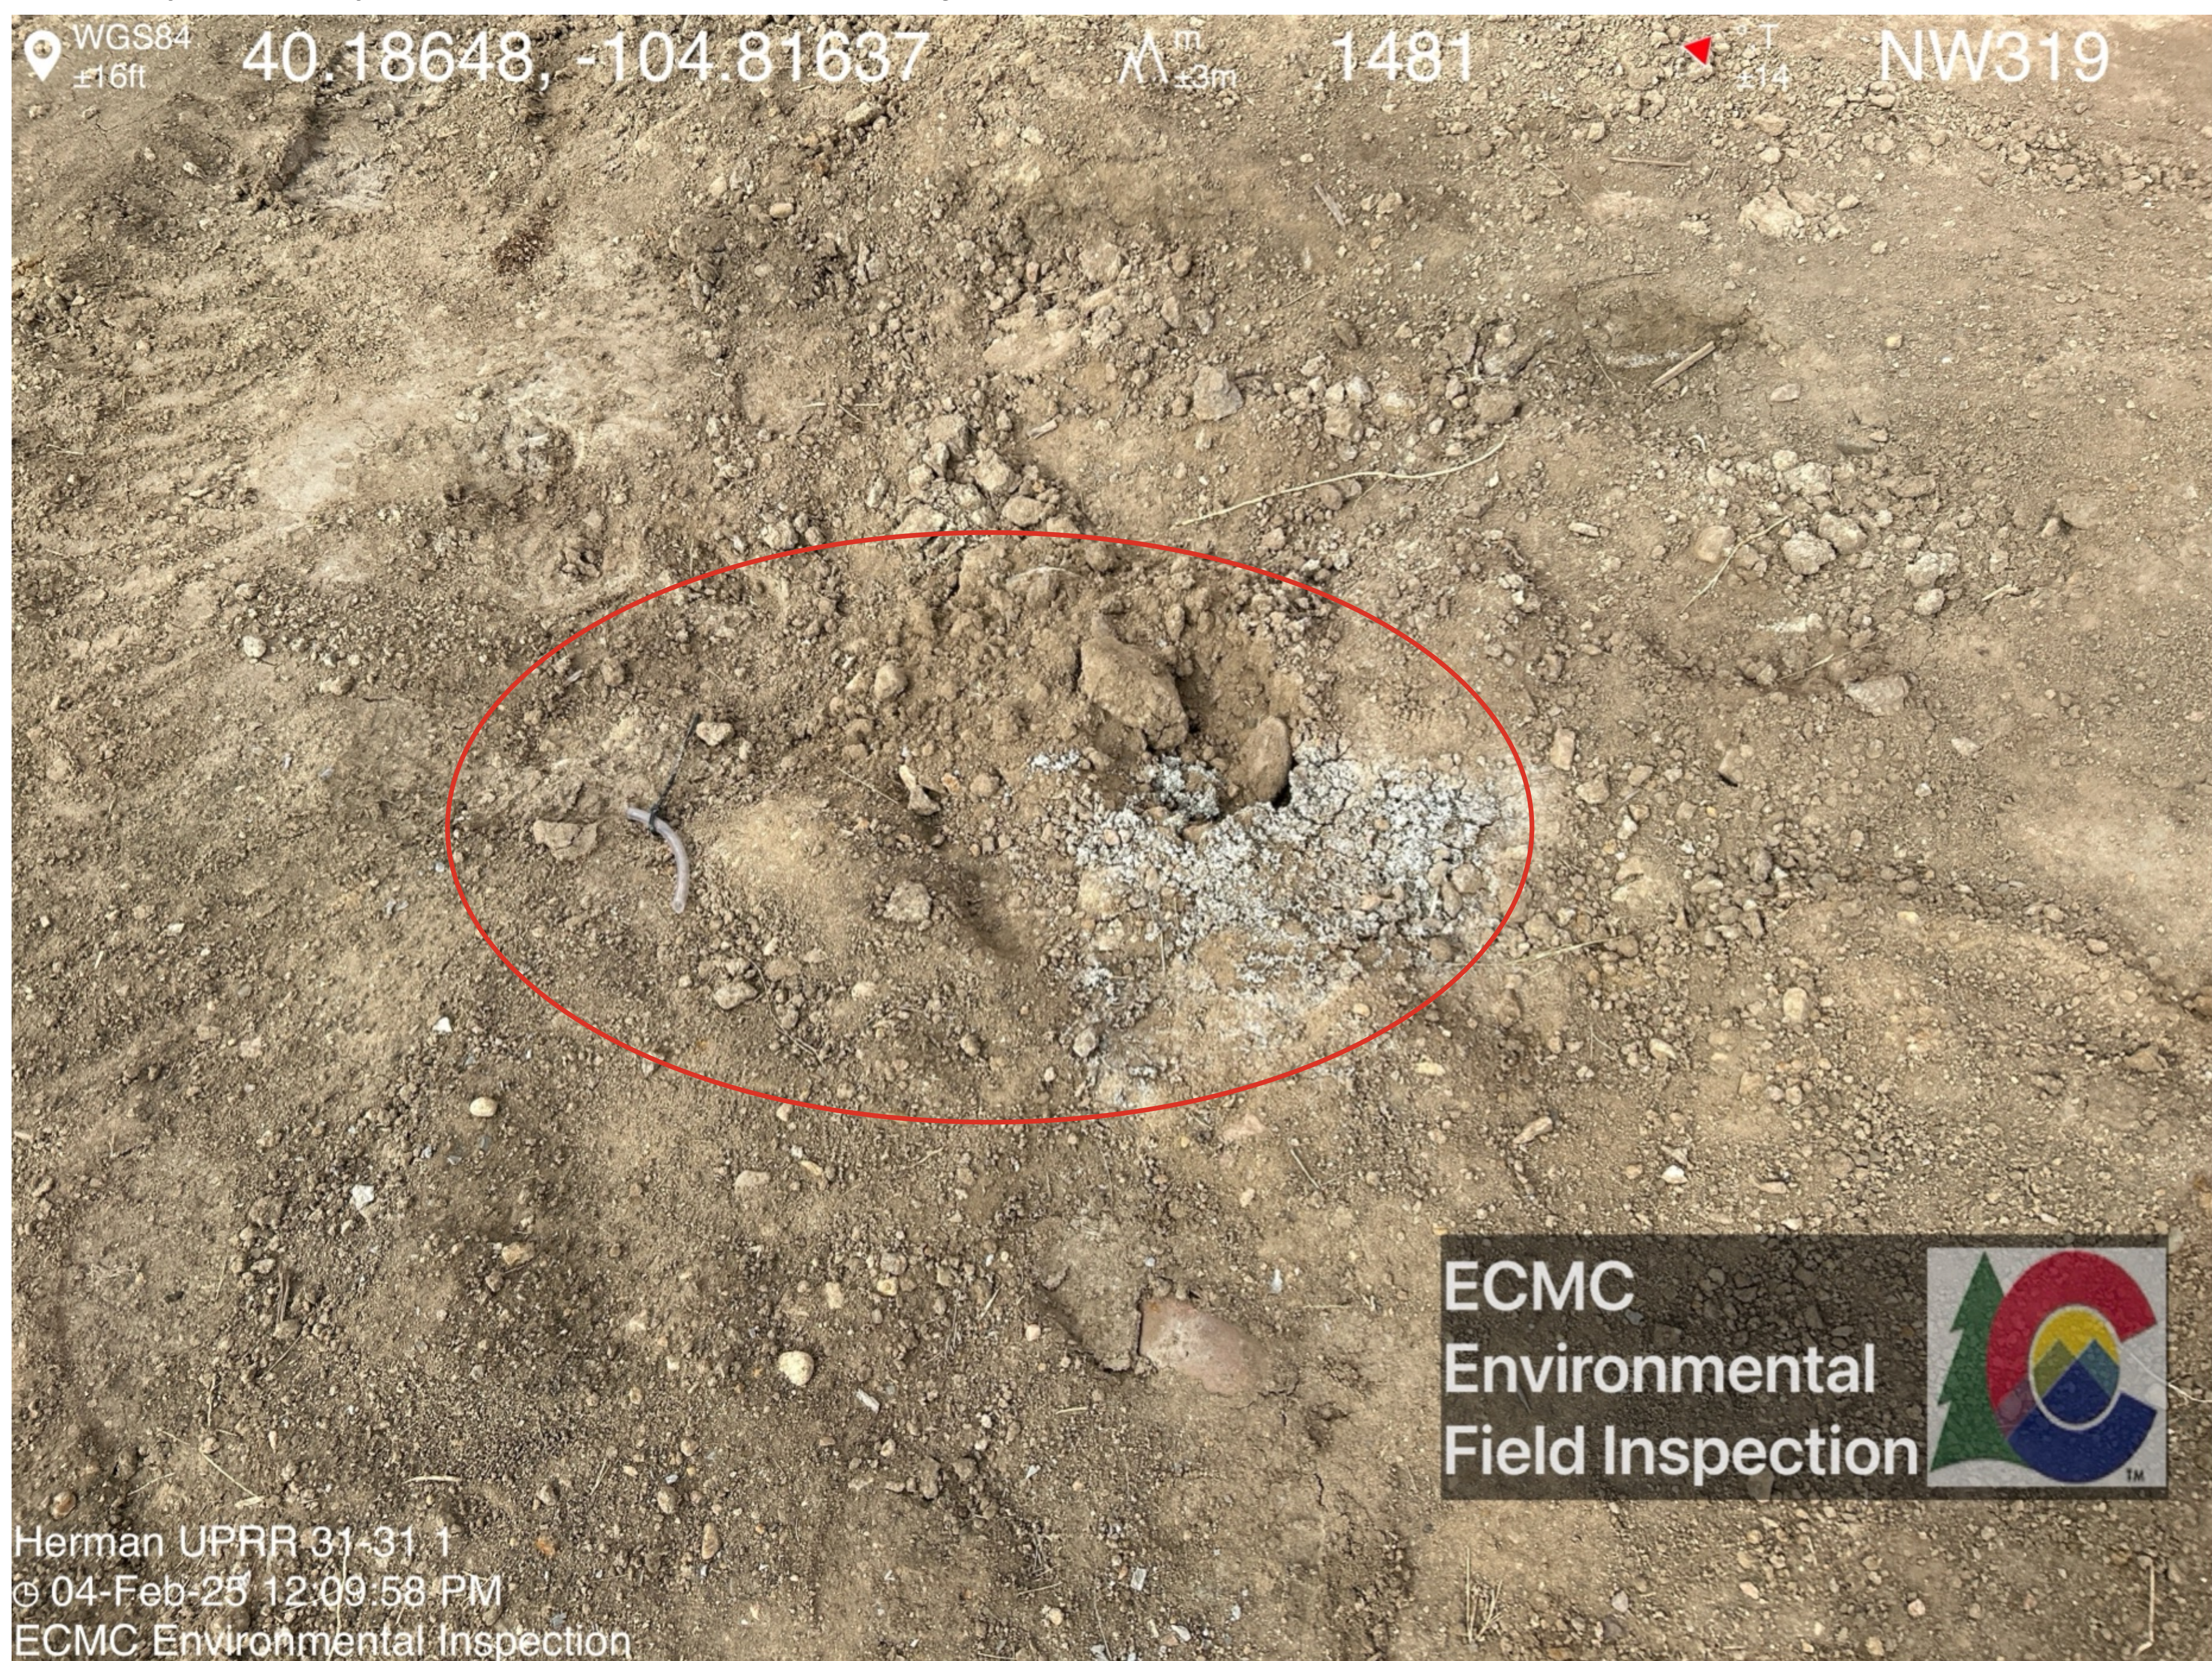
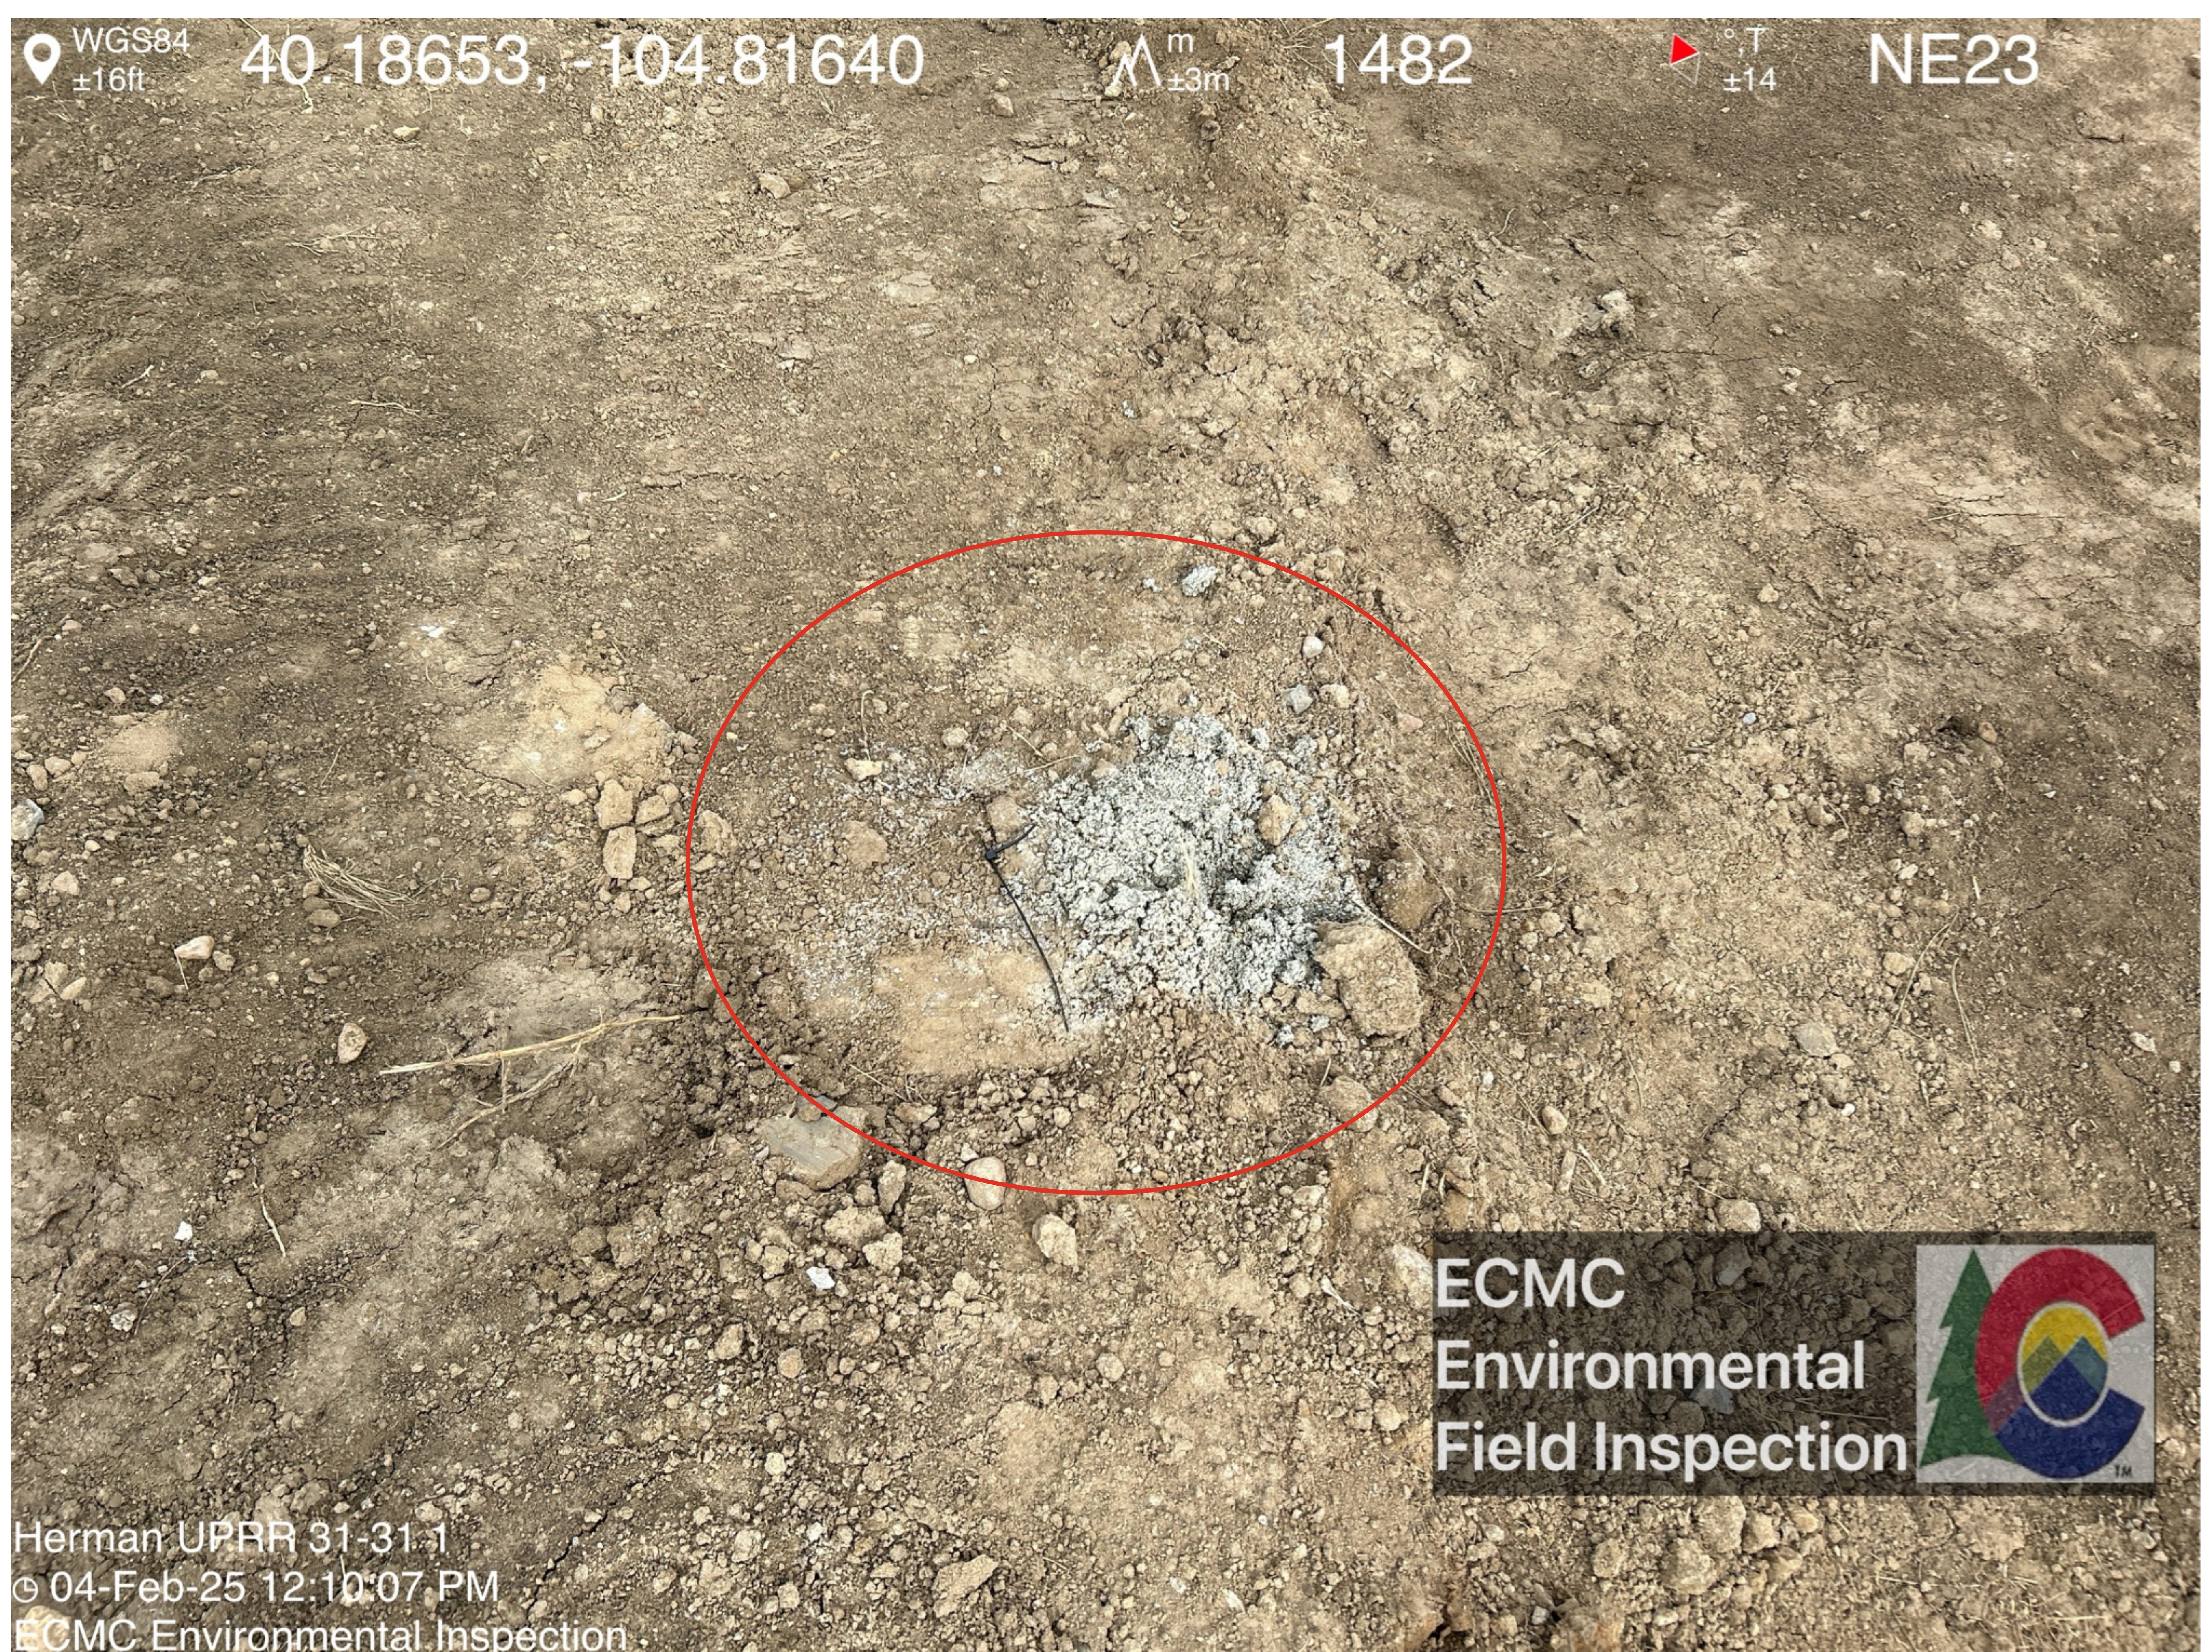
Soil vapor sample locations observed adjacent to the former wellhead.
