Herman UPRR 31-31.1  
© 04-Feb-25 11:55:33 AM  
ECMC Environmental Inspection

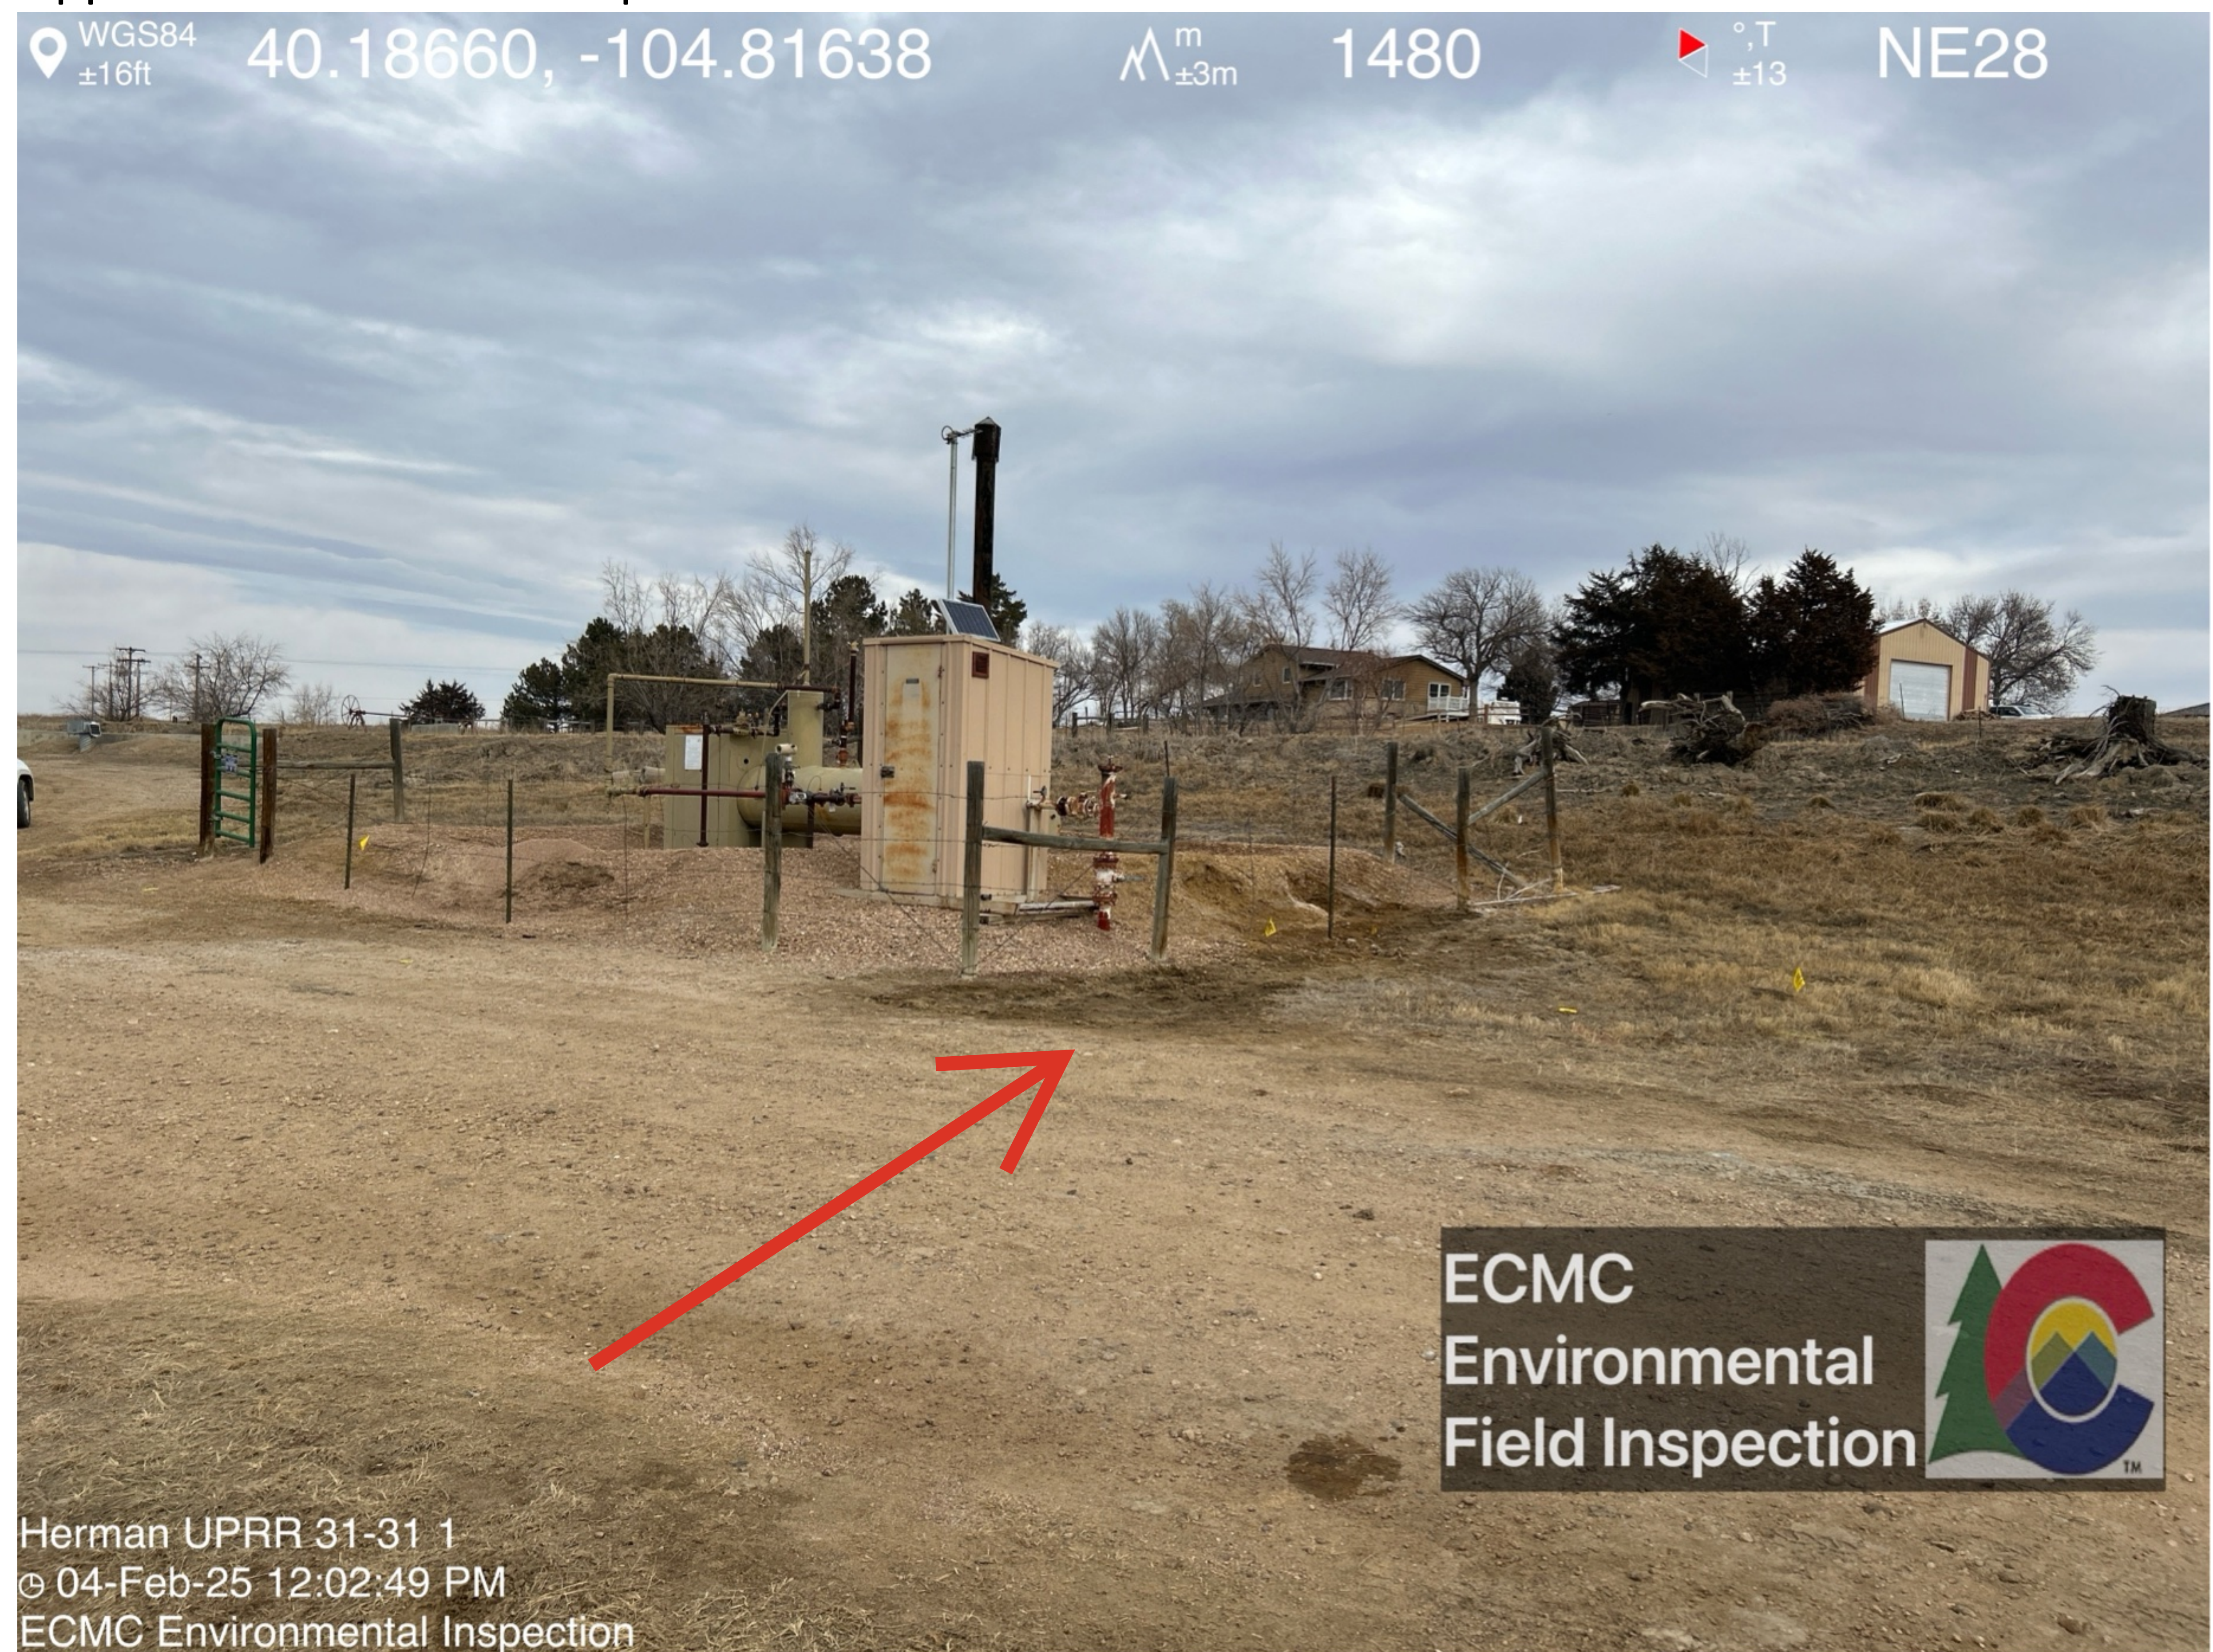
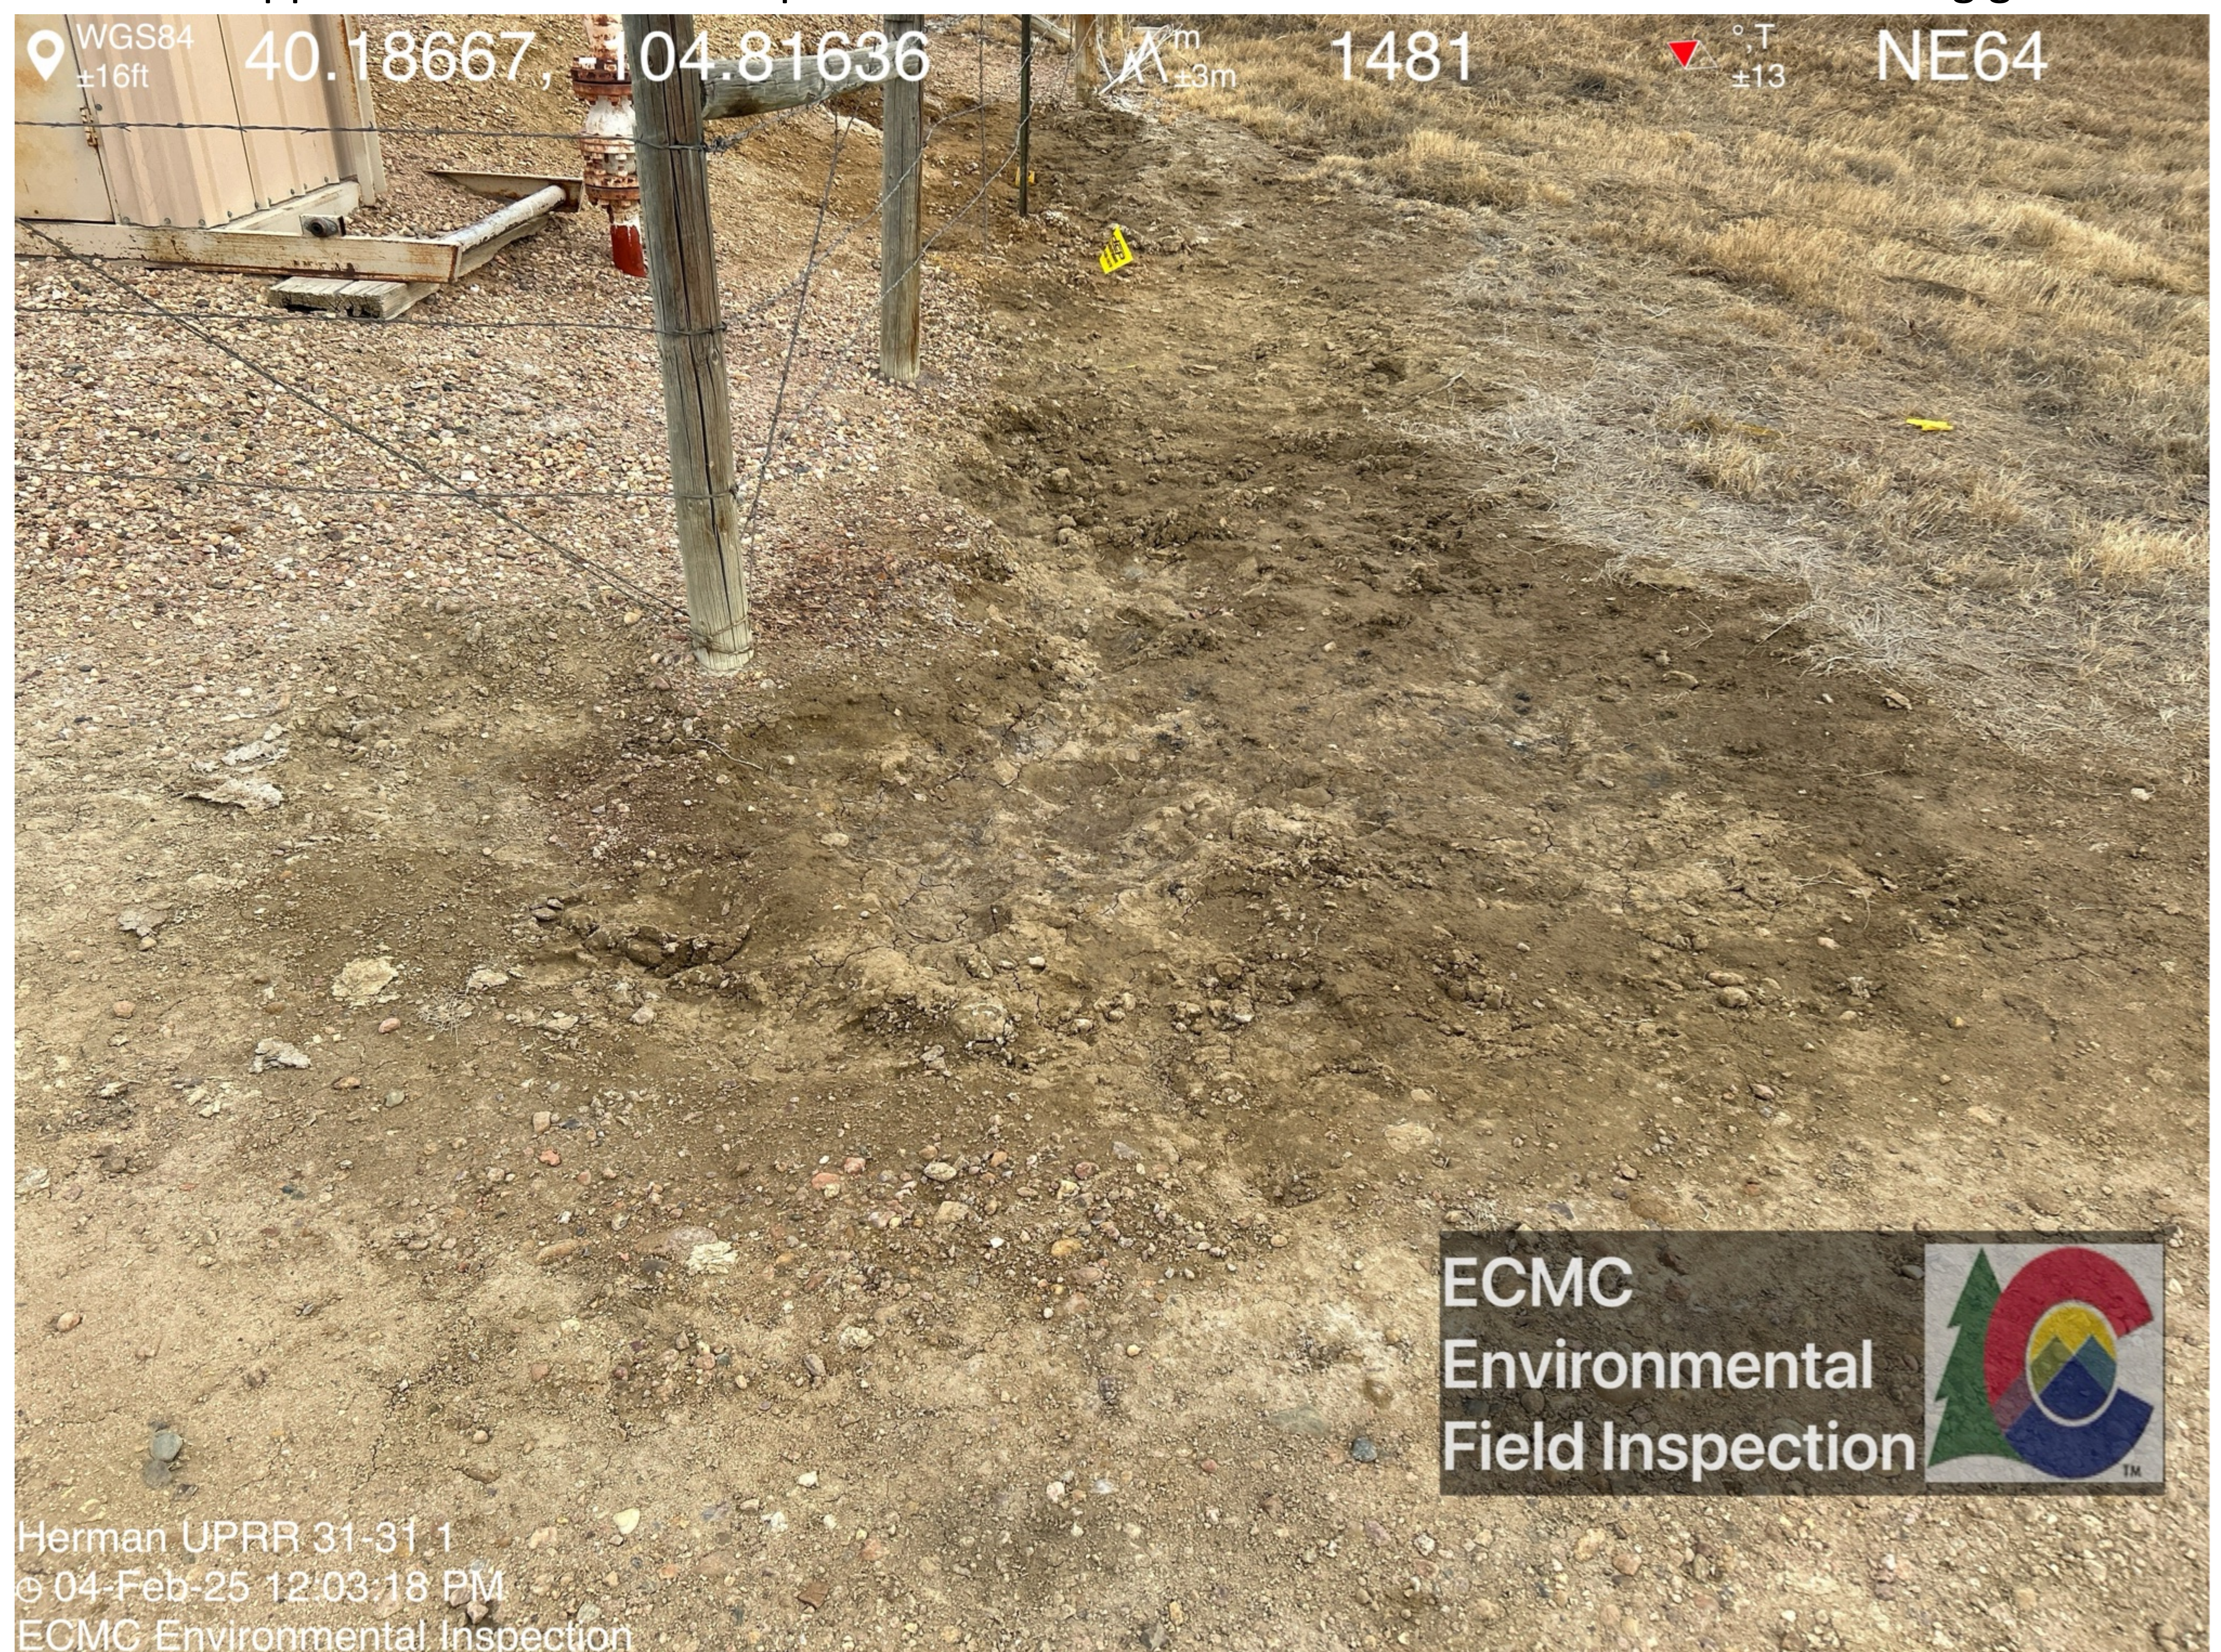
Soil in the approximate location of Spill ID 489153 was moist and lower than the surrounding grade.

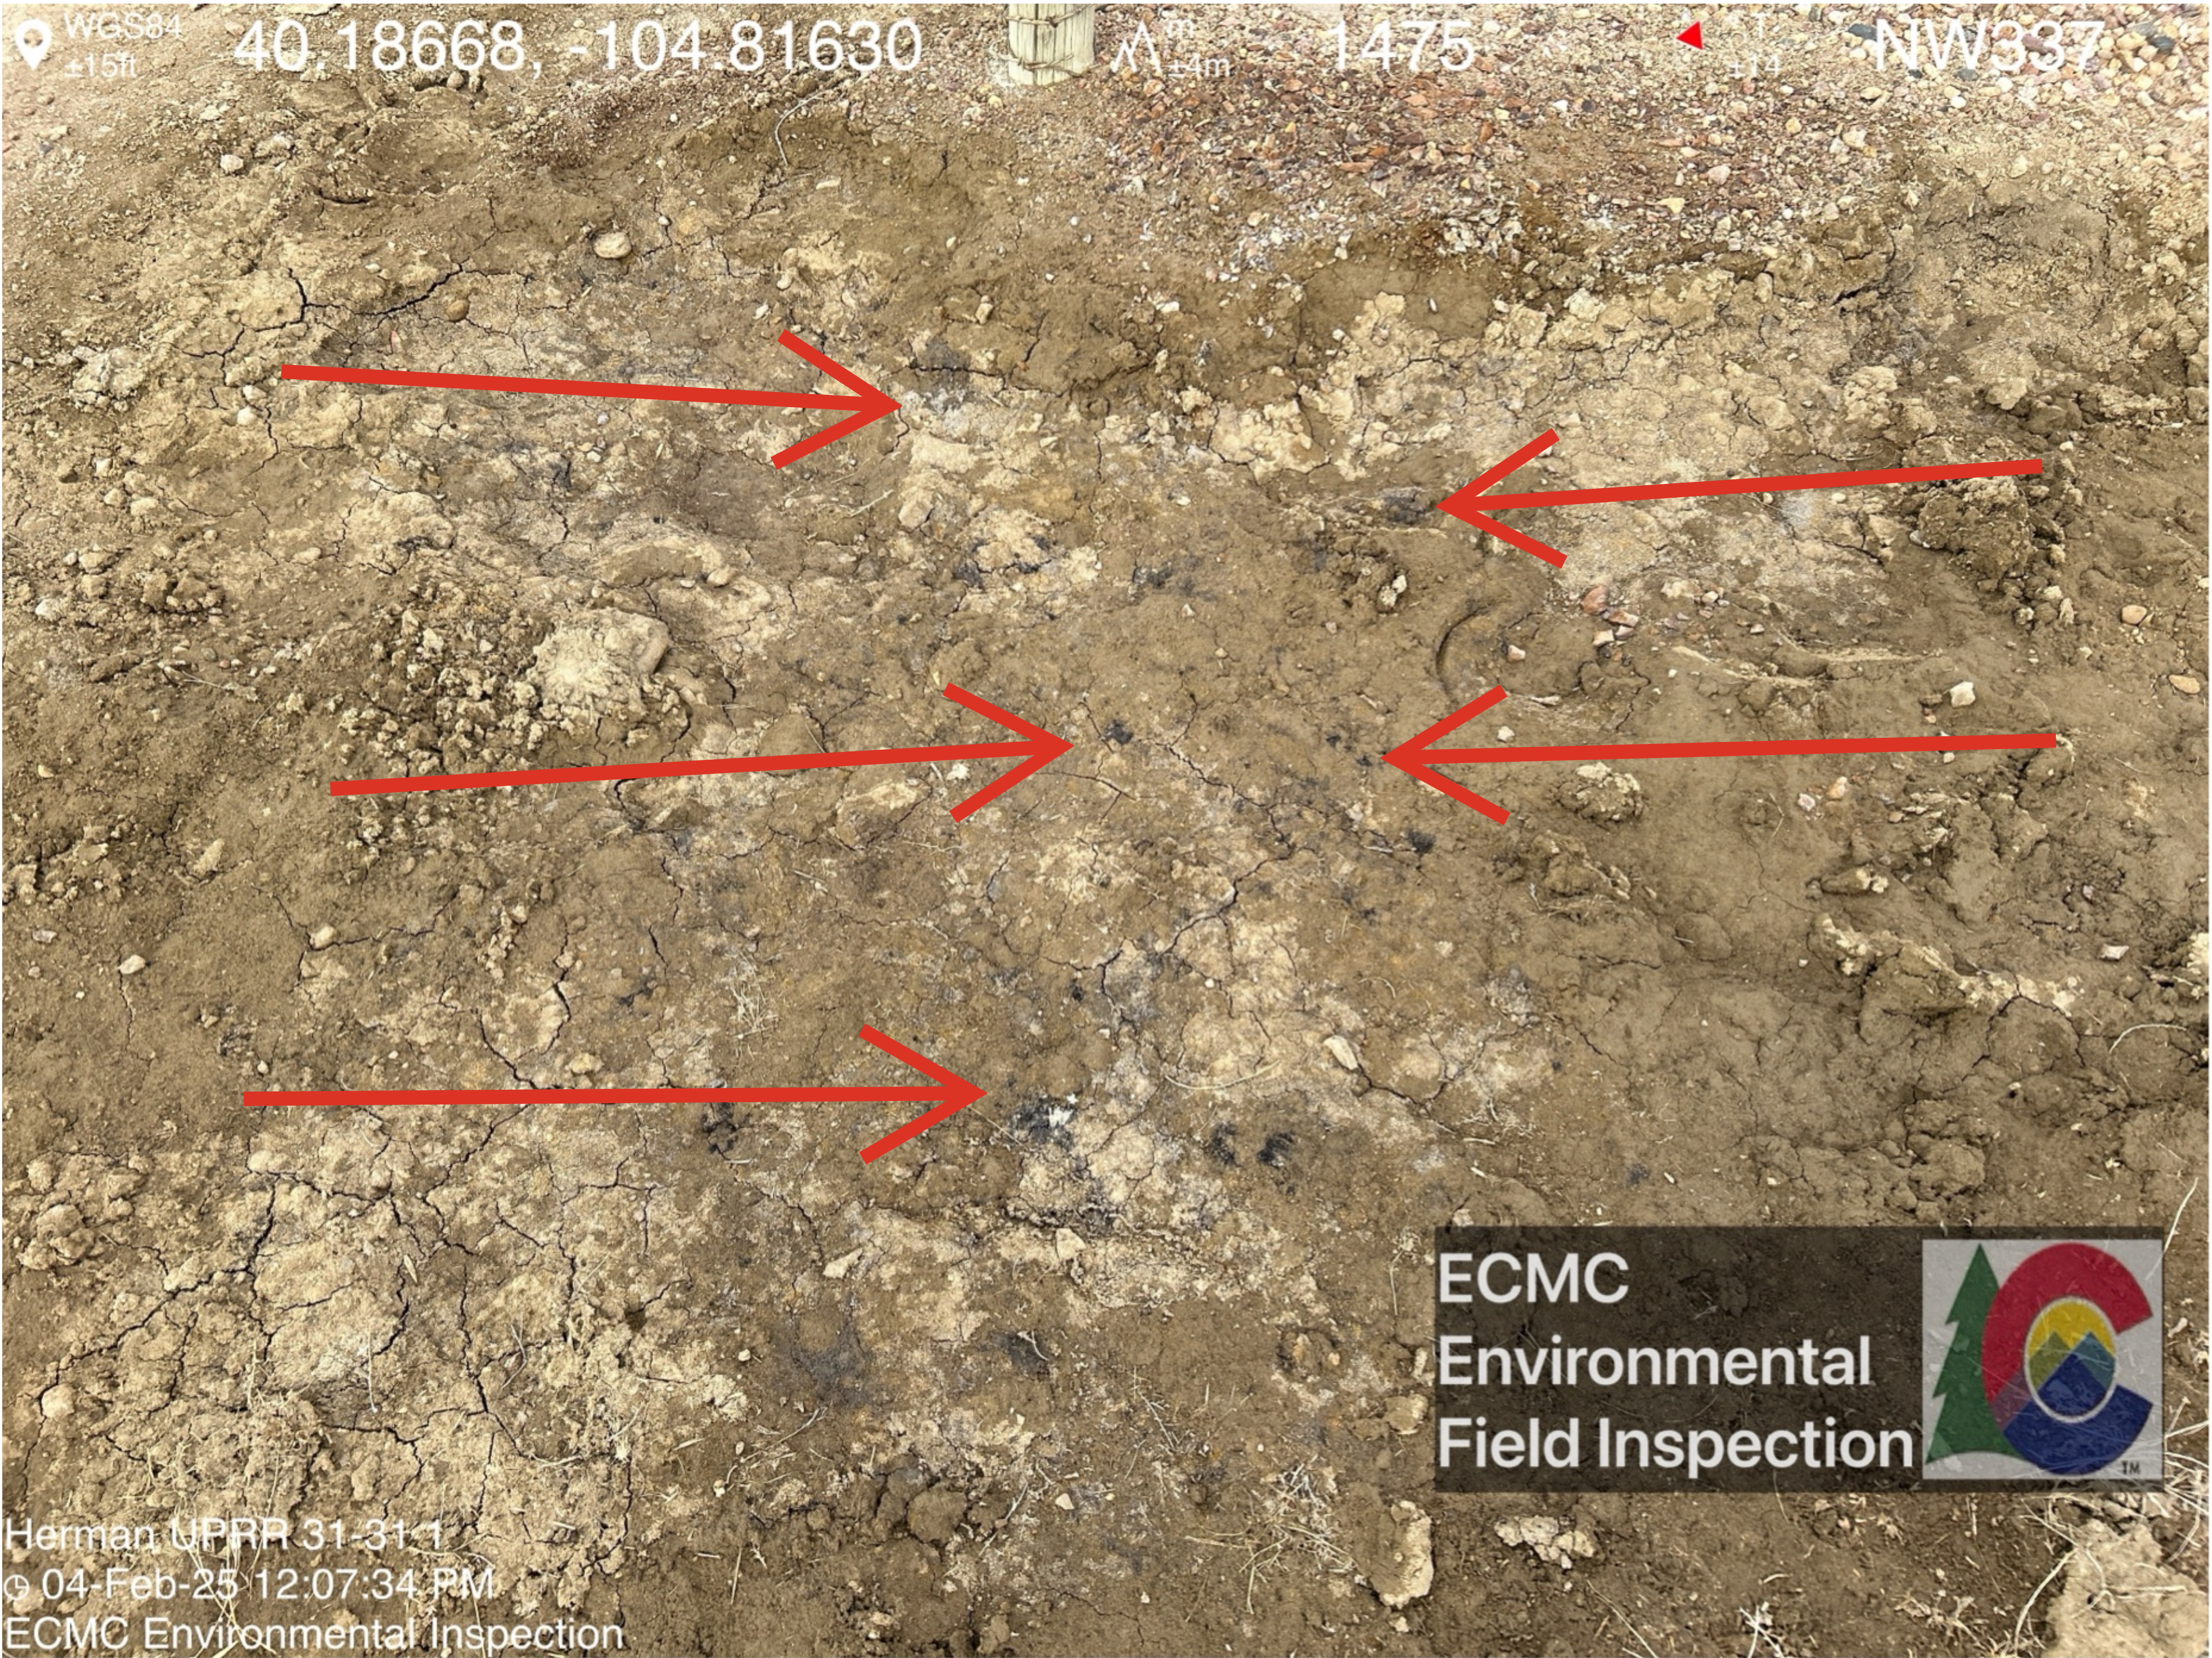
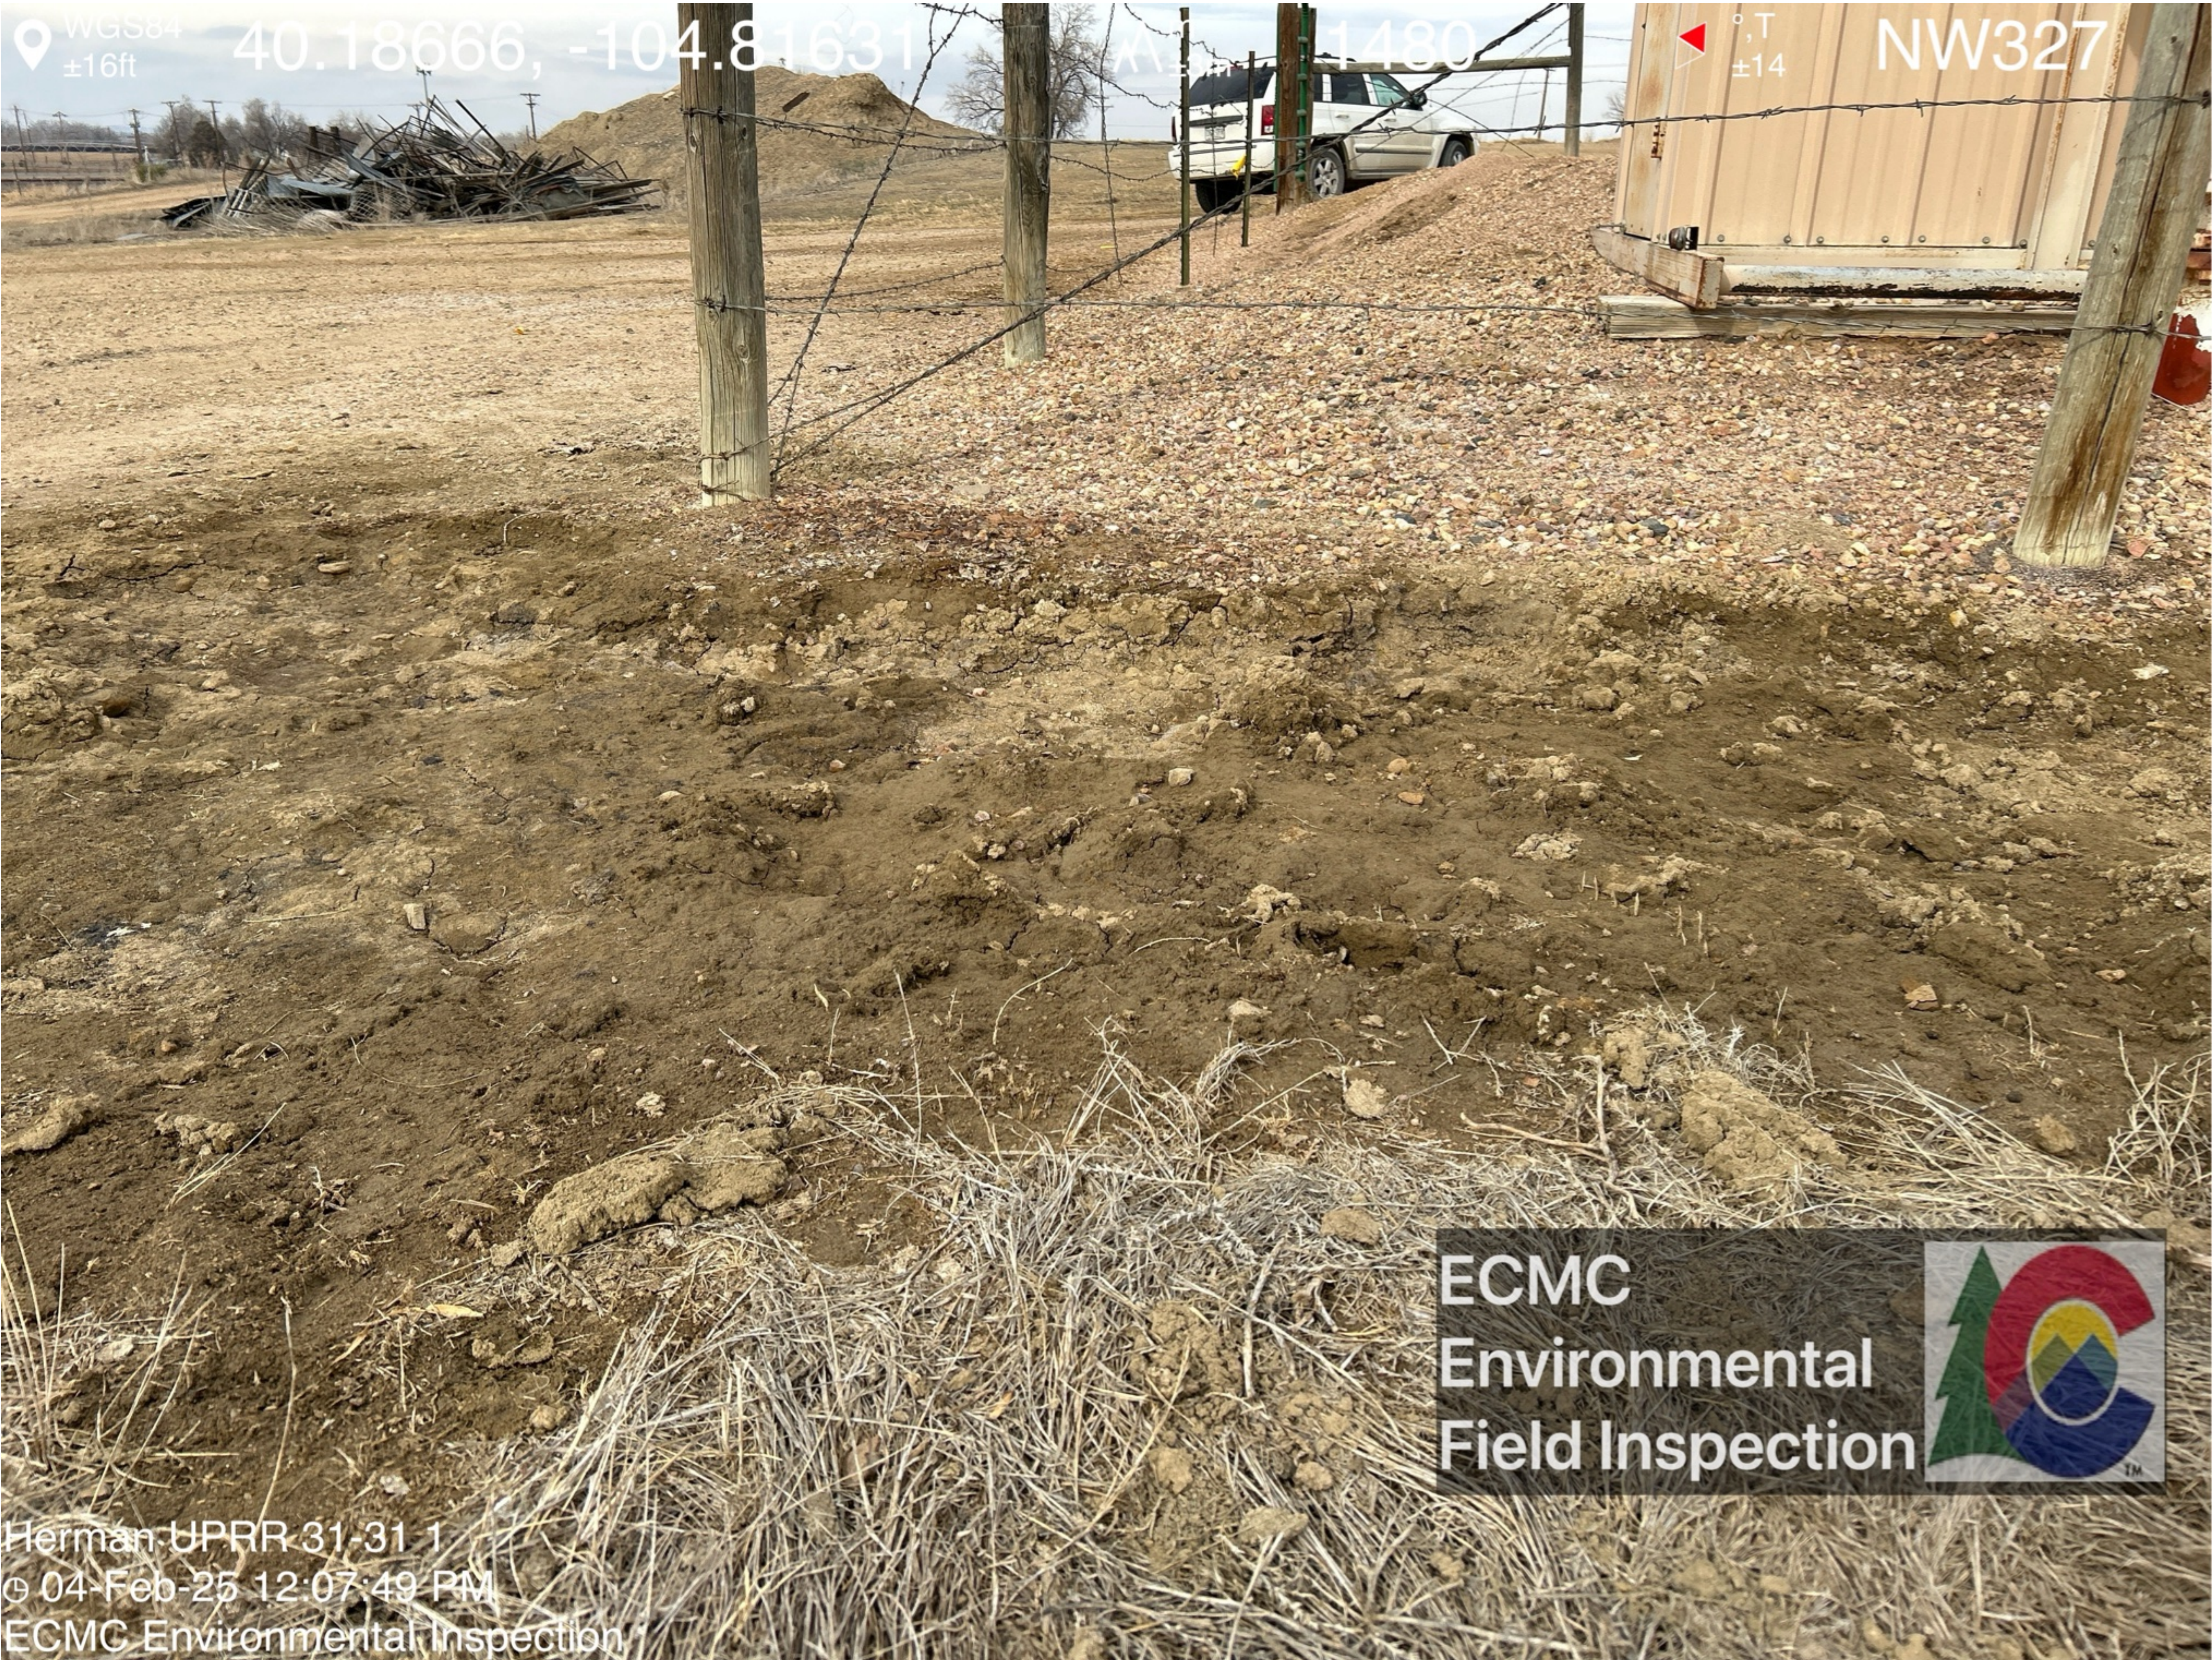
Spots of black staining were visible in the approximate location of Spill ID 489153.

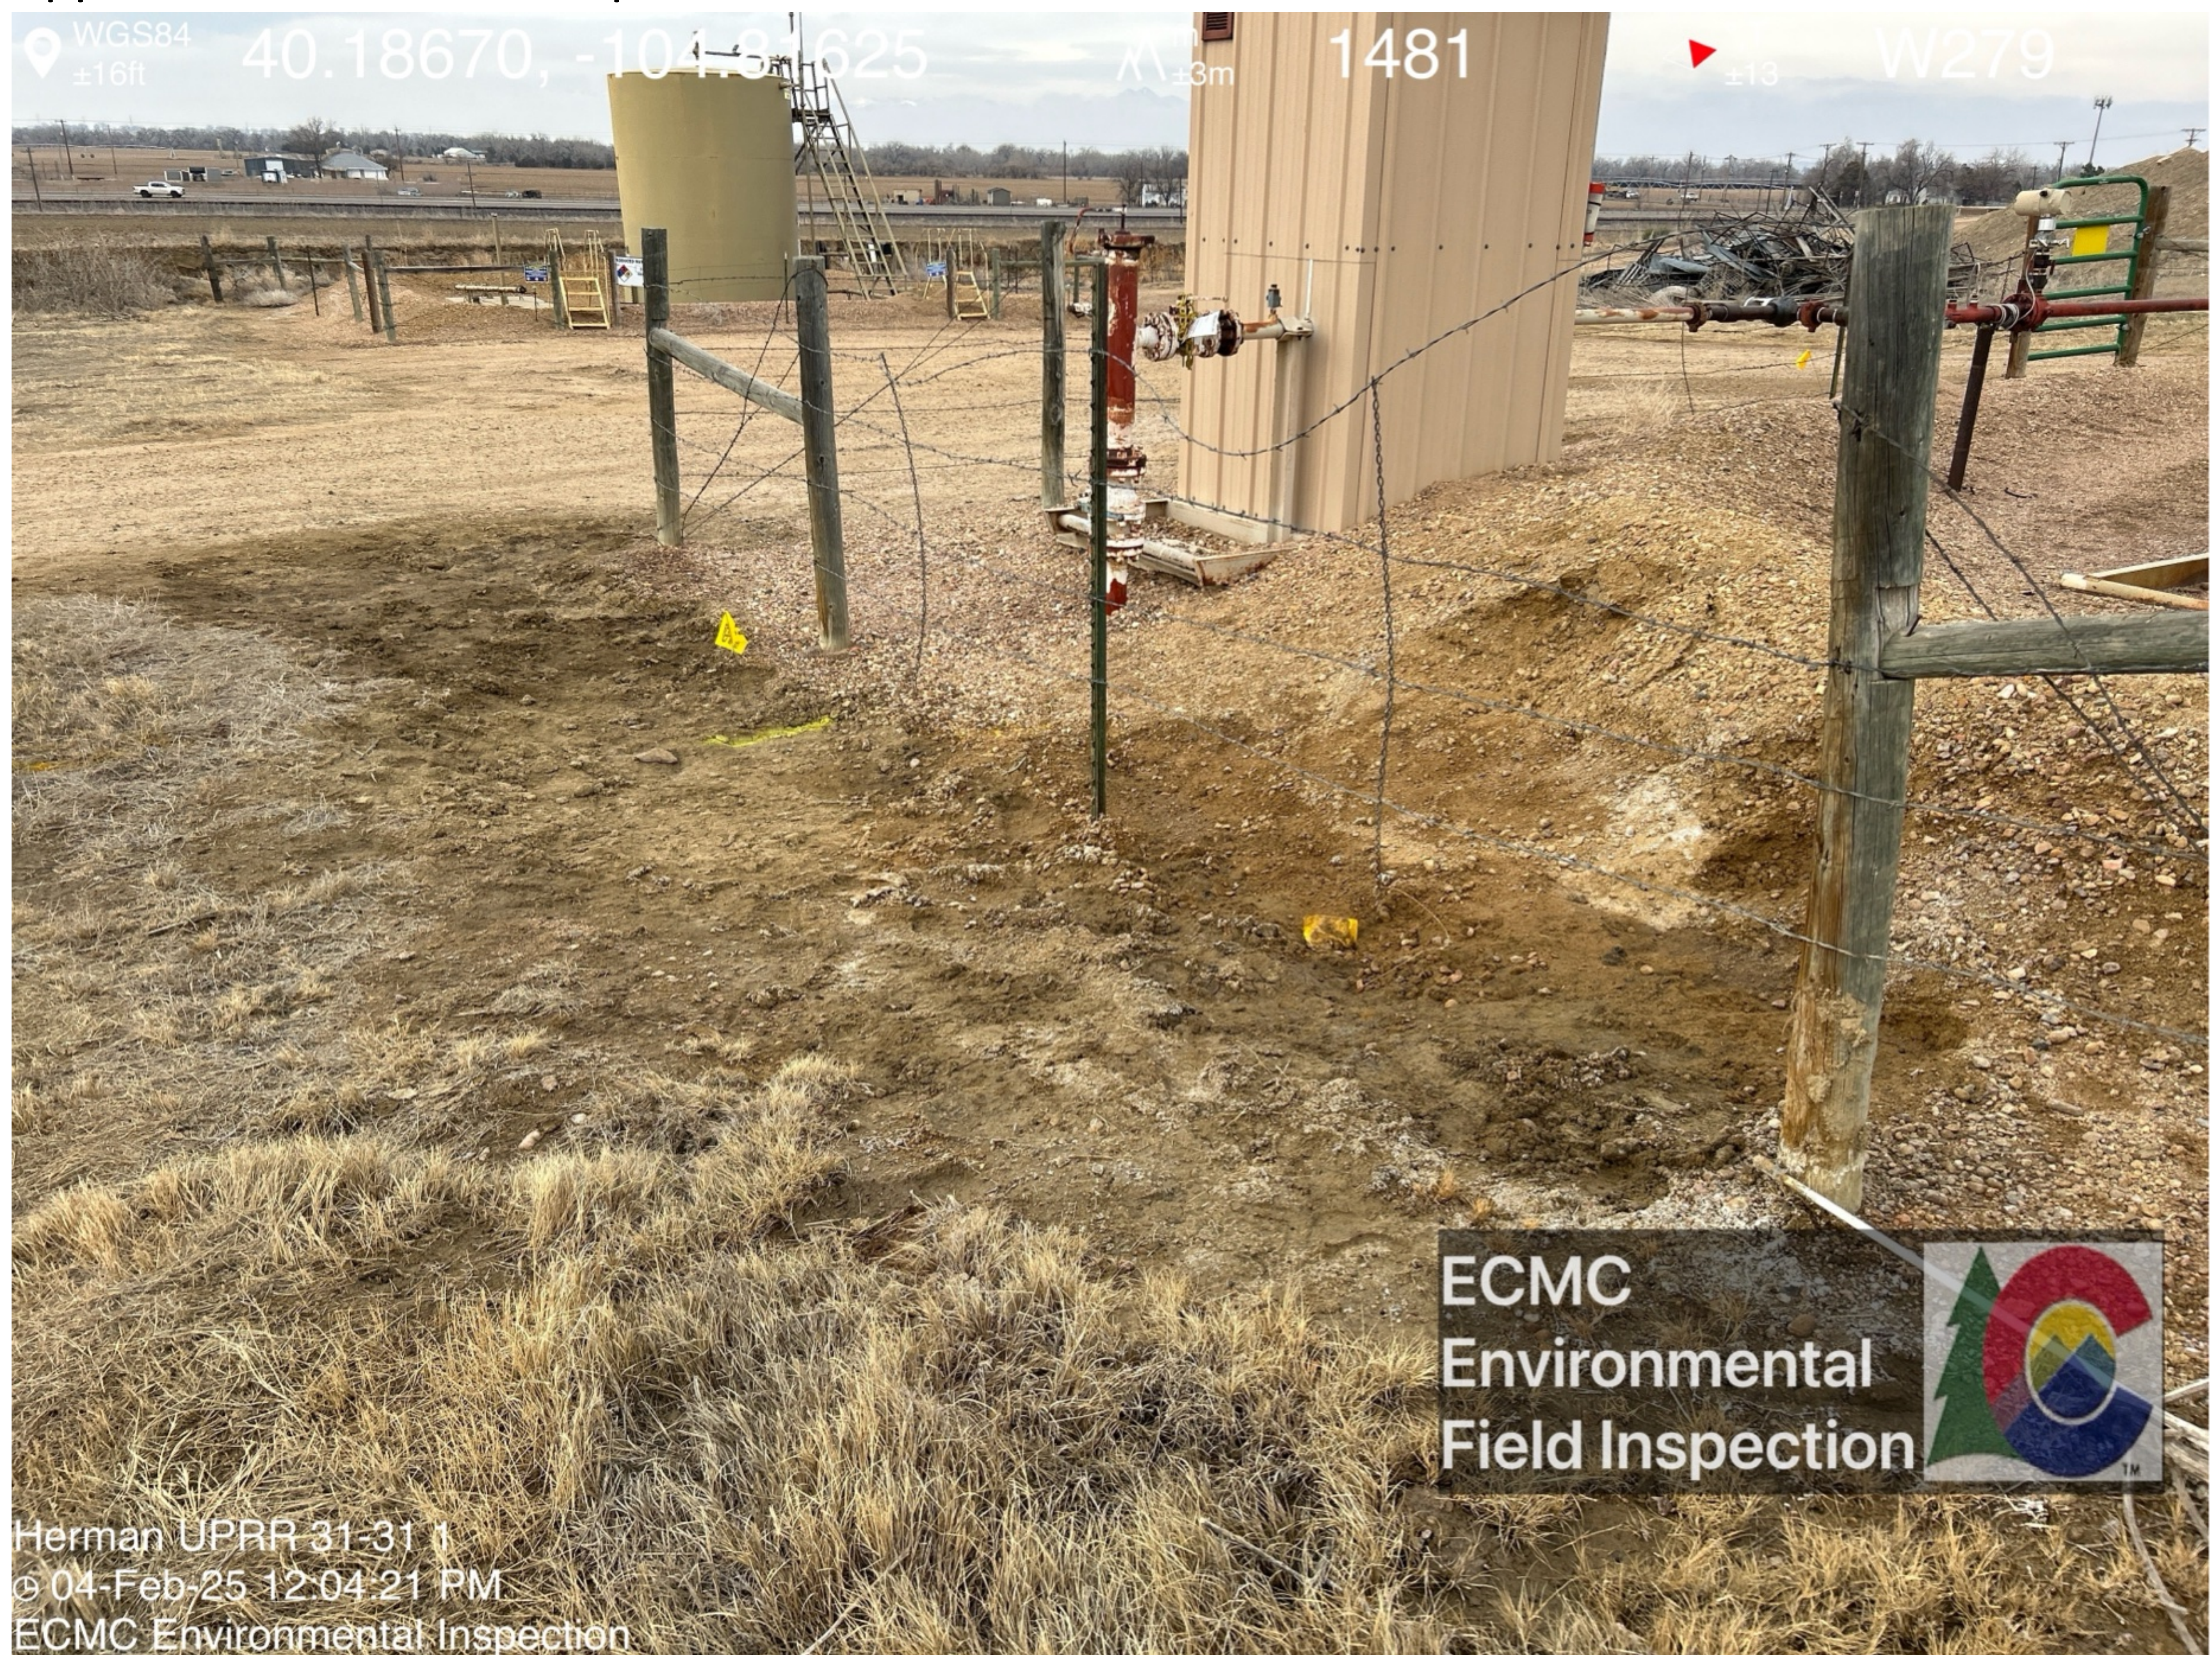
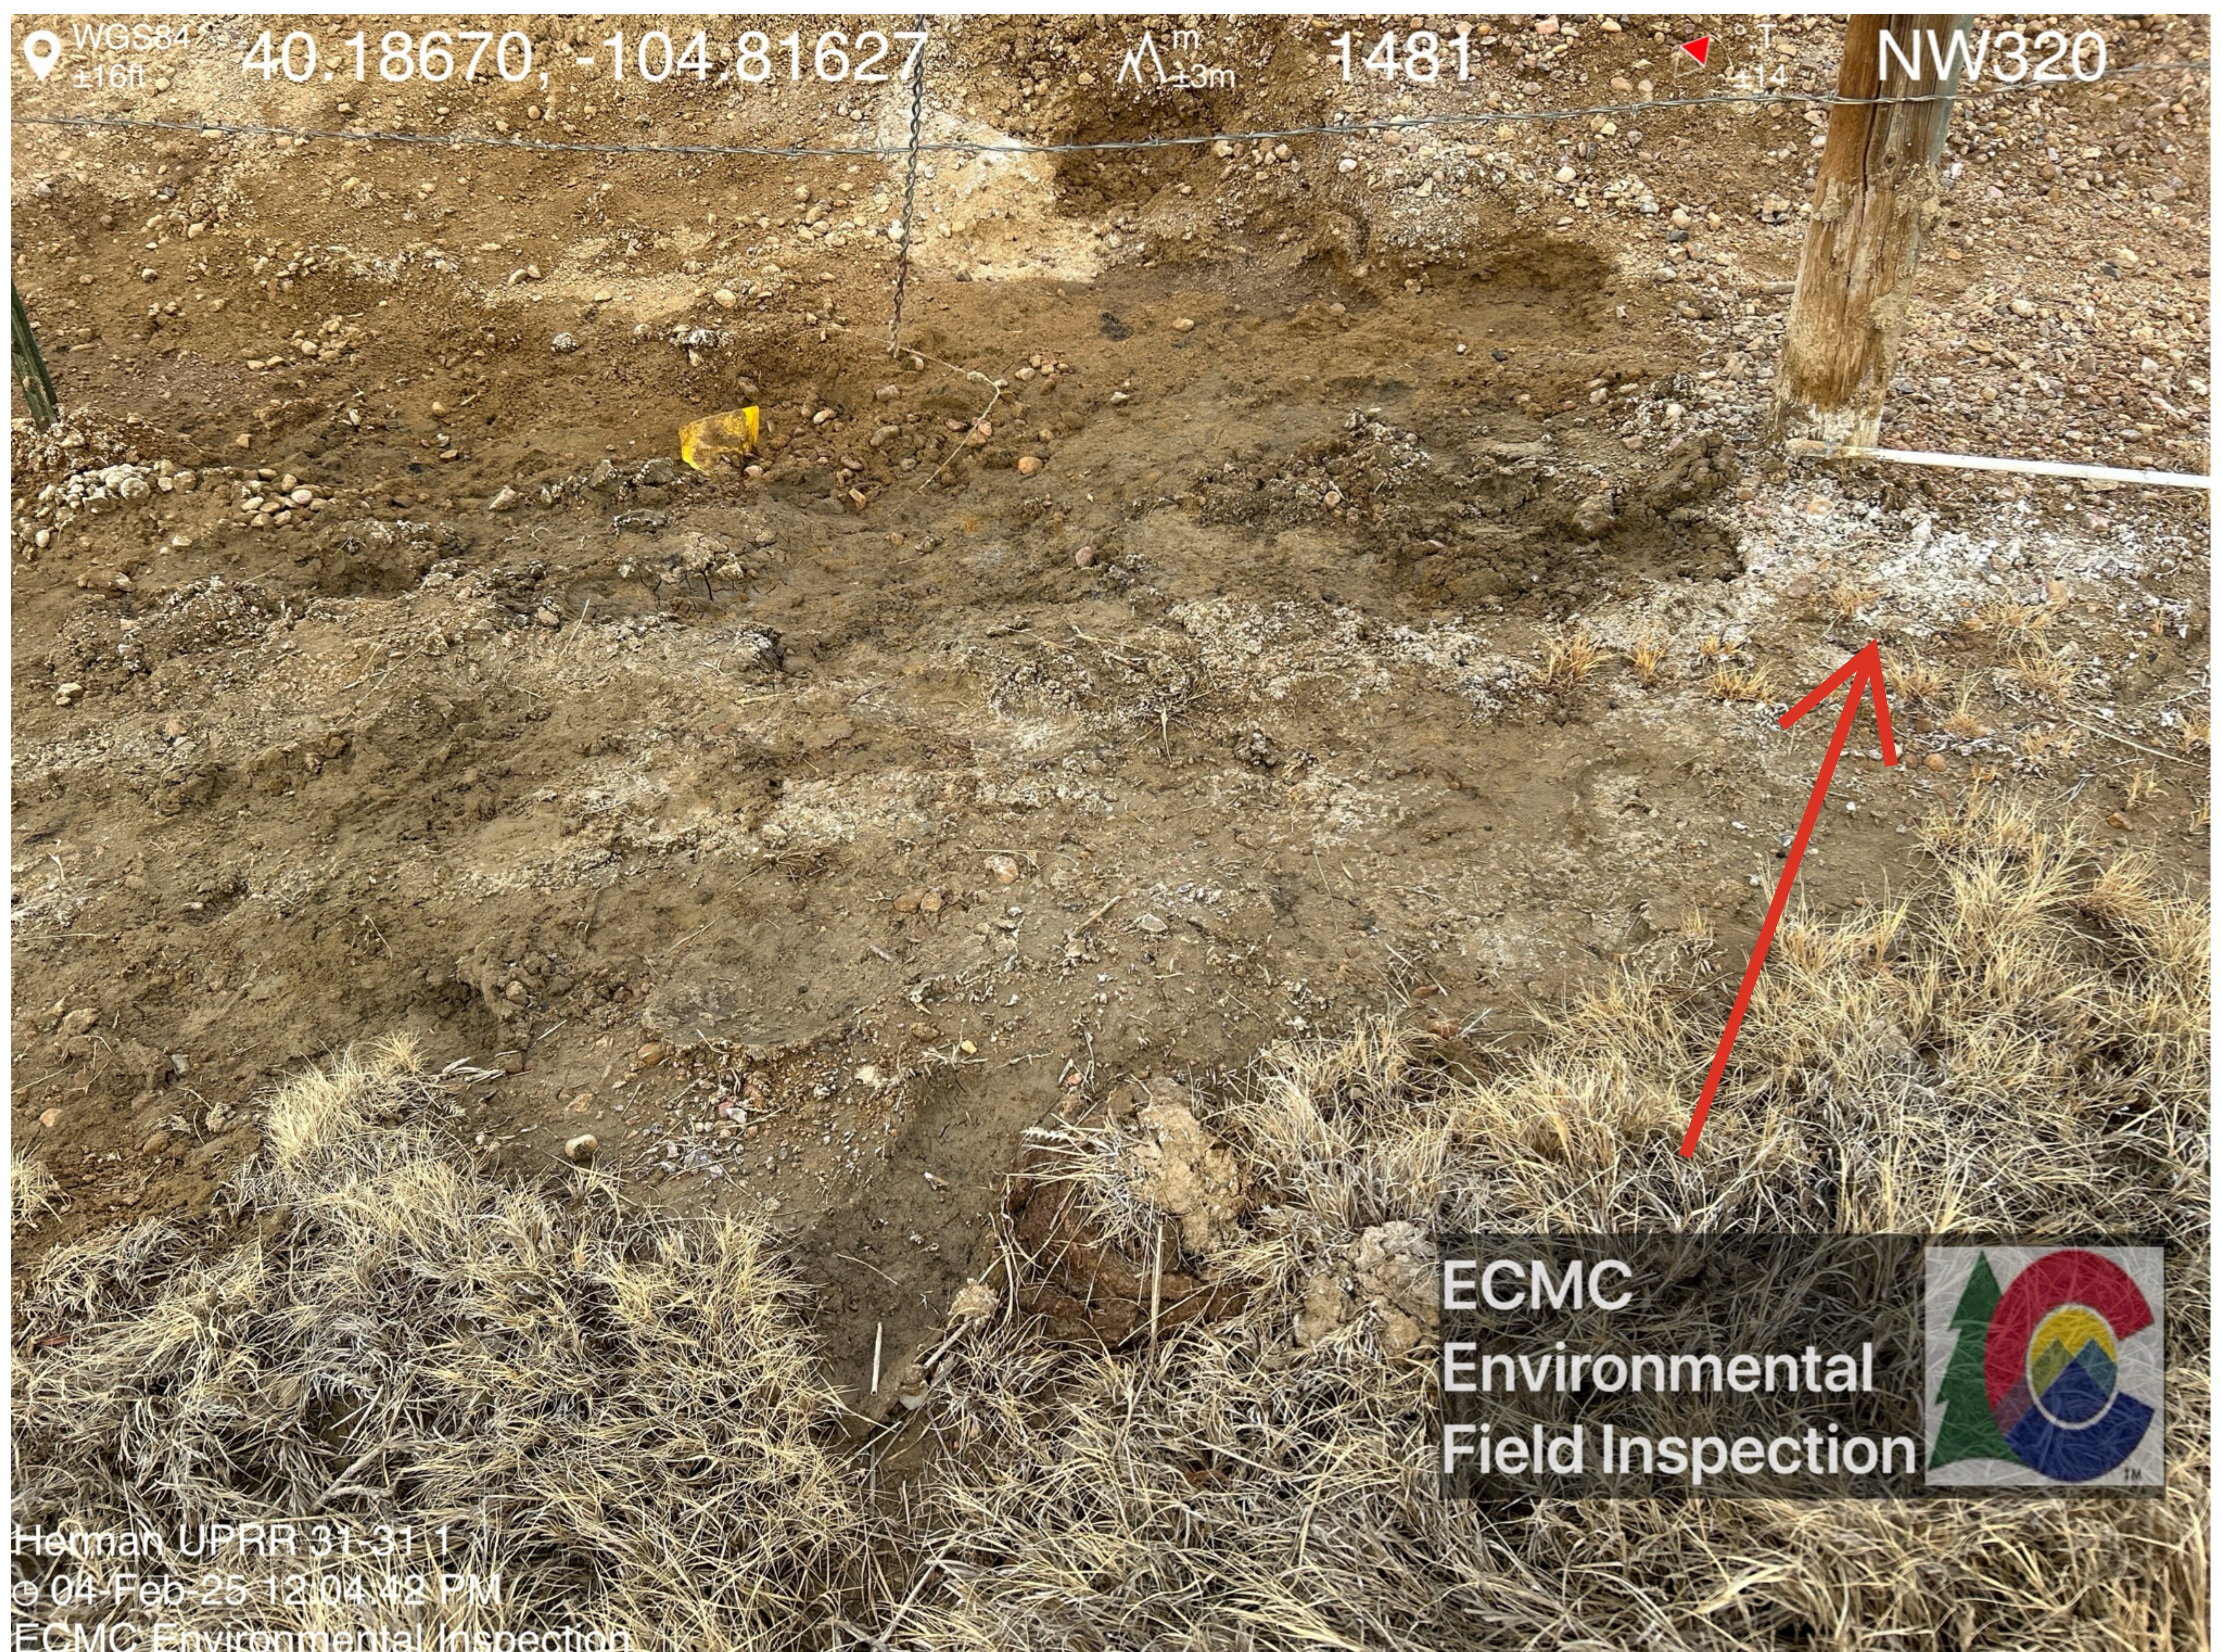
Salt crusting was visible adjacent to the spill location.
