Herman UPRR 31-31.1  
© 04-Feb-25 11:55:33 AM  
ECMC Environmental Inspection

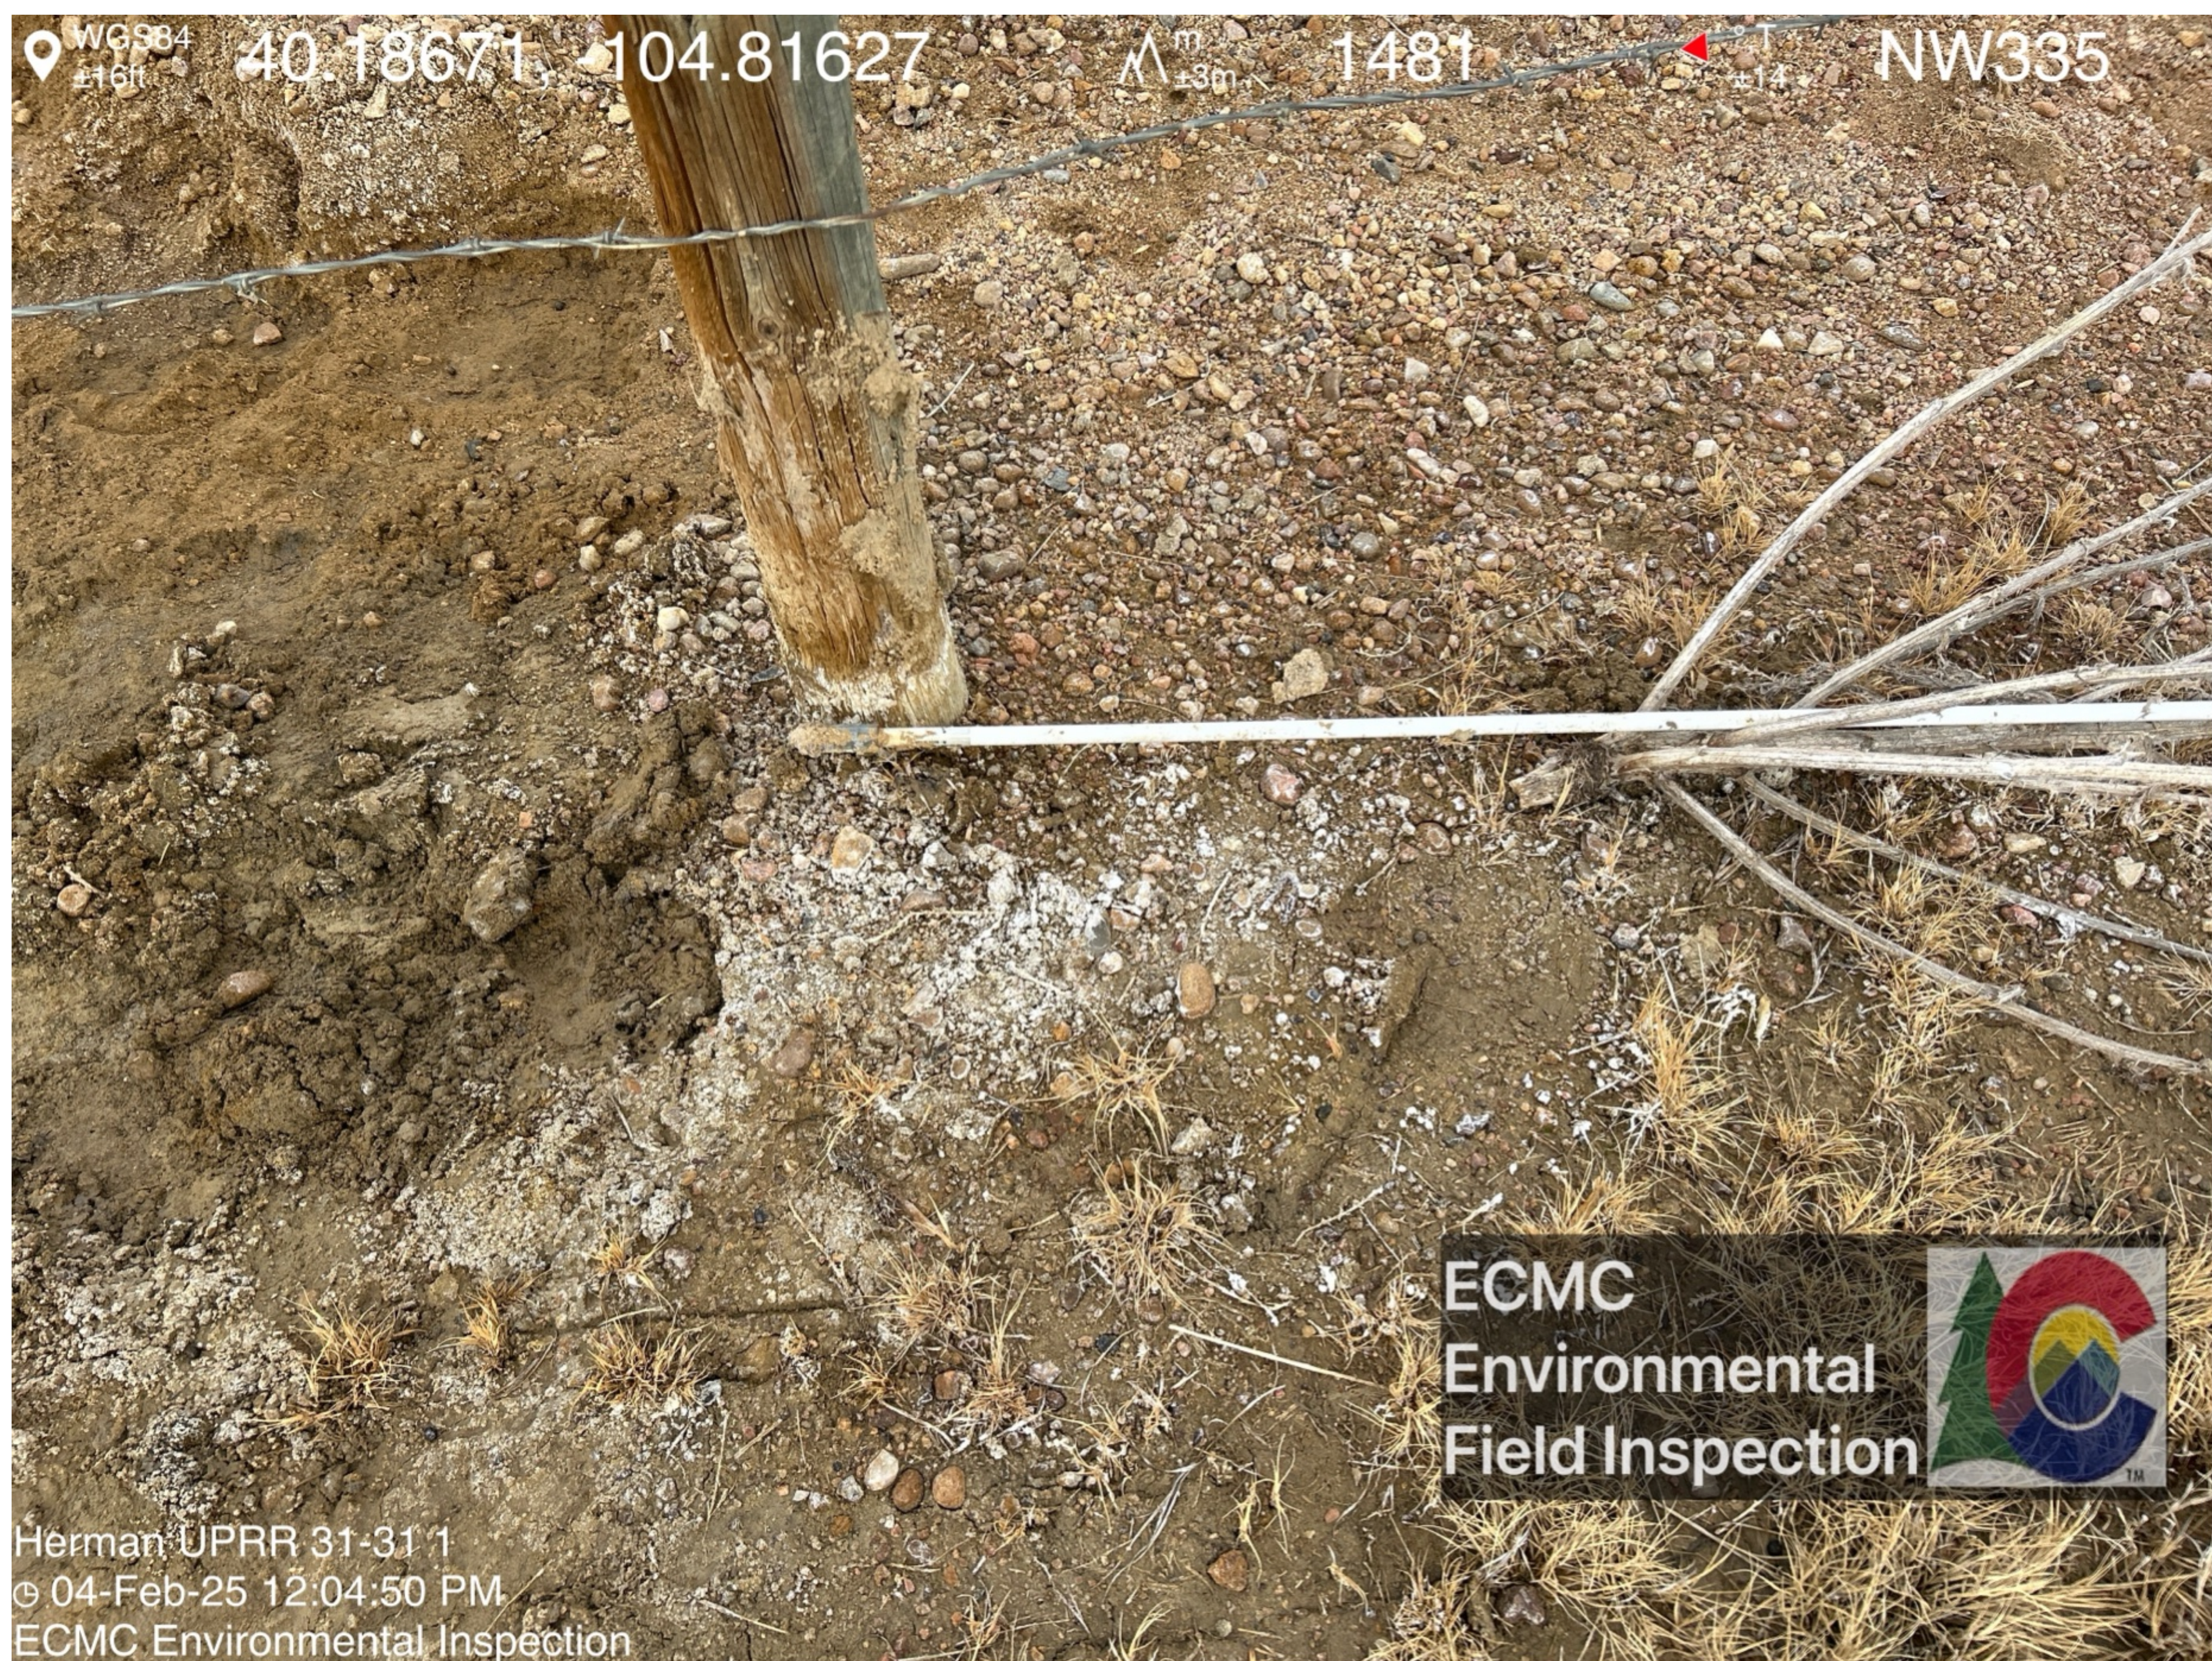
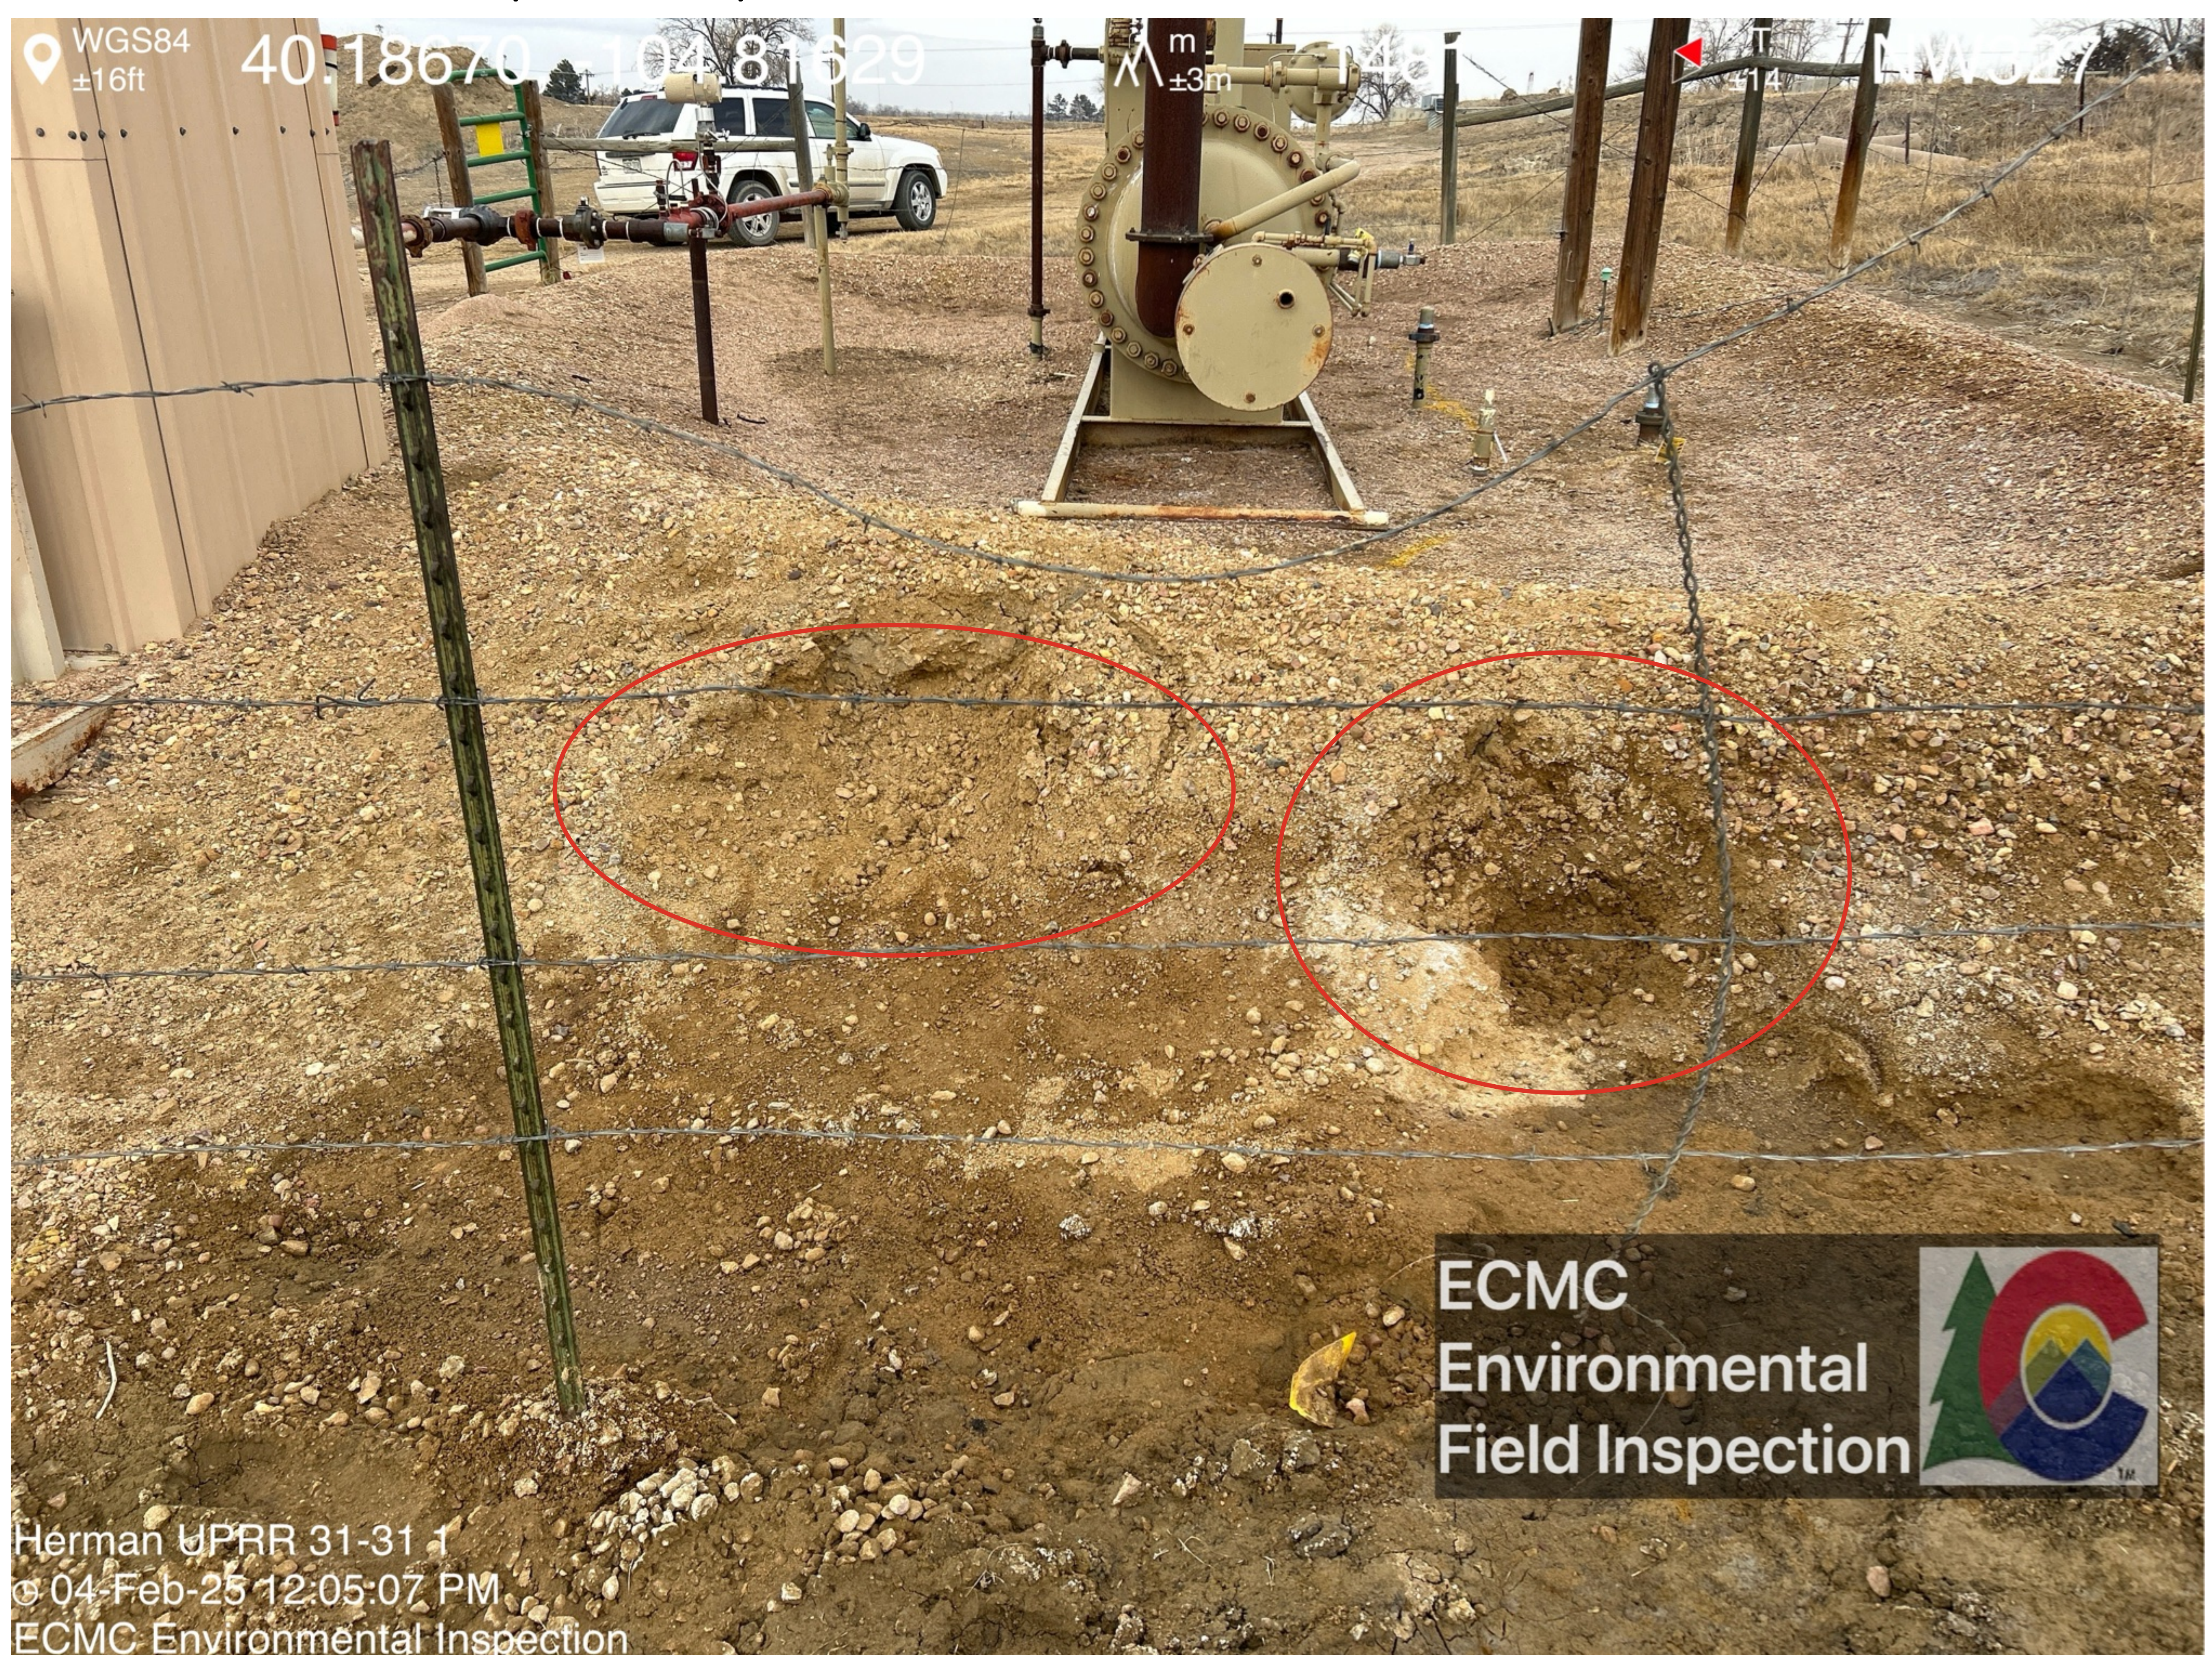
Soil on the separator berm, adjacent to Spill ID 489153 was observed disturbed. Degradation documented in Field Inspection Report 717900095 remains.

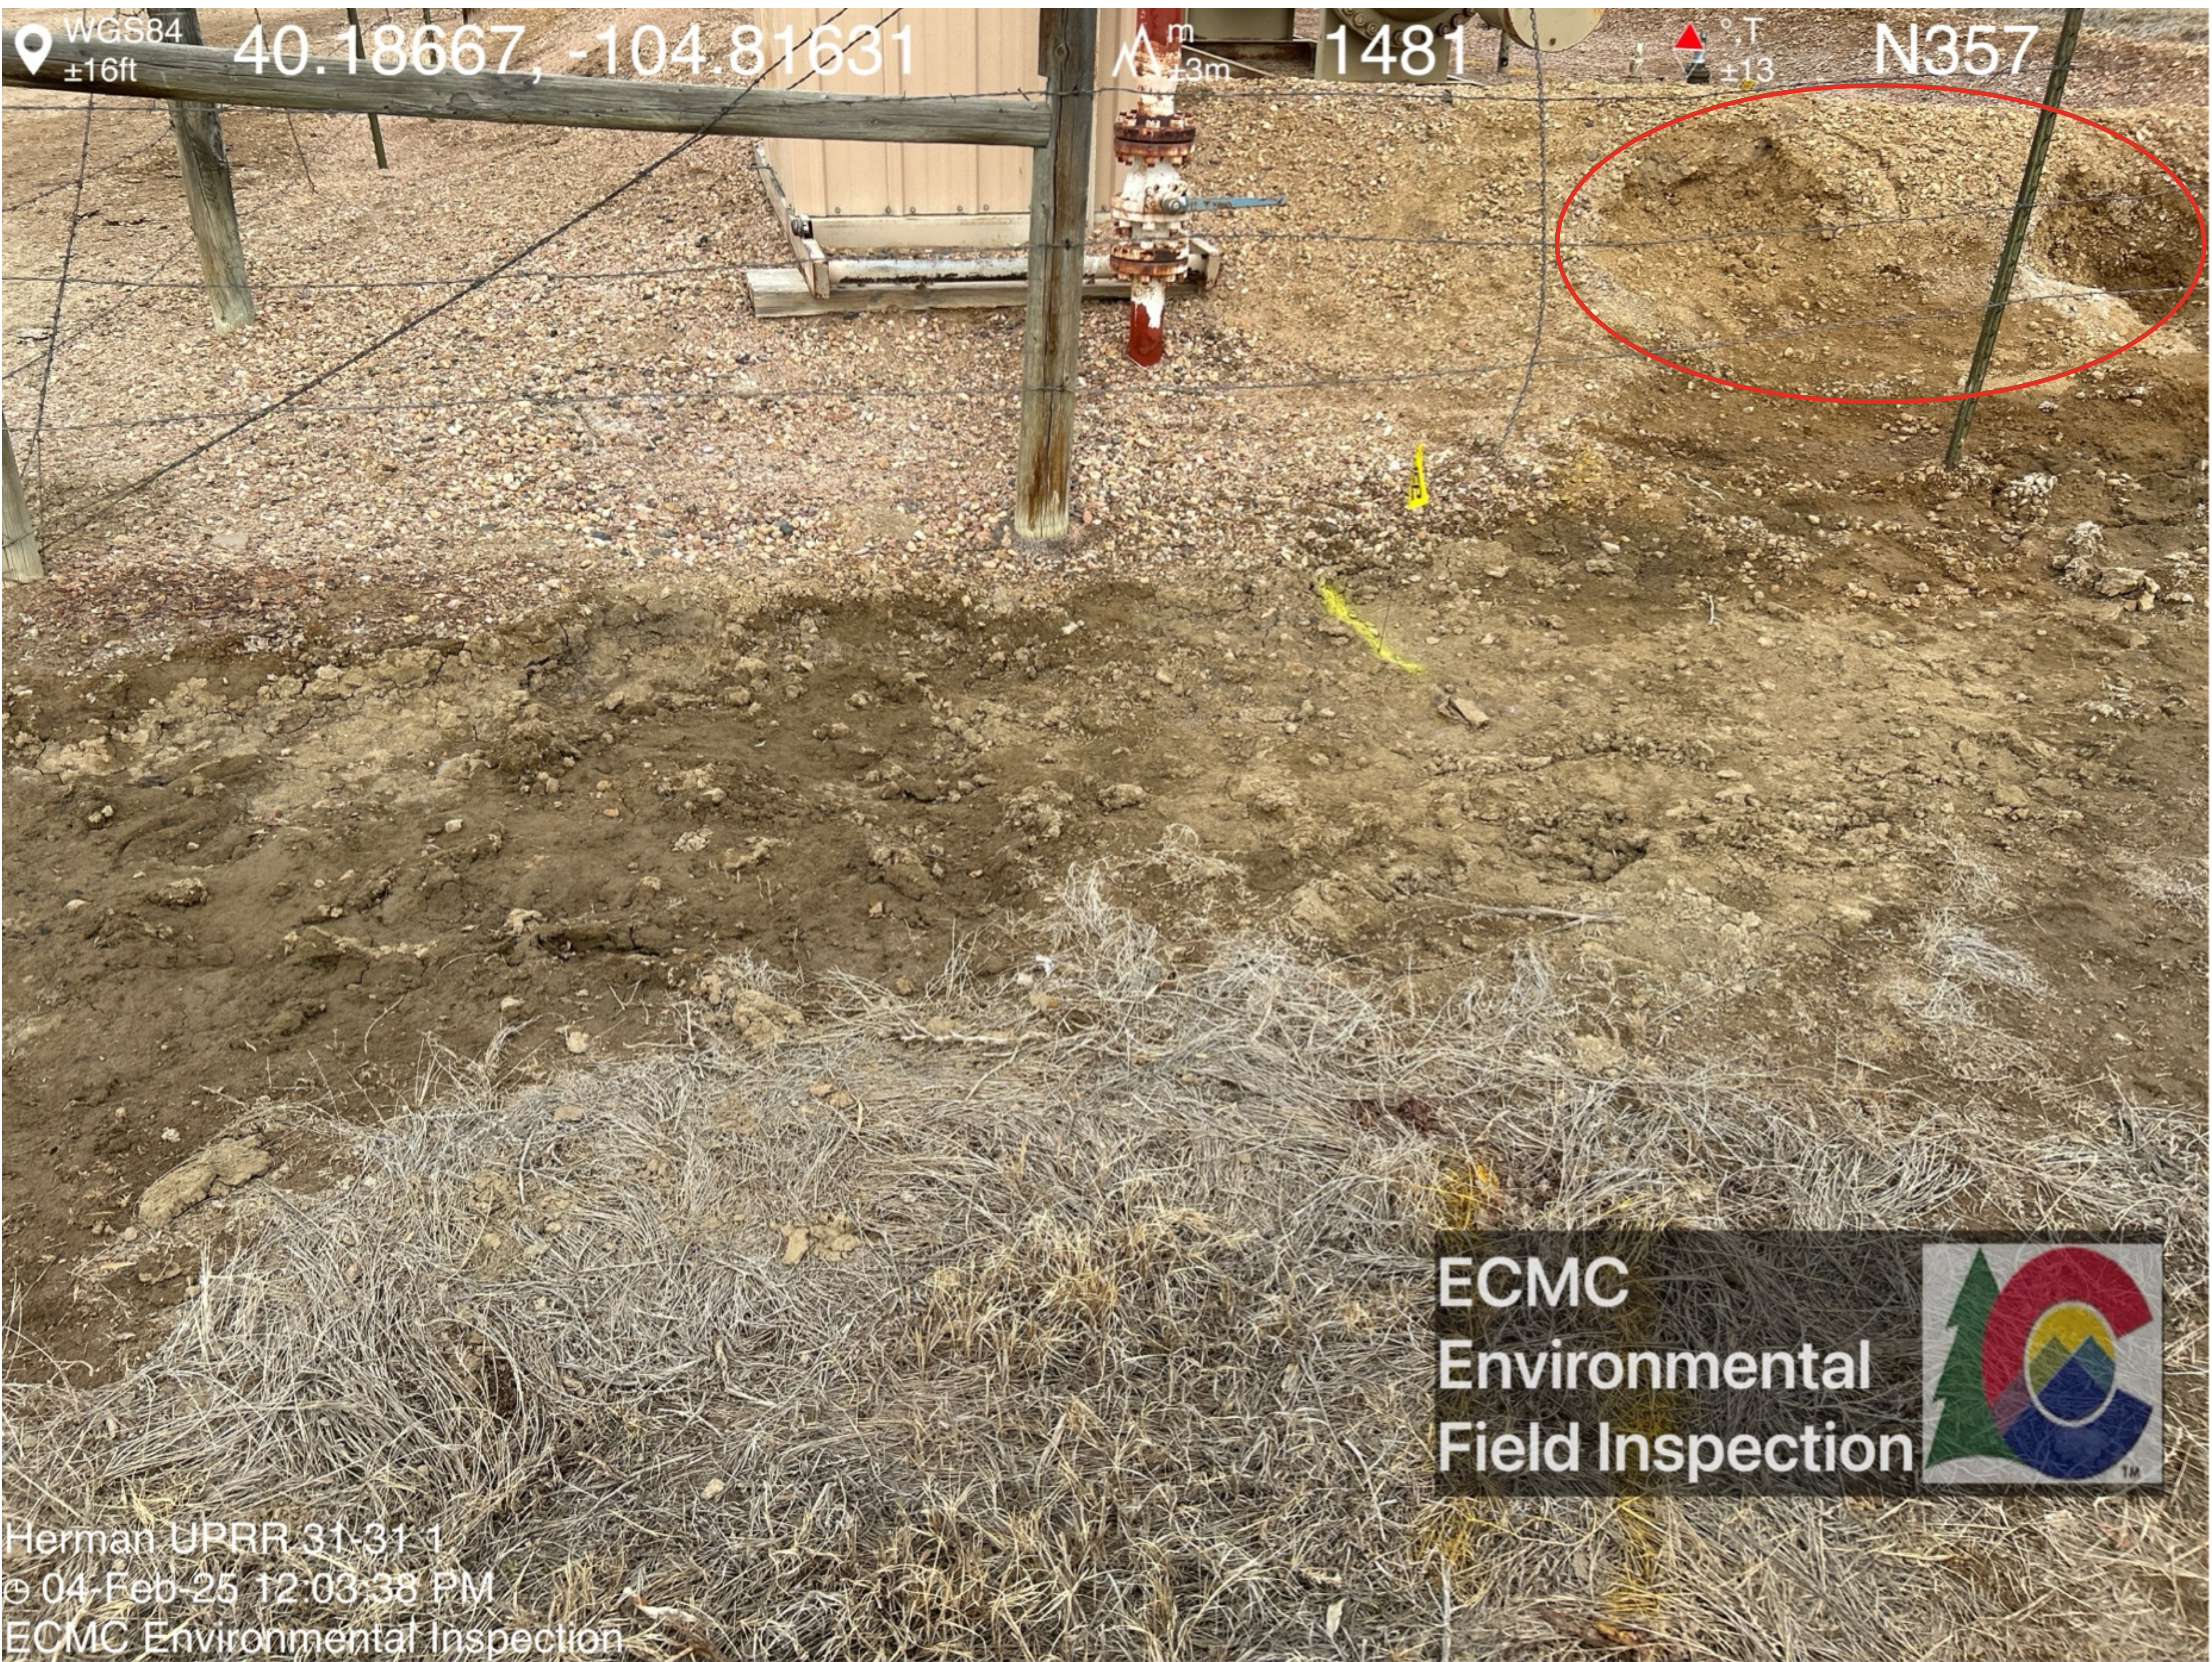
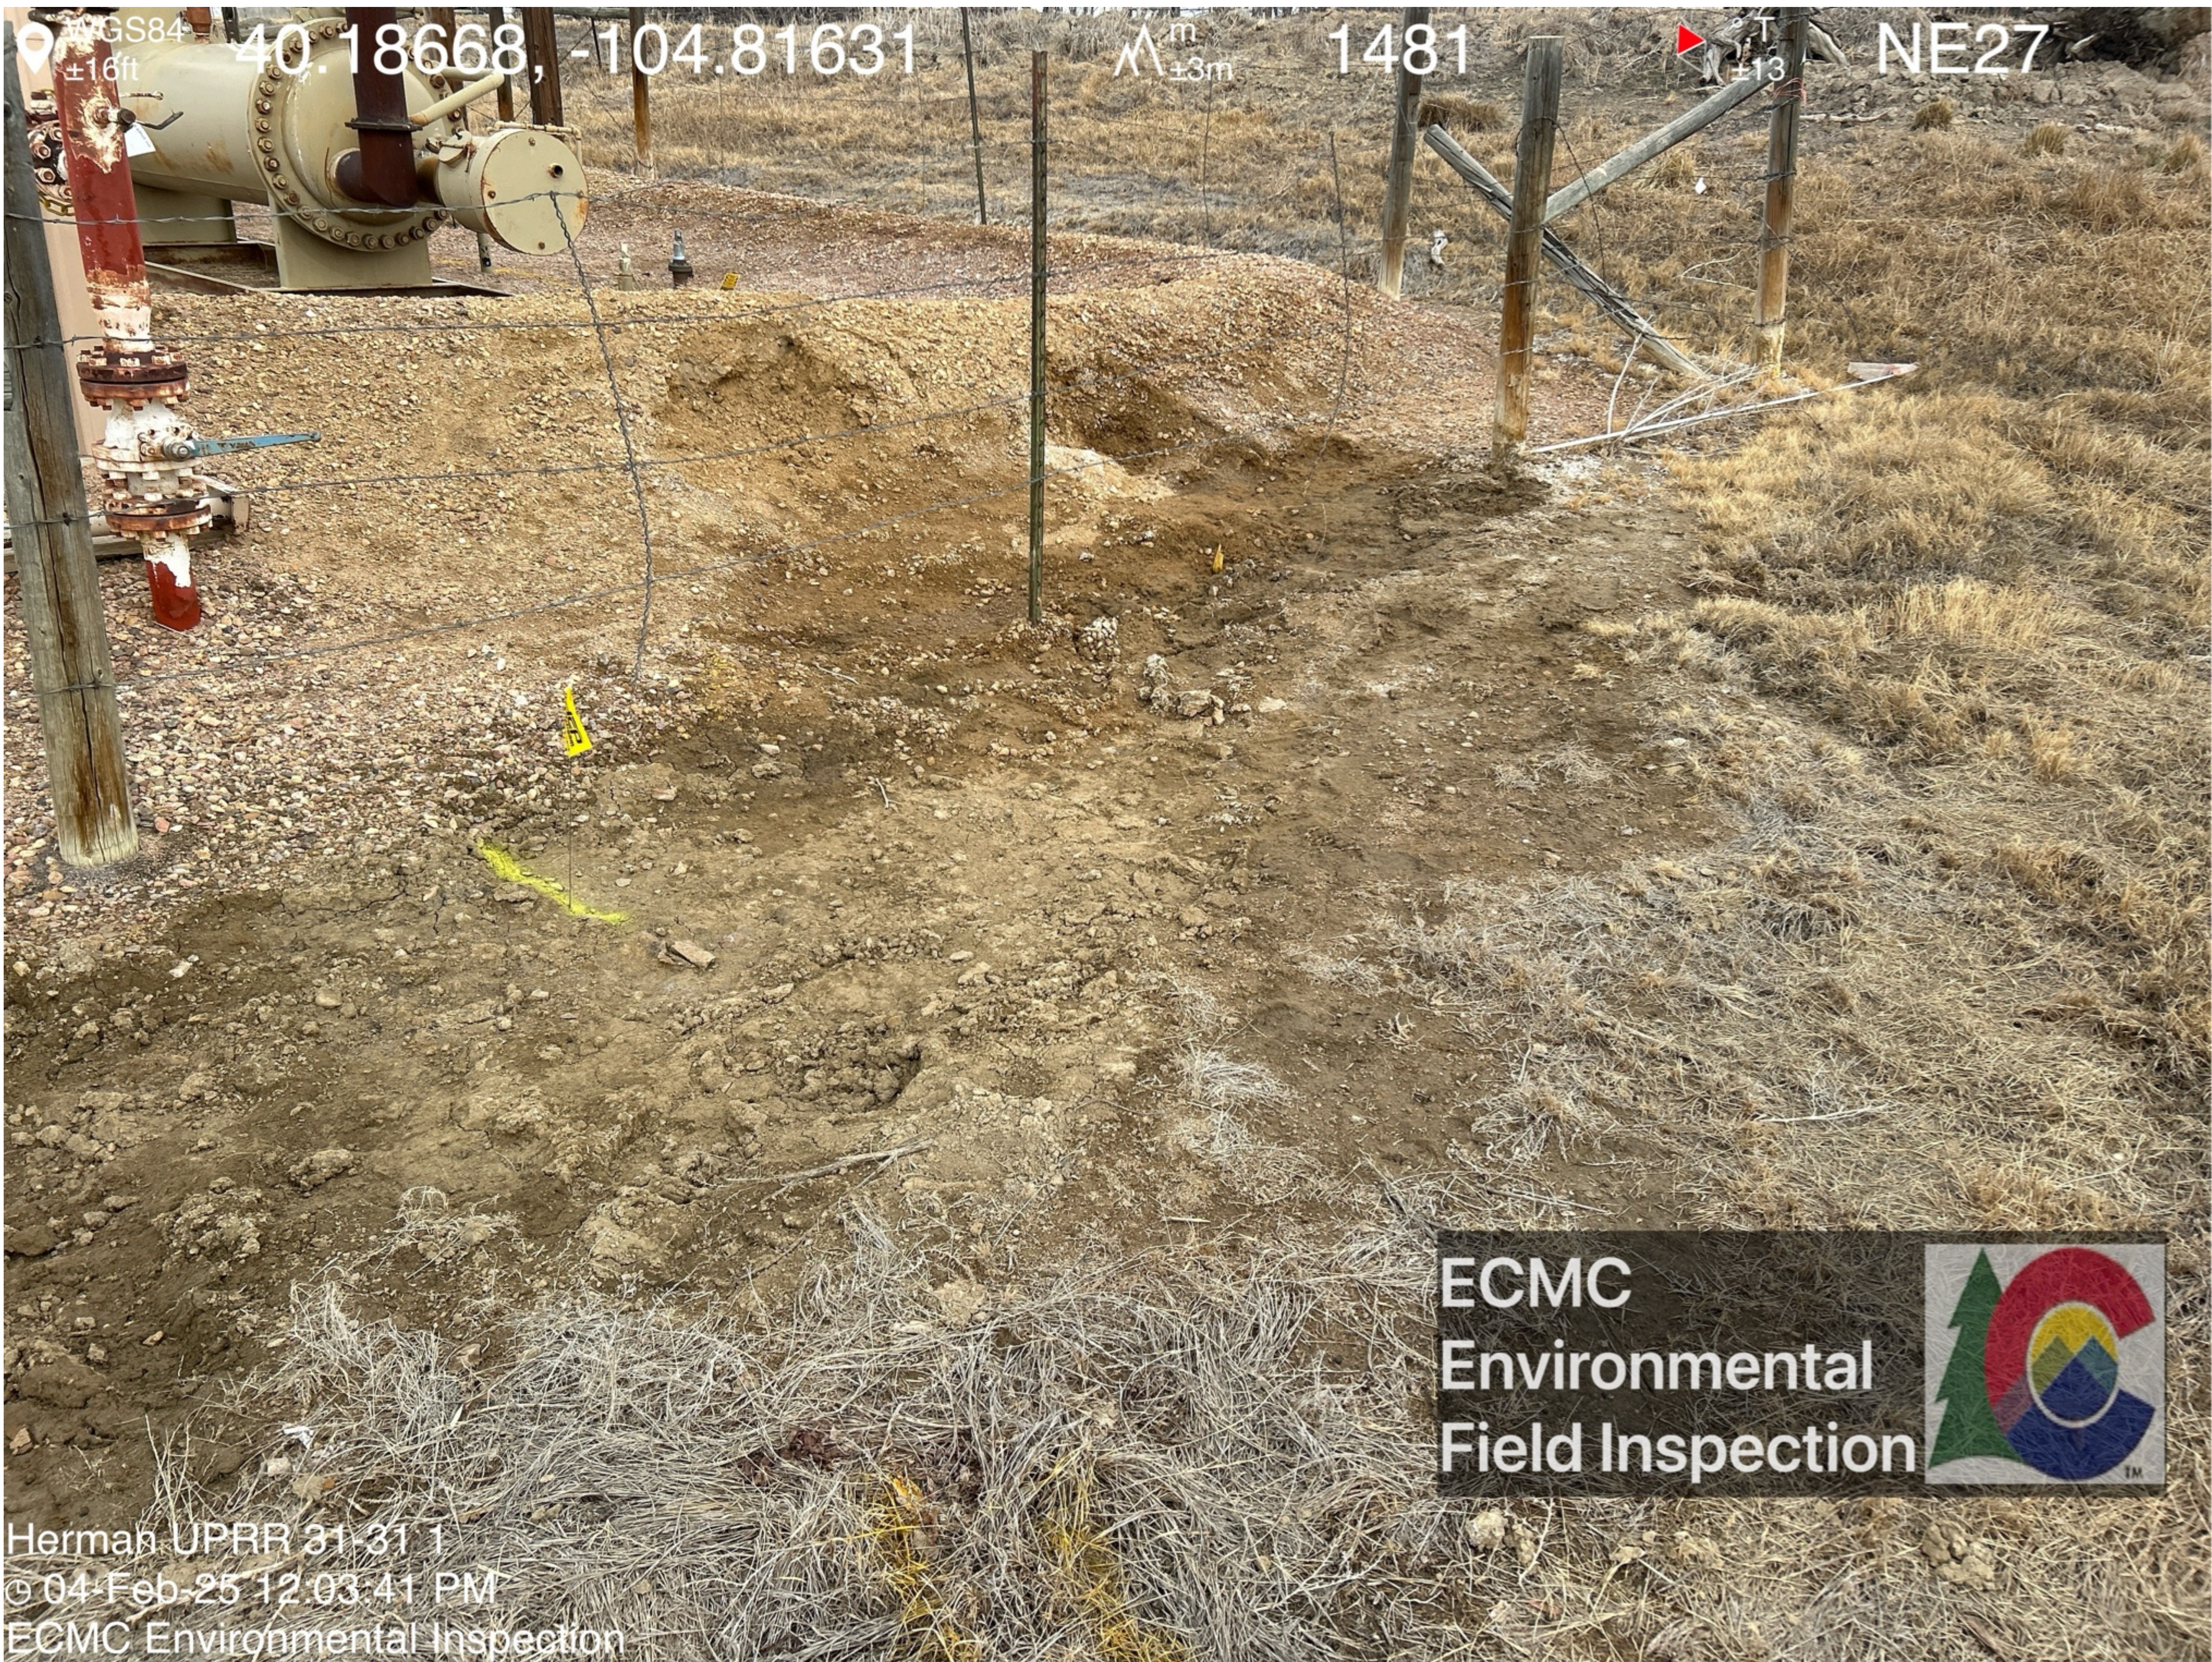
Soil on the separator berm, adjacent to Spill ID 489153 was observed disturbed.

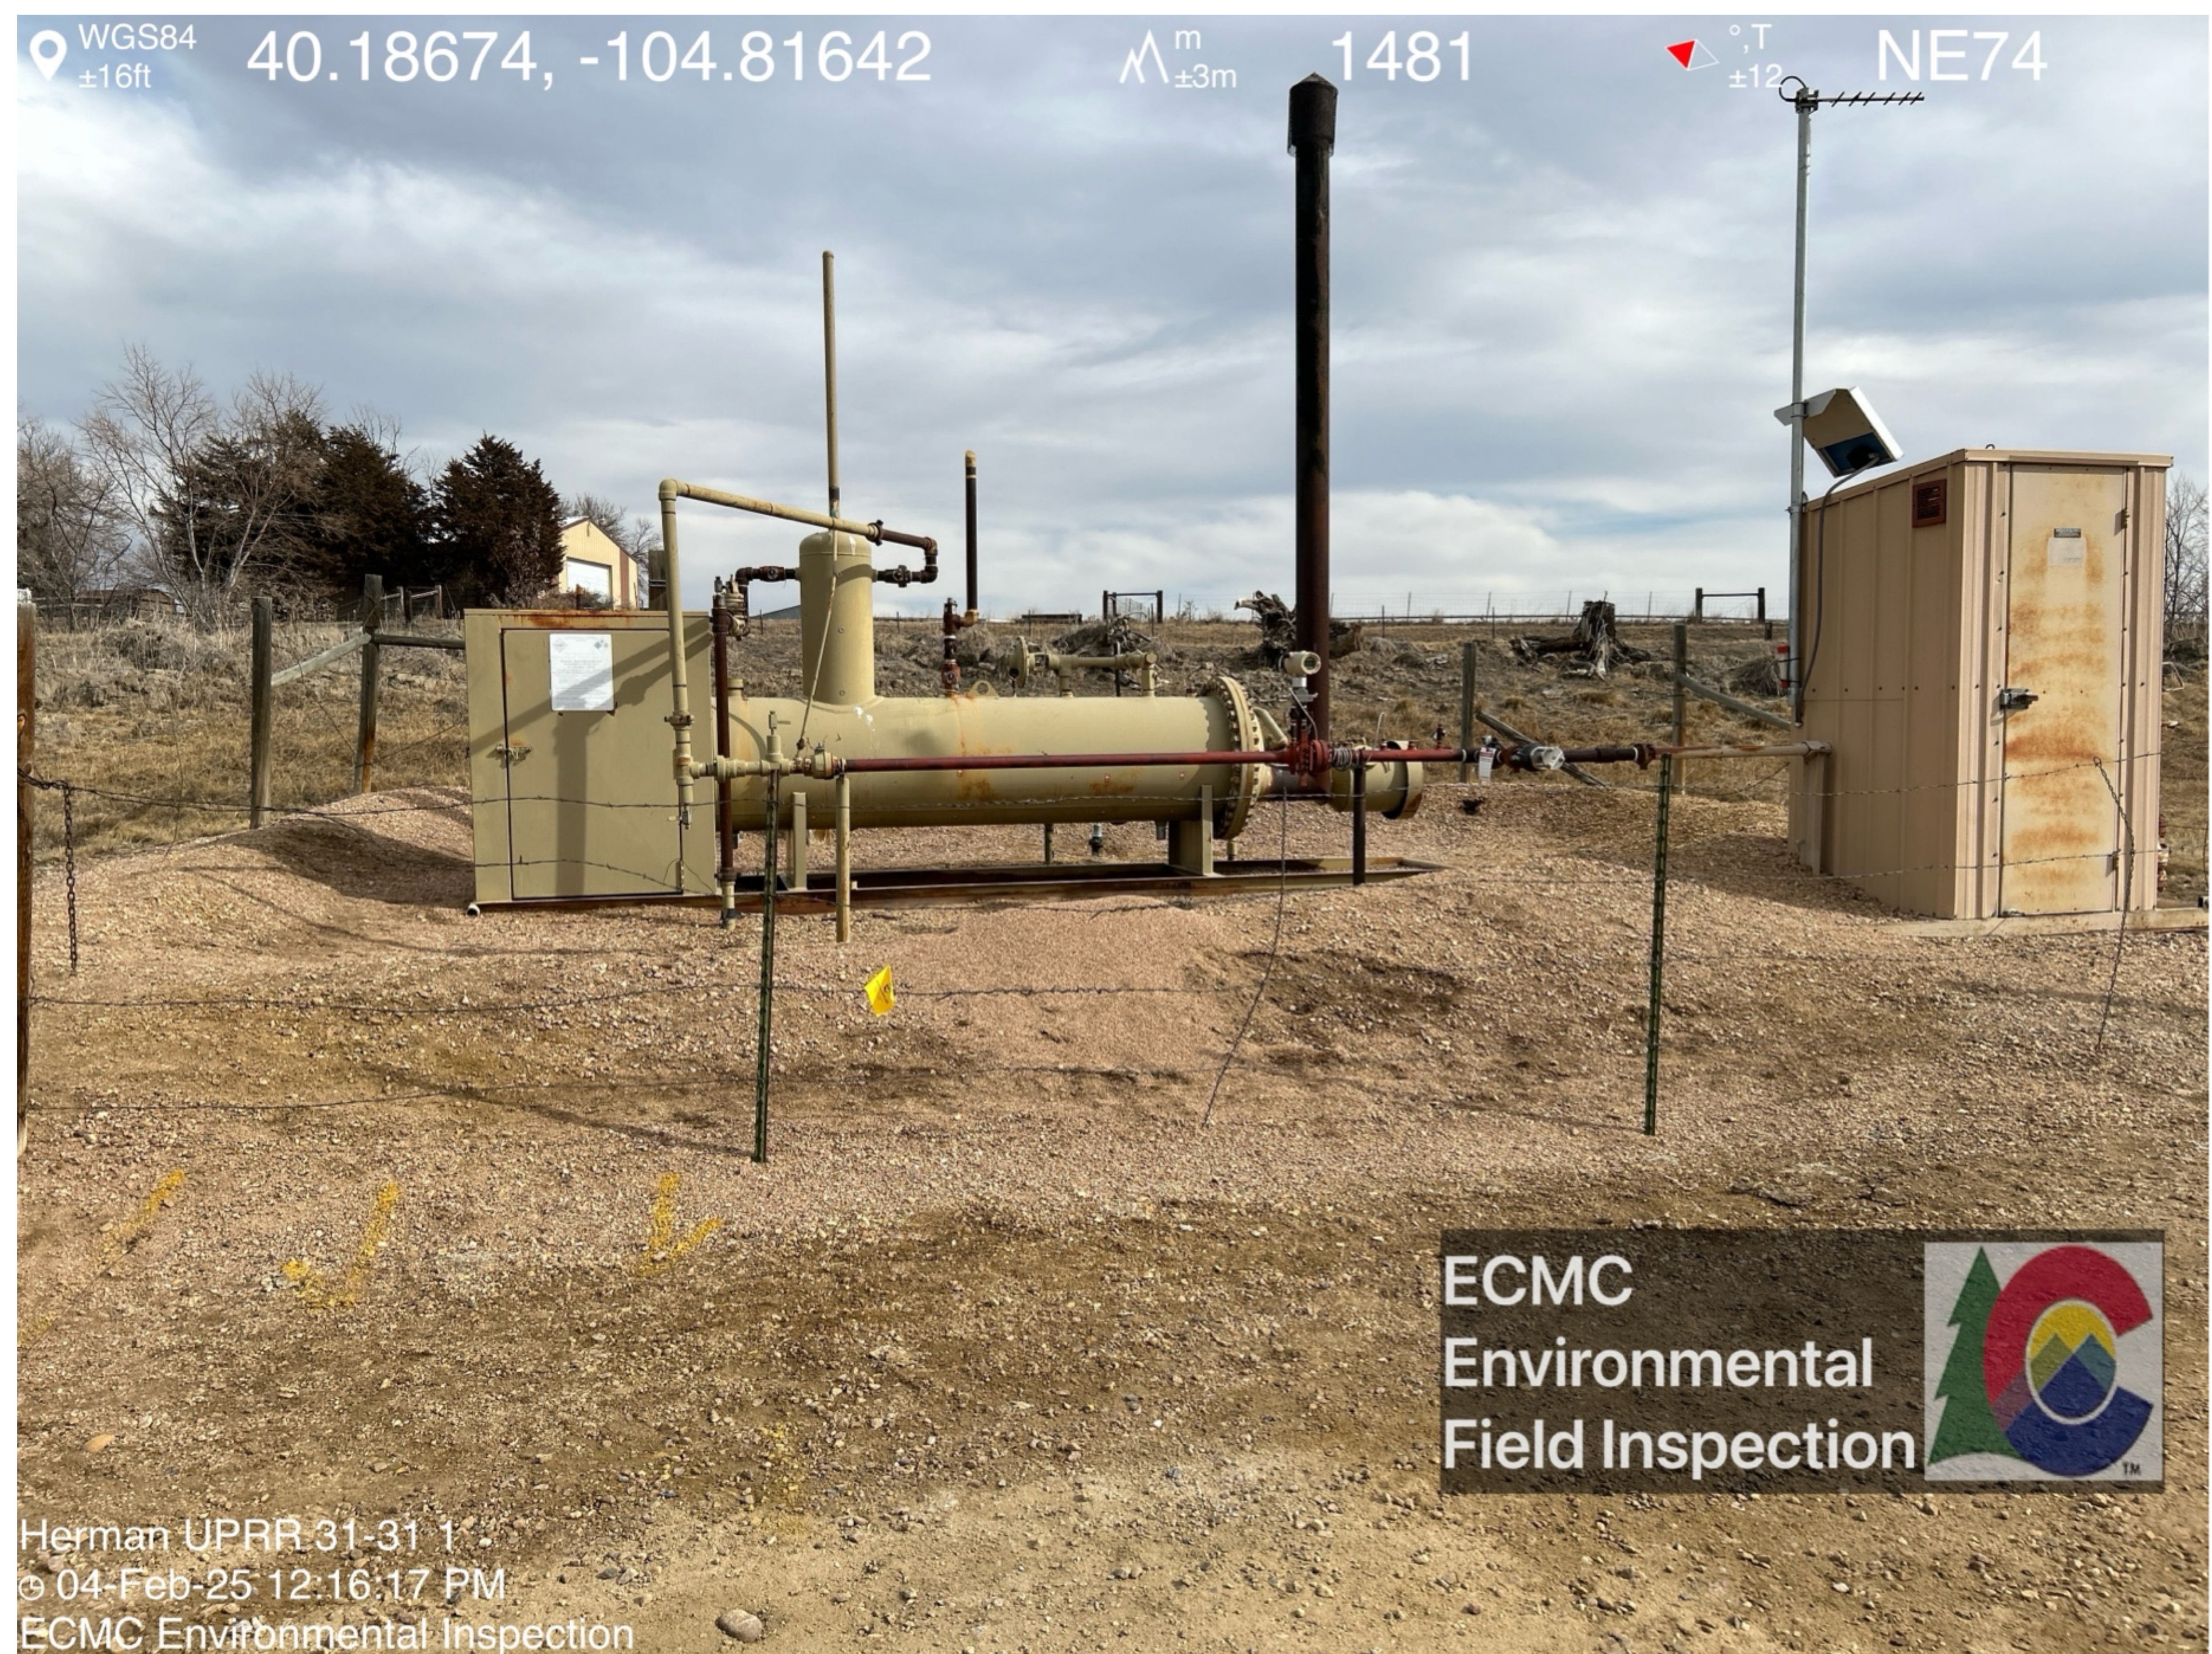
Separator berm degradation documented in Field Inspection Report 717900095 remains

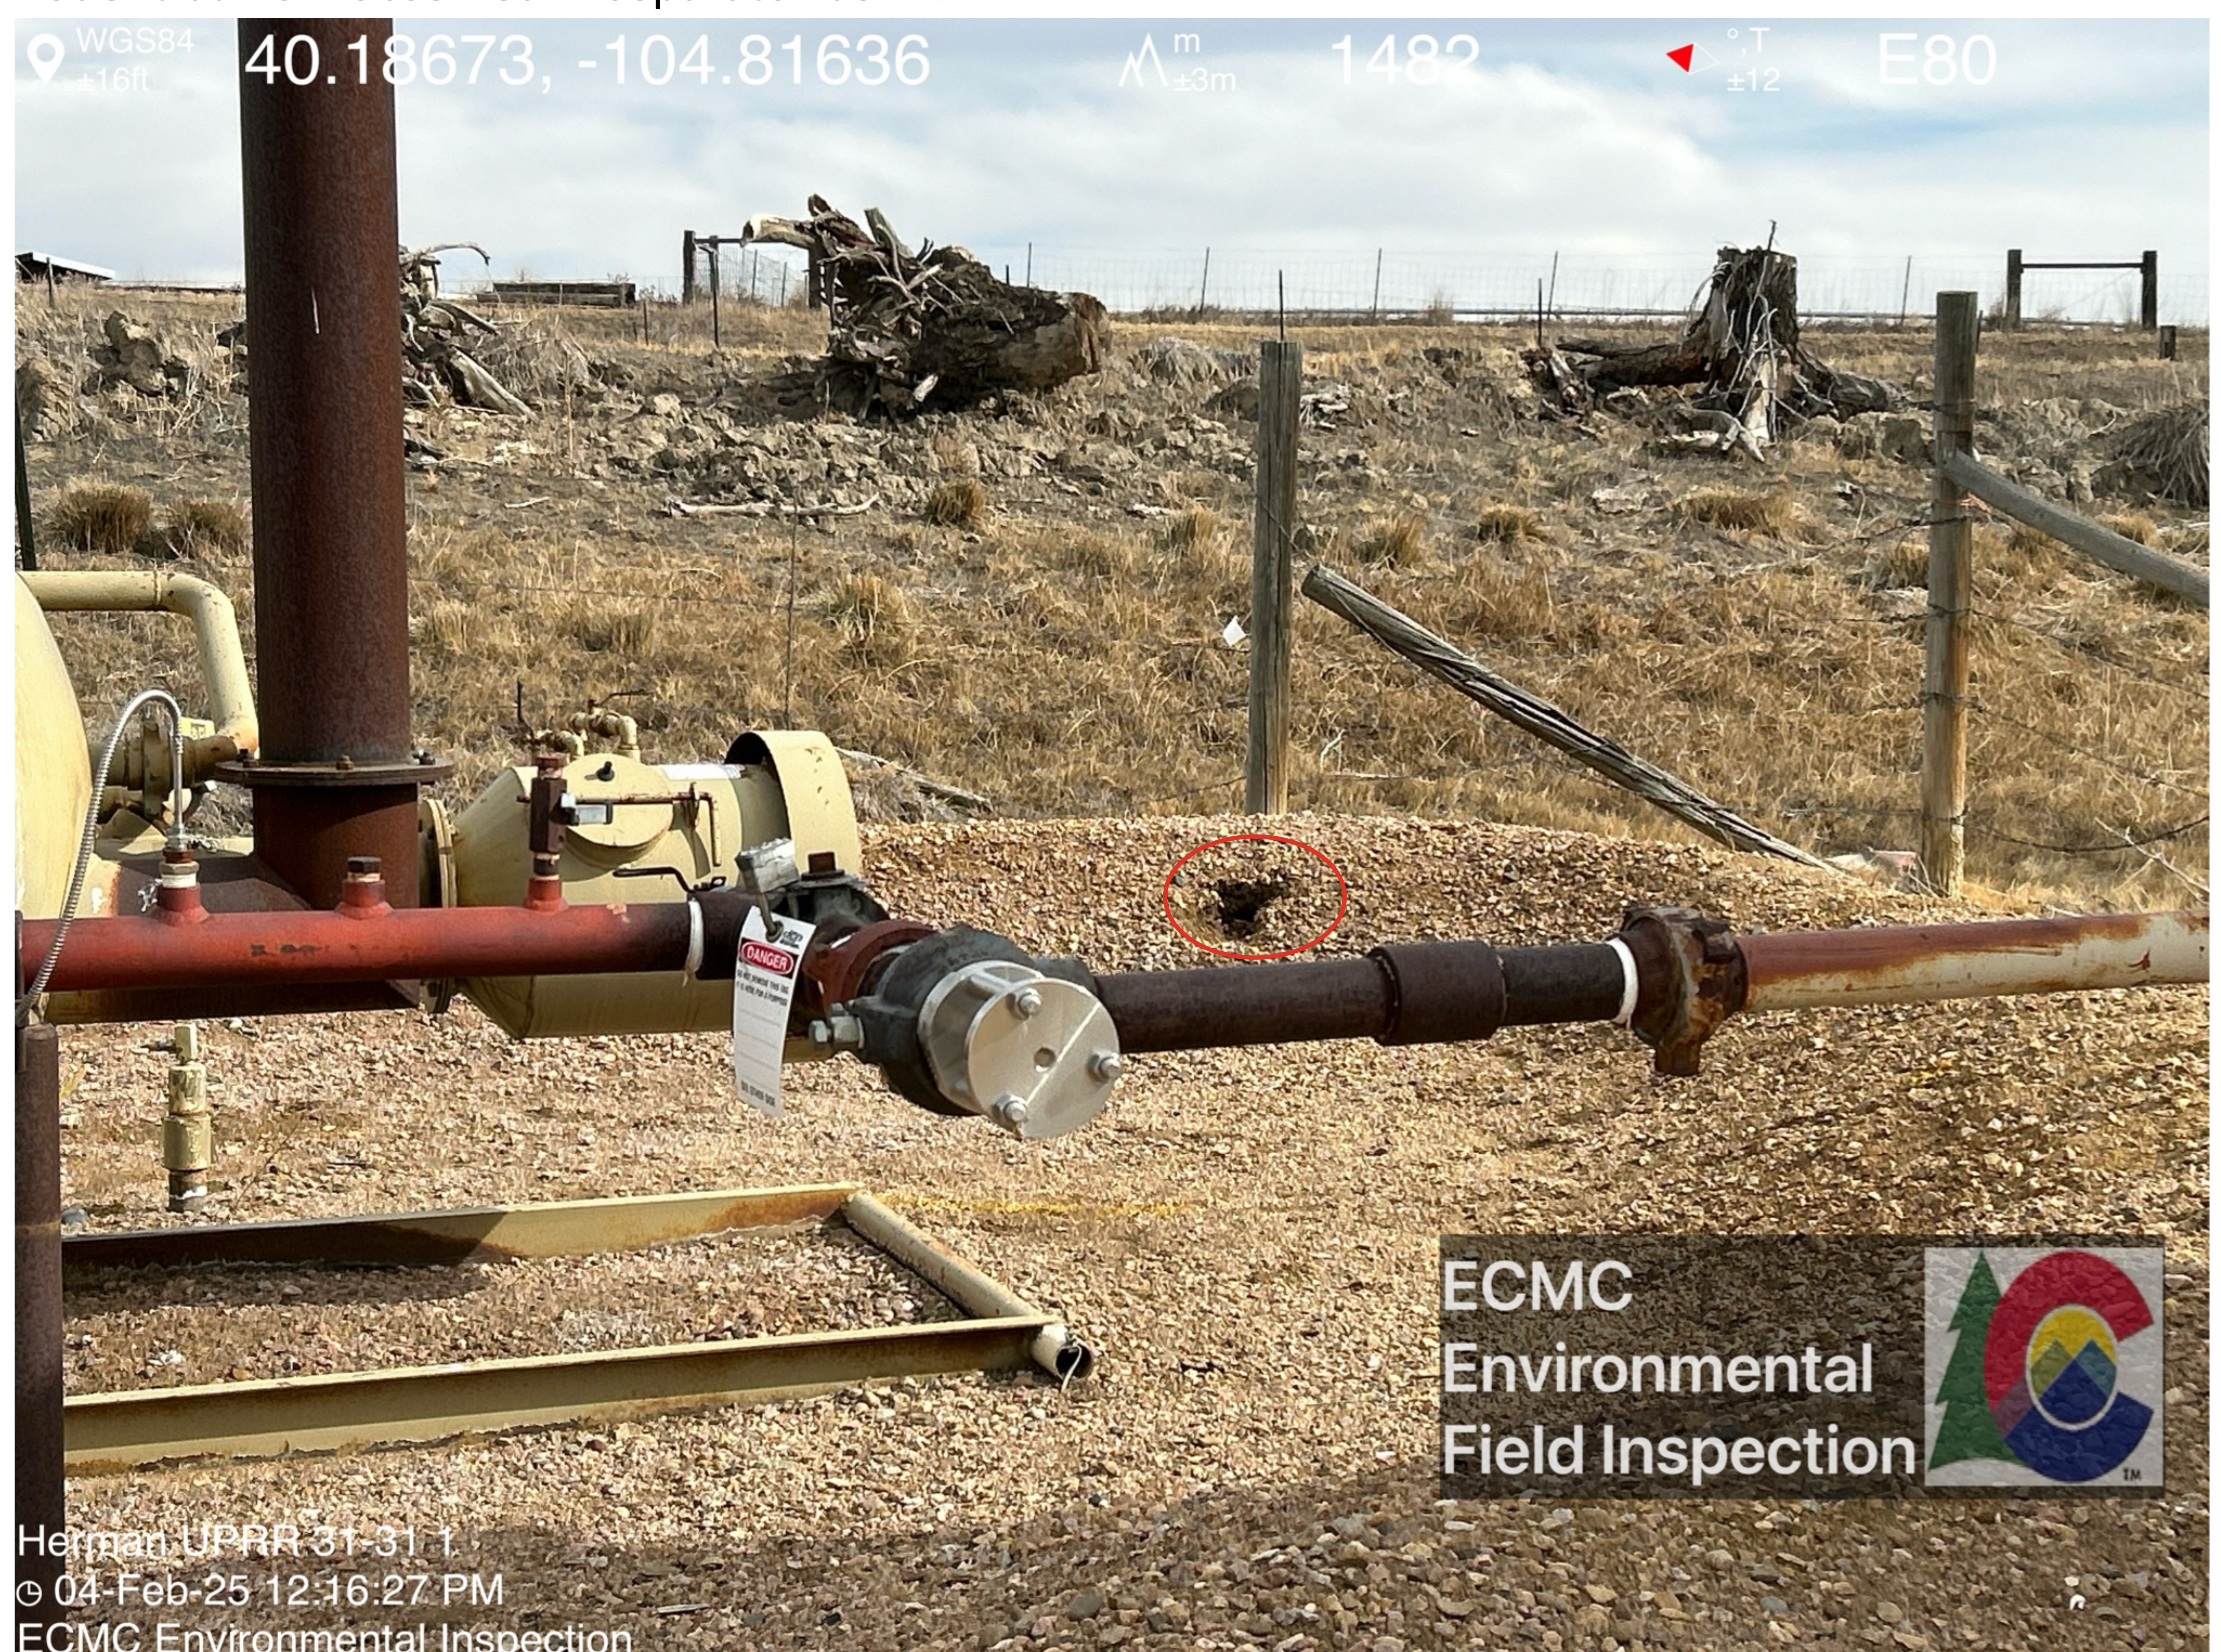
Rodent burrow observed in separator berm.
