Herman UPRR 31-31.1  
© 04-Feb-25 11:55:33 AM  
ECMC Environmental Inspection

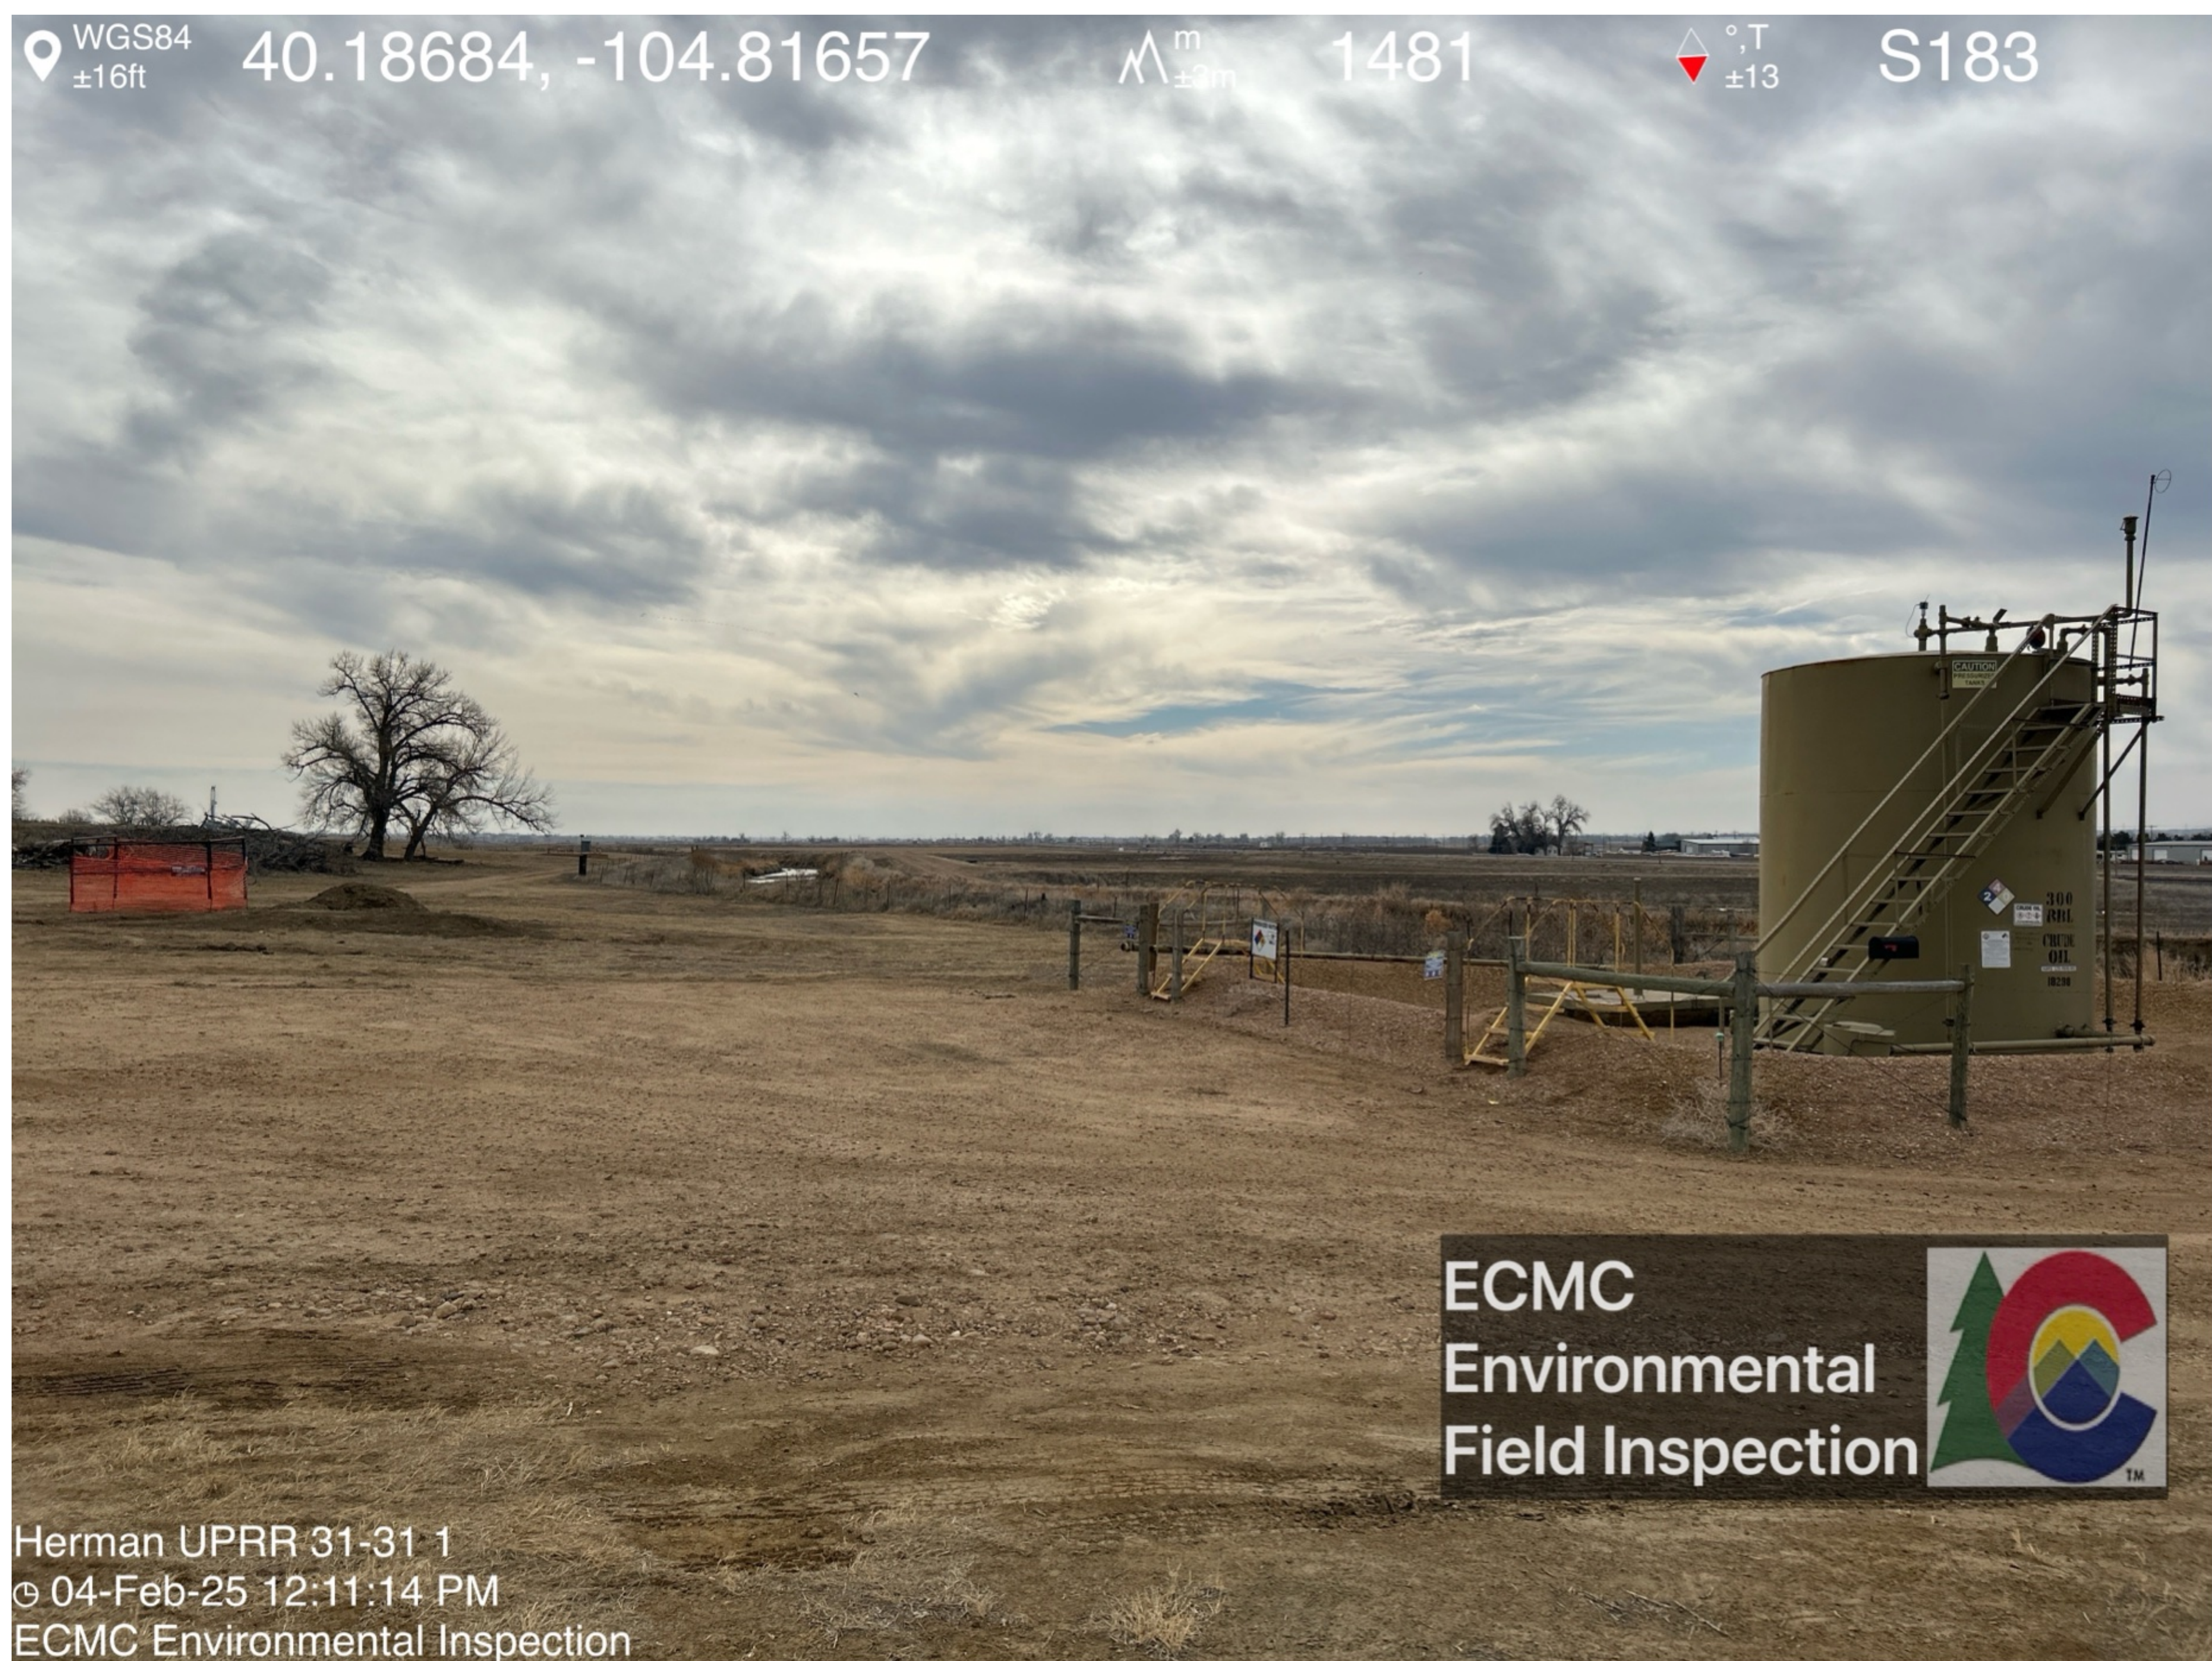
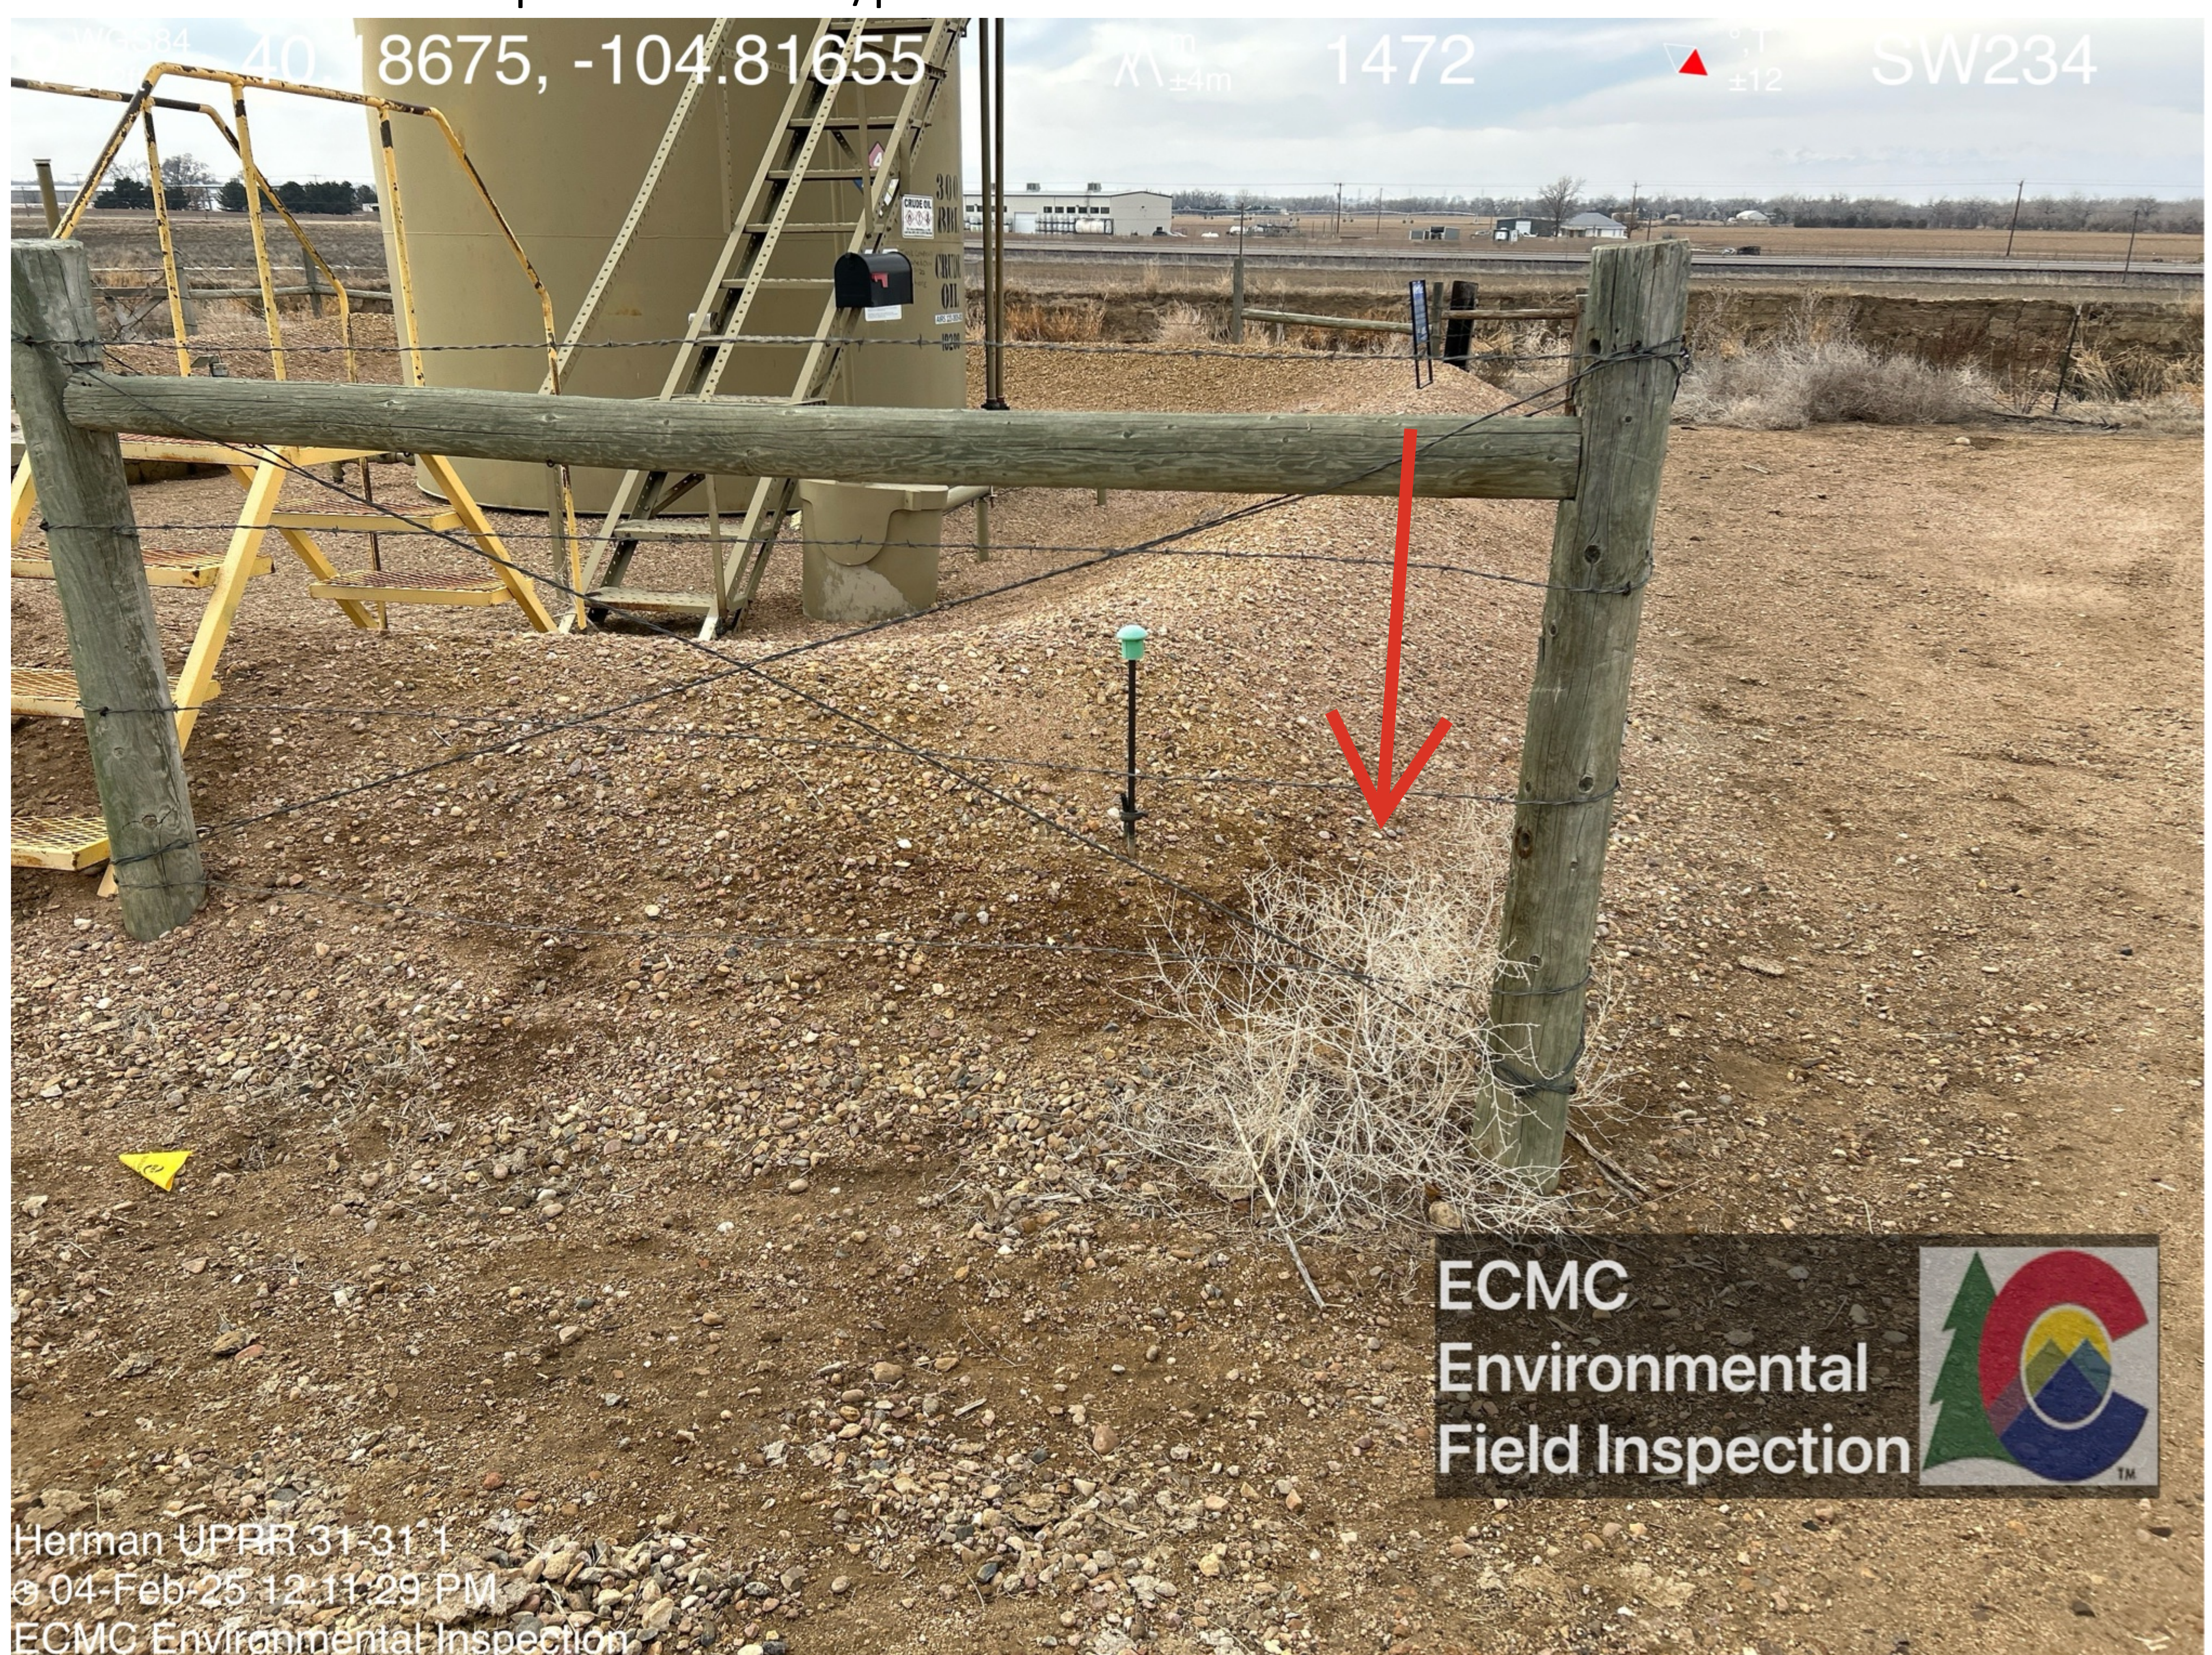
Debris observed within production tank/produced water vault berm.

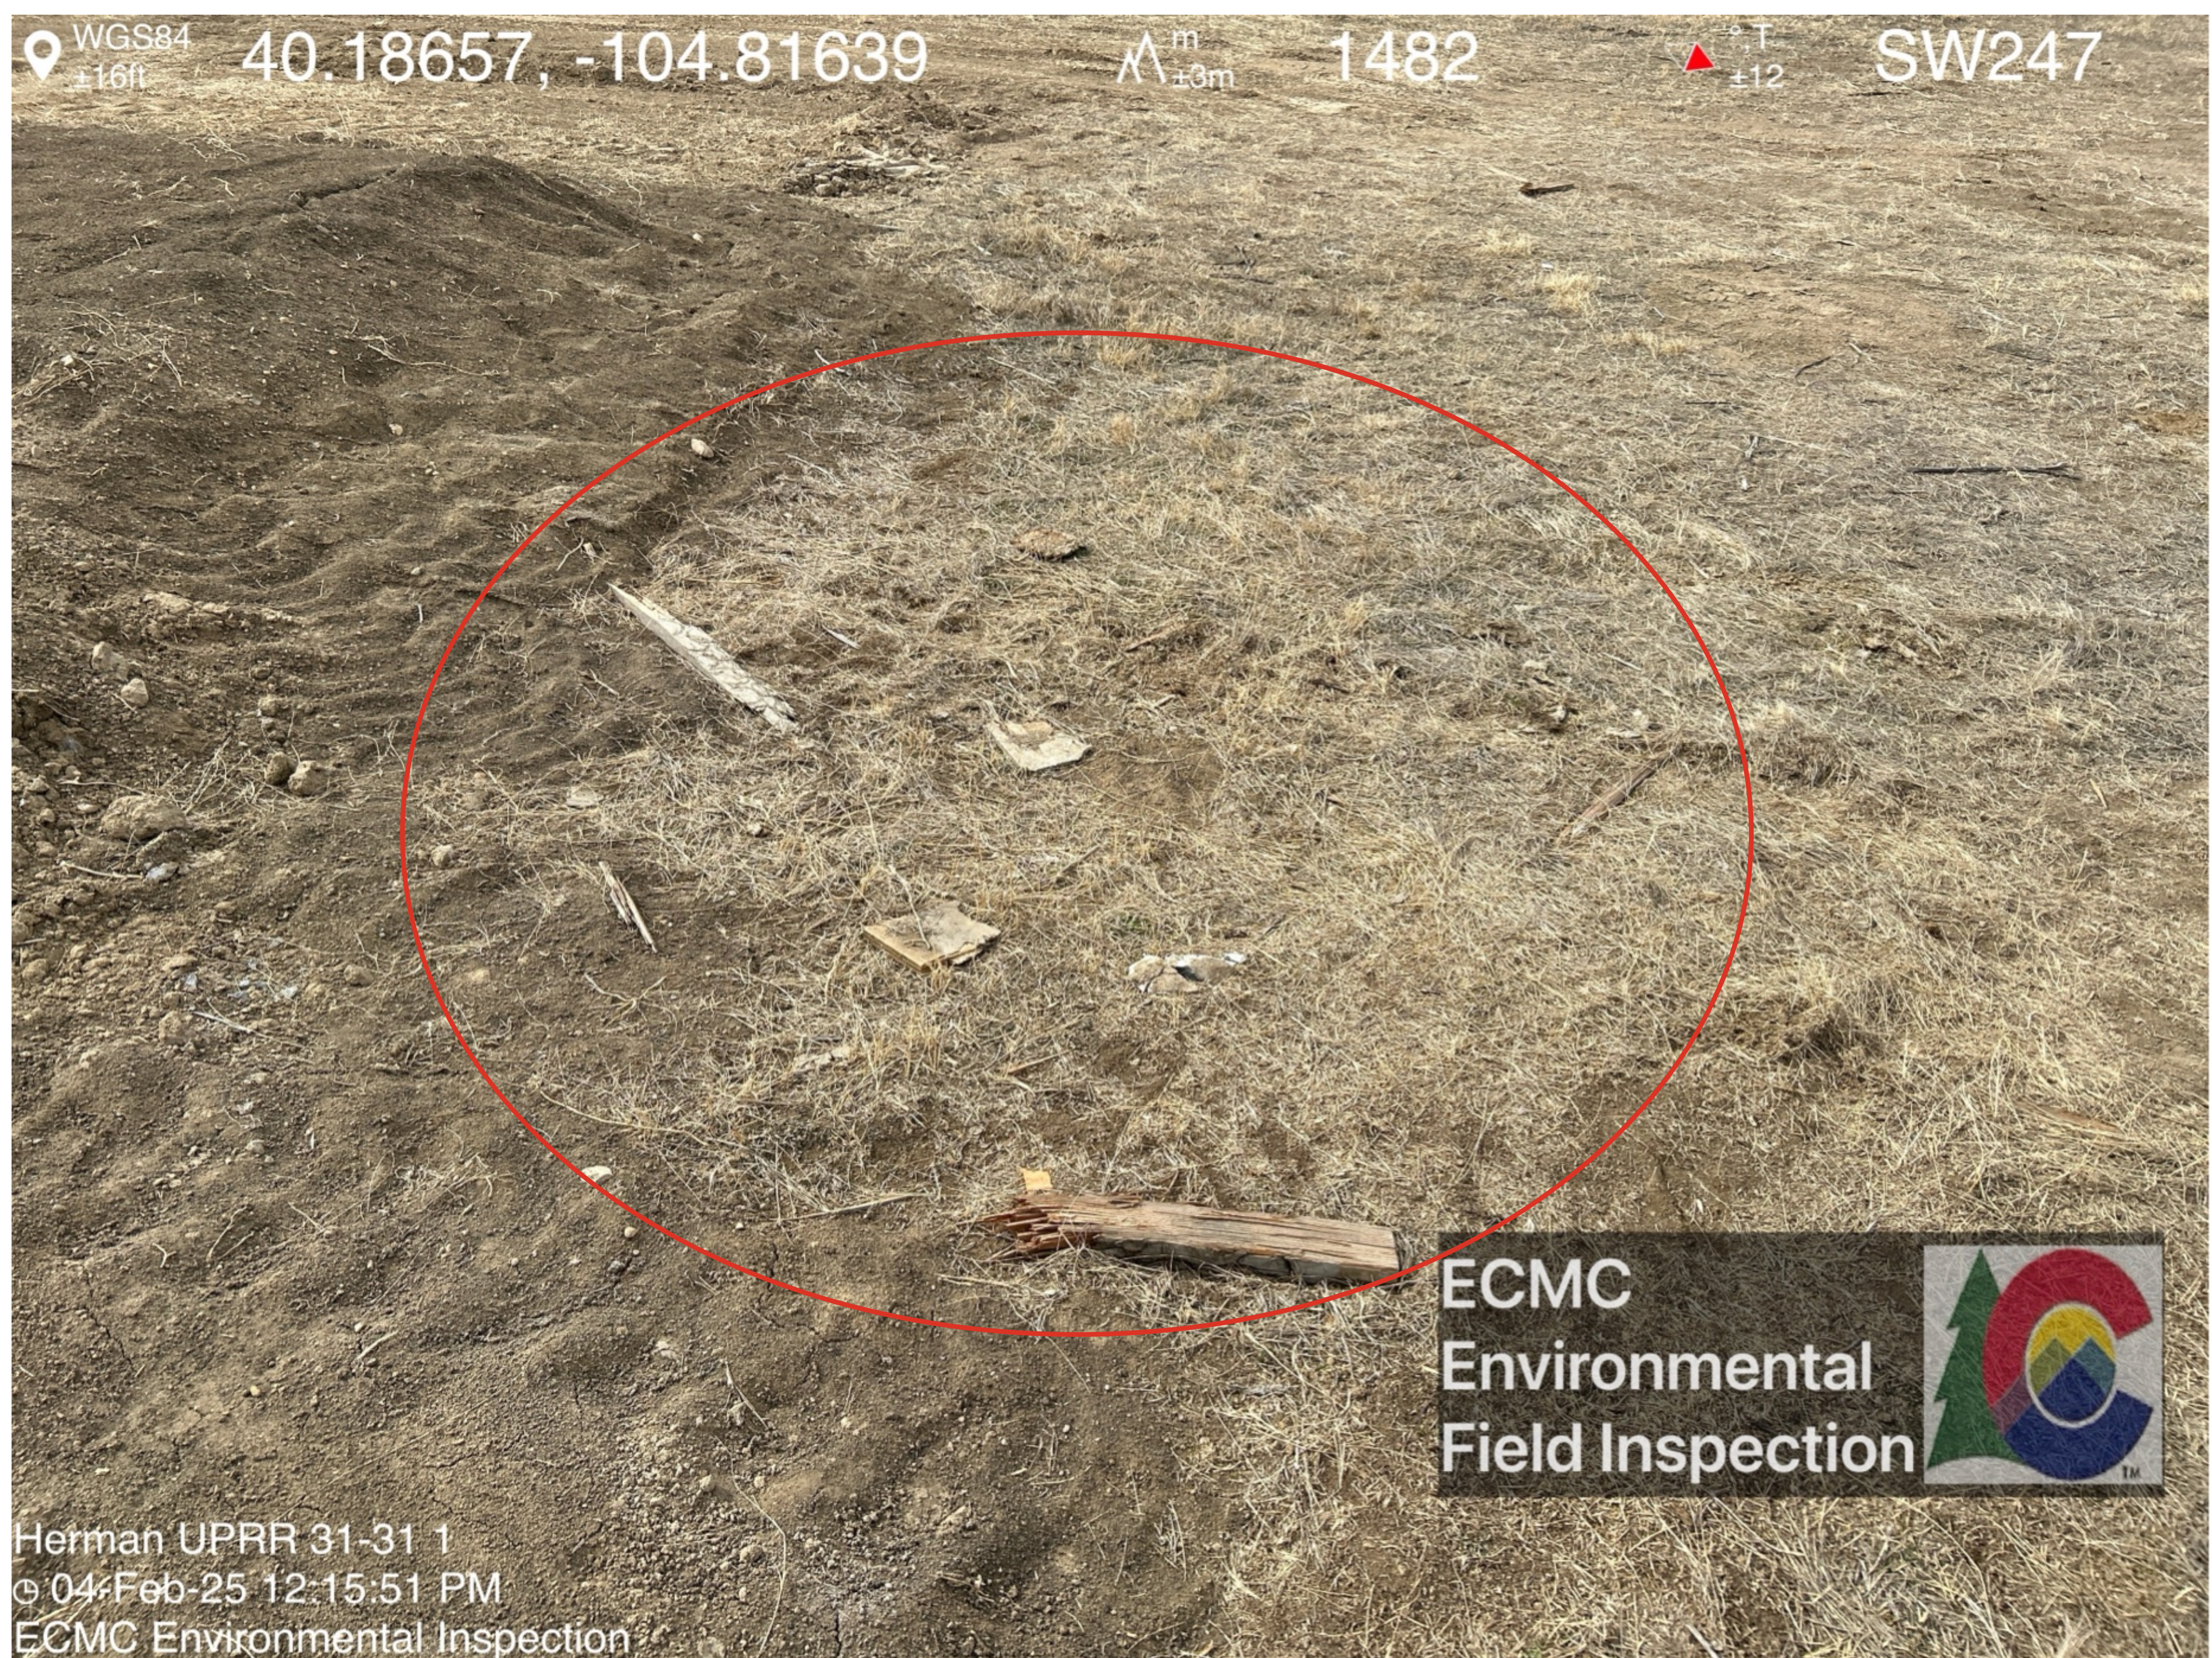
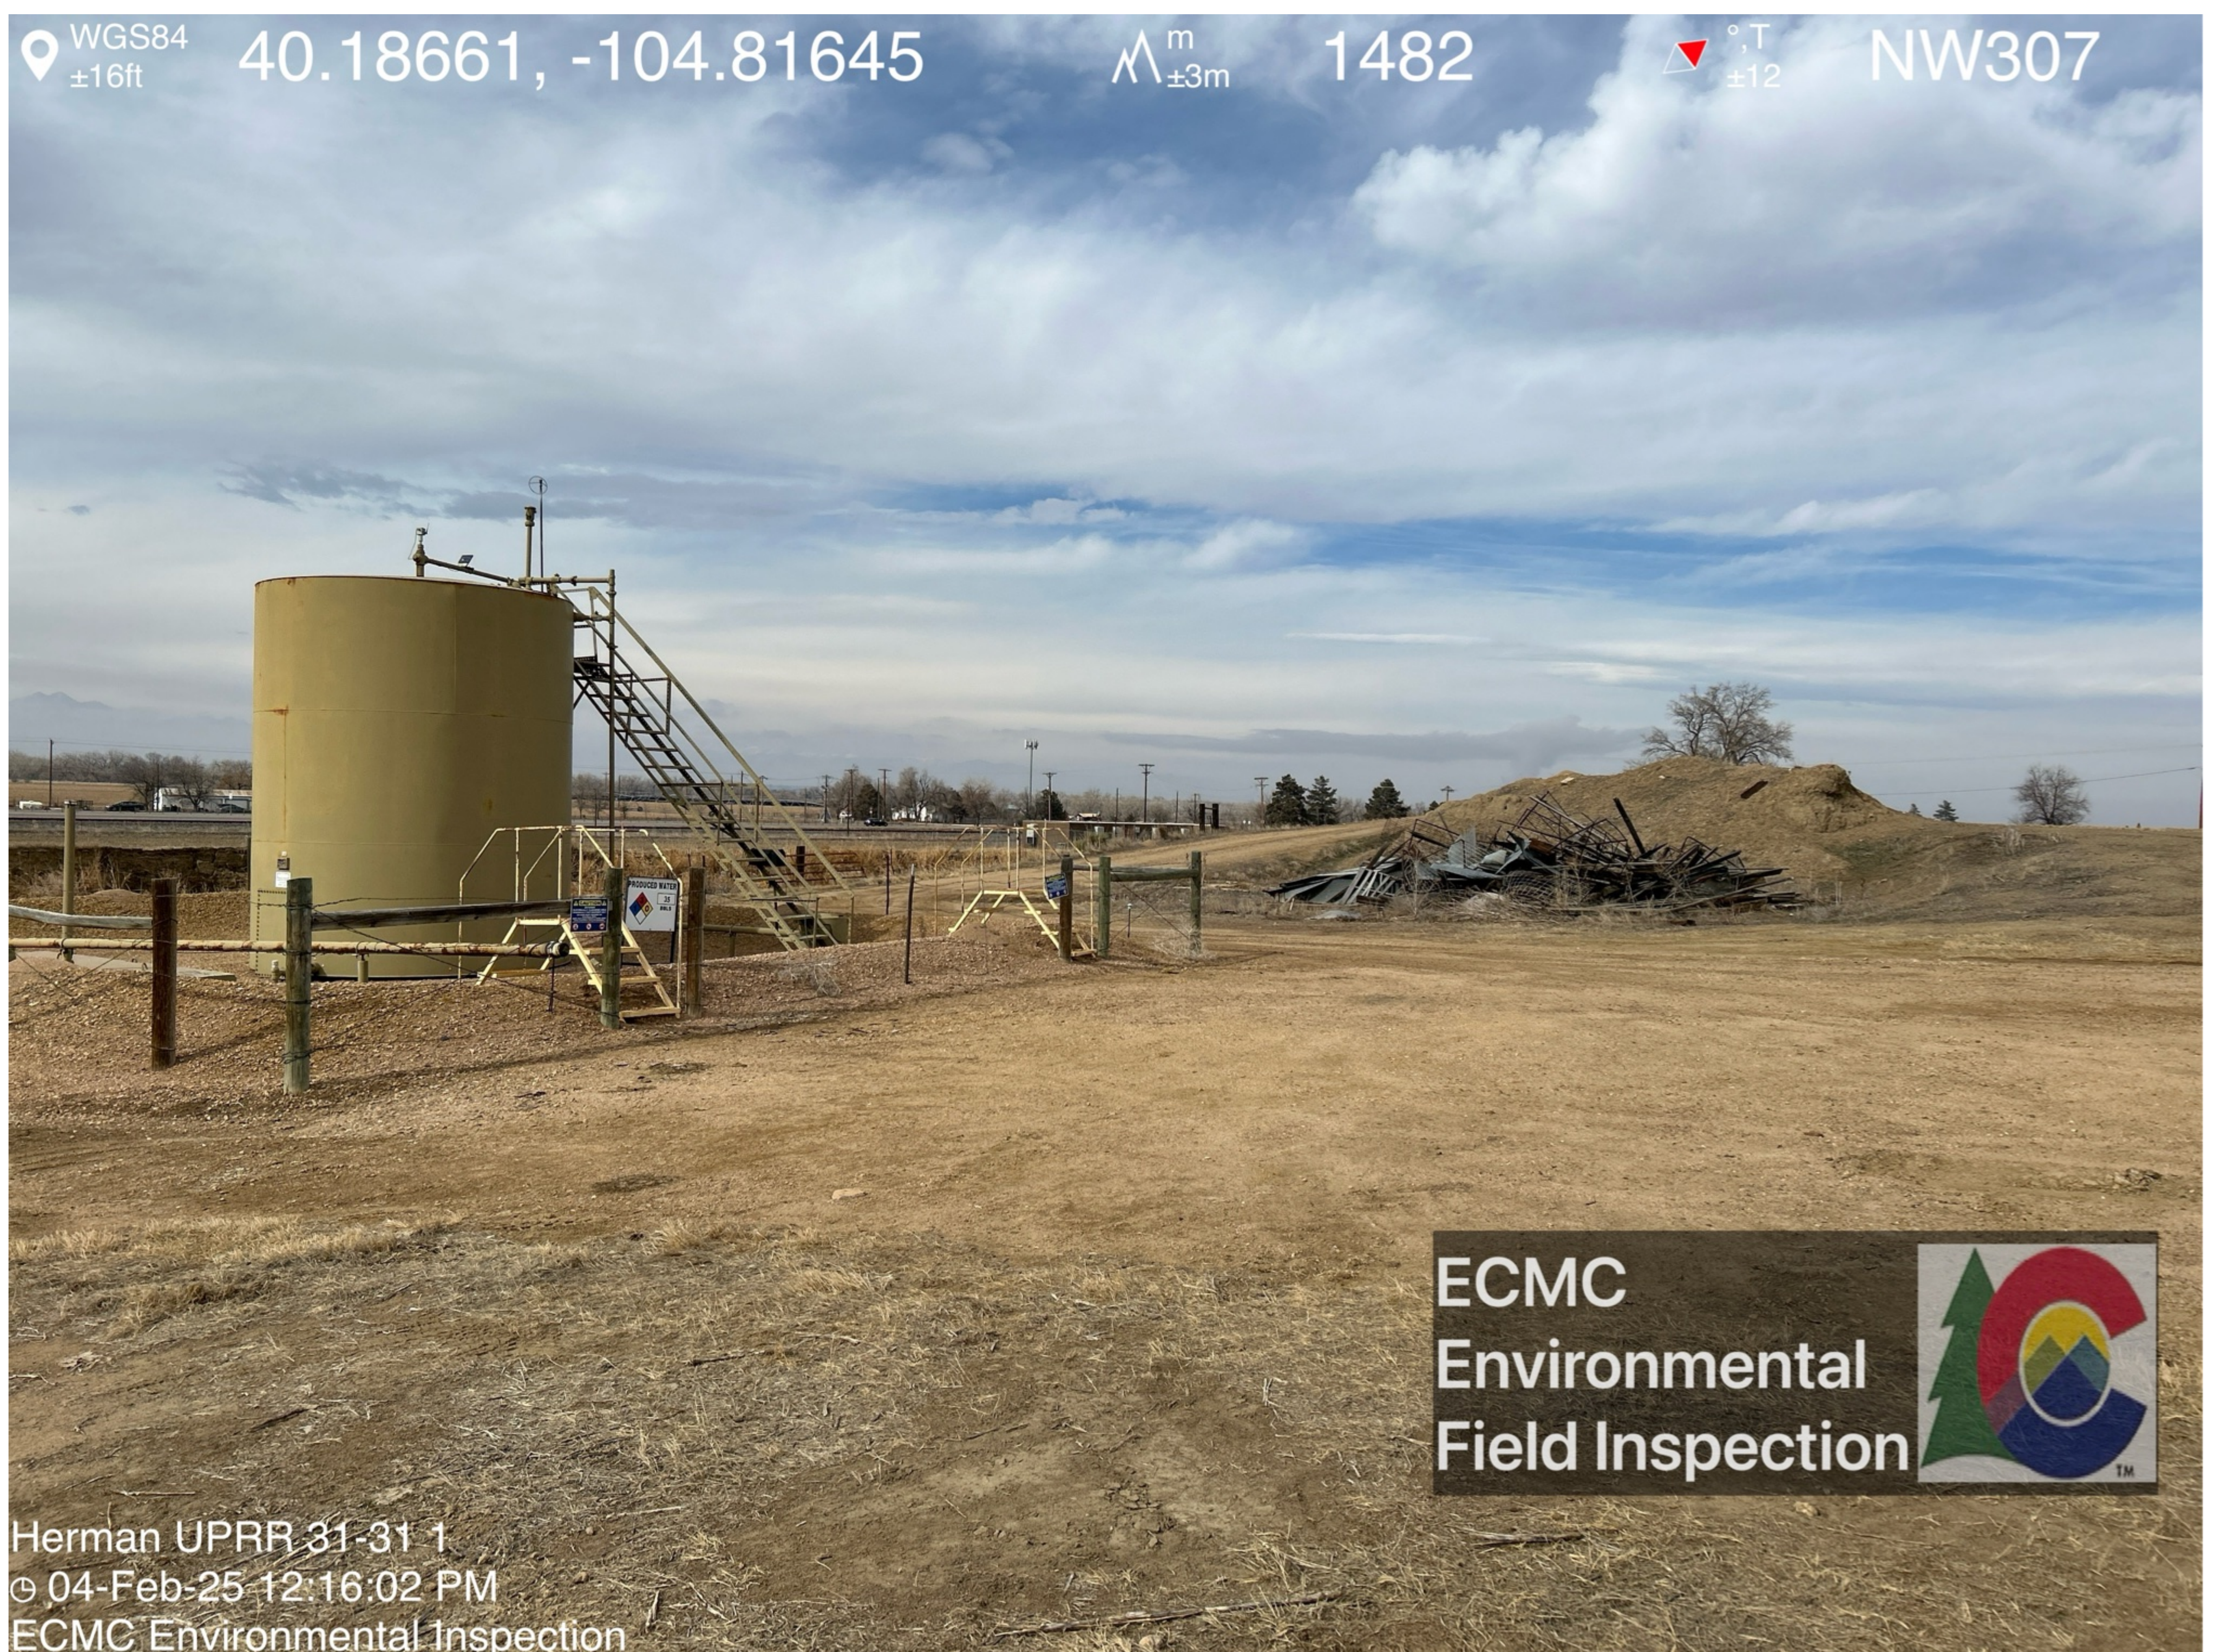
Debris observed adjacent to the former wellhead and soil stockpile area.

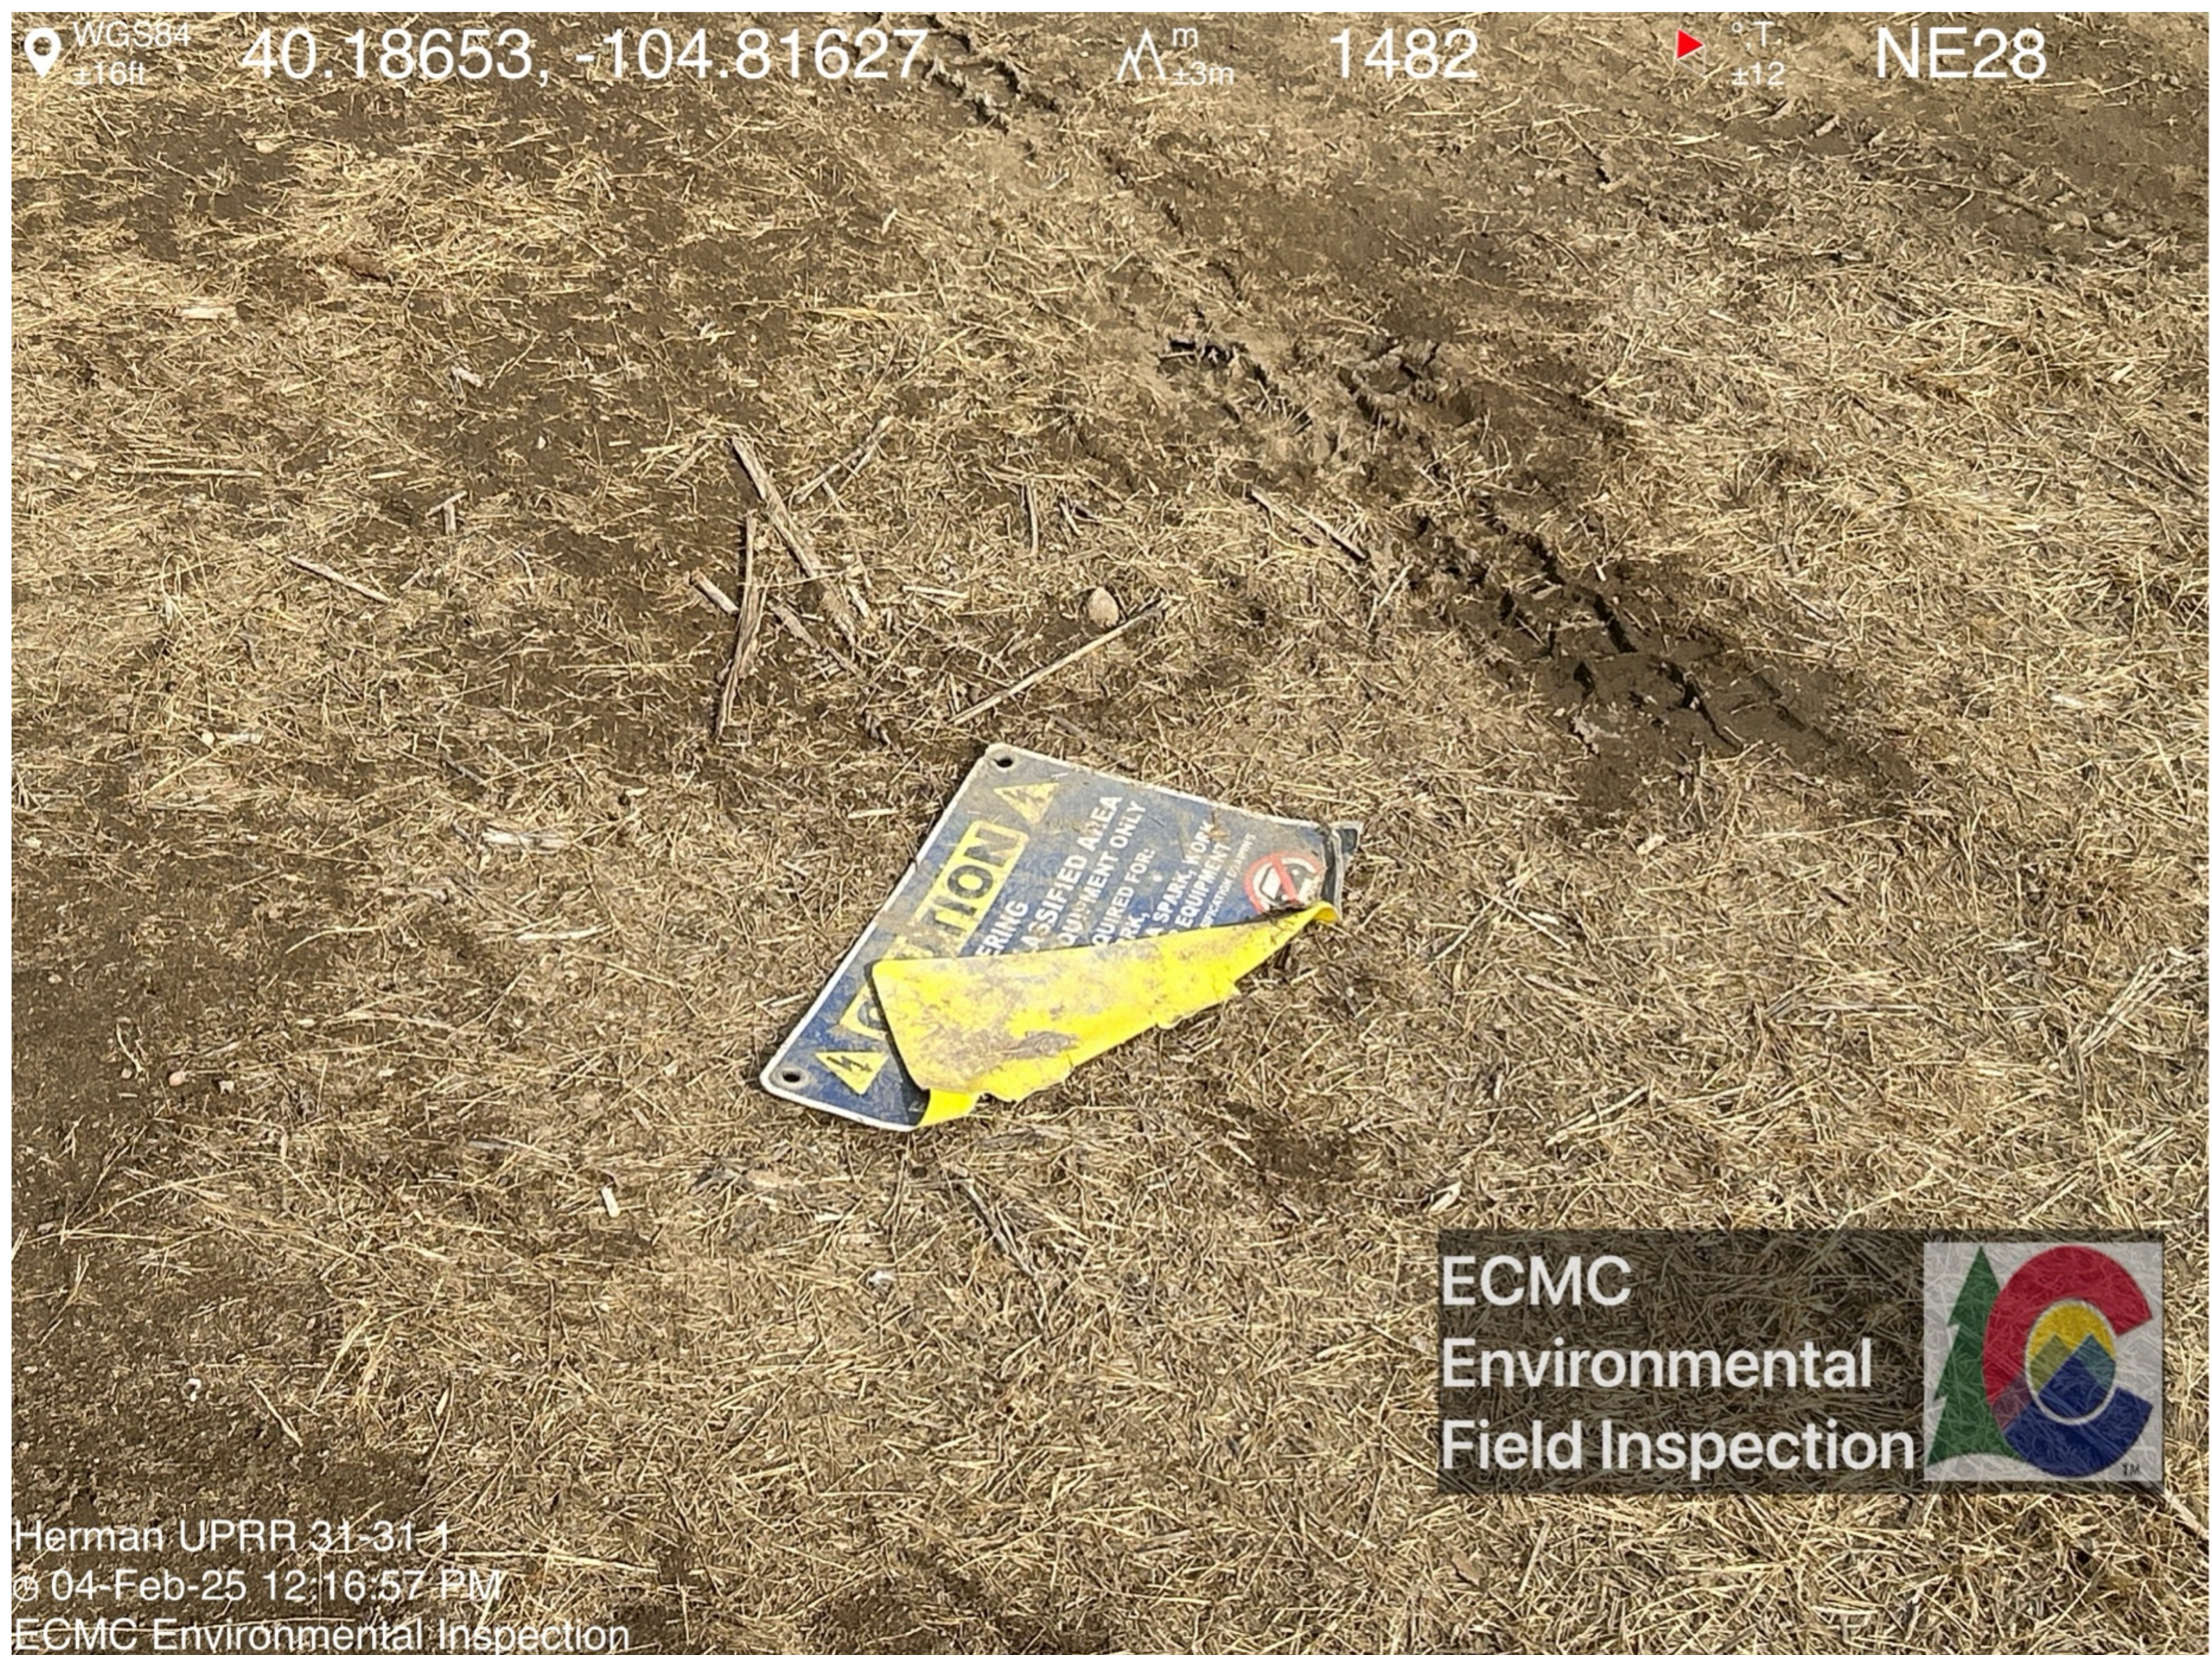
Trash observed on location.

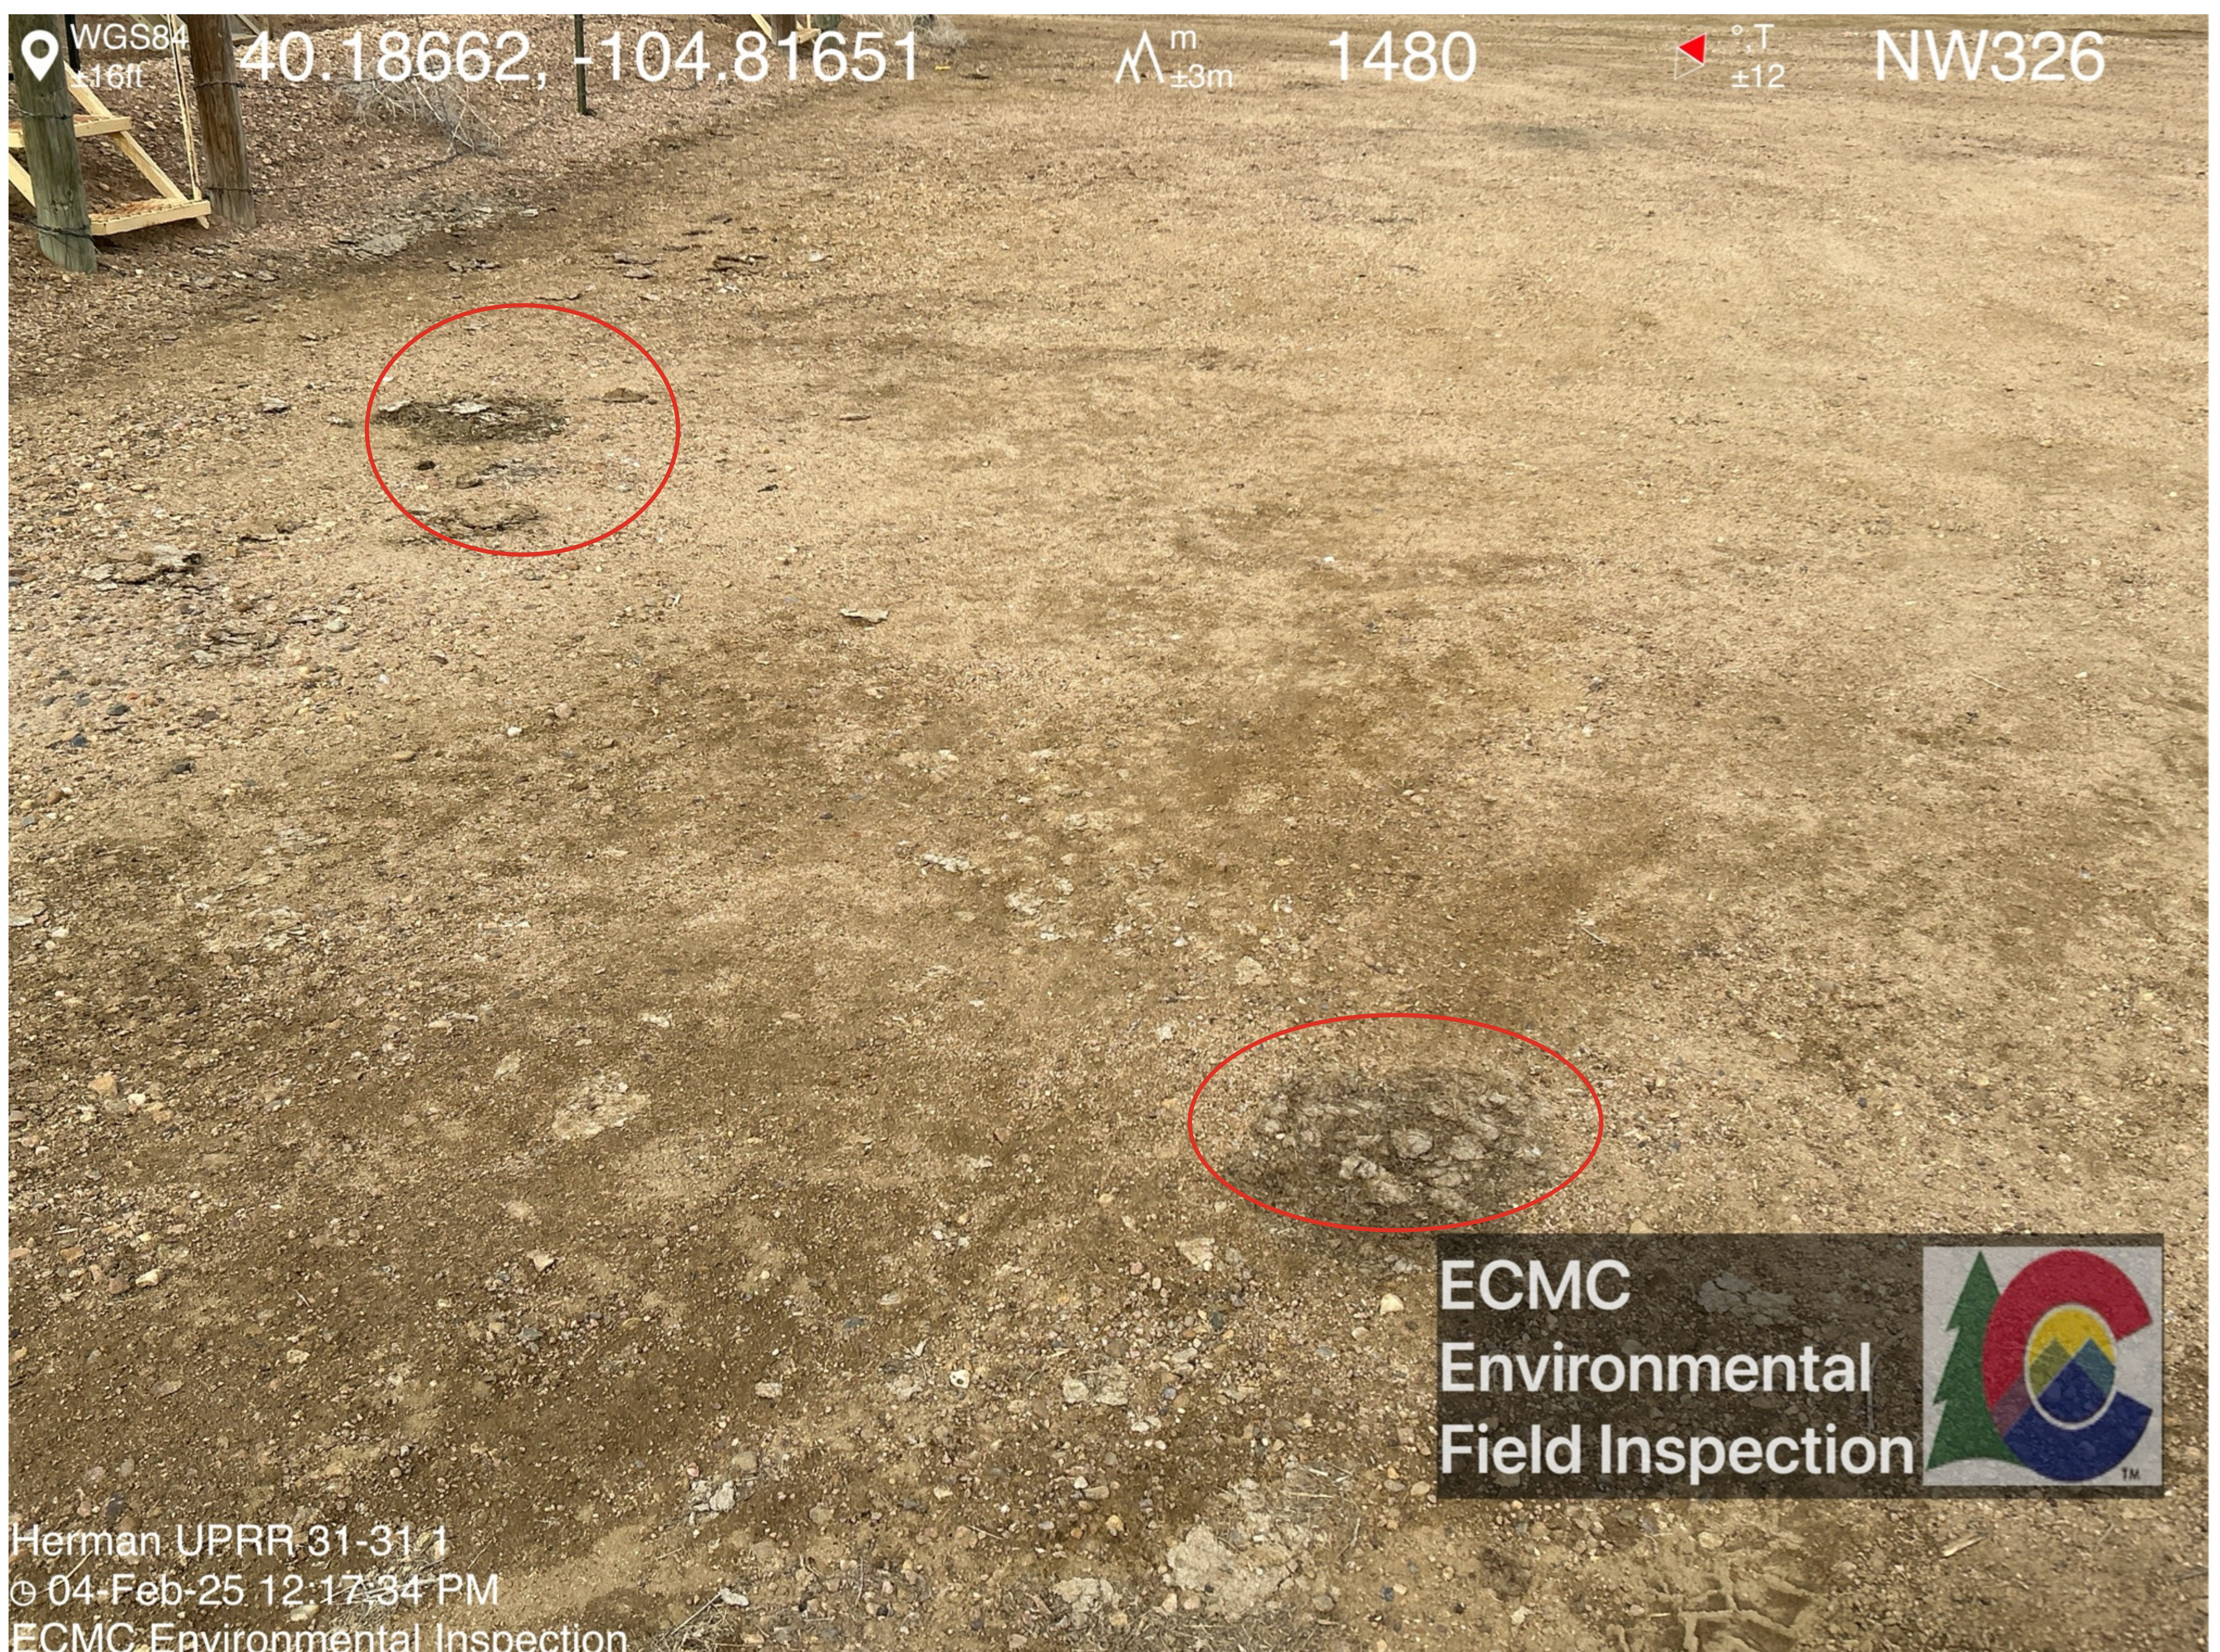
Livestock manure observed on location.
