Inspection/Audit Photos
Location Name: QB Energy GMU 23-14 (C26NW) Pad
Location #: 335163

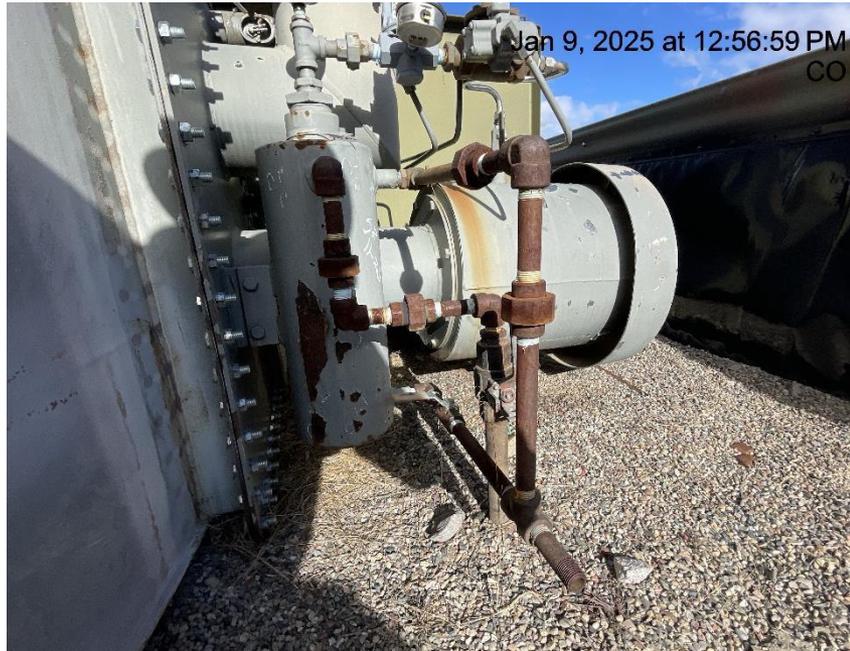
Photo # 7693 From inspection 708905468 conducted on 01/09/2025 PRV vent line does not comply with CECMC pressure safety device rules

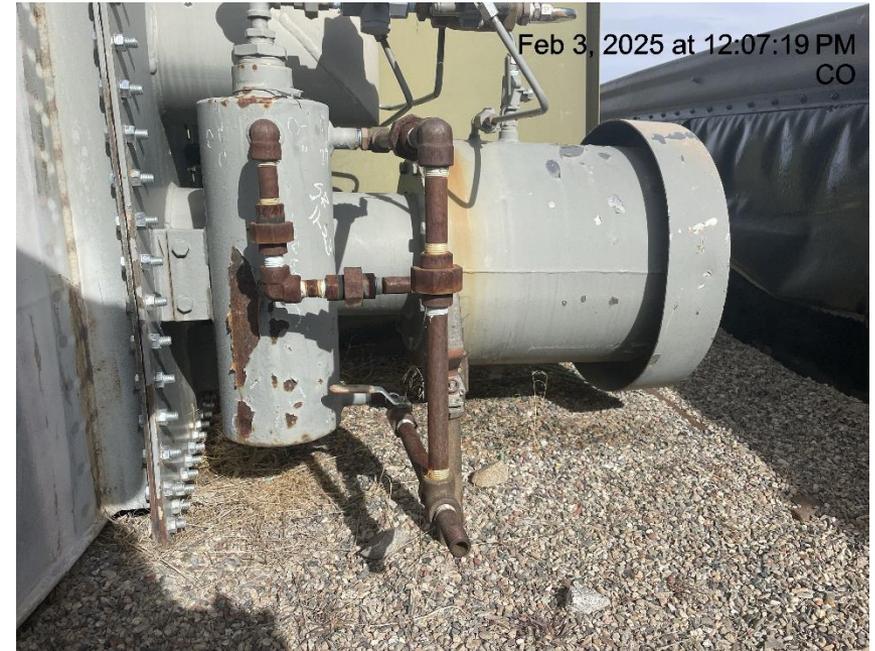
Photo # 3094 PRV vent line does not comply with CECMC pressure safety device rules

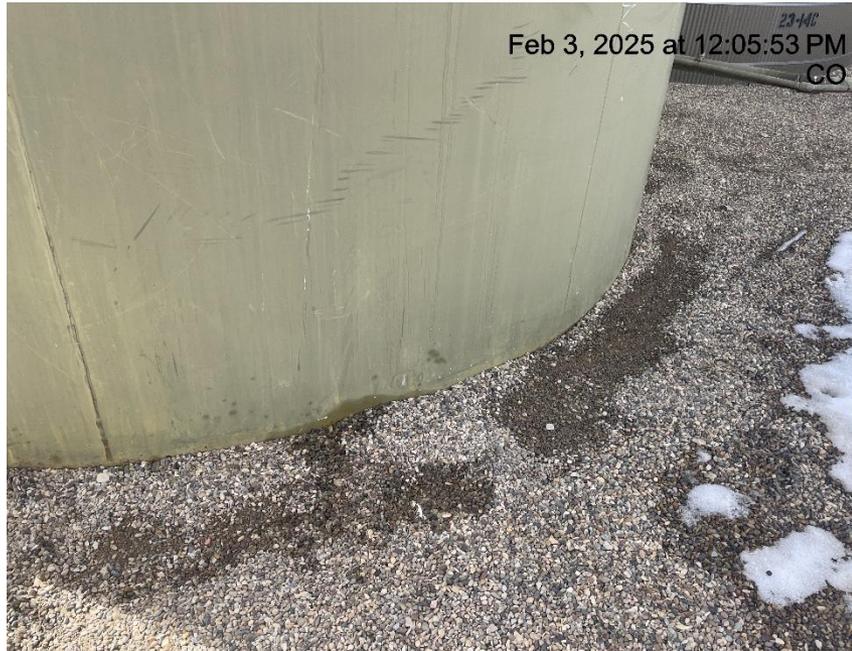
Photo # 3095 Staining in secondary containment

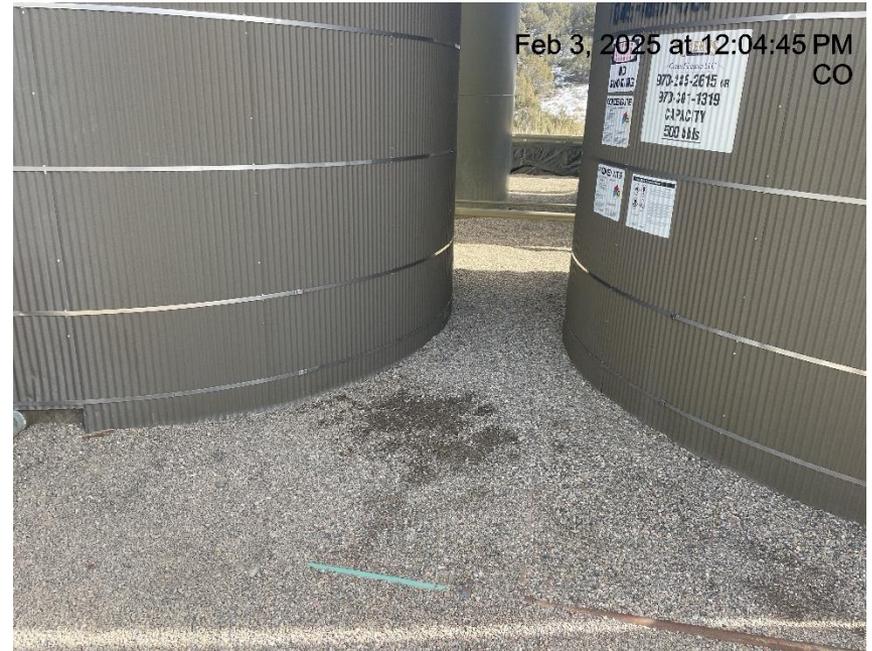
Photo # 3096 Staining in secondary containment
