Inspection Photos
Location Name: Eyestone 3-35
API Number: 125-07469

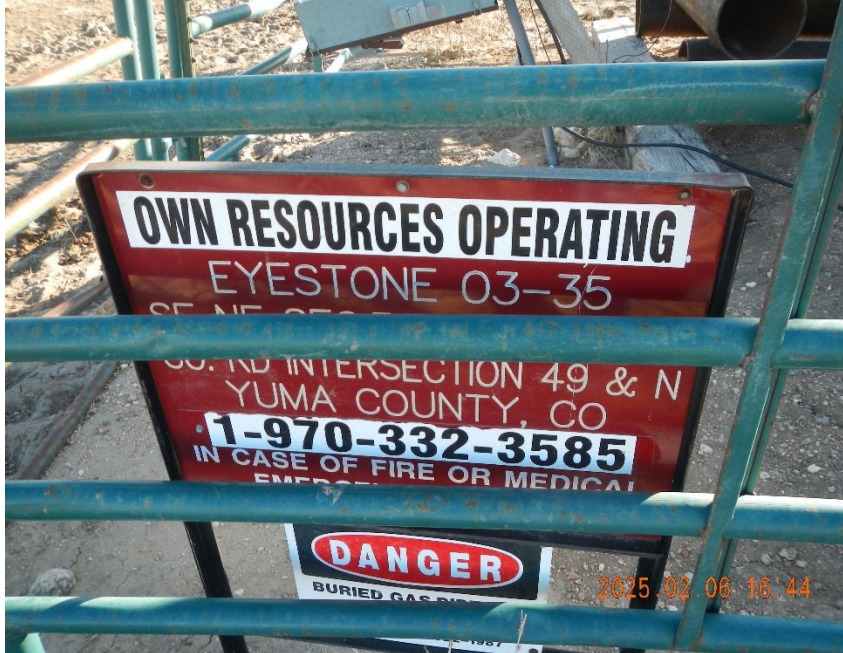
1. Lease sign at well location.

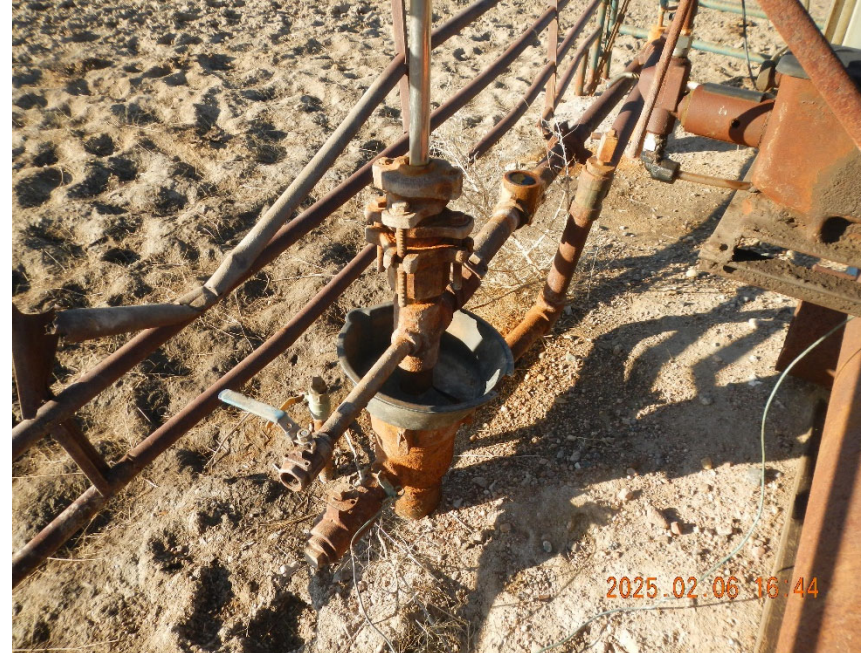
2. View of wellhead.

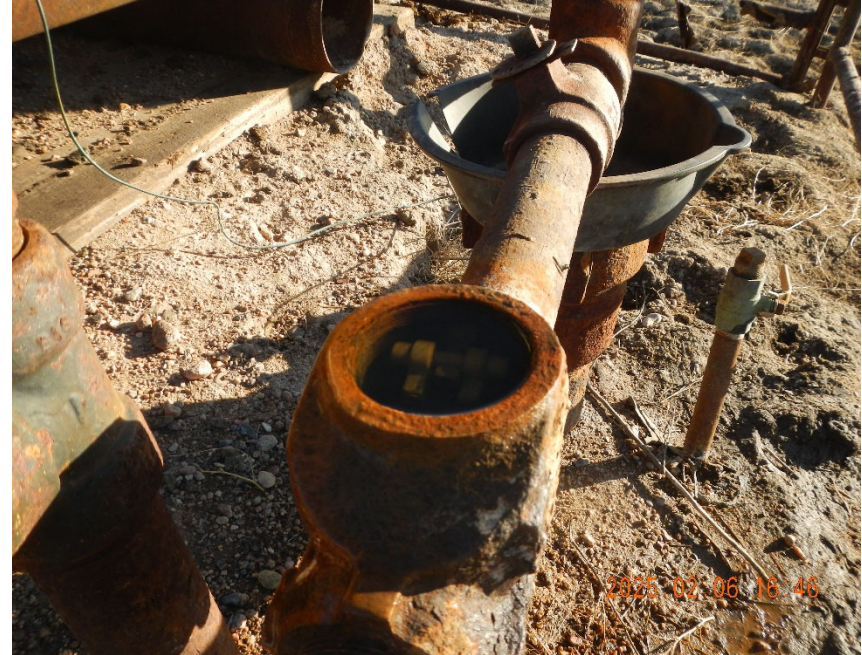
4. View of check valve with missing cap.

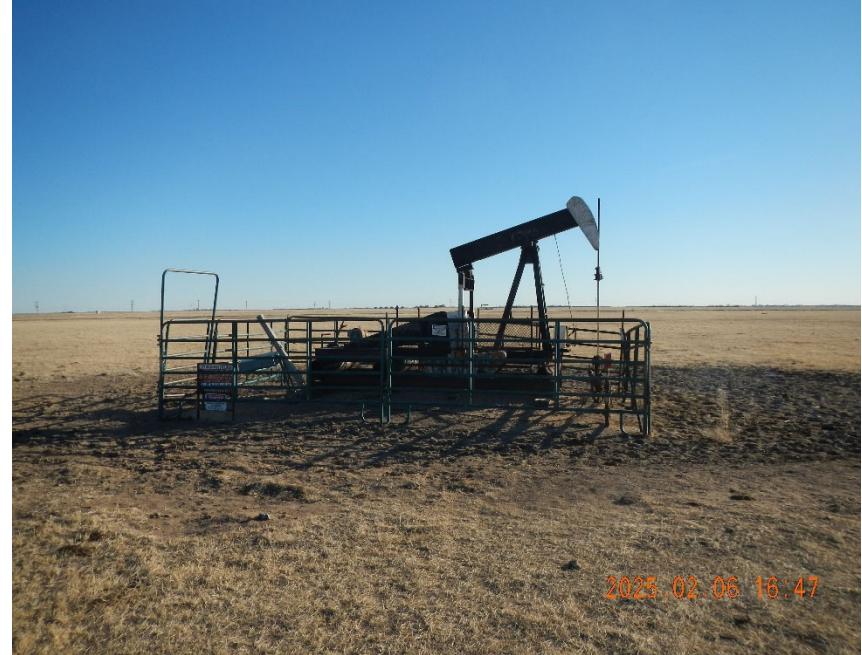
6. Well location overview.

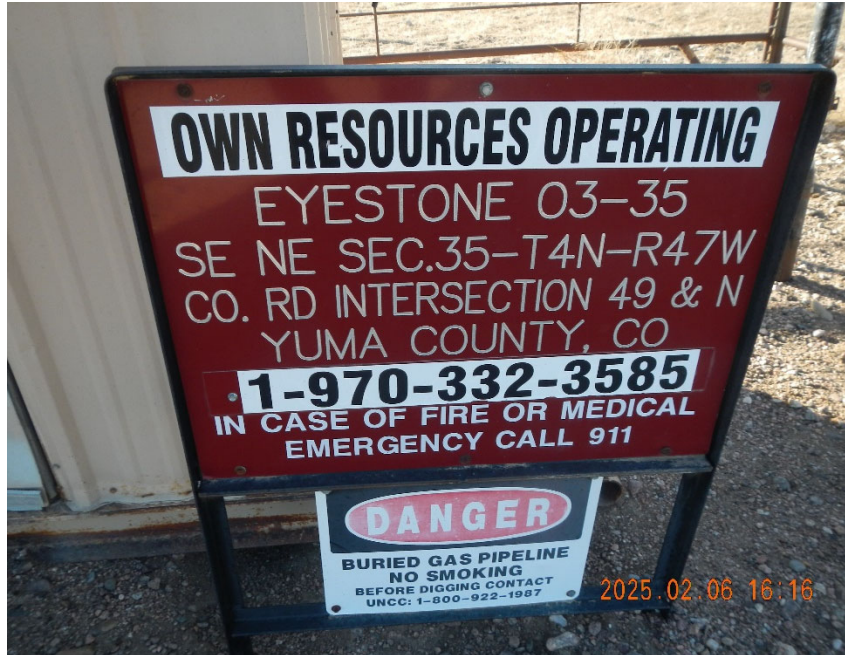
7. Lease sign at gathering location.

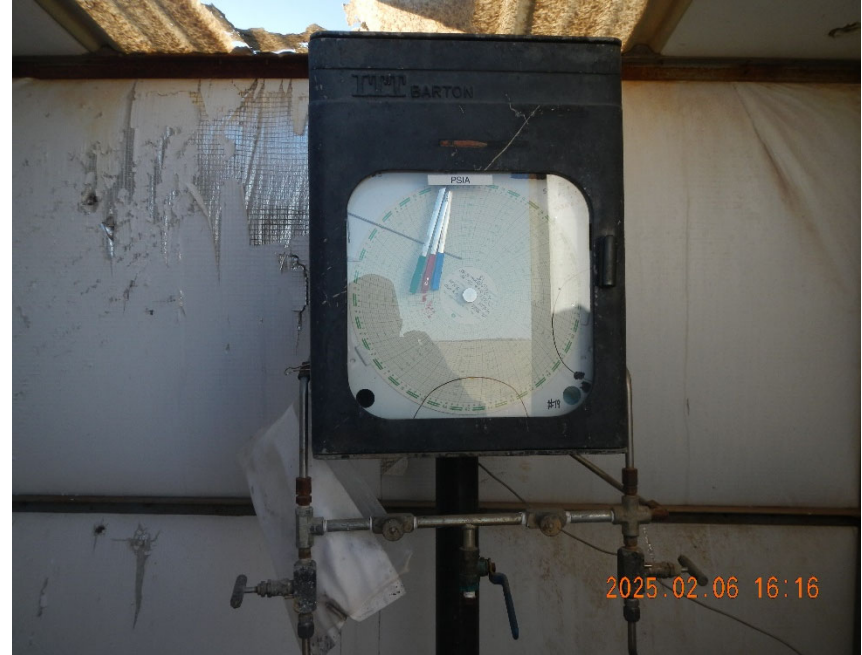
8. Gas meter inside meter shed.

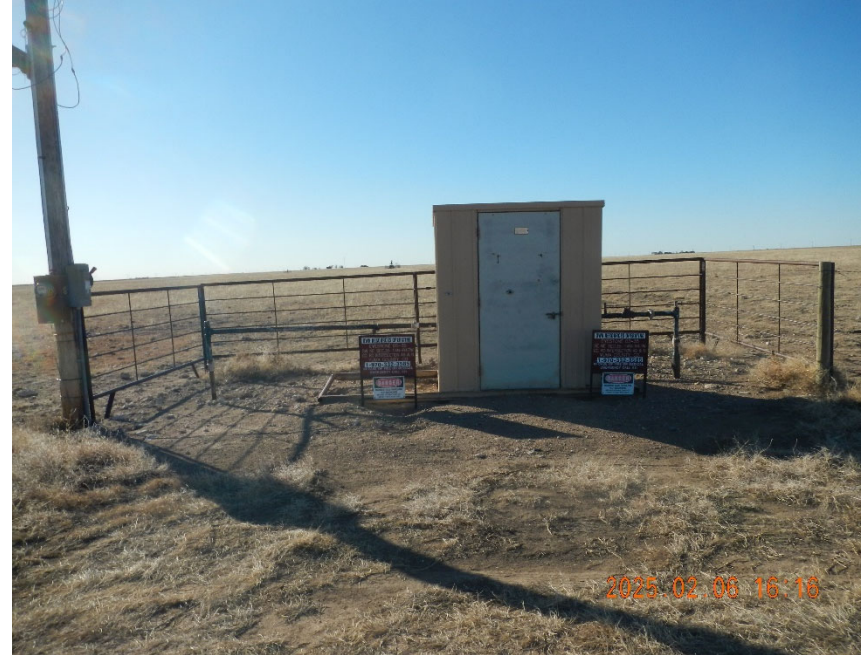
10. Gathering location overview.
