Inspection/Audit Photos
Location Name: QB Energy HILL 16-5B1 (E16) Pad
Location #: 334915

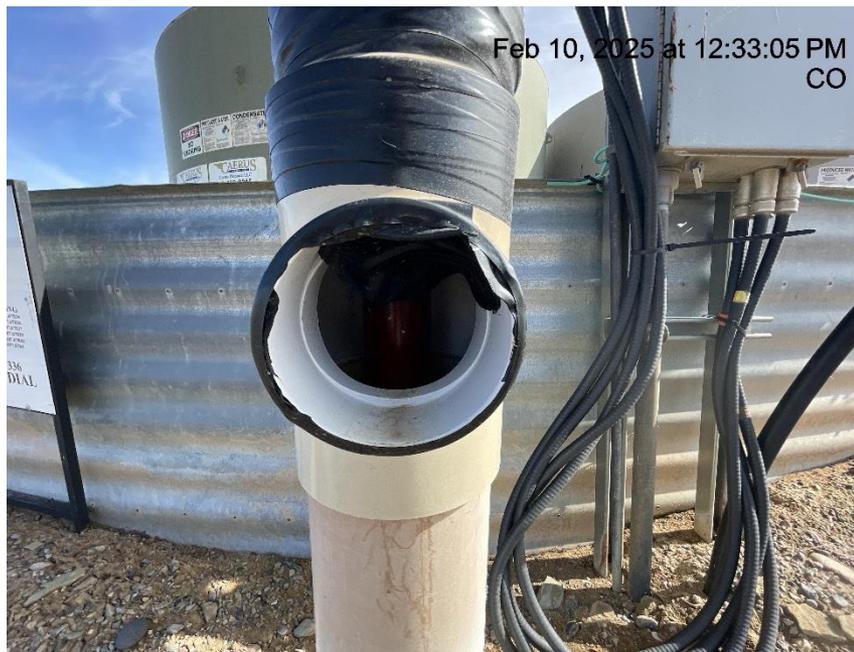
Photo # 4640 Flowline heating insulation open ended/wildlife hazard/available for entry by wildlife

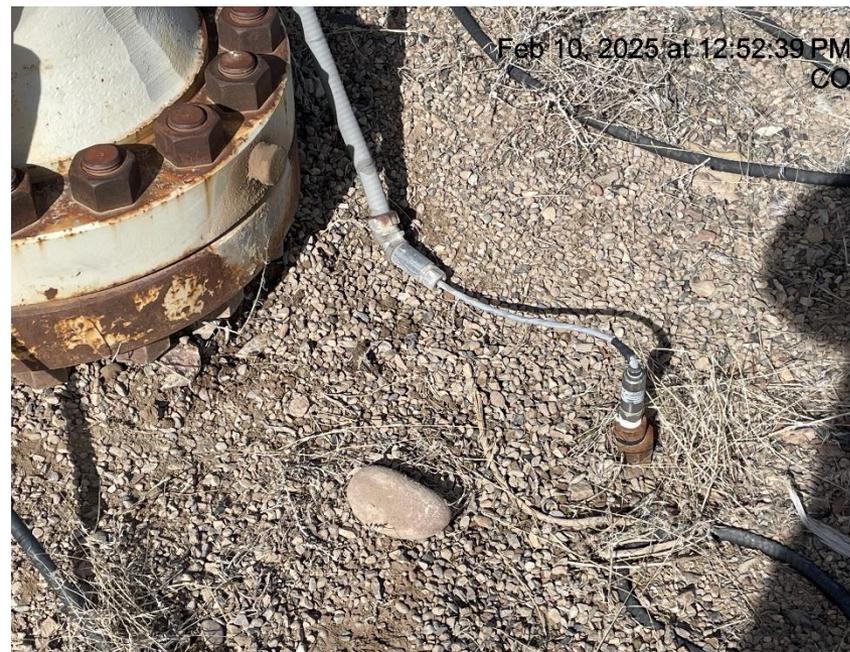
Photo # 4641 Valves used for annular pressure monitoring buried & not exposed/not in compliance with CECMC rules (HILL 16-4A1 well)

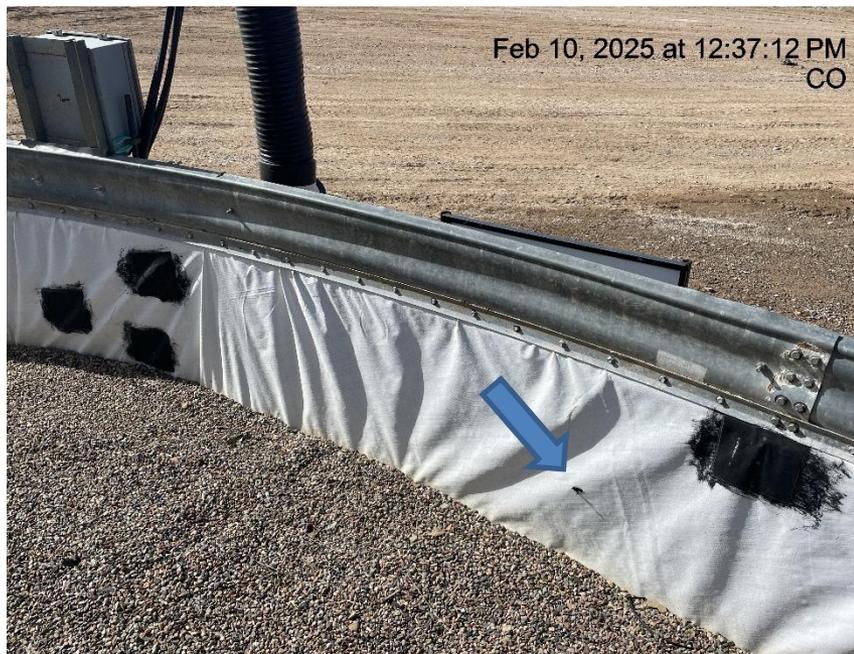
Photo # 4642 Hole in liner/liner needs maintenance

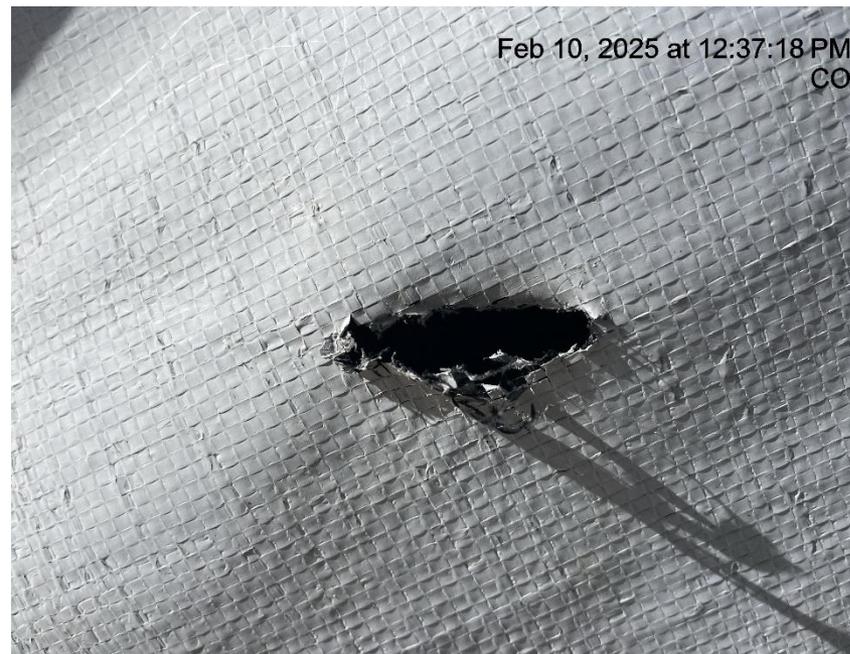
Photo # 4643 Hole in liner/liner needs maintenance

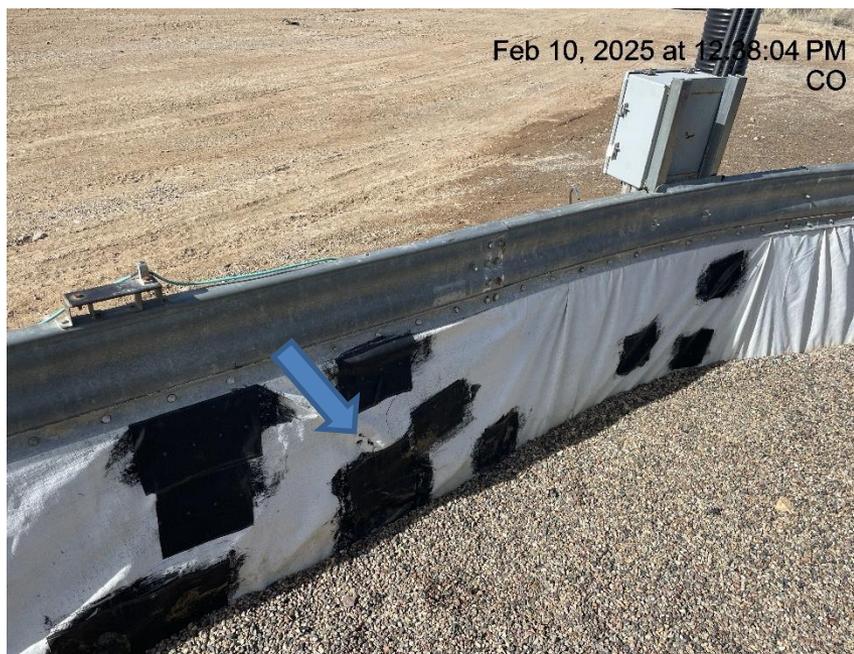
Photo # 4644 Hole in liner/liner needs maintenance

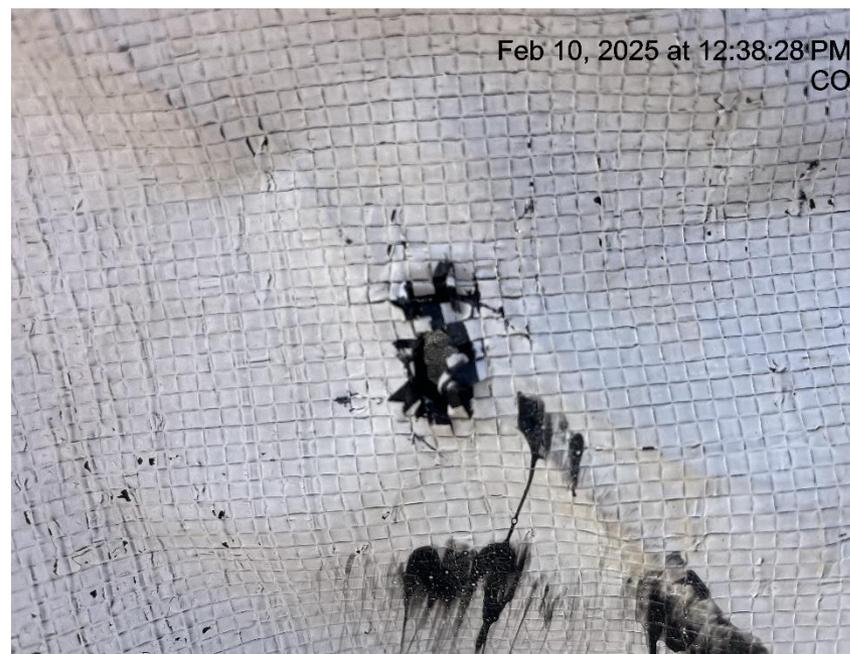
Photo # 4645 Hole in liner/liner needs maintenance

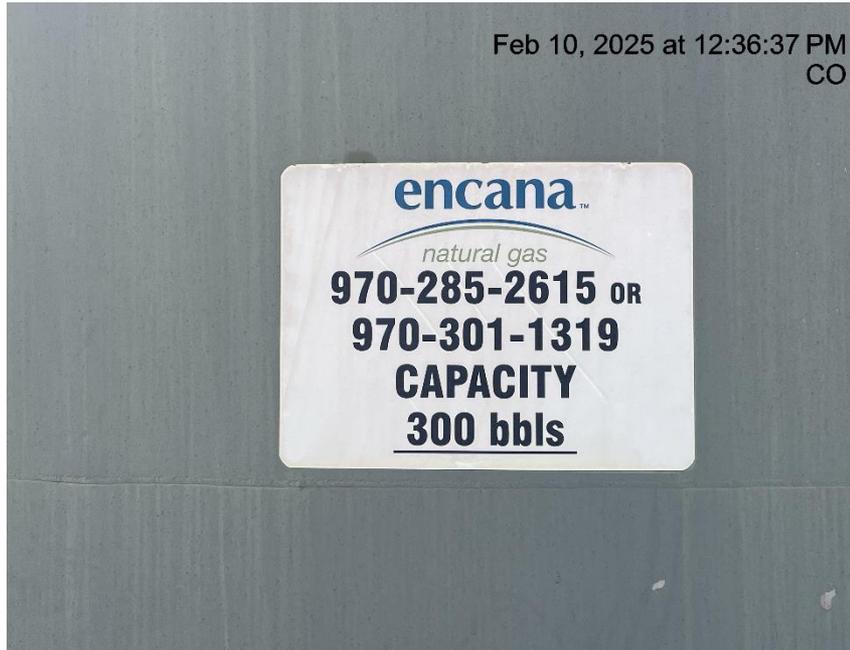
Photo # 4646 Tank label contains inaccurate information
