Inspection/Audit Photos

Location: TEP ROCKY MOUNTAIN LLC MV/11-11 PAD

Location ID: 334809

Date: 02/11/2025

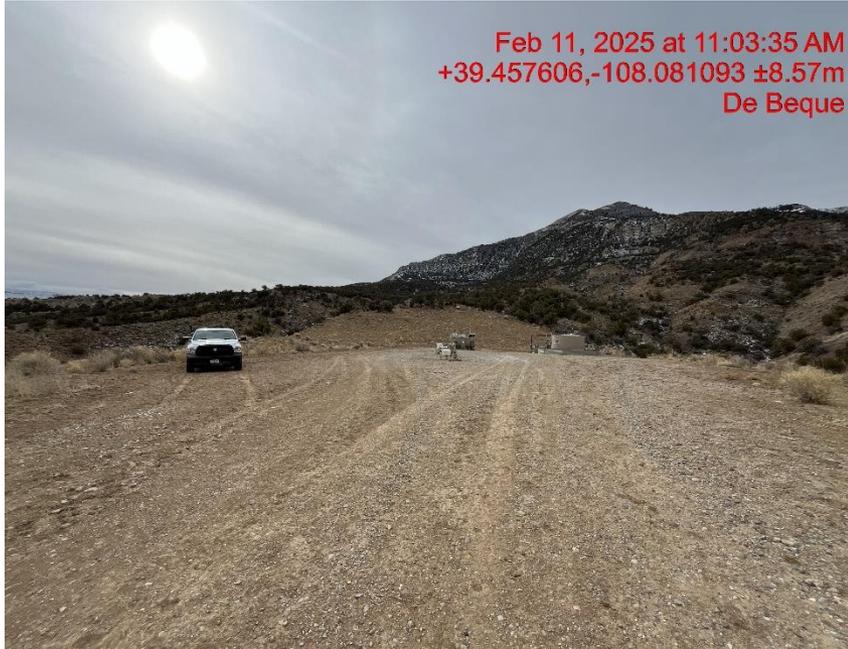
Photo # 4664 Entrance to location

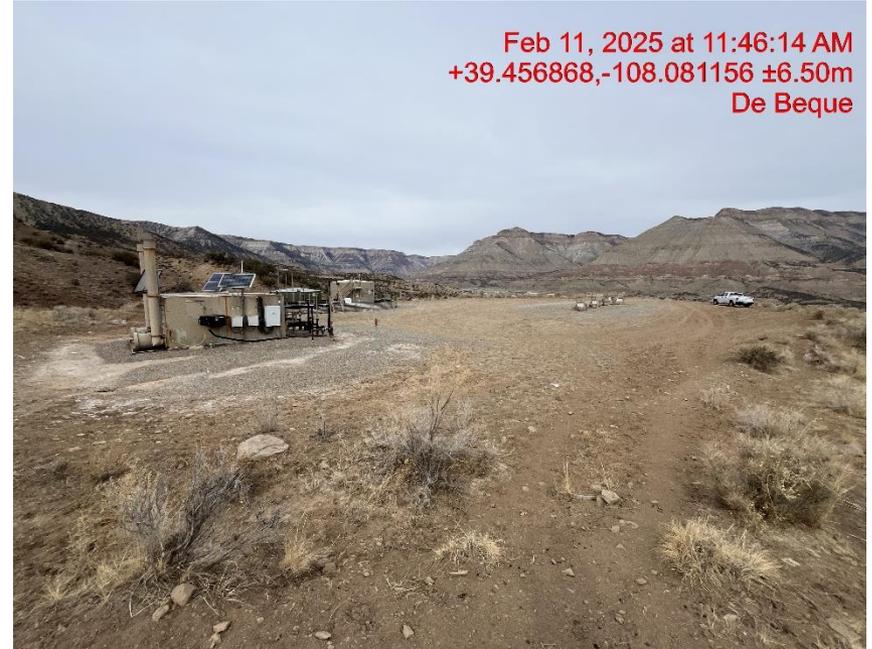
Photo # 4690 SE corner of location

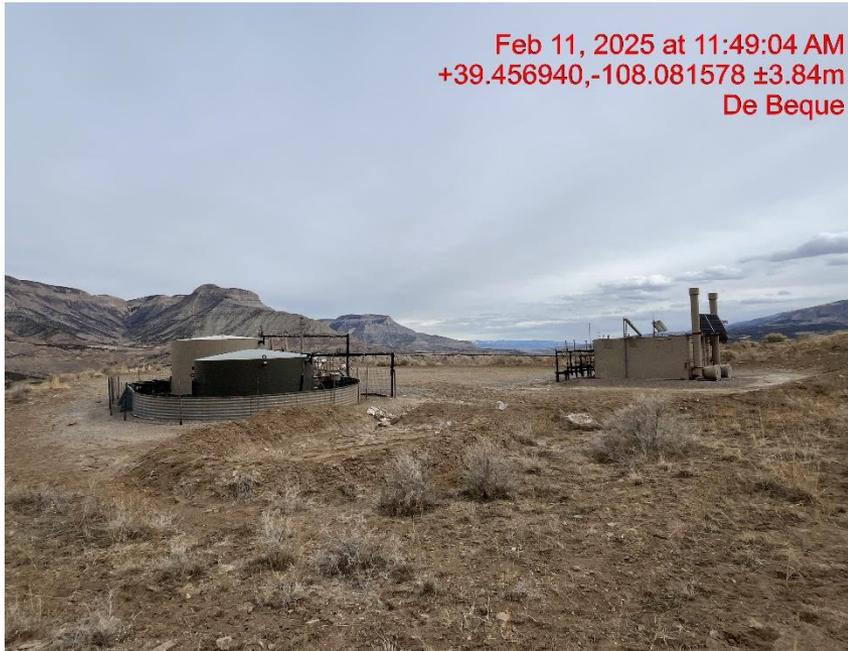
Photo # 4691 SW corner of location

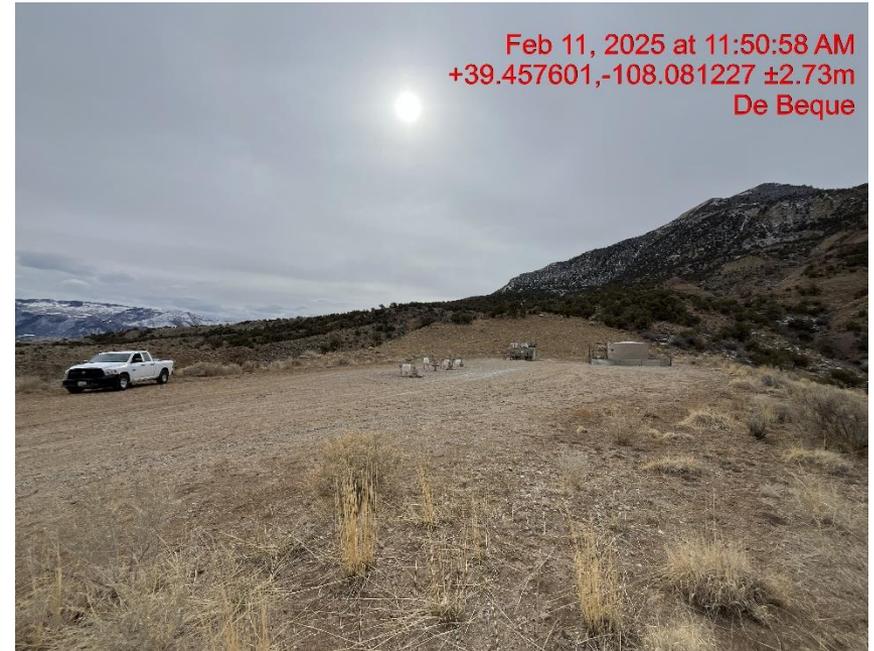
Photo # 4692 NW corner of location

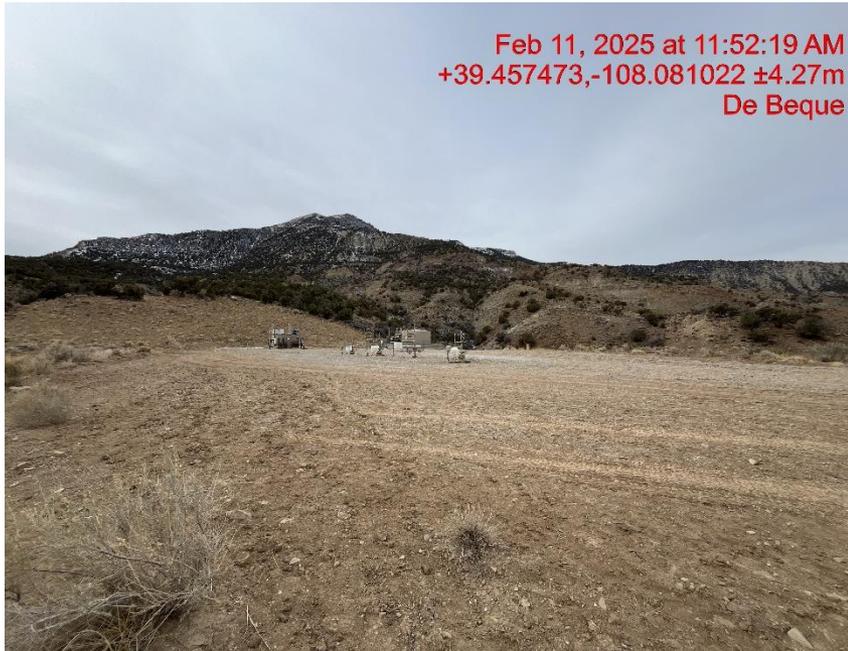
Photo # 4693 NE corner of location

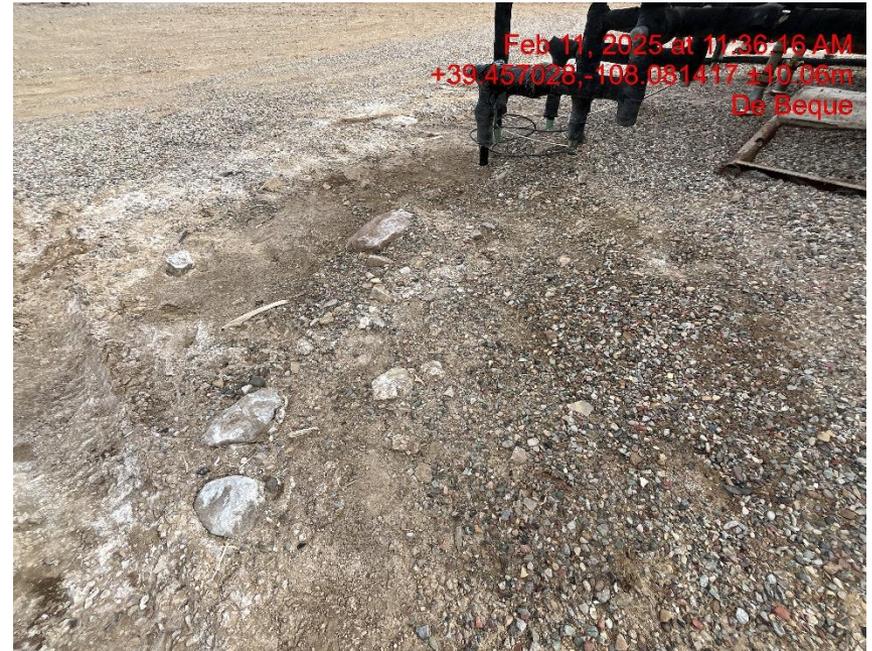
Photo # 4682 Staining

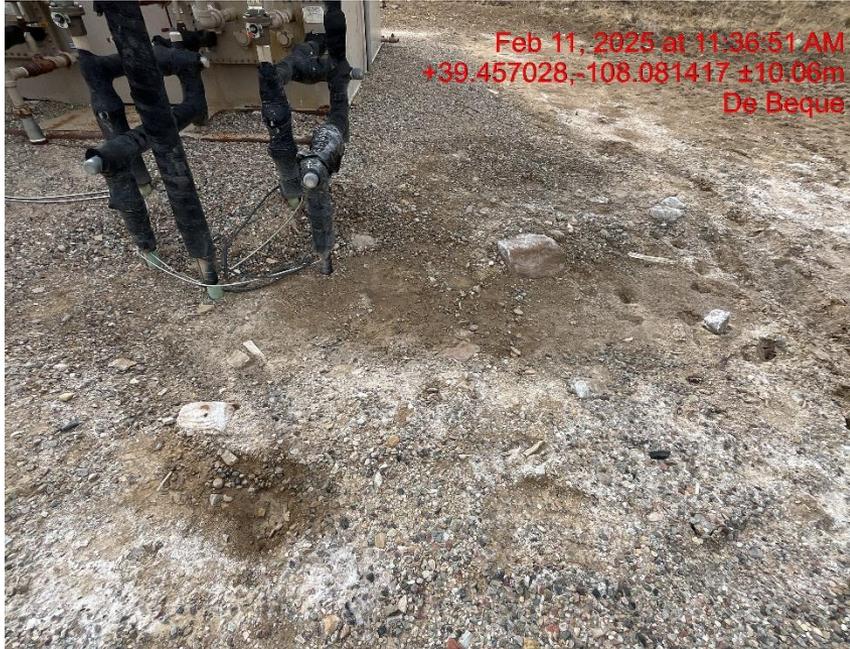
Photo # 4683 Staining

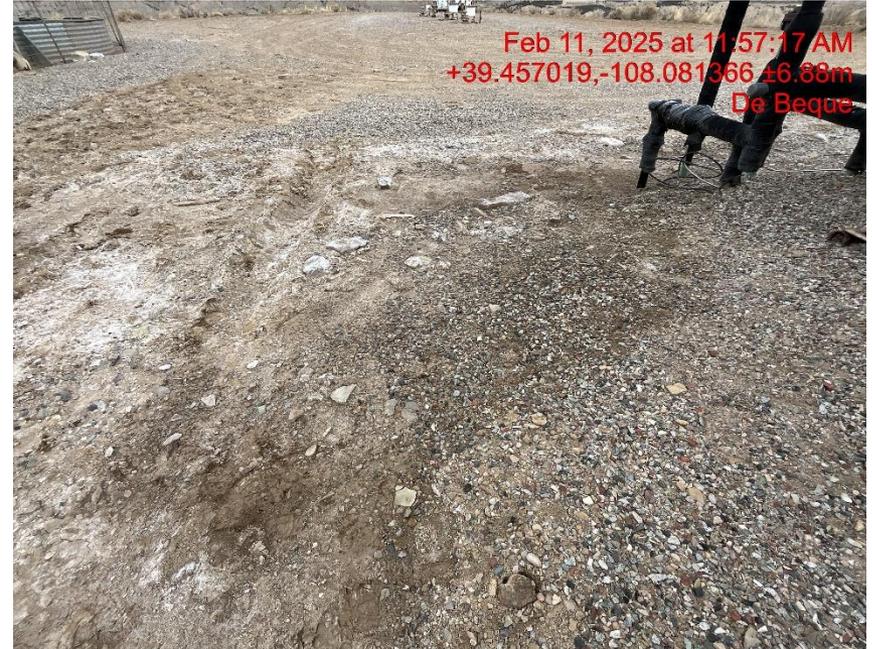
Photo # 4699 Staining

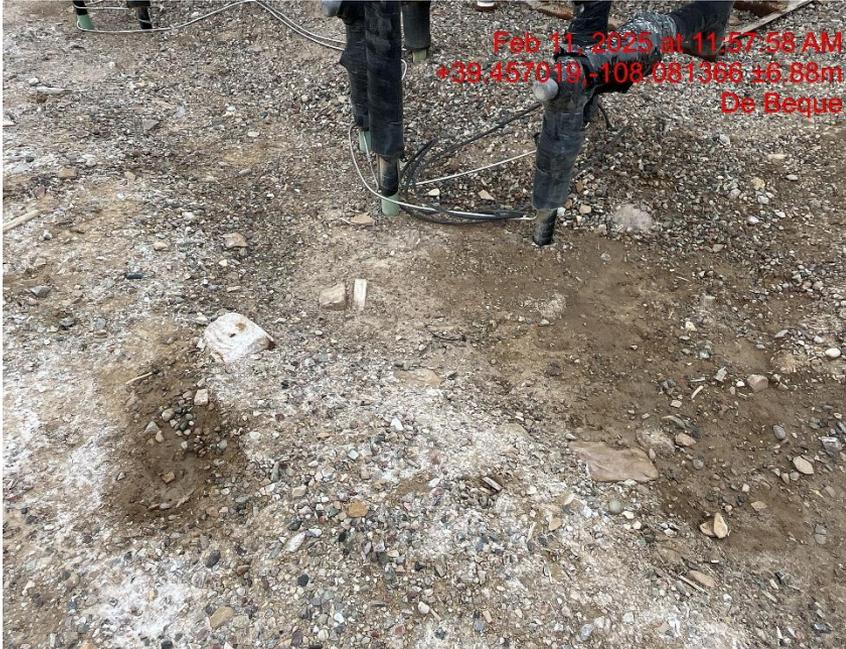
Photo # 4701 Staining

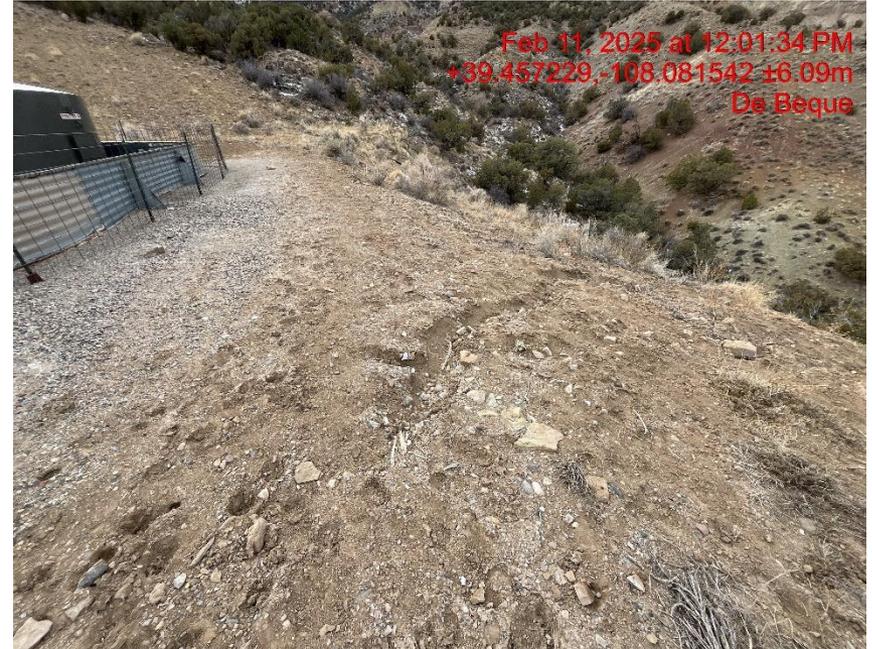
Photo # 4703 Erosion & transport of sediment off location/insufficient BMP's

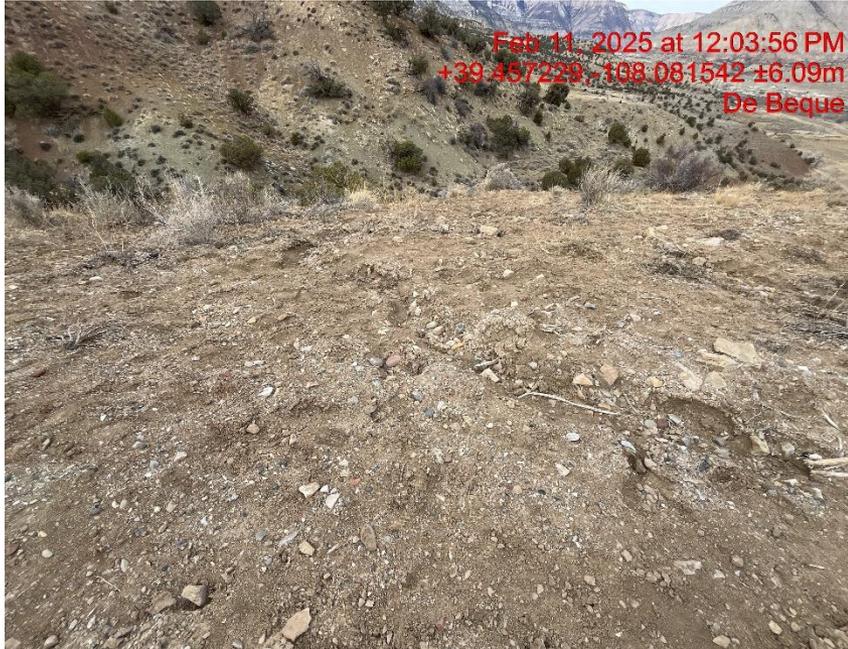
Photo # 4708 Erosion & transport of sediment off location/insufficient BMP's

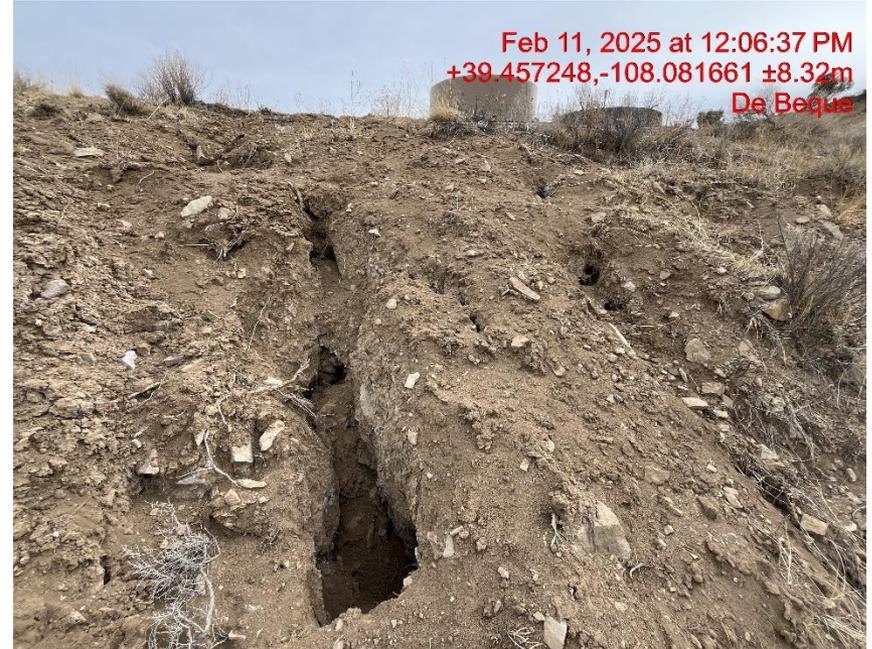
Photo # 4713 Subsidence on slope, additionally is a wildlife hazard

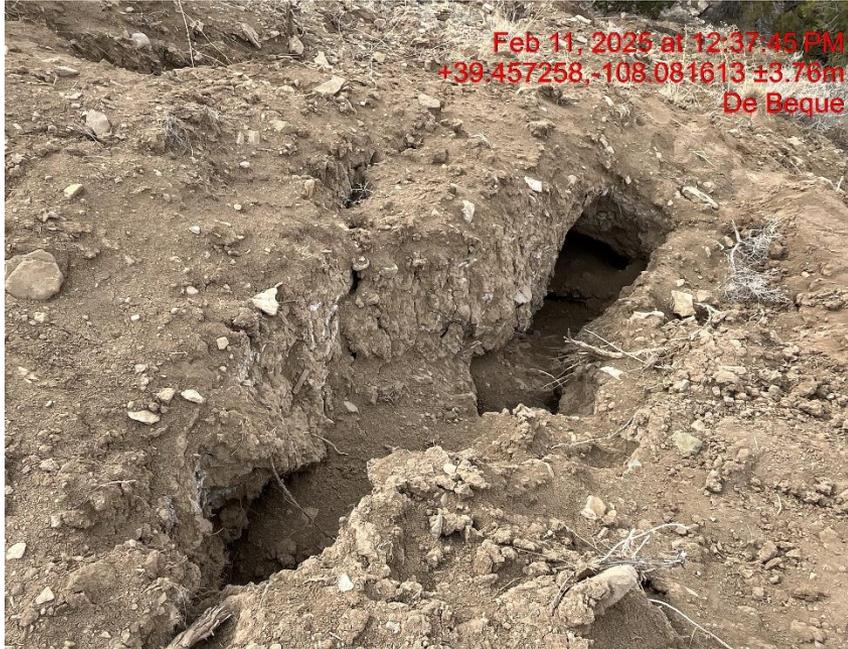
Photo # 4759 Subsidence on slope, additionally is a wildlife hazard

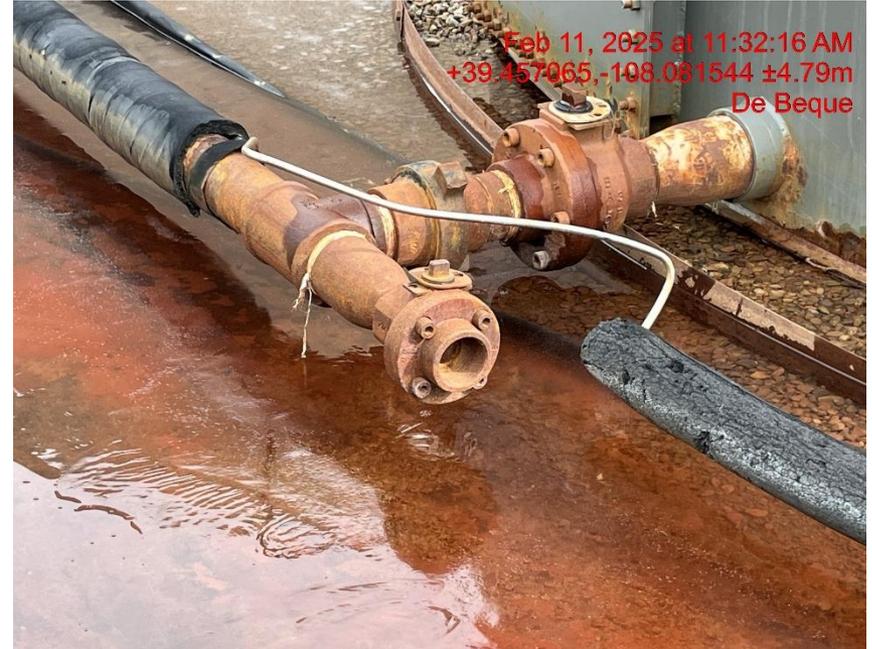
Photo # 4679 Open ended load line
