# Inspection Photos

Loc: 484358

Operator: DESERT EAGLE OPERATING LLC

Inspection Date: 2/10/2025

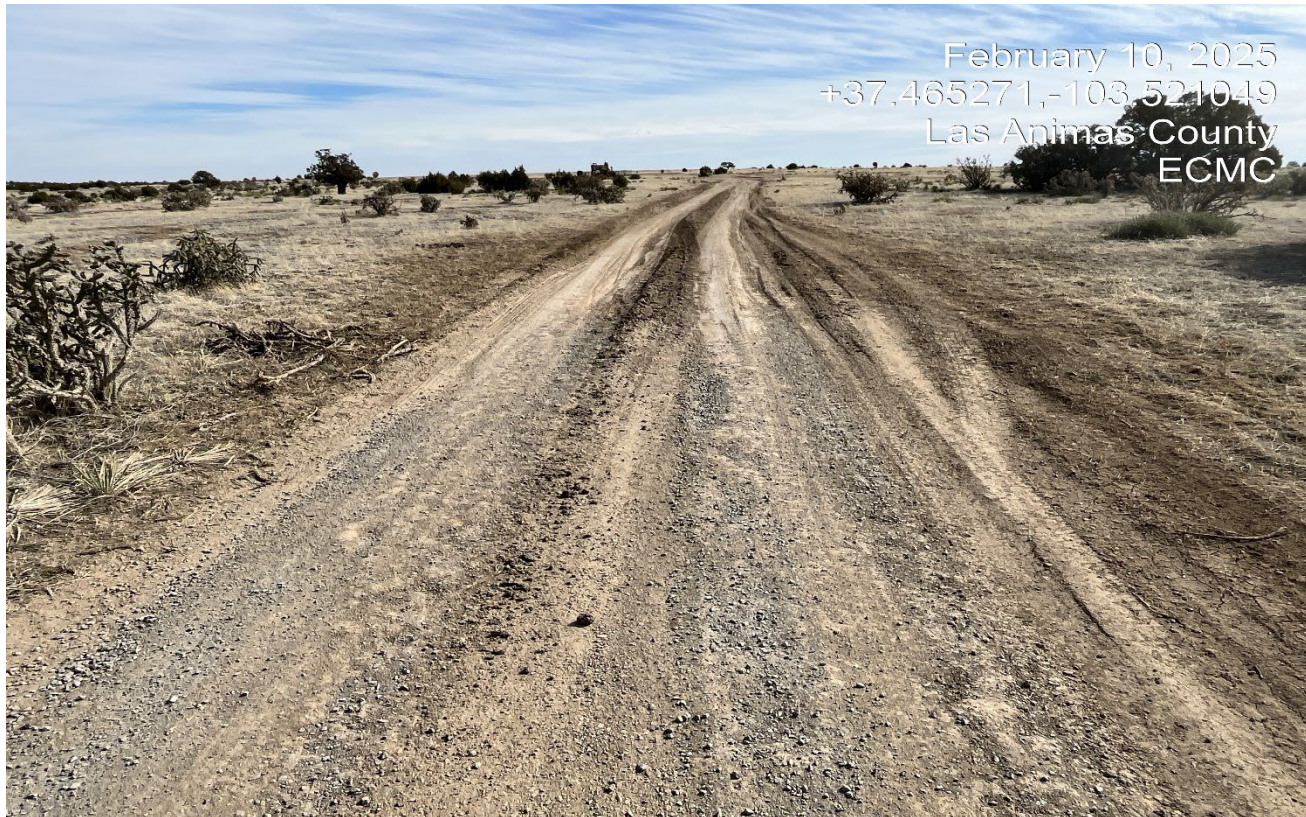
**Photo 1.** Facing east along the access road. This area of the road is rutted and needs to be repaired with BMP's.

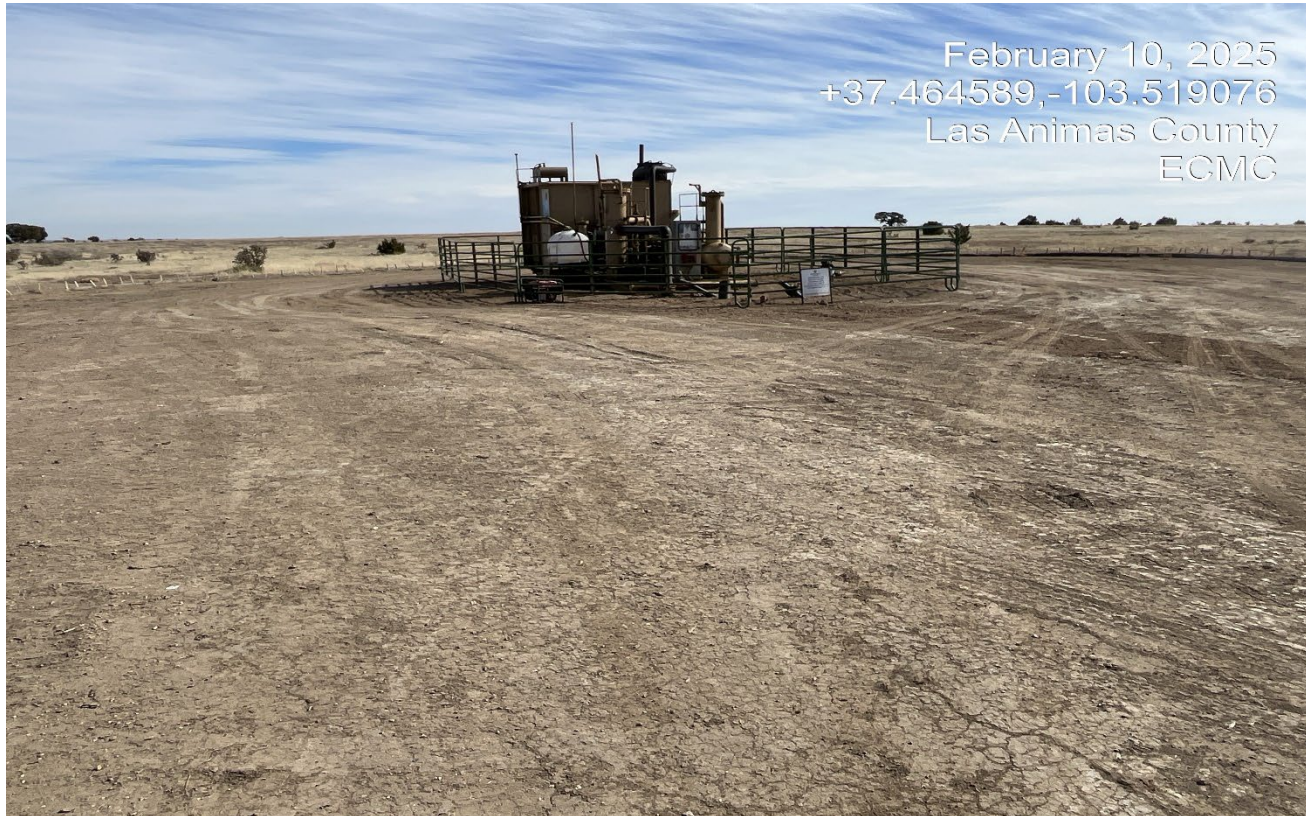
**Photo 2.** Facing east toward the wellsite and engine compressor.

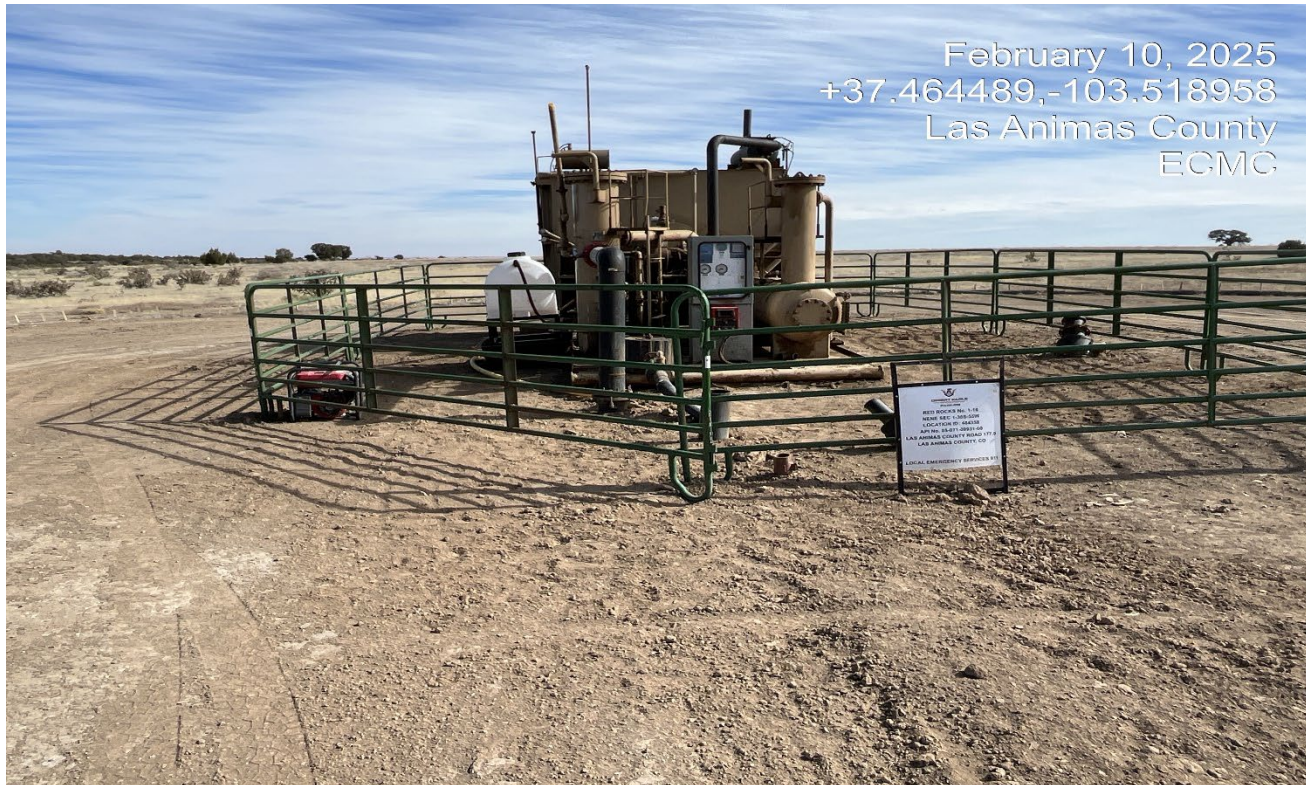
**Photo 3.** Facing east at the wellsite and engine compressor.

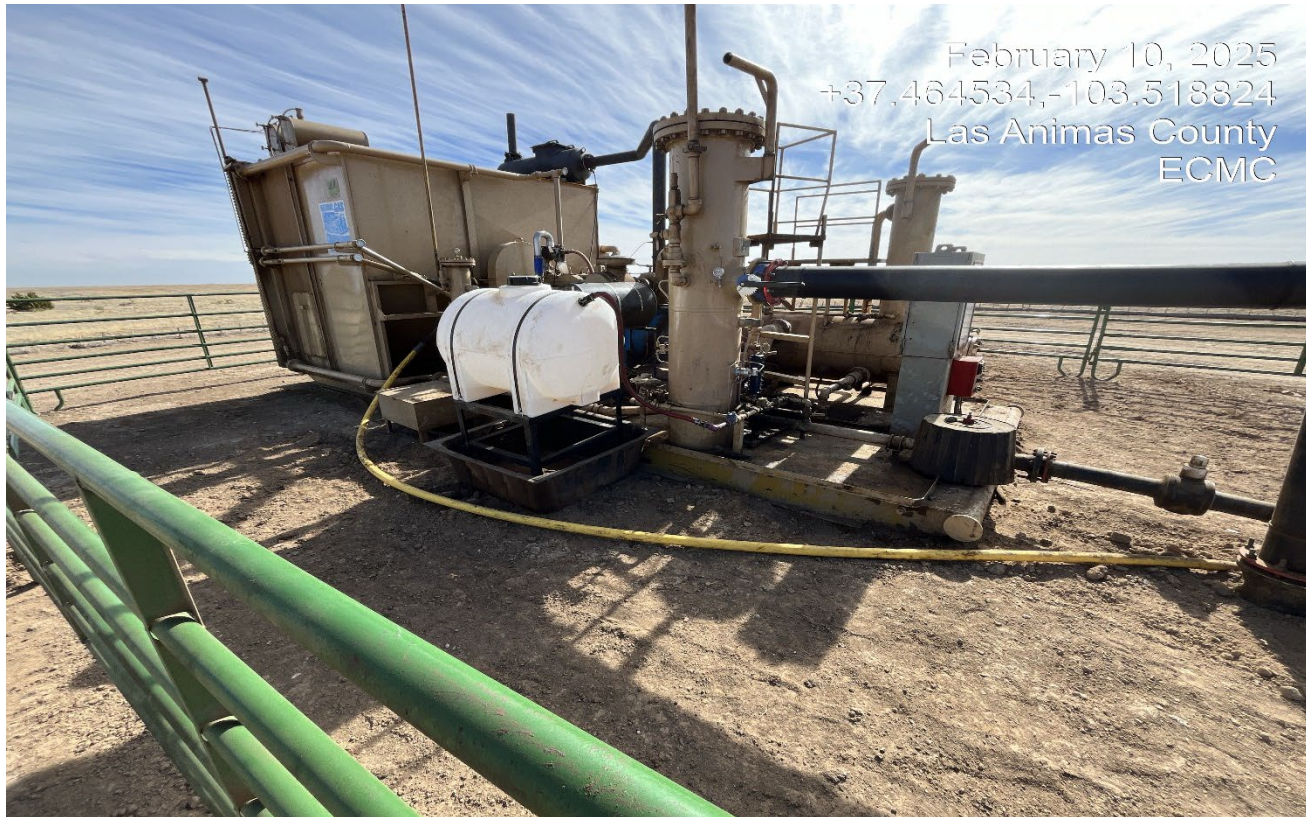
**Photo 4.** Facing toward the engine compressor.

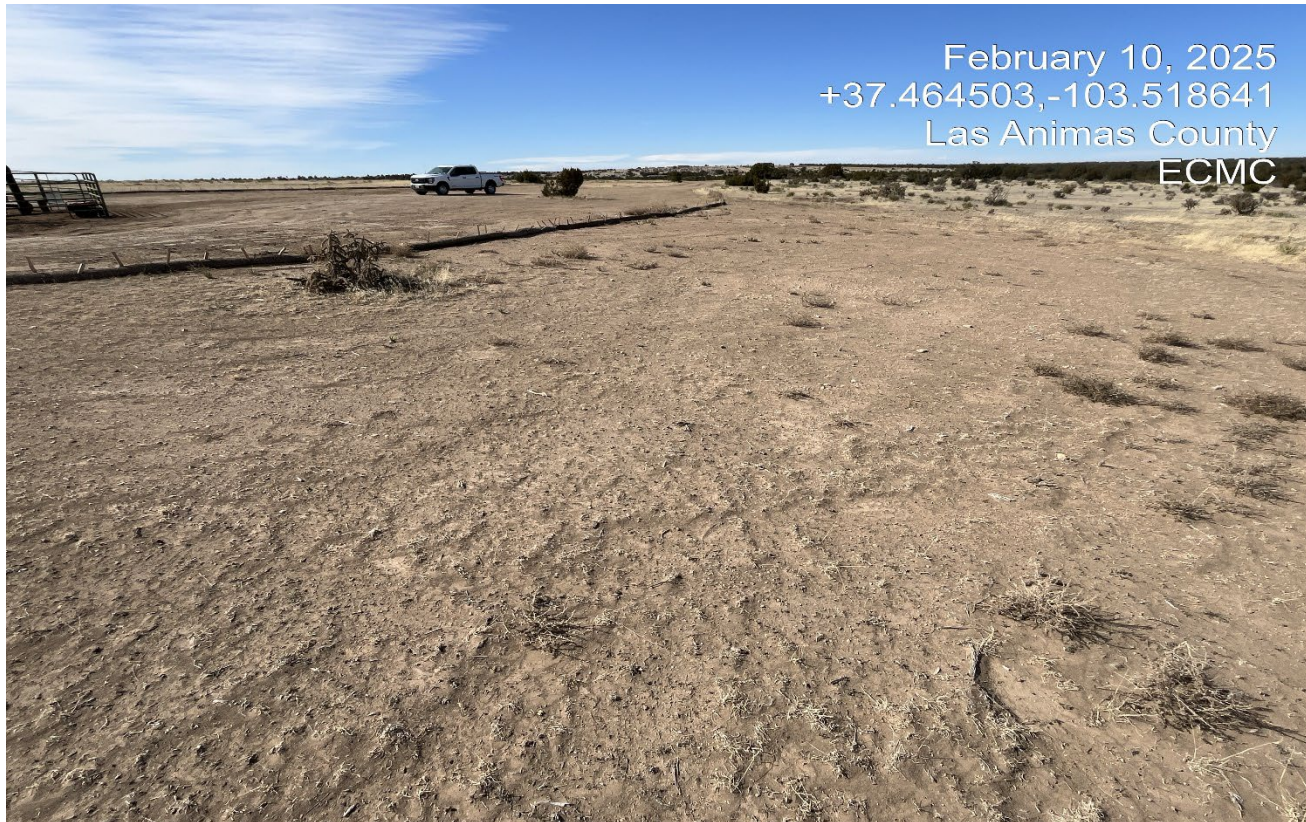
**Photo 5.** Northeast corner facing west. Perimeter wattles have been reinstalled. Disturbed area have not establish perennial vegetation.

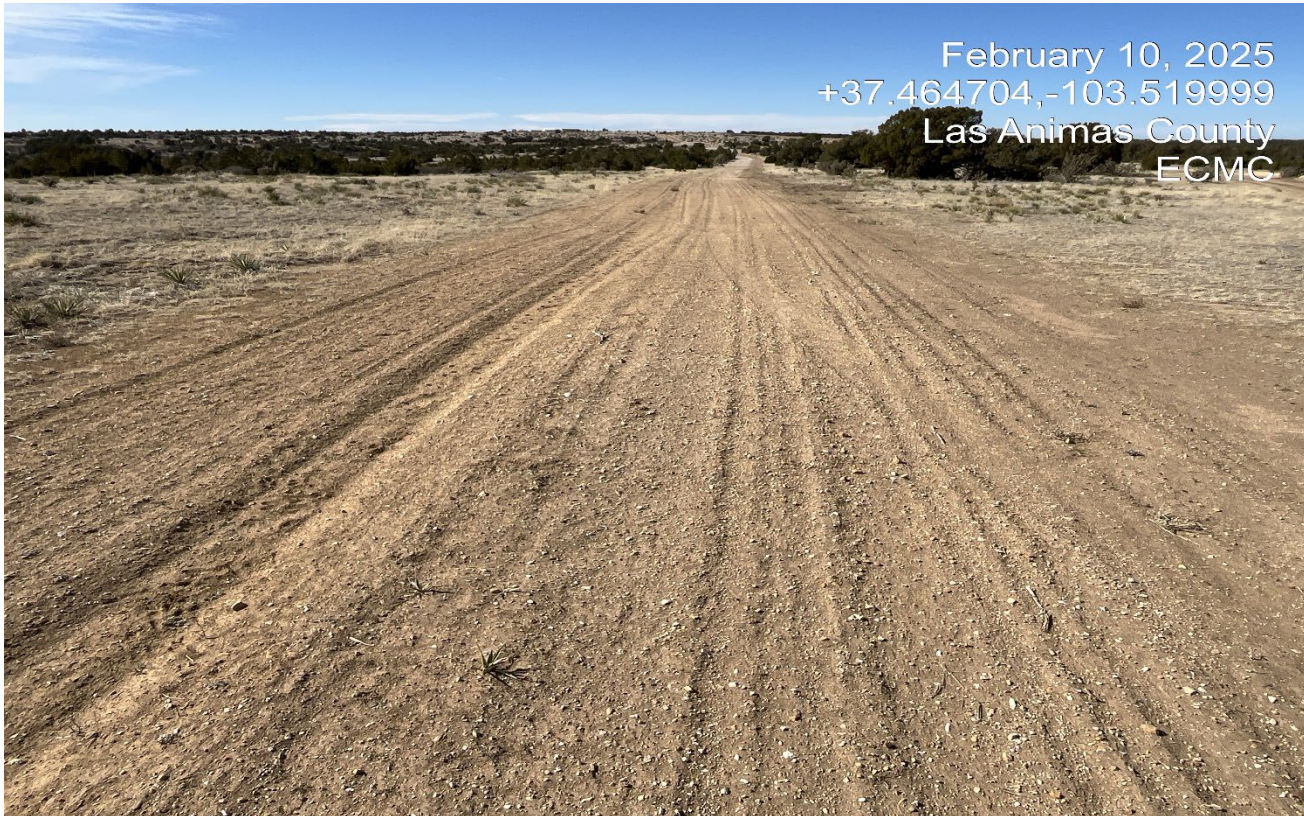
**Photo 6.** Facing west toward the flowline disturbance.
