# Failure Report

## Verdad Resources

County Line Utility Line  
1/9/2025

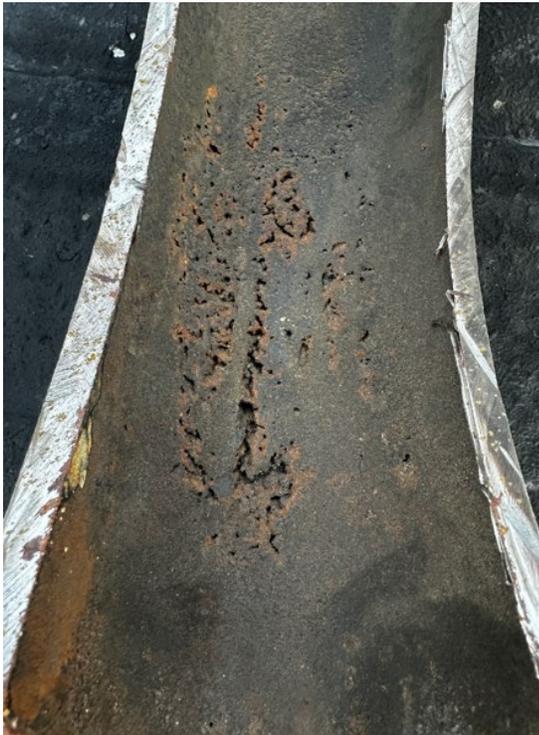
West Header

- Pipe from connecting line for west and east headers
- Batch treating older wells
- CO2 corrosion
- Line was stagnant for long period
  - Causing an acceleration metal loss
