**Inspection Photos**  
**Location Name: Pete Montoya 1**  
**Location ID: 311280**

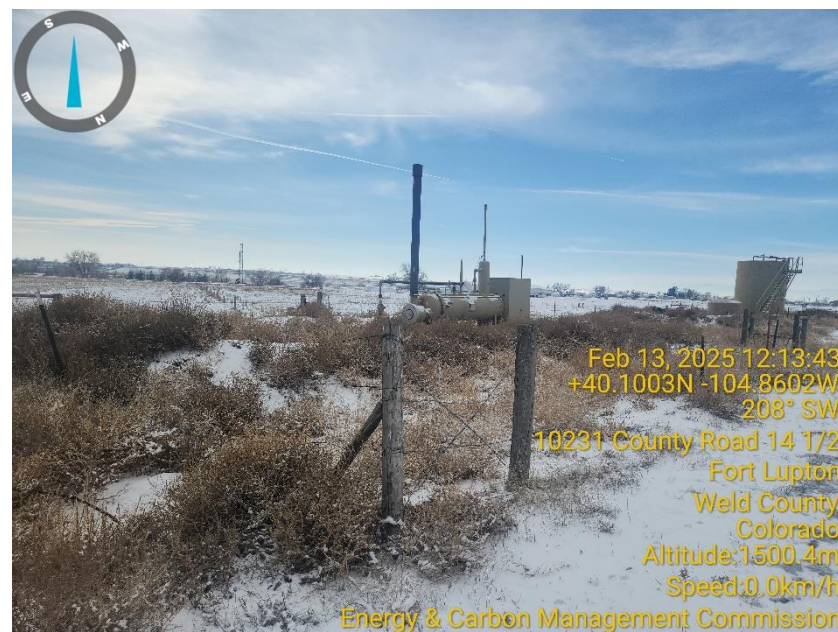
**Photo 2 Dead vegetation around Horizontal Heated separator.**

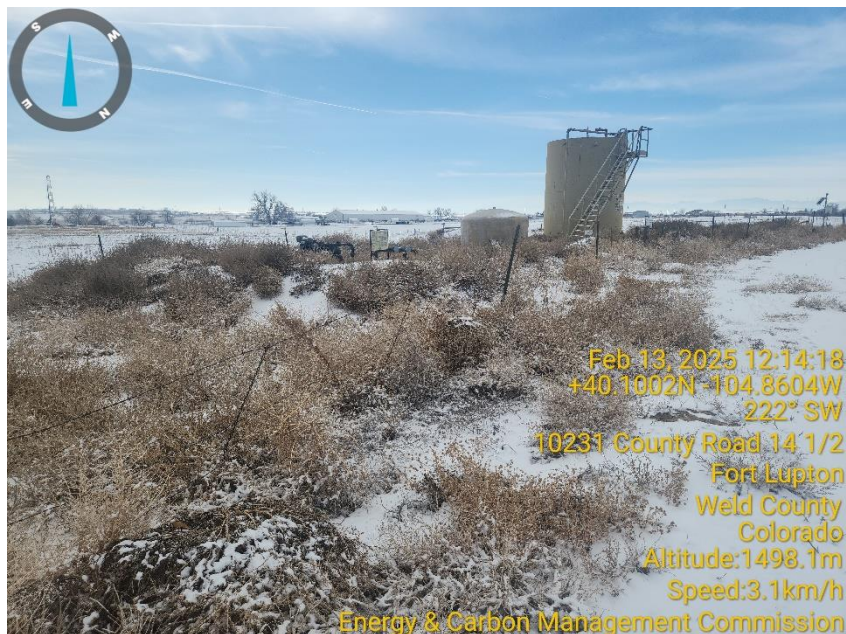
**Photo 3 Dead vegetation inside/outside tank battery fencing.**

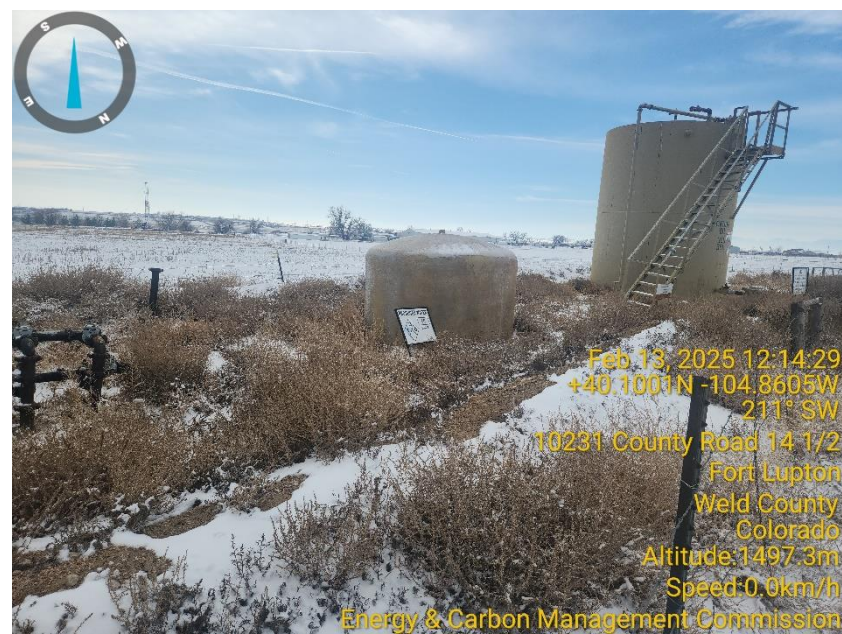
**Photo 4 Dead vegetation around flow line manifold & around the tanks .**

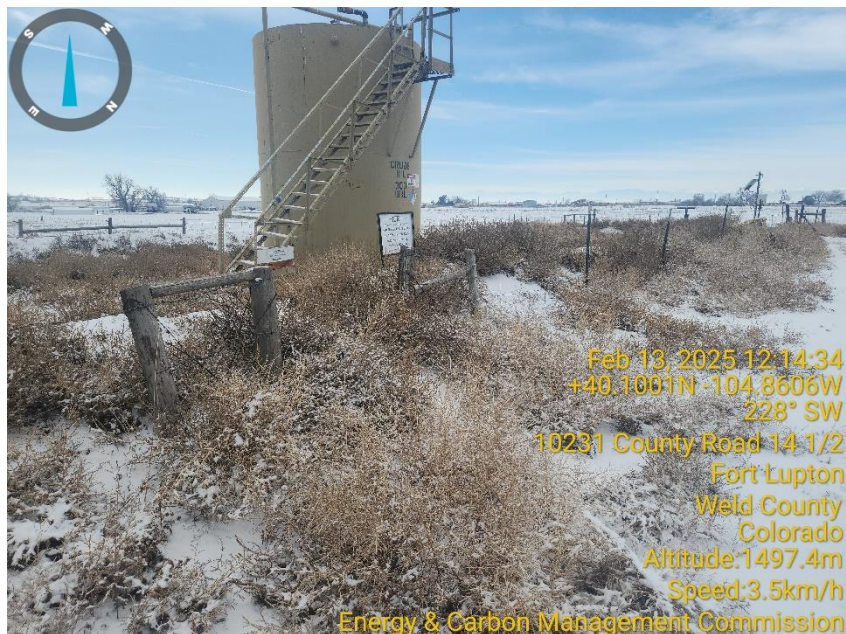
Photo 5 Dead vegetation inside/outside tank battery fencing & berm.

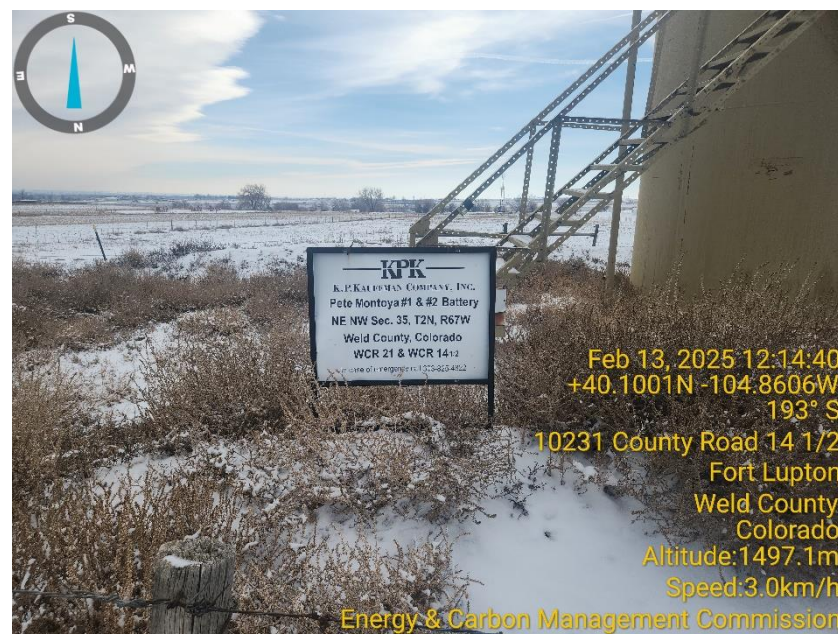
Photo 6 Tank battery sign.

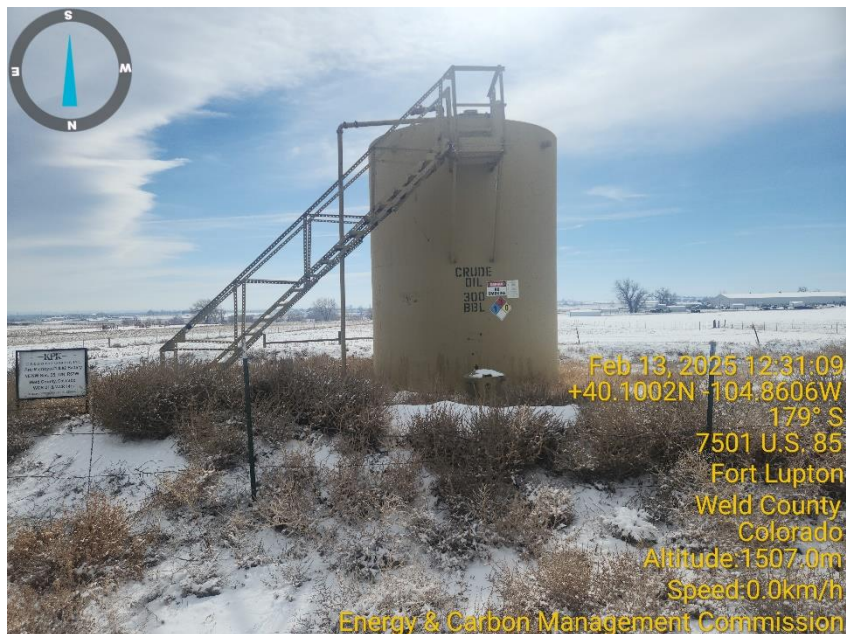
Photo 7 Tank battery, dead vegetation inside/outside tank battery fencing.

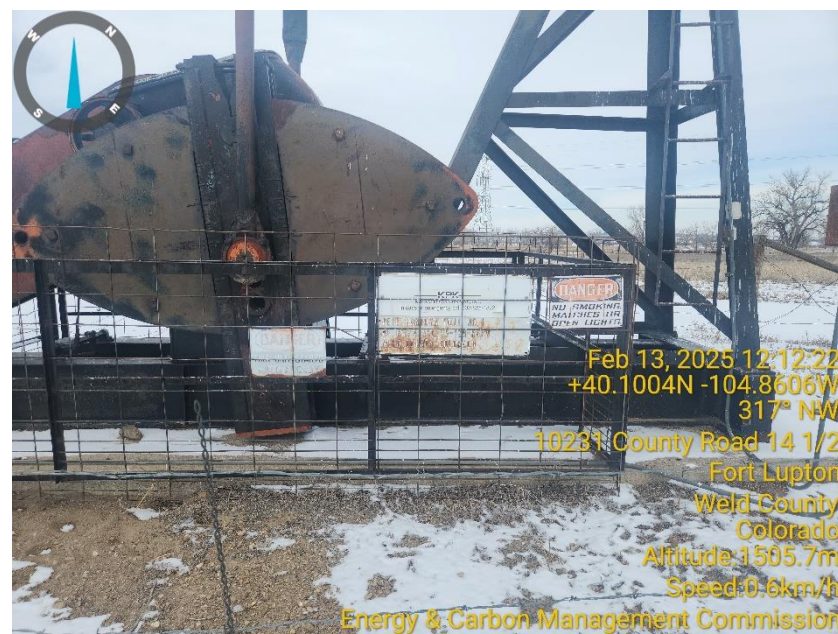
Photo 8 Wellhead sign.

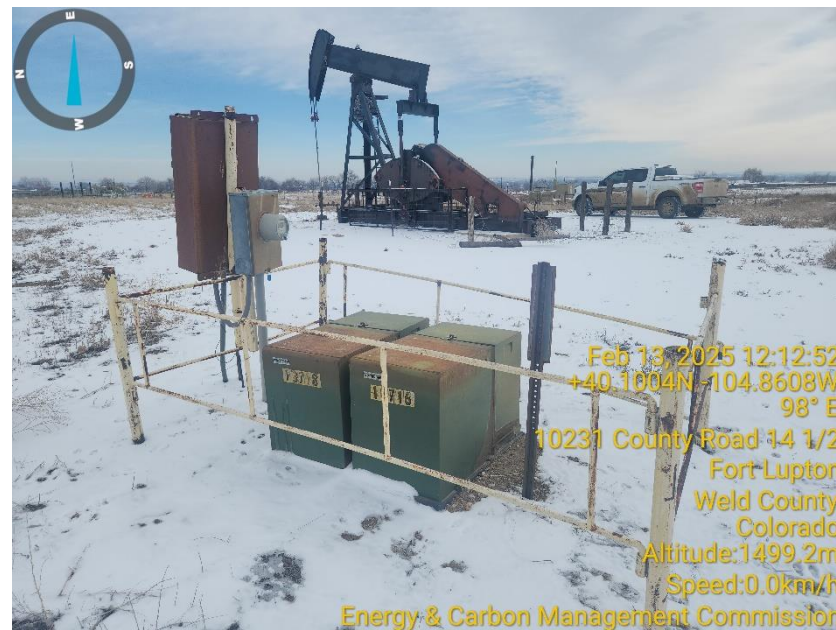
Photo 10 Ancillary equipment.

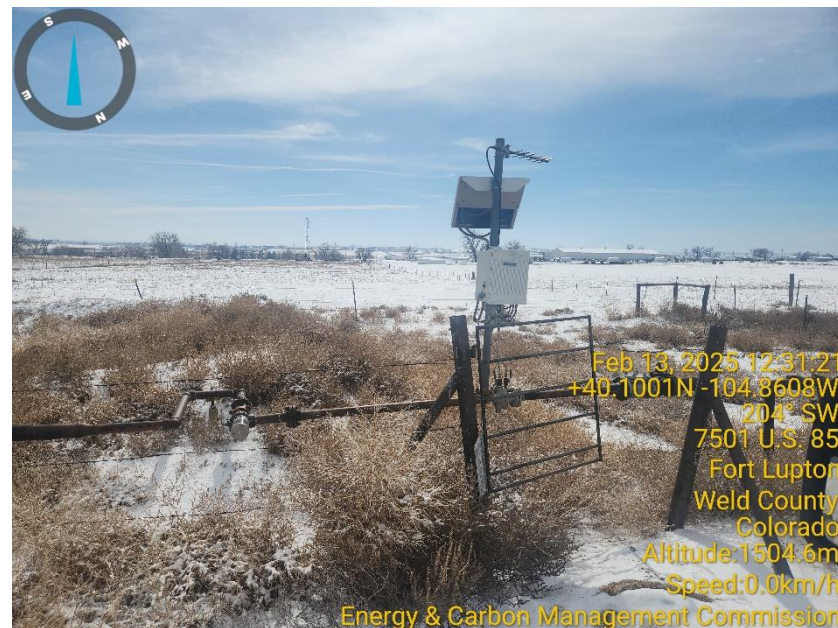
Photo 12 Gas Meter run.

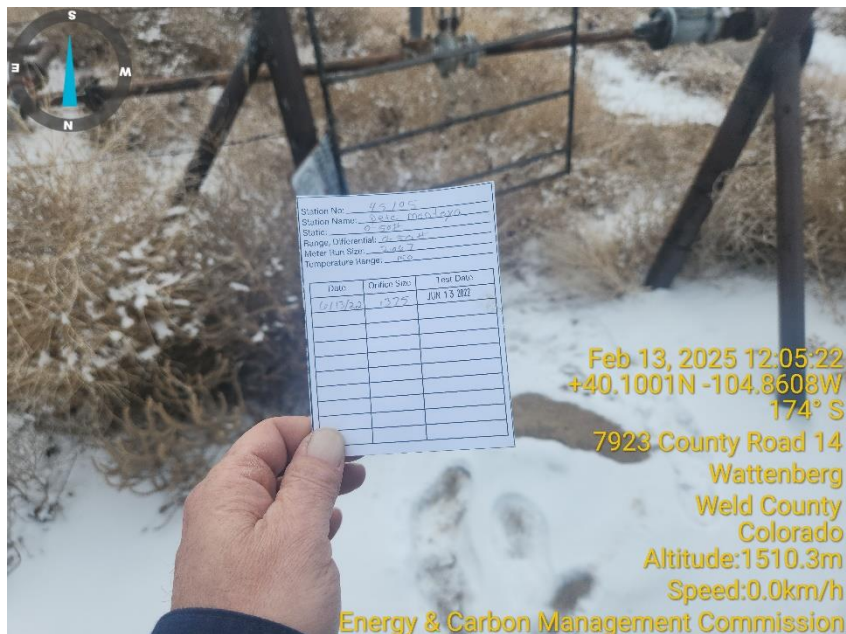
Photo 13 Card indicates that calibration is not current.
