Inspection/Audit Photos
Location Name: QB Energy SHIDELER (G32NE) Pad
Location #: 334853

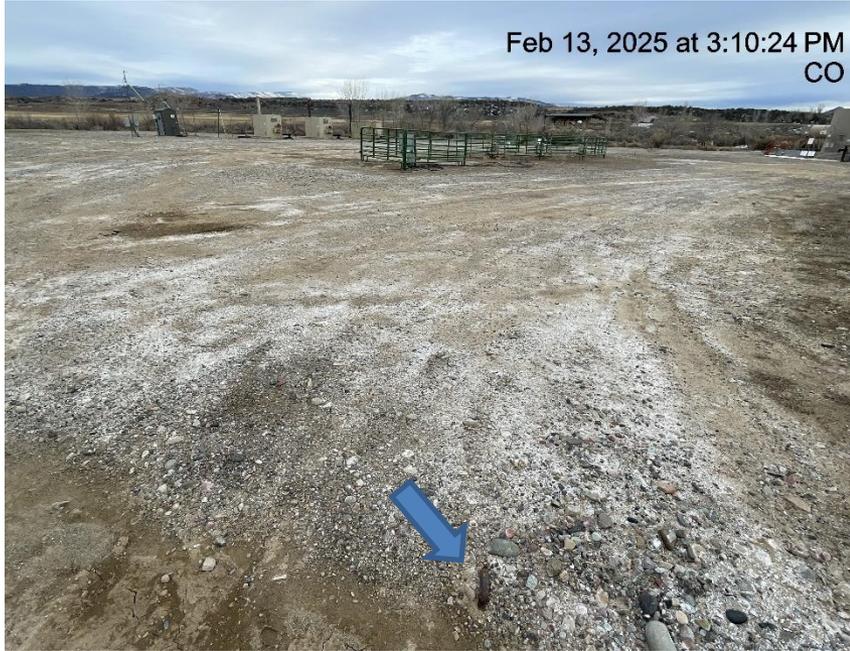
Photo # 6016 Unmarked deadman

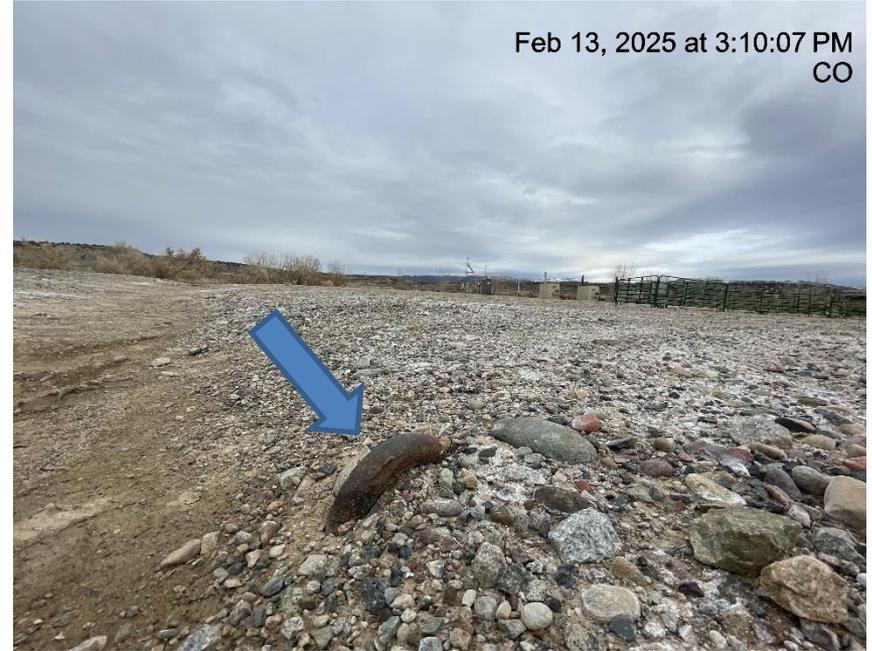
Photo # 6017 Same unmarked deadman

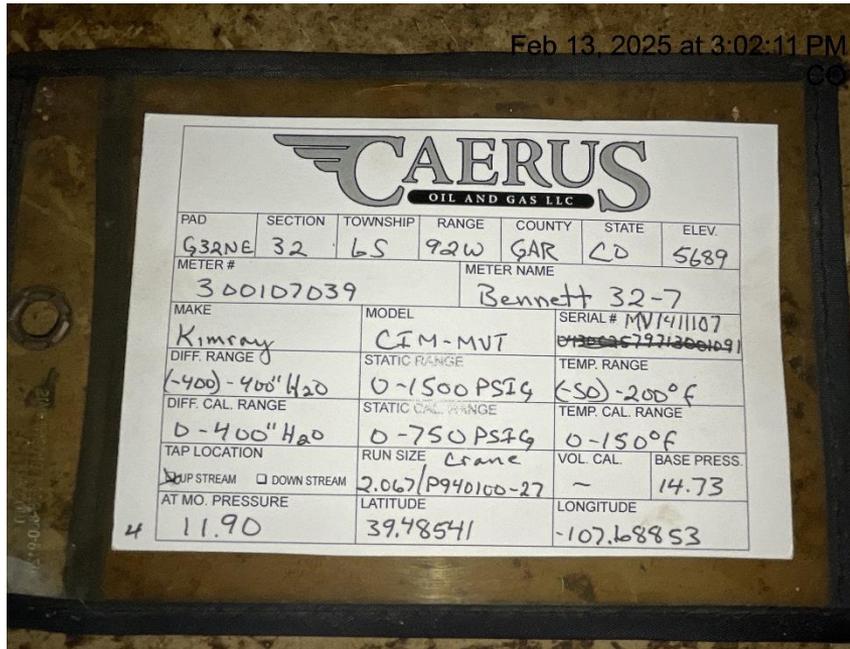
Photo # 6018 Cal card

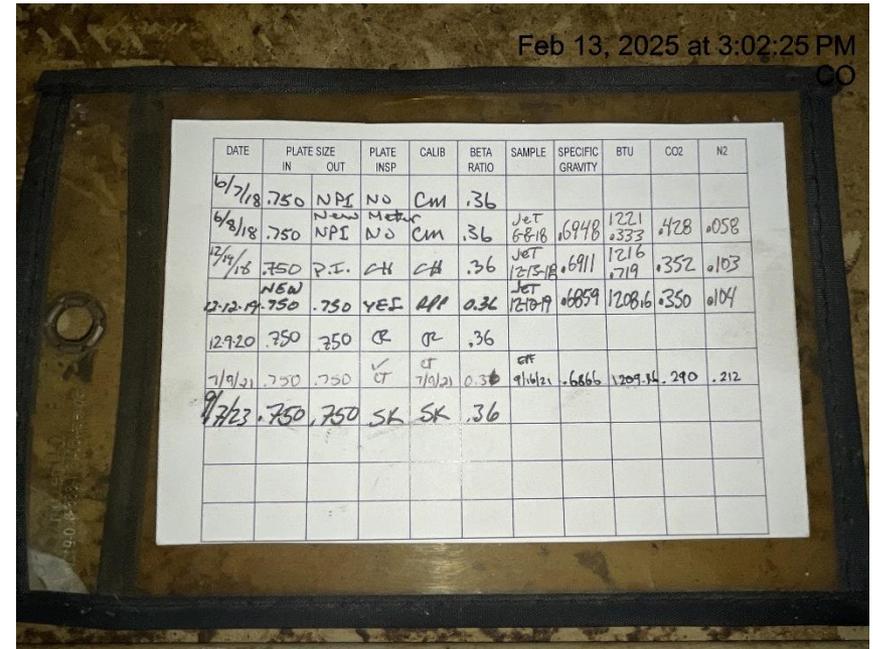
Photo # 6019 Meter not calibrated annually/not in compliance with CECMC rules

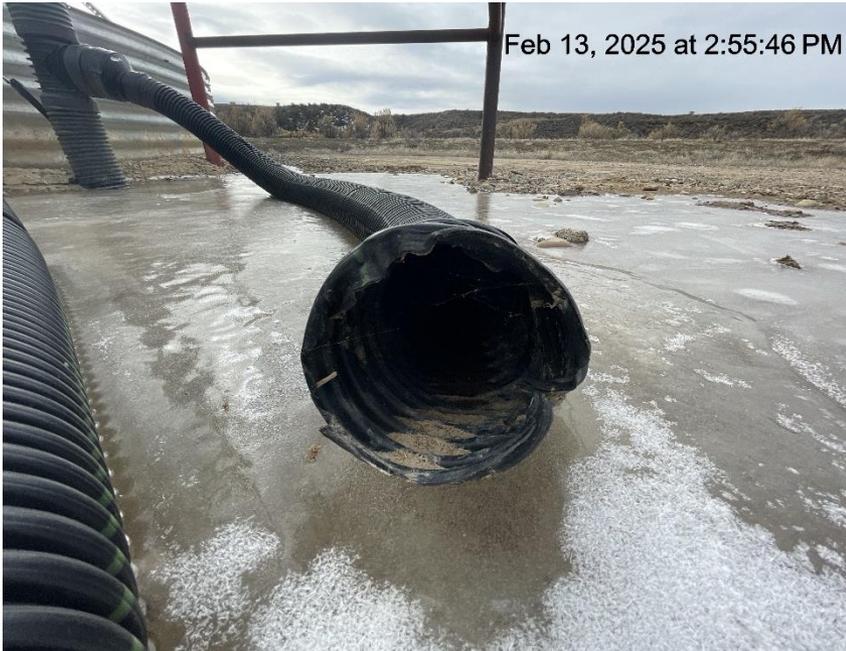
**Photo # 6020 Flowline heating insulation open ended
/wildlife hazard/available for entry by wildlife**

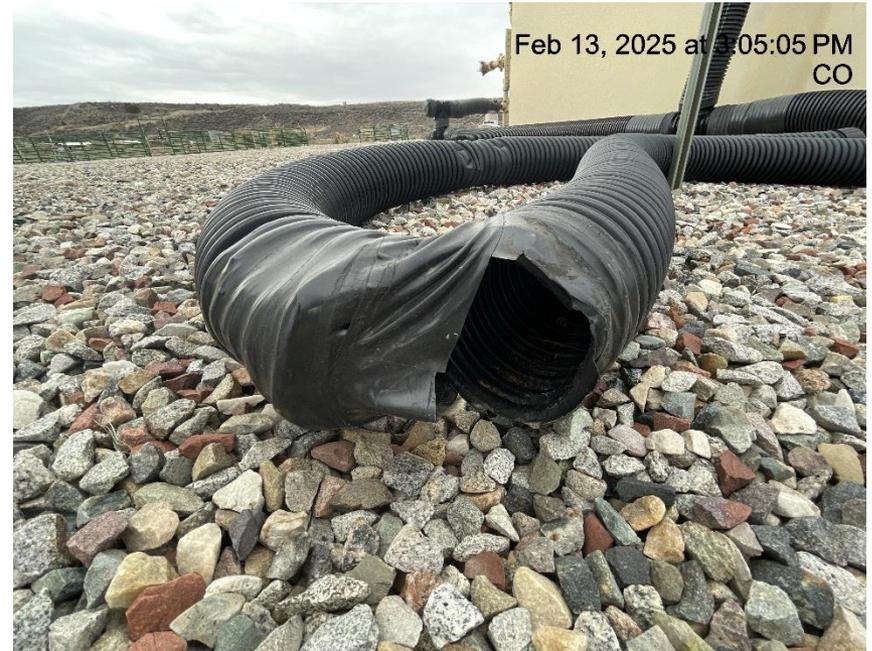
**Photo # 6021 Flowline heating insulation damaged/wildlife
hazard/available for entry by wildlife**
