Inspection/Audit Photos

Location Name: TEP ROCKY MOUNTAIN LLC LOUTHAN 41B-34 Pad

Location ID: 335439

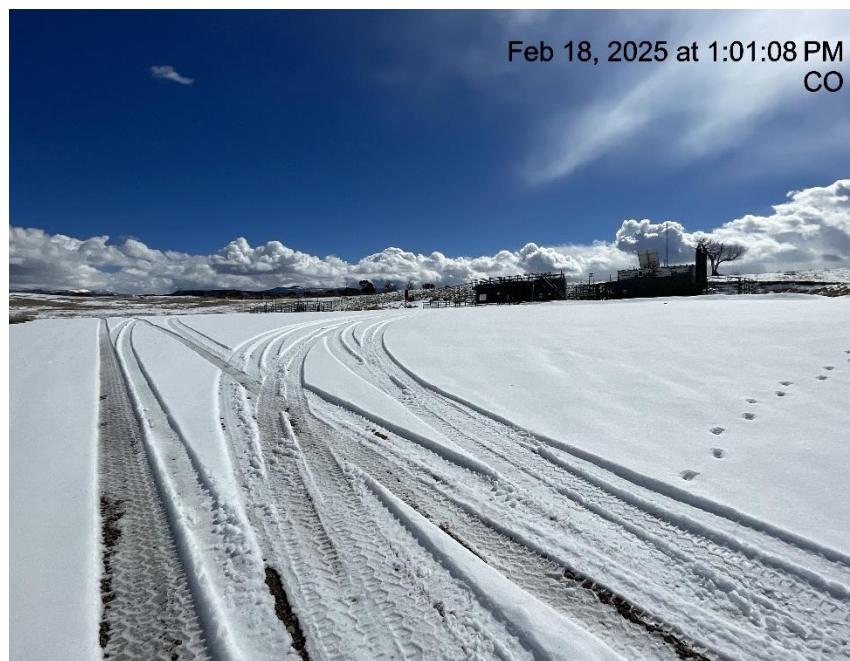
Photo # 6357 From entrance to location

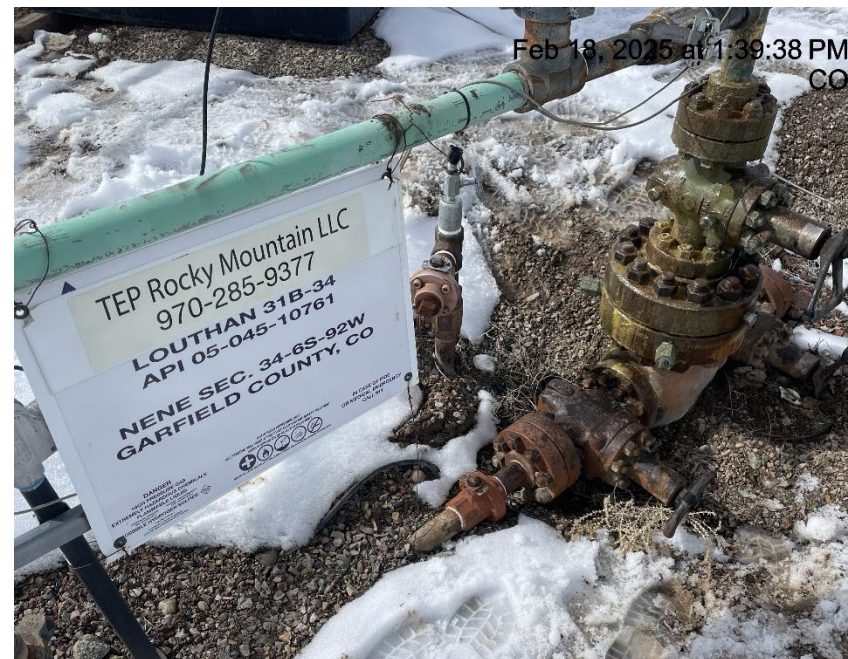
Photo # 6364 Mechanical condition – possible wellhead leak on the LOUTHAN 31B-34 wellhead

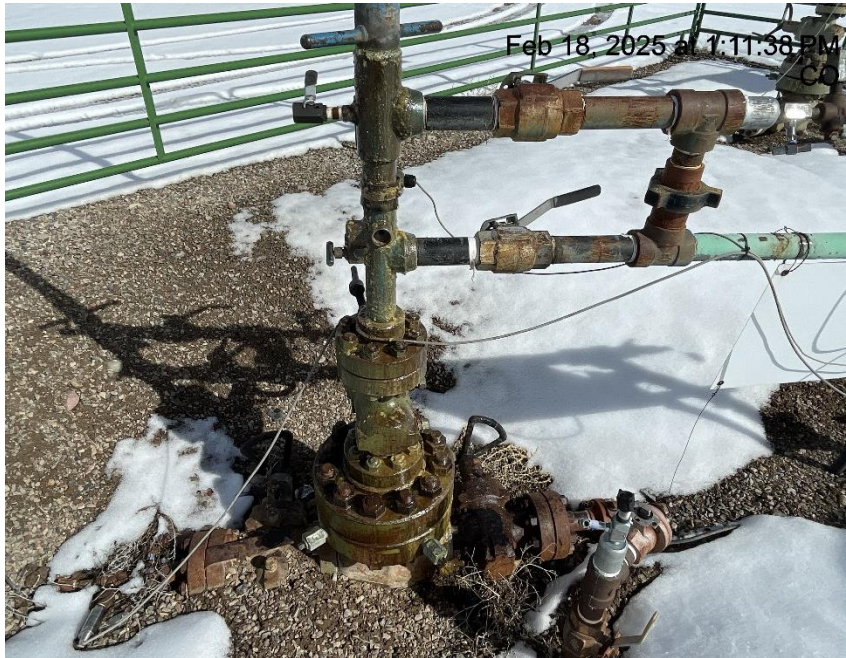
Photo # 6365 Mechanical condition – possible wellhead leak on the LOUTHAN 31B-34 wellhead

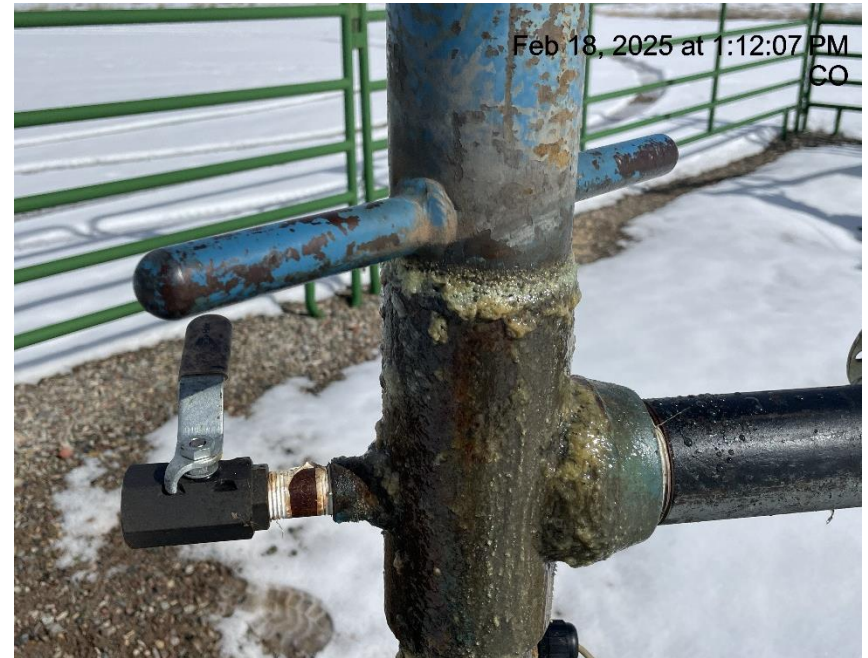
Photo # 6366 Mechanical condition – possible wellhead leak on the LOUTHAN 31B-34 wellhead

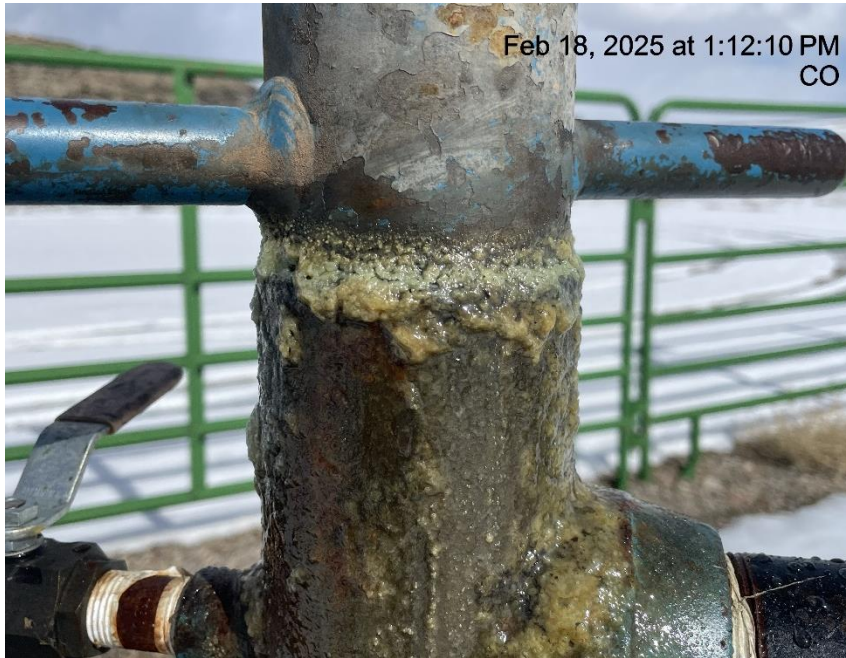
Photo # 6367 Mechanical condition – possible wellhead leak on the LOUTHAN 31B-34 wellhead

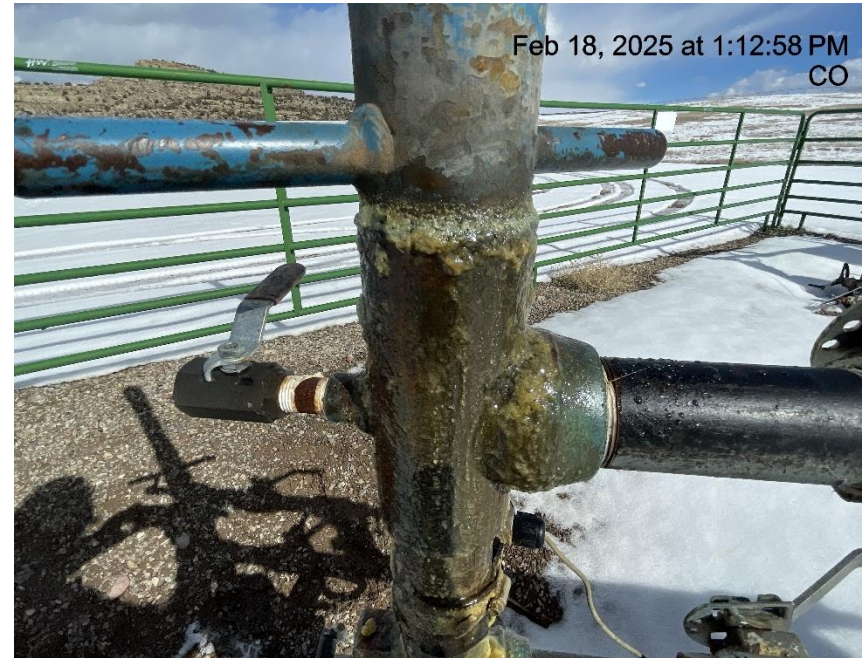
Photo # 6368 Mechanical condition – possible wellhead leak on the LOUTHAN 31B-34 wellhead

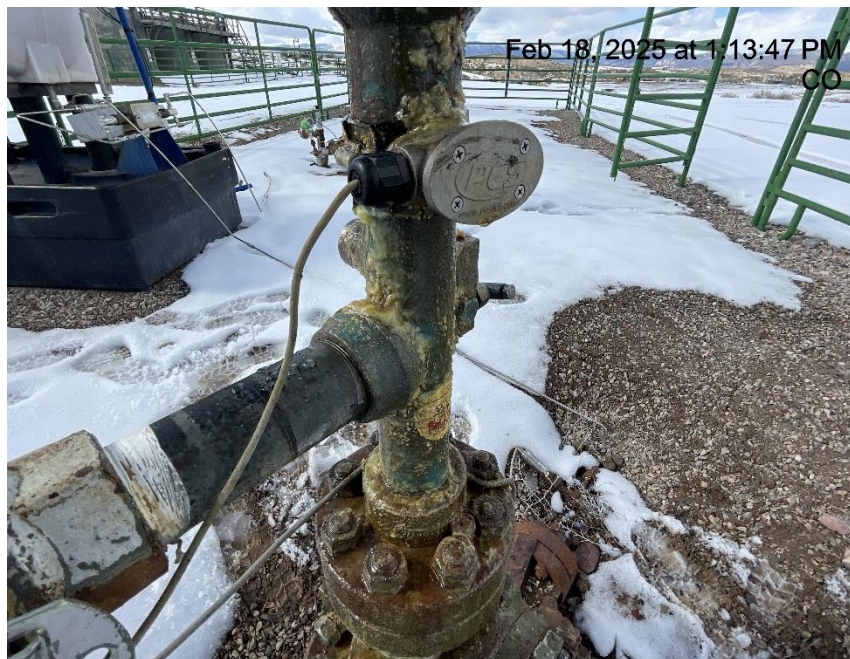
Photo # 6369 Mechanical condition – possible wellhead leak on the LOUTHAN 31B-34 wellhead

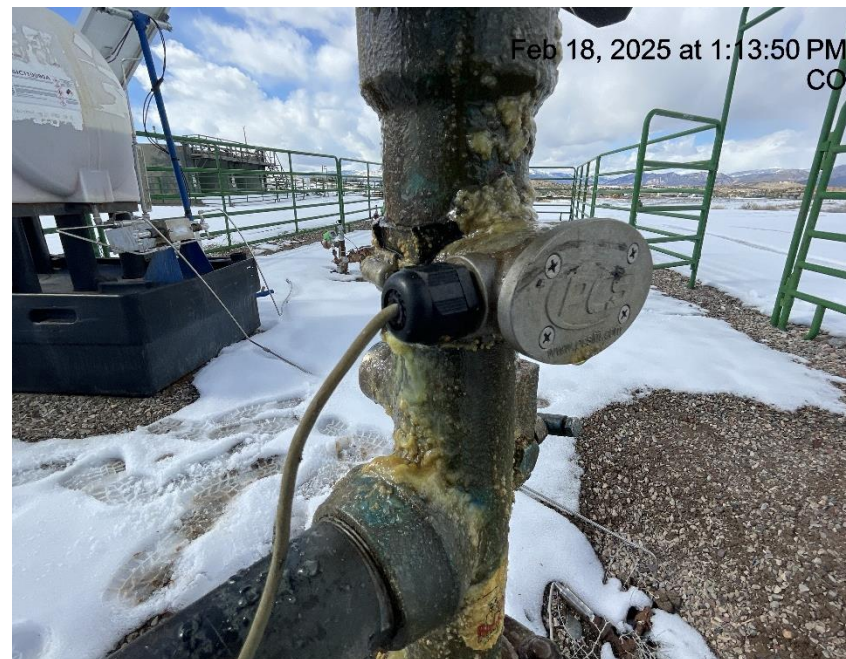
Photo # 6370 Mechanical condition – possible wellhead leak on the LOUTHAN 31B-34 wellhead

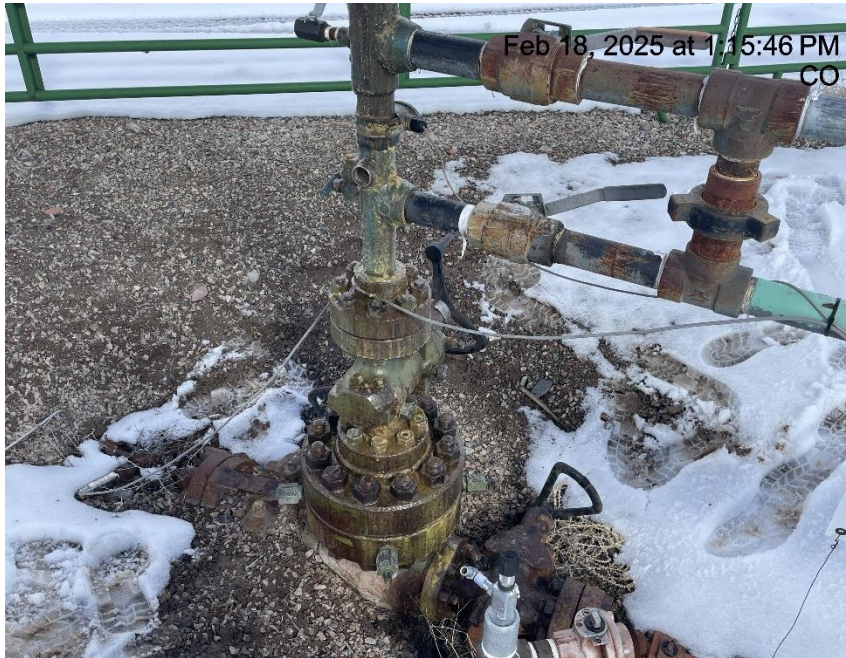
Photo # 6371 Mechanical condition – possible wellhead leak on the LOUTHAN 31B-34 wellhead

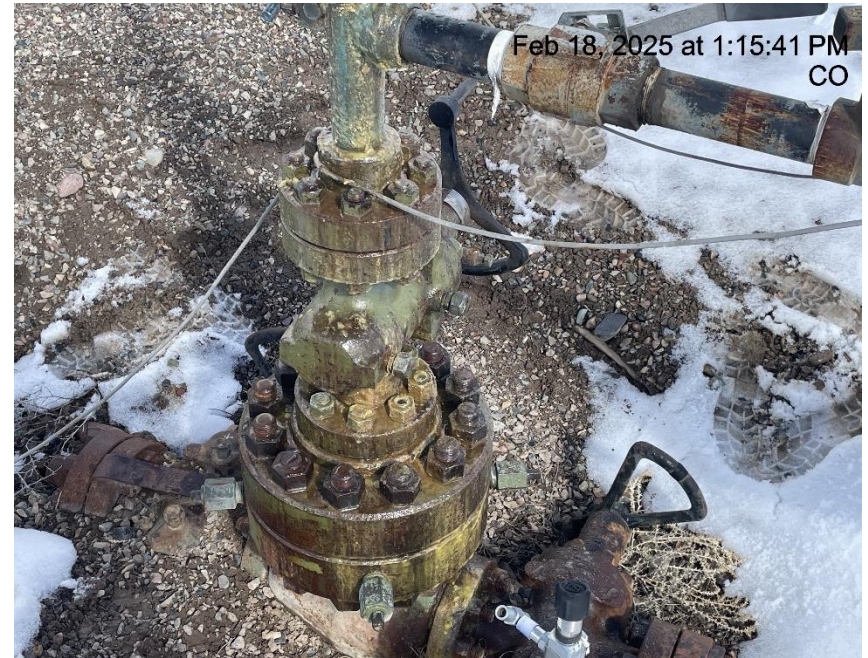
Photo # 6372 Mechanical condition – possible wellhead leak on the LOUTHAN 31B-34 wellhead

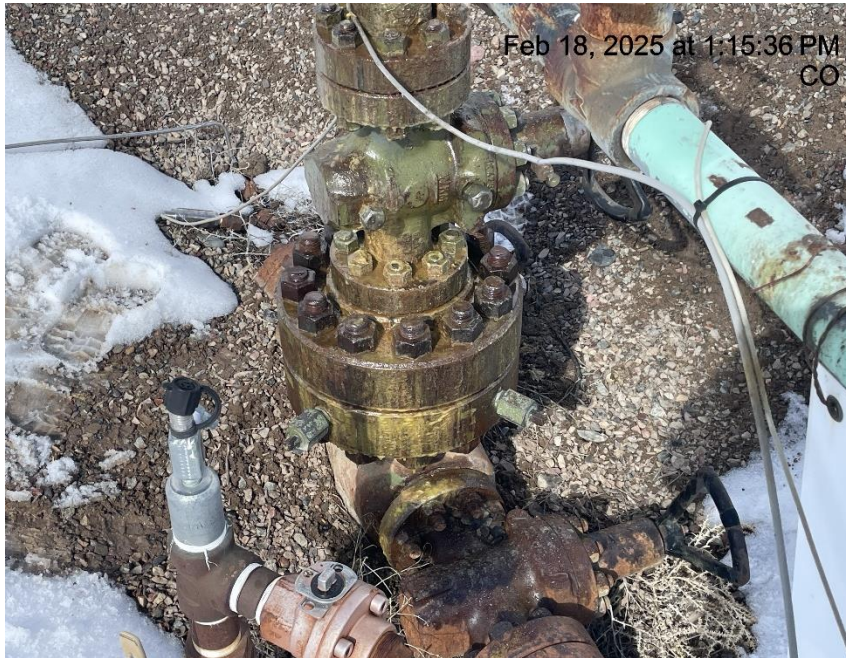
Photo # 6373 Mechanical condition – possible wellhead leak on the LOUTHAN 31B-34 wellhead

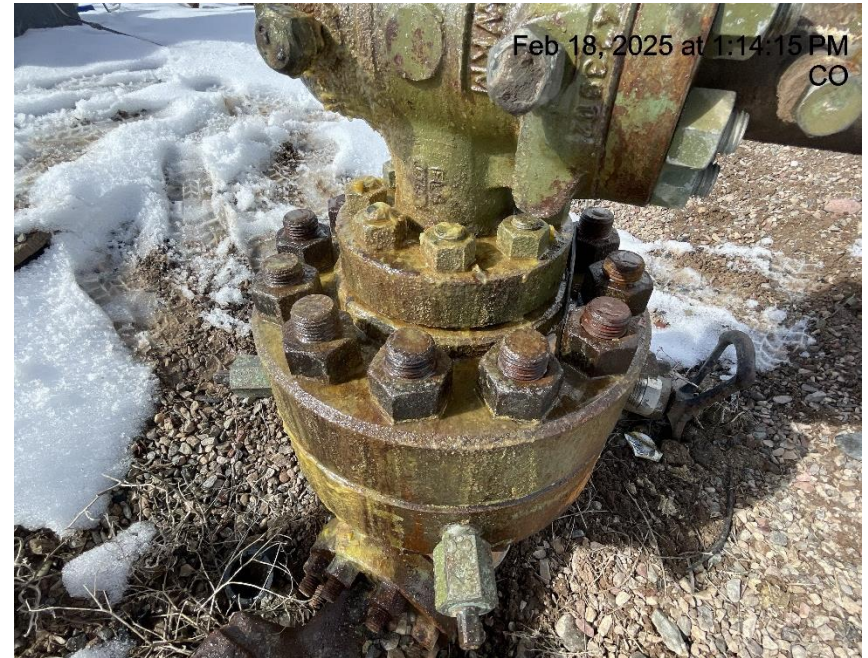
Photo # 6374 Mechanical condition – possible wellhead leak on the LOUTHAN 31B-34 wellhead

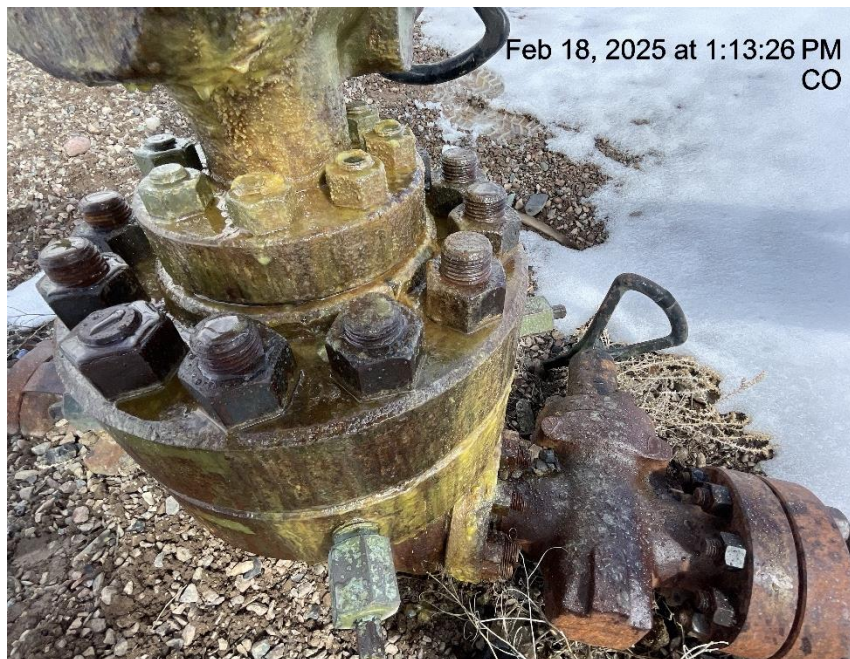
Photo # 6375 Mechanical condition – possible wellhead leak on the LOUTHAN 31B-34 wellhead

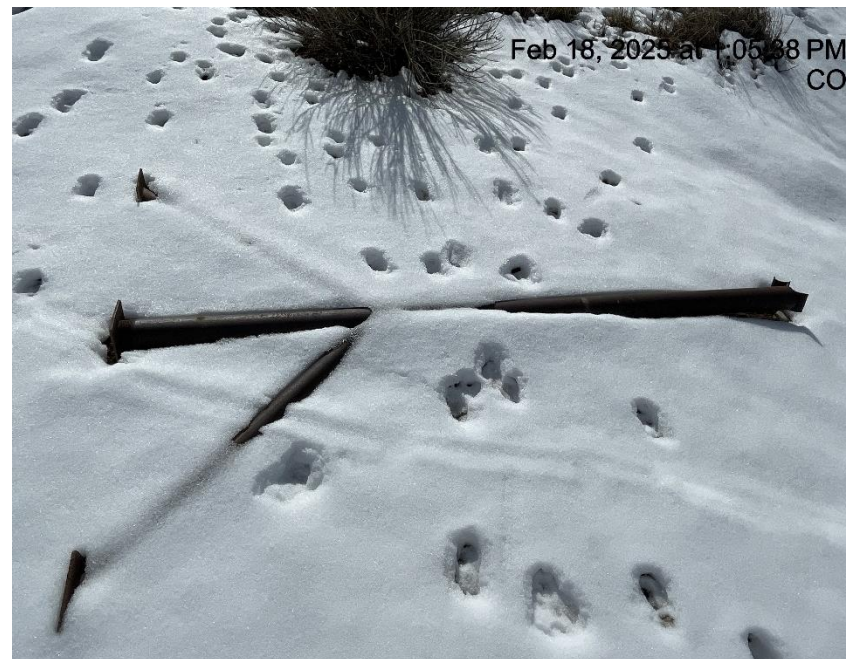
Photo # 6376 Debris

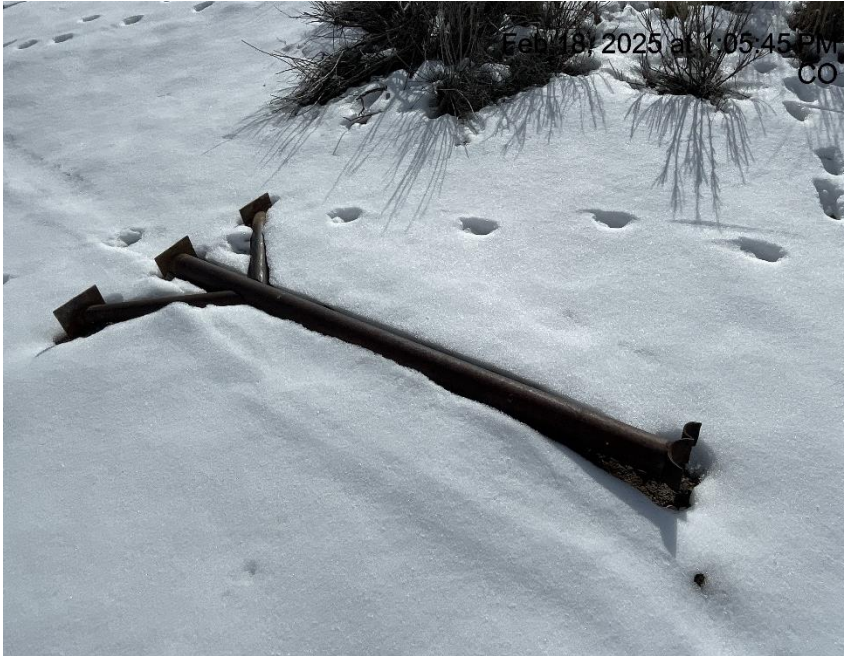
Photo # 6377 Debris

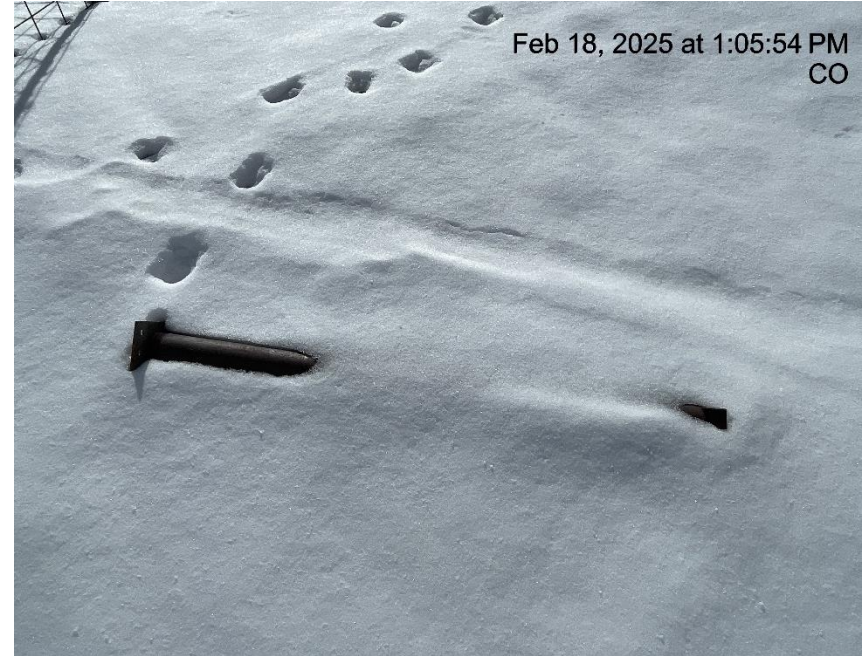
Photo # 6378 Debris
