Inspection/Audit Photos

Location: QB ENERGY HYRUP-68S96W/2NESW (PAD-2 K)

Location ID: 334342

Date: 02/18/2025

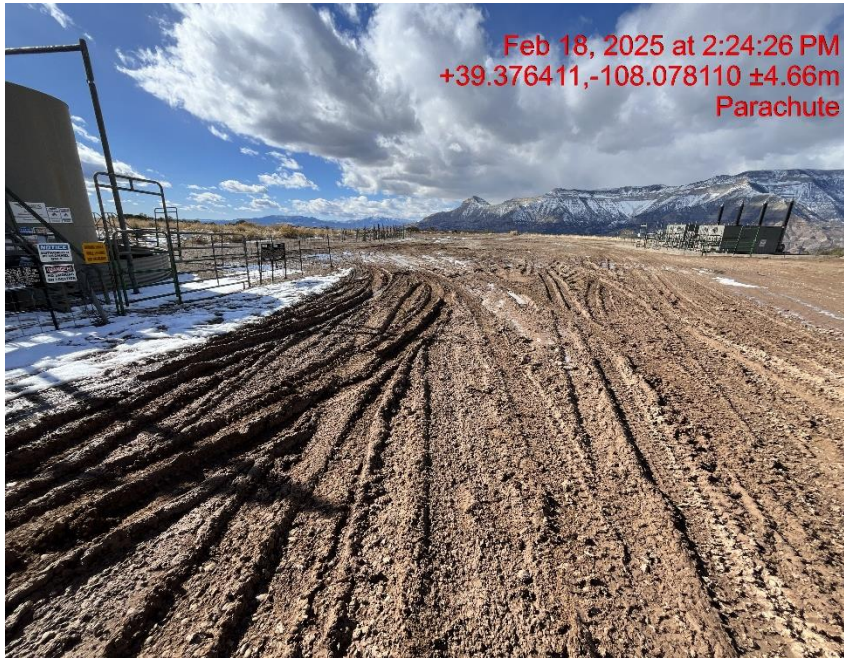
Photo # 5309 Lack of stabilization/compaction on location and lease road/insufficient tracking BMP's

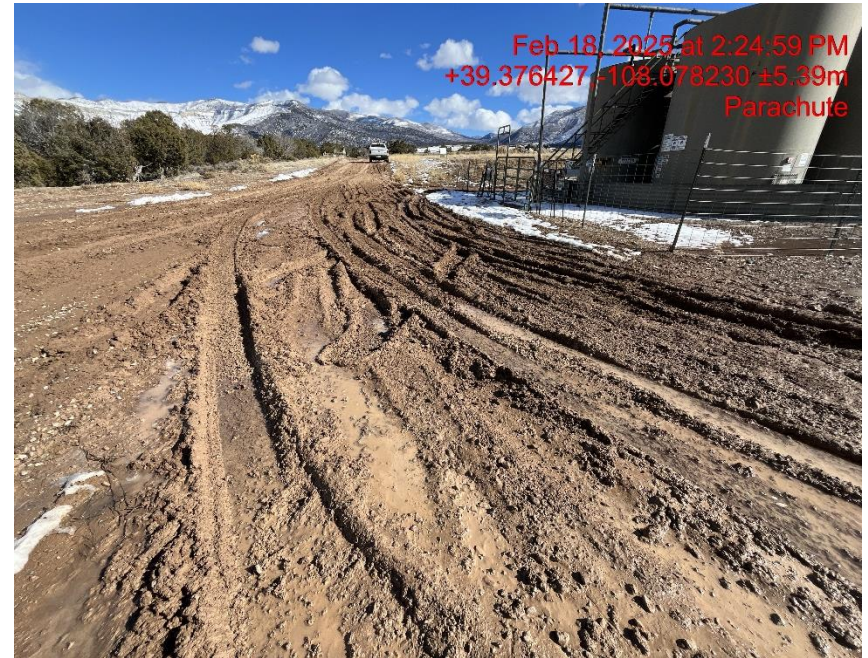
Photo # 5310 Lack of stabilization/compaction on location and lease road/insufficient tracking BMP's

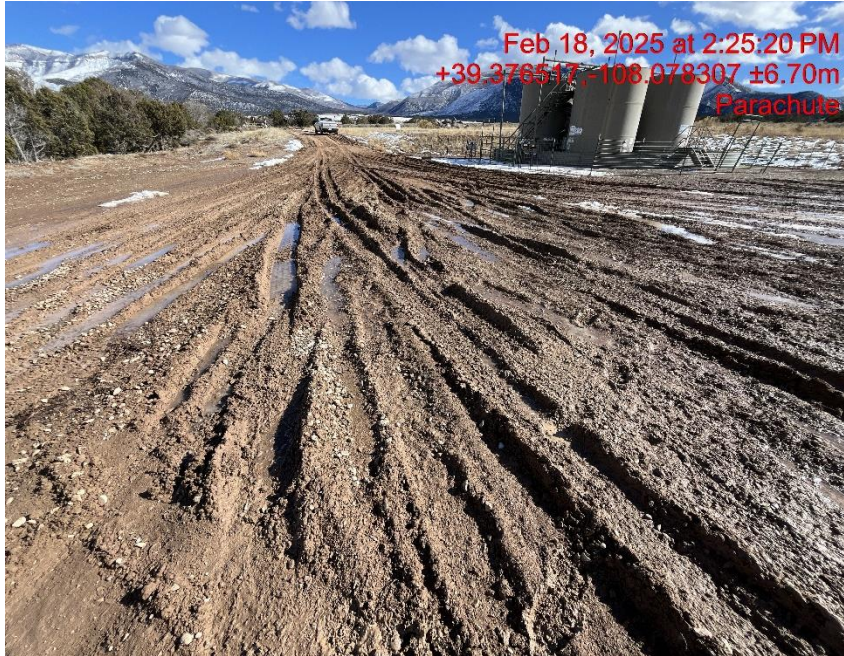
Photo # 5311 Lack of stabilization/compaction on location and lease road/insufficient tracking BMP's

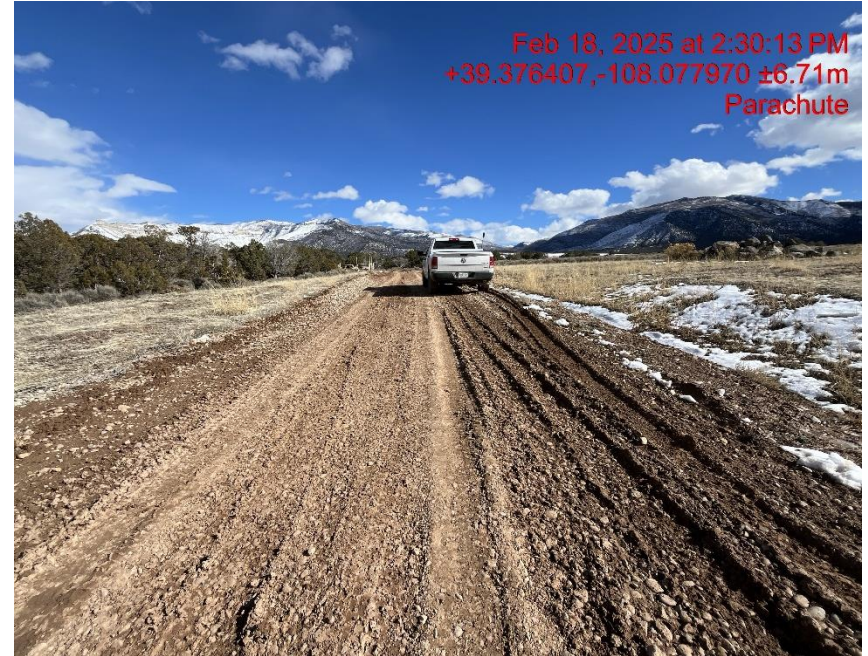
Photo # 5316 Lack of stabilization/compaction on location and lease road/tracking onto lease road/insufficient tracking BMP's
