# Final Reclamation and Stormwater Inspection

January 27, 2025

Well Name: WILLIAMS H. PELTIER #12-20

Inspection Document #: 718600336

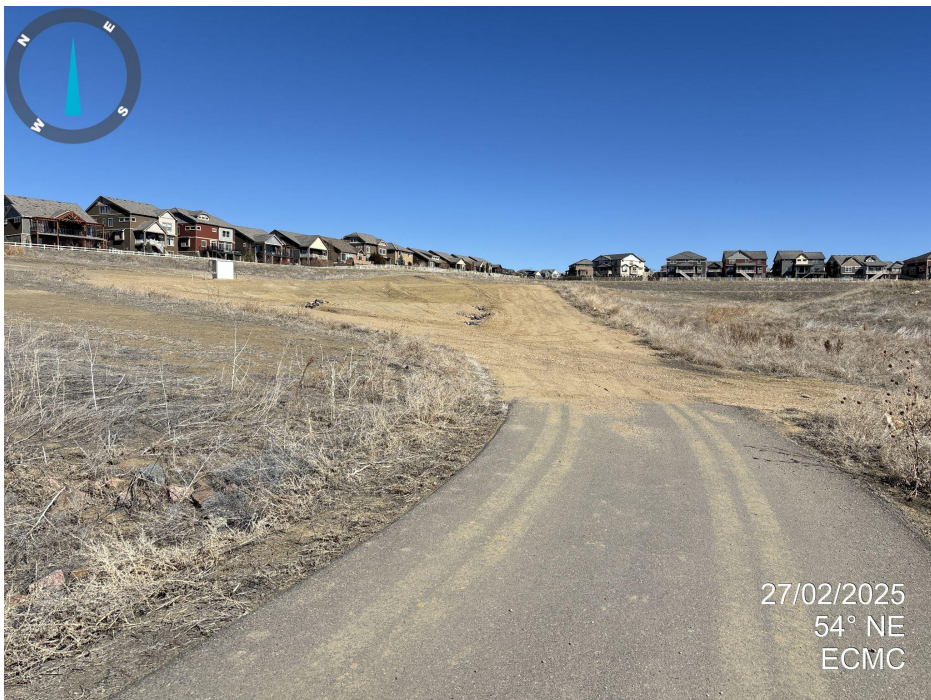
**Photo 1.** Looking northeast across location. Reclamation work has not begun on the pad.

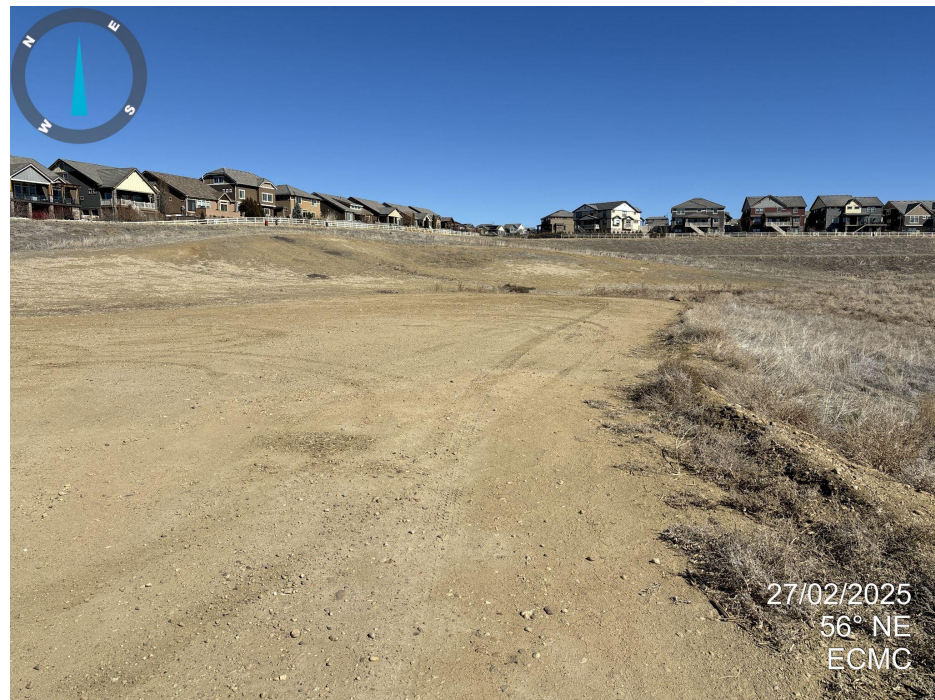
**Photo 2.** Picture taken on eastern side of pad looking northeast across former wellbore. Excavations are filled.

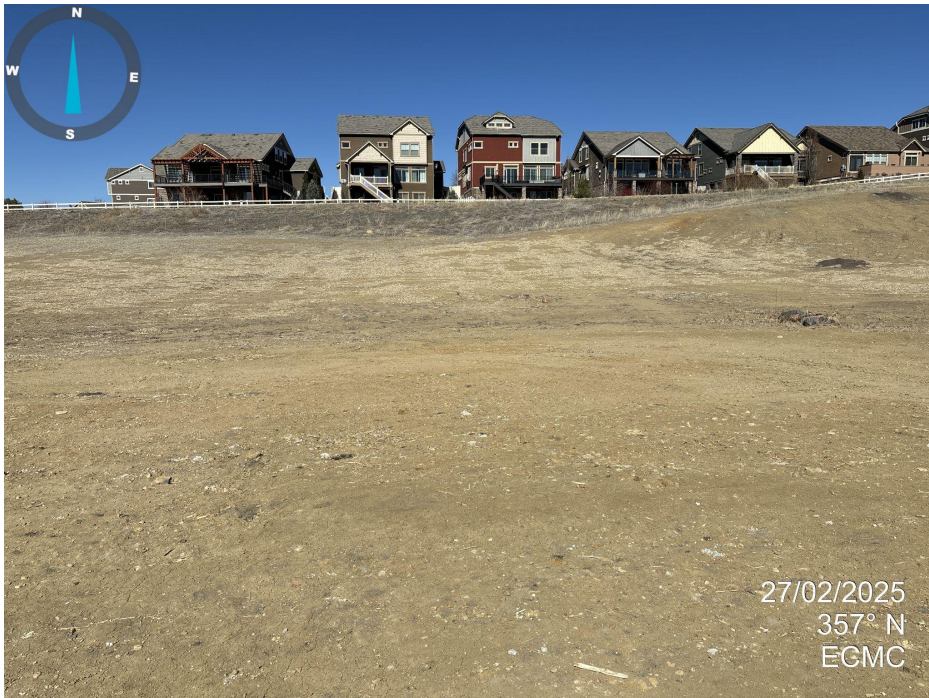
**Photo 3.** Looking north from wellbore. The area to the north, east and west of the pad appears to have reclamation work conducted.

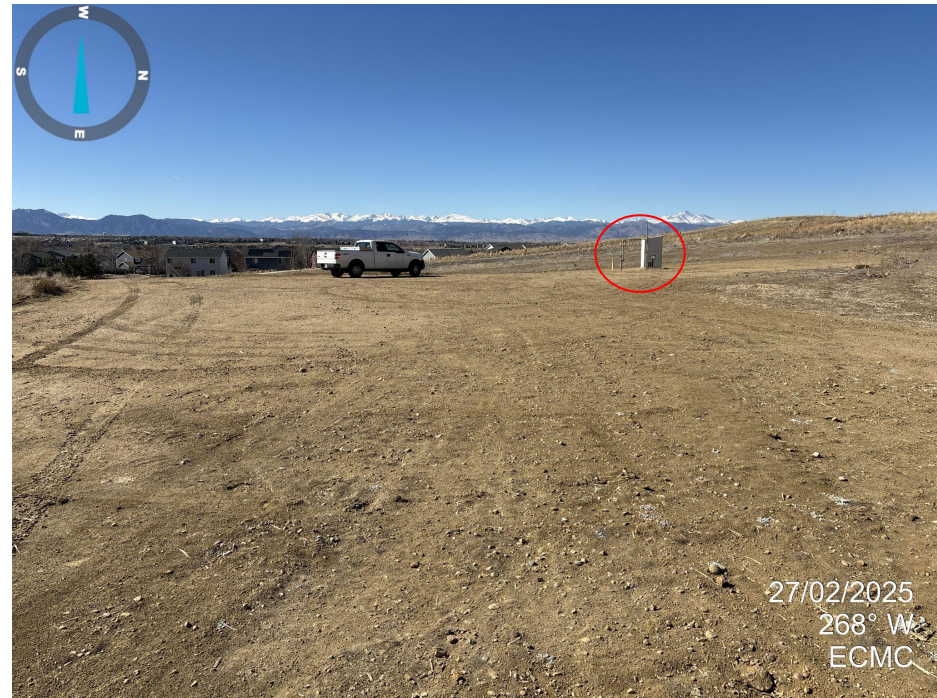
**Photo 4.** Looking west from wellbore. A shed and riser remain on location (red circle).

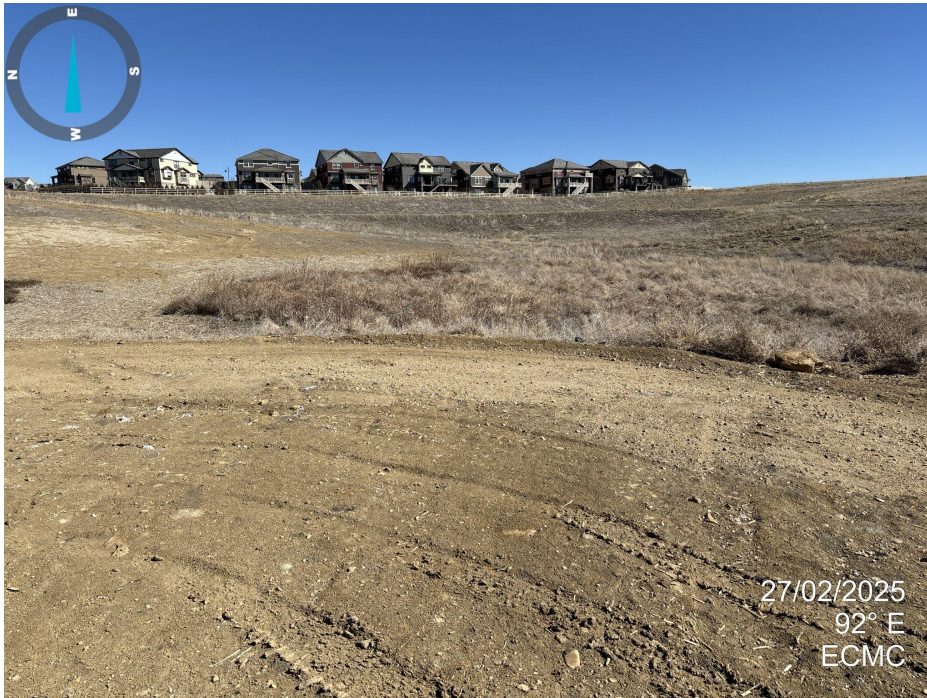
**Photo 5.** Looking east from wellbore. 5 abandoned locations are associated with this location, they do not appear to have been drilled.

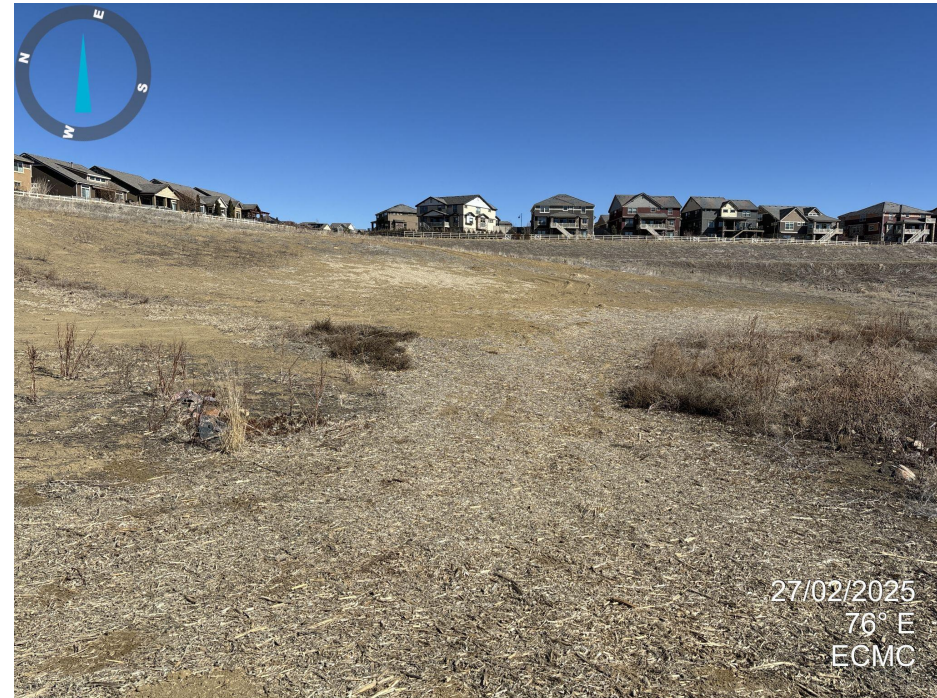
**Photo 6.** Looking east from the edge of the pad. Stormwater BMPs (rock check dams) are present in this area. Corn/straw cover is present in this area. At the time of inspection no germination was observed and ground was primarily bare soil. Undesirable weeds Kochia and Russian thistle are present in the areas around the well pad.

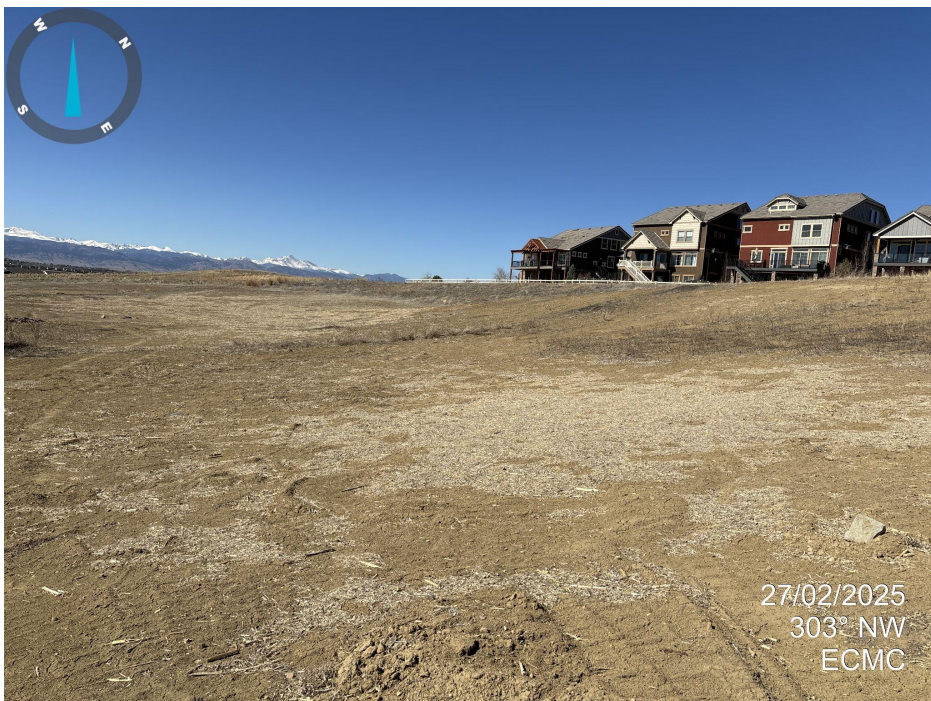
**Photo 7.** Photo taken to the north of the pad looking west. This area is outside the pad to the north. See Photo 6 comments.

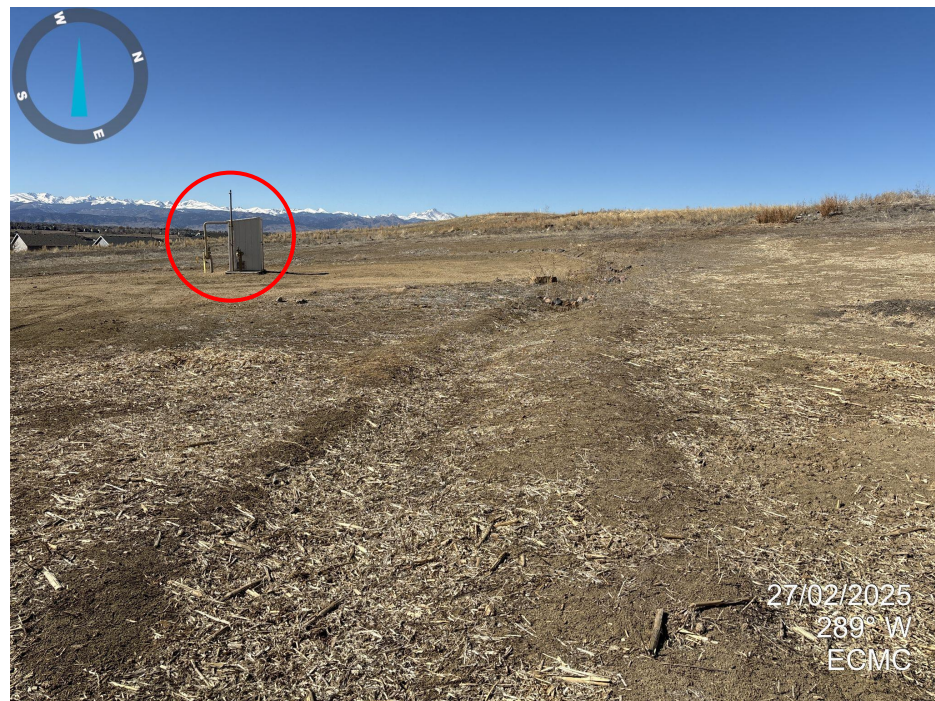
**Photo 8.** Looking west across the north side of pad. A perimeter ditch with rock check dams is in place. Shed with pipe riser remains on location (red circle), also pictured in Photo 4.

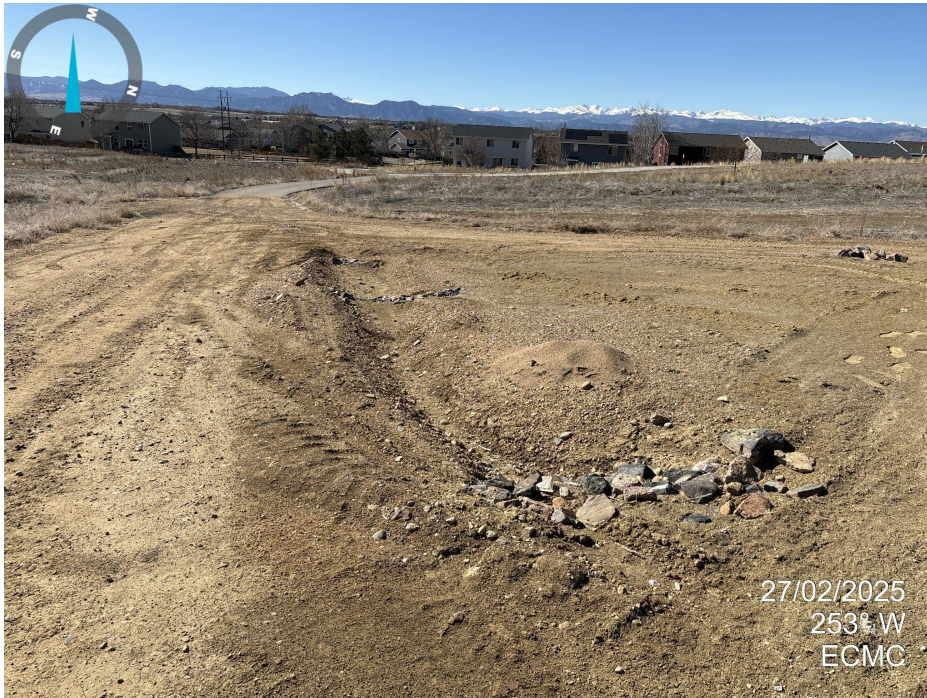
**Photo 9.** Looking west across the former tank battery in the center part of location. Check dams are present, dams are full of sediment.

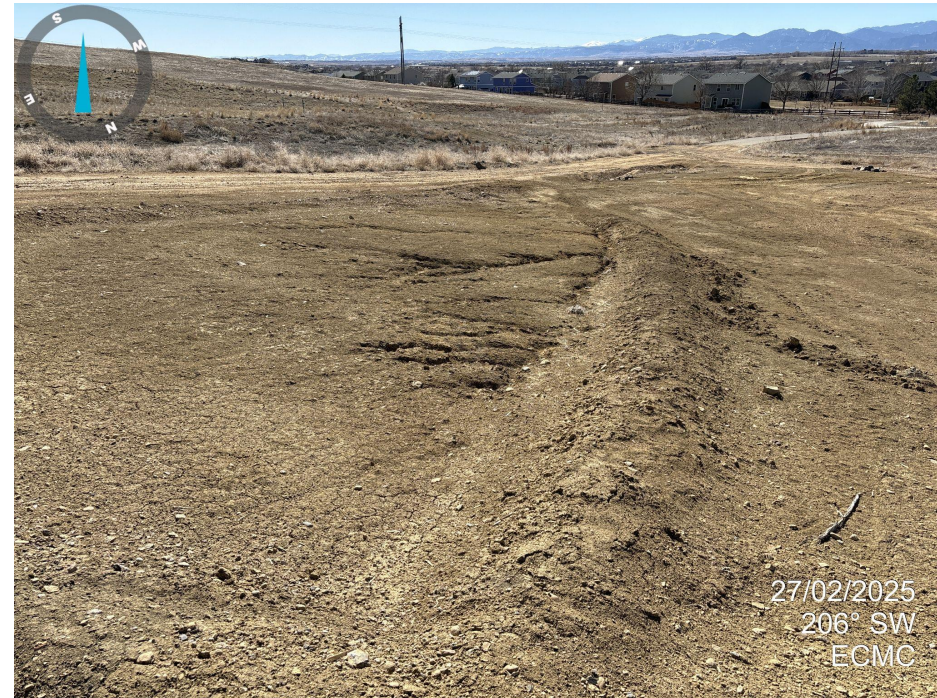
**Photo 10.** Looking south across former tank battery. Erosion channels are present.
