Inspection Photos

API: 009-06574

Operator: WEST TEXAS OPERATING
CO LLC DBA XTREME ENERGYCO

Inspection Date: 3/4/2025

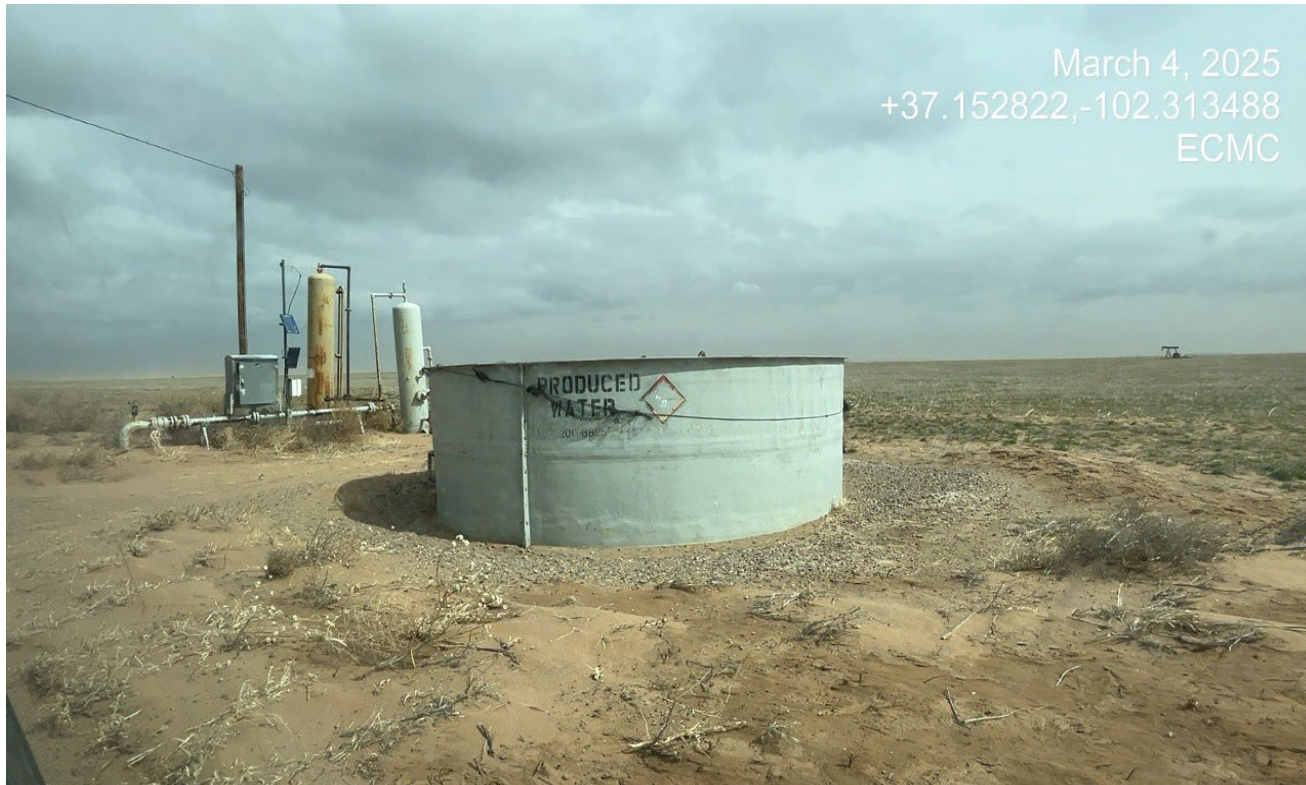
Photo 1. Facing northeast toward the offsite tank battery. The tank does not have sufficient secondary containment and the labels are missing.

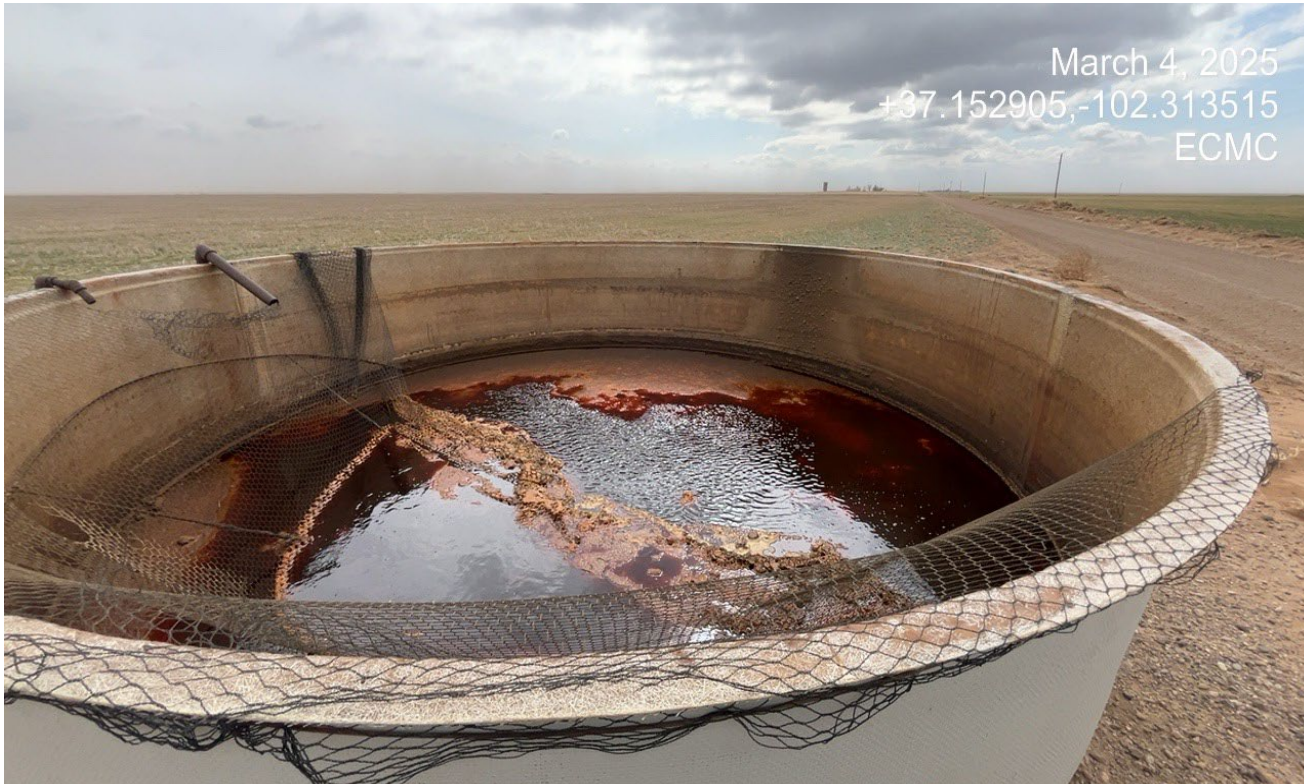
Photo 2. The netting on the tank is not maintained to prevent wildlife entry.

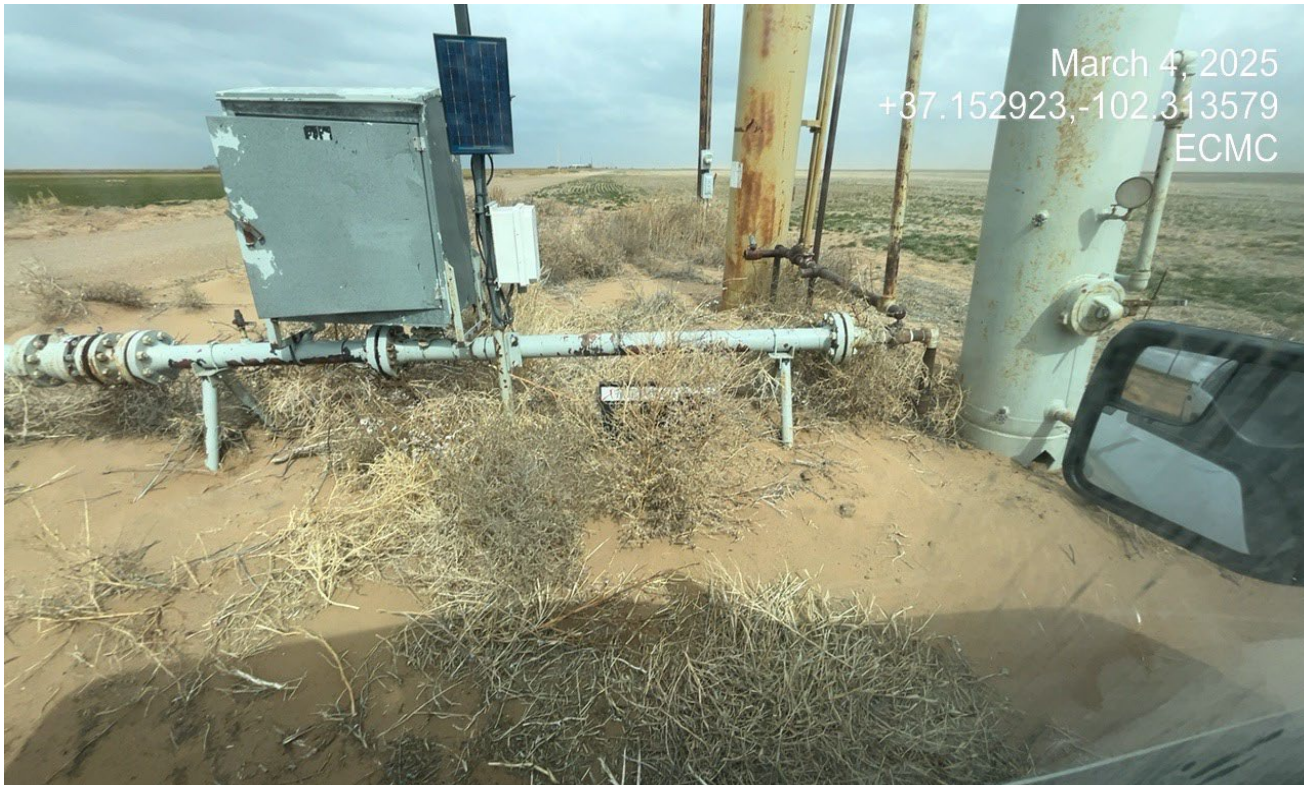
Photo 3. The sign is partially buried in the sand and weeds are around the equipment..

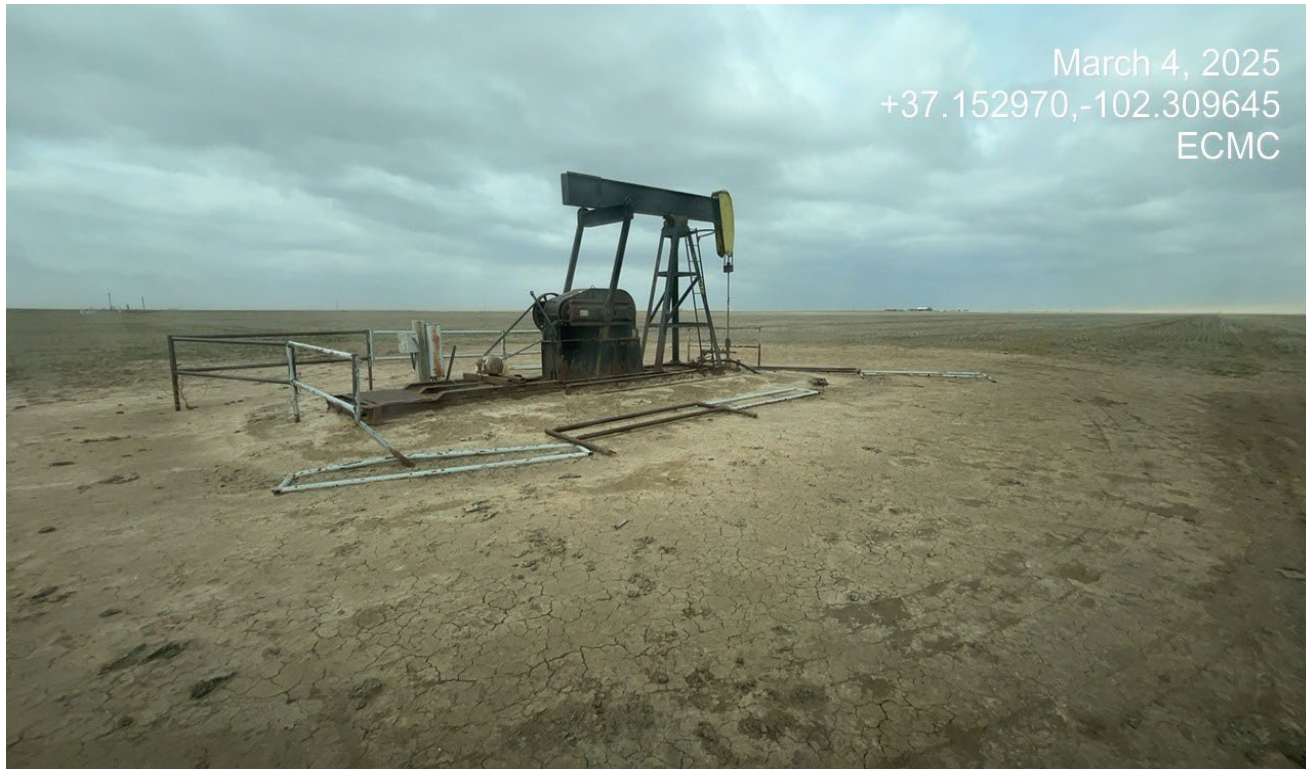
Photo 4. Facing northwest toward the wellsite. The fence panels have fallen over around the pumpjack.
