Inspection Photos

API: 009-06577

Operator: WEST TEXAS OPERATING
CO LLC DBA XTREME ENERGYCO

Inspection Date: 3/4/2025

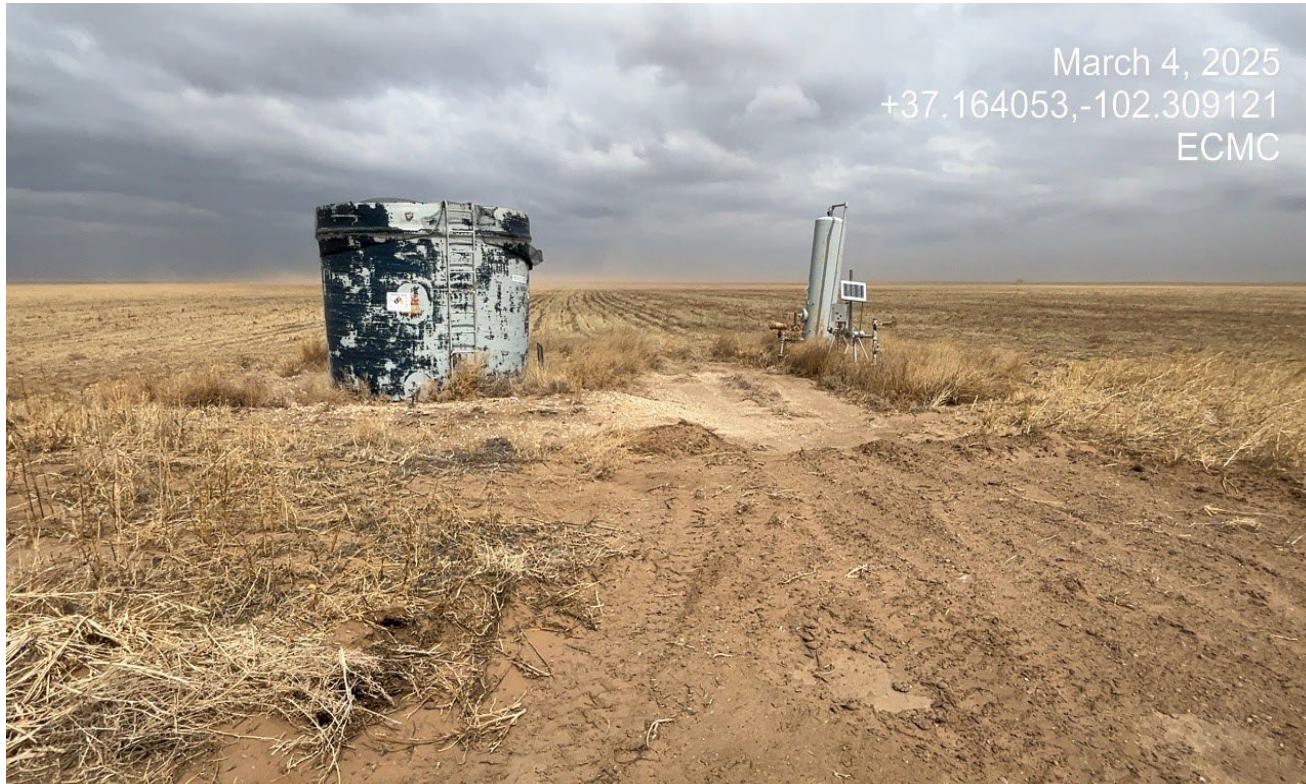
Photo 1. Facing north toward the offsite tank battery. The tank does not have sufficient secondary containment.

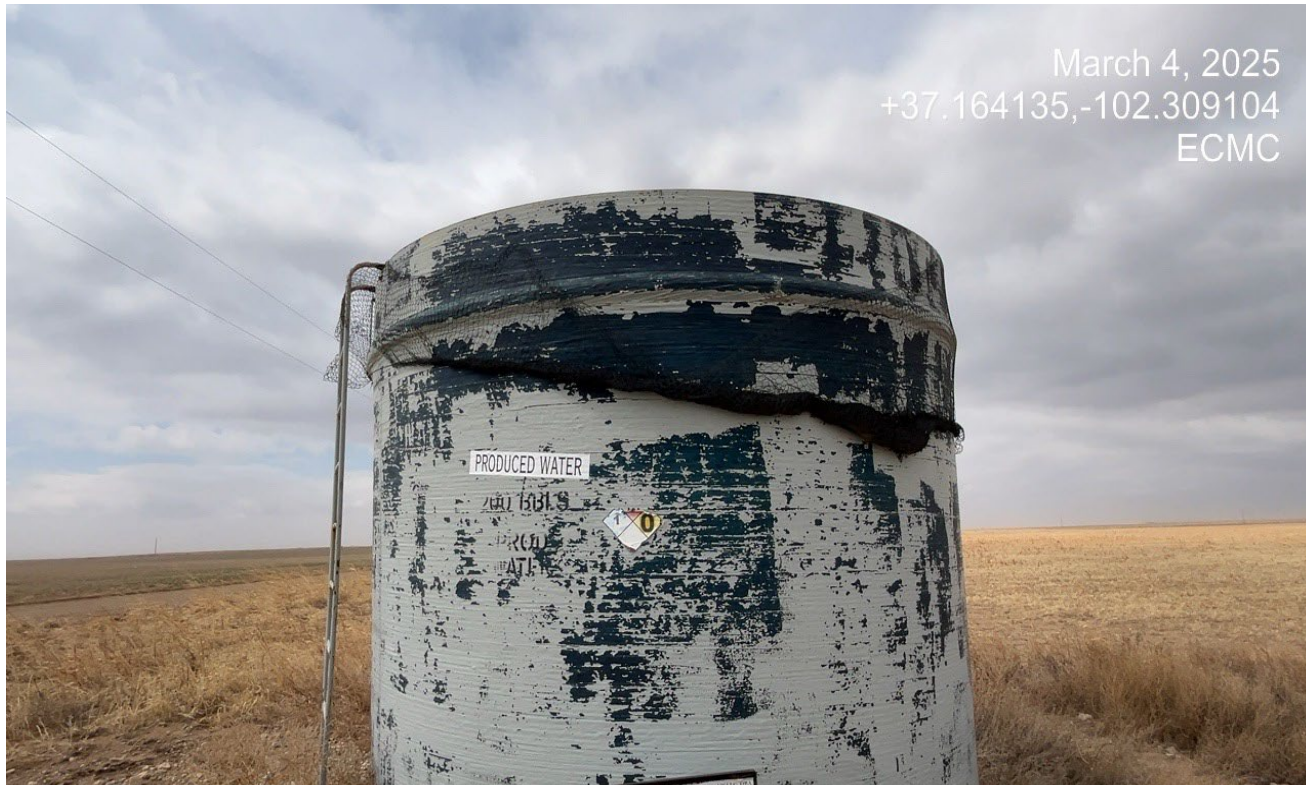
Photo 2. The netting on the tank is not maintained to prevent wildlife entry.

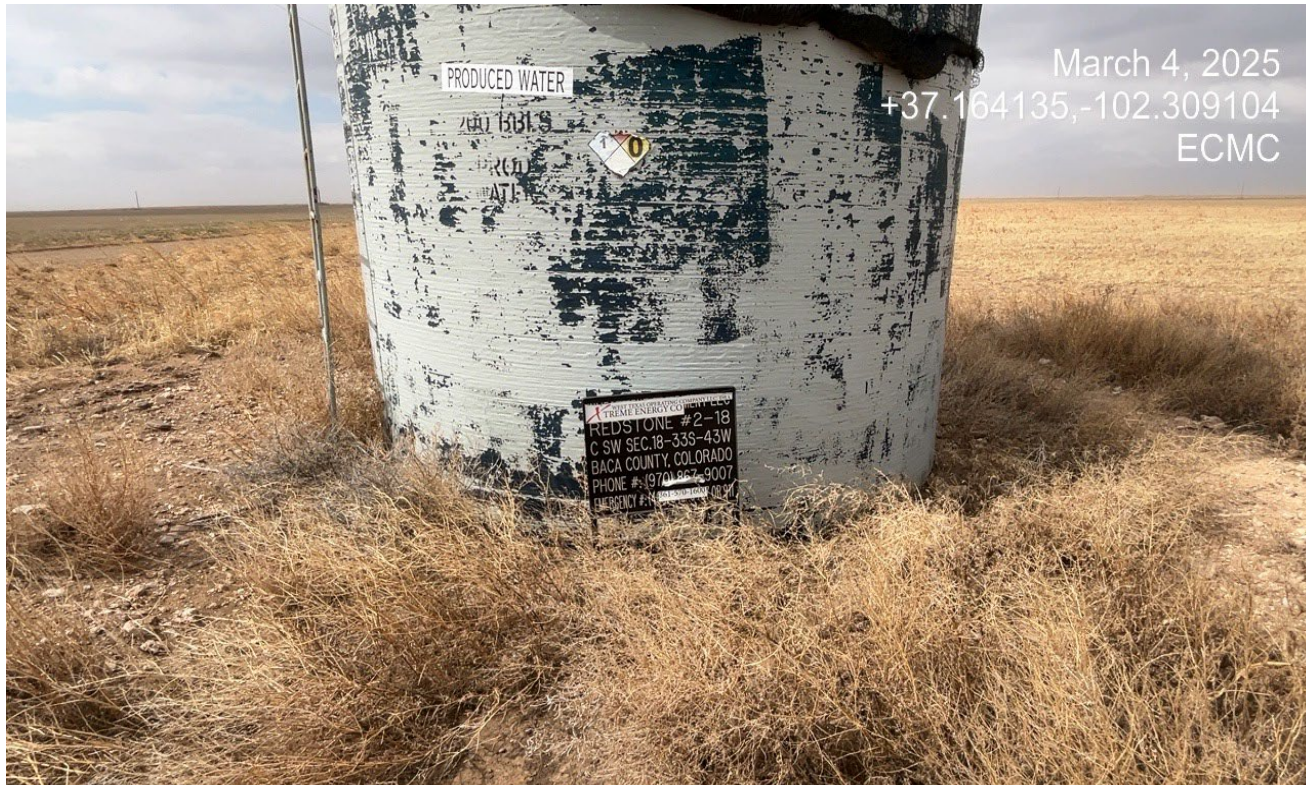
Photo 3. The secondary containment is insufficient to contain a spill and there are weeds around the tank.

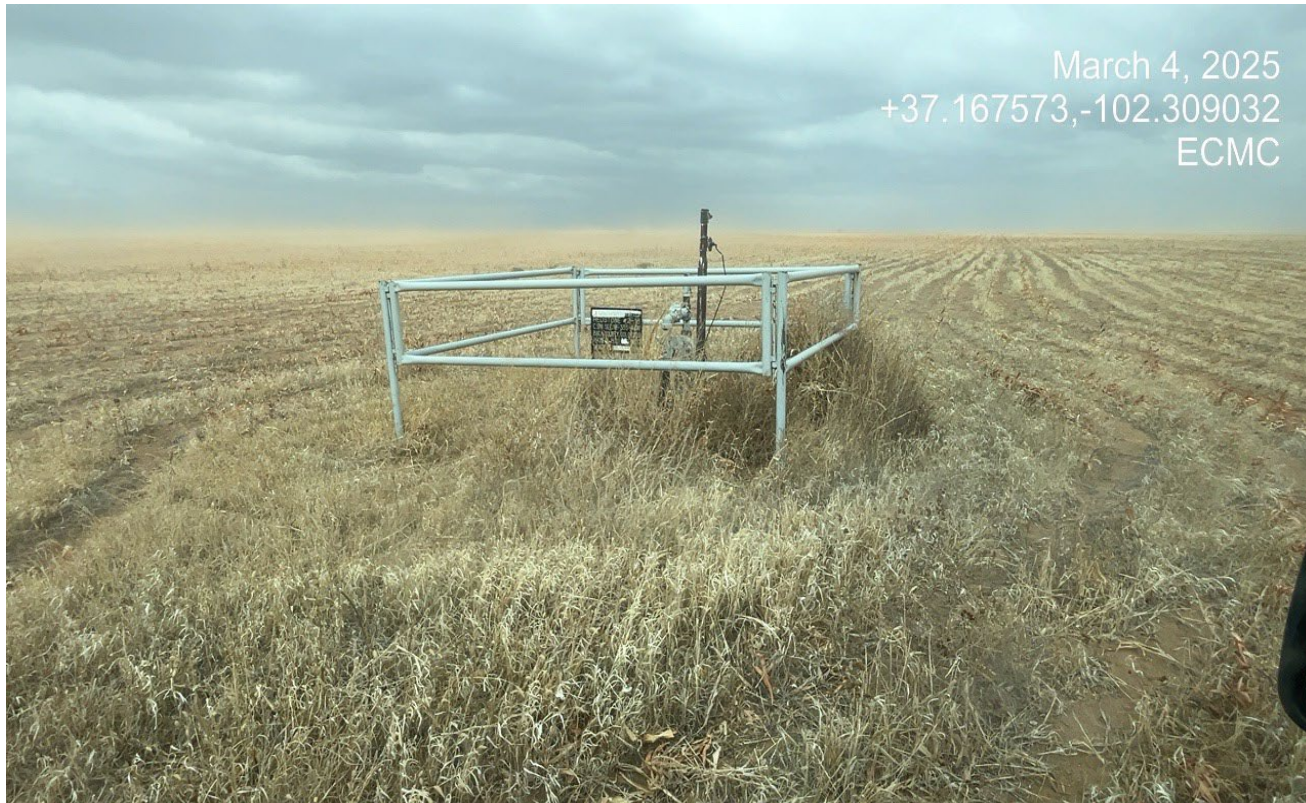
Photo 4. Facing northwest toward the wellsite.
