Interim Reclamation and Stormwater Inspection

Operator: CIVITAS NORTH LLC - 10661

Location ID: 454760

Inspection Photos
Location Name: Grotheer 5-61 #11A
Location ID: 454760

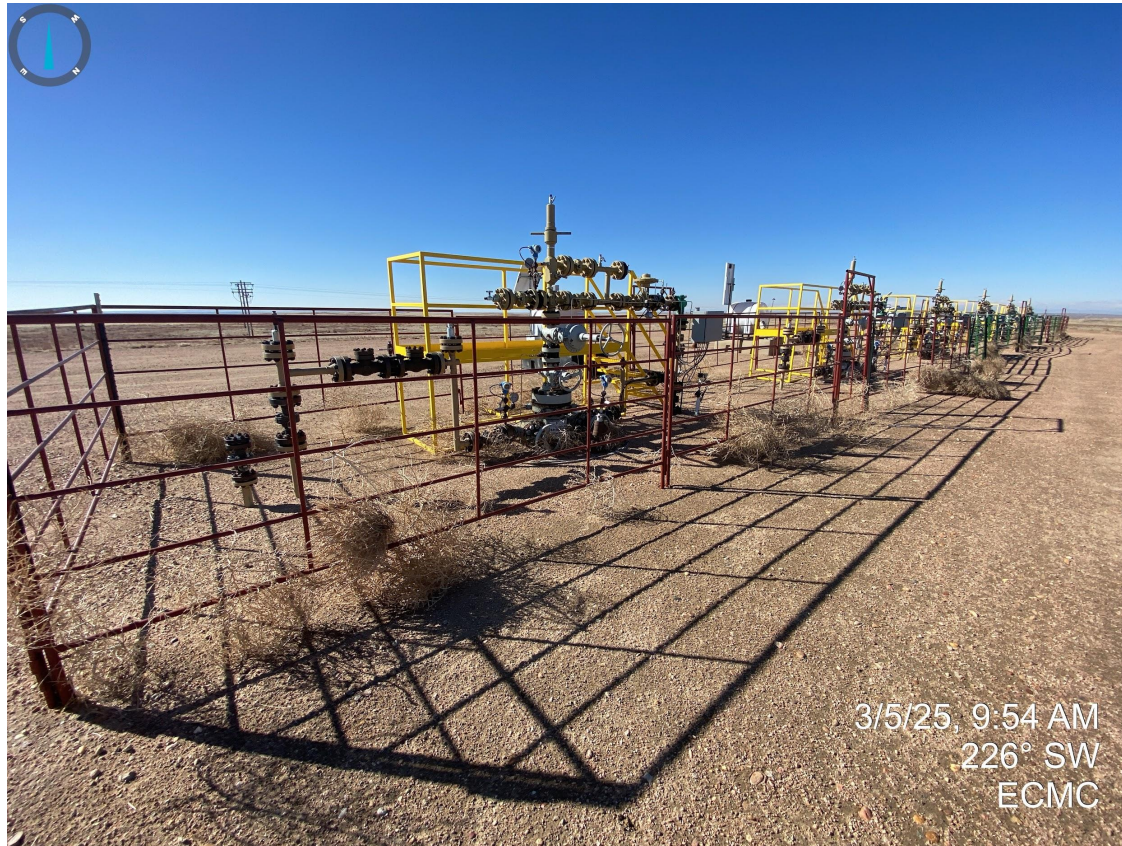
Photo 1. Tumbleweed debris within well equipment.

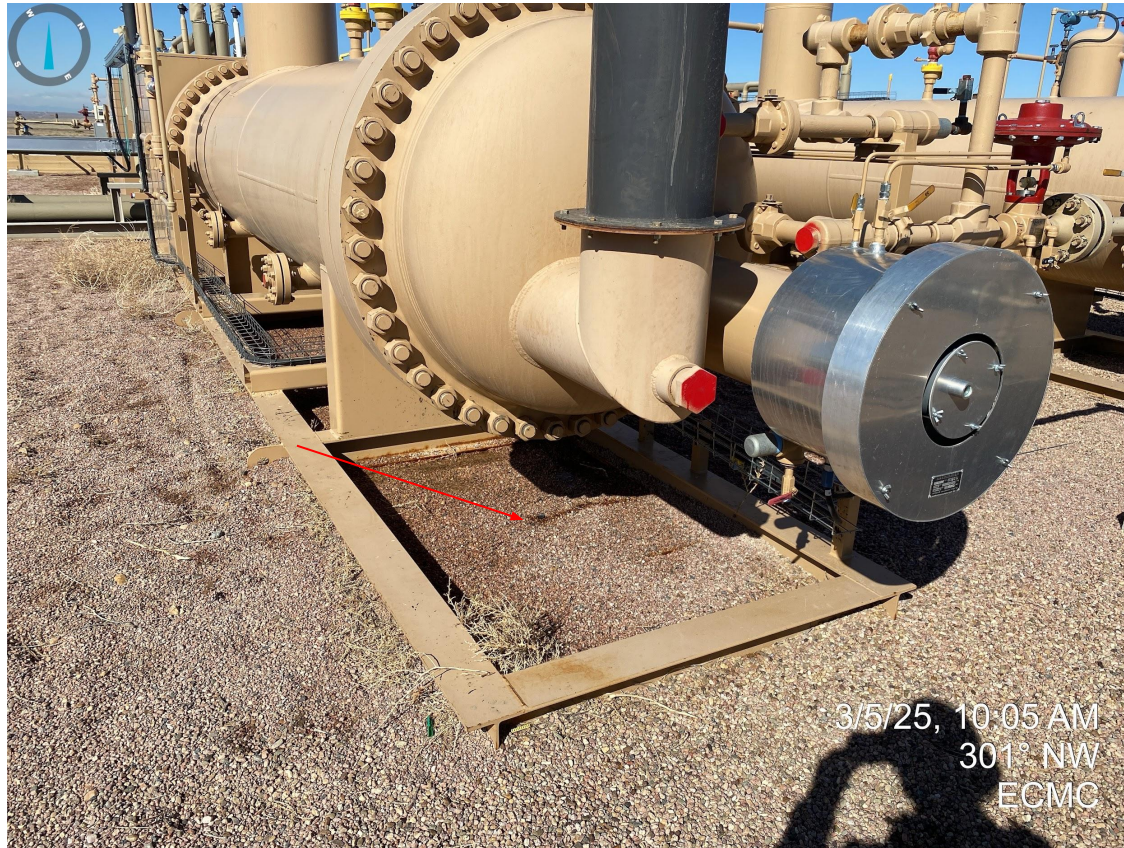
Photo 2. Stained soil observed under separator.

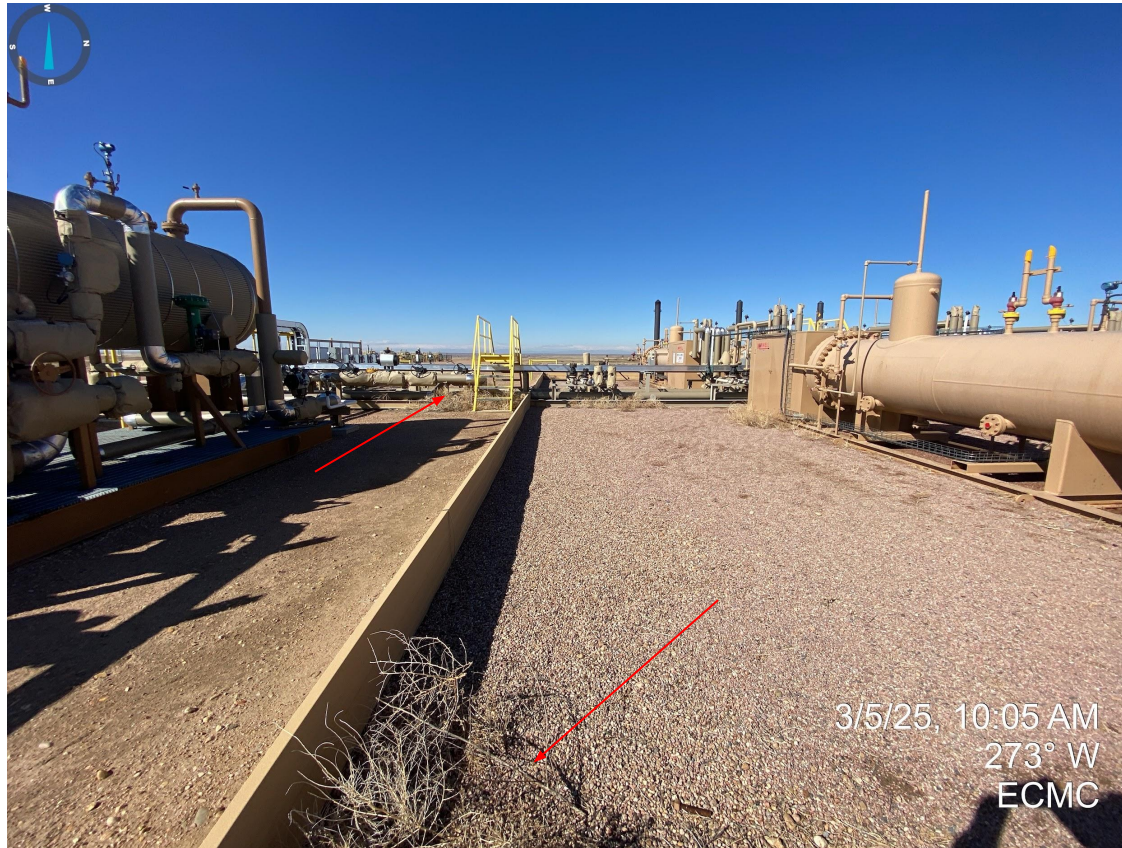
Photo 3. Tumbleweed debris observed within equipment.

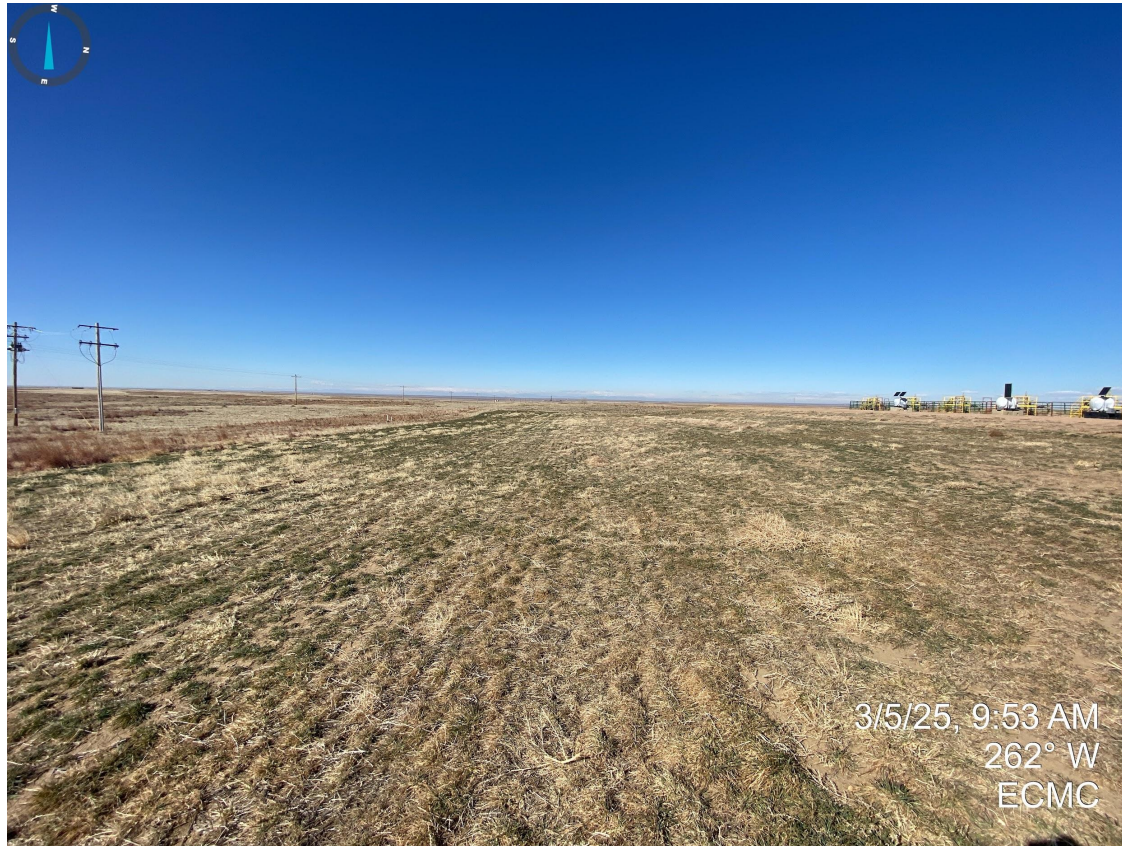
Photo 4. Southern interim areas appear to be progressing towards Rule 1003 with evidence of germination observed.

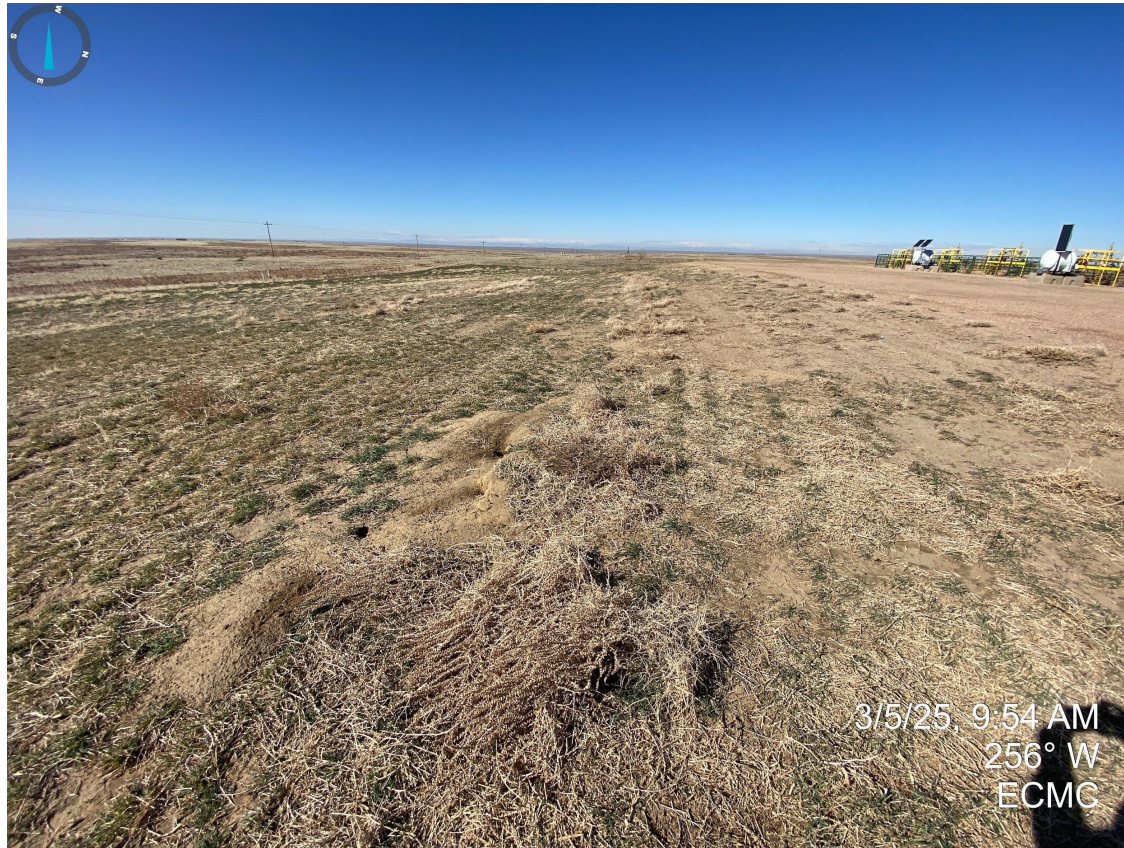
Photo 5. Russian thistle observed on edge of pad/interim areas.

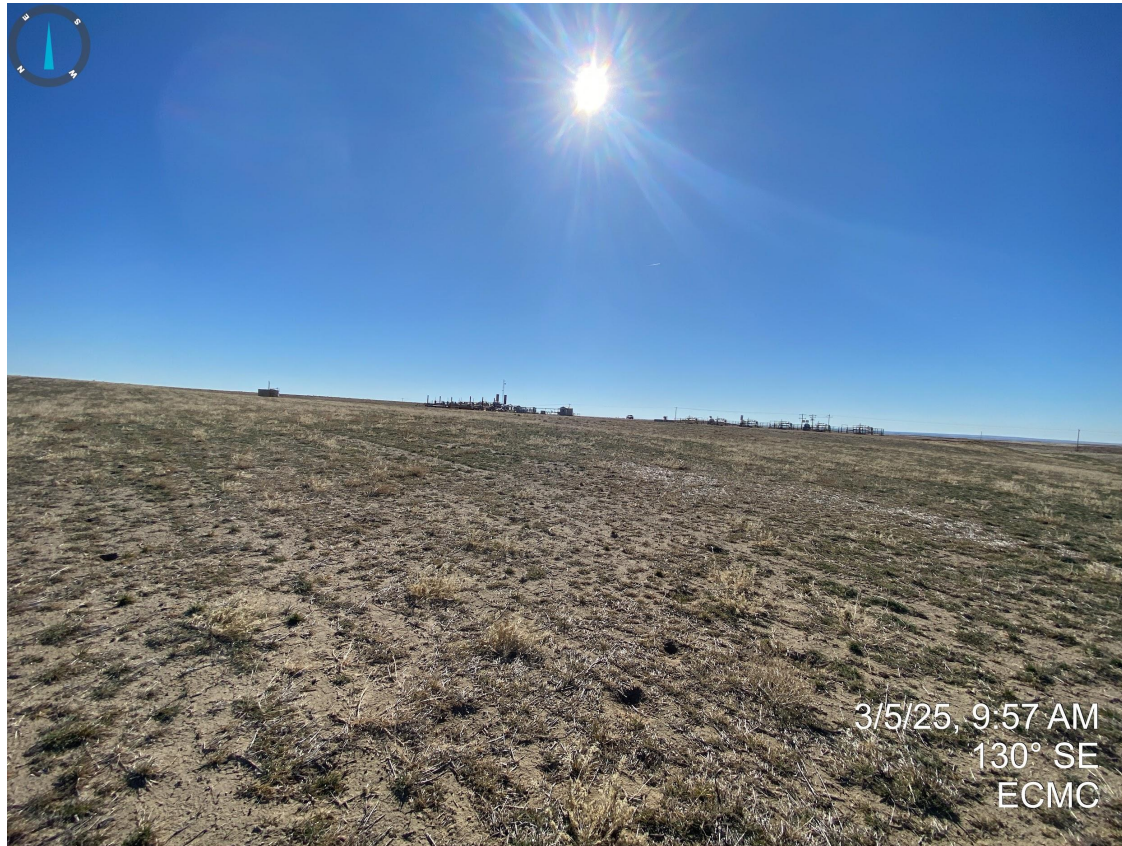
Photo 6. Northern interim areas appear to be progressing towards Rule 1003 with evidence of germination observed.

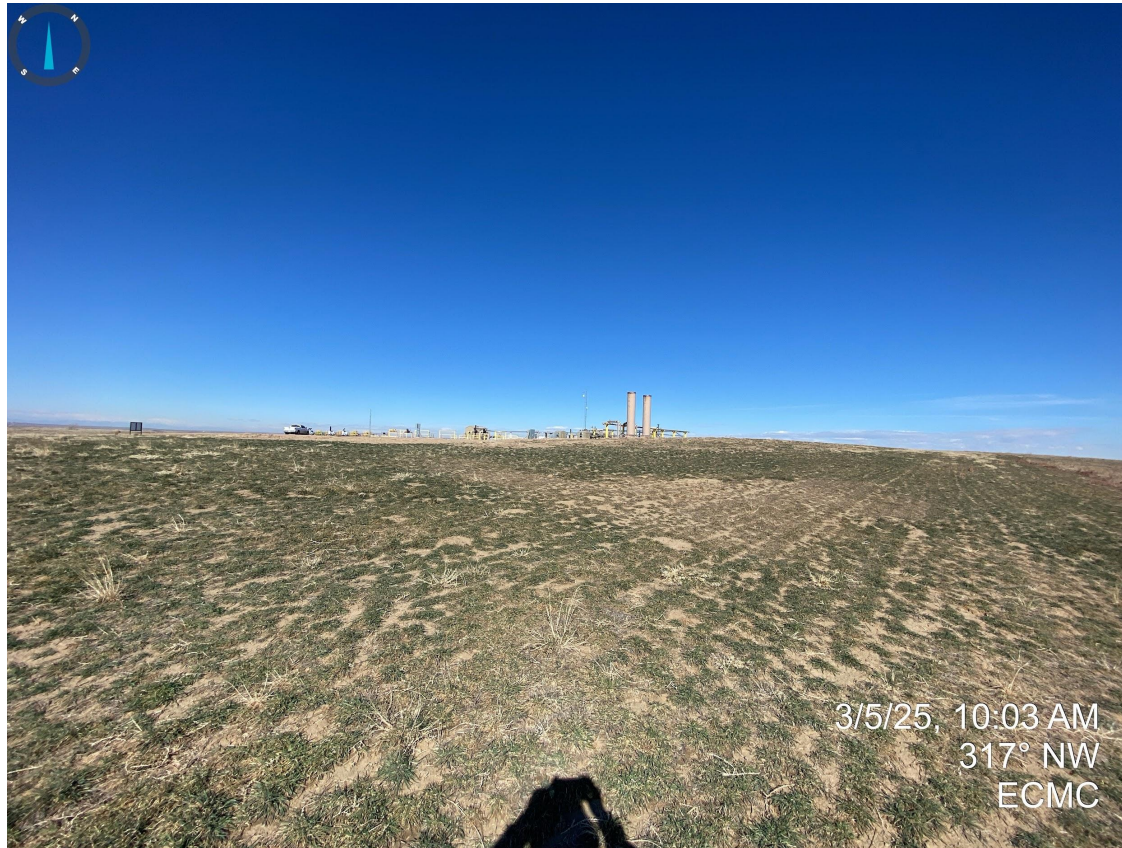
Photo 7. Eastern interim areas appear to be progressing towards Rule 1003 with evidence of germination observed.
