# Inspection/Audit Photos

Location: LARAMIE ENERGY LLC Esperanza/9-5 Pad

Location ID: 334510

Date: 03/3/2025

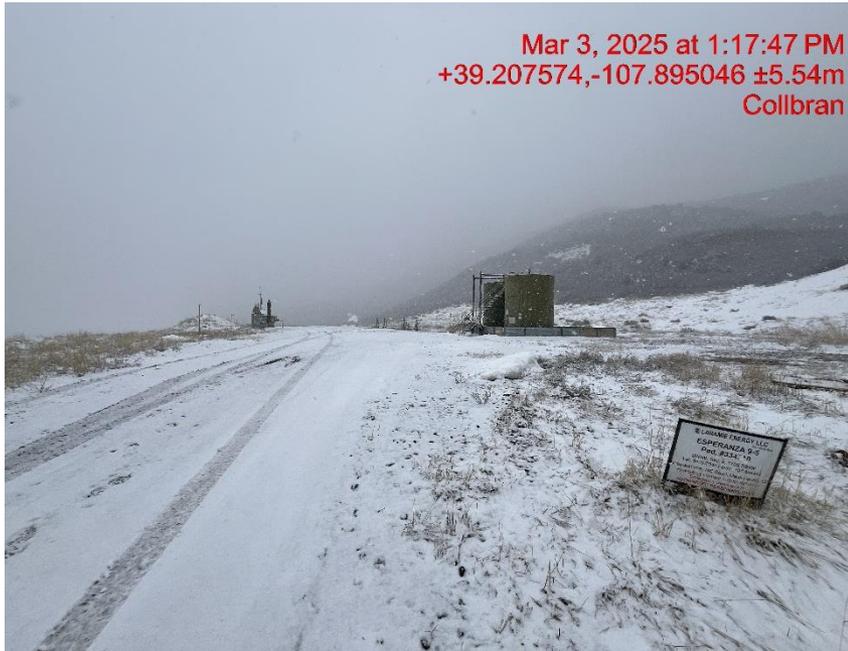
Photo # 6289 Entrance to location

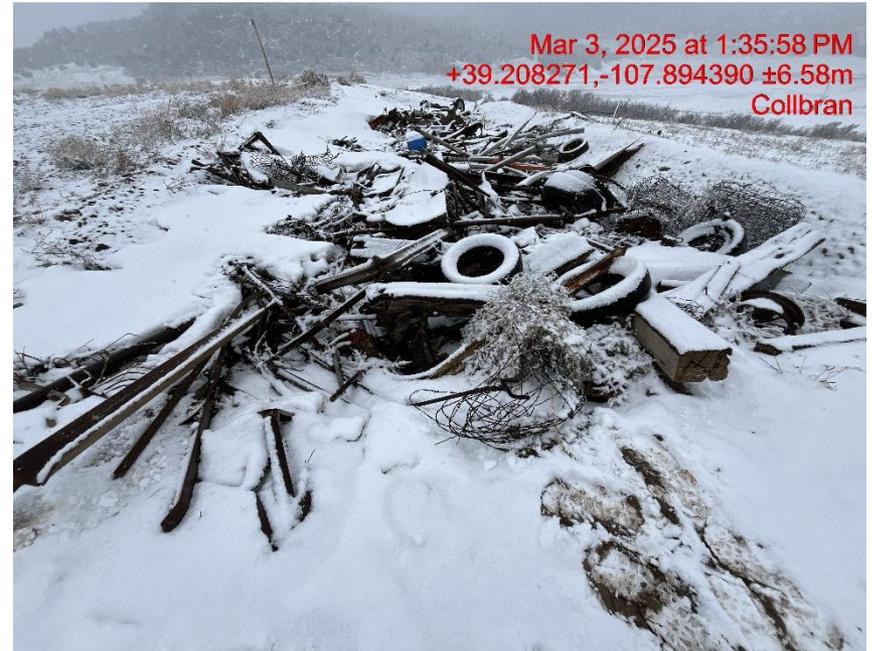
Photo # 6310 Debris in the interim area - debris is interfering with interim reclamation & some of the debris also constitutes a wildlife hazard

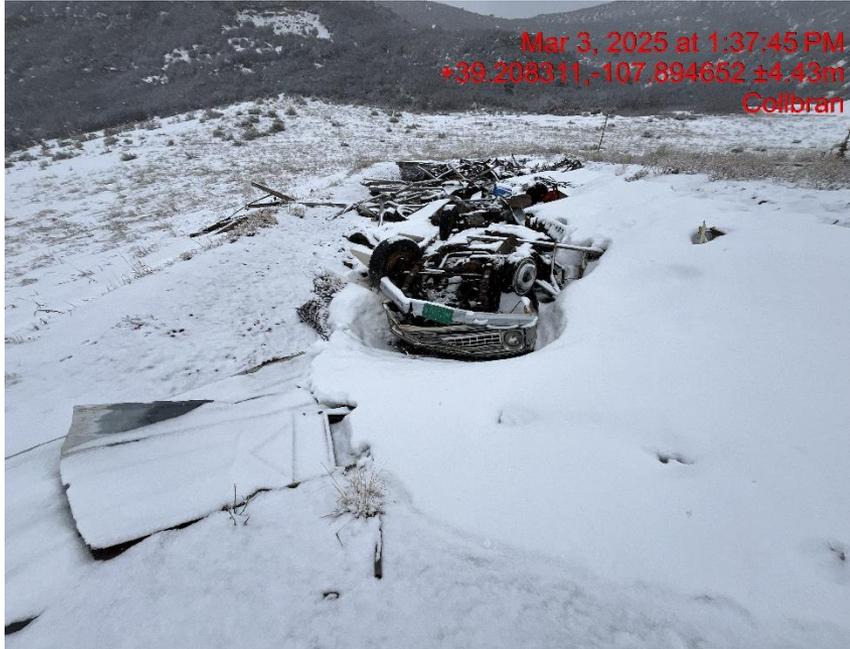
**Photo # 6315 Debris in the interim area - debris is interfering with interim reclamation & some of the debris also constitutes a wildlife hazard**

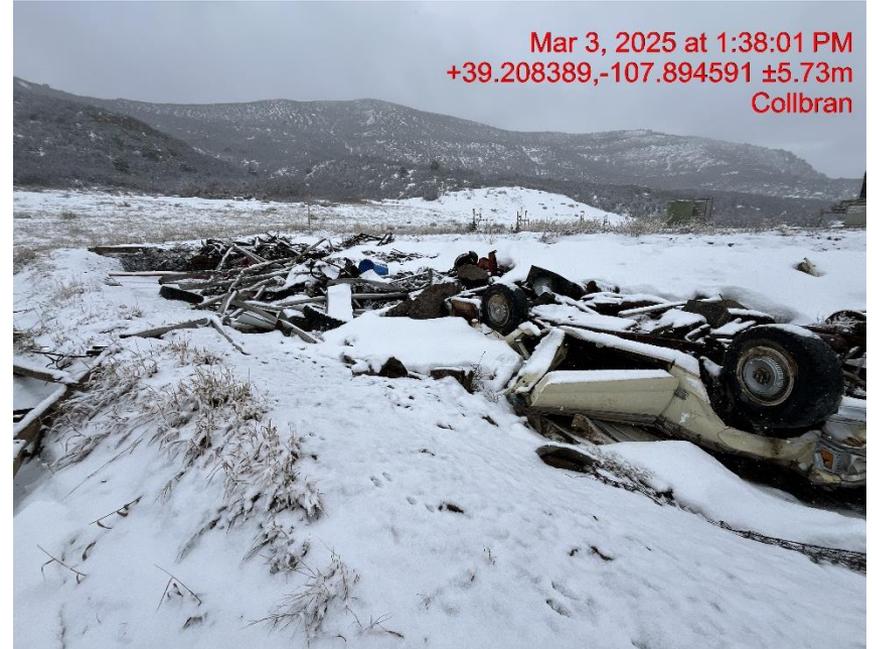
**Photo # 6316 Debris in the interim area - debris is interfering with interim reclamation & some of the debris also constitutes a wildlife hazard**

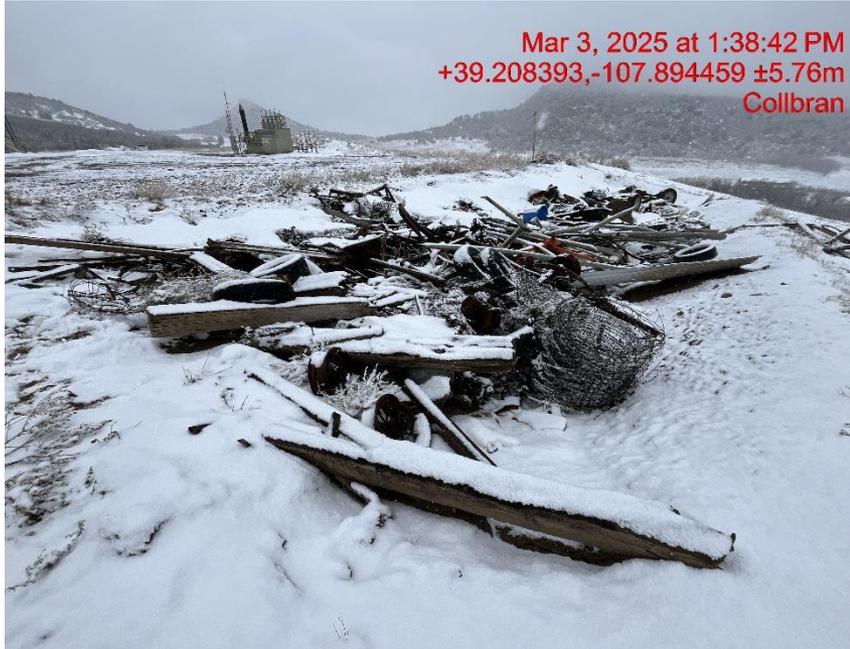
**Photo # 6318 Debris in the interim area - debris is interfering with interim reclamation & some of the debris also constitutes a wildlife hazard**

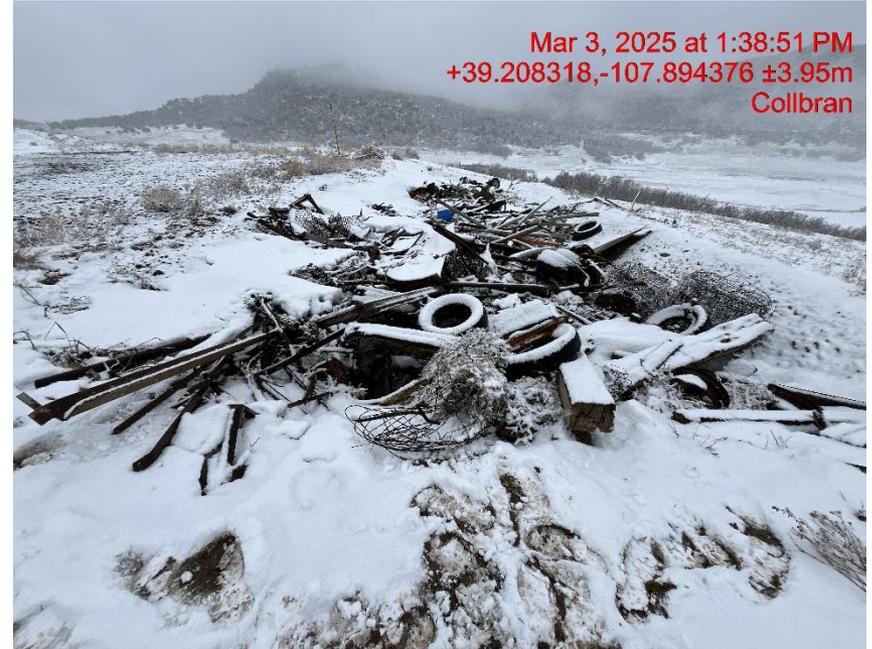
**Photo # 6319 Debris in the interim area - debris is interfering with interim reclamation & some of the debris also constitutes a wildlife hazard**

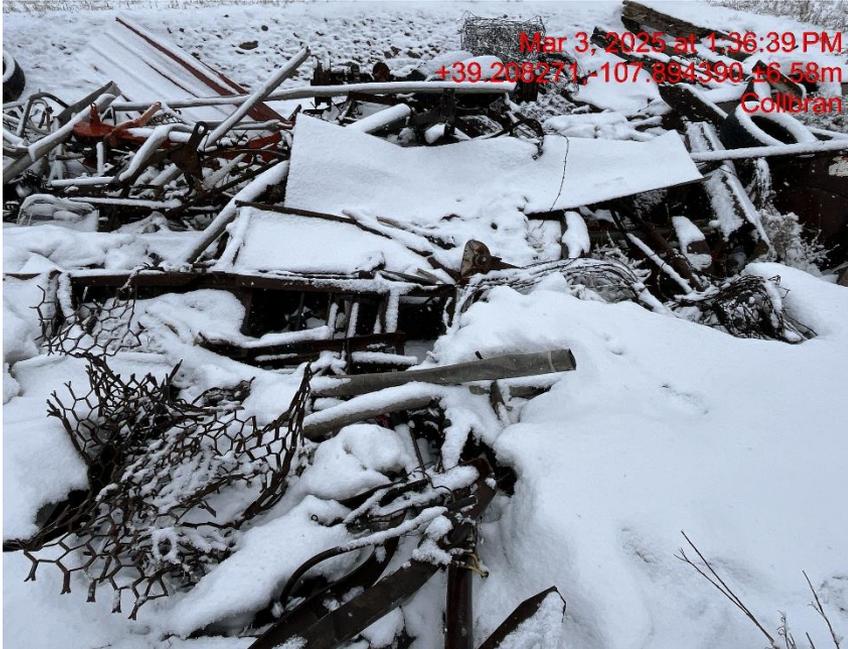
**Photo # 6313 Debris in the interim area - debris is interfering with interim reclamation & some of the debris also constitutes a wildlife hazard**

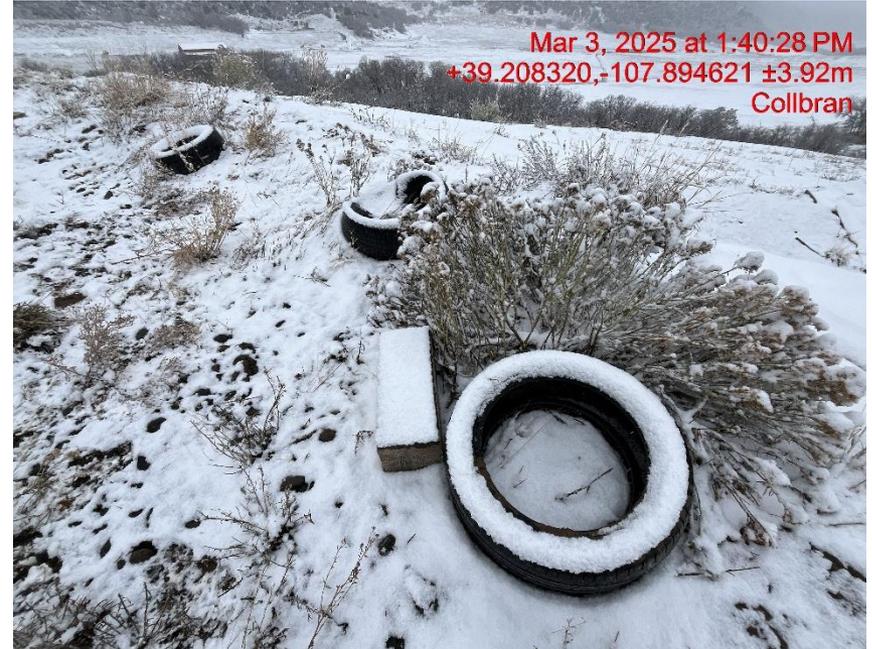
**Photo # 6323 Debris**
