Interim Reclamation and Stormwater Inspection

Operator: BONANZA CREEK ENERGY OPERATING
COMPANY LLC - 8960

Location ID: 431184

Inspection Photos
Location Name: Pronghorn T-3 Pad
Location ID: 431184

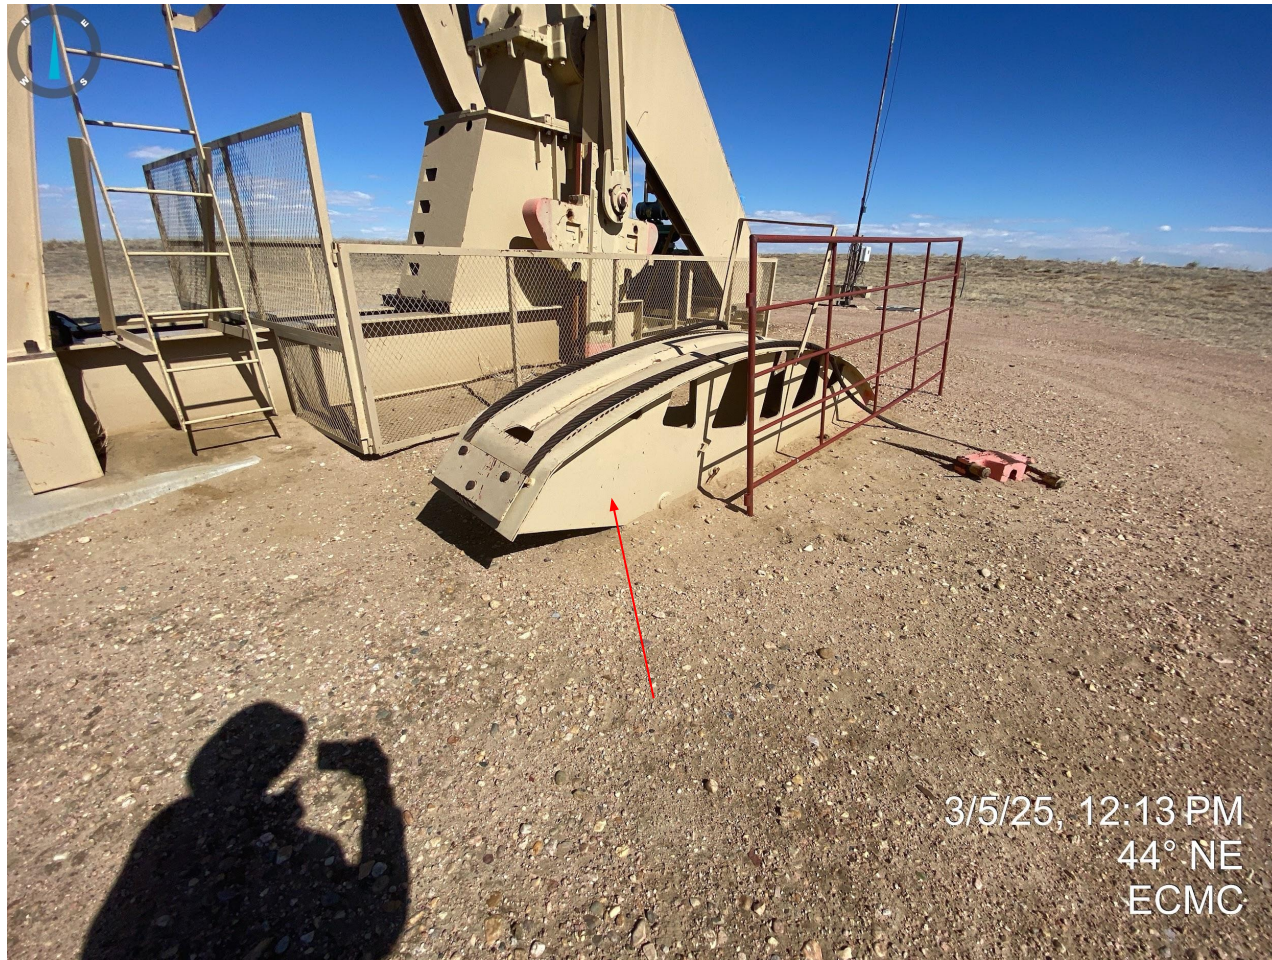
Photo 1. Unused equipment observed at pumpjack.

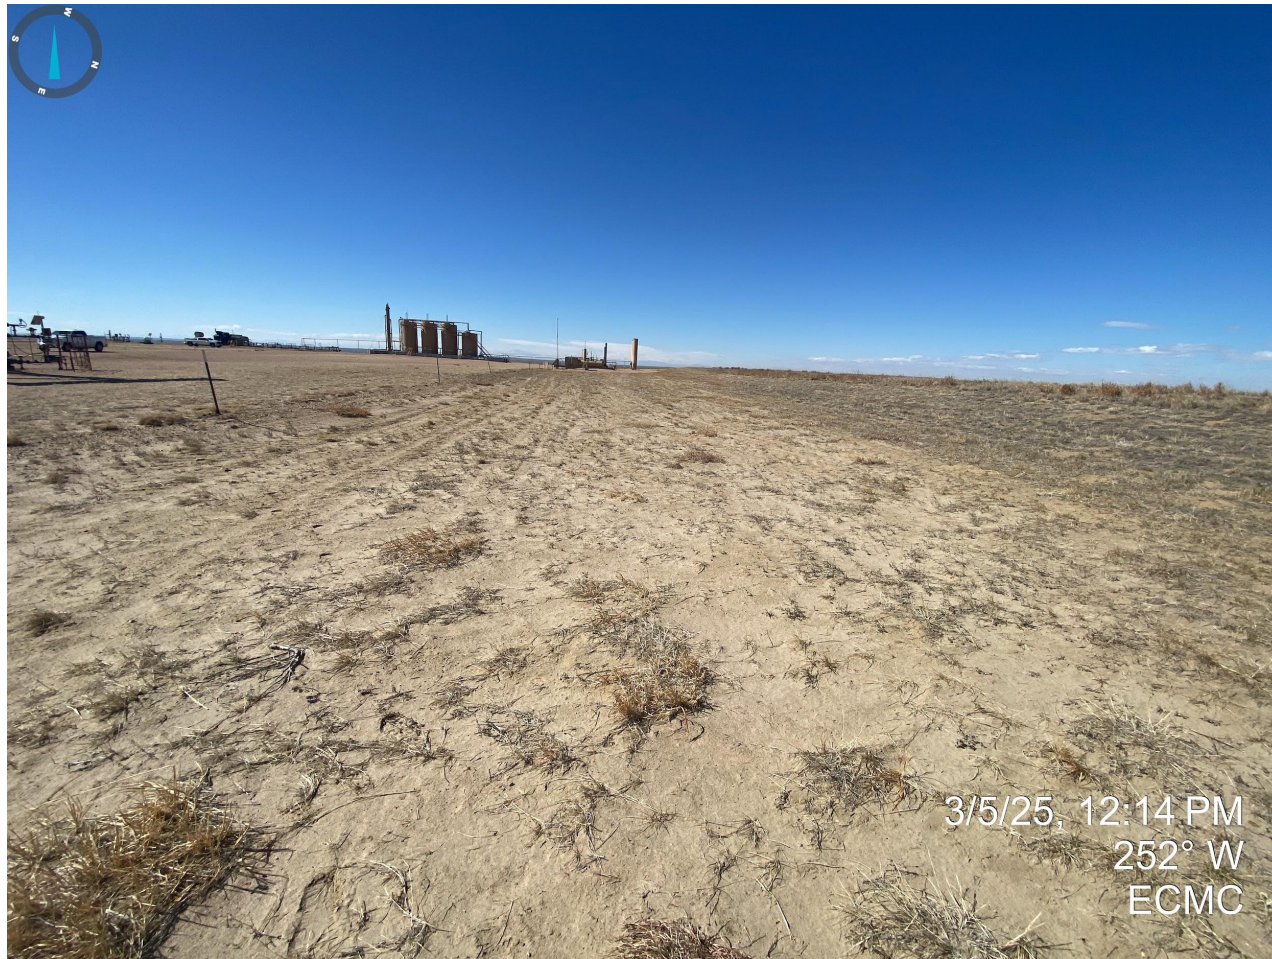
Photo 4. Northern interim areas. Interim areas do not appear to be progressing towards reclamation standards with evidence of non-uniform vegetation cover resulting in bare/unstabilized soils.

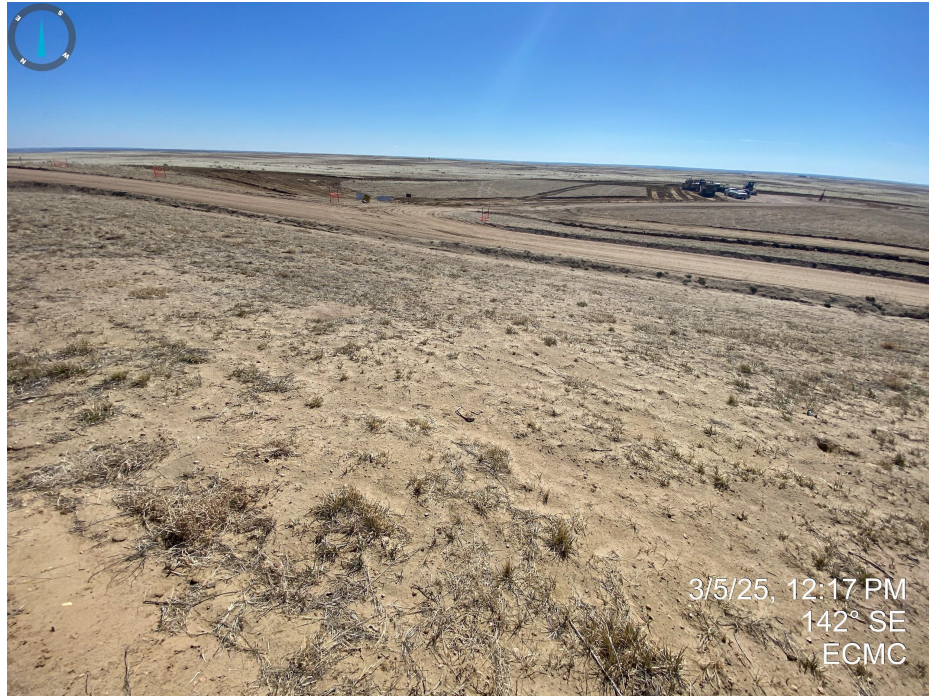
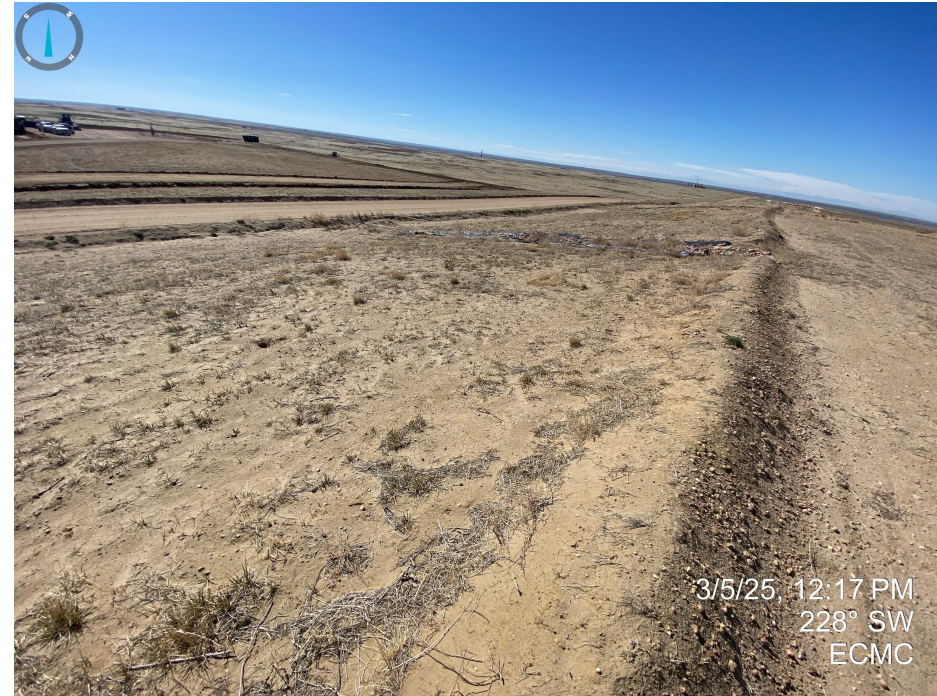
Photos 5 & 6. Southern interim areas. Interim areas do not appear to be progressing towards reclamation standards with evidence of non-uniform vegetation cover resulting in bare/unstabilized soils.

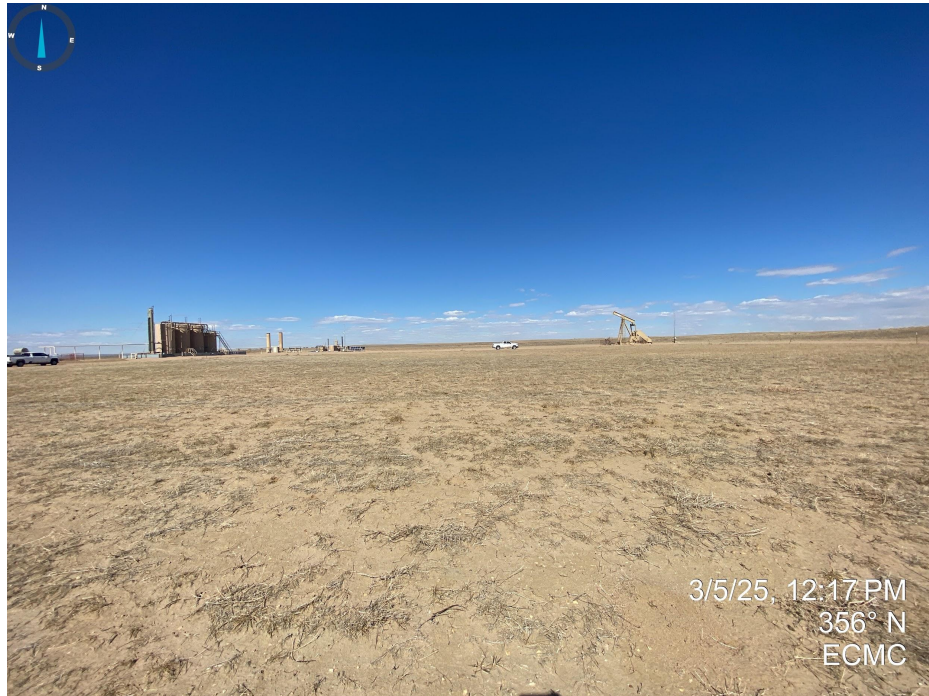
Photos 7 & 8. Center interim areas. Interim areas do not appear to be progressing towards reclamation standards with evidence of non-uniform vegetation cover resulting in bare/unstabilized soils. Photo 7 (left) taken from the southern end and Photo 8 (right) taken from the northern end.

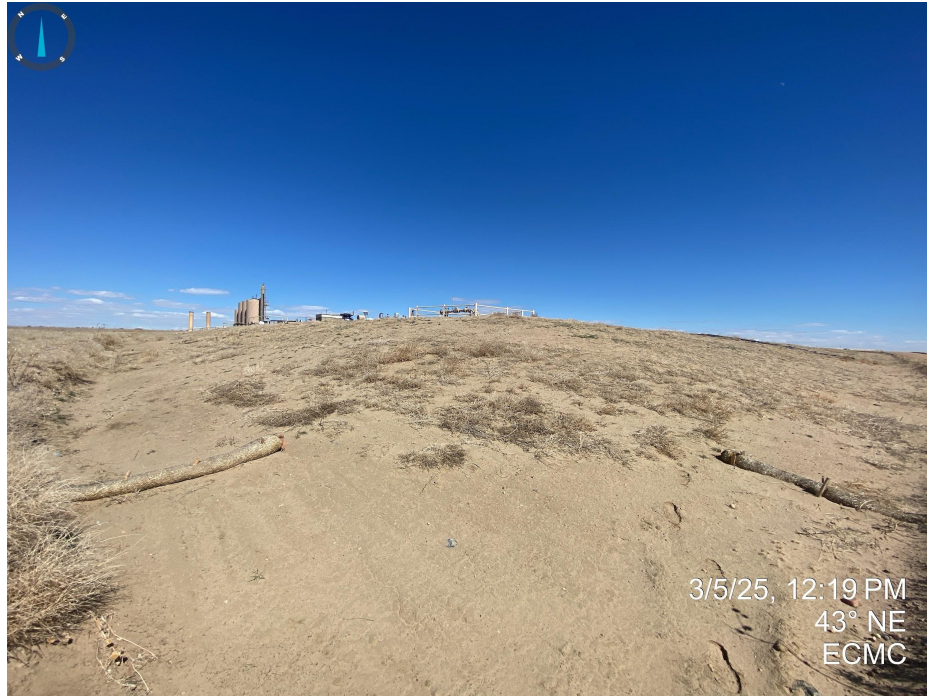
Photos 9 & 10. Taken from the southwest corner of the location, facing northeast (left; Photo 9) and east (right; Photo 10). Interim areas do not appear to be progressing towards reclamation standards with evidence of non-uniform vegetation cover resulting in bare/unstabilized soils and undesirable vegetation (russian thistle).
