Inspection/Audit Photos
Location Name: QB Energy BJM 31-6C (H36NW) Pad
Location ID: 334966

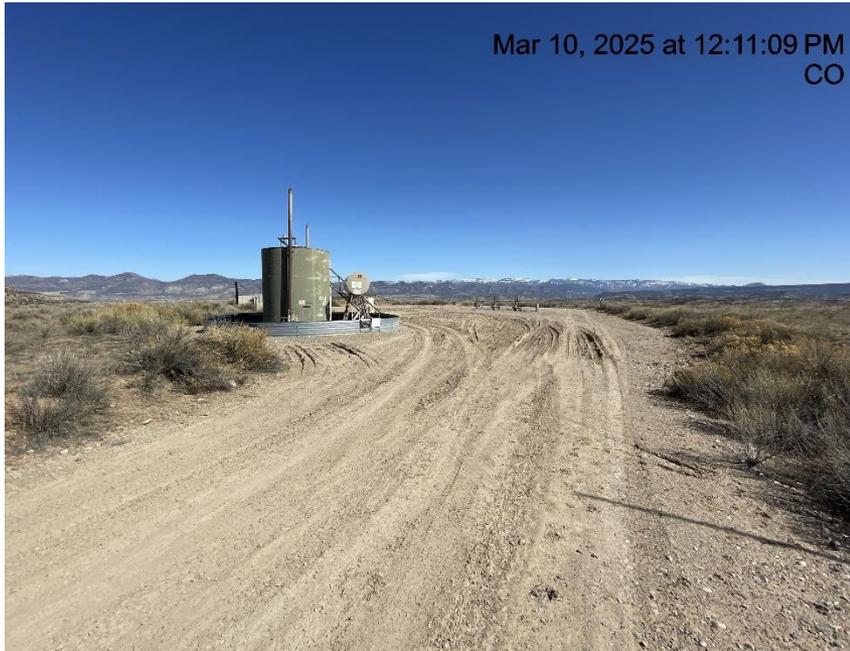
Photo # 1717 From entrance to location

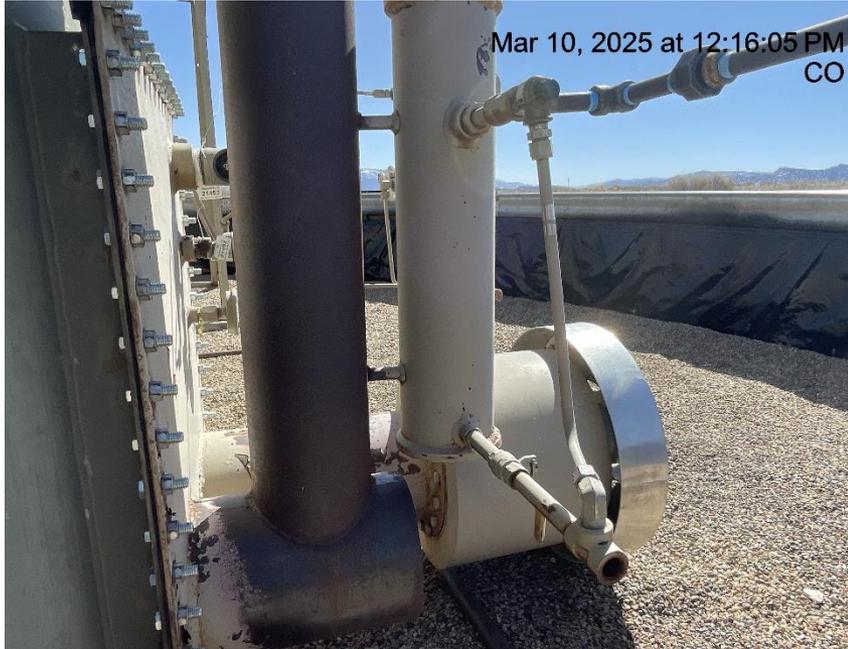
Photo # 1723 PRV vent line does not comply with CECMC rules

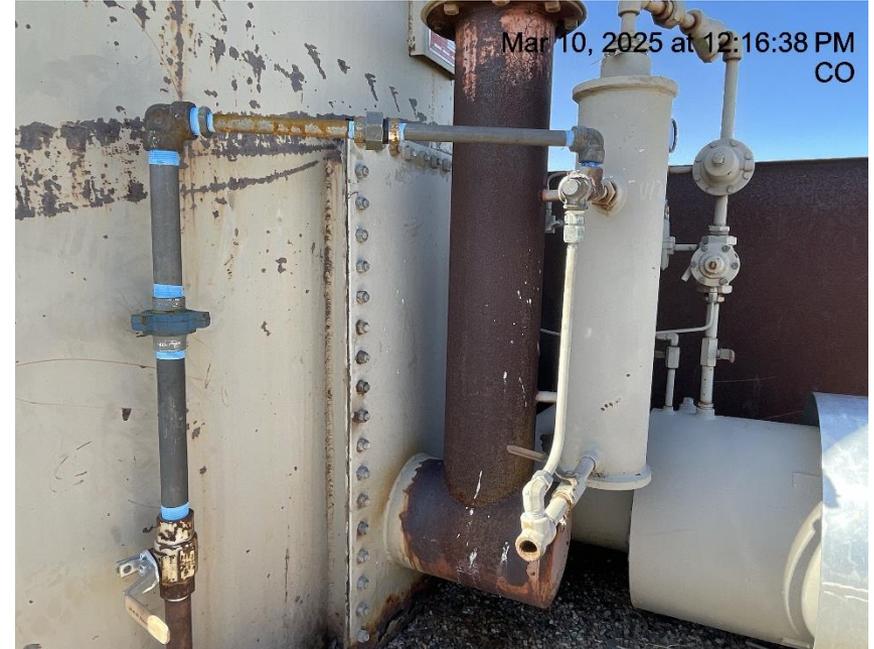
Photo # 1724 PRV vent line does not comply with CECMC rules
