Construction and Stormwater Inspection

March 17, 2025

Operator: BISON IV OPERATING LLC - 10670

Location ID: 486770

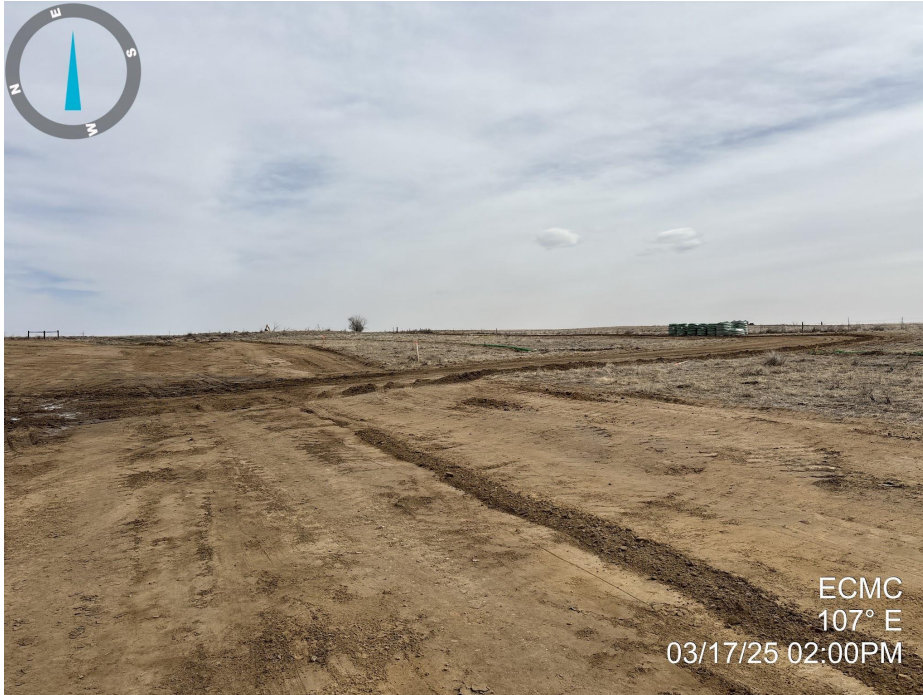
Photo 1. Photo taken from the southern perimeter of the site, near the location's entrance from the access road, facing East. Photo illustrates that the Operator has installed a ditch BMP.

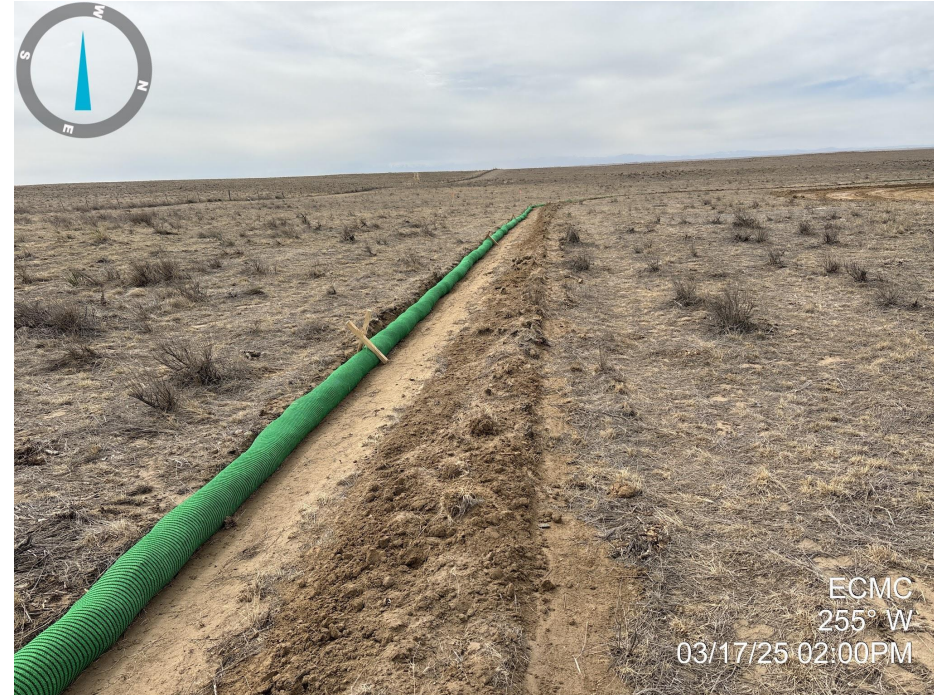
Photo 2. Photo taken from the southern perimeter of the site, facing West. Photo illustrates that a temporary BMP has been installed along the perimeter of the site.

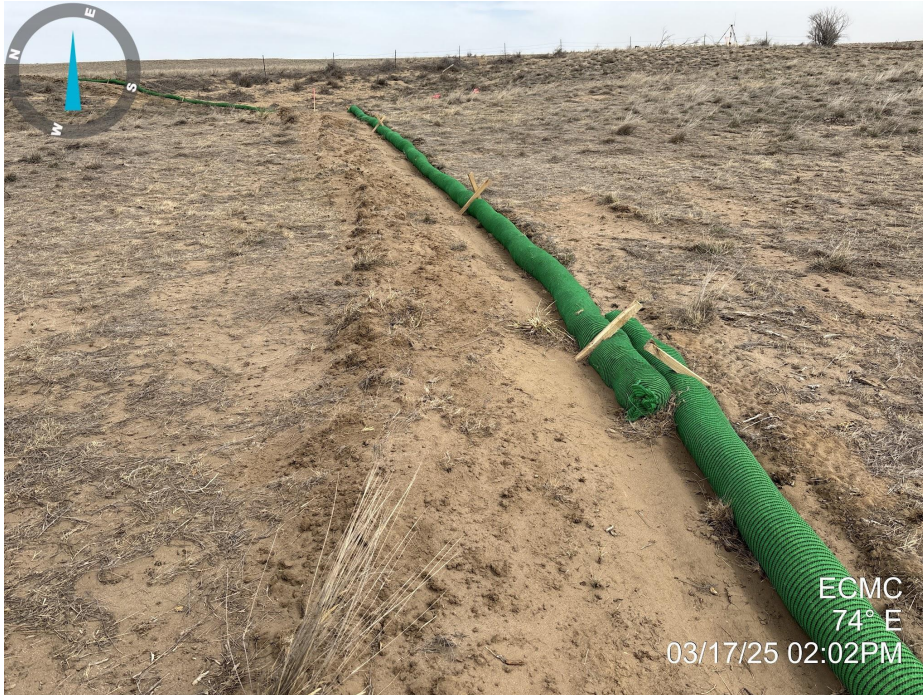
Photo 3. Photo taken from the southeastern perimeter of the site, facing East. See comments under photo 2.

Note: Wattles have been overlapped per good engineering practices.

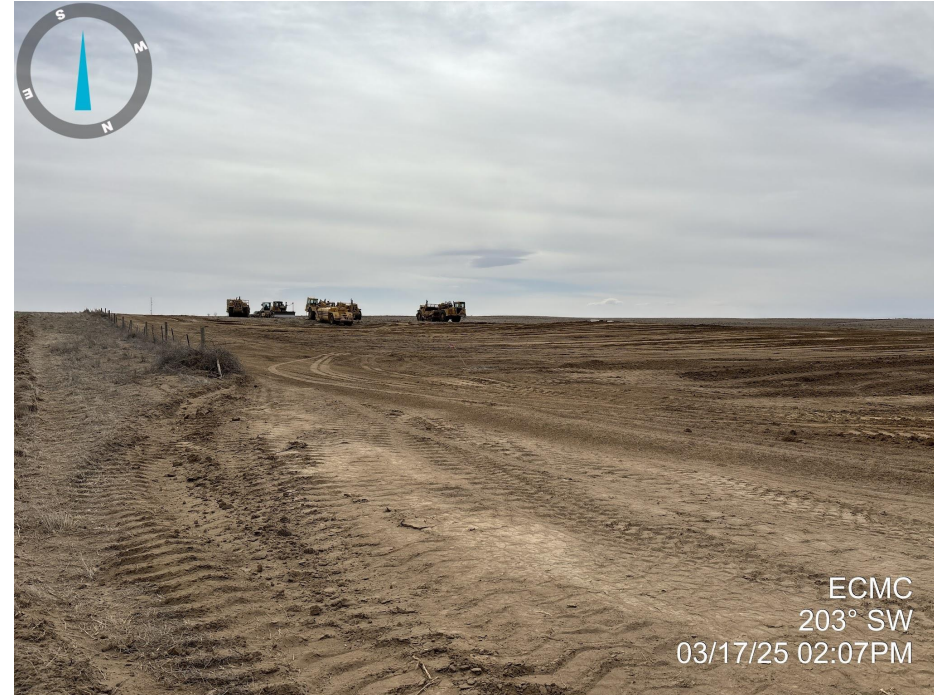
Photo 4. Photo taken from the northeastern portion of the location, facing Southwest. Photo illustrates Operator is in the process of topsoil salvage.

Note: At the time of this inspection, major construction activities were not occurring.

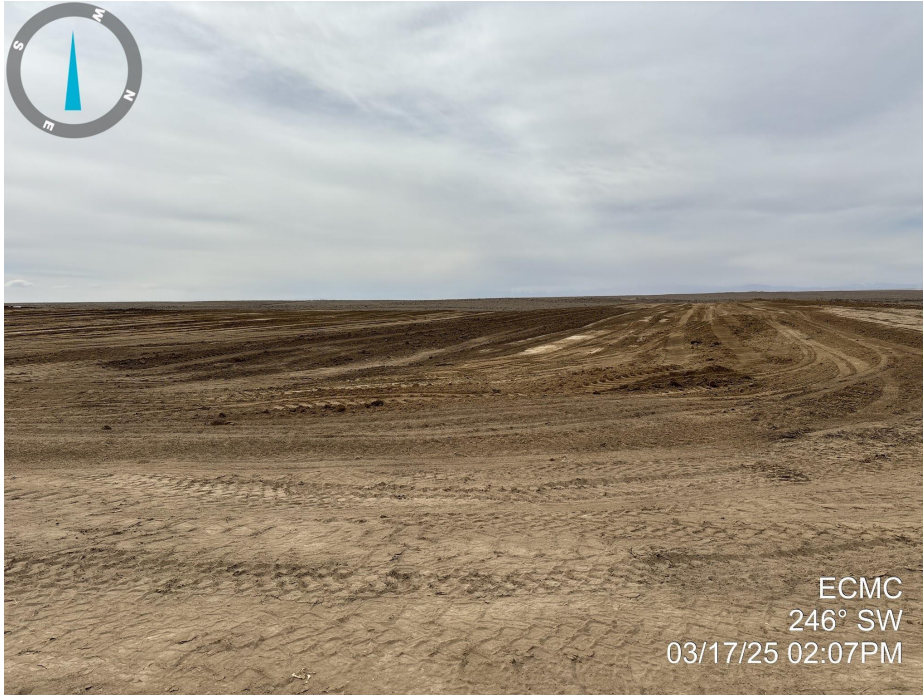
Photo 5. Photo taken from the northeastern portion of the working pad, facing southwest. Photo illustrates a portion of the topsoil stockpile.

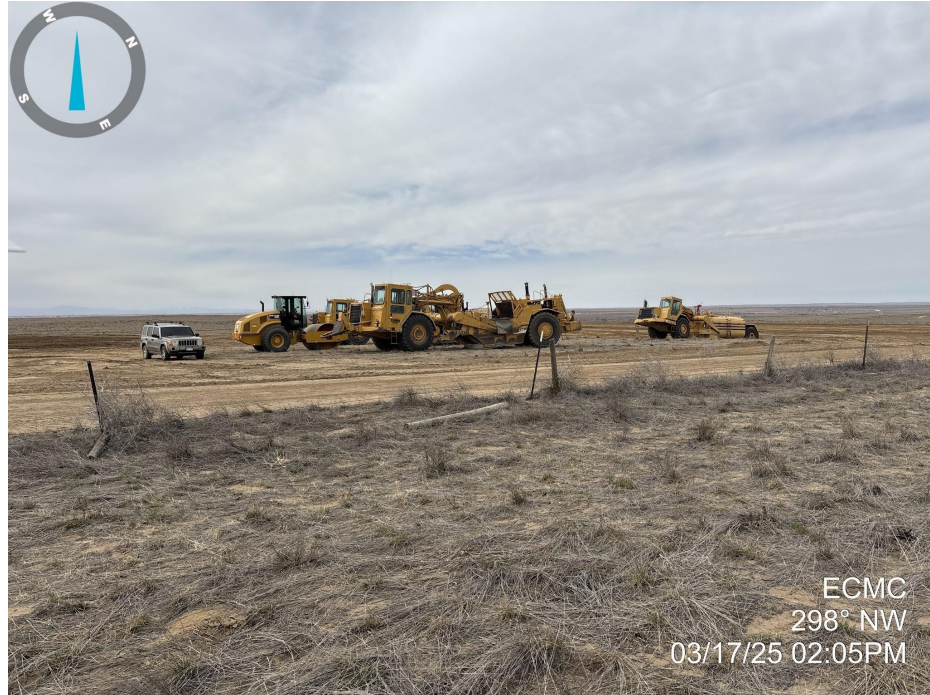
Photo 6. Photo taken from the east perimeter of the location, facing Northwest. See comments under Photo 4.

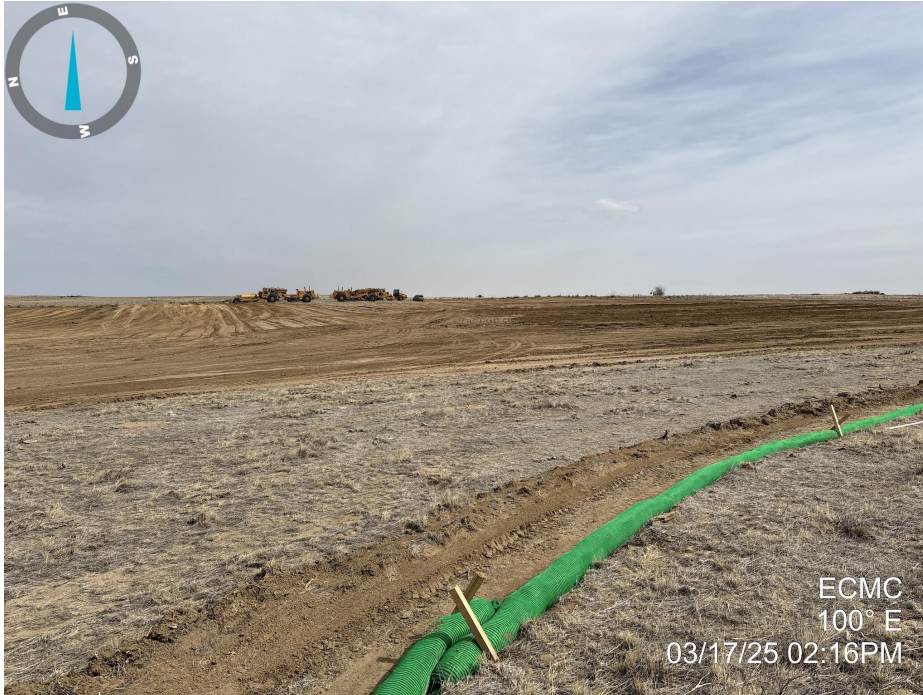
Photo 7. Photo taken from the western perimeter of the site, facing East. See comments under Photo 2.

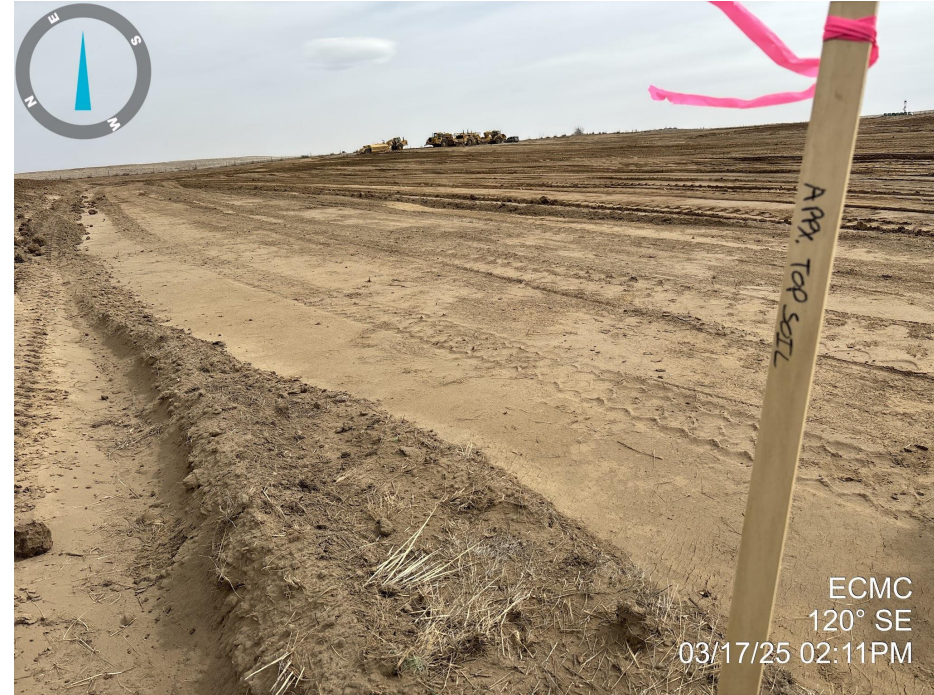
Photo 8. Photo taken from northwestern portion of the site, facing Southeast. Photo illustrates that the operator has marked the topsoil stockpile location.

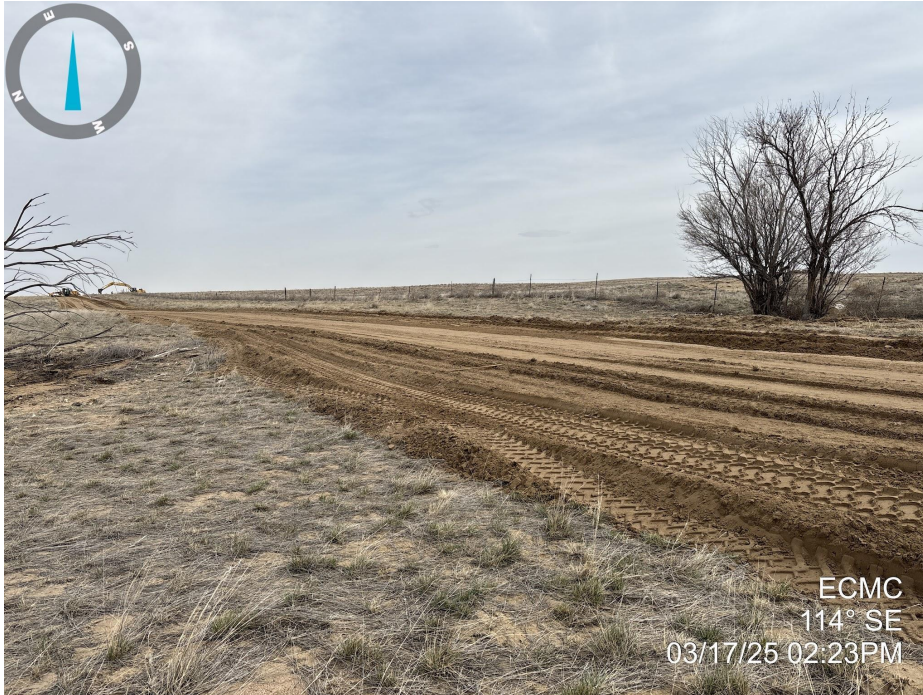
Photo 9. Photo taken along a portion of the western access road. Photo illustrates Operator is using access road topsoil as fill material and there are no access road BMPs.

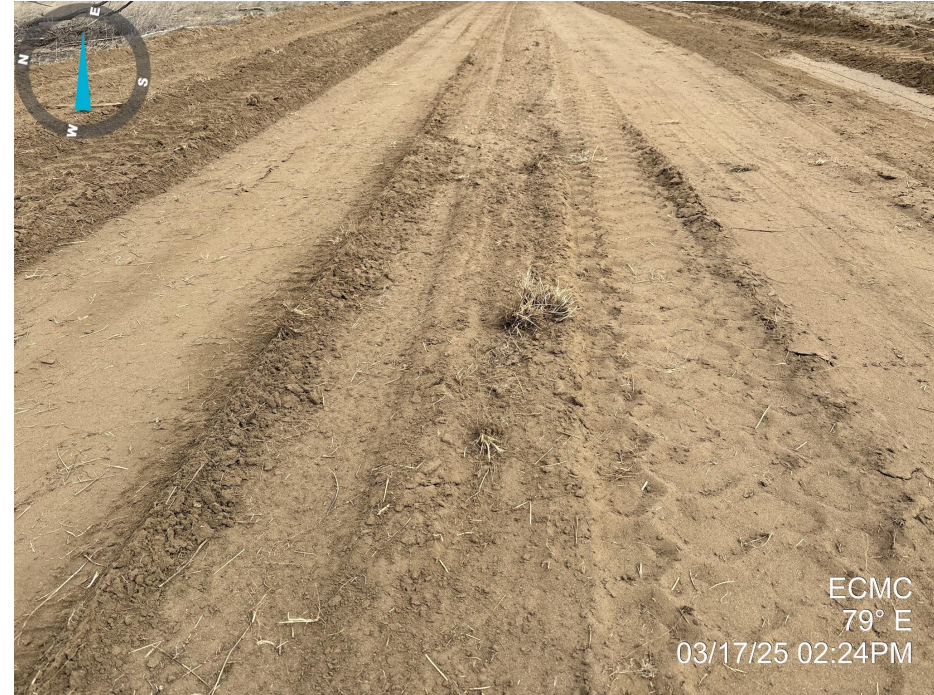
Photo 10. Photo taken from the previous photo location, along the access road, facing East. The photo illustrates vegetation and topsoil being used as fill material to construct the access road.

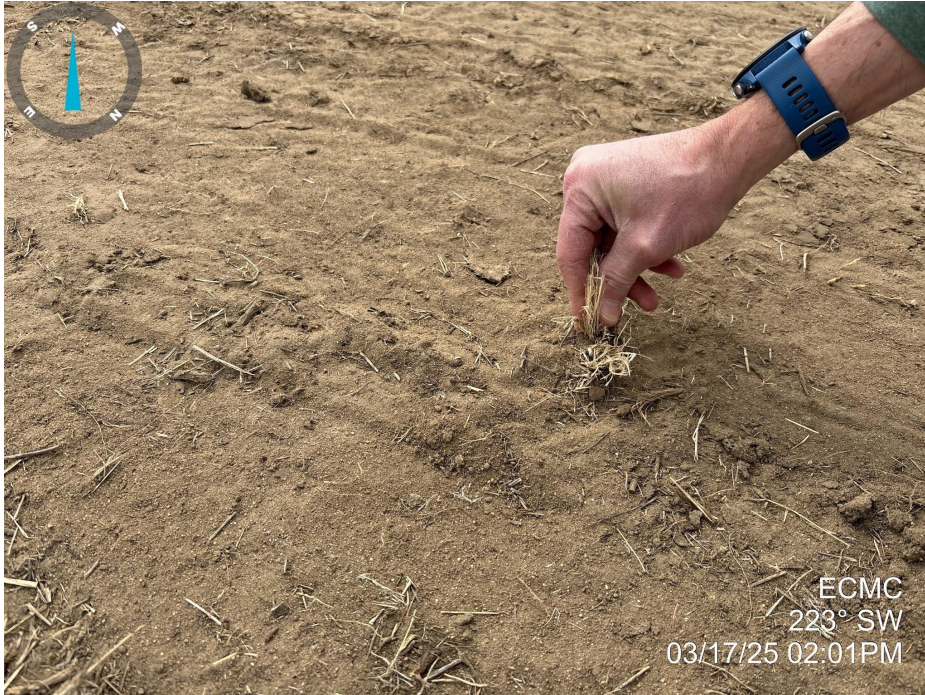
Photo 11. Photo taken from the western portion of the access road. Photo illustrates the Operator has only grubbed the access road and has not salvaged topsoil.

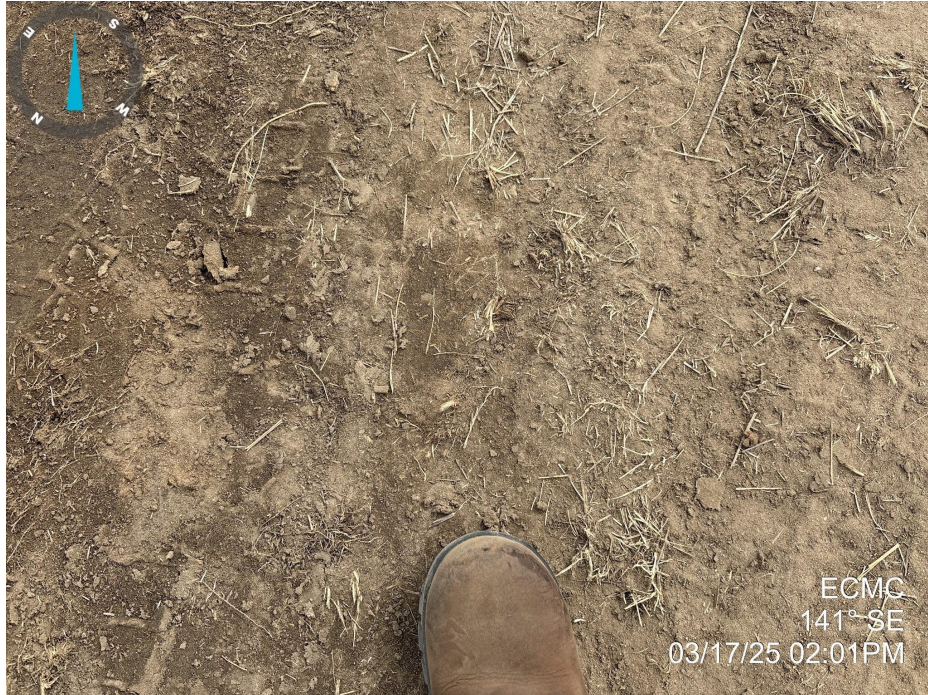
Photo 12. Photo taken from the access road. See comments under photo 11.
