Inspection Photos

API: 071-07311

Operator: WAPITI OPERATING LLC

Inspection Date: 3/20/2025

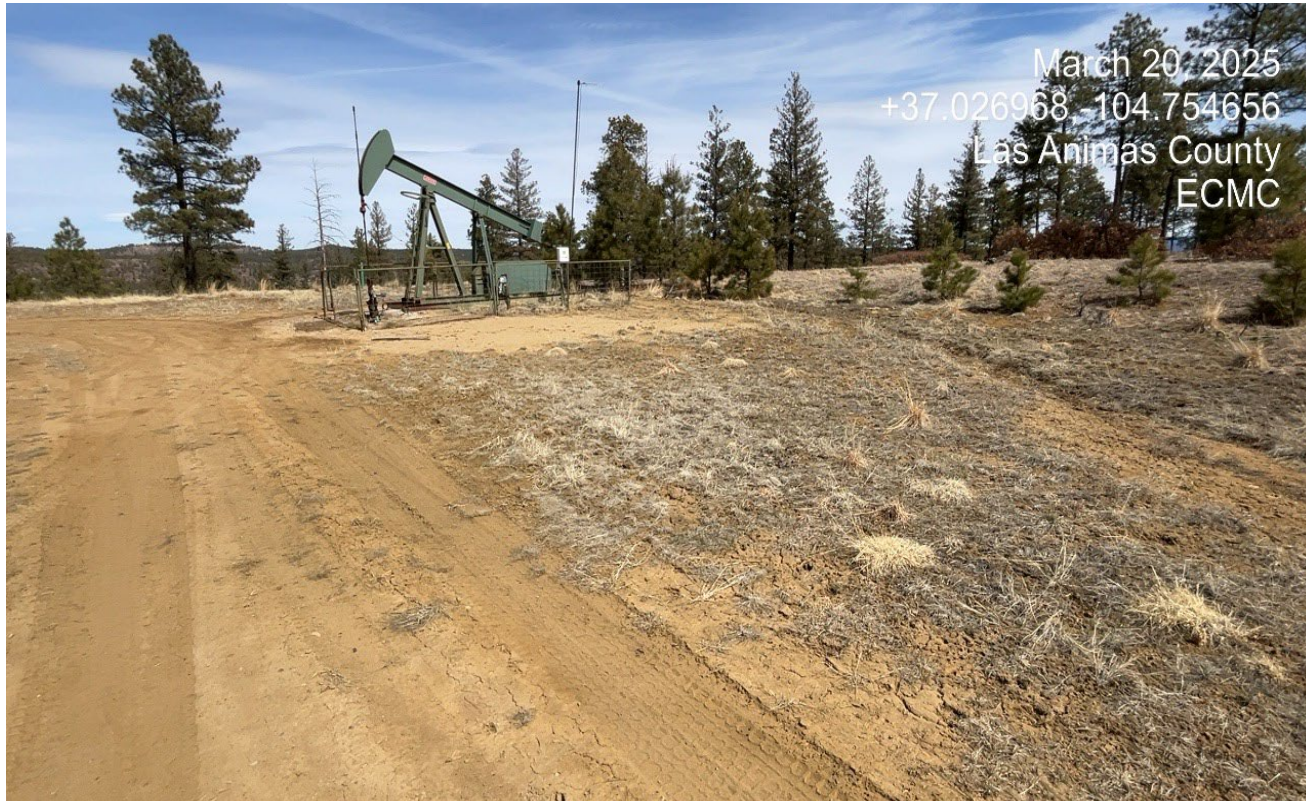
Photo 1. Facing north toward the wellsite.

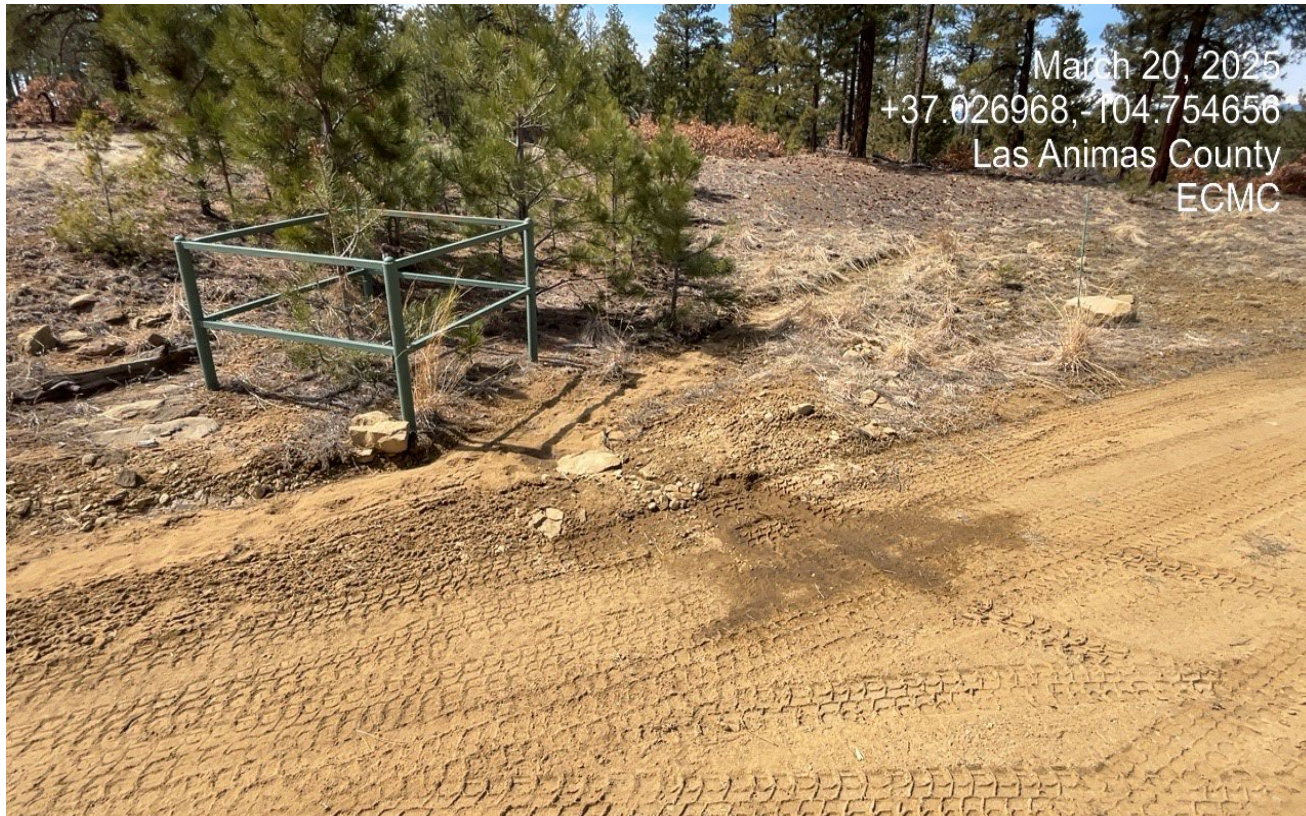
Photo 2. There is stained soil at this flowline valve that needs to be cleaned up.

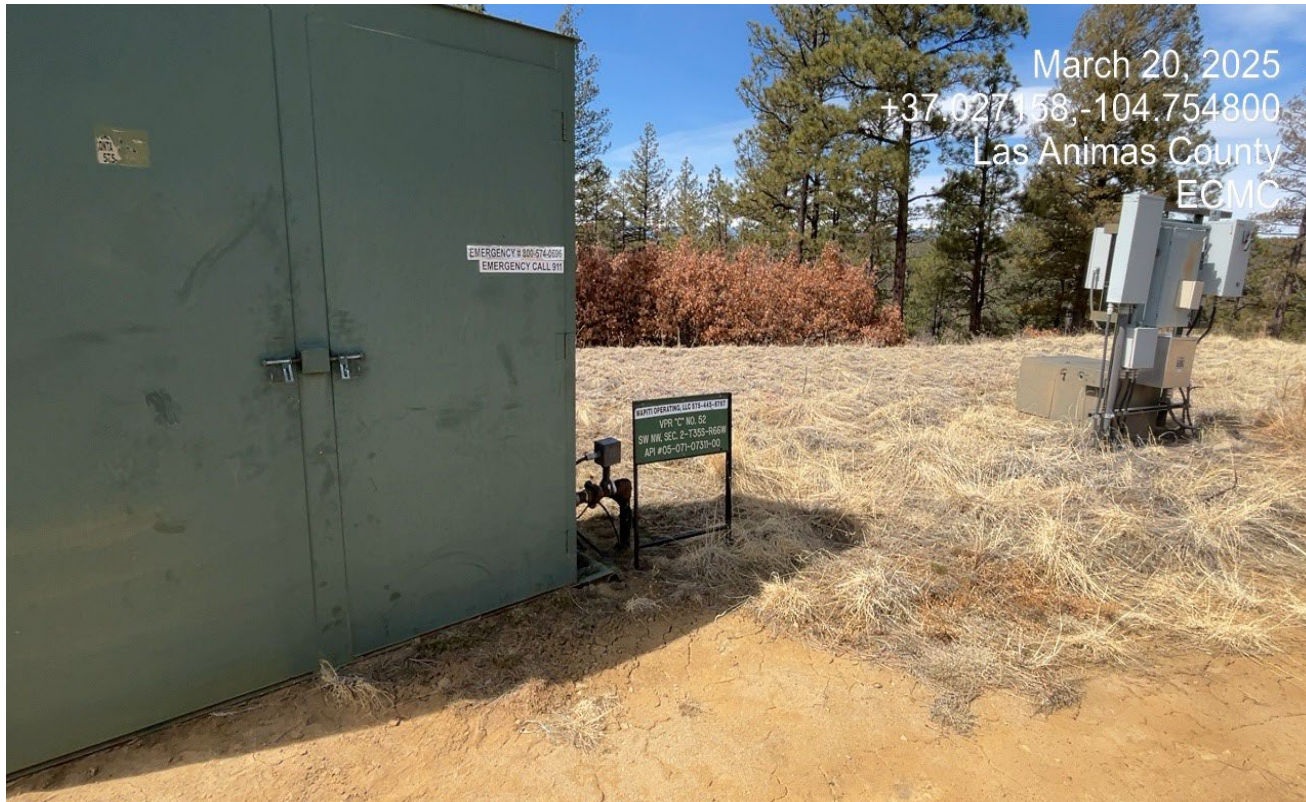
Photo 3. Well sign is posted by the meter shed.

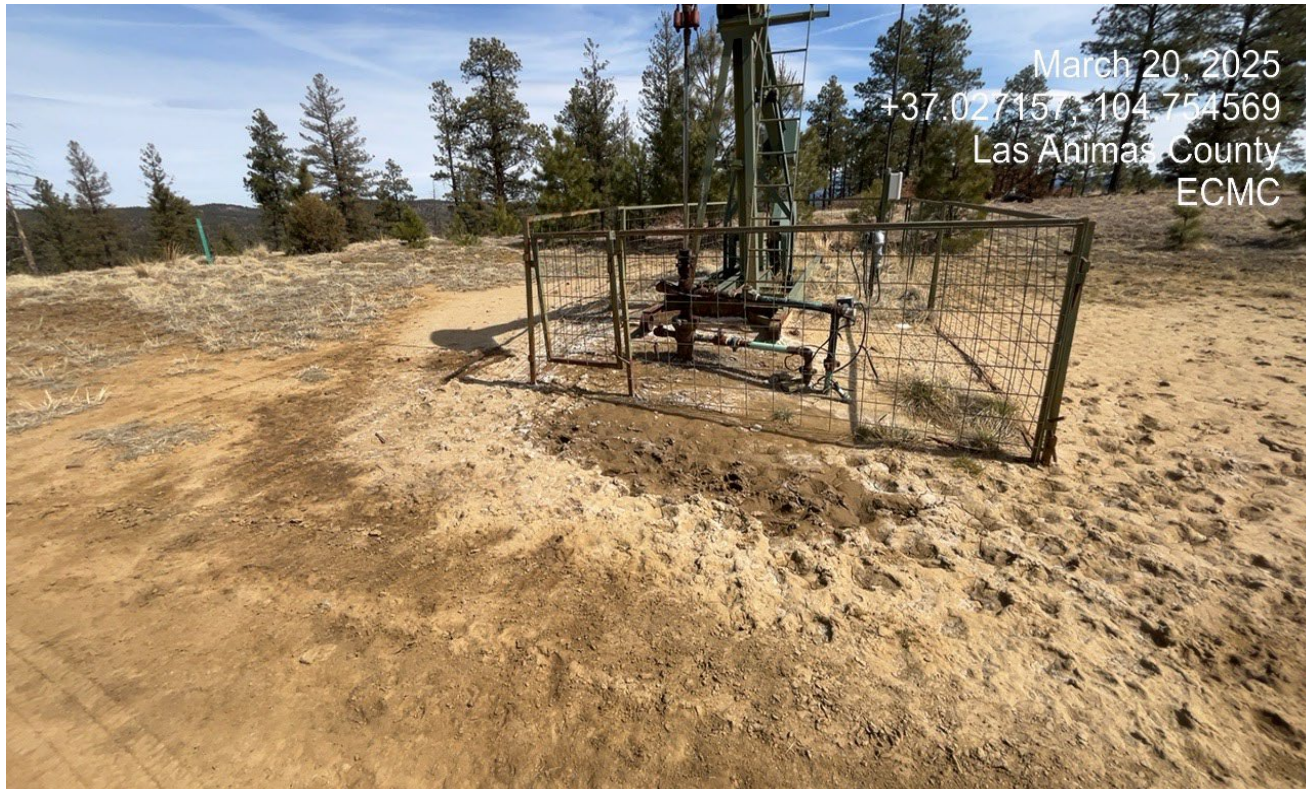
Photo 4. There is wet stained soil at the wellhead from a PW leak that needs to be cleaned up. Ensure leak is controlled.

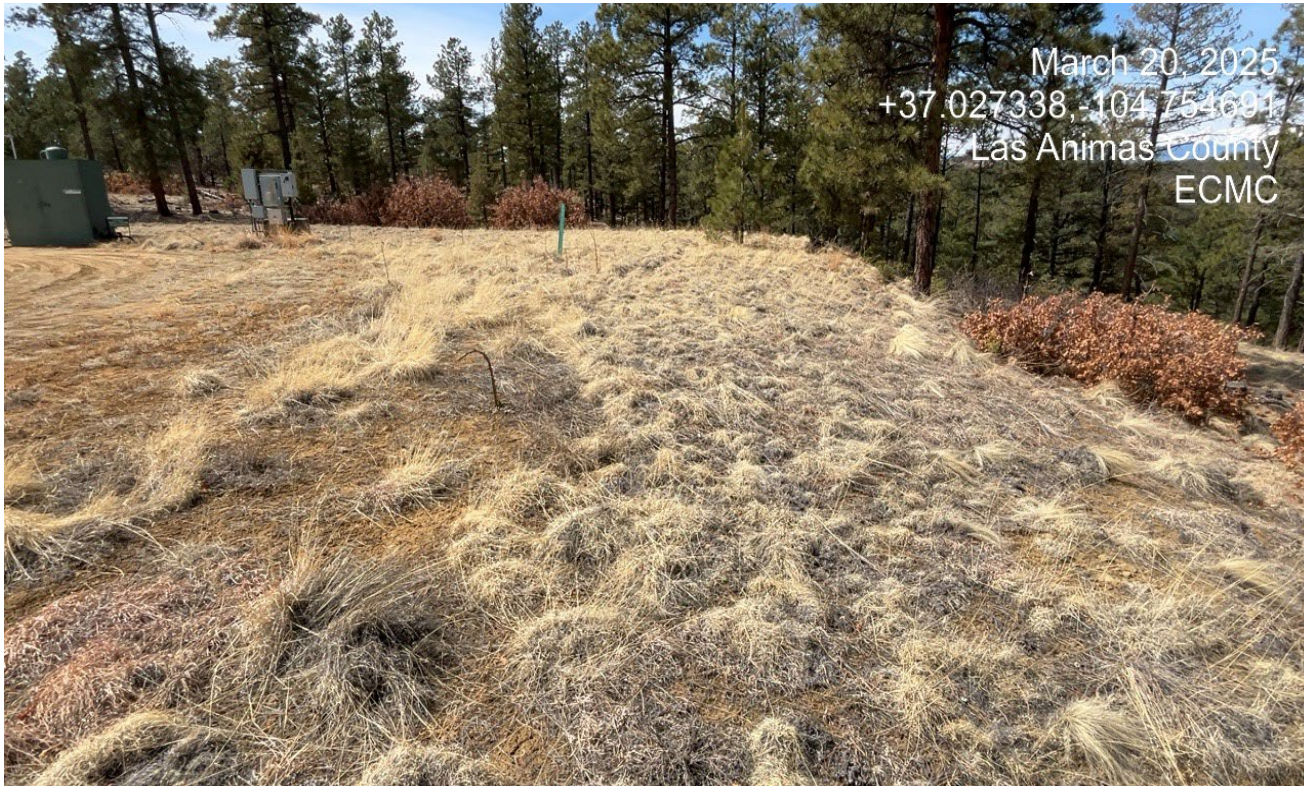
Photo 5. Facing west along the fill slope which is stabilized with vegetation.
