**Inspection/Audit Photos**  
**Location Name: TEP Rocky Mountain LLC CSF B Pad**  
**Location # 335054**

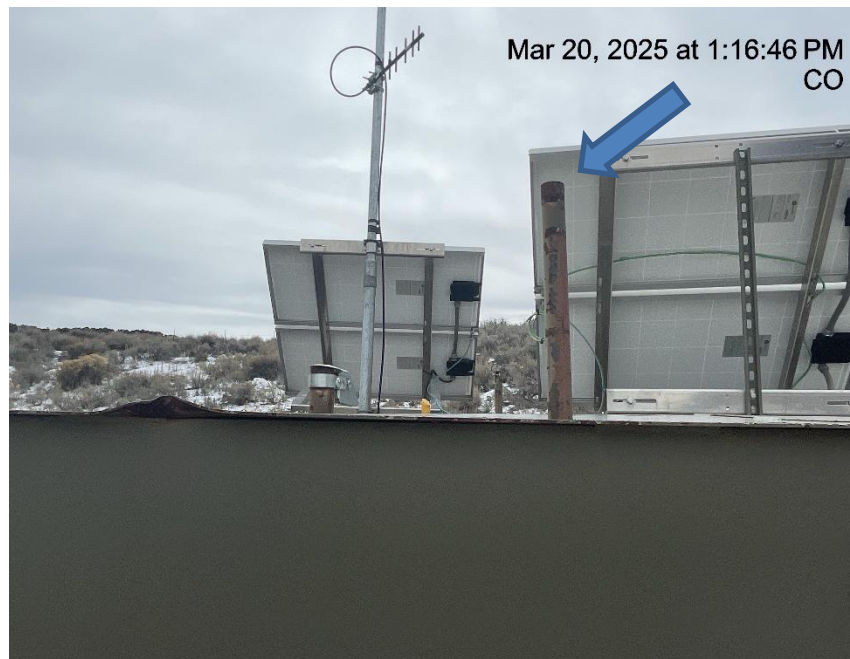
**Photo # 5853 PRV vent line does not comply with CECMC pressure safety device rules**

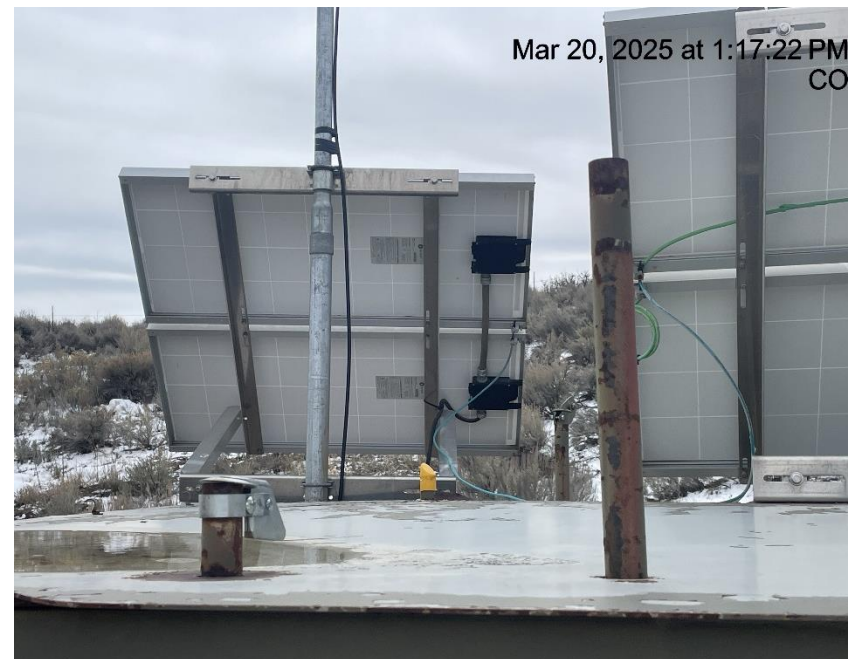
**Photo # 5854 PRV vent line does not comply with CECMC pressure safety device rules**

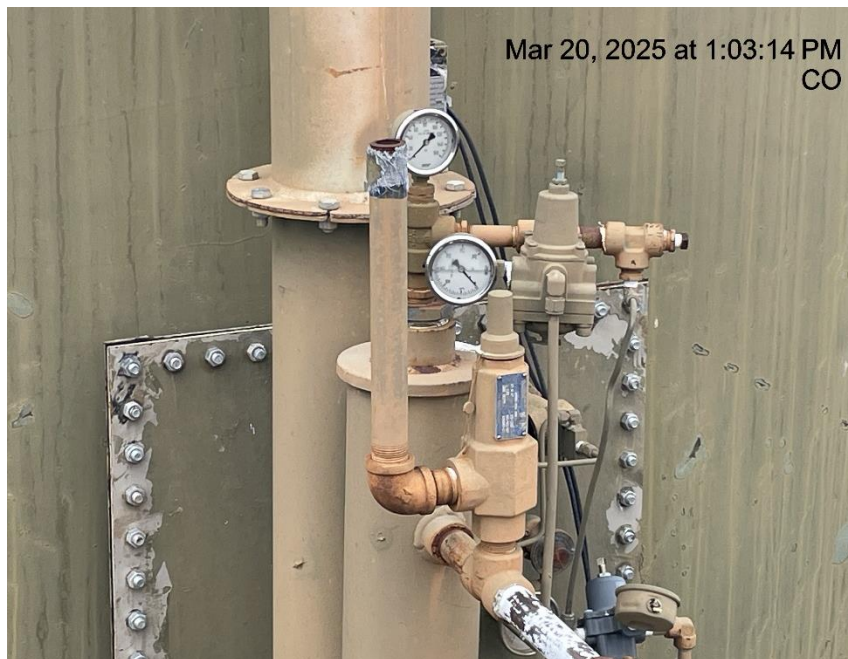
**Photo # 5855 PRV vent line does not comply with CECMC pressure safety device rules**

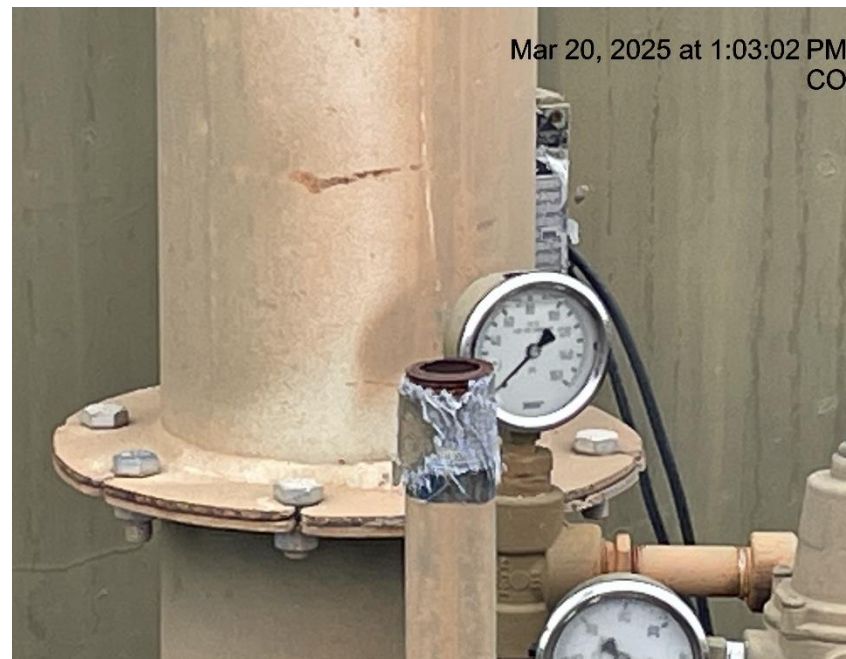
**Photo # 5856 PRV vent line does not comply with CECMC pressure safety device rules**

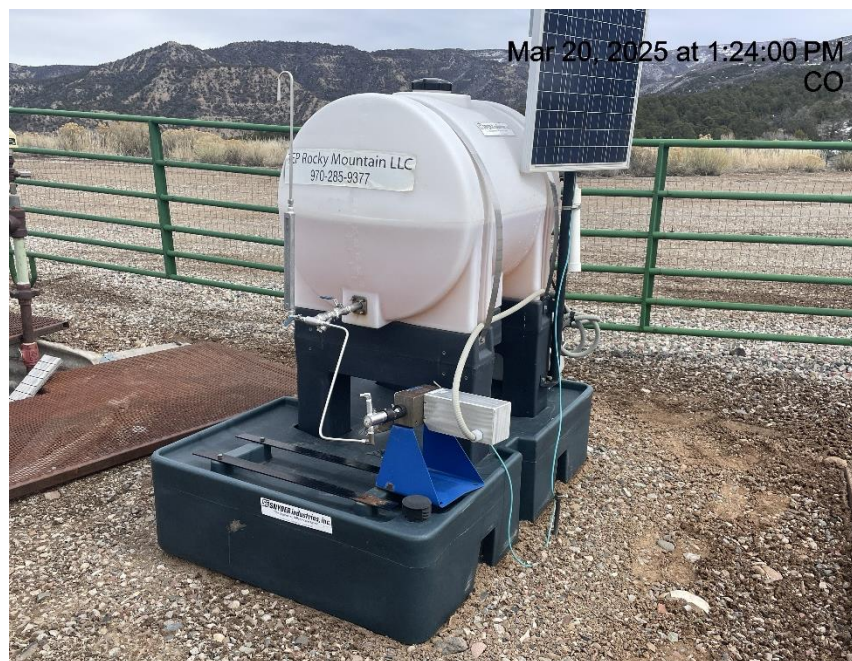
Photo # 5857 Unused equipment

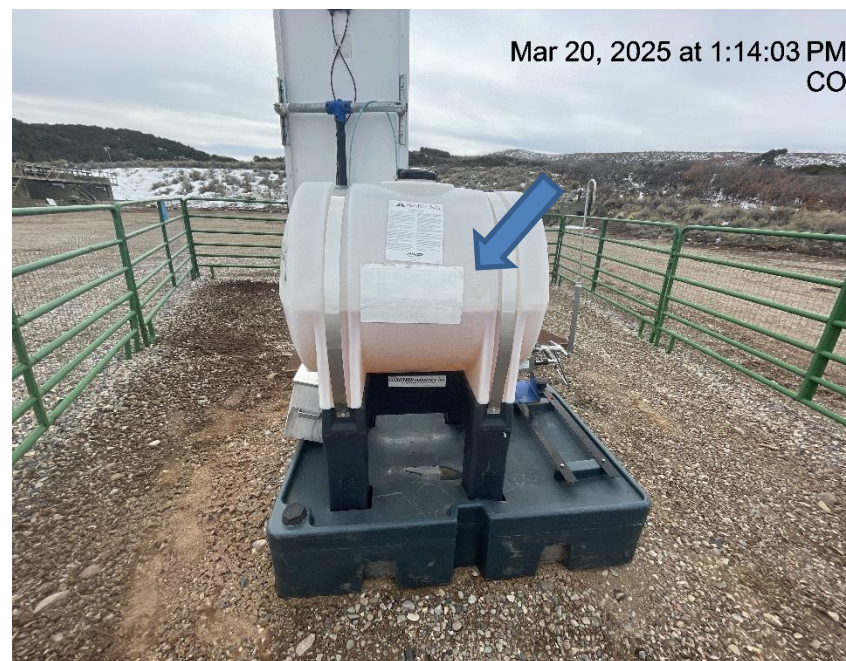
Photo # 5858 Same unused equipment (Additionally the chemical tank label is faded & illegible)

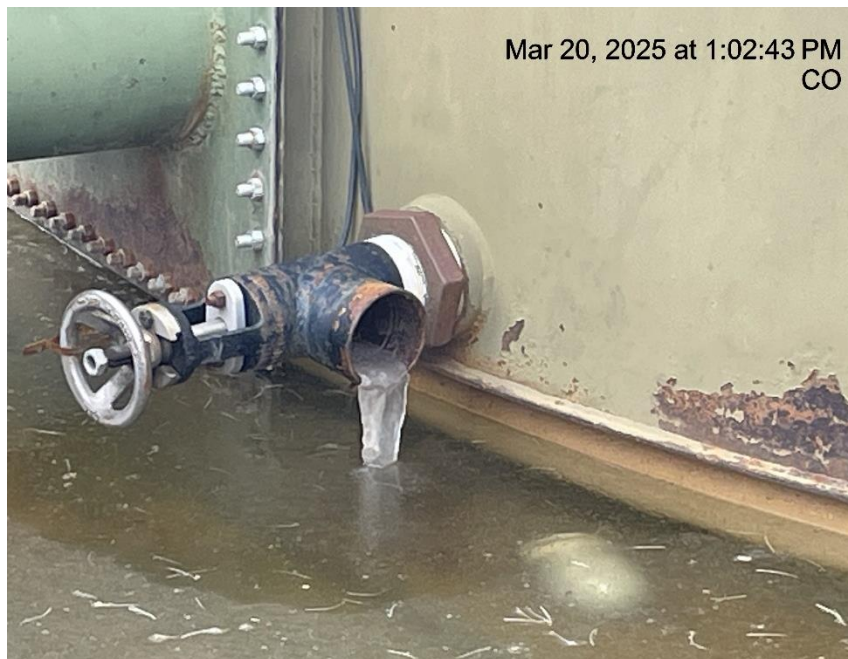
**Photo # 5859 Open ended load line (Additionally ice that has formed at the valve/load line could indicate a possible leak)**

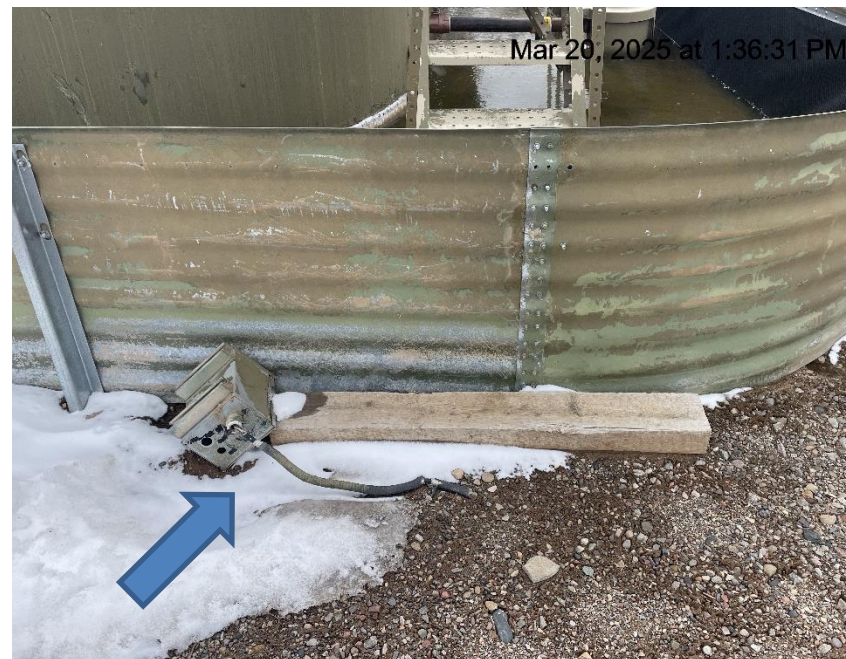
**Photo # 5860 Debris**
