Inspection/Audit Photos

Location: LARAMIE ENERGY LLC Hayward/0993-25-09 Pad

Location ID: 455725

Date: 03/24/2025

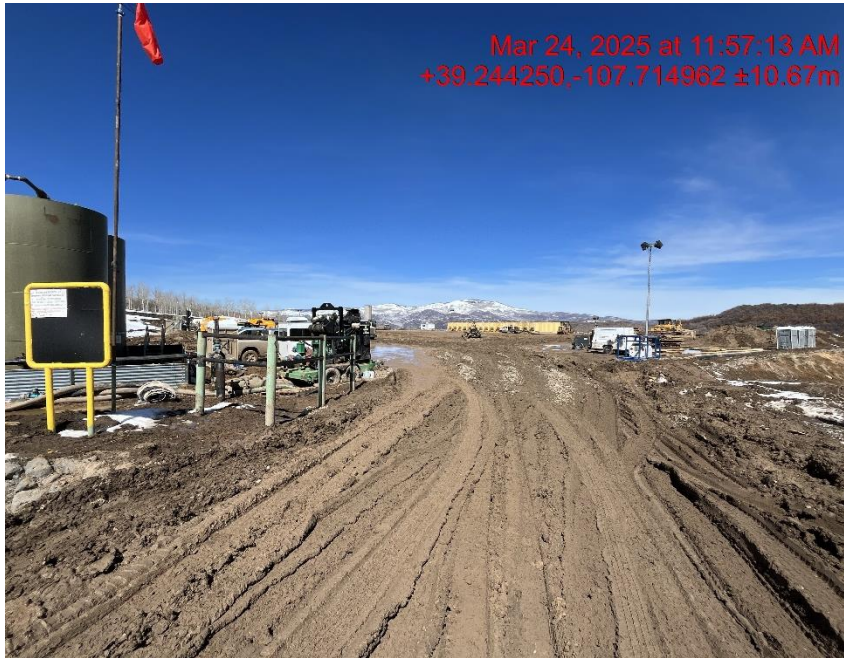
Photo # 6681 Entrance to location/Lack of stabilization/compaction/insufficient tracking BMP's

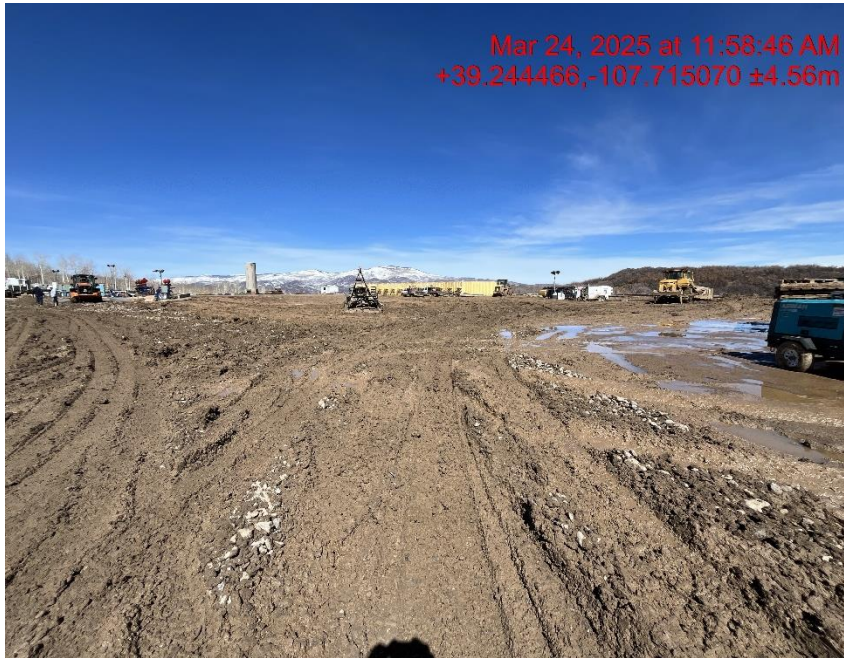
Photo # 6683 Lack of stabilization/compaction on location/insufficient tracking BMP's

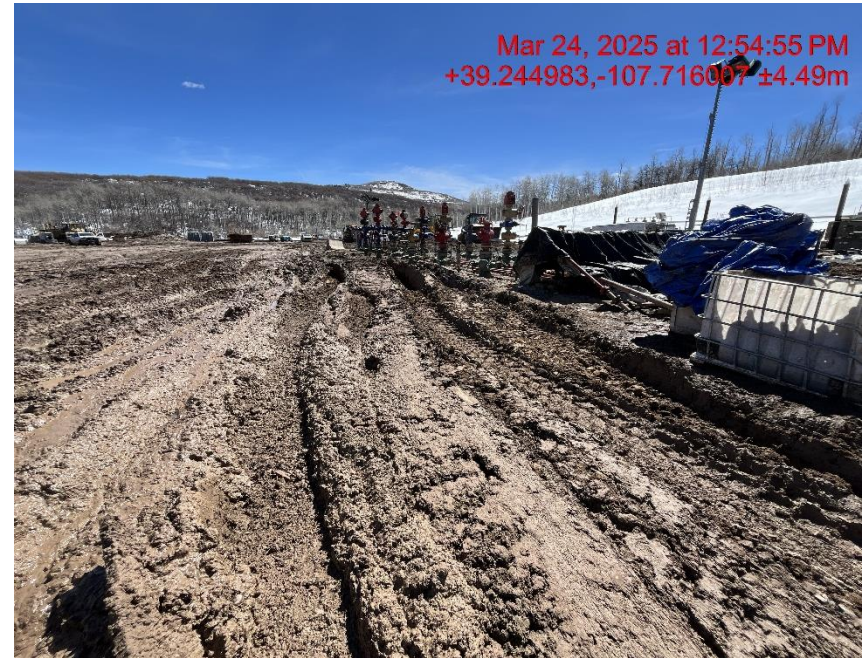
Photo # 6687 Lack of stabilization/compaction on location/insufficient tracking BMP's

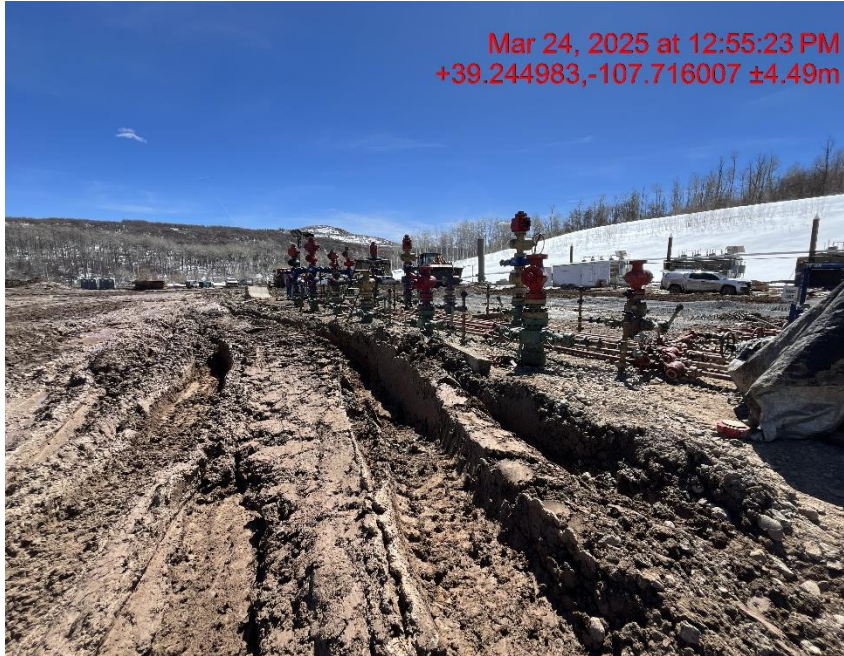
Photo # 6688 Lack of stabilization/compaction on location/insufficient tracking BMP's

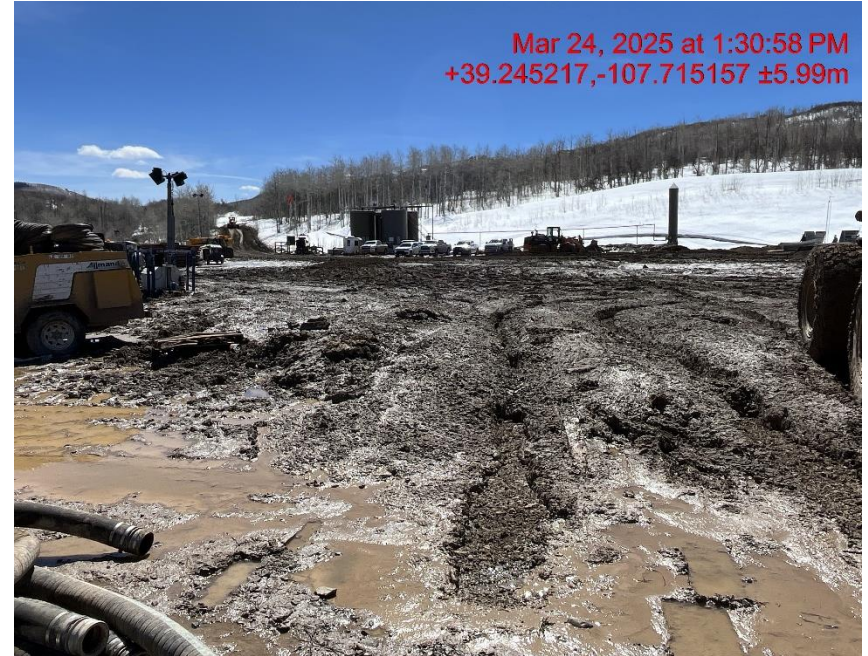
Photo # 6707 Lack of stabilization/compaction on location/insufficient tracking BMP's

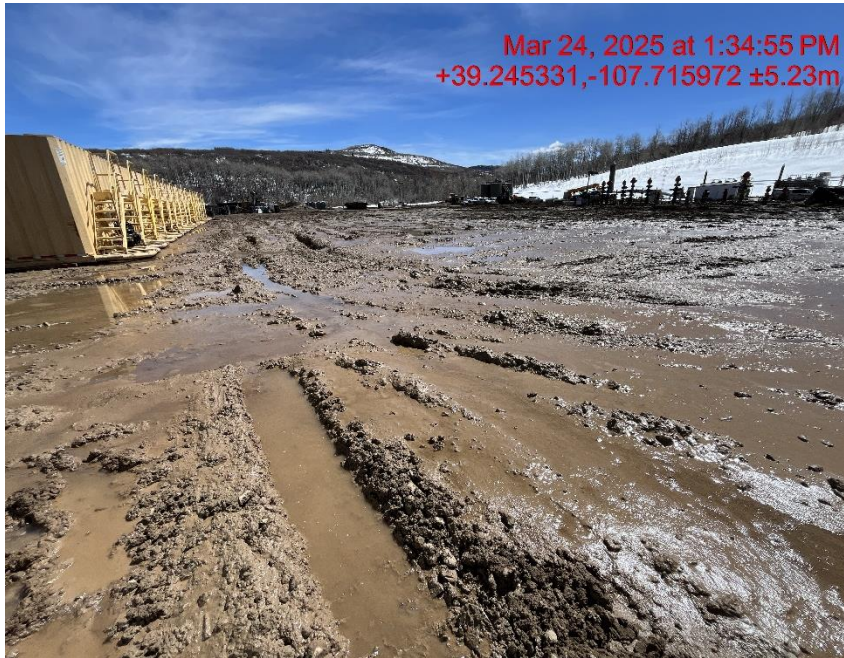
Photo # 6710 Lack of stabilization/compaction on location/insufficient tracking BMP's

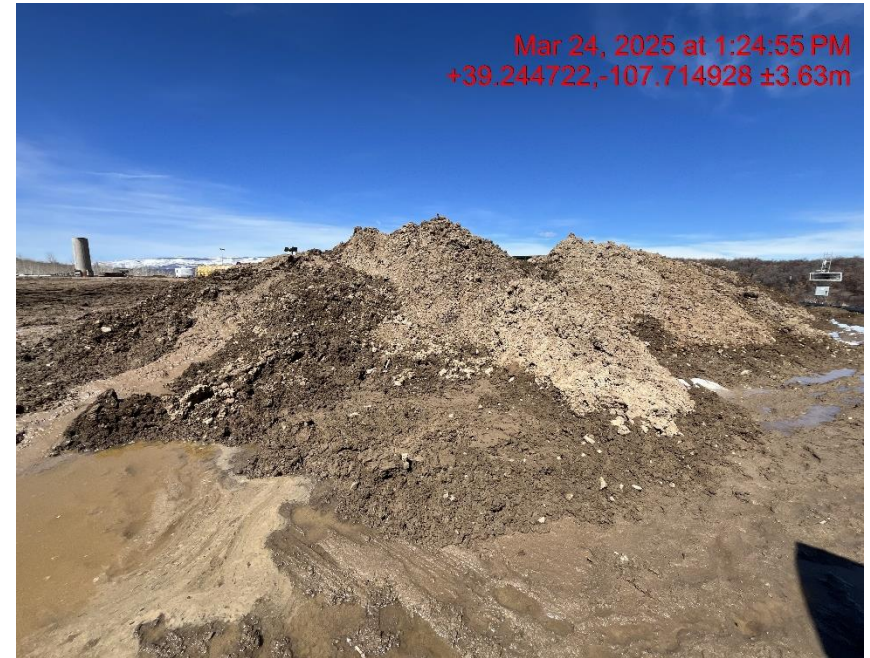
Photo # 6698 Stockpiled soils on location with no BMP's

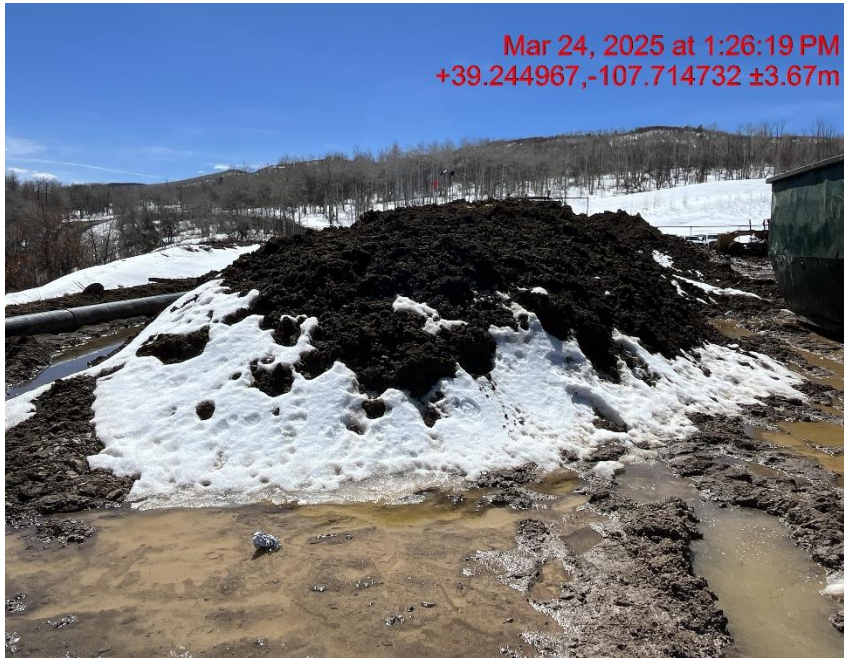
Photo # 6699 Stockpiled soils on location with no BMP's

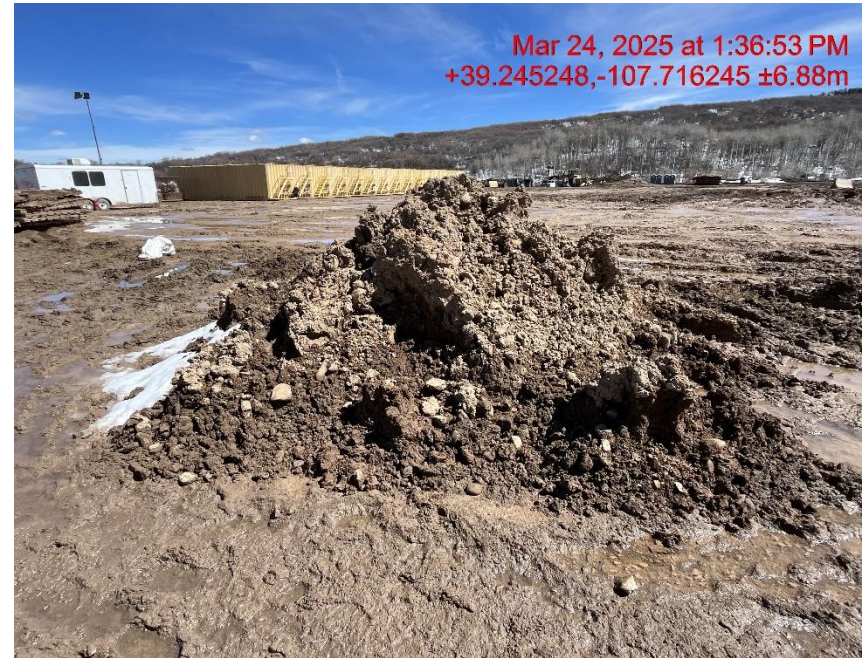
Photo # 6712 Stockpiled soils on location with no BMP's

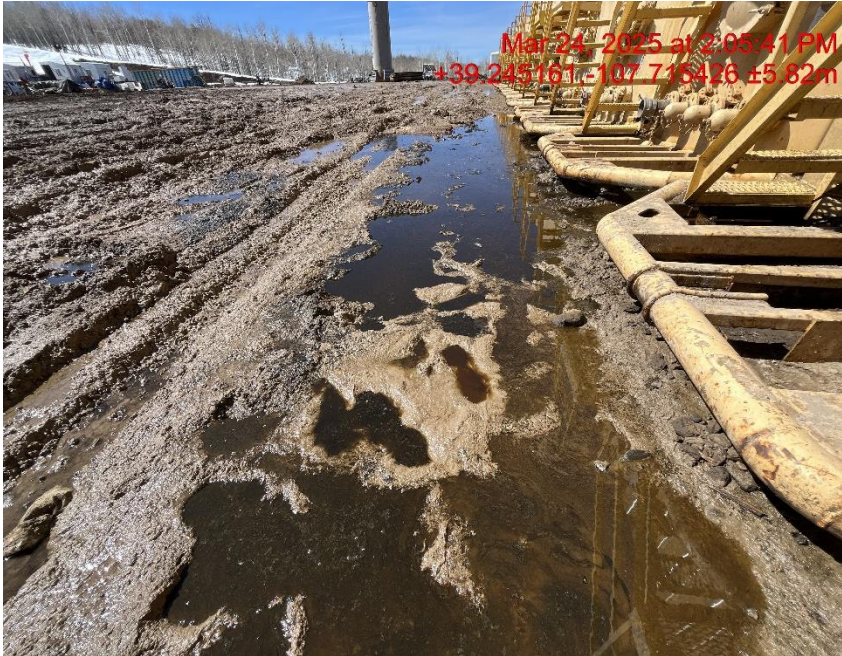
Photo # 6738 Unknown fluid around frac tanks

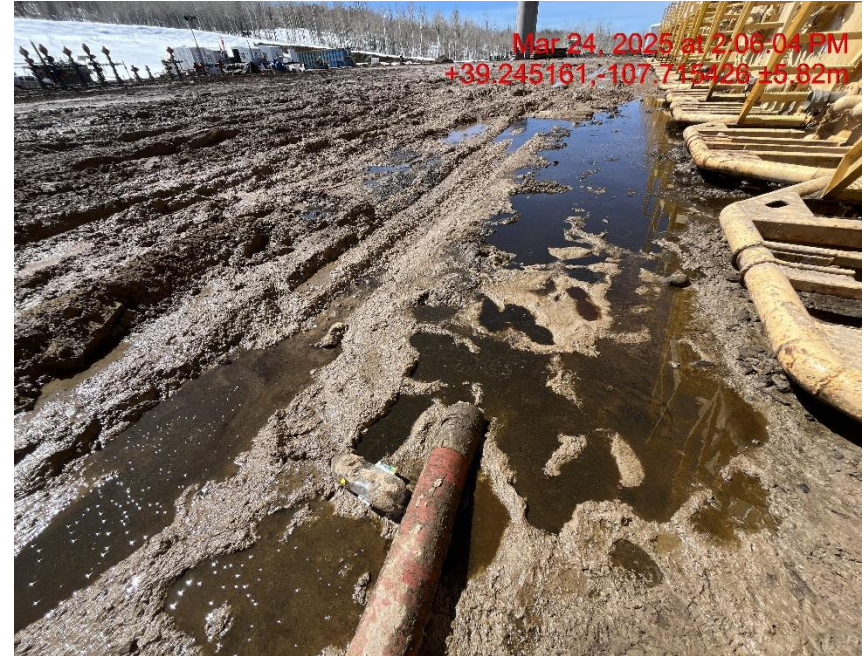
Photo # 6739 Unknown fluid around frac tanks

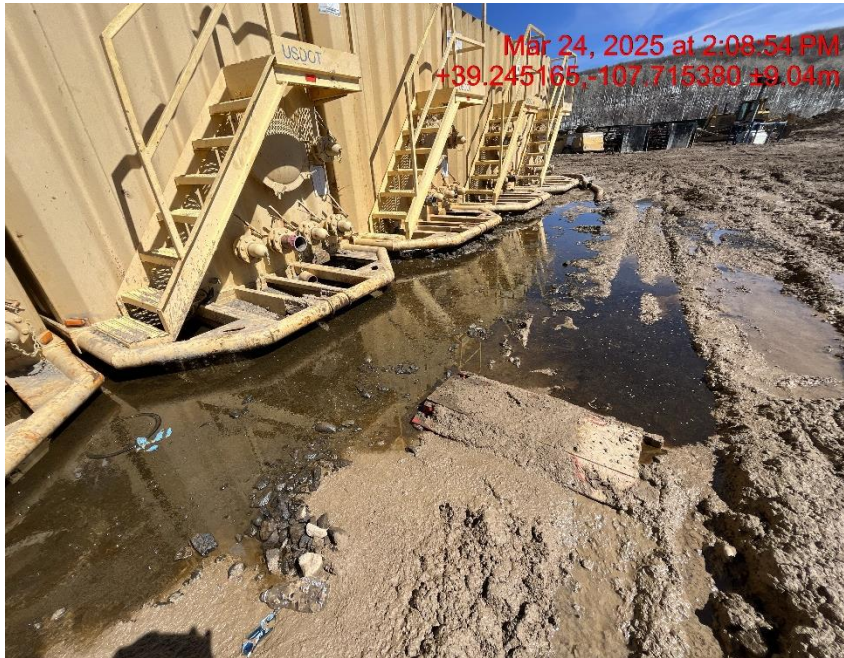
Photo # 6742 Unknown fluid around frac tanks

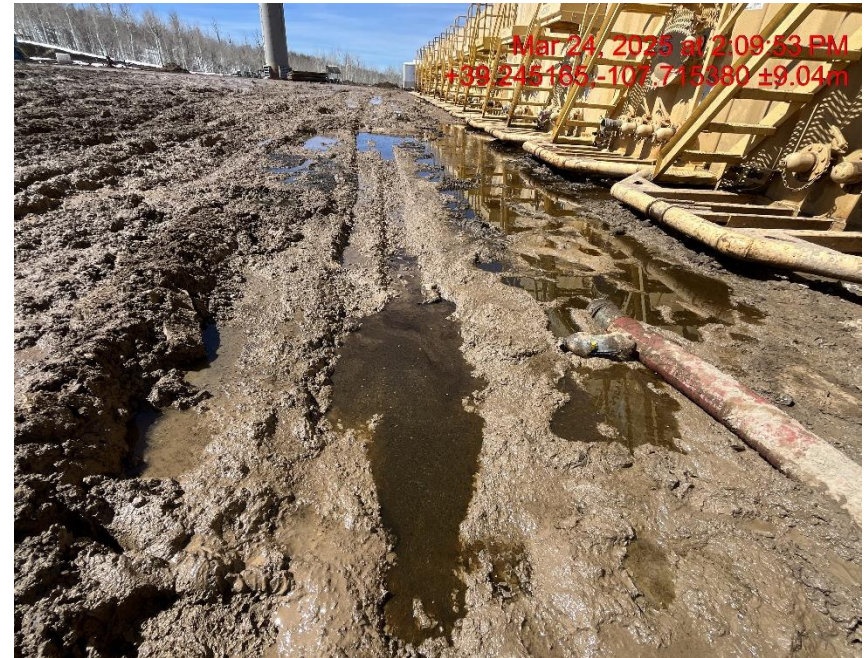
Photo # 6745 Unknown fluid around frac tanks

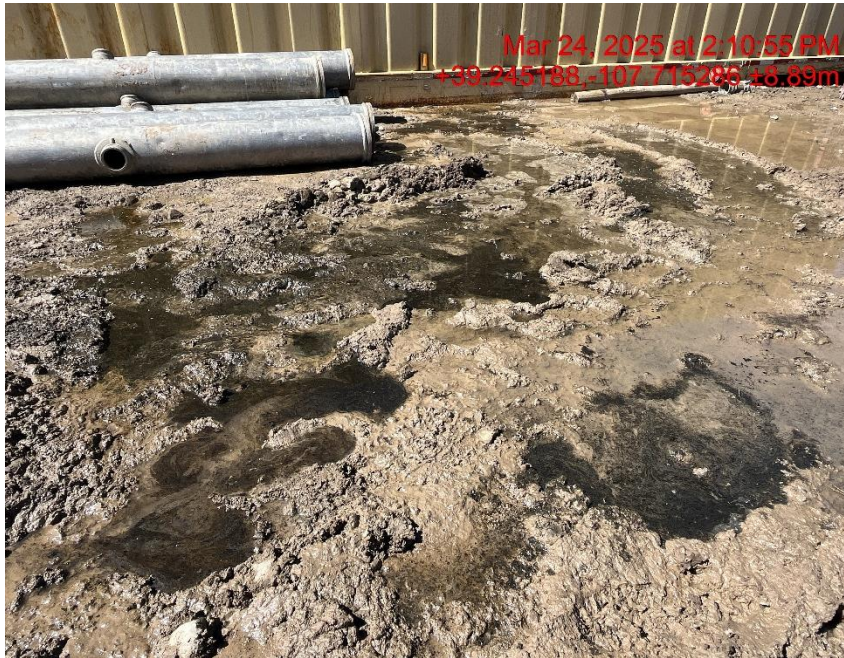
Photo # 6746 Unknown fluid around frac tanks

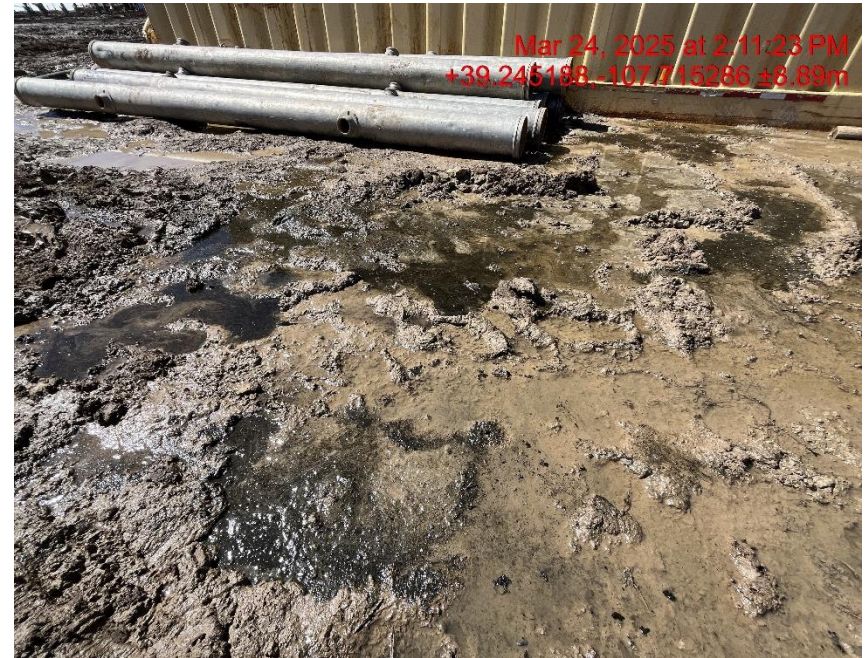
Photo # 6747 Unknown fluid around frac tanks

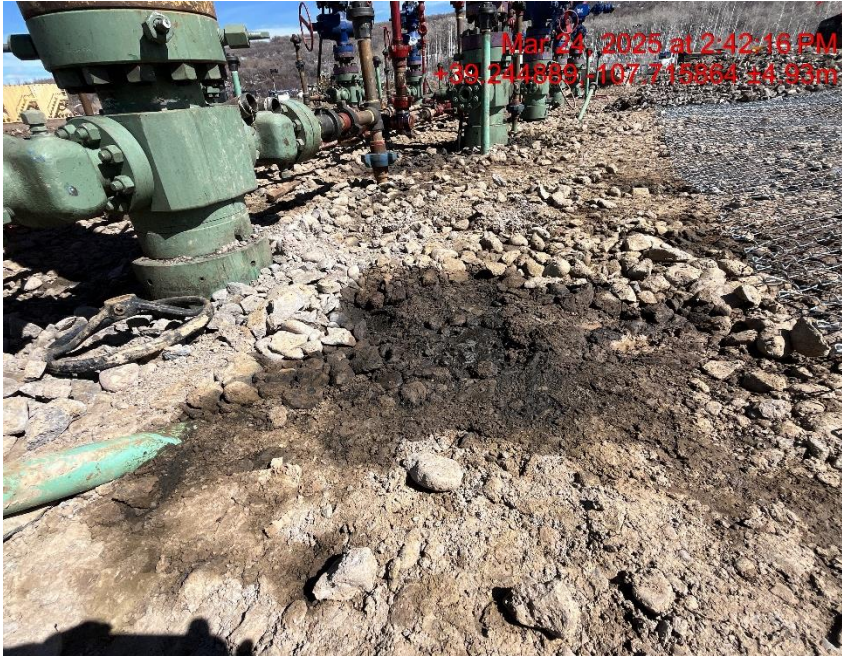
Photo # 6757 Staining on location

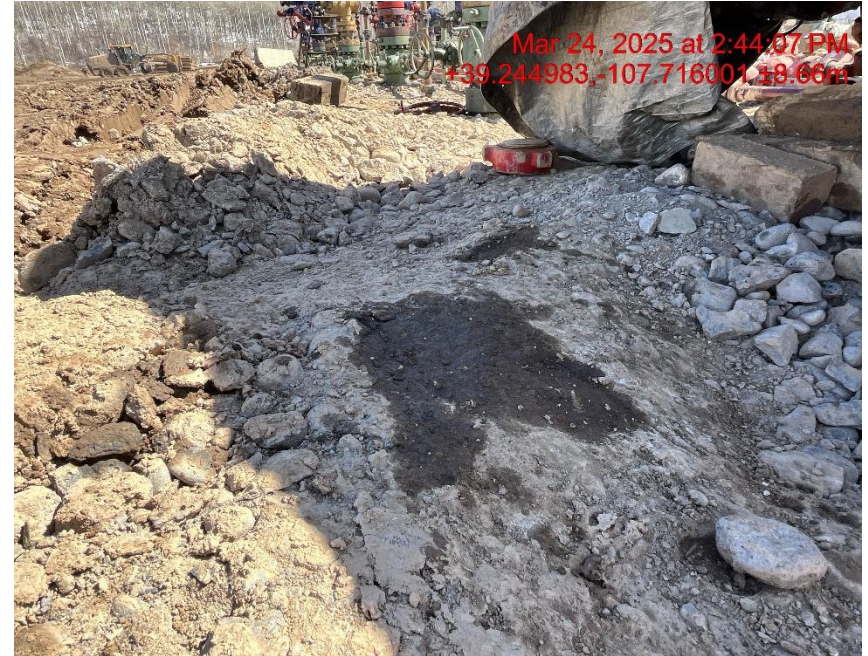
Photo # 6759 Staining on location

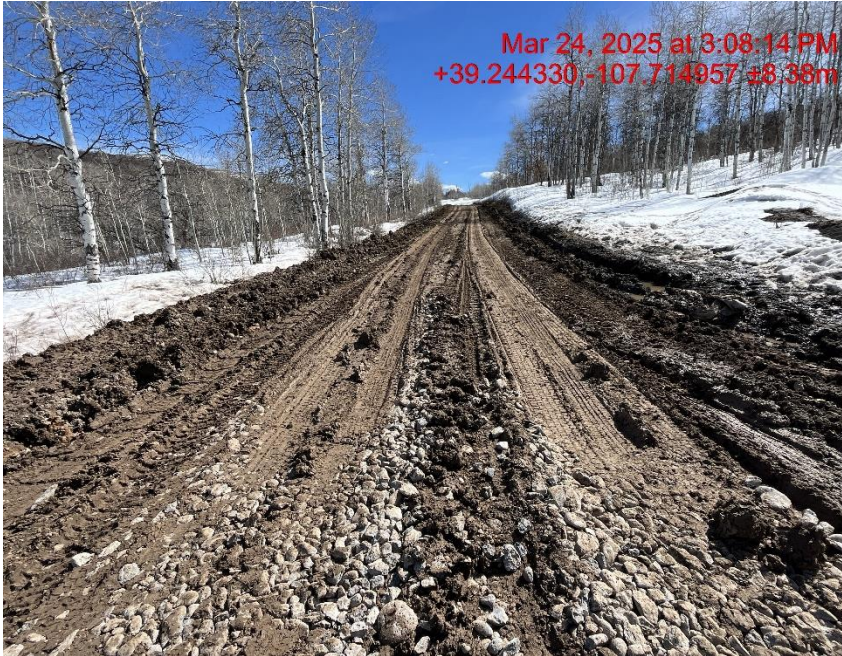
Photo # 6766 Vehicle tracking onto lease road/Insufficient tracking BMP's

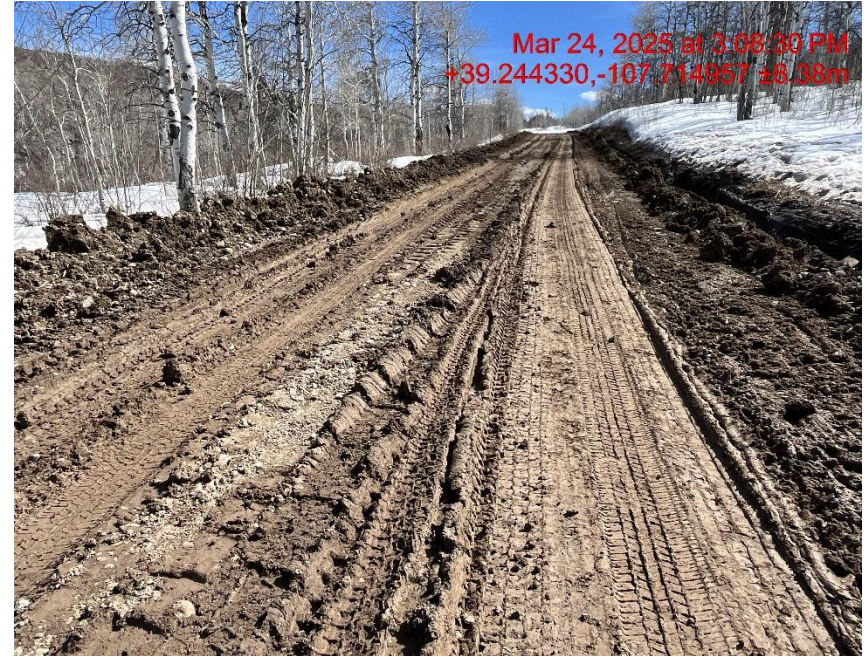
Photo # 6767 Vehicle tracking onto lease road/Insufficient tracking BMP's

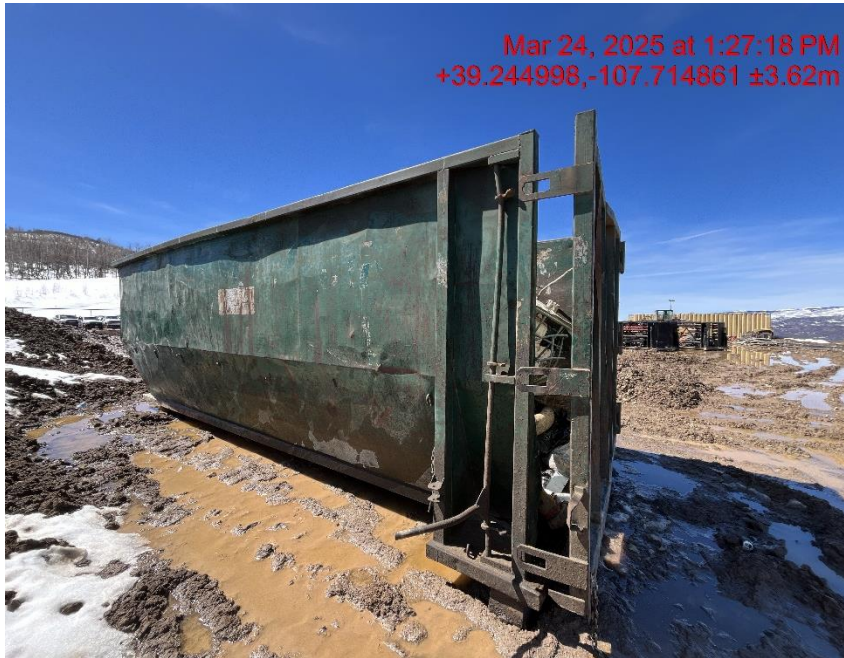
Photo # 6700 Dumpster open & available for entry by wildlife/wildlife hazard

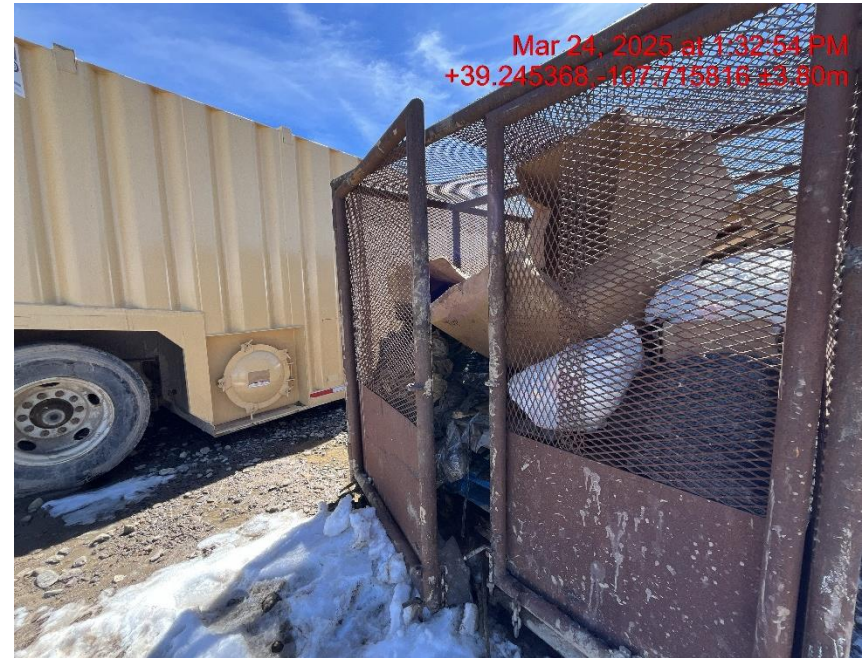
Photo # 6709 Dumpster open & available for entry by wildlife/wildlife hazard

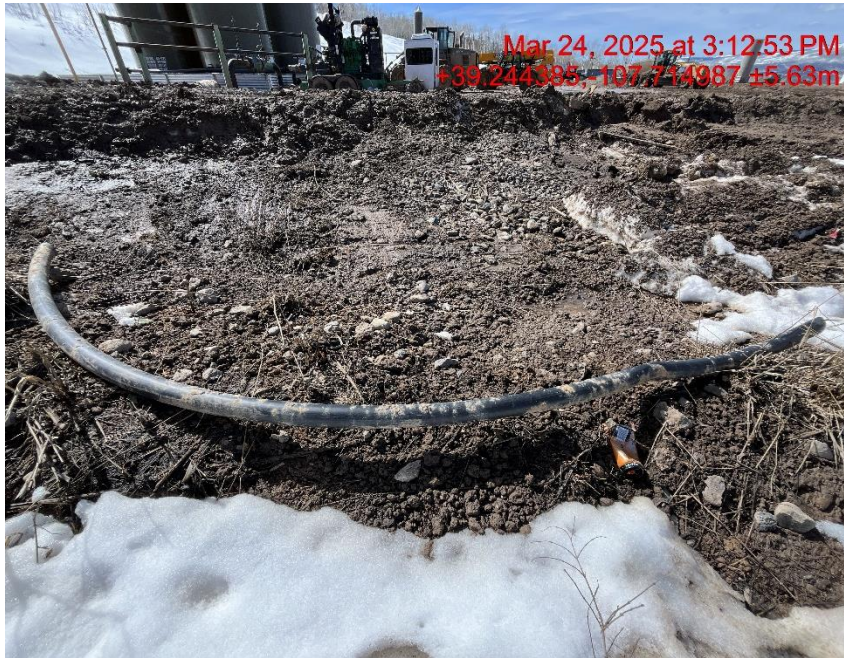
Photo # 6768 Debris

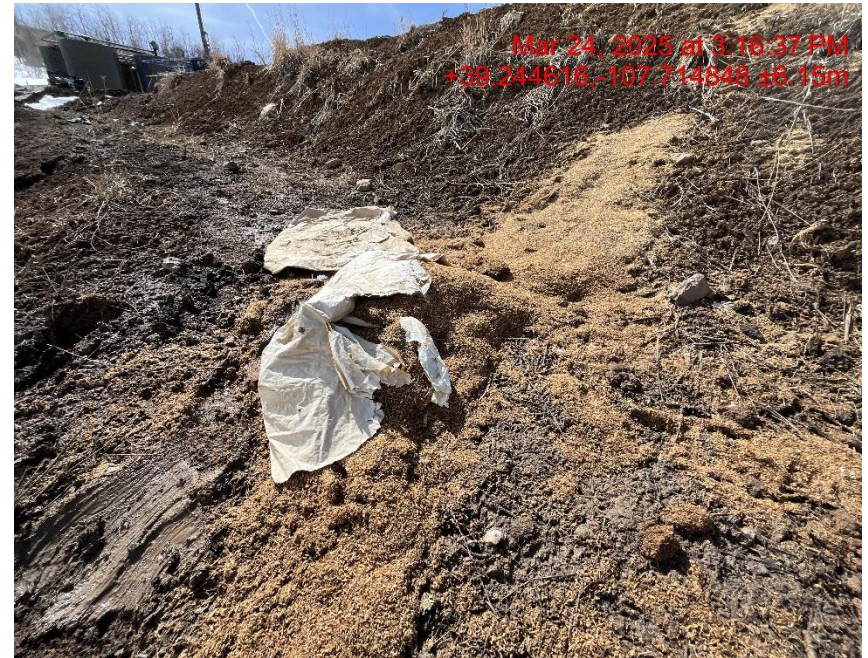
Photo # 6769 Debris

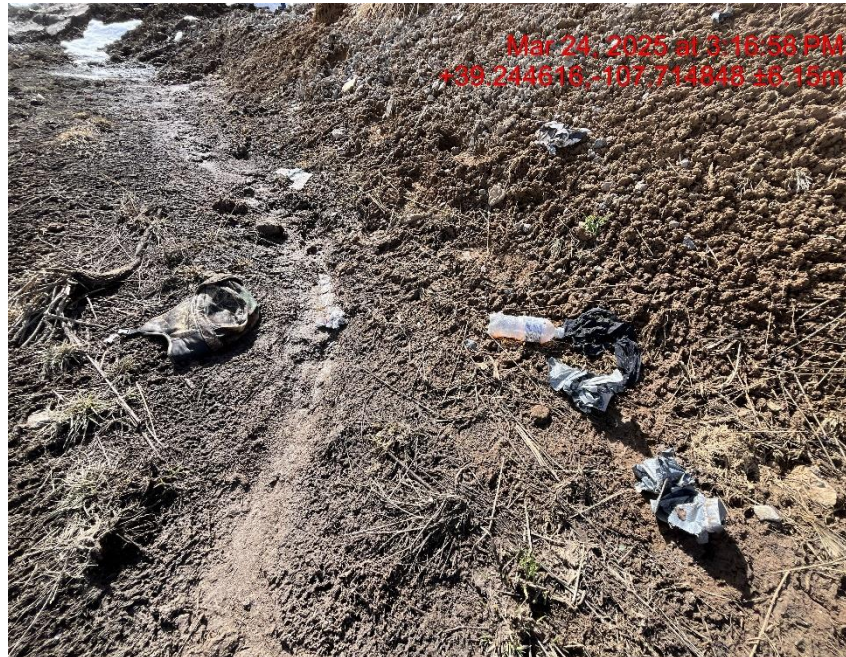
Photo # 6770 Debris
