Inspection Photos

API: 055-06316

Operator: OXY USA INC

Inspection Date: 3/26/2025

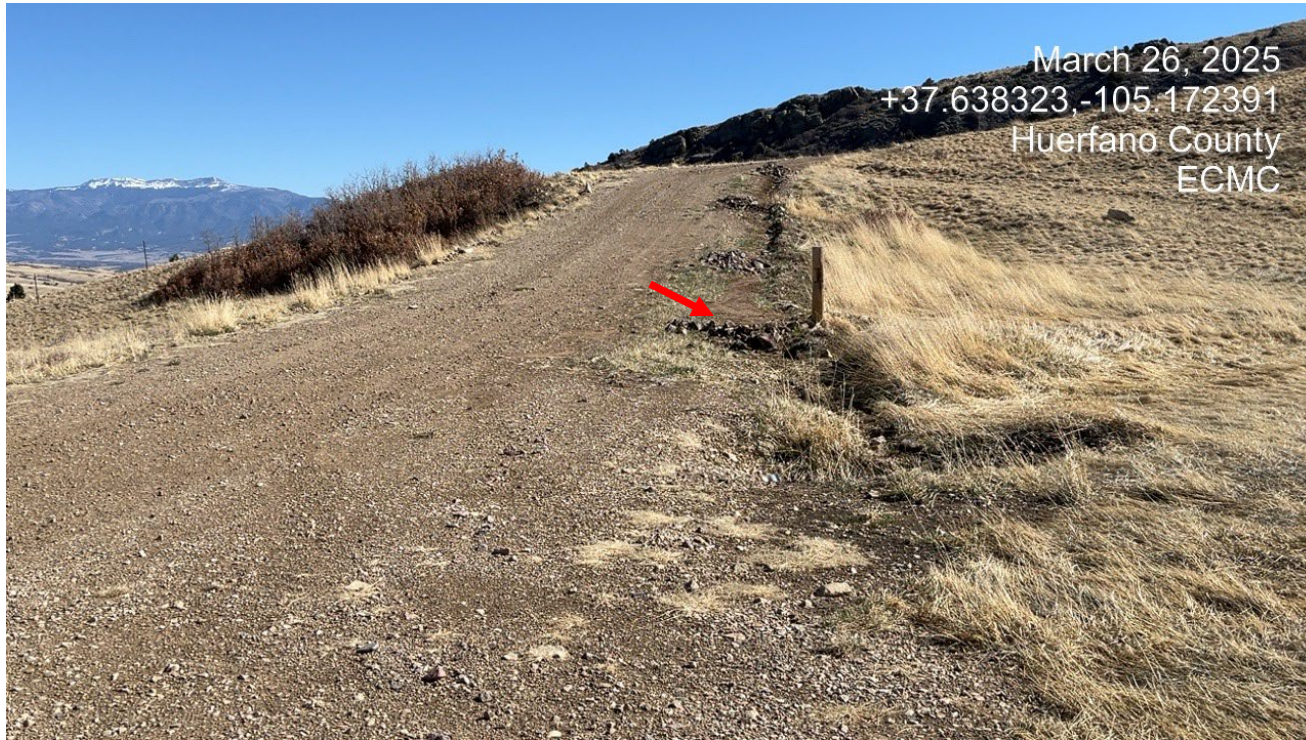
Photo 1. Facing northeast toward the access road. The rock check dams shown at red arrow are filled in with sediment and require maintenance.

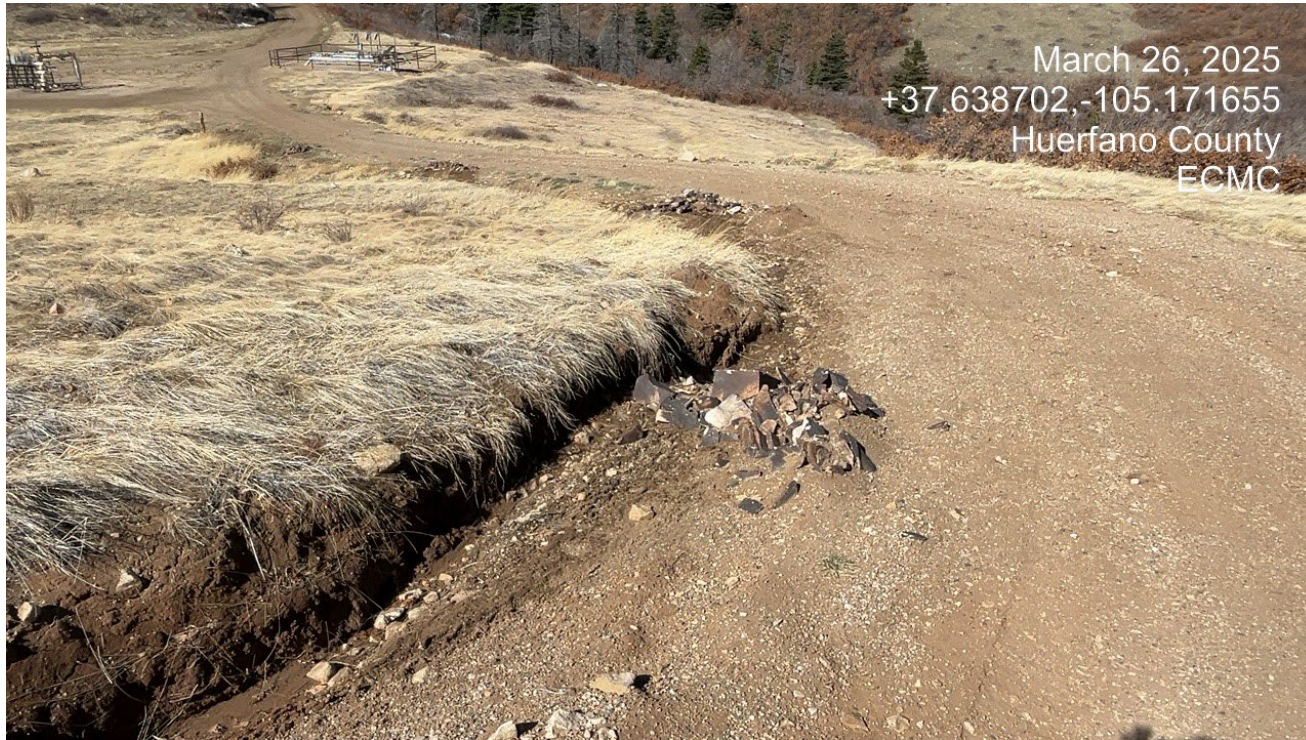
Photo 2. Facing back northwest along the access road. Theis check dam is in needof maintenance.

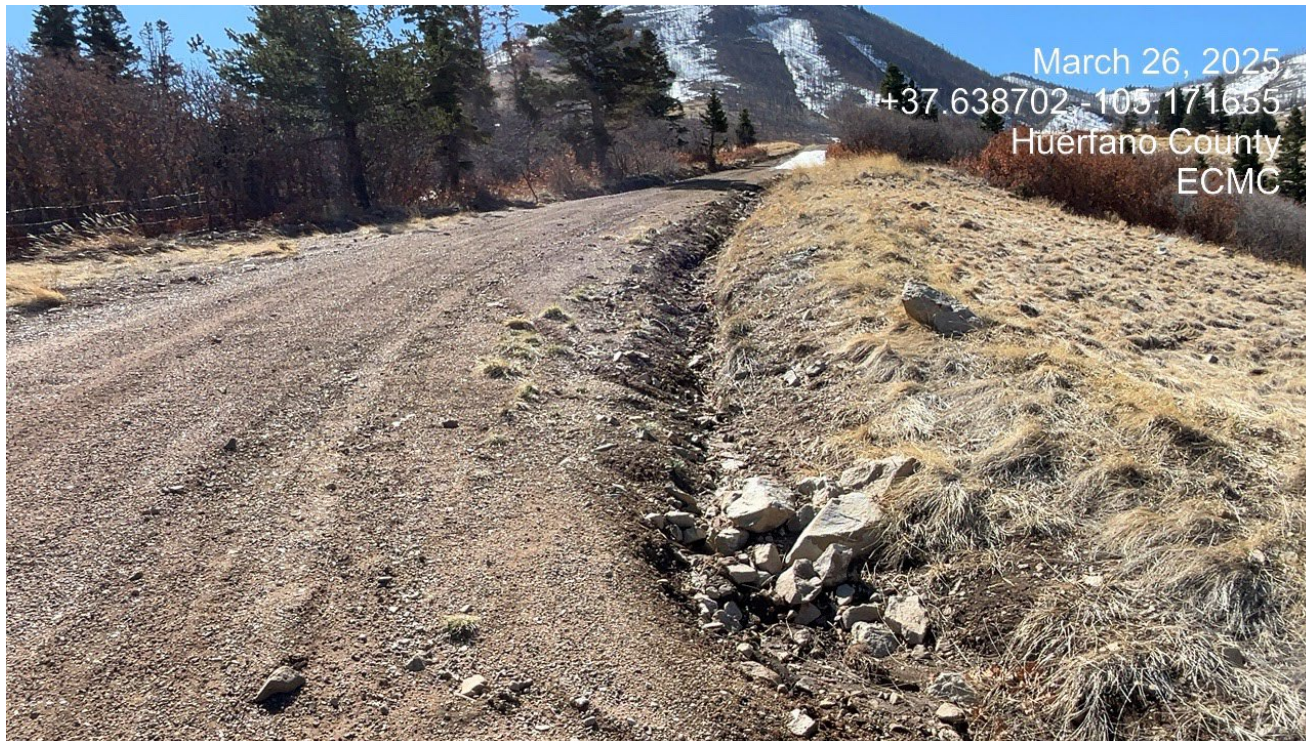
Photo 3. Facing southeast as the access road ascends to the location. There are insufficient BMP's to prevent erosion. Previous CA was not completed.

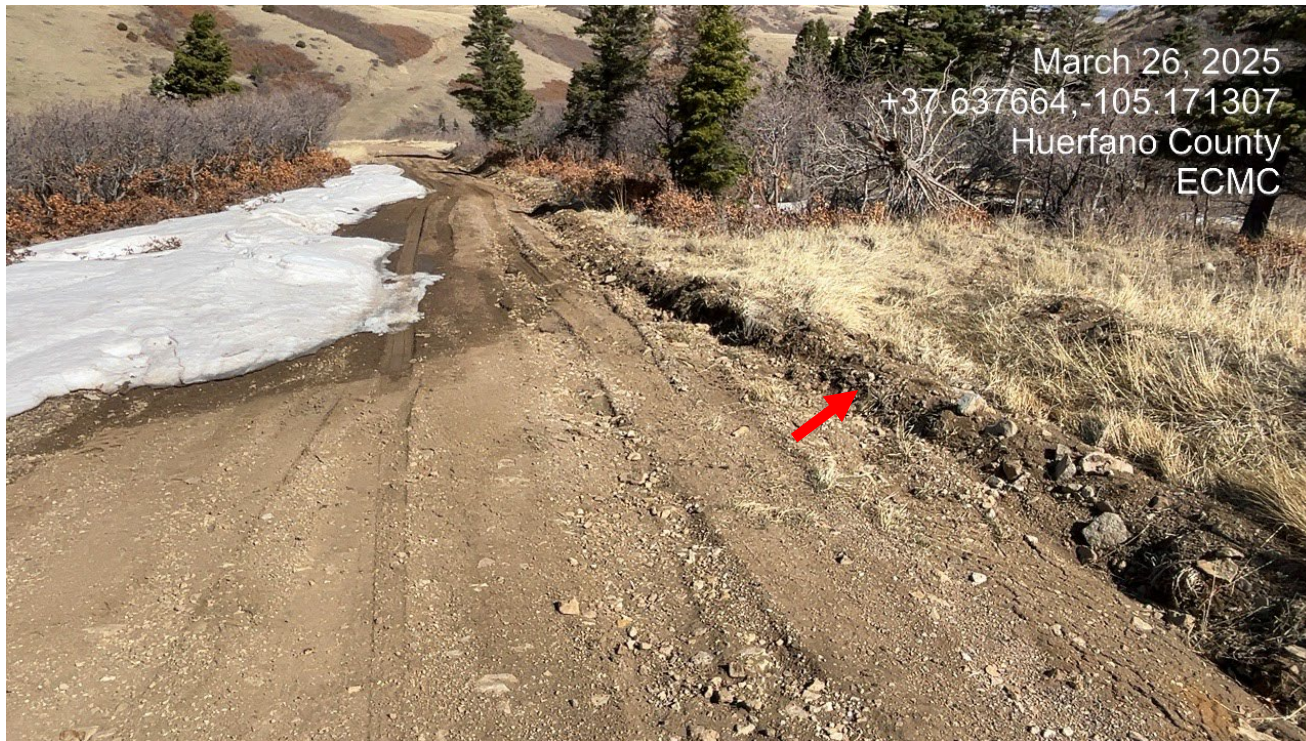
Photo 4. Facing back north the steep grade of access road. Stormwater is not being diverted off the road which is causing erosion of the road. Stormwater should be divert toward red arrow and into a sediment trap. A water bar would also help direct stormwater off the road.
