Facility 4
© 19-Mar-25 12:40:47 PM
ECMC Environmental Inspection

ECMC
Environmental
Field Inspection

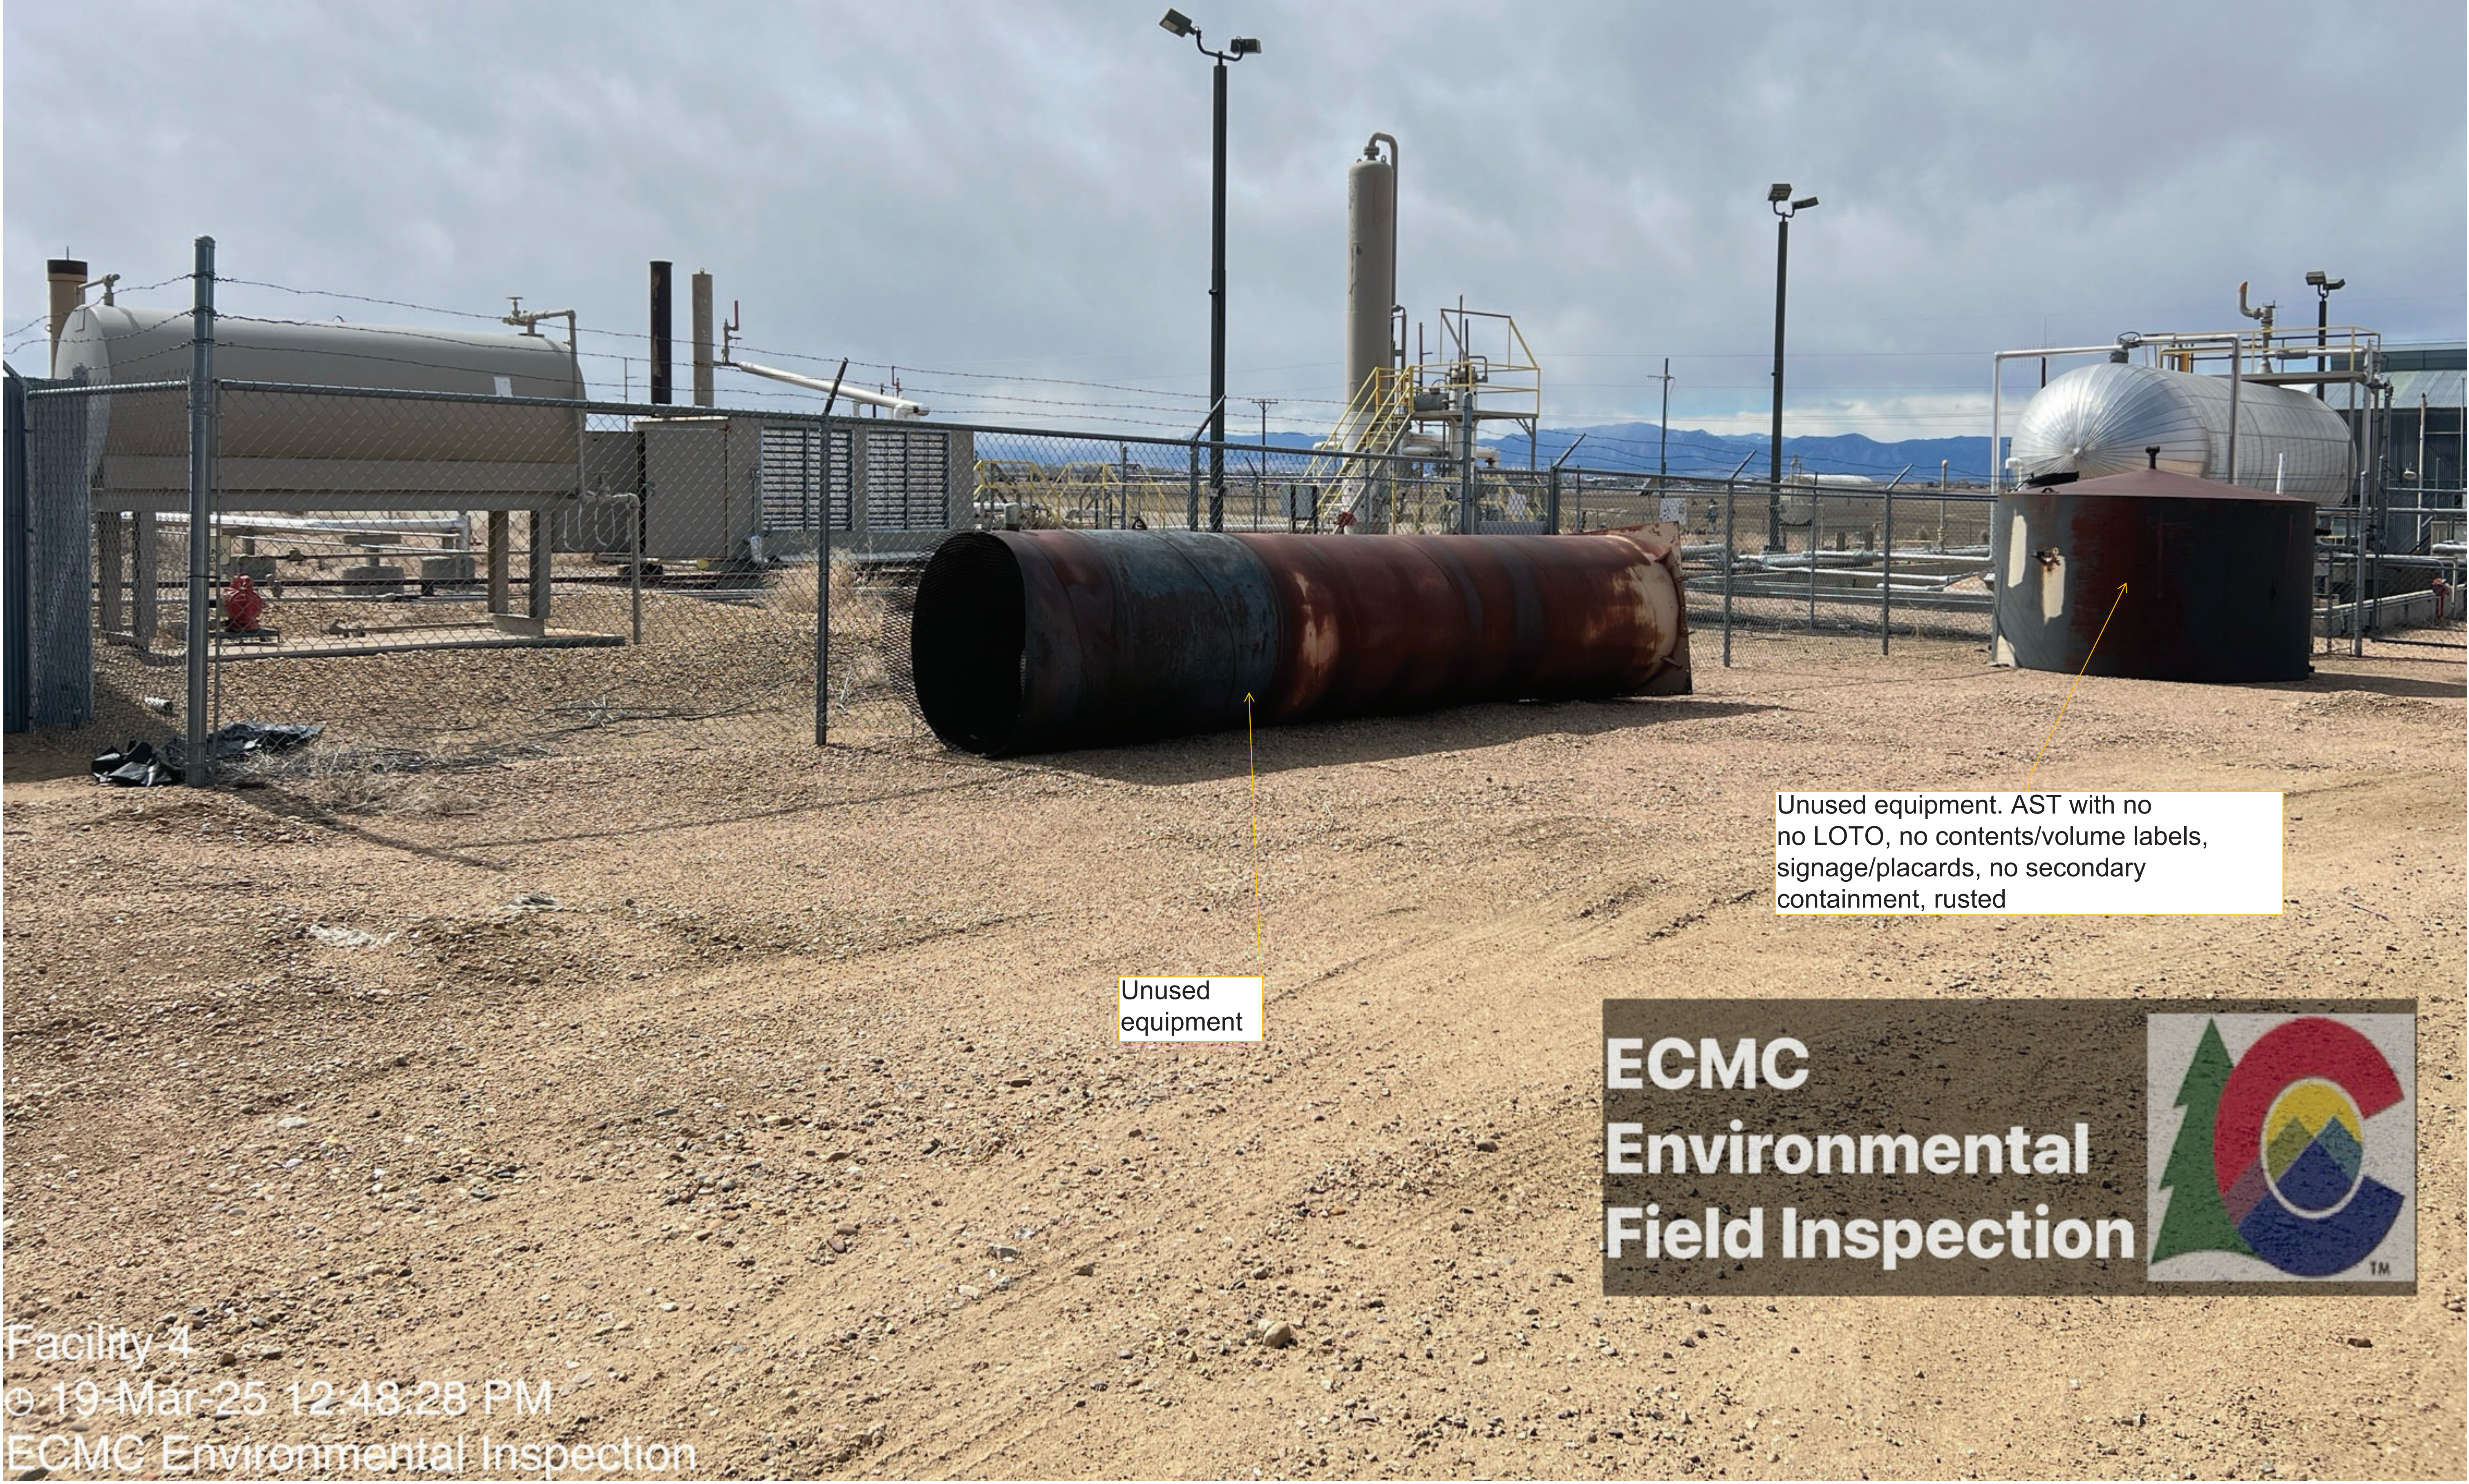
Unused
equipment

Unused equipment. AST with no
no LOTO, no contents/volume labels,
signage/placards, no secondary
containment, rusted

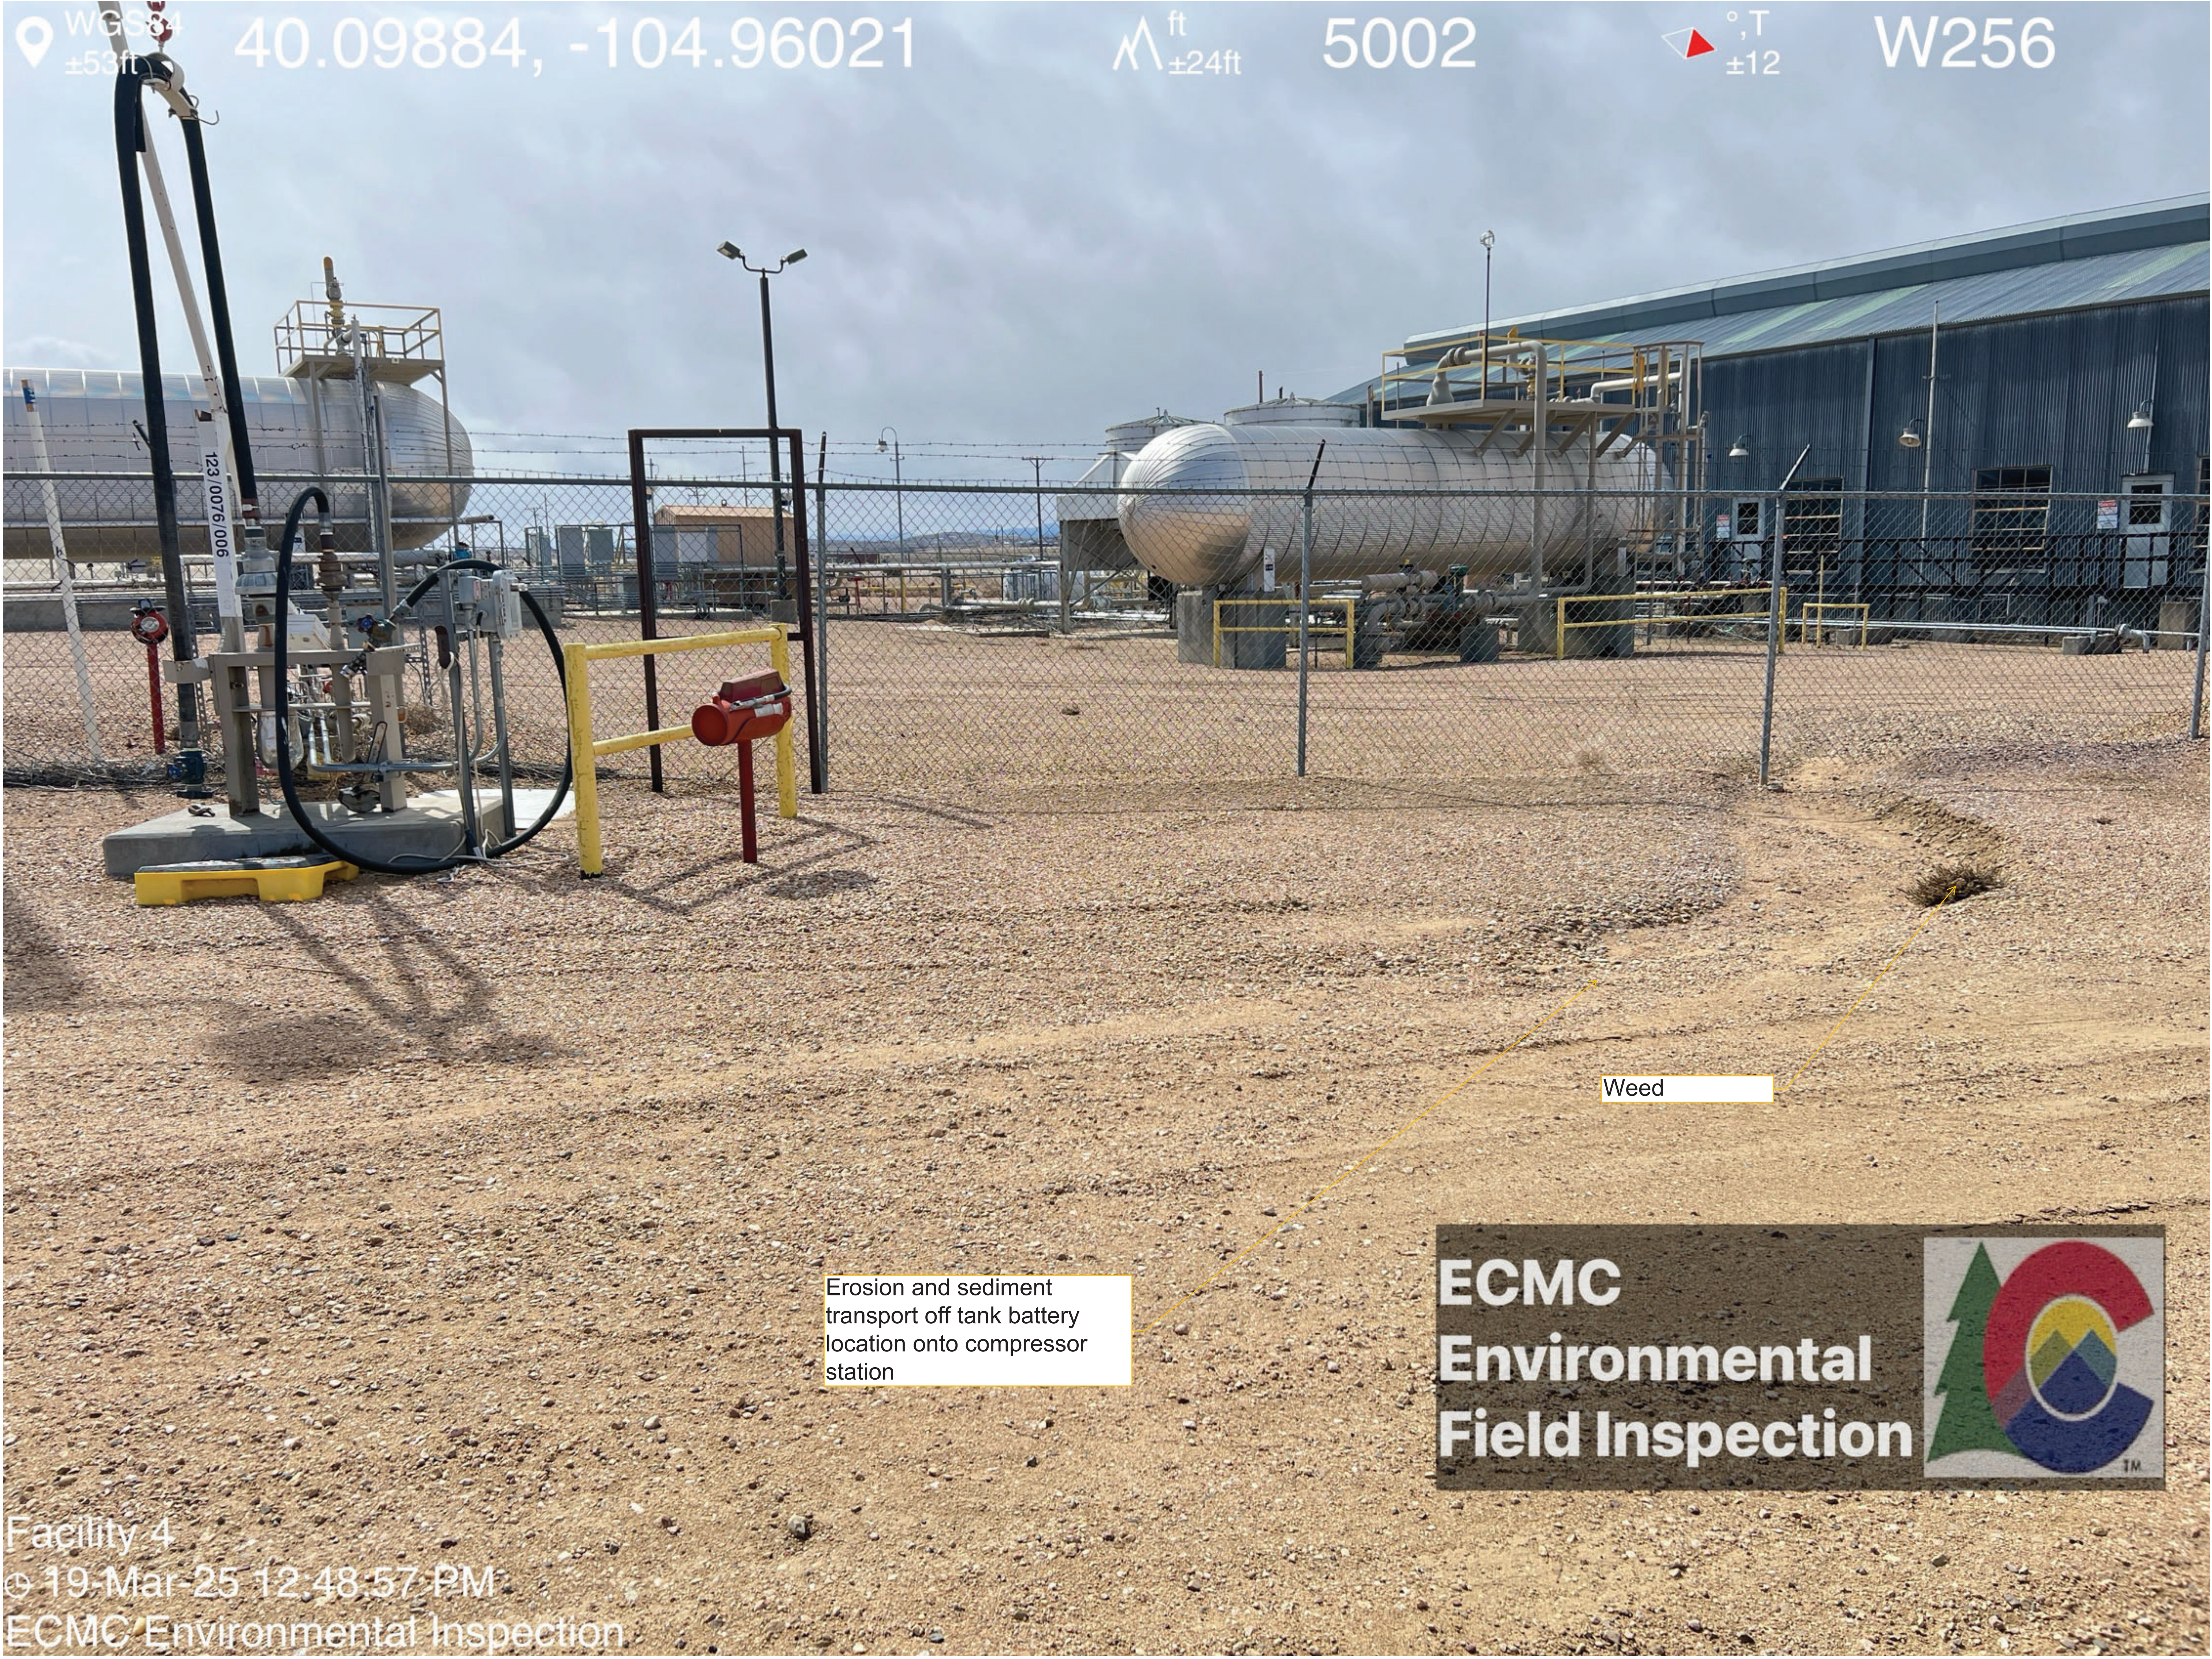
Erosion and sediment
transport off tank battery
location onto compressor
station

Weed

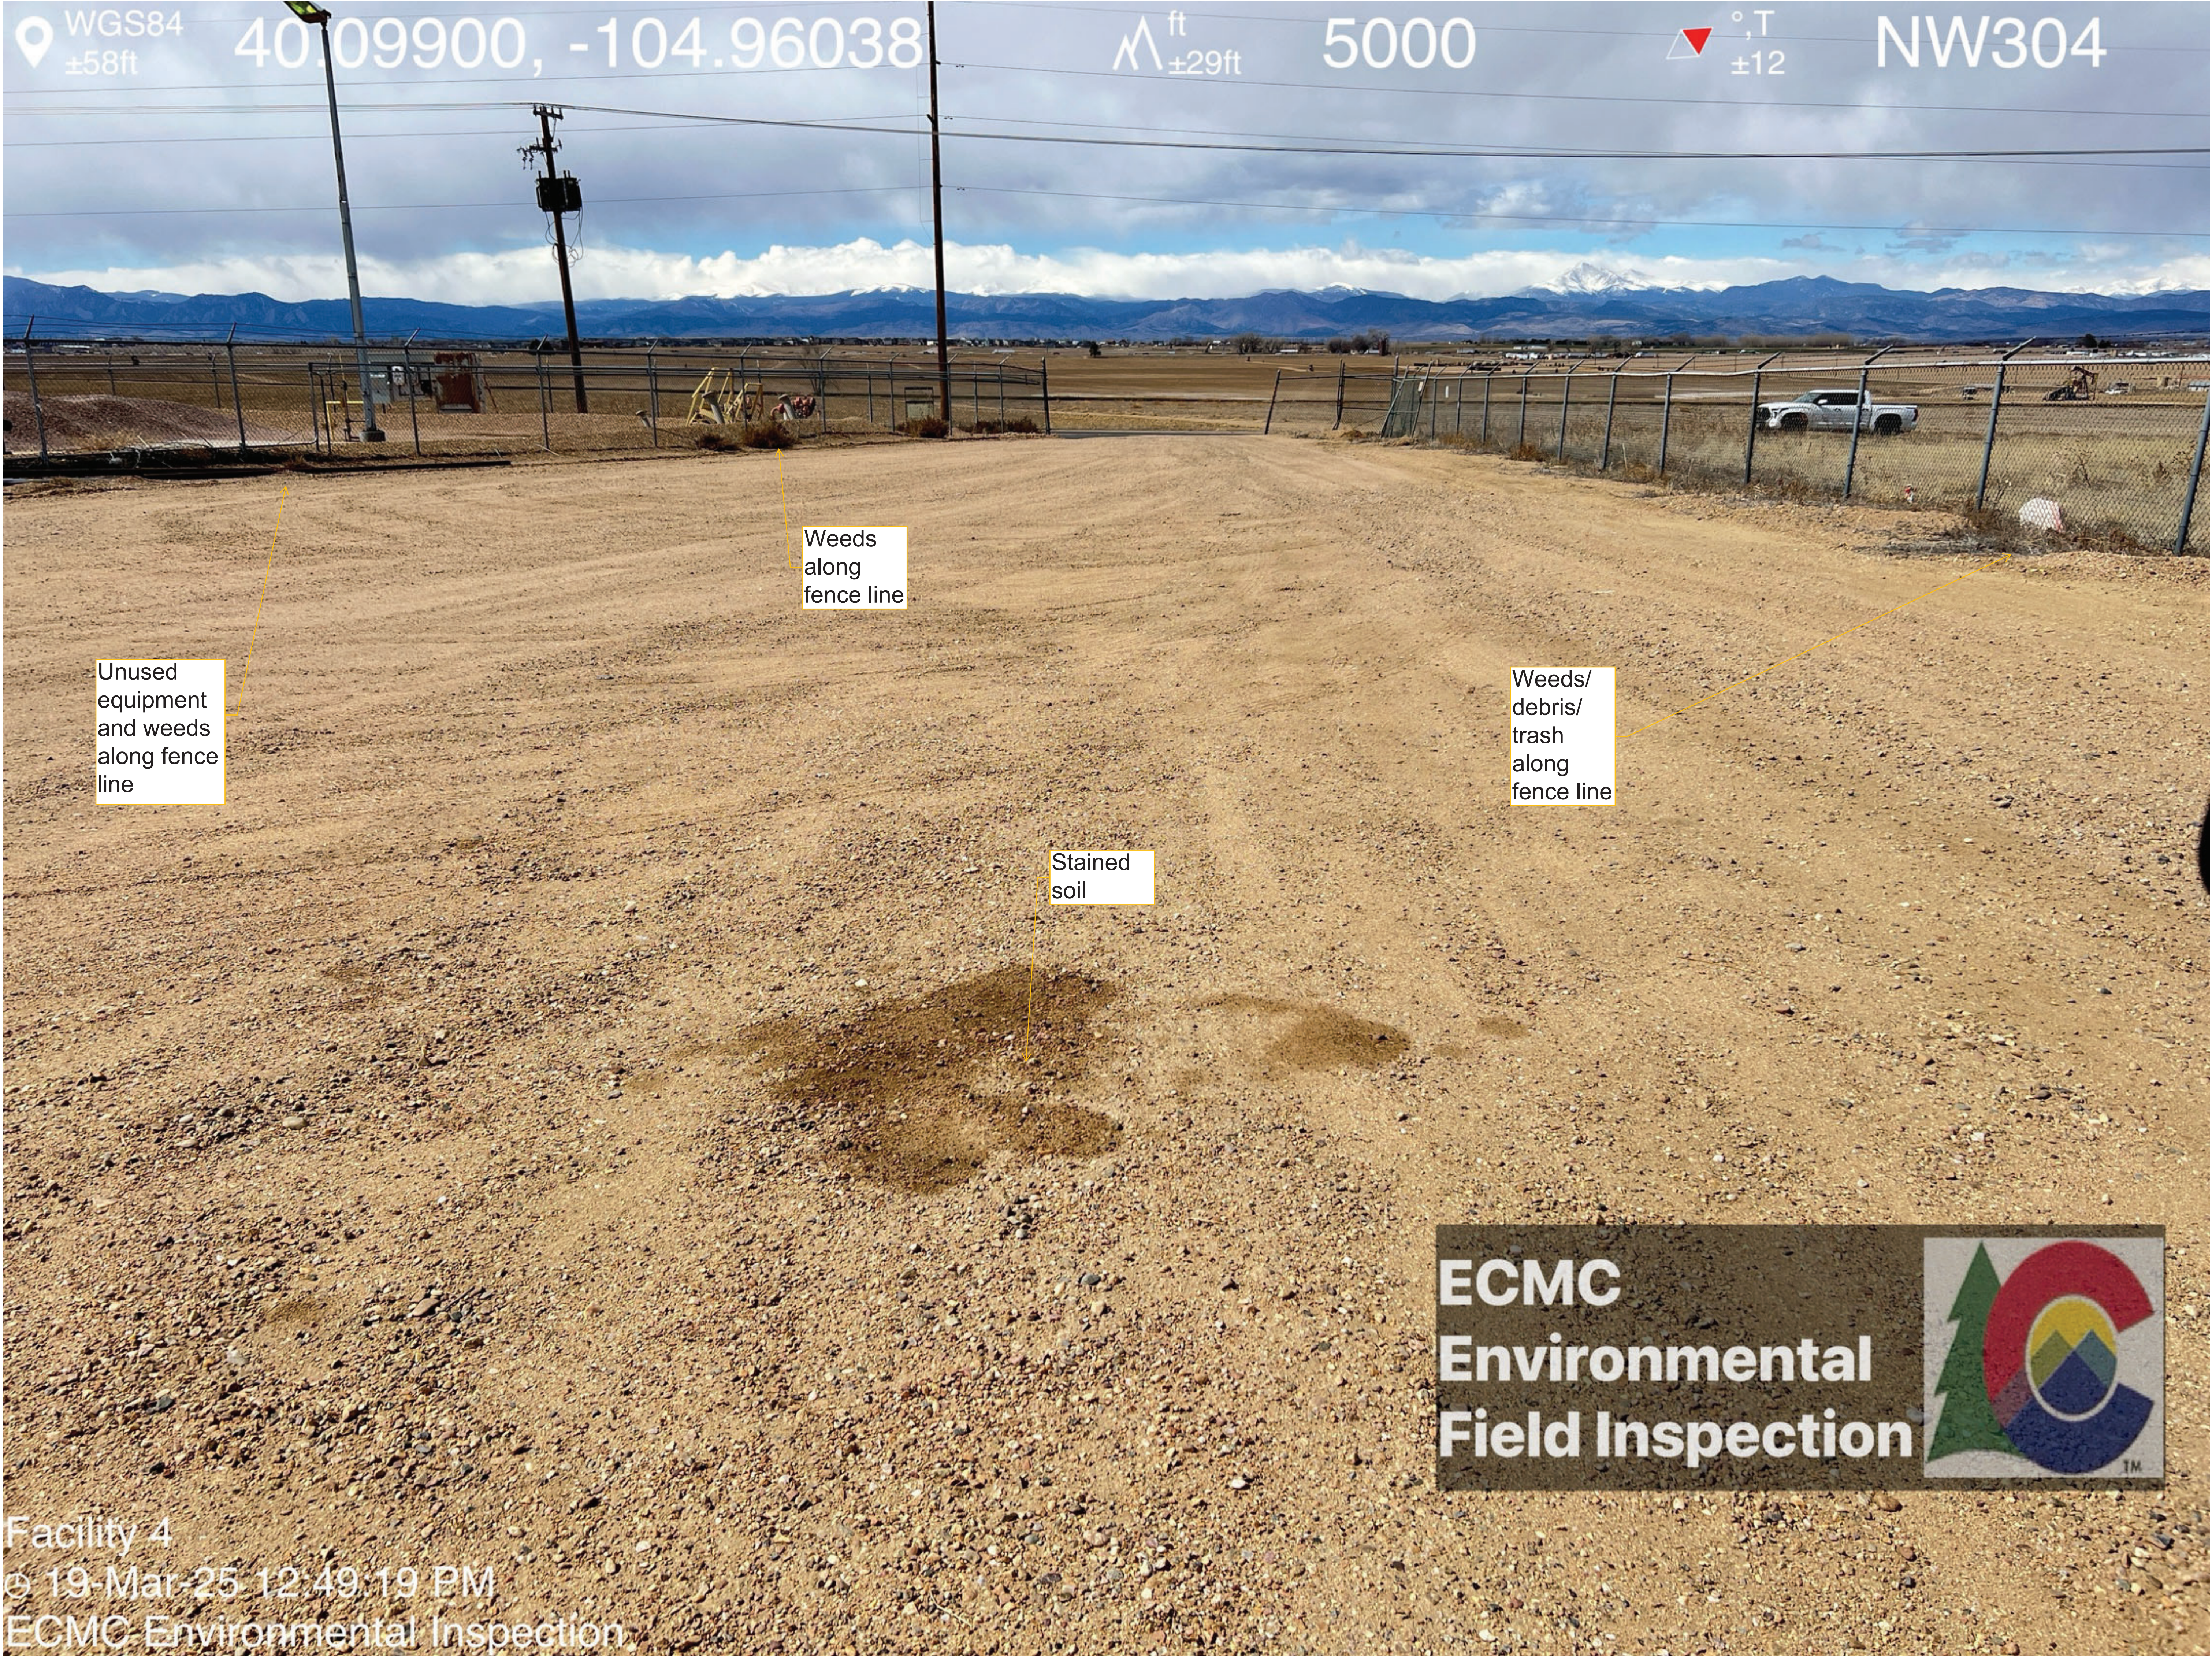
Unused
equipment
and weeds
along fence
line

Weeds
along
fence line

Weeds/
debris/
trash
along
fence line

Stained
soil

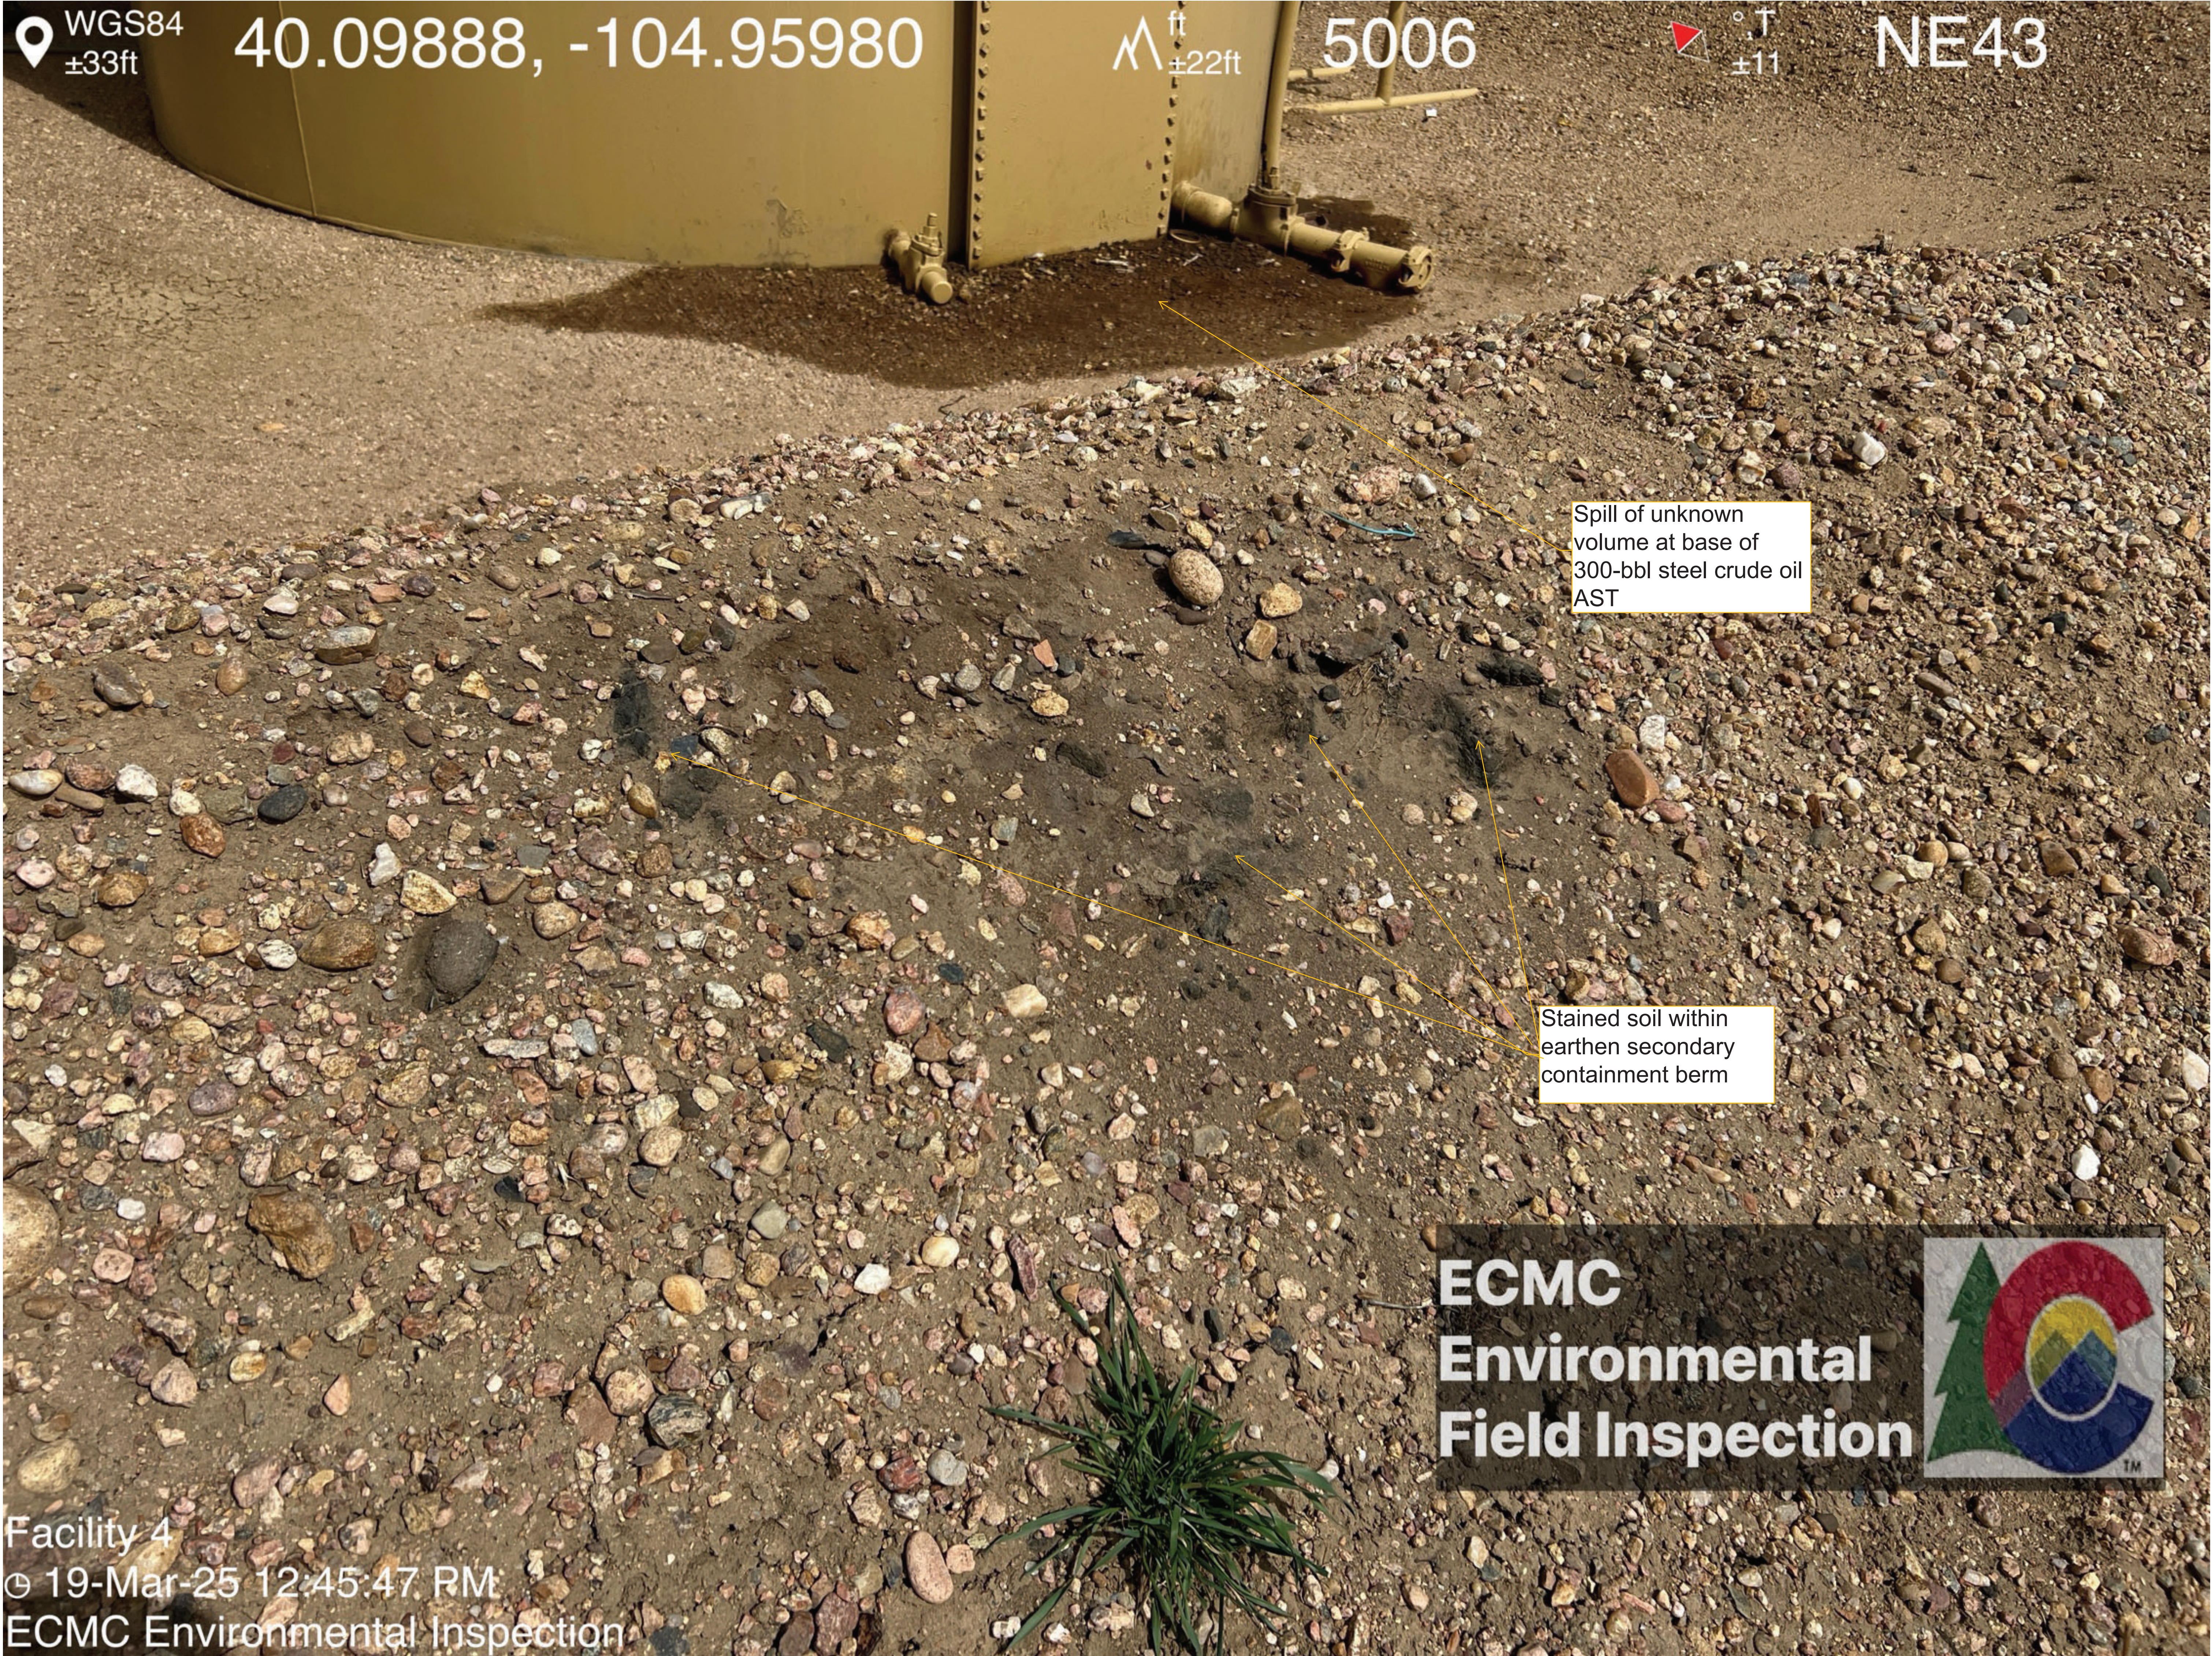
Spill of unknown volume at base of 300-bbl steel crude oil AST

Stained soil within earthen secondary containment berm
