# PCU FED/B27-197, #485795 Annotation Report

# PCU FED/B27-197, #485795 Field Note Report

**Operator:** CAERUS PICEANCE LLC - 10456

**Location ID:** 485795

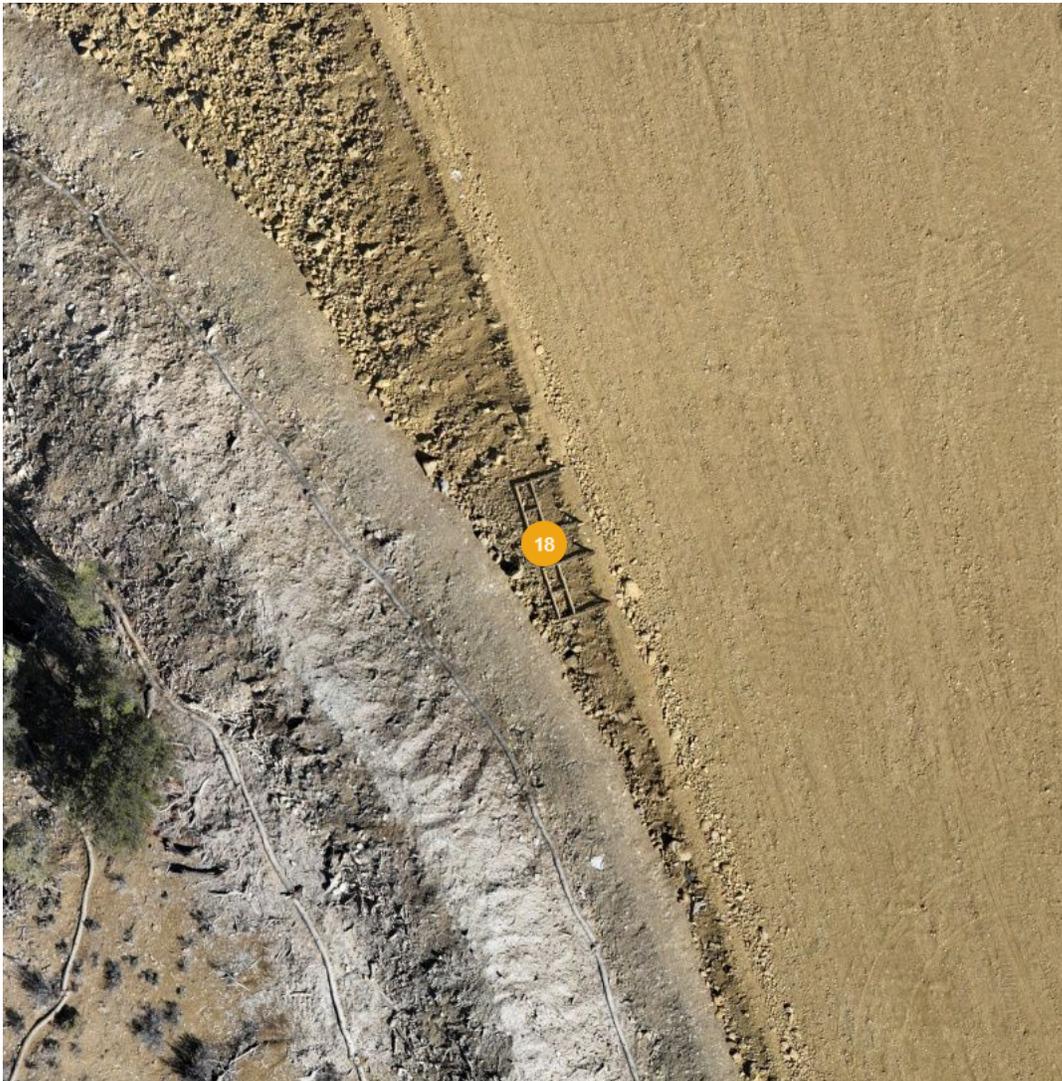
18 - Observation

Equipment improperly stored on fill slopes of the Location.

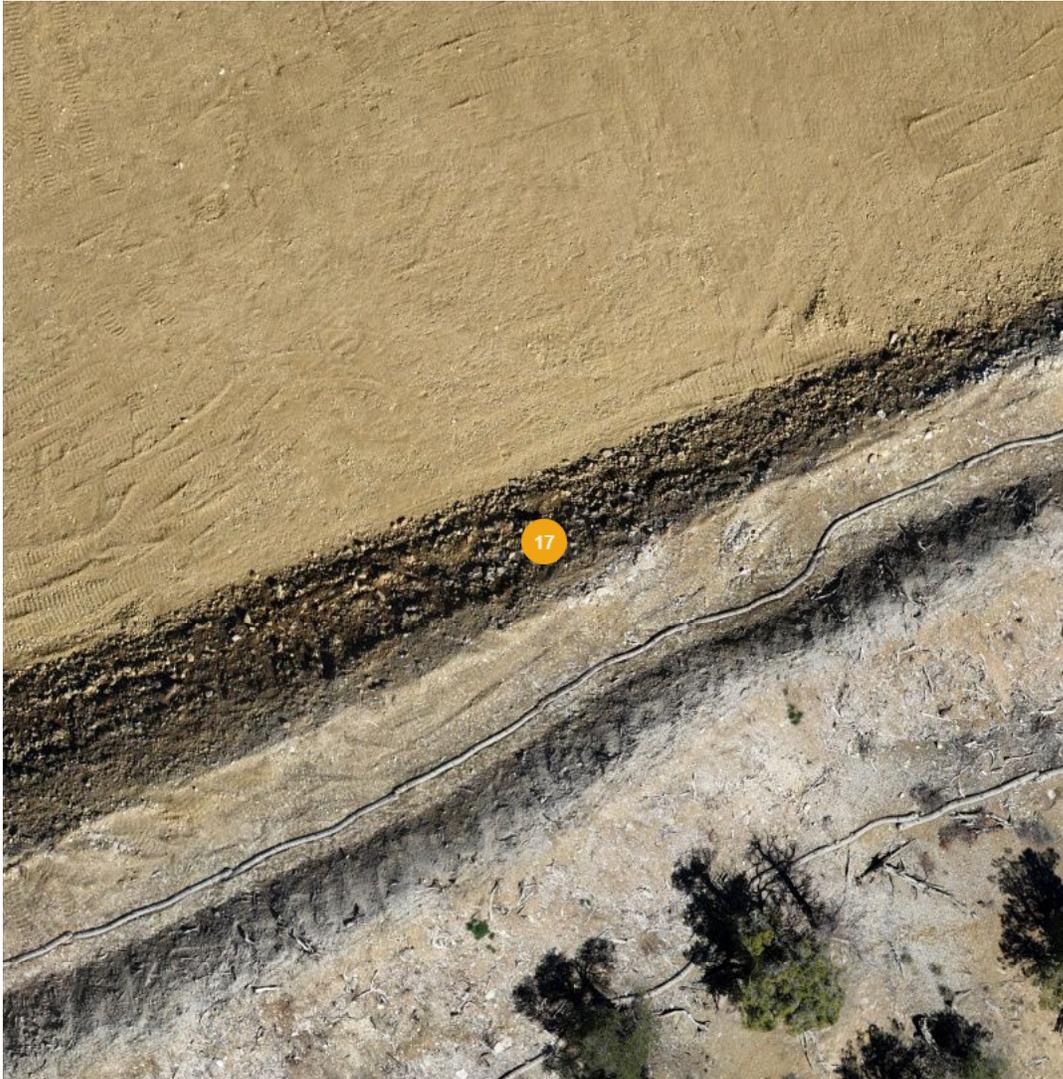
17 - Observation

Pallet. Requires removal

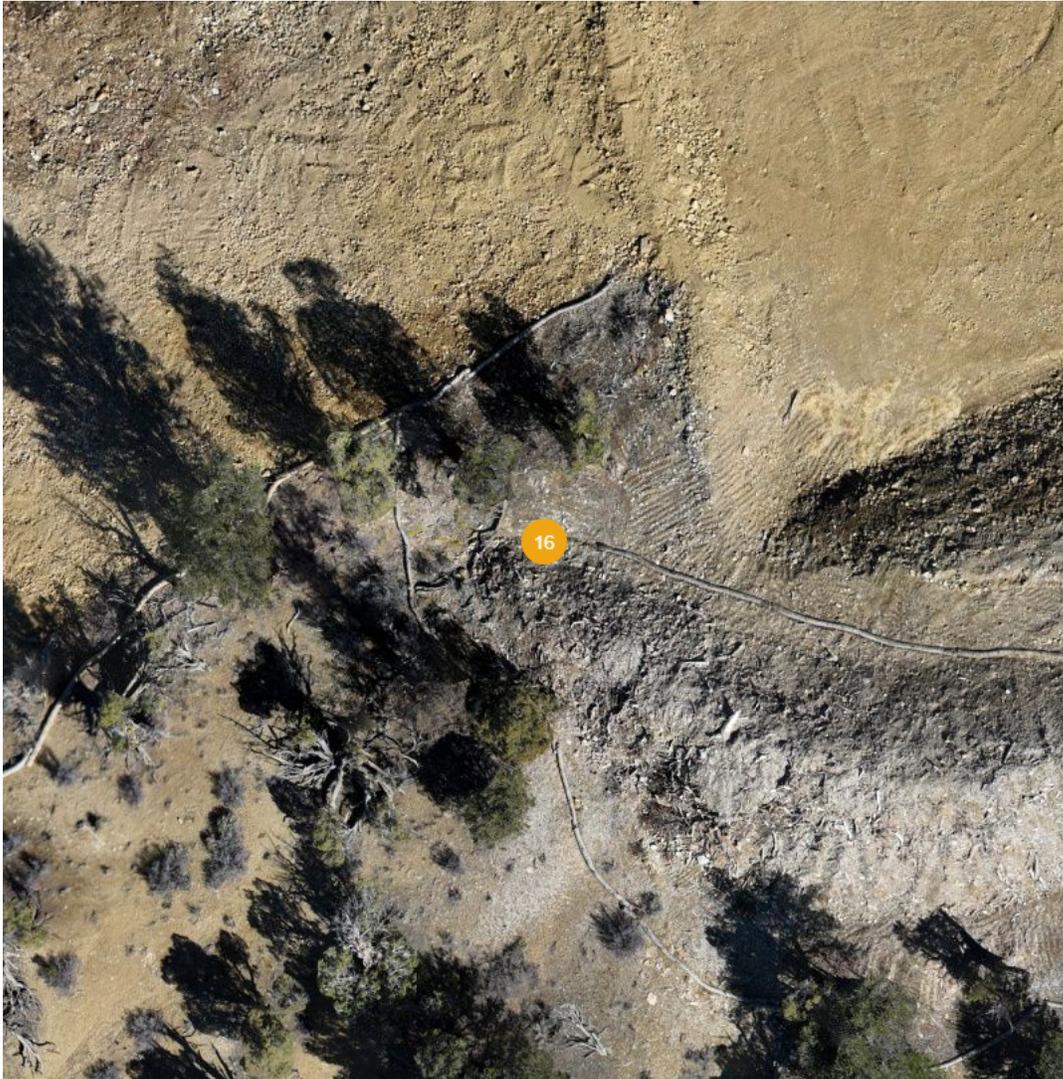
16 - Observation

Summary:	Erosion log has been removed- perimeter controls at the topsoil stockpile missing or insufficient.
Created:	Mar 27, 2025, 3:18pm by Aaron Trujillo
Cost of Repair:	—
Lat/Long:	39.9400211, -108.2695168
Northing:	1233124.2 US ft
Easting:	2223553.8 US ft
Elevation:	-3.11 US ft

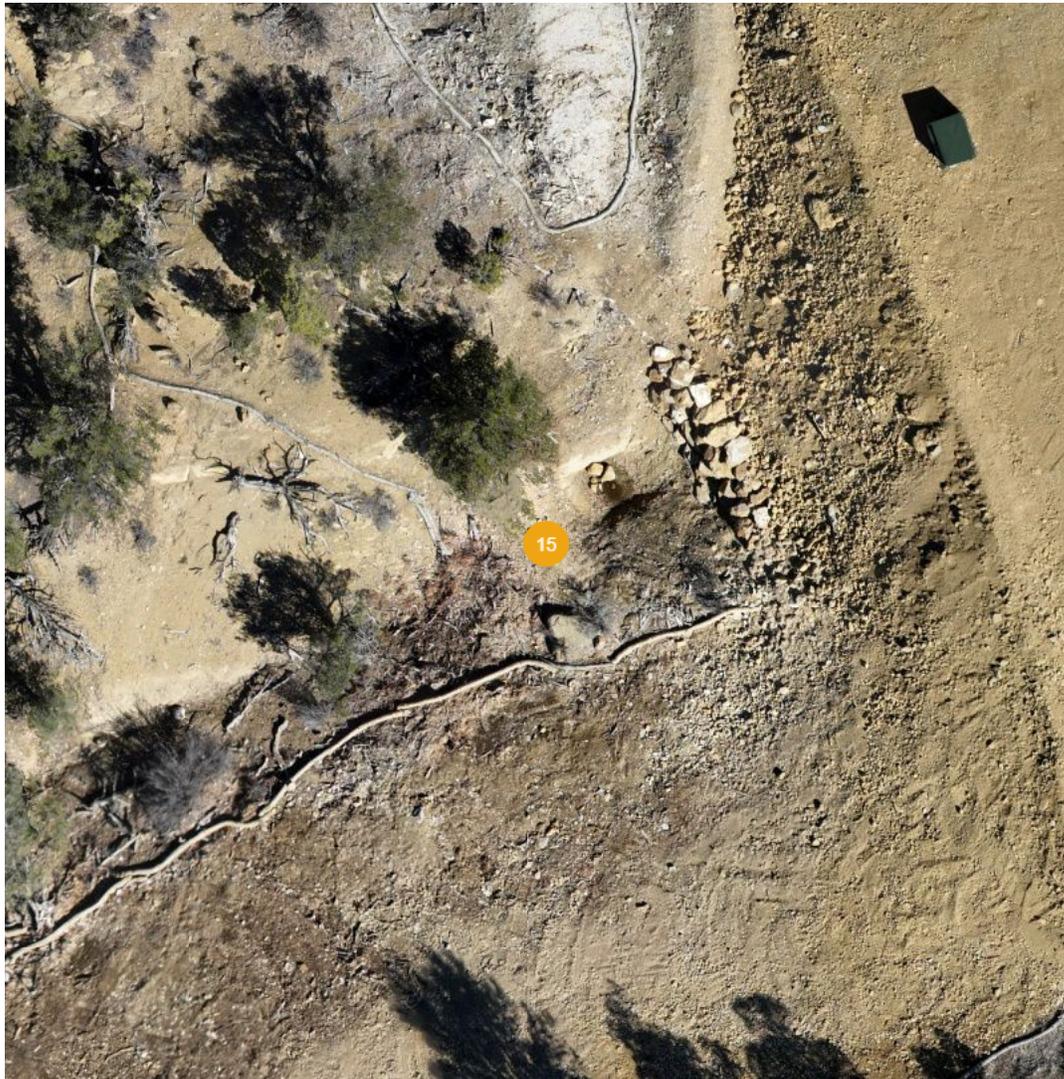
15 - Observation

Summary: Outlet has not been constructed per good engineering practices. Outlet is inadequate in size as slope below rip-rap is bare; slopes are loose unconsolidated soil. Outlet has also not been constructed with geotextile lining in conjunction with the Rip-rap material.

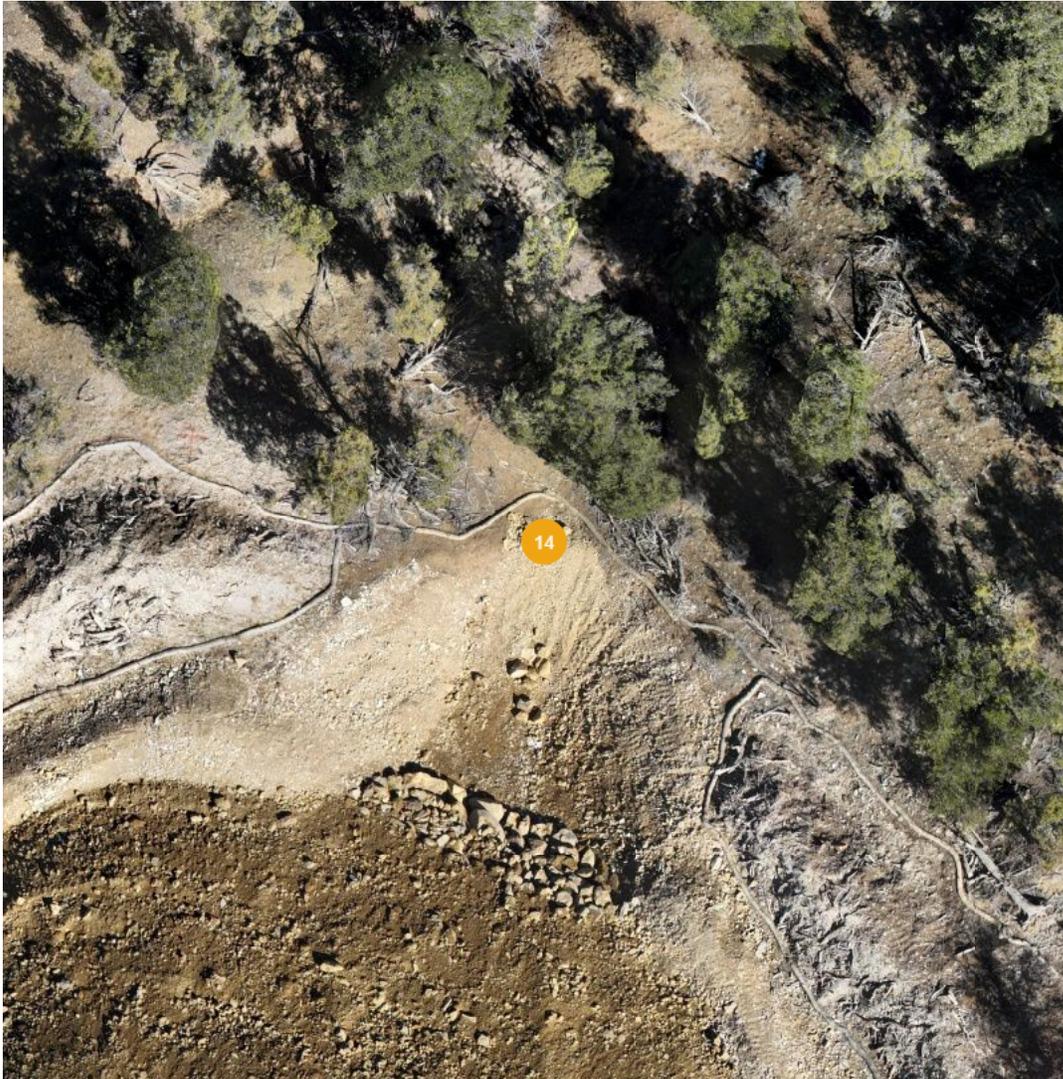
14 - Observation

Summary: Outlet has not been constructed per good engineering practices; Outlet has not been constructed with geotextile lining in conjunction with the Rip-rap material.

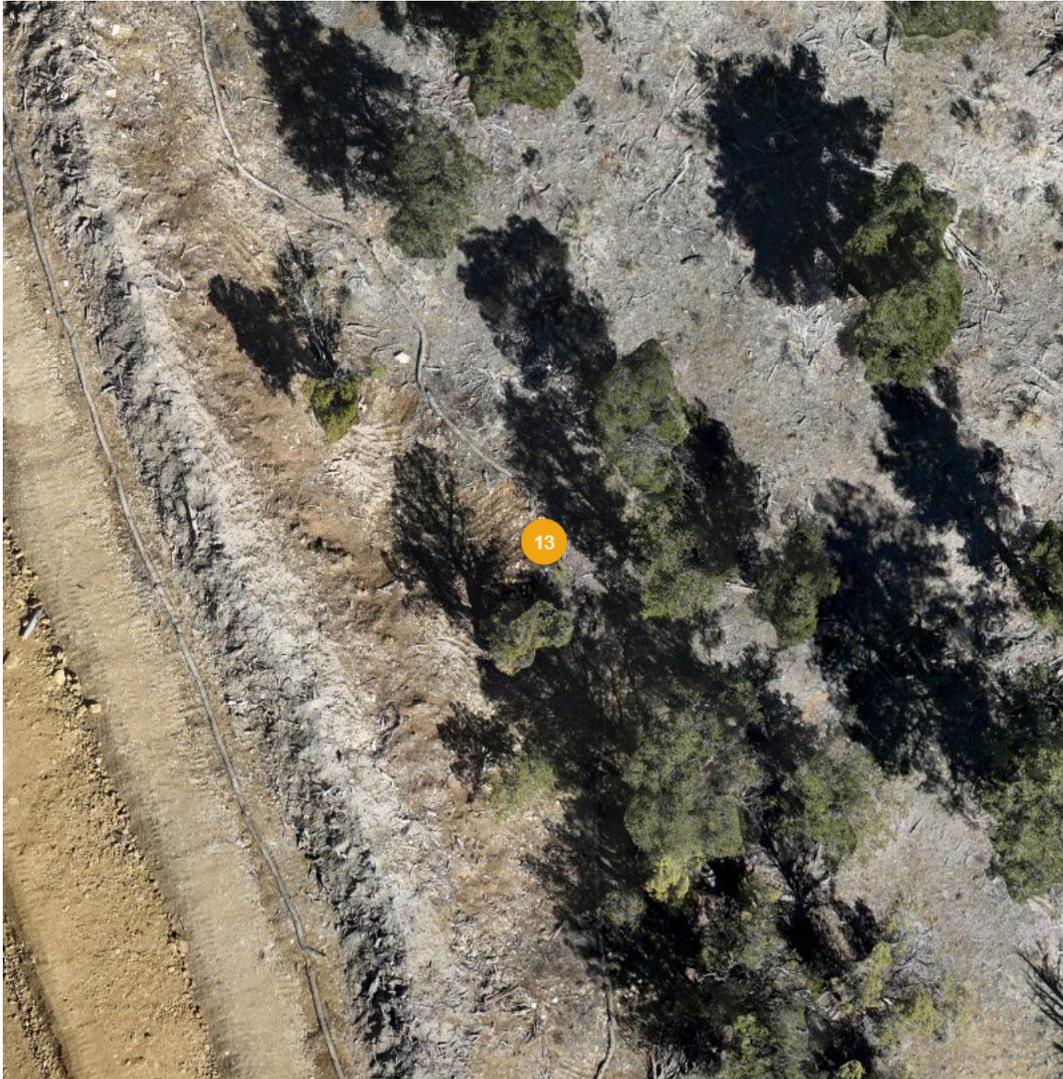
13 - Observation

Erosion Log in disrepair.

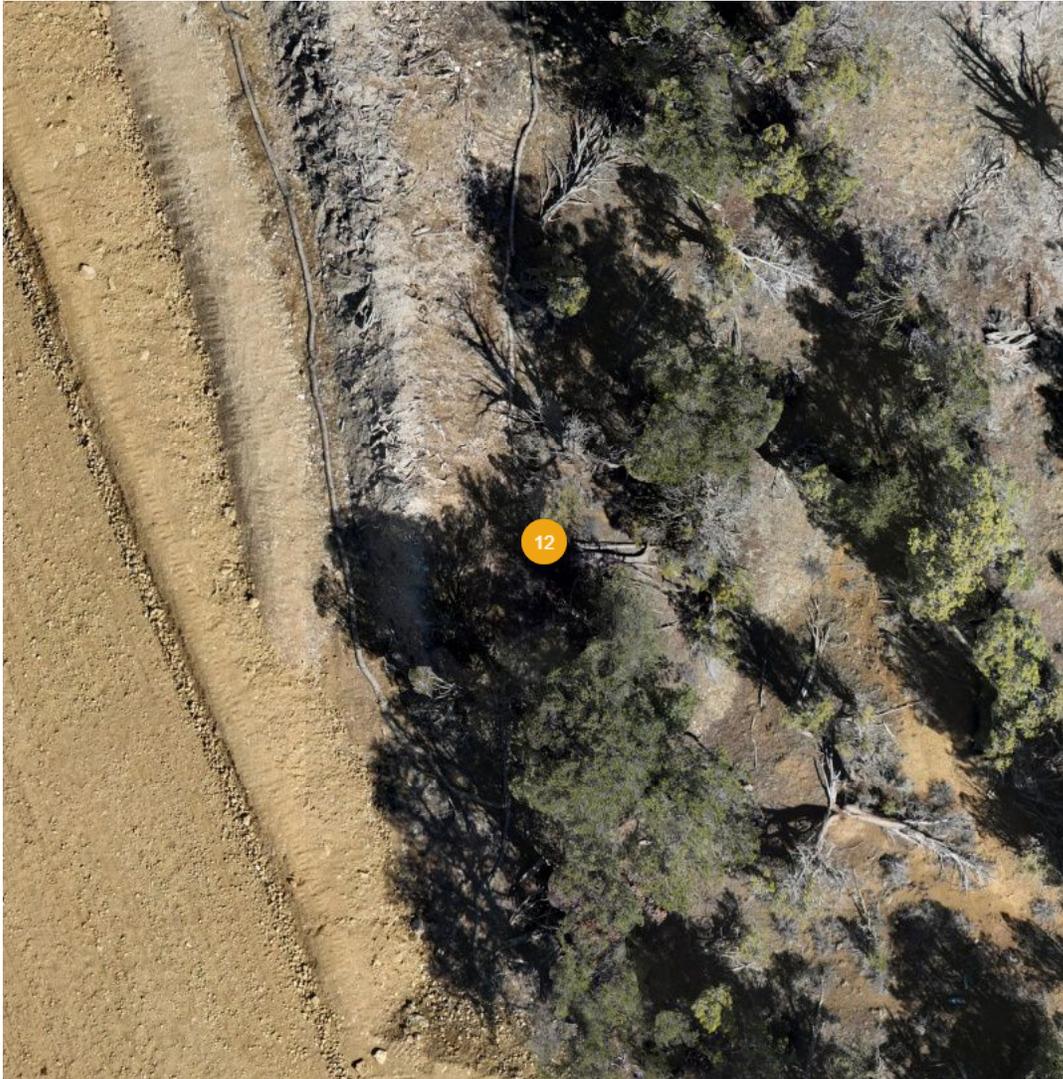
12 - Observation

Erosion Log ins disrepair

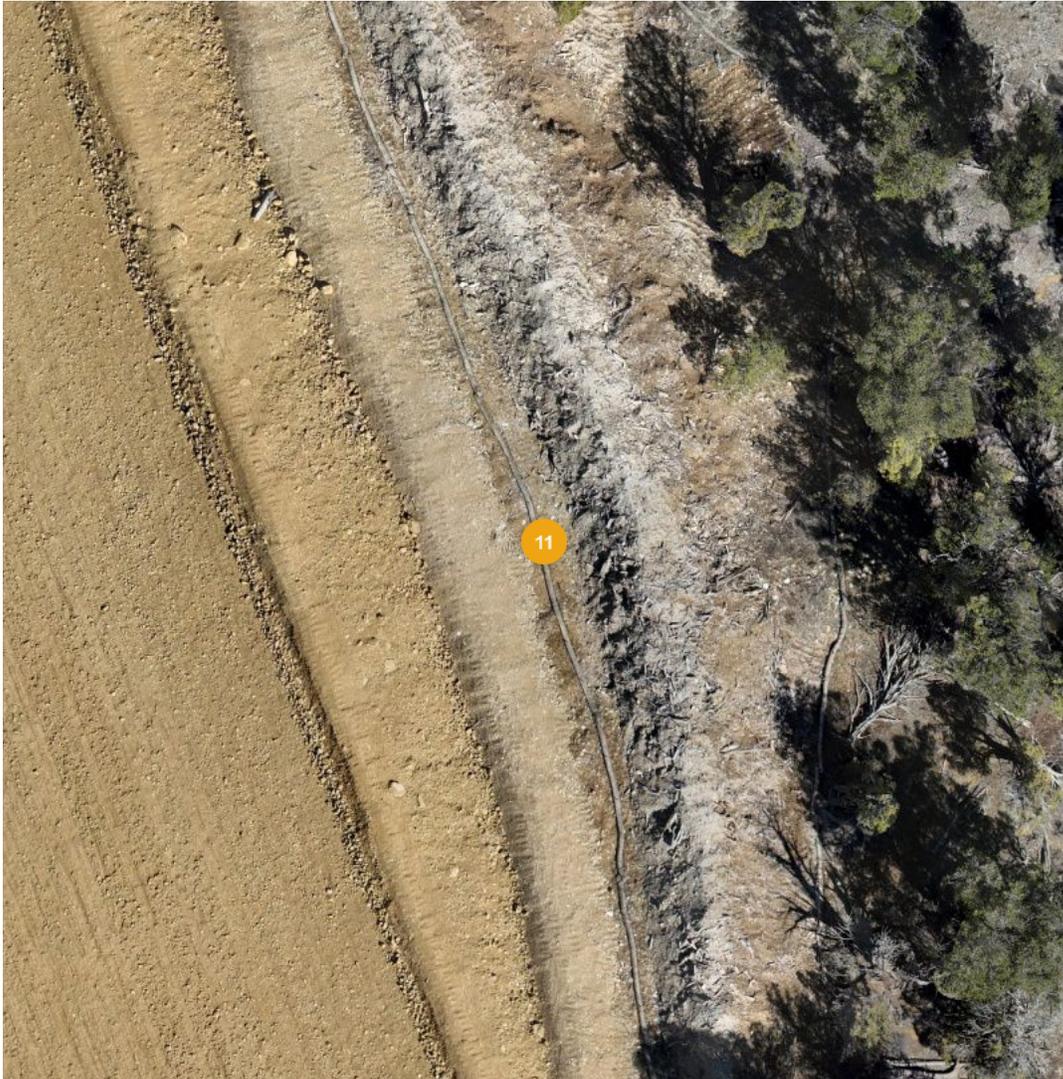
11 - Observation

Erosion Log in disrepair.

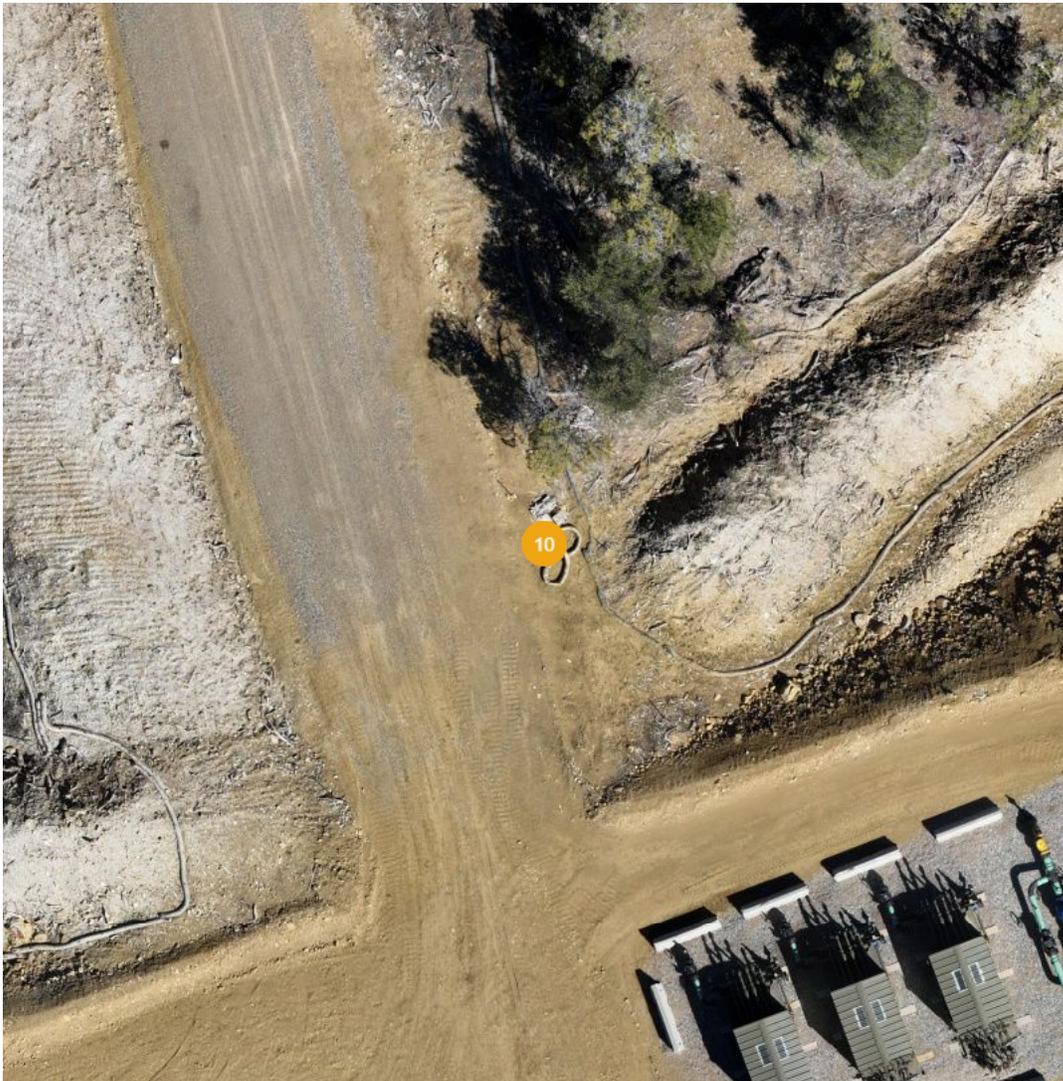
10 - Observation

Requires removal

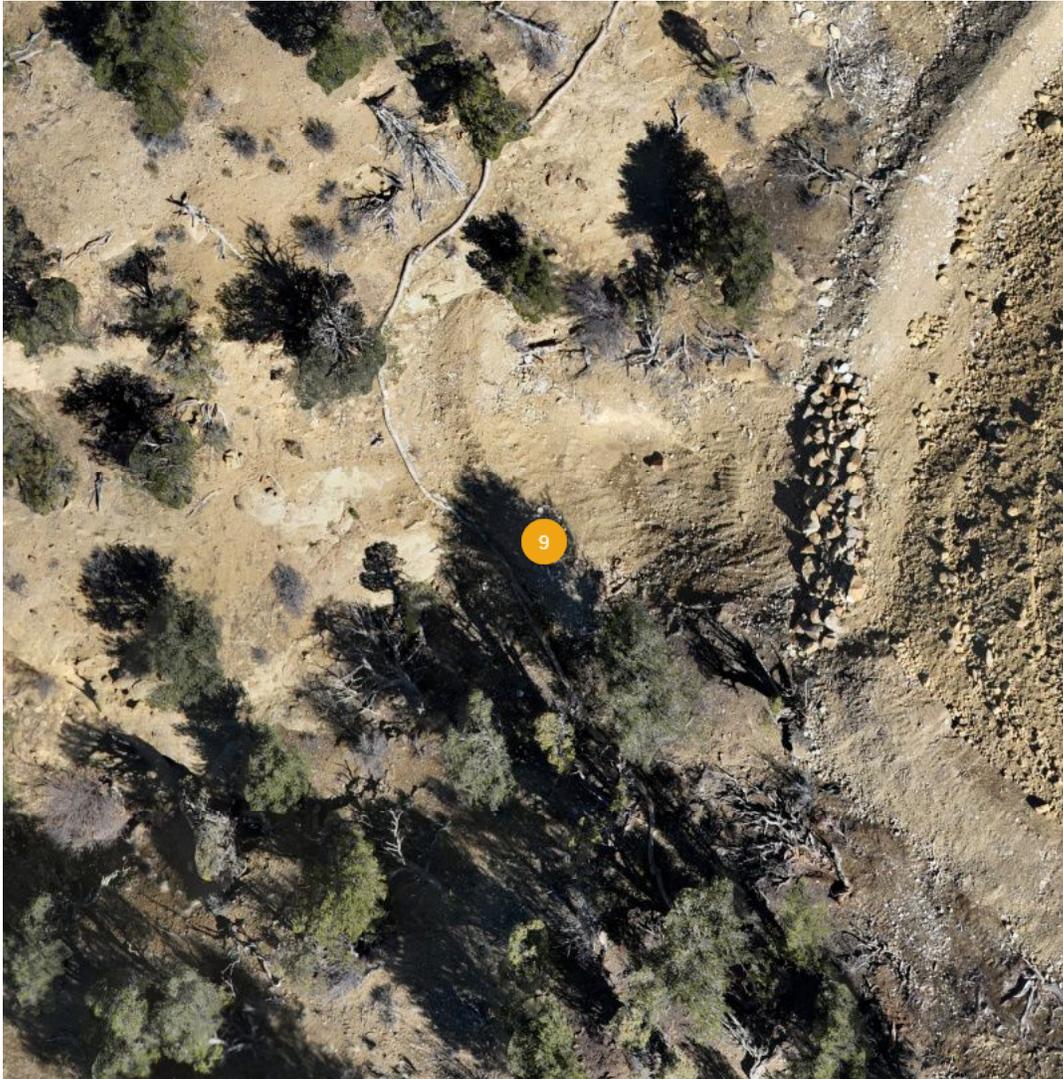
9 - Observation

Summary: Outlet has not been constructed per good engineering practices. Outlet is inadequate in size as slope below rip-rap is bare; slopes are loose unconsolidated soil. Outlet has also not been constructed with geotextile lining in conjunction with the Rip-rap material.

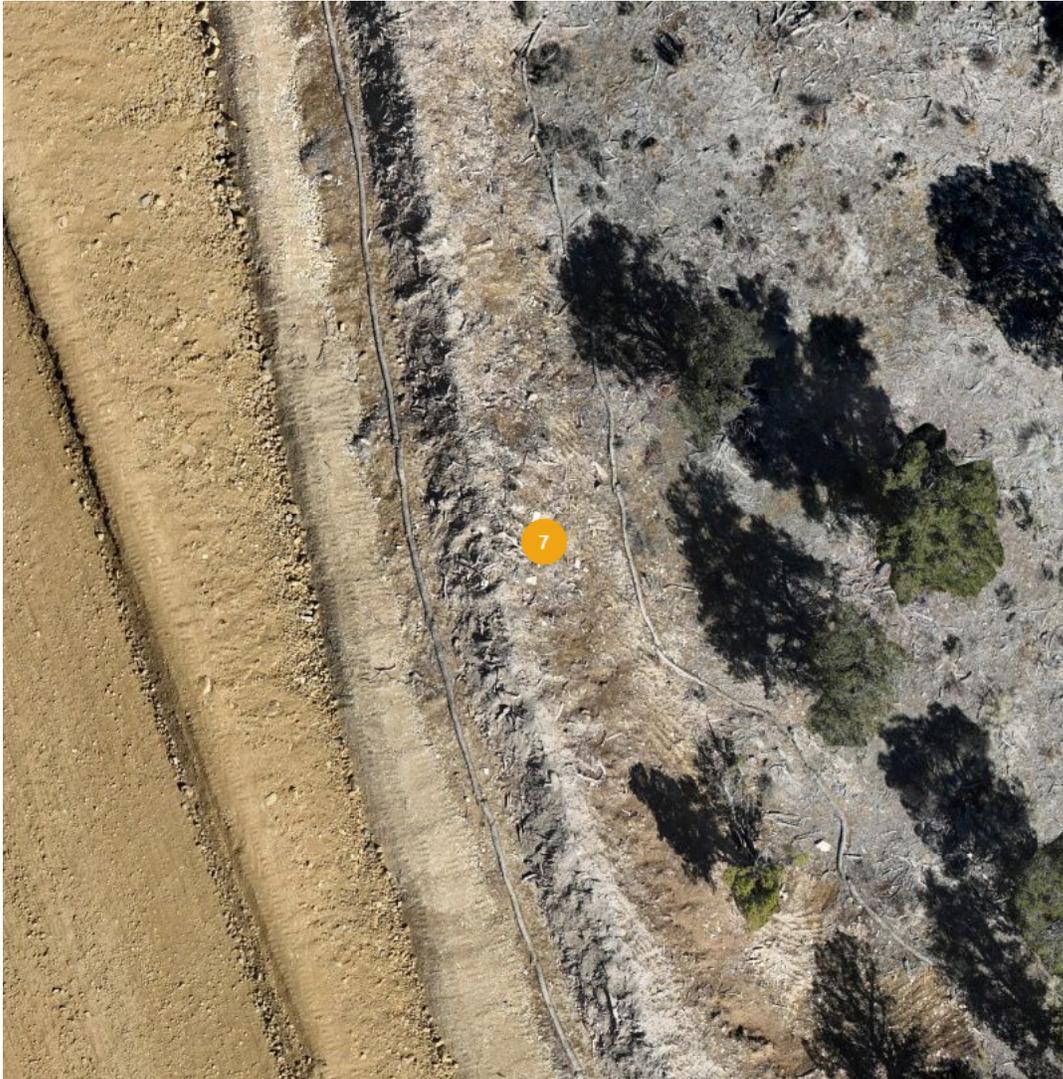
7 - Observation

Summary: Hydromulch on eastern side of the topsoil stockpile has not been installed per good engineering, or maintained in proper functioning condition.

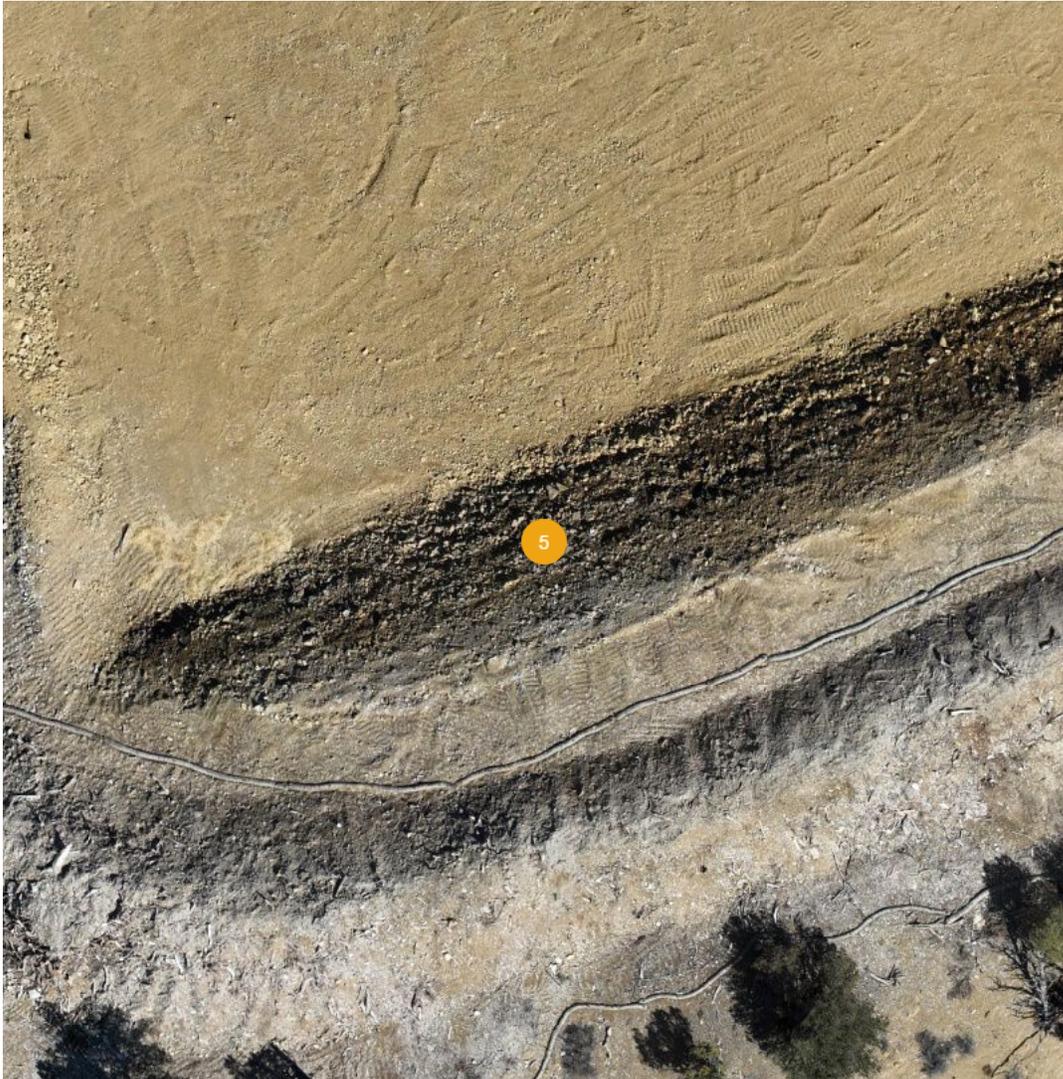
5 - Observation

Summary: BMPs to stabilize the cut slopes, as well as to minimize erosion and degradation at the slopes are missing or insufficient.

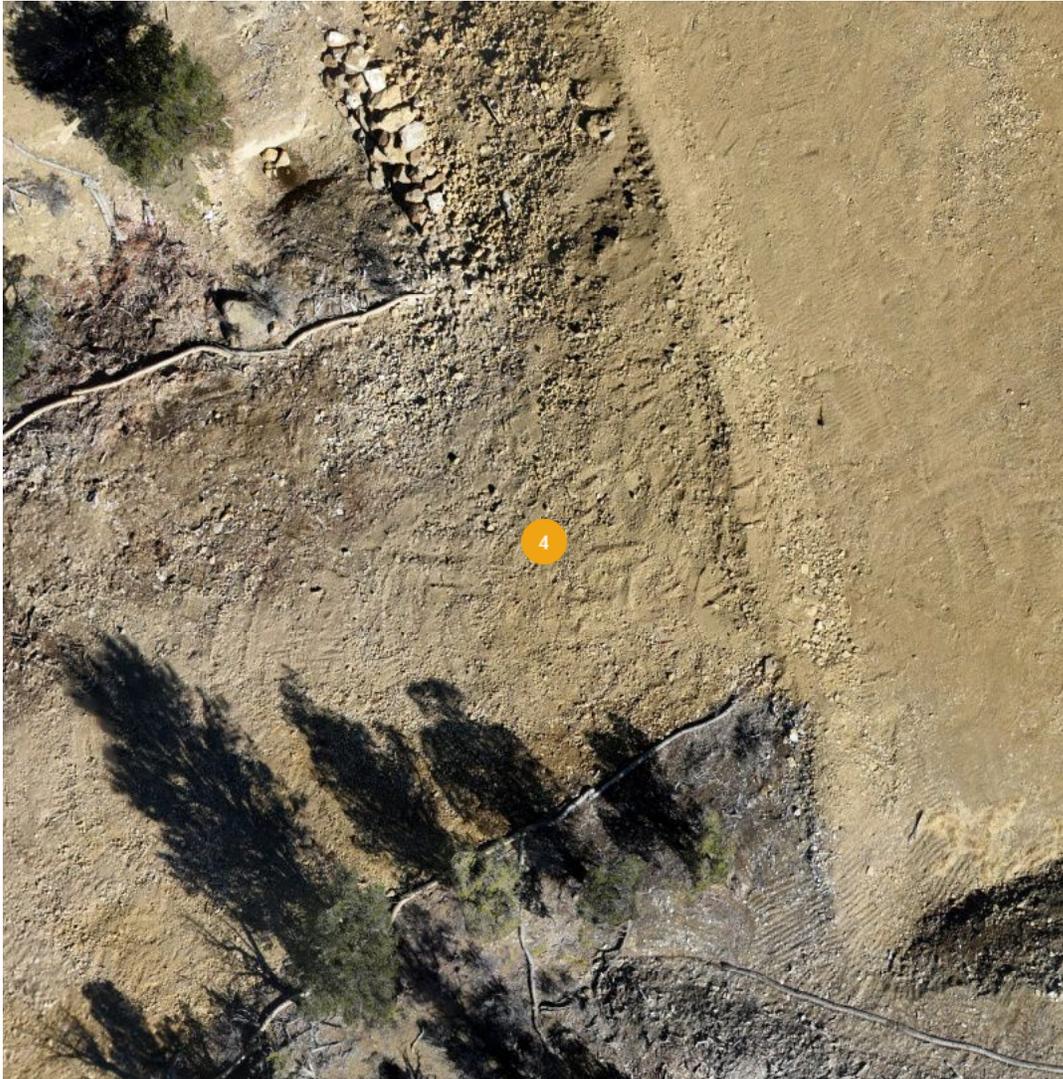
4 - Observation

Summary: BMPs to stabilize soils missing or insufficient. Erosion logs not installed per good engineering practices along sections.

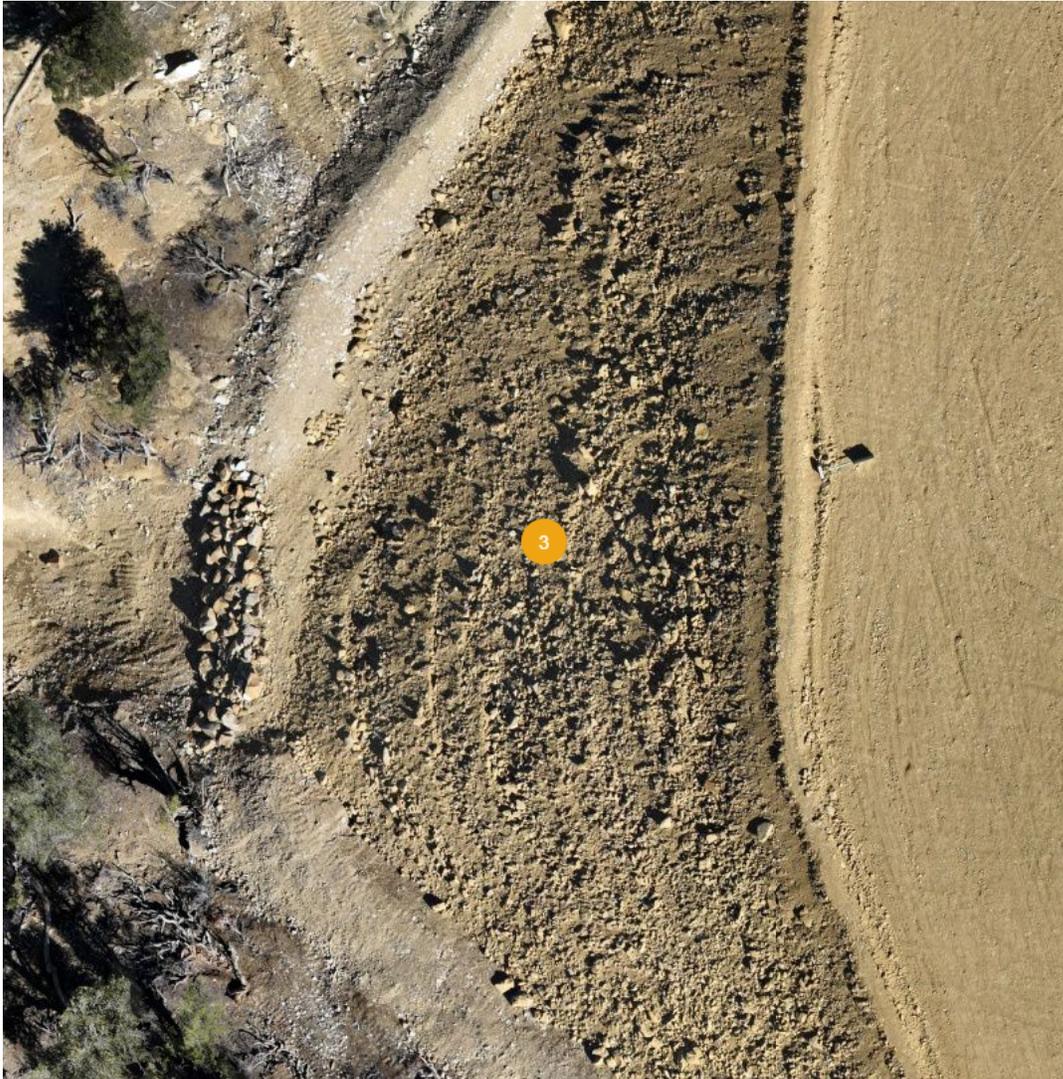
3 - Observation

Summary: BMPs to stabilize the fill slopes, as well as to minimize erosion and degradation at the slopes are missing or insufficient.

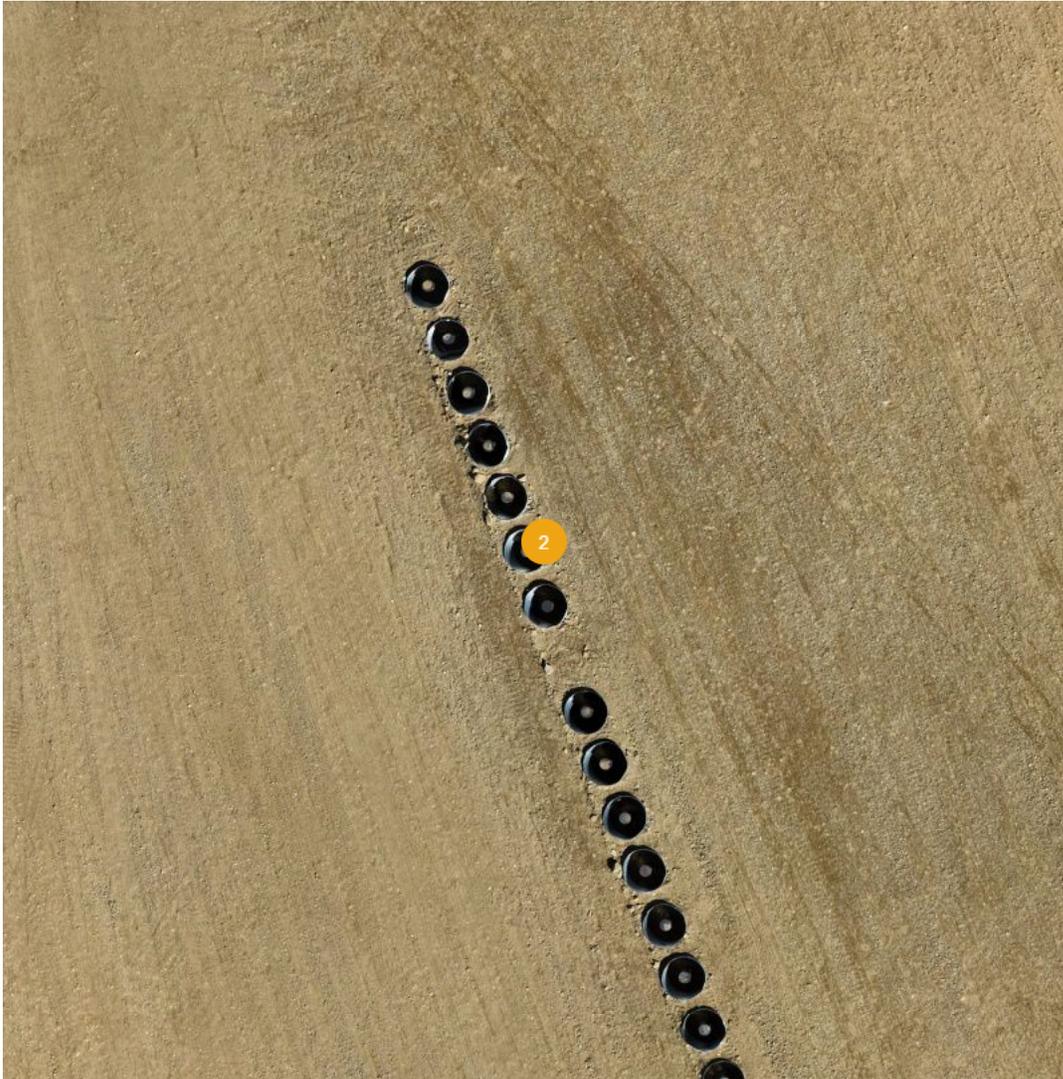
2 - Observation

Cellars have not been covered pursuant to Rule 406.e

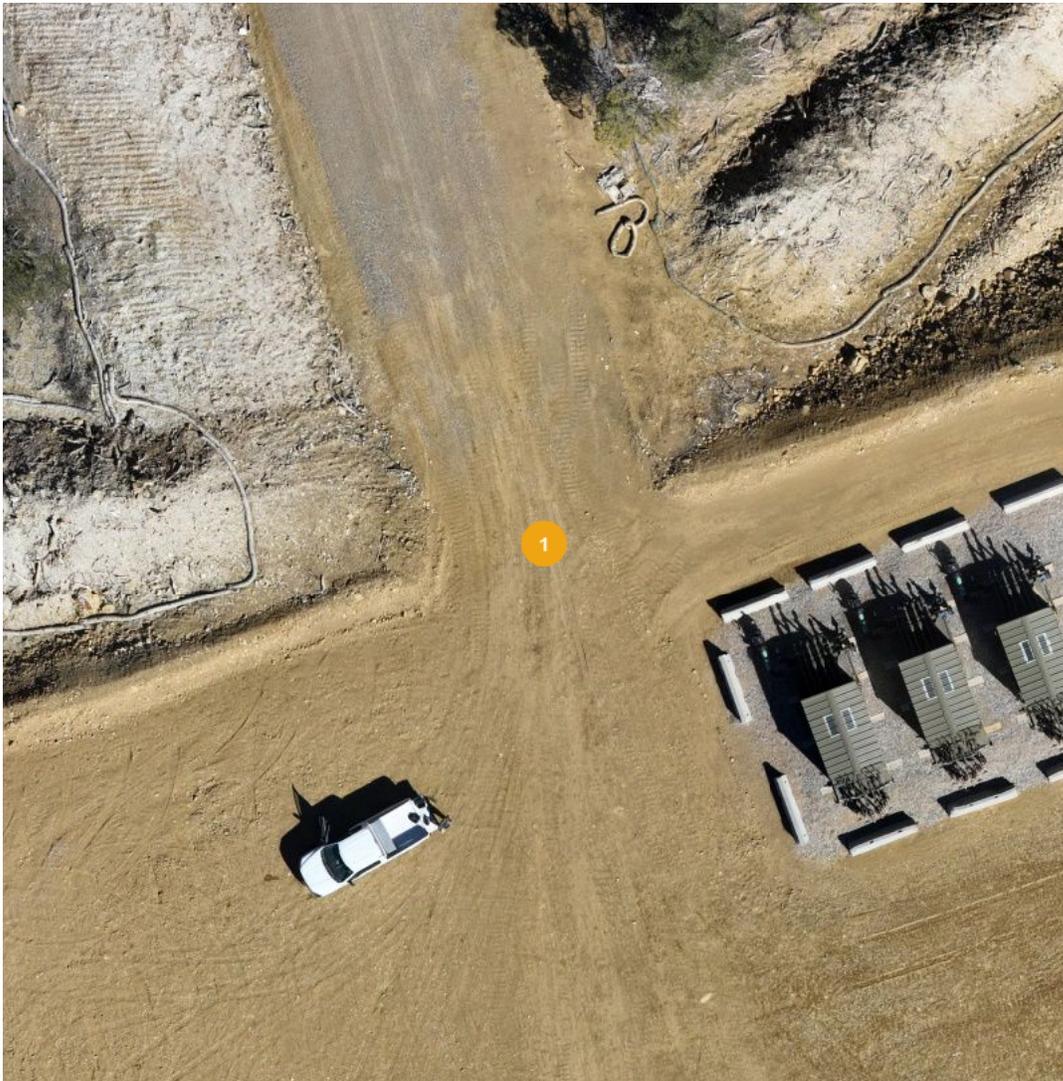
1 - Observation

Summary:	Location signage not posted at Location entrance. Form 2A Location Permit not posted on Location.
Created:	Mar 26, 2025, 11:21am by Aaron Trujillo
Cost of Repair:	—
Lat/Long:	39.9416167, -108.2695236
Northing:	1233705.2 US ft
Easting:	2223570.0 US ft
Elevation:	-5.30 US ft

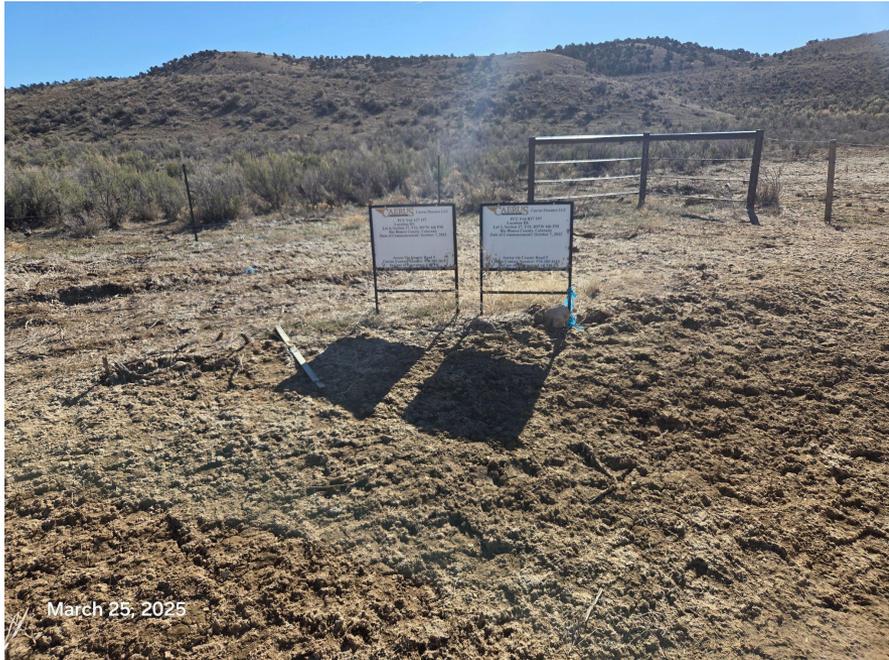
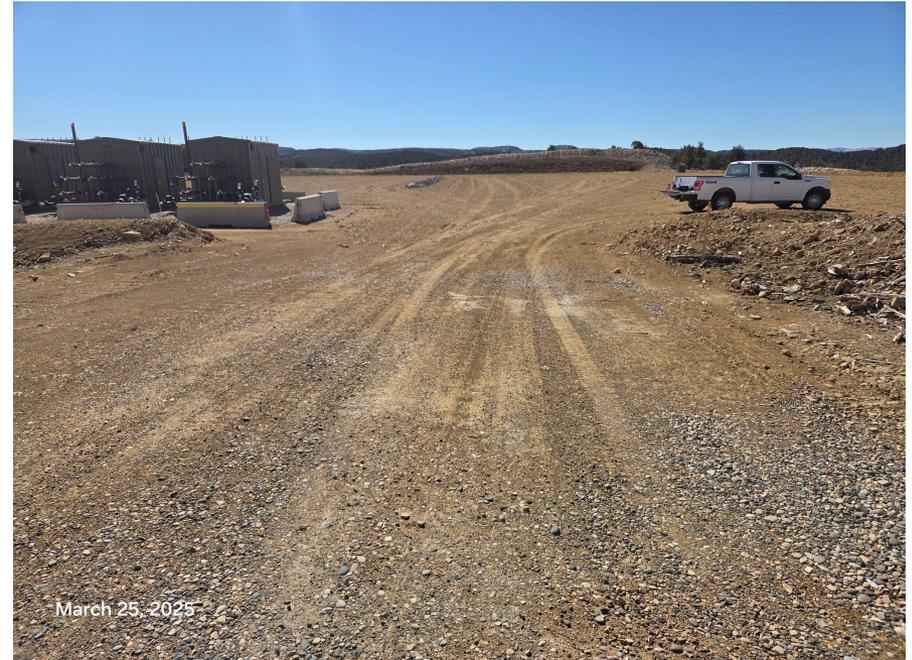
**Photo 1:** Photo left shows signage at the intersection of the lease road and public road pursuant to Rule 406.b. Photo right shows Location signage pursuant to 605.a has not been posted at the Location's entrance; a copy of the approved Form 2A has also not been posted on the Location.

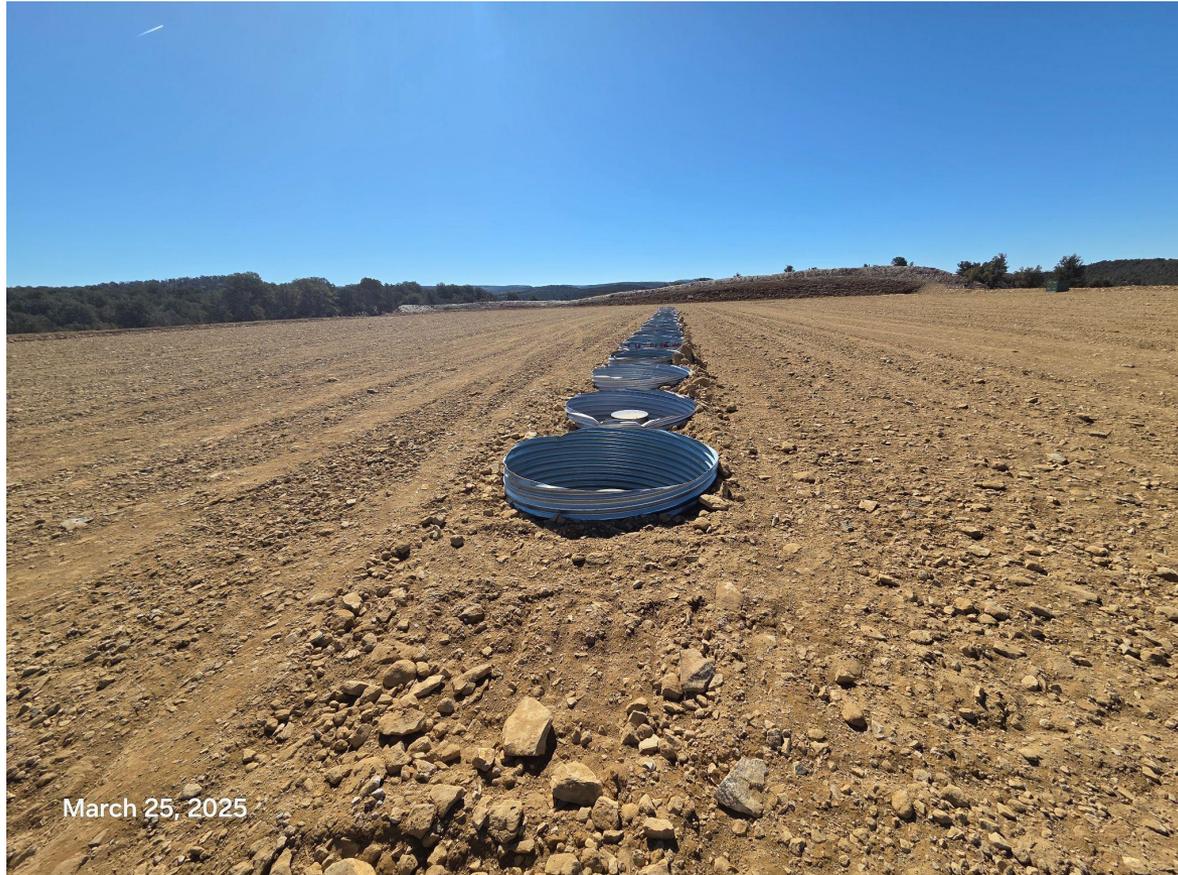
**Photo 4:** Photo taken from the central areas of the Location, facing south. Photo shows conductors set on the Location. Photo also shows cellars have not been covered.

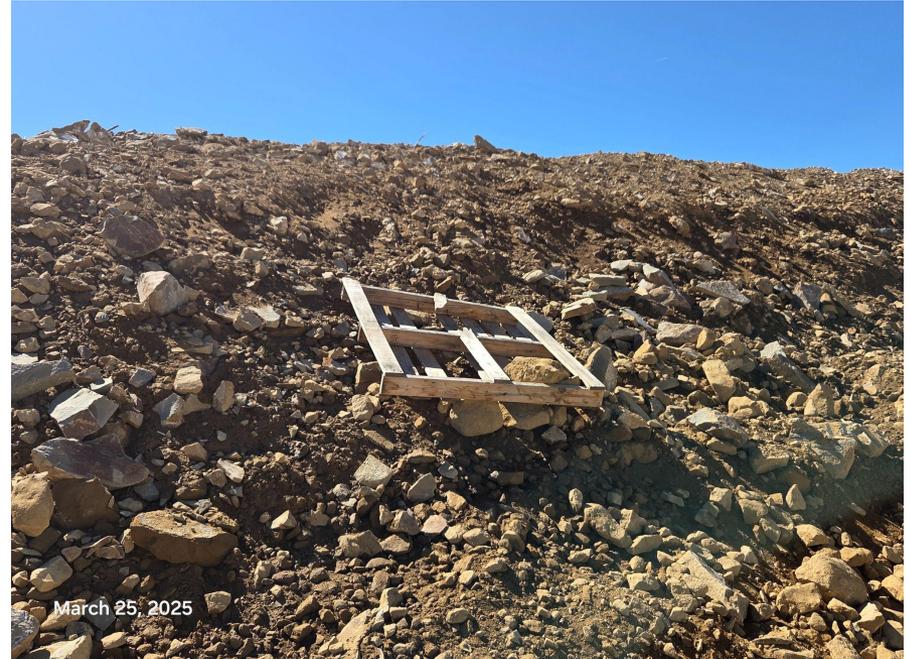
**Photo 6:** Photo shows unused erosion log, stakes and pallet stored on the north end, and the cut slopes at the south end of the Location.

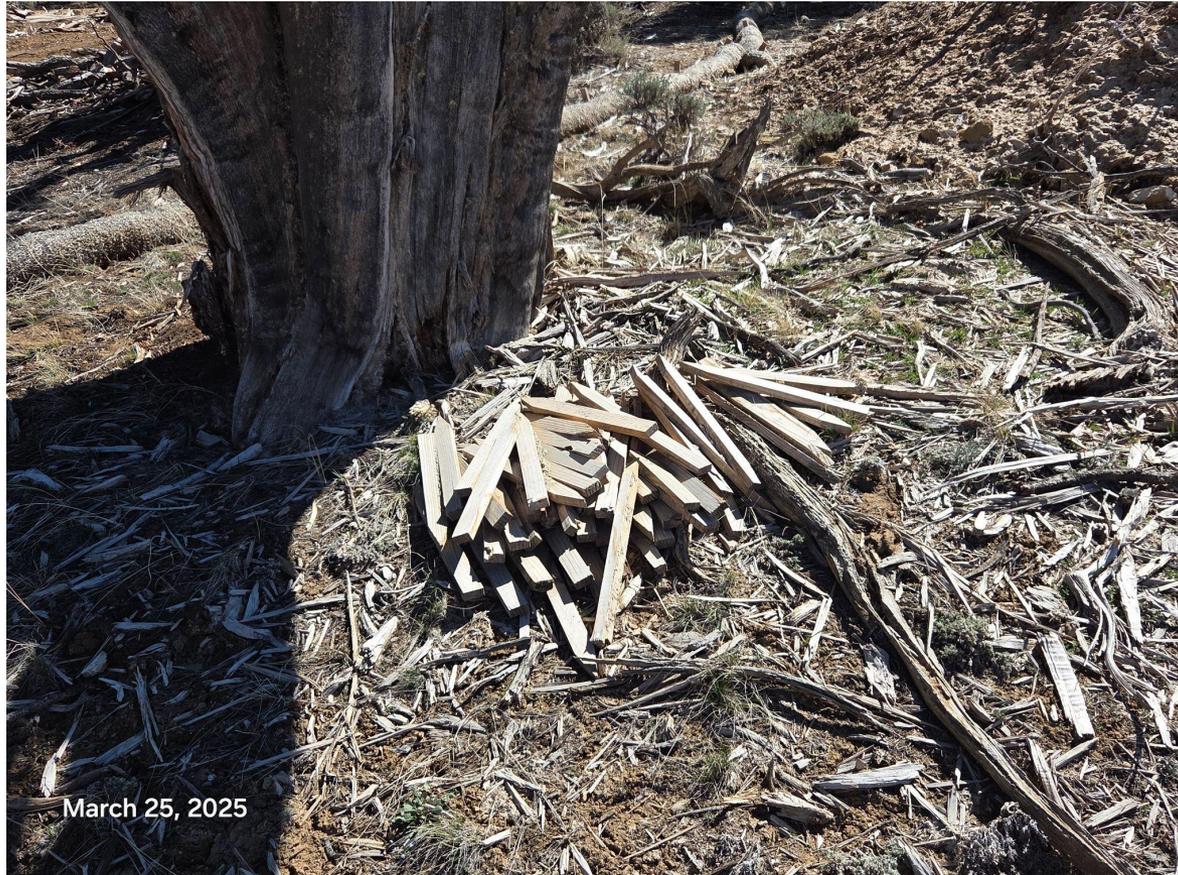
**Photo 7:** Photo taken from the southwest end of the Location. Photo shows unused stakes.
