# PCU FED/B27-197, #485795 Annotation Report

# PCU FED/B27-197, #485795 Field Note Report

**Operator:** CAERUS PICEANCE LLC - 10456

**Location ID:** 485795

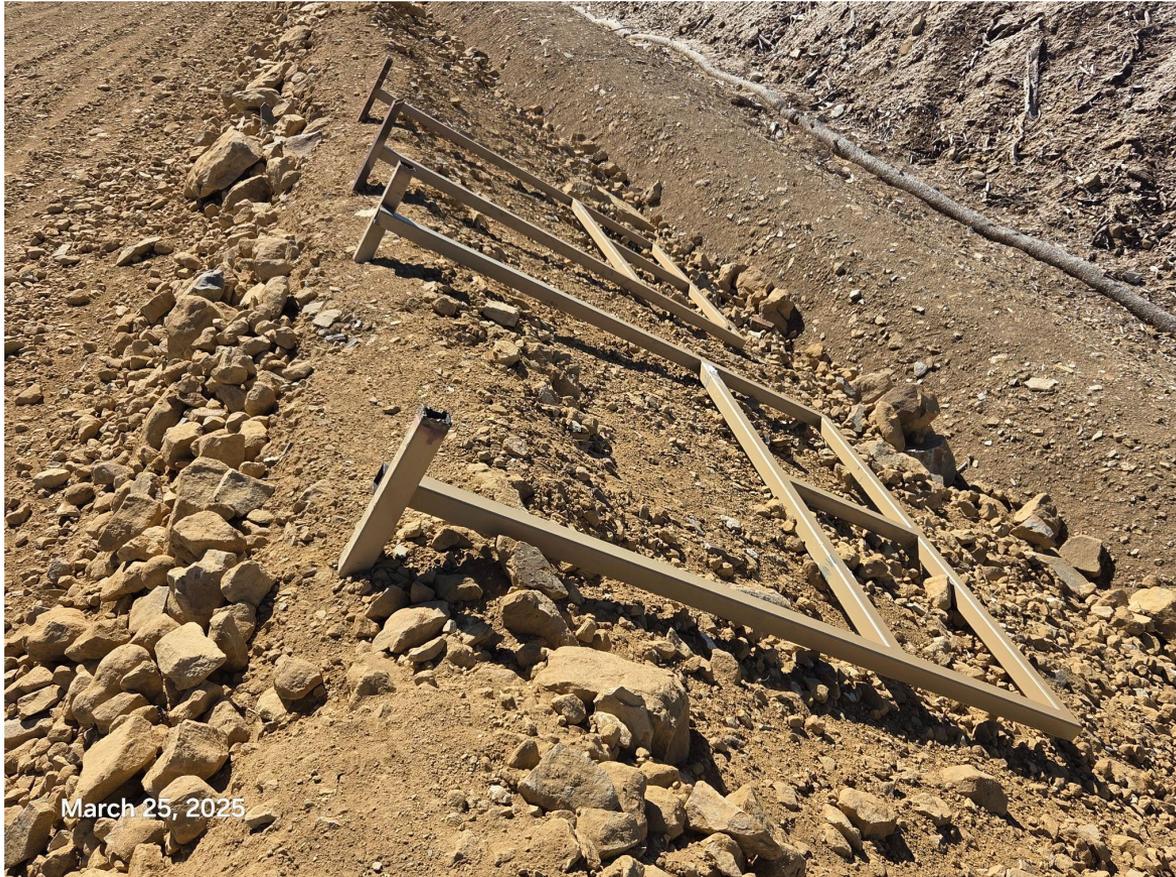
**Photo 8:** Photo shows what appears to be metal signage posts(?) improperly stored on the fill slopes of the Location.

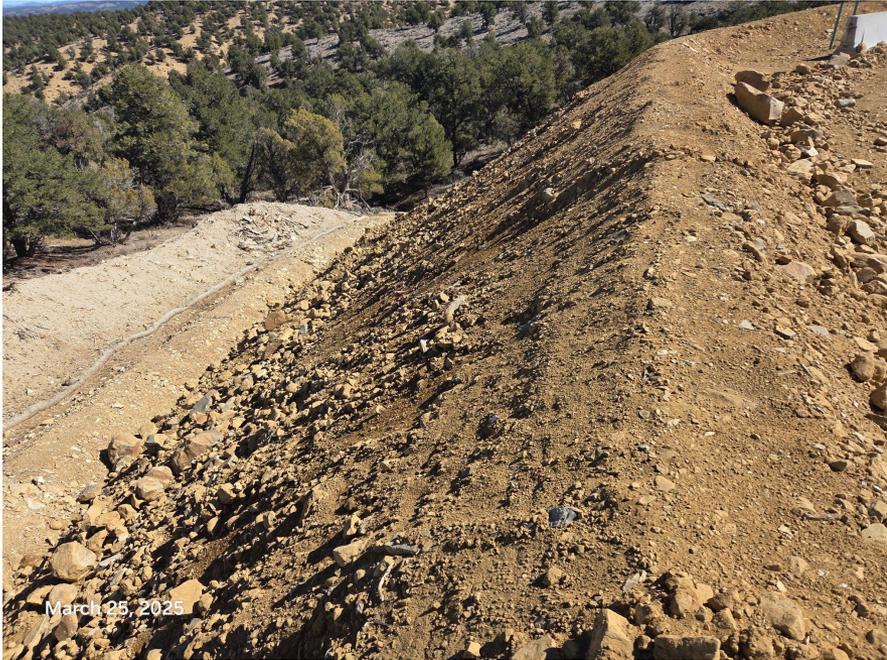
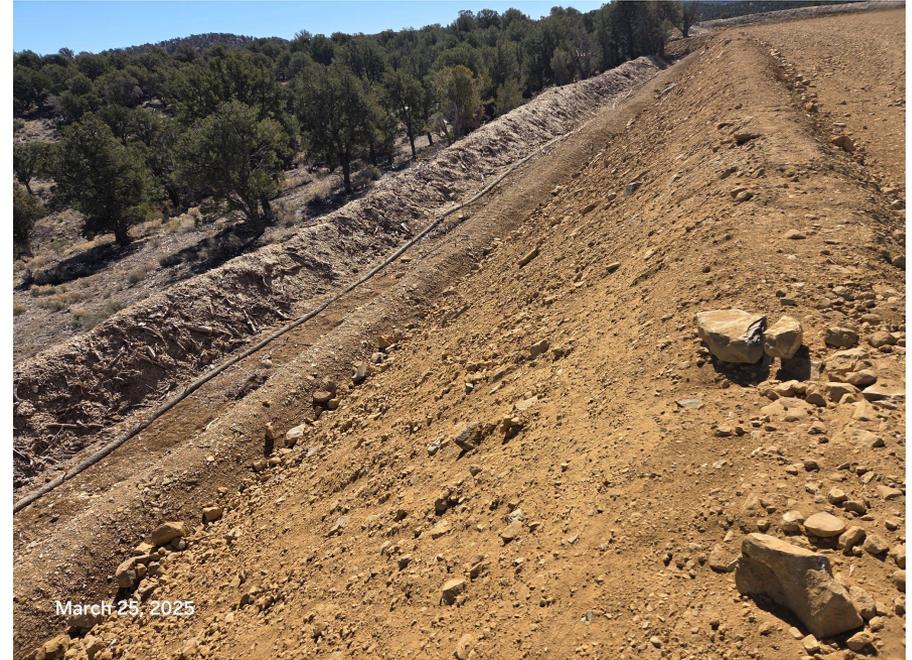
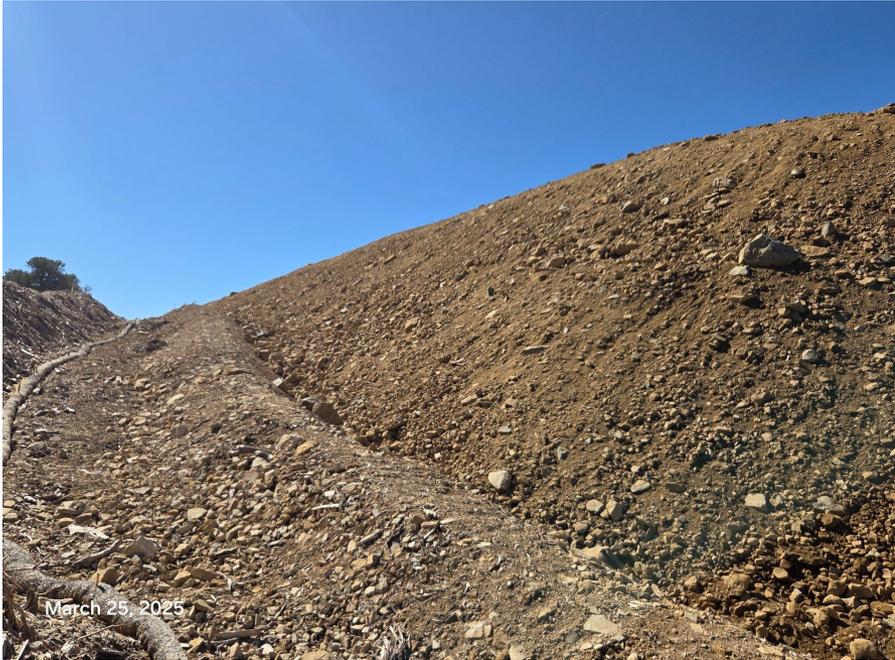
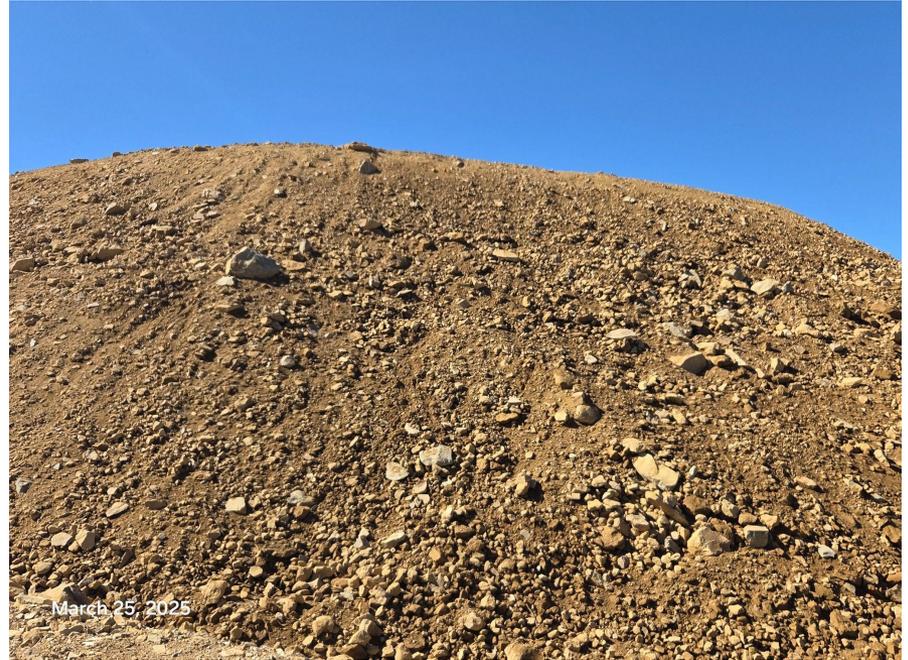
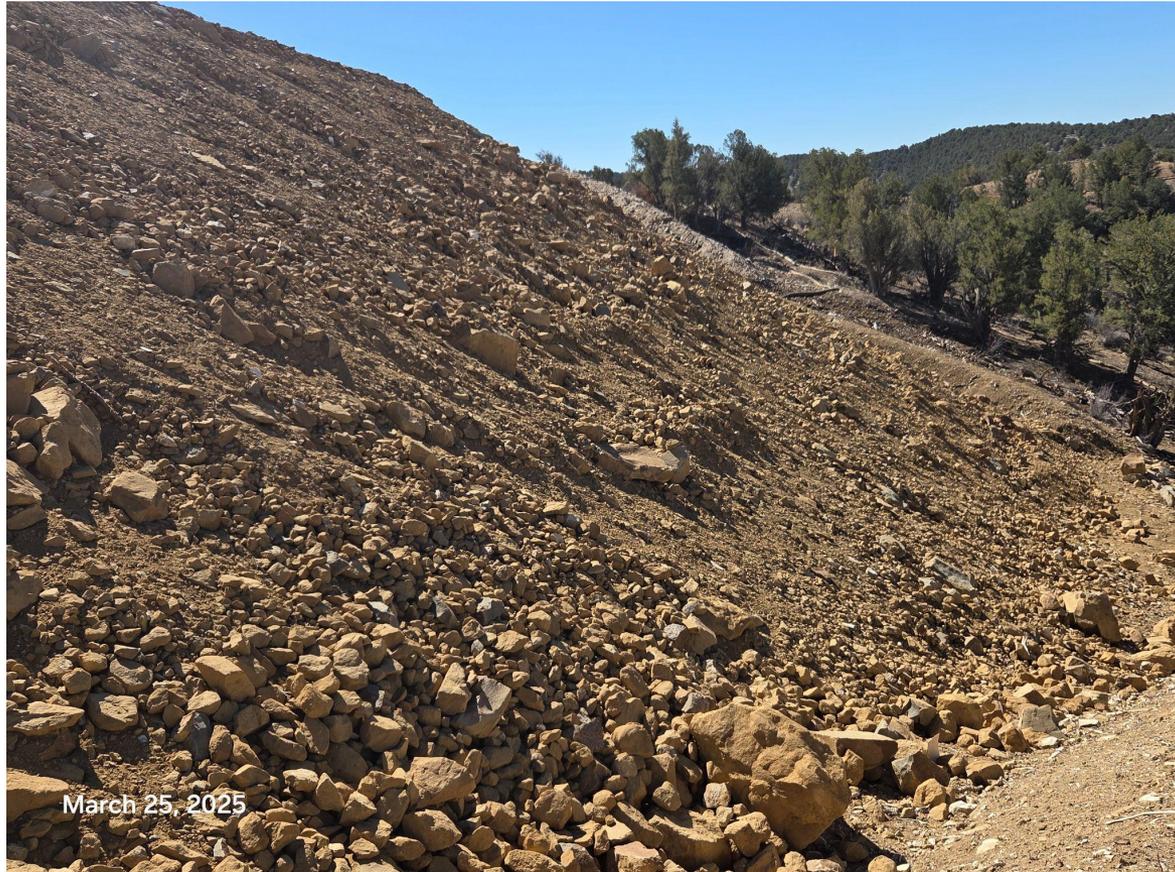
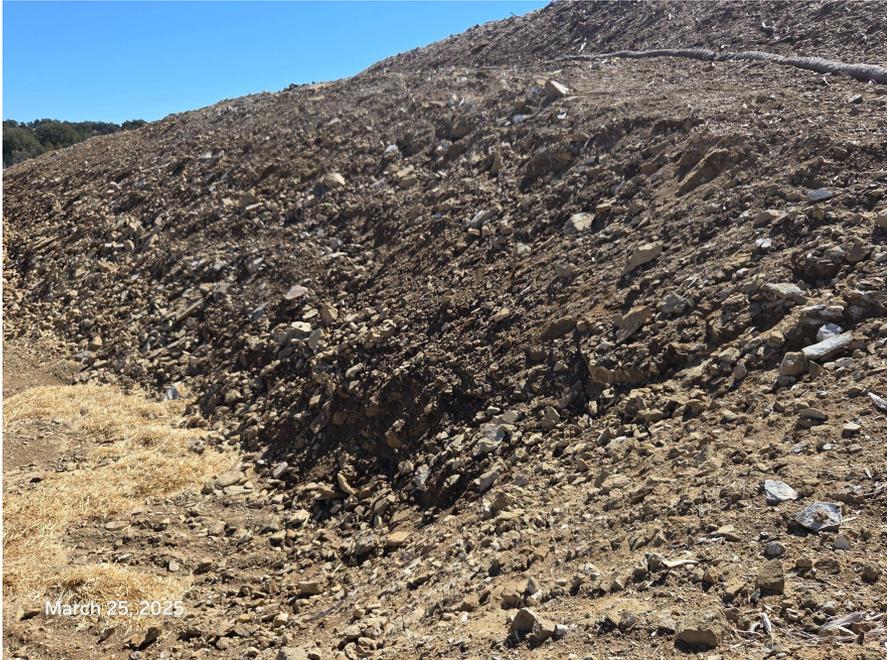
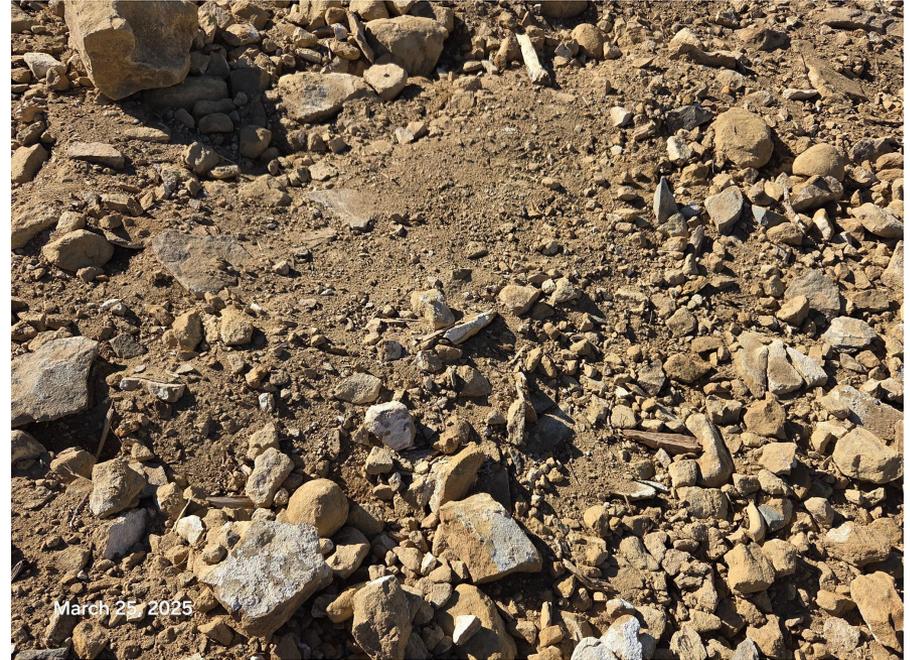
**Photo 9:** Photos 9-12 examples showing the cut and fill slopes of the Location. Cut and fill slopes composed of fine soils and rock aggregate. Photos show BMPs to stabilize, as well as to minimize erosion and degradation at the slopes are missing or insufficient.

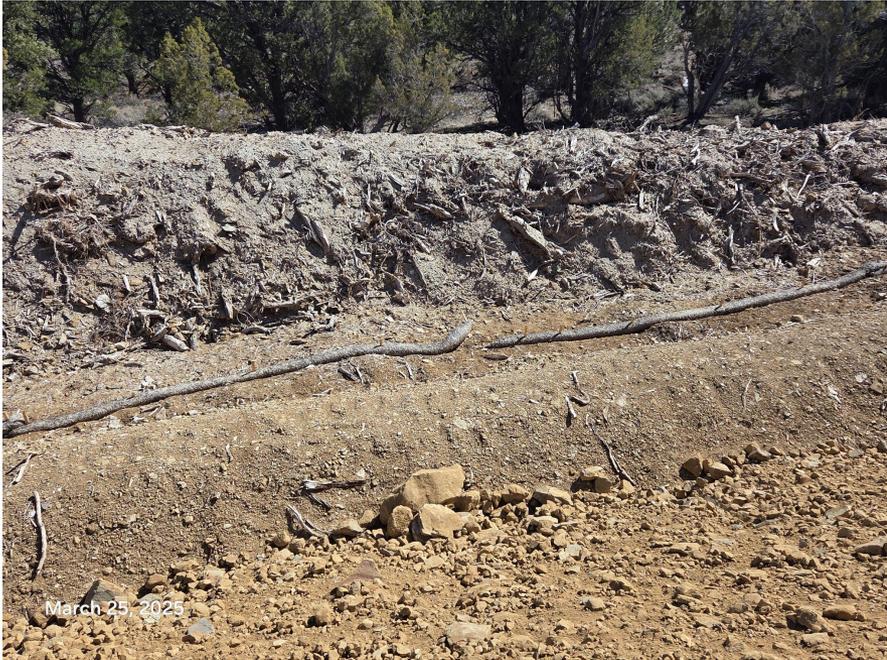
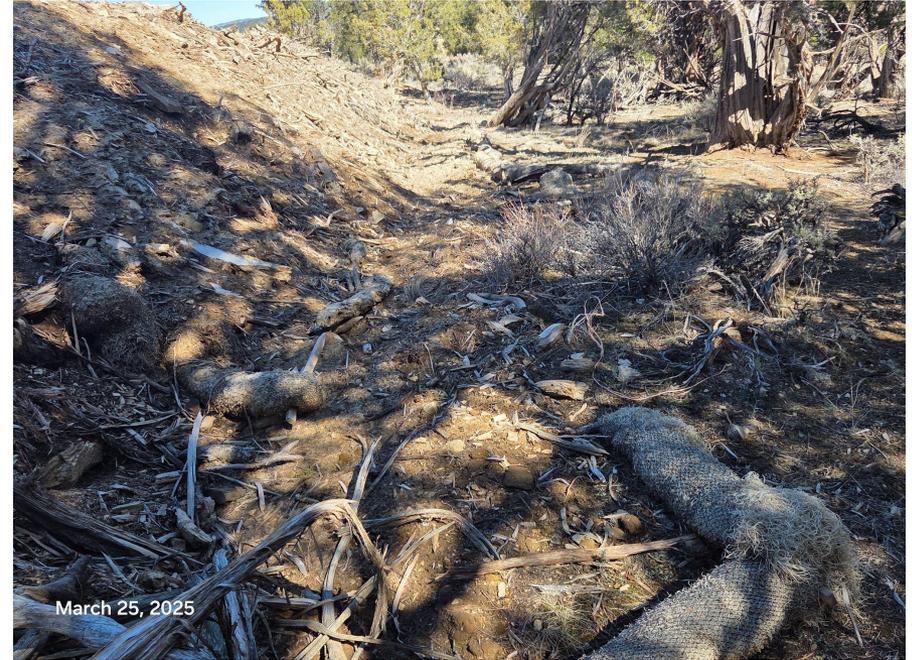
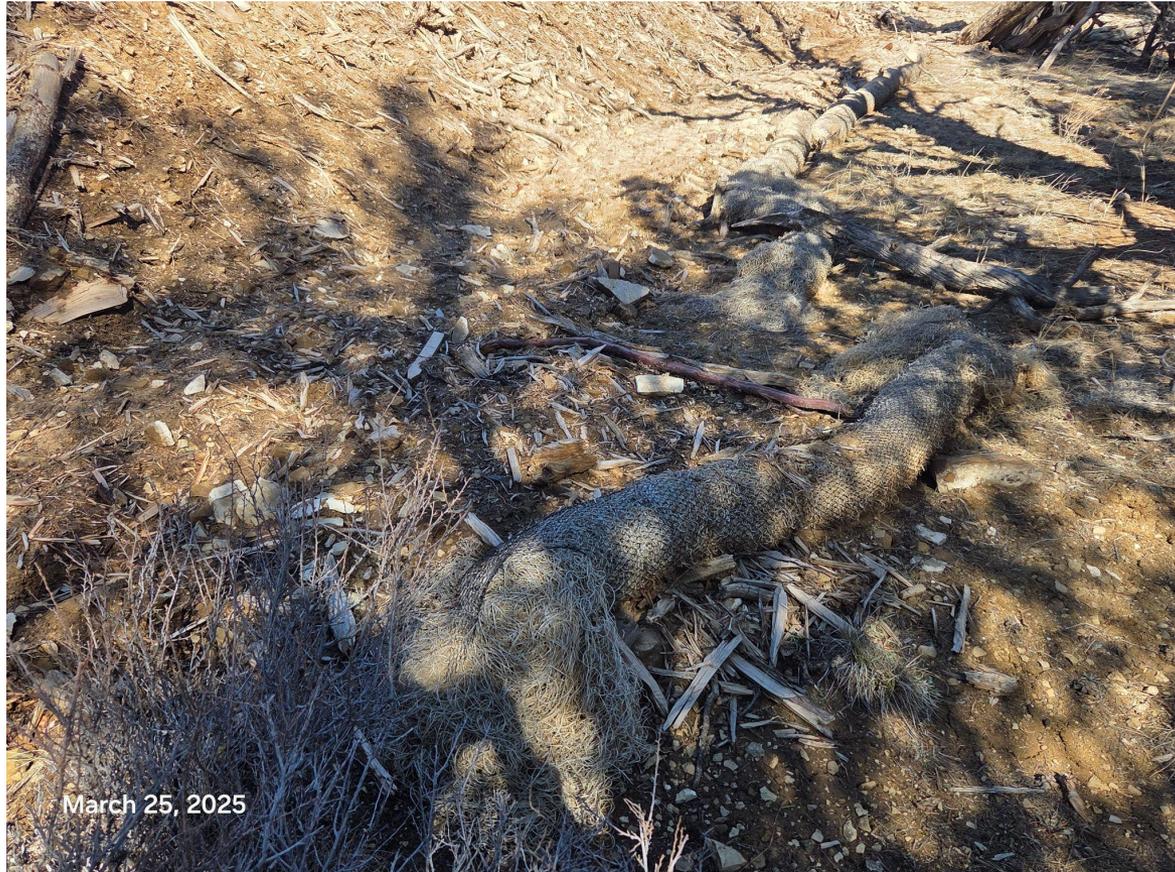
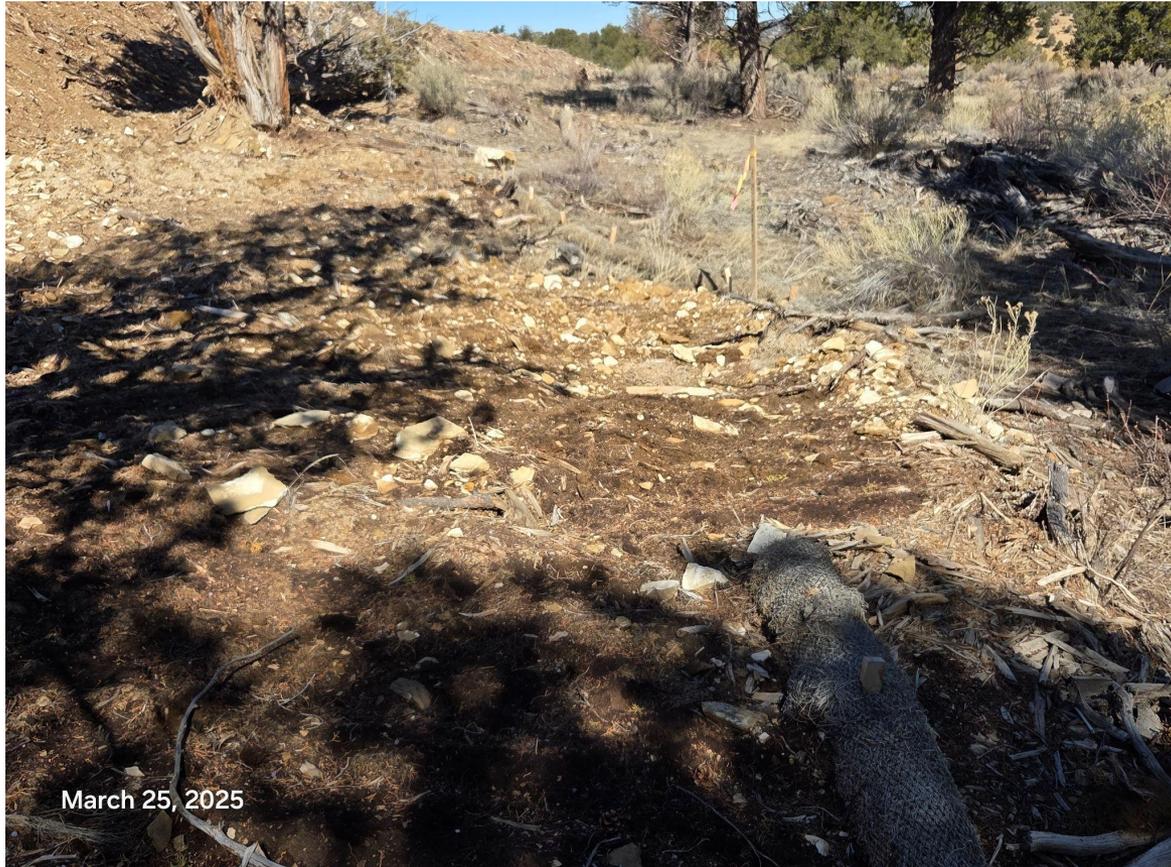
**Photo 13:** Photos 13-15 examples showing erosion logs at the topsoil stockpile on the east end of the Location are in disrepair. Photo left example showing hydromulch applied to the topsoil stockpiles.

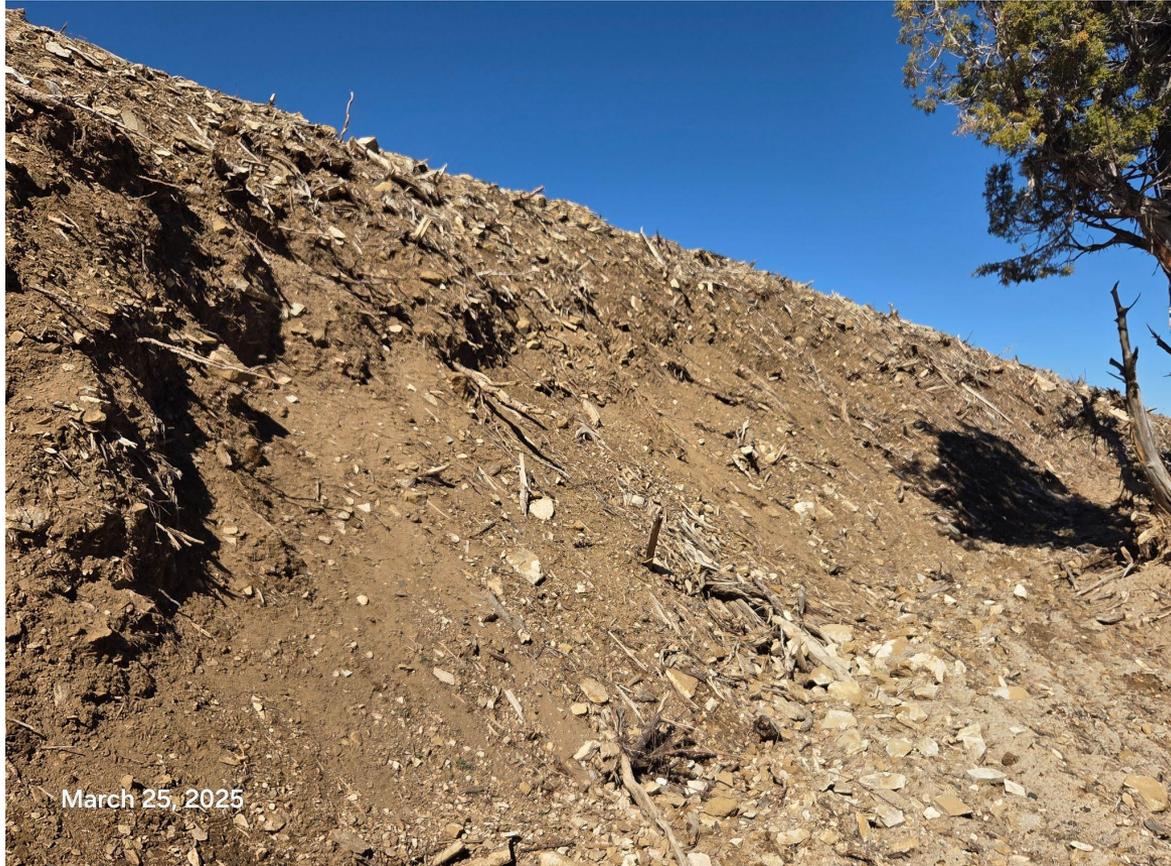
**Photo 16:** Photos taken from the east facing slopes of the eastern topsoil stockpile. Photo example showing BMP (mulch) has not been installed per good engineering practice, or maintained in proper functioning condition; soils at stockpile are bare and lack stabilization; germination within these areas not apparent.

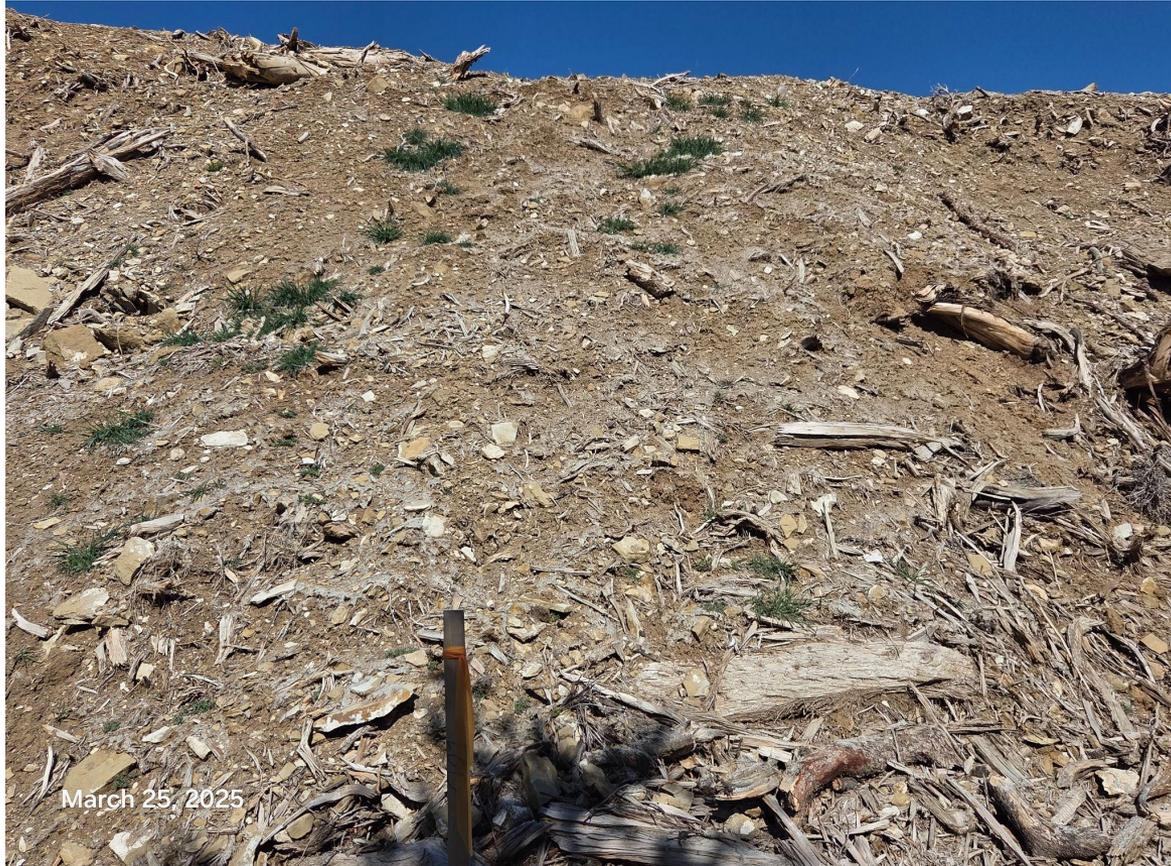
**Photo 19:** Photos taken from the south facing slopes of the southern topsoil stockpile. BMP show signs of disrepair, though plant germination is evident.

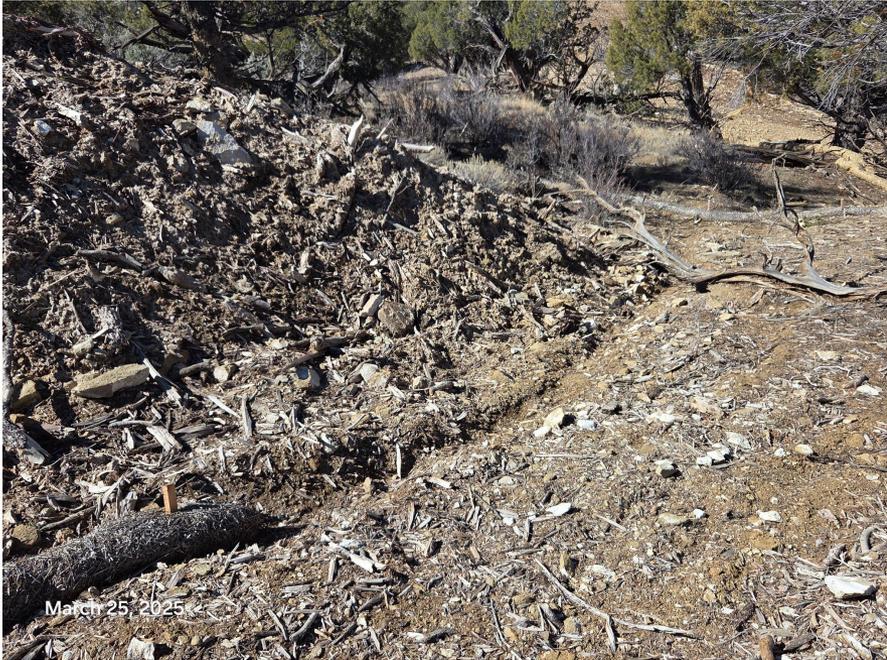
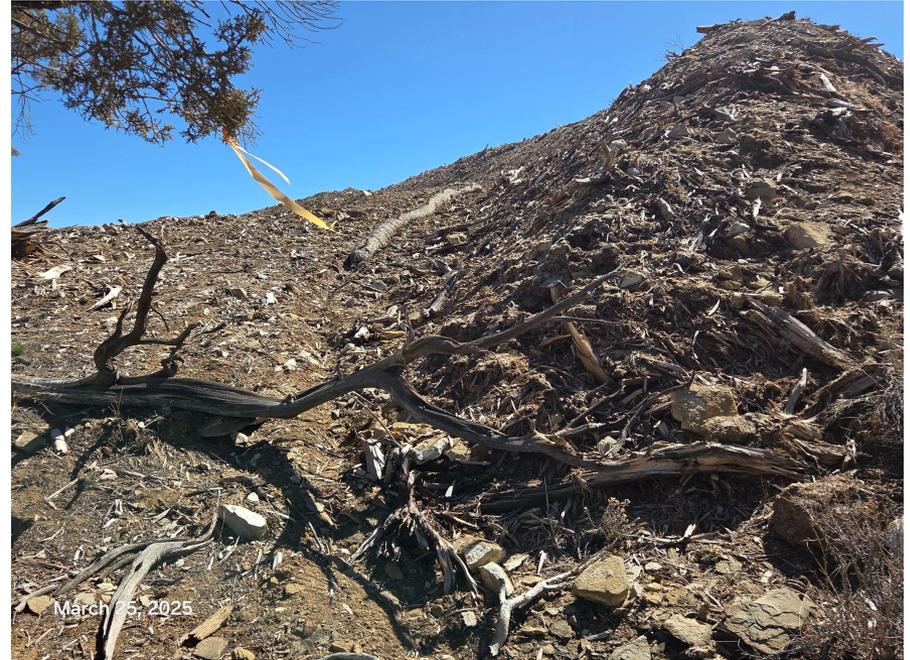
**Photo 20:** Photos taken from the topsoil stockpile on the southwest end of the Location. Photo shows perimeter controls (erosion log) are missing/have been removed

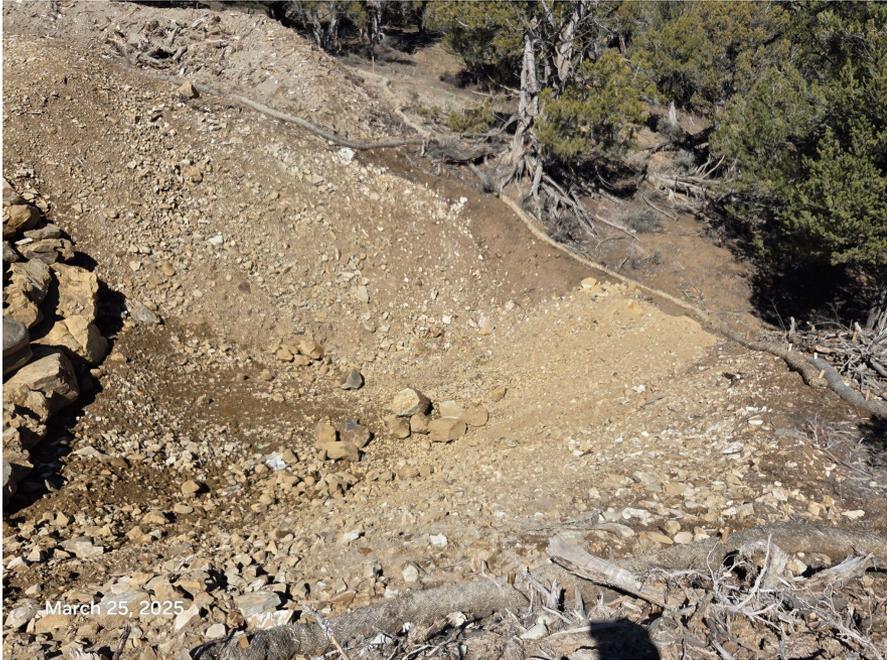
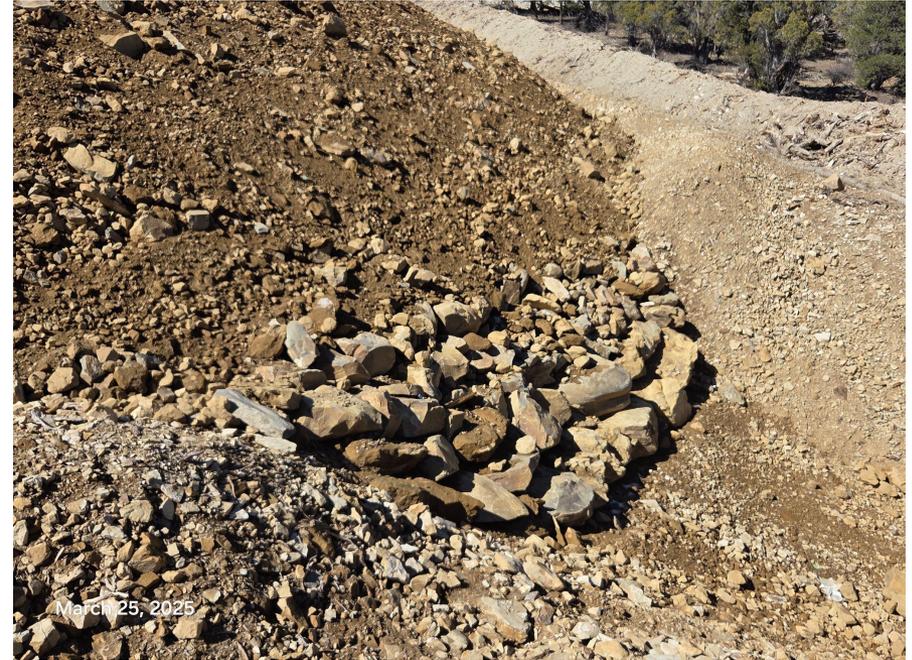
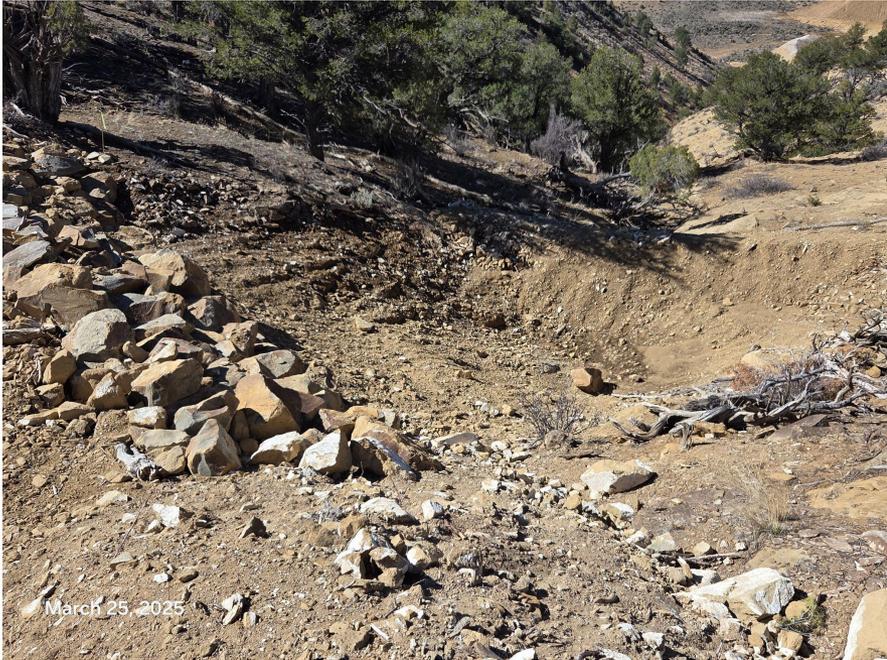
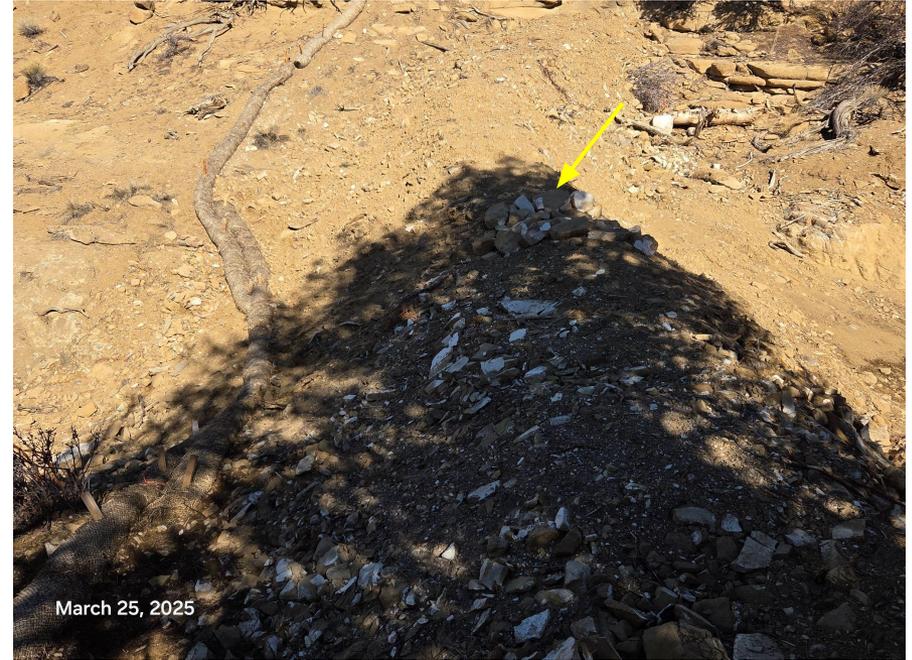
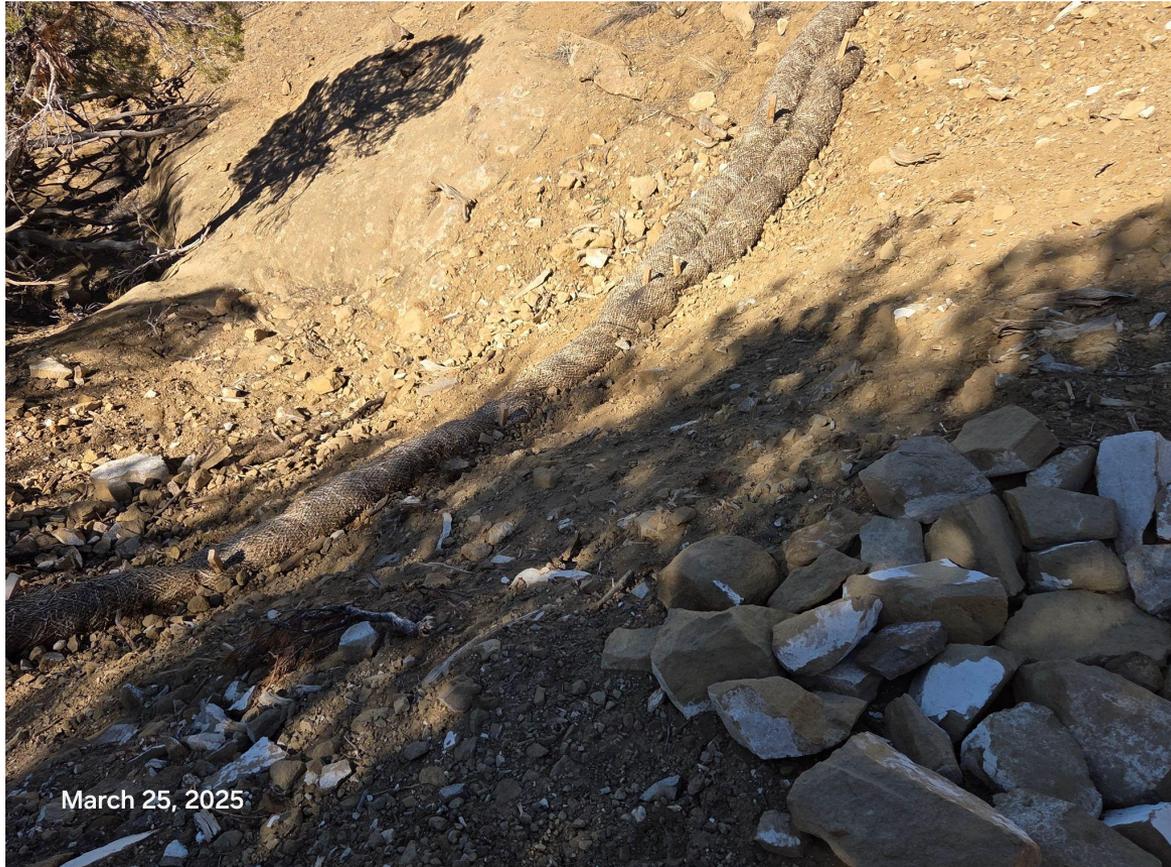
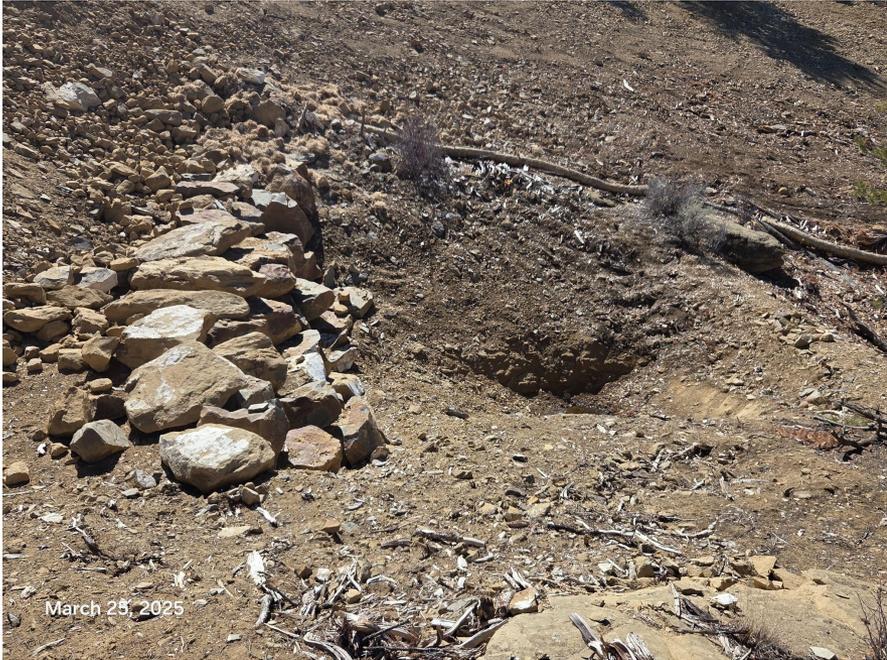
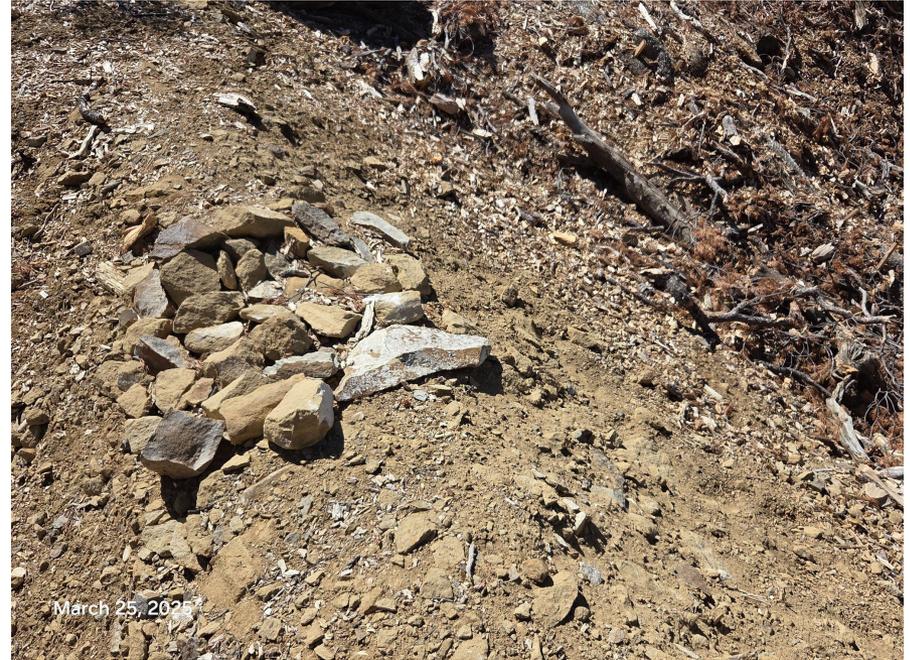
**Photo 21:** Photos taken from the sediment trap on the northeast end of the Location. Sediment traps on the Location have not been installed with a properly engineered outlet. Outlets at the Northwest and southwest sediment traps are inadequate in size; the slopes at the outlets are only partially armored; soils below the outlets are loose, unconsolidated soils. Additionally, outlets at all three traps have not been constructed with geotextile lining in conjunction with the rip-rap material per good engineering practice.

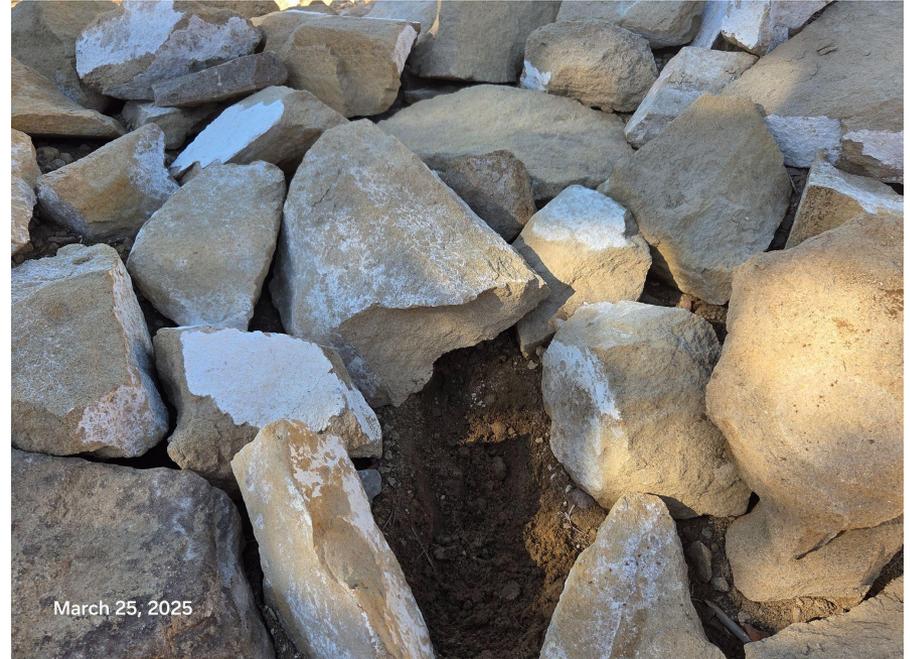
**Photo 23:** Photos taken from the sediment trap on the northwest end of the Location. See comments under photo 21. Photo right example showing outlets at all three traps have not been constructed with geotextile lining in conjunction with the rip-rap material per good engineering practice.

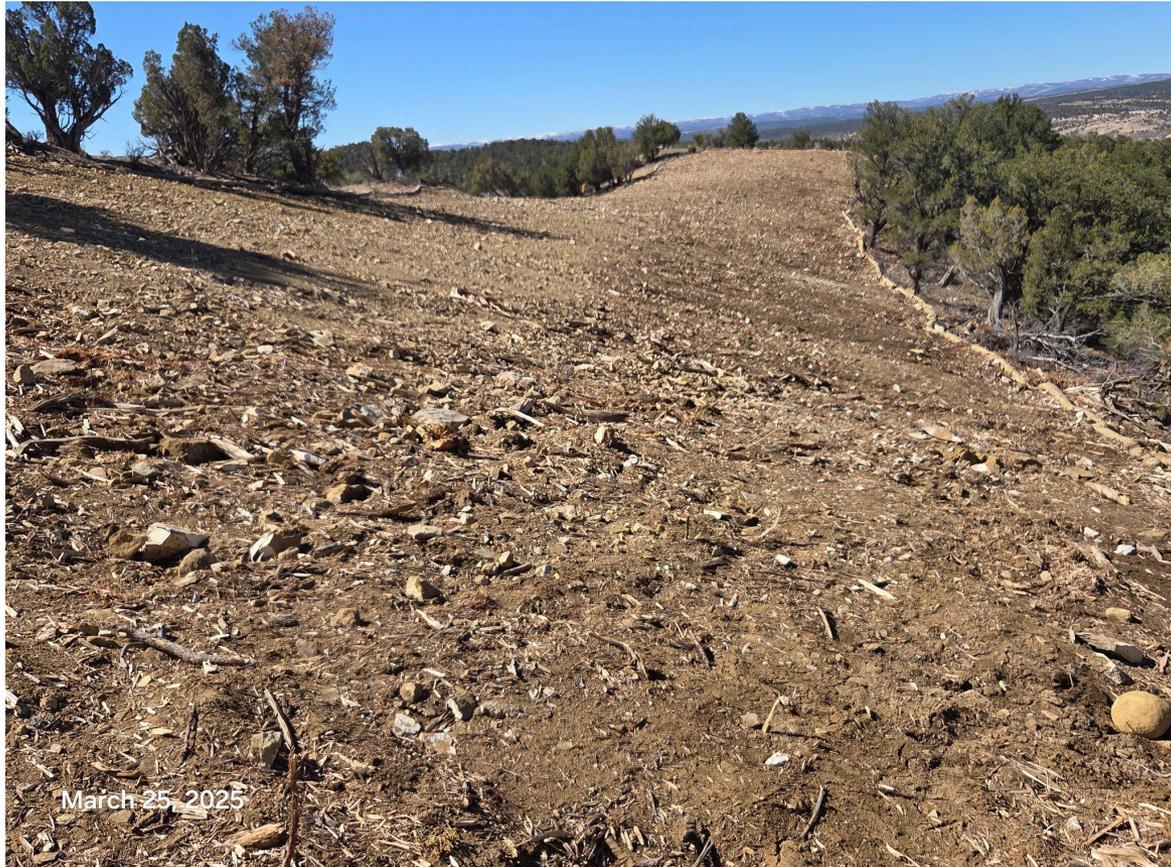
**Photo 26:** Photo taken from the southwest end of the Location, facing west. Photo shows the pipeline corridor disturbance associated with the Location, leading to the CPD Location. Photo shows BMPs to stabilize, as well as to minimize erosion and degradation are missing from the pipeline disturbance.

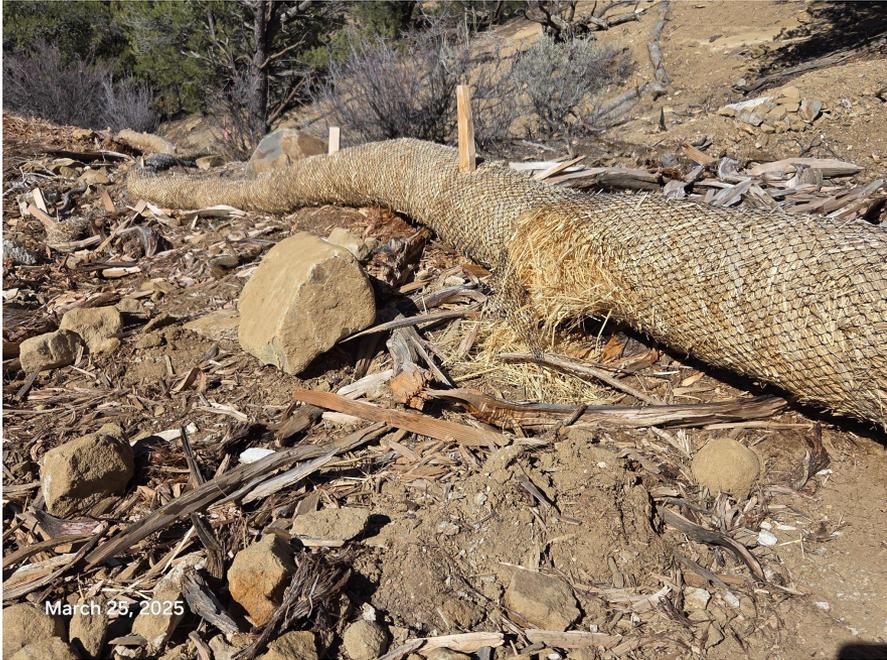
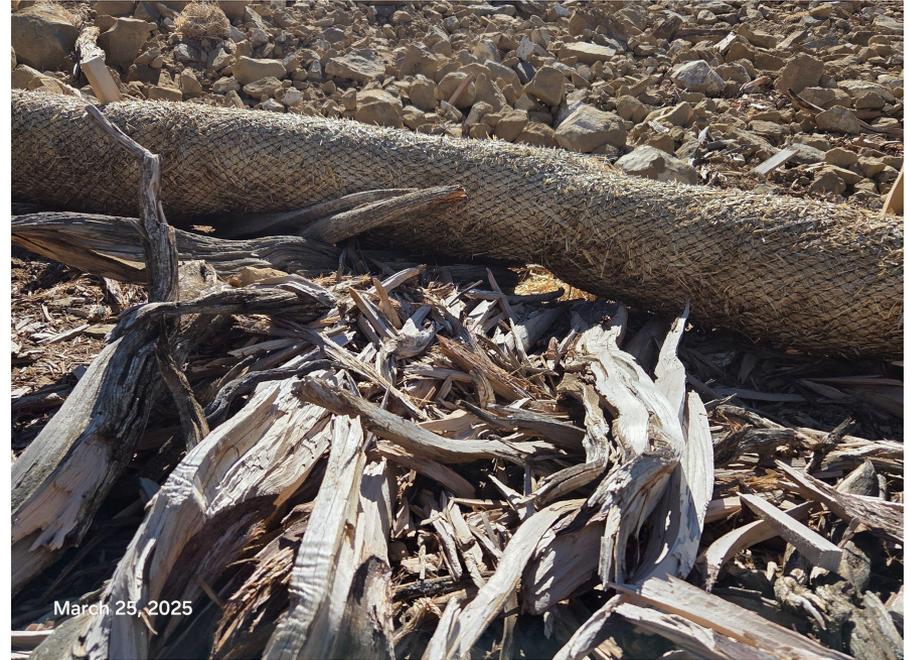
**Photo 27:** Continued from photo 26. Photos examples showing the erosion logs implemented along the pipeline disturbance areas have not been installed per good engineering practices; erosion logs have not been properly trenched or backfilled, and/or have been placed on grubbed material with no soil-surface contact

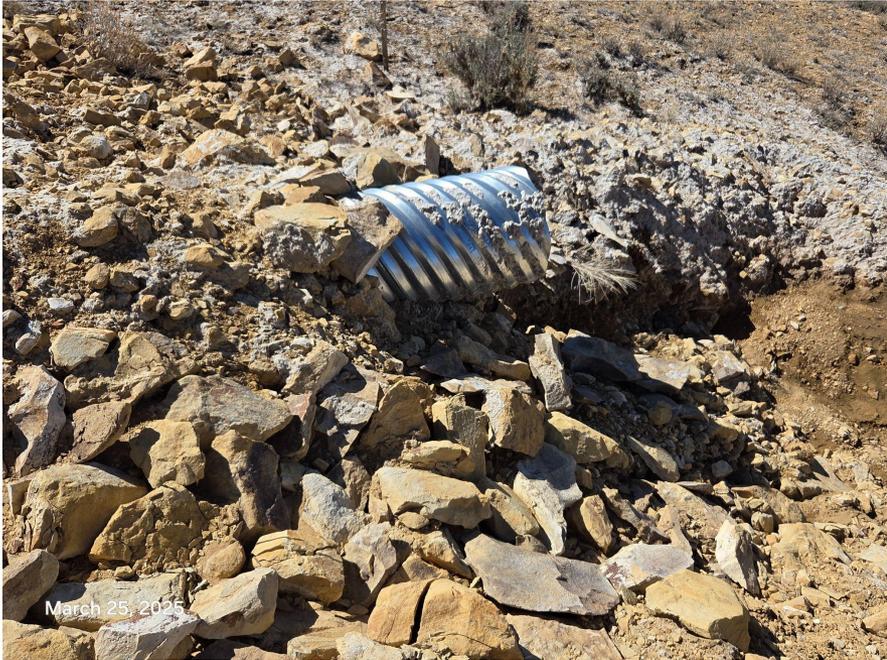
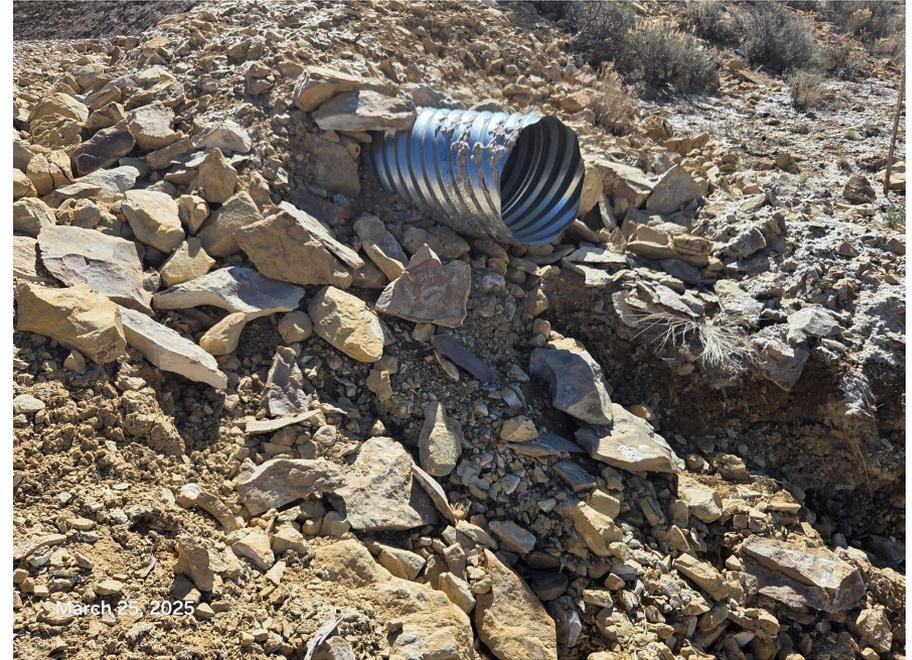
**Photo 29:** Photos 29-35 show culverts / sediment traps constructed along access road; Photos examples showing BMPs have not been installed per good engineering practices. Armoring observed to be insufficient at several culverts. Inlets/outlets at the sediment traps have not been installed per good engineering practices, including rip-rap material in conjunction with geotextile lining; degradation evident.

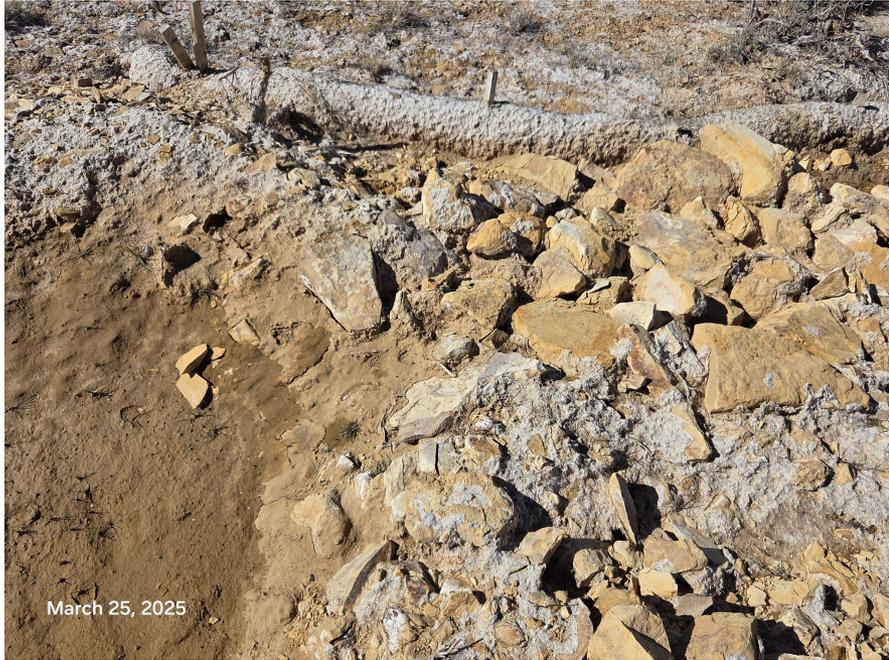
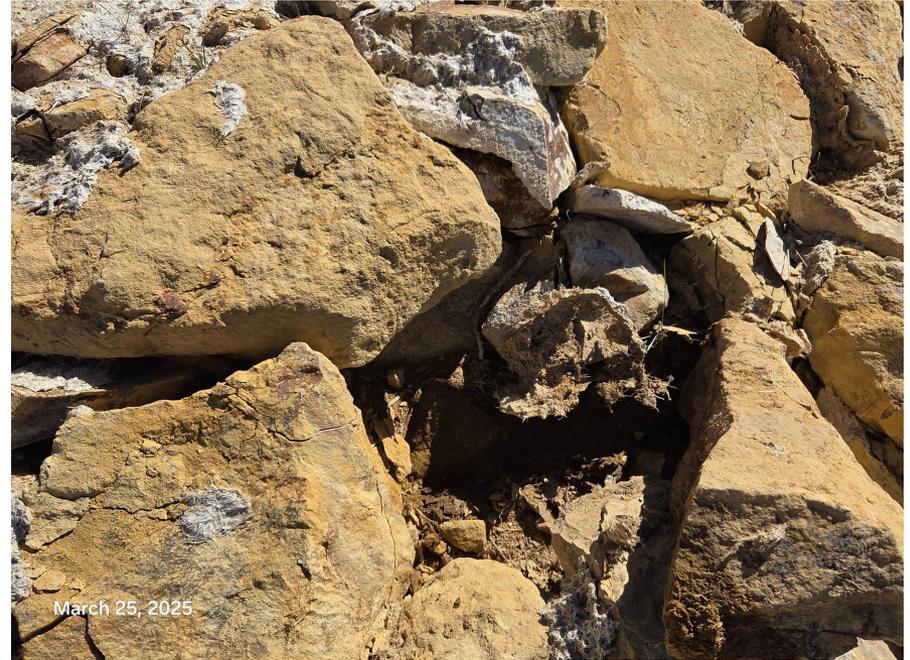
**Photo 30:** See comments under photo 29. Sediment traps have not been installed per good engineering practices, including rip-rap material in conjunction with geotextile lining.
