# PCU FED/B27-197, #485795 Annotation Report

# PCU FED/B27-197, #485795 Field Note Report

**Operator:** CAERUS PICEANCE LLC - 10456

**Location ID:** 485795

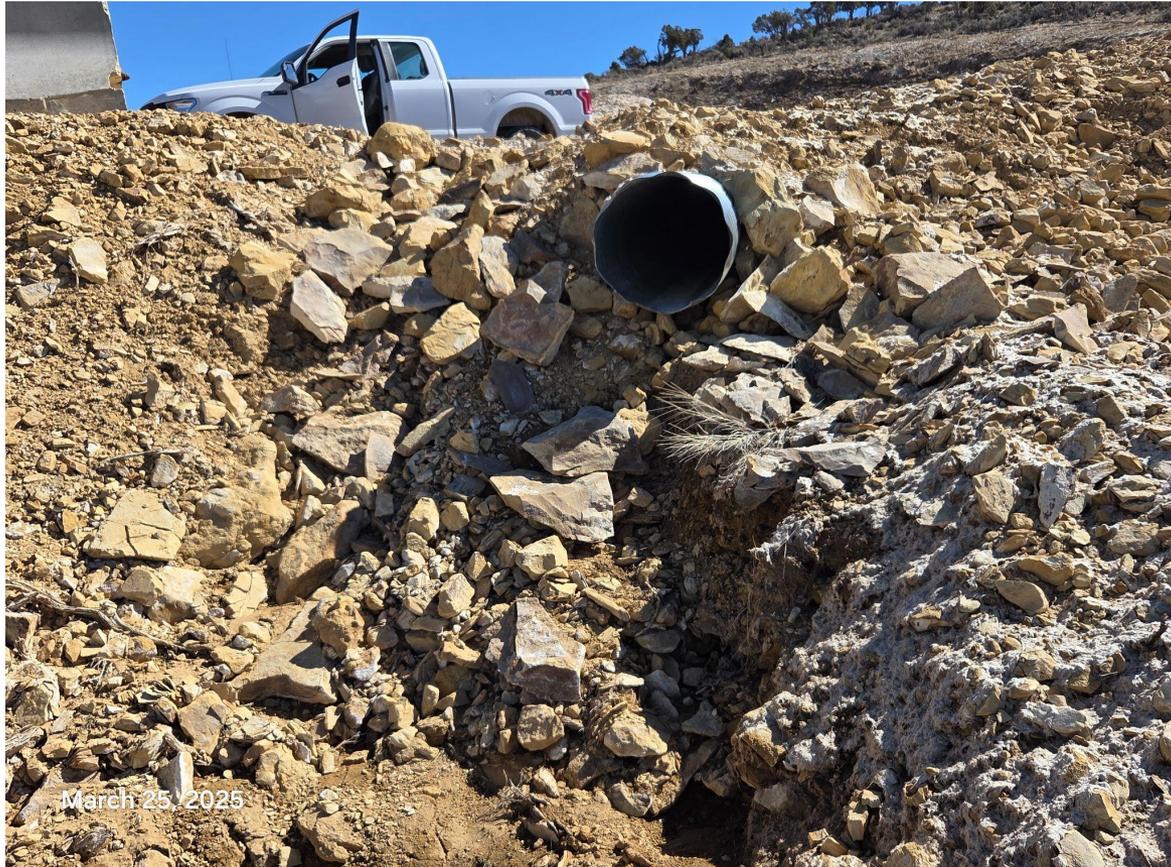
**Photo 29:** Photos 29-35 show culverts / sediment traps constructed along access road; Photos examples showing BMPs have not been installed per good engineering practices. Armoring observed to be insufficient at several culverts. Inlets/outlets at the sediment traps have not been installed per good engineering practices, including rip-rap material in conjunction with geotextile lining; degradation evident.

**Photo 31:** See comments under photo 29. Photo shows degradation below the culvert outlet

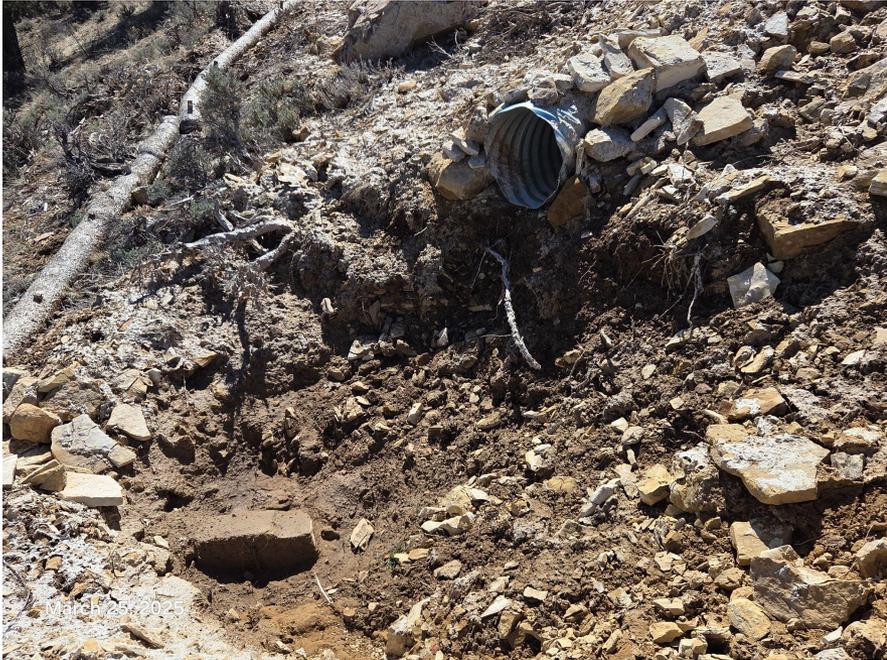
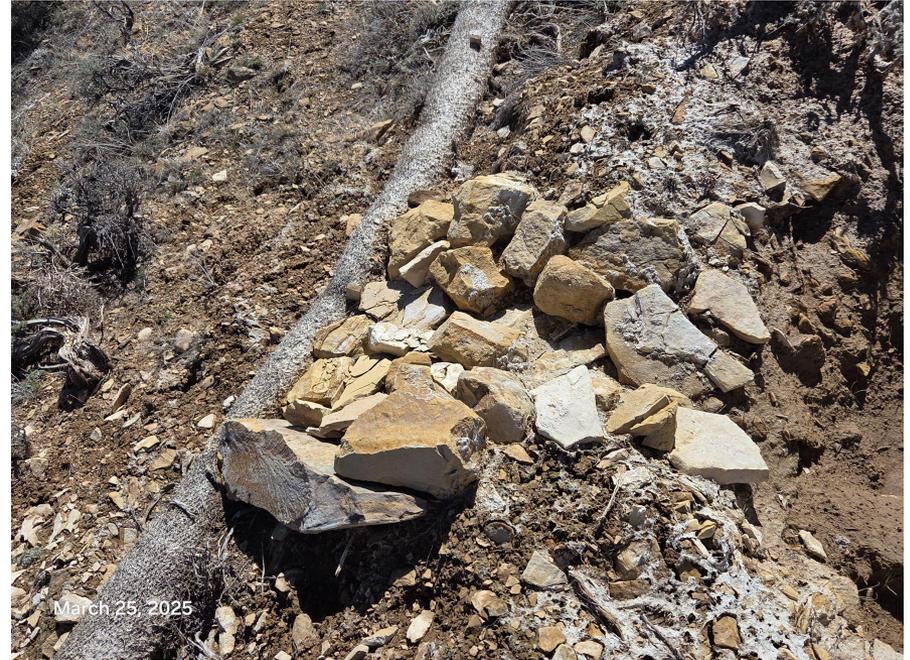
**Photo 32:** See comments under photo 29. Degradation at culvert outlet observed. Outlet not per good engineering practice.

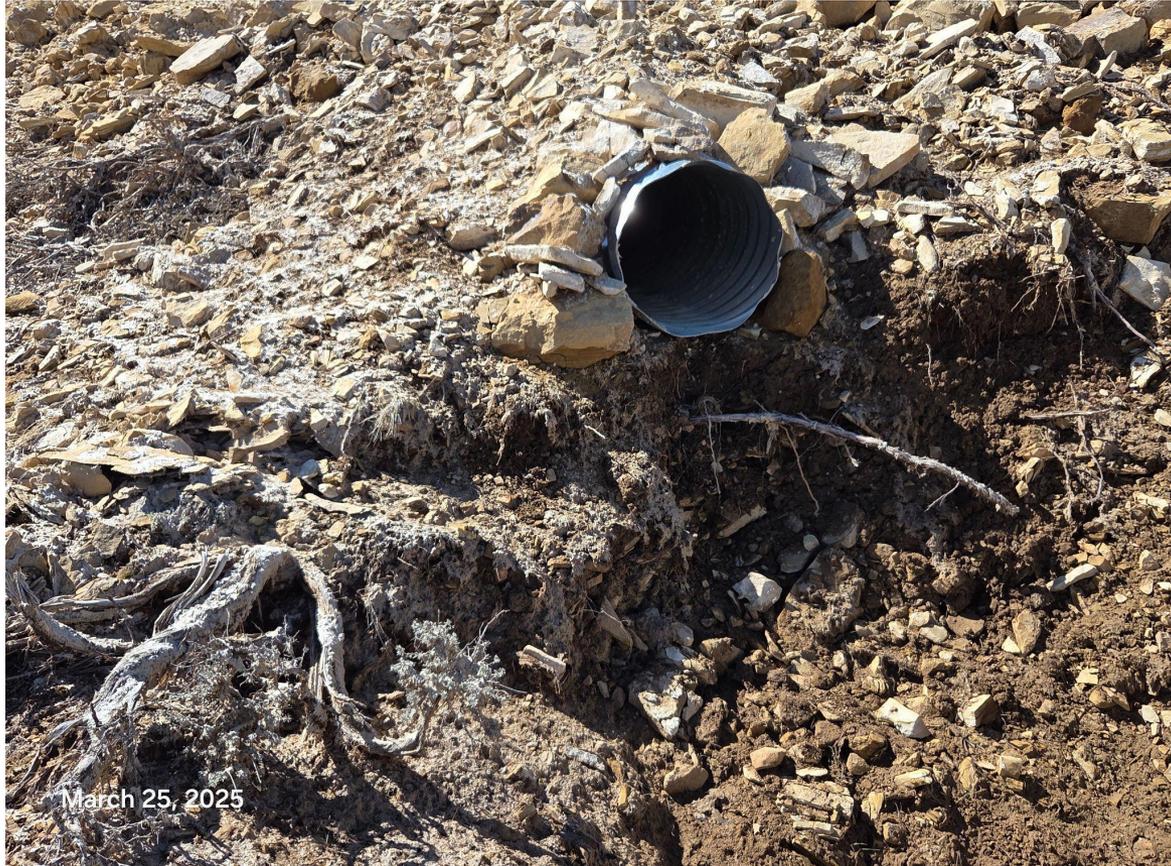
**Photo 33:** See comments under photo 29. Degradation at culvert outlet observed.

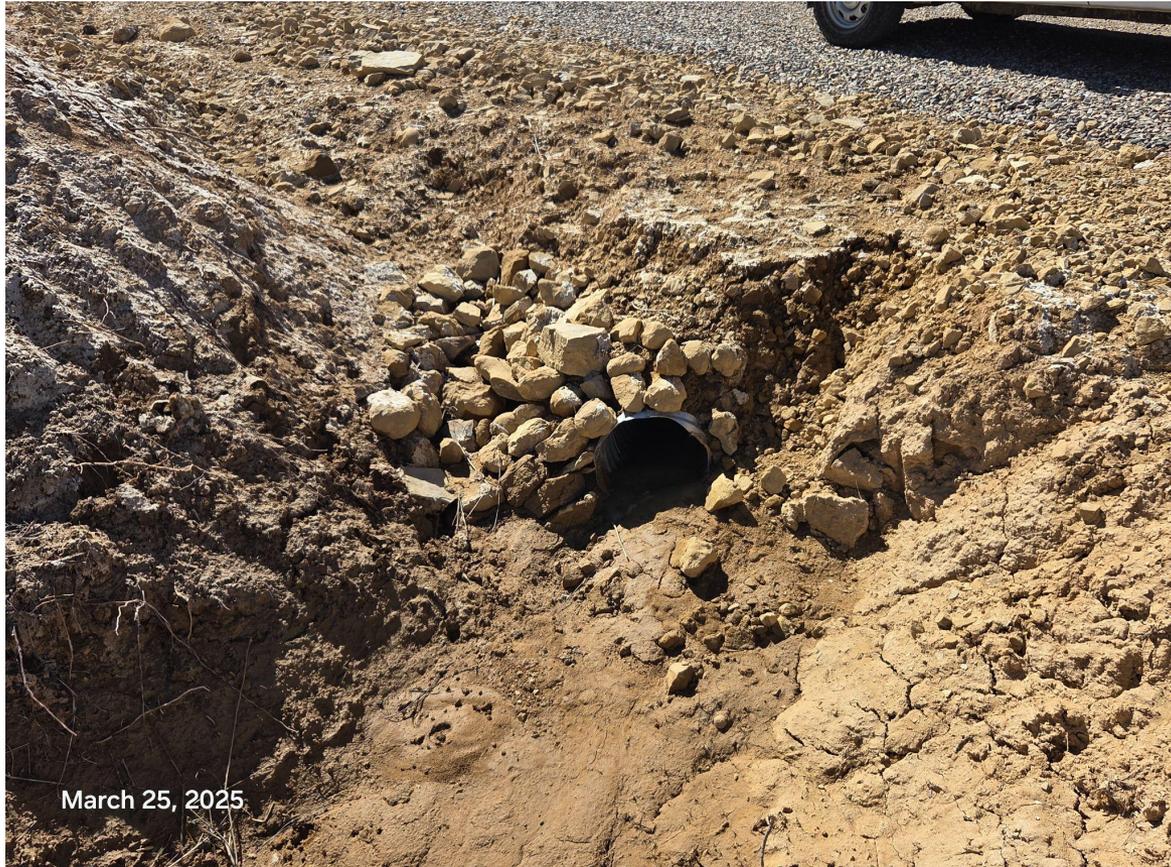
**Photo 34:** See comments under photo 29. Armoring at culvert insufficient; Degradation at culvert observed.

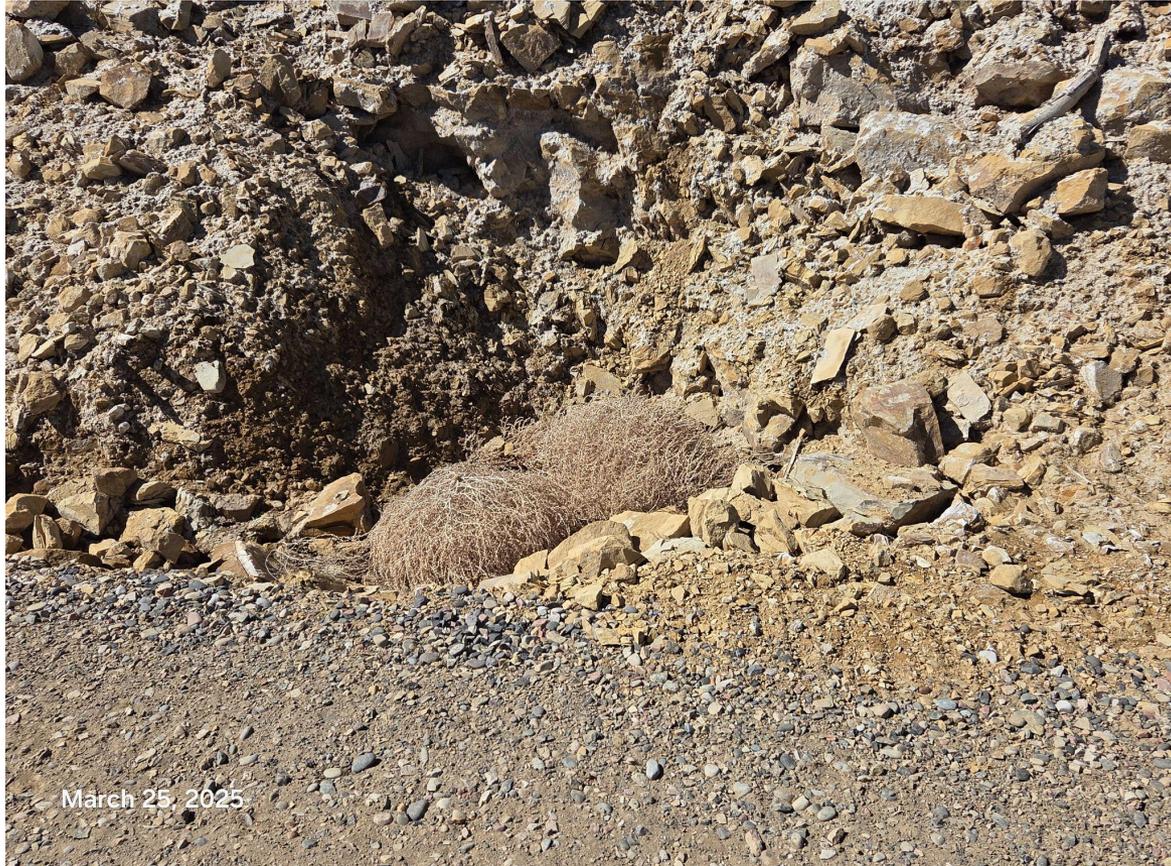
**Photo 35:** Photo example showing weed debris accumulation observed at culverts.
