Interim Reclamation and Stormwater Inspection

Operator: PADCO LLC - 24500

Location ID: 317037

Inspection Document #: 718700228

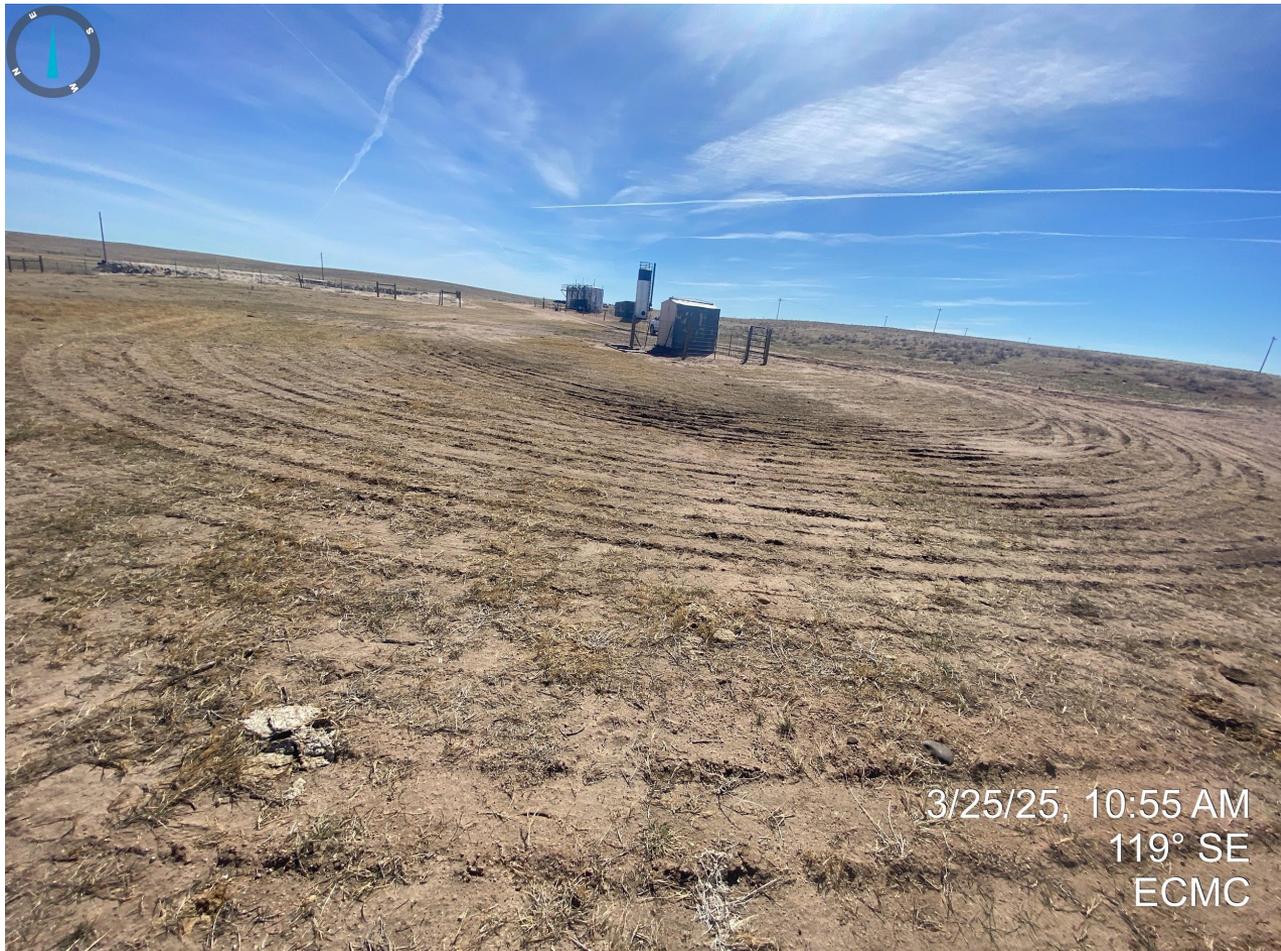
Photo 1. Vehicle traffic appears to be occurring outside of the established access roads/production areas with rutting and site degradation evident.

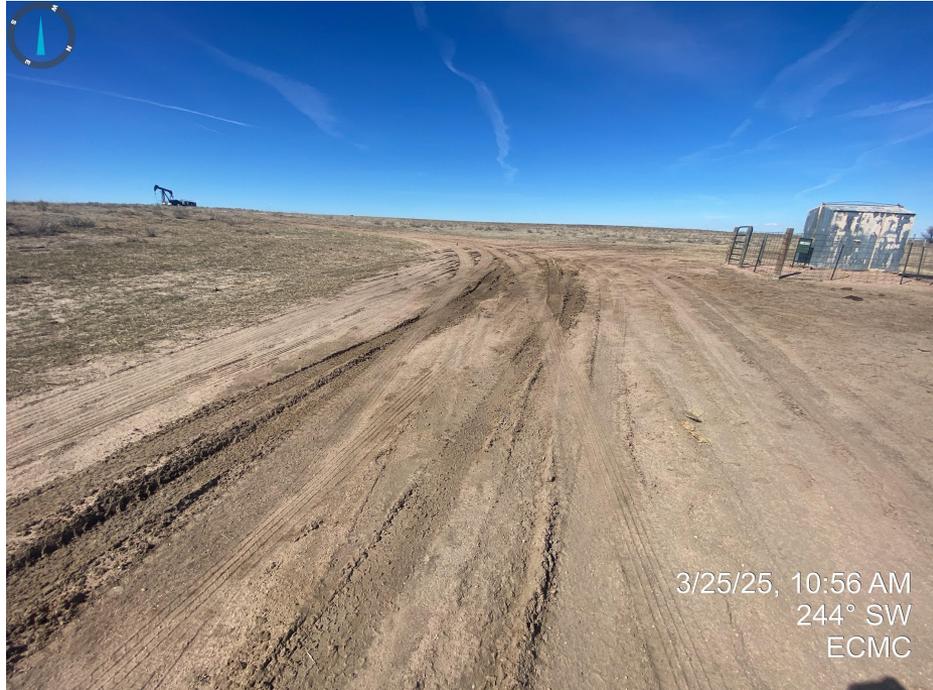
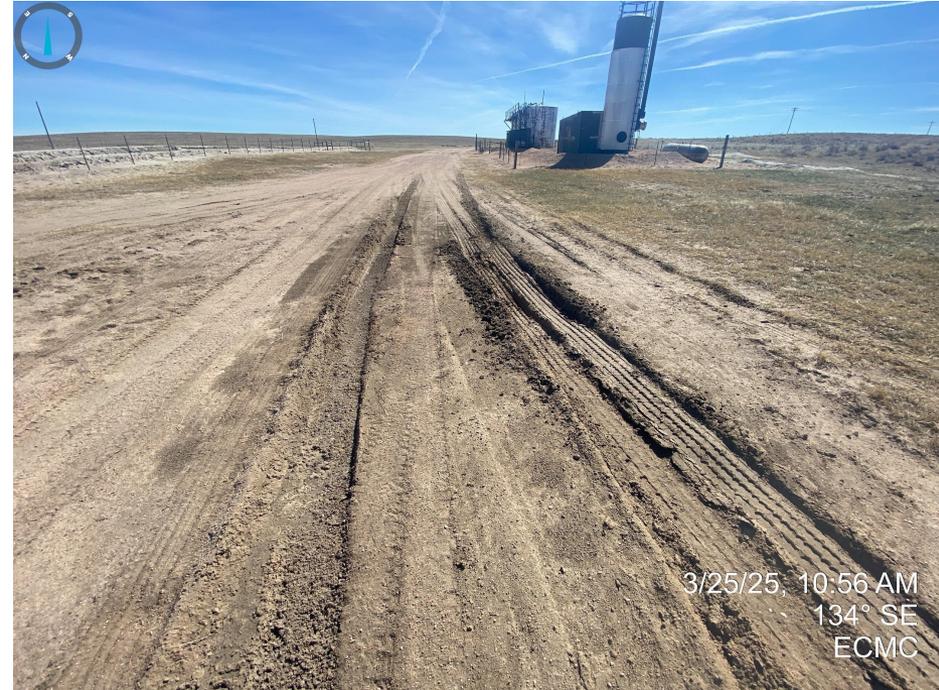
Photos 2 & 3. Rutting and site degradation observed along portions of the access road.

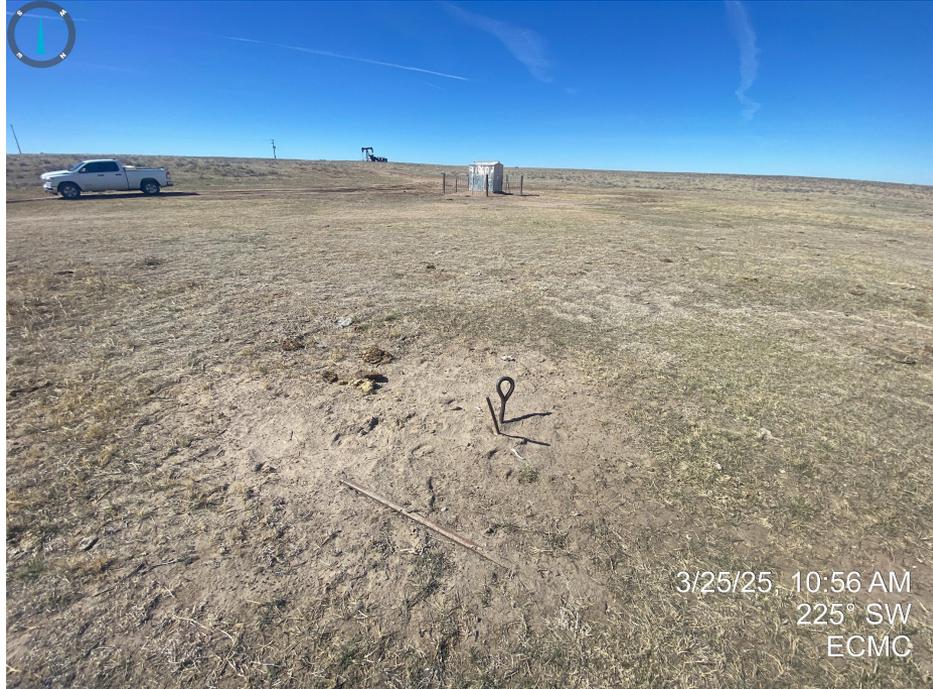
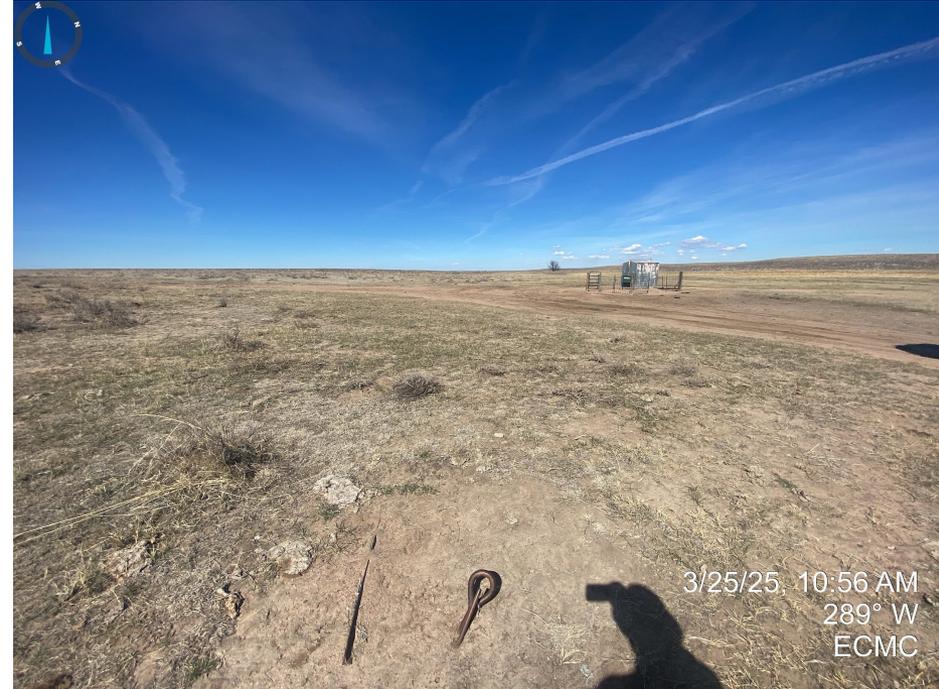
Photos 4 & 5. Guy line anchors do not appear to be properly marked; Photo 4 (left) taken from the northeast and Photo 5 (right) taken from the southeast.

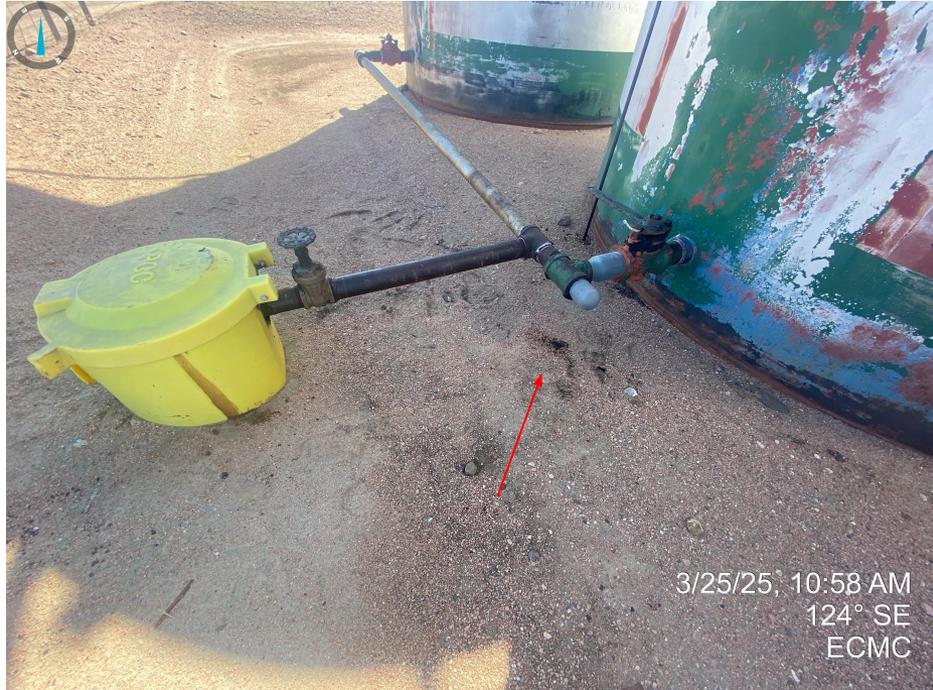
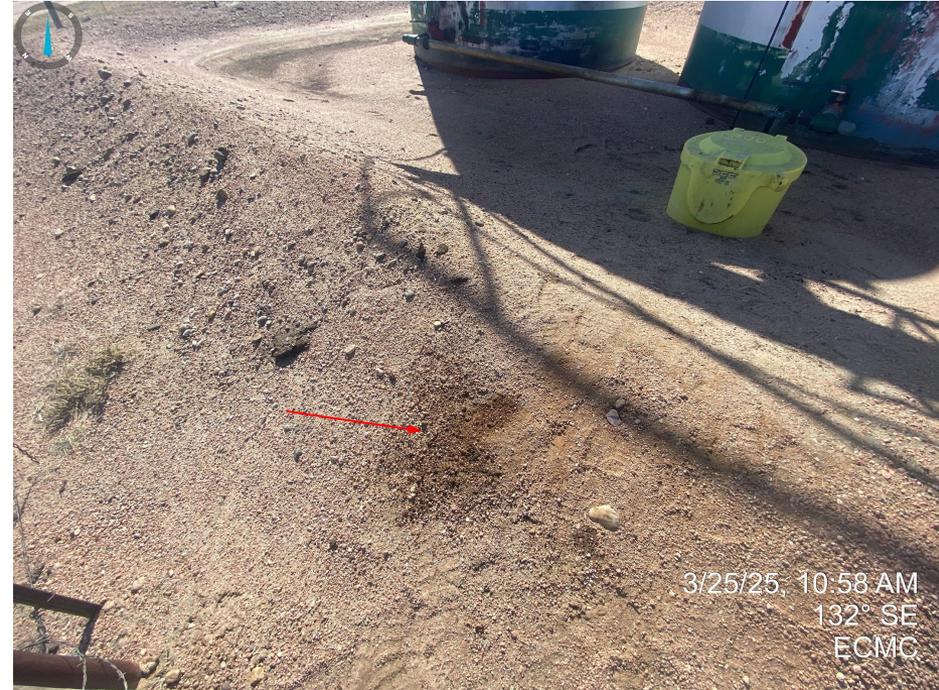
Photos 6 & 7. Stained soil observed near the tank battery.

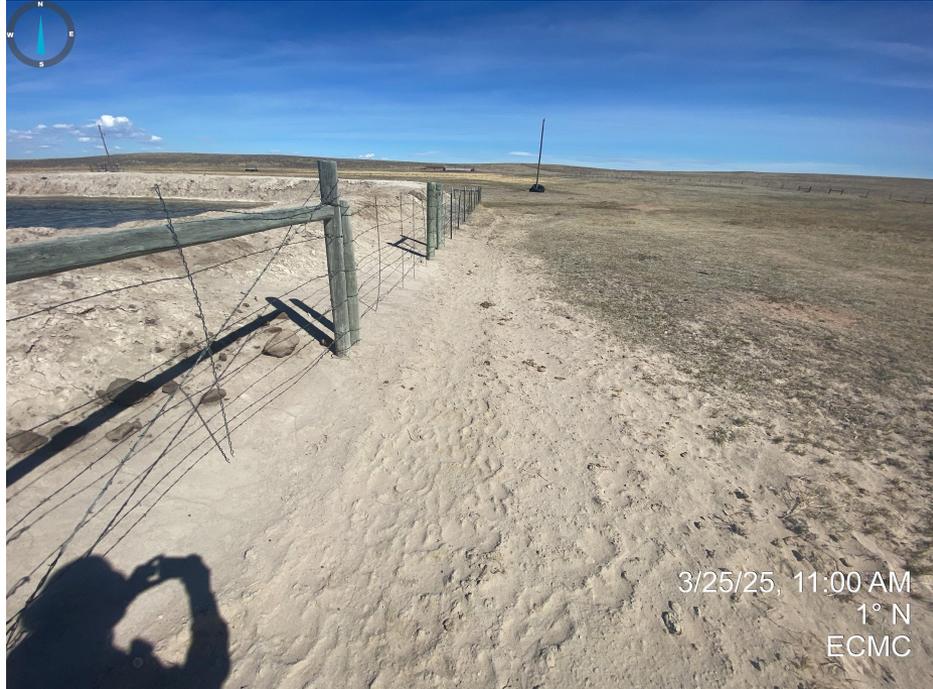
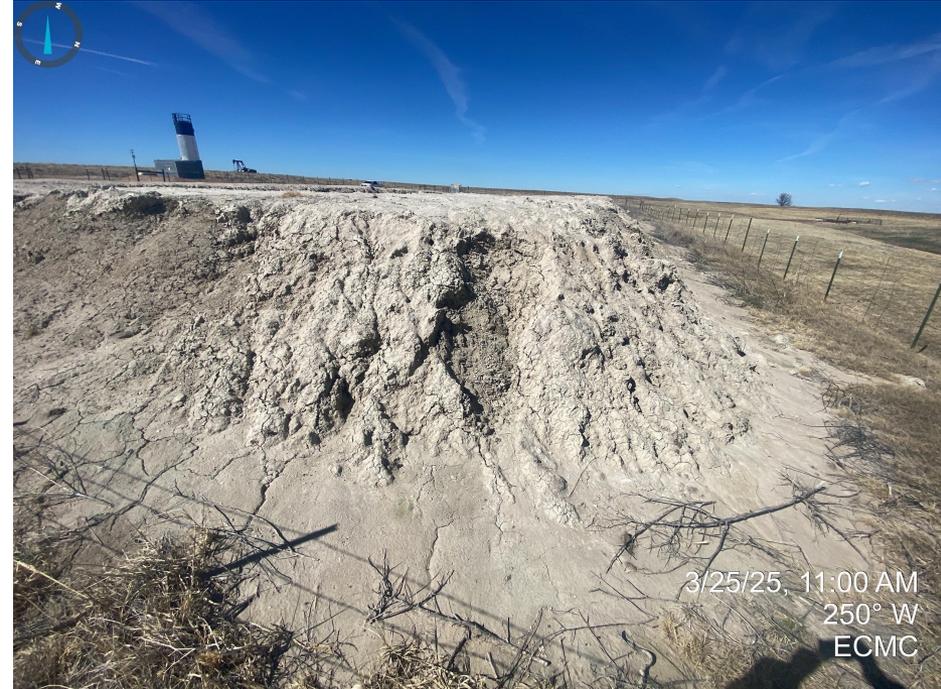
Photos 8 & 9. Erosion degradation and sediment transport observed on the eastern portion of the produced water pit.

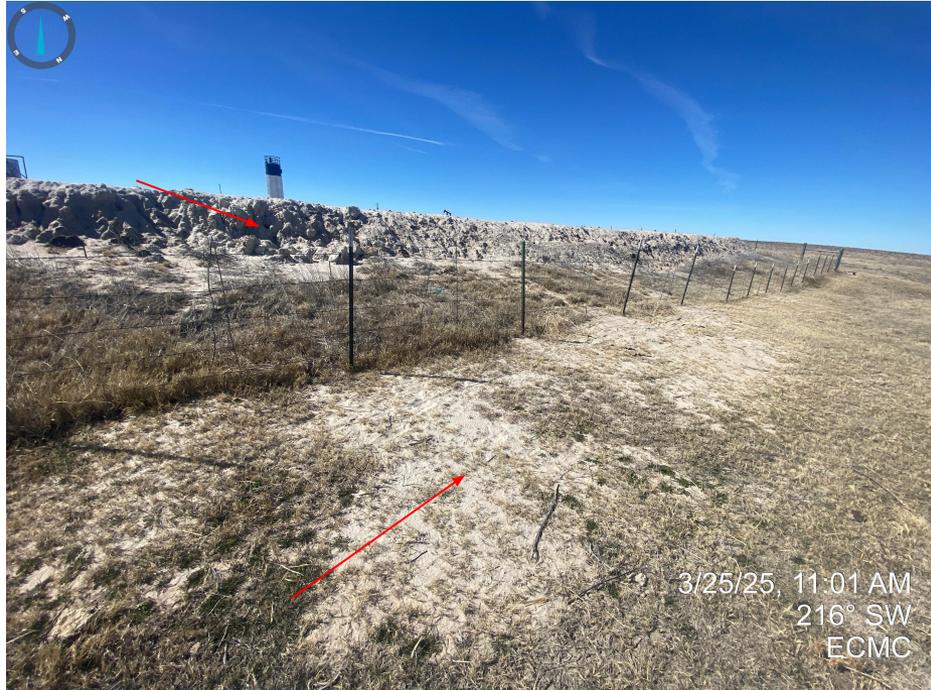
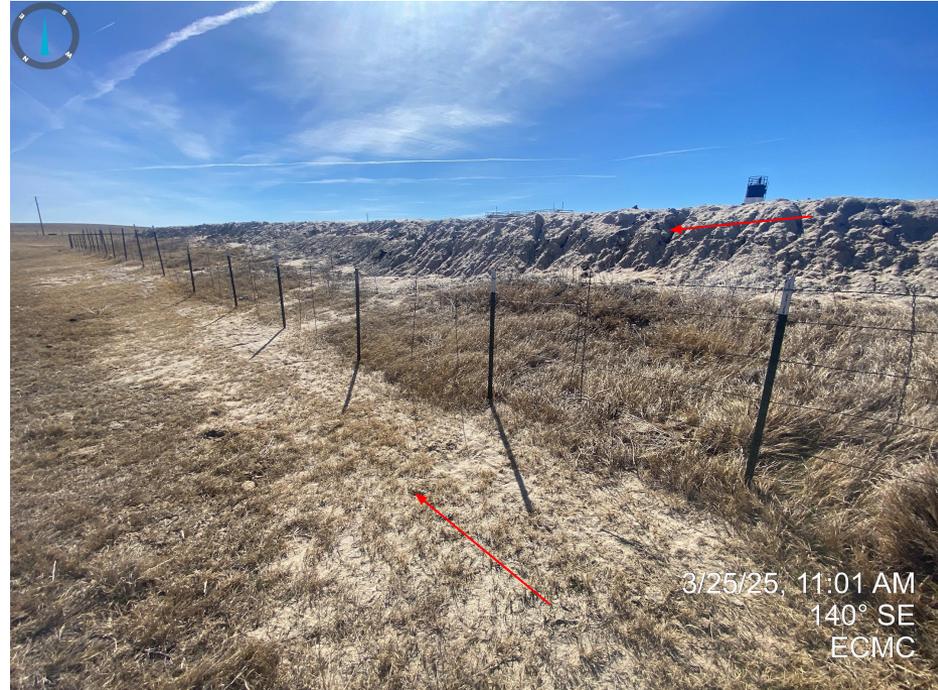
Photos 10 & 11. Erosion degradation and sediment transport observed on the northern portion of the produced water pit.

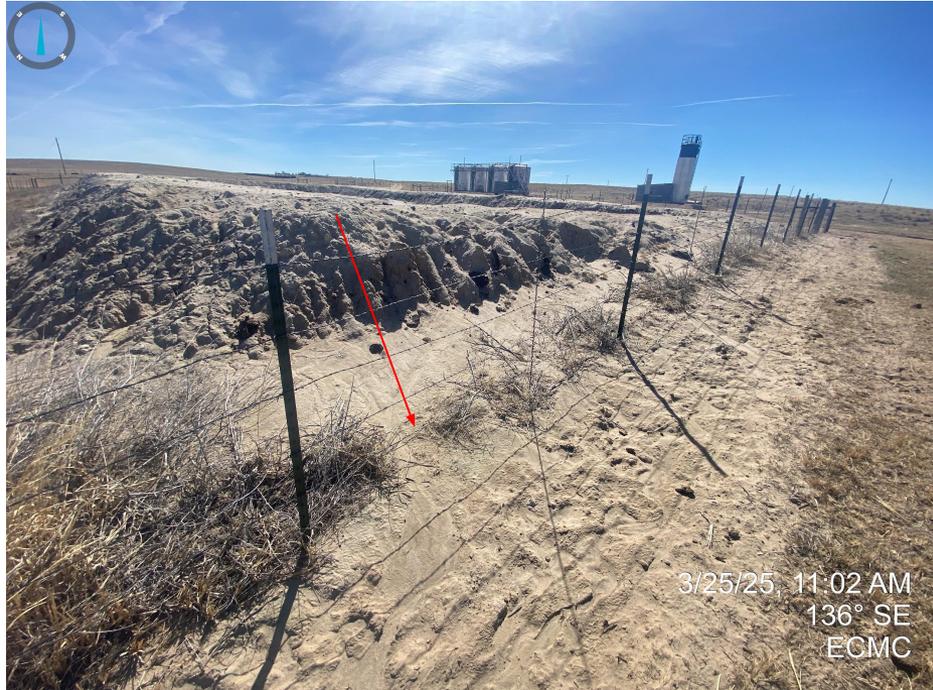
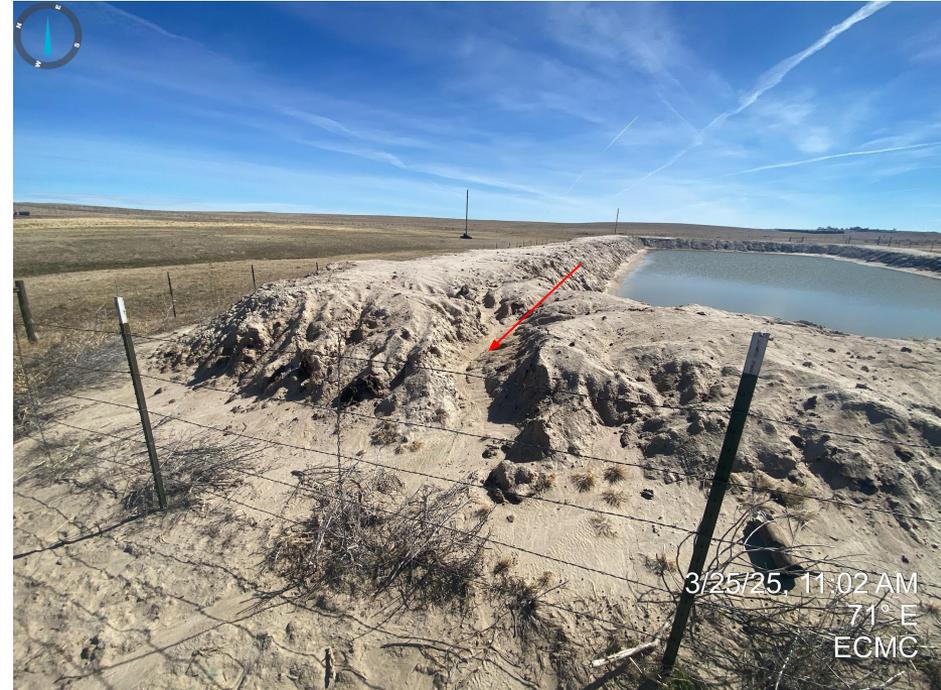
Photos 12 & 13. Erosion degradation and sediment transport observed on the western portion of the produced water pit.
