Final Reclamation and Stormwater Inspection

Location ID: 320128

Well Name: ANDERSON #5

Inspection Document #: 718600437

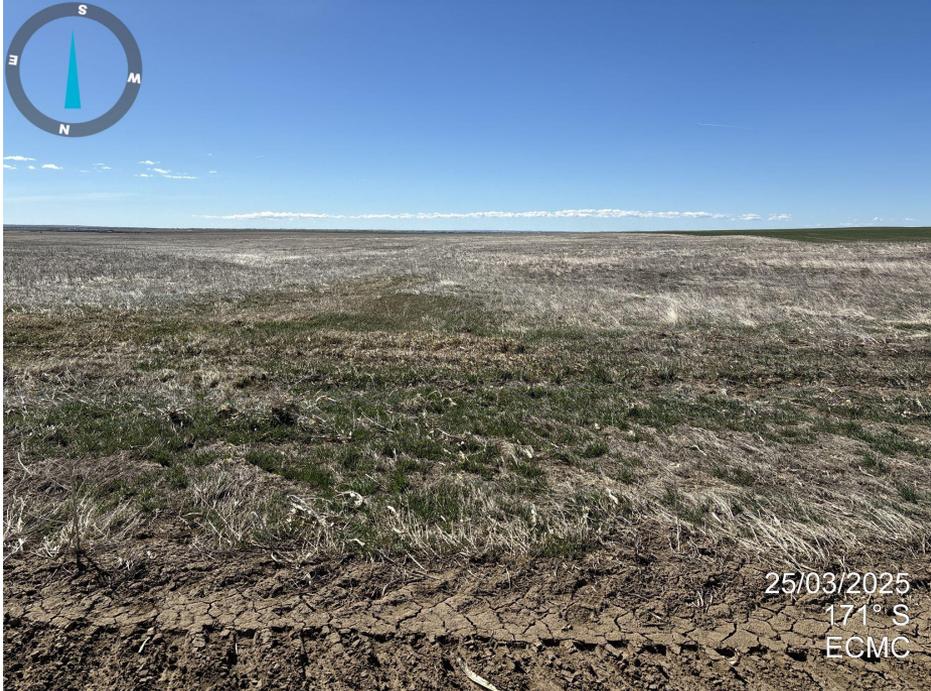
Photo 1. Looking south down the former access road. Oil and gas equipment has been removed. The northern portion of access road is primarily list C noxious weed Downy Brome. Some desirable vegetation is beginning to establish on the access road.

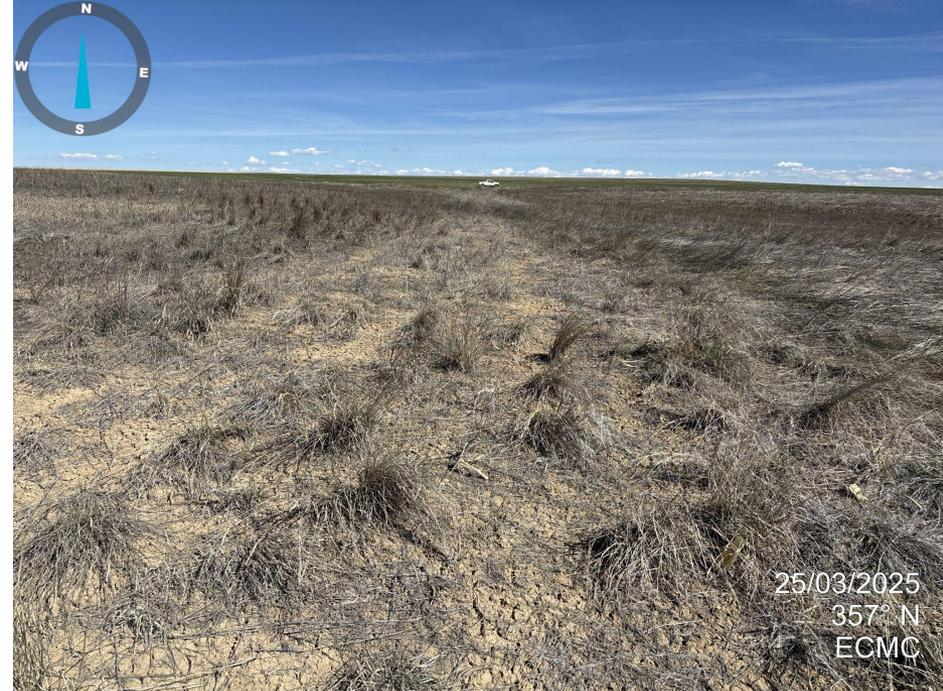
Photo 2. Access road near the well location looking north. An area with less vegetation than surrounding area. Desirable vegetation appears to be progressing towards 80% coverage.

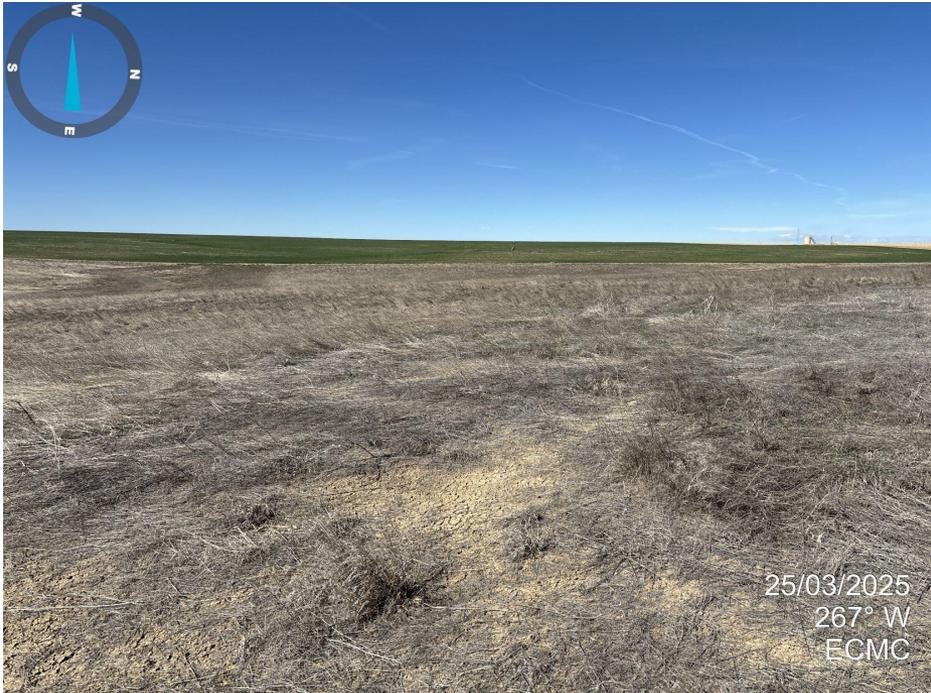
Photo 3. Looking west across the wellsite. Well location has some bare spots and predominantly downy brome. There is some desirable vegetation present on location.

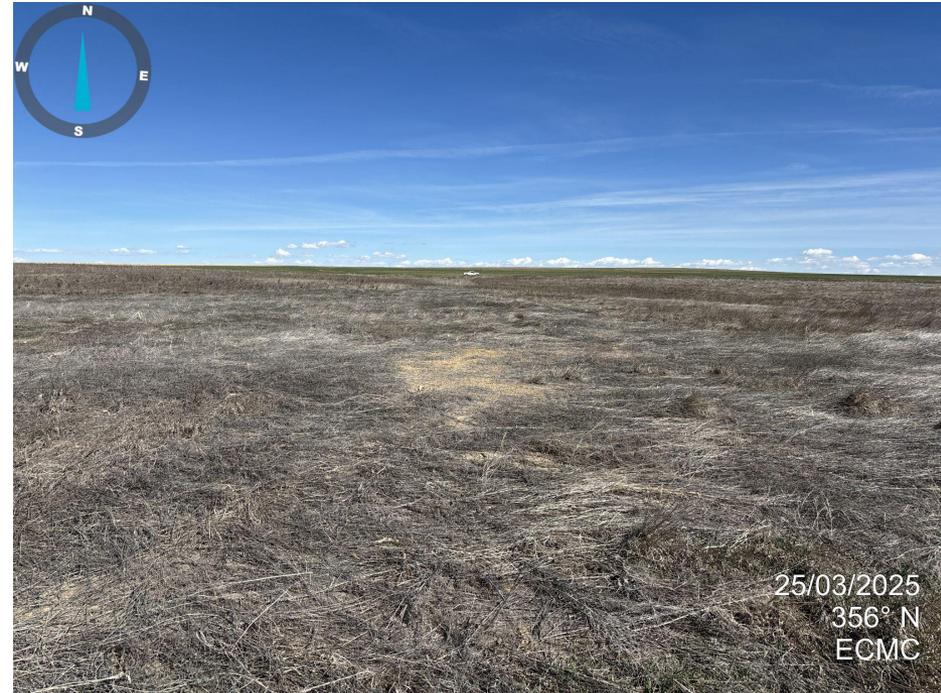
Photo 4. Looking north across location. No oil and gas equipment remains. Bare spot visible.

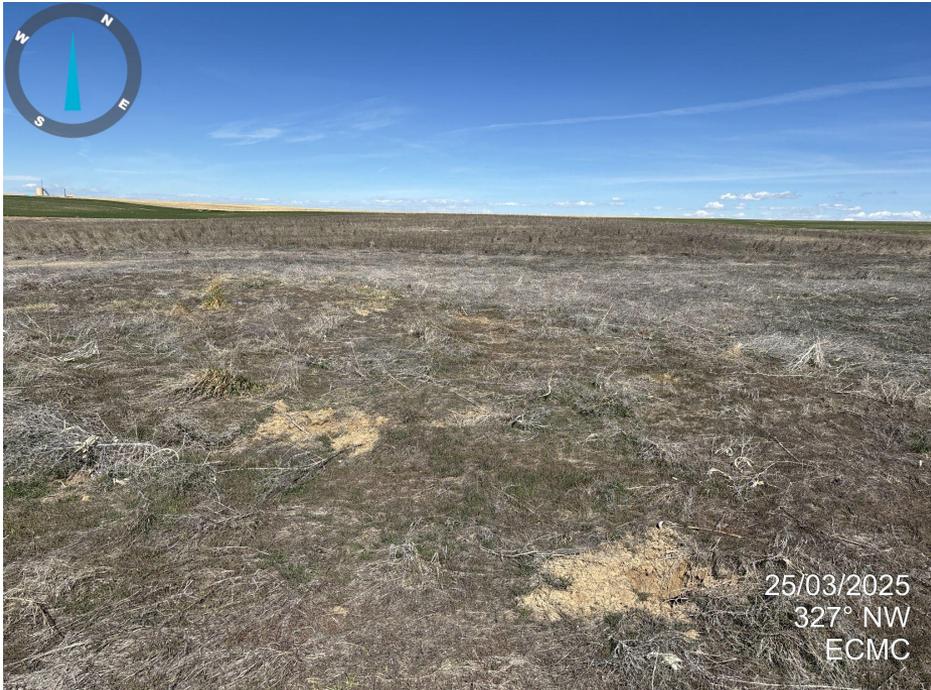
Photo 5. Looking northwest across wellbore. Primarily Downy Brome. Undesirable weed Kochia is present on location. Some desirable vegetation has established on location.

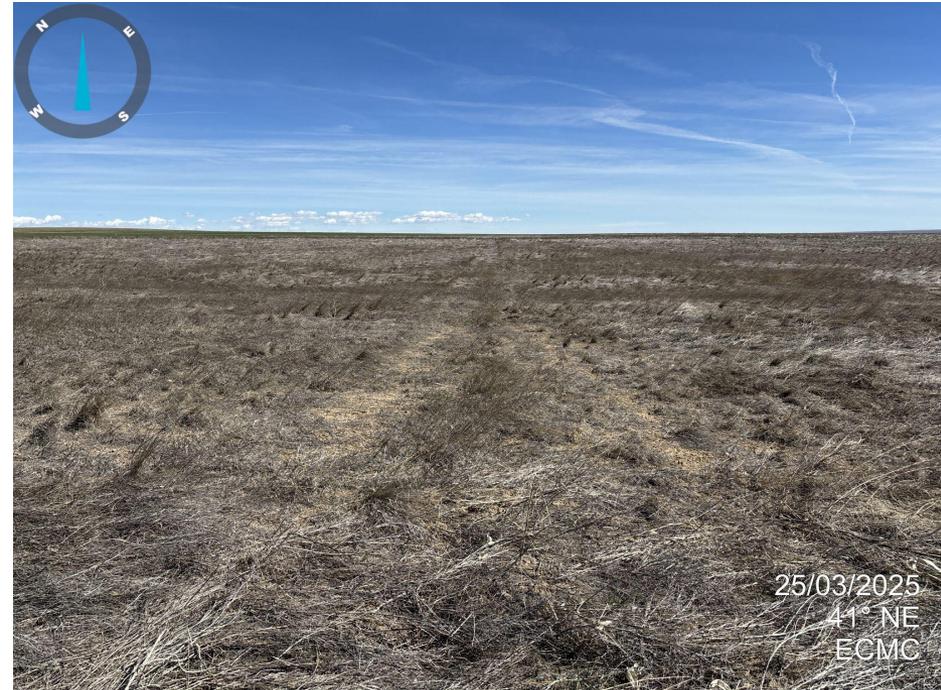
Photo 6. Looking northeast down two track towards flowline joint/ spill #445184. Desirable vegetation appears to be progressing on two track.

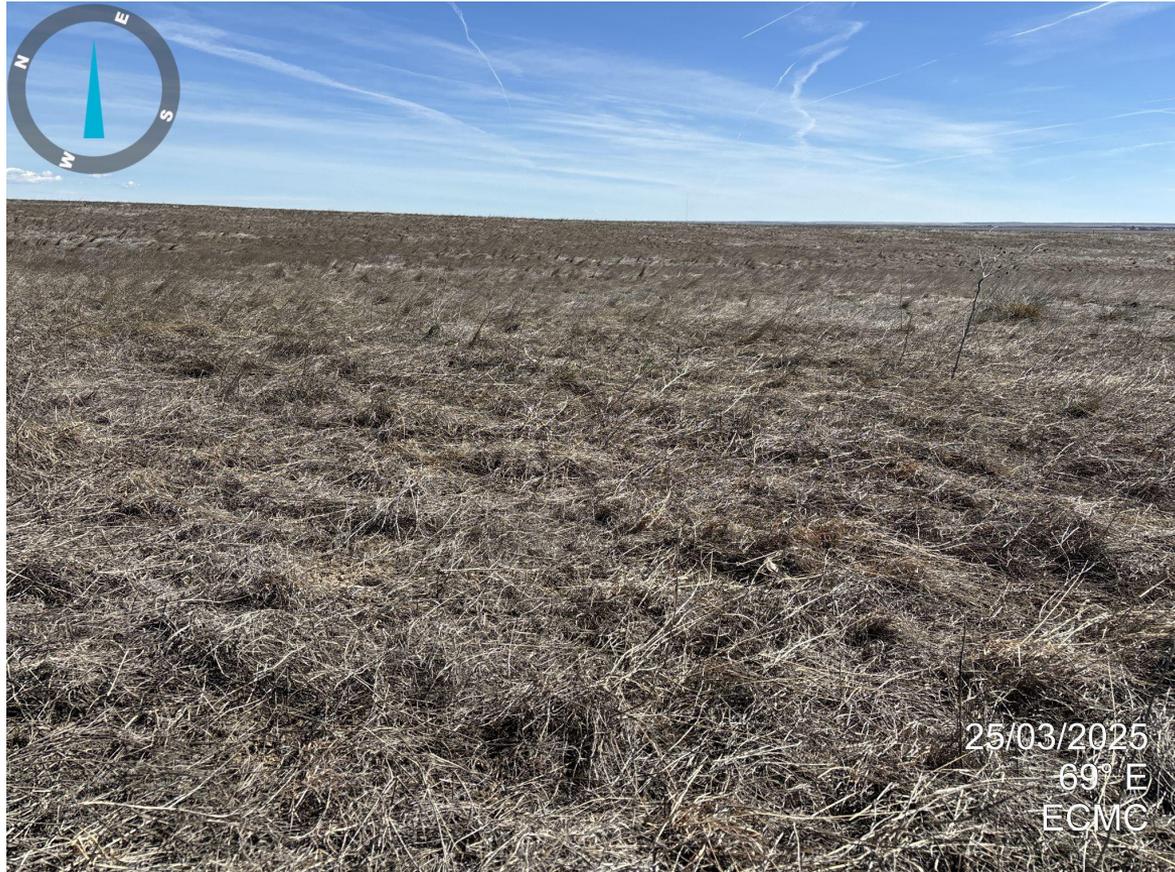
Photo 7. Reference vegetation to the east of well location.
