# Construction and Stormwater Inspection

March 28, 2025

Operator: CRESTONE PEAK RESOURCES OPERATING LLC

Location Name: Aspen 3-65/15-14 South

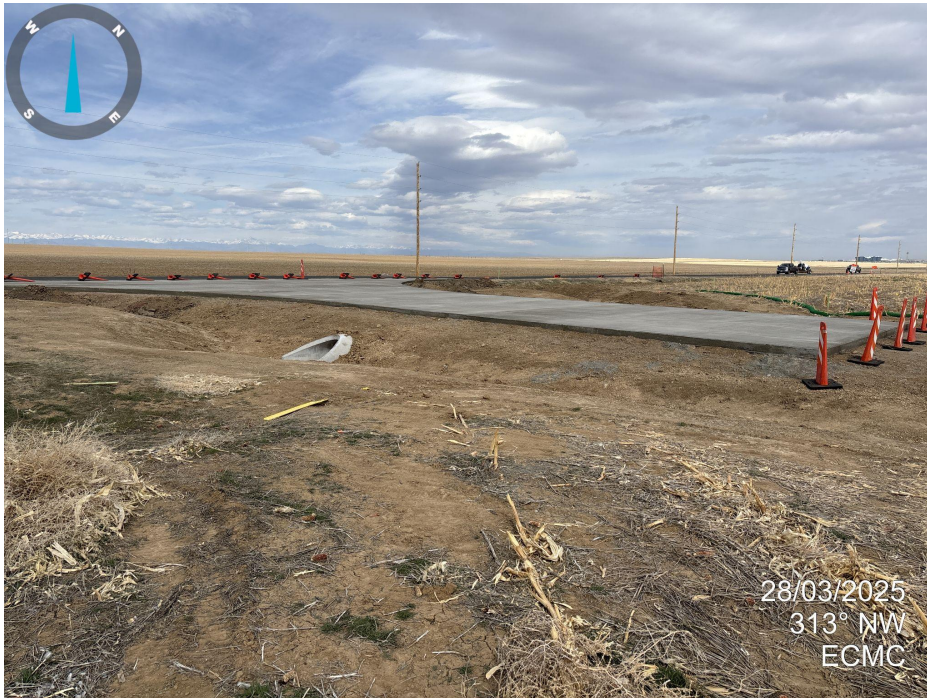
**Photo 1.** Concrete apron and culvert installed at access road entrance. Cones are in place at time of inspection blocking road.

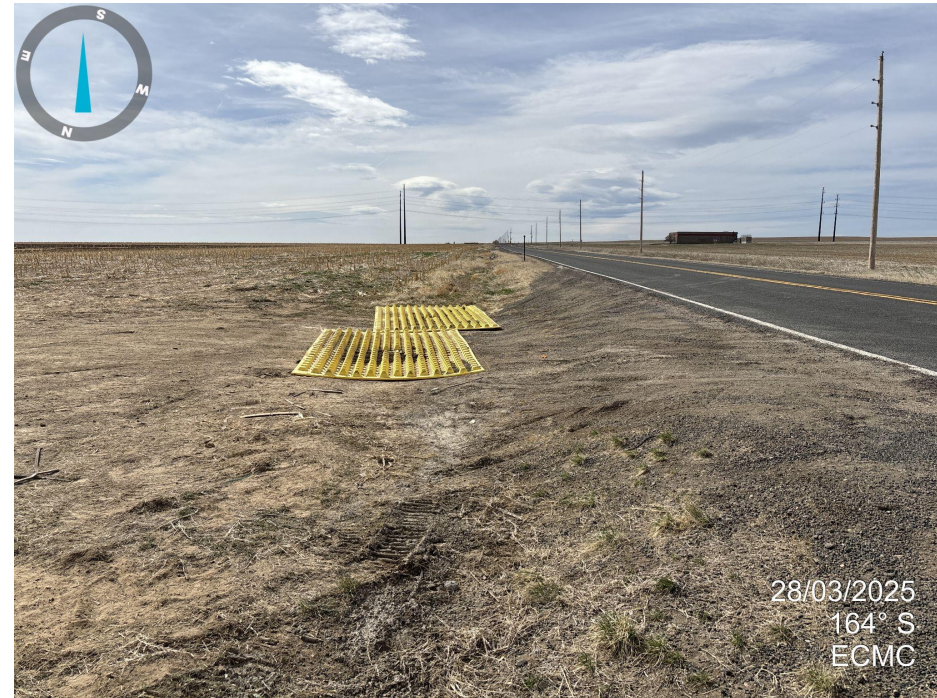
**Photo 2.** Secondary entrance located south of approved access road. Vehicle tracking BMP present. Reference photo 19.

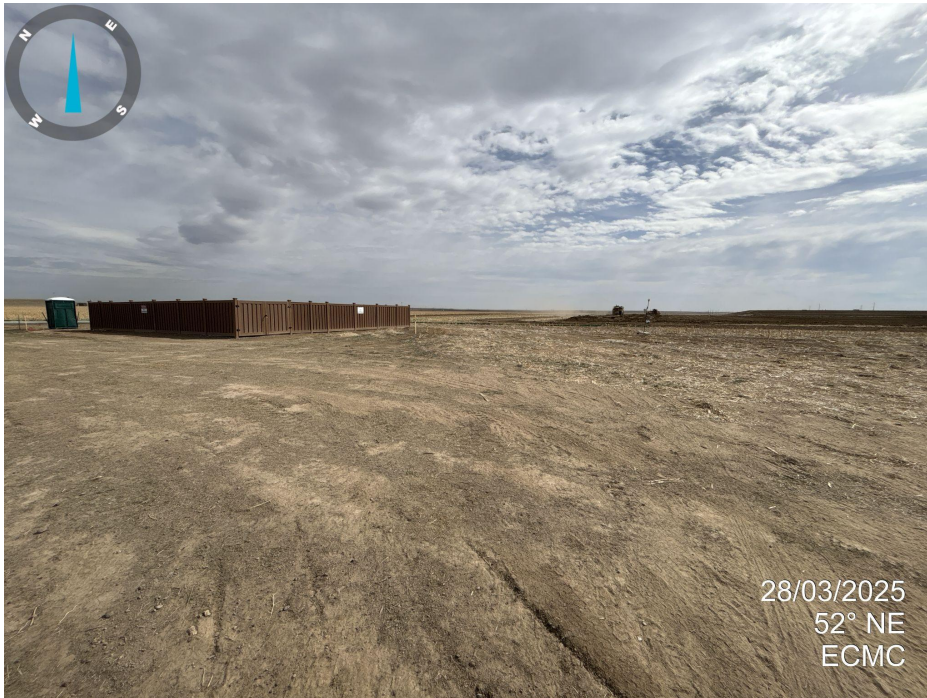
**Photo 3.** Looking north east from secondary entrance. Topsoil was not salvaged in this area. It appears vehicles have been driving/ parking on the topsoil in this area. Reference photo 19.

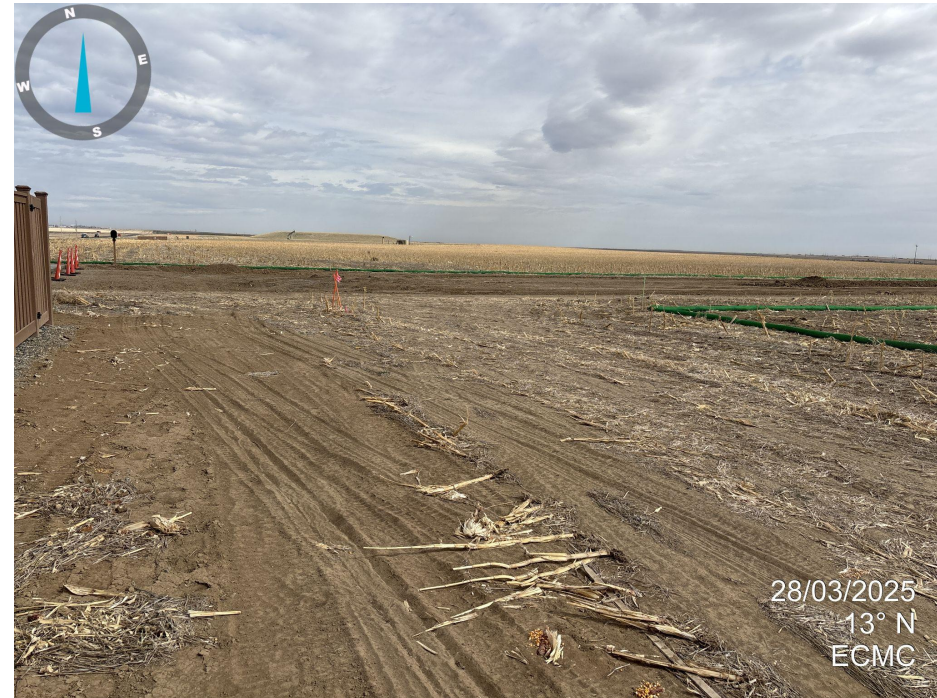
**Photo 4.** Looking north down southern unapproved access road. See photo 3 comments. Reference photo 19.

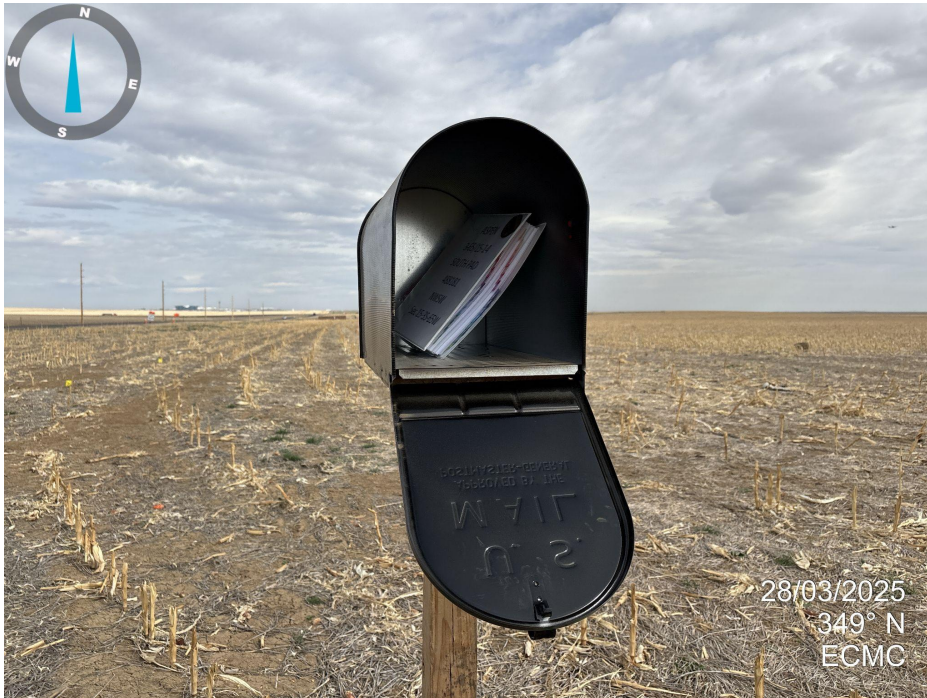
**Photo 5.** Form 2A is present on location.

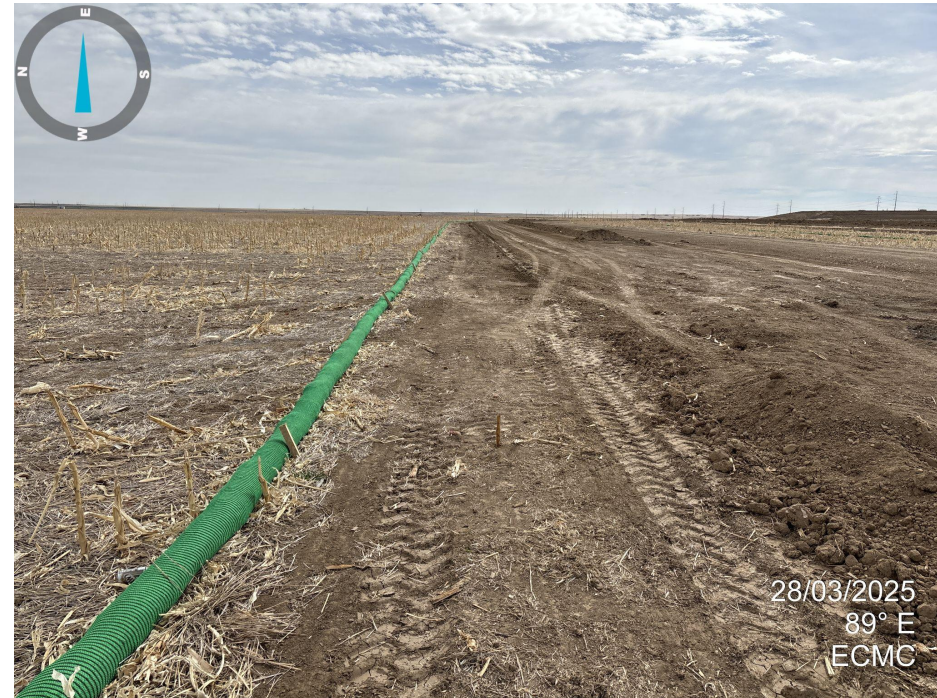
**Photo 6.** Filtrex installed on both sides of access road and around portion of the outer limits of disturbance of location. Access road appears to be graded with a ditch present on the southern side.

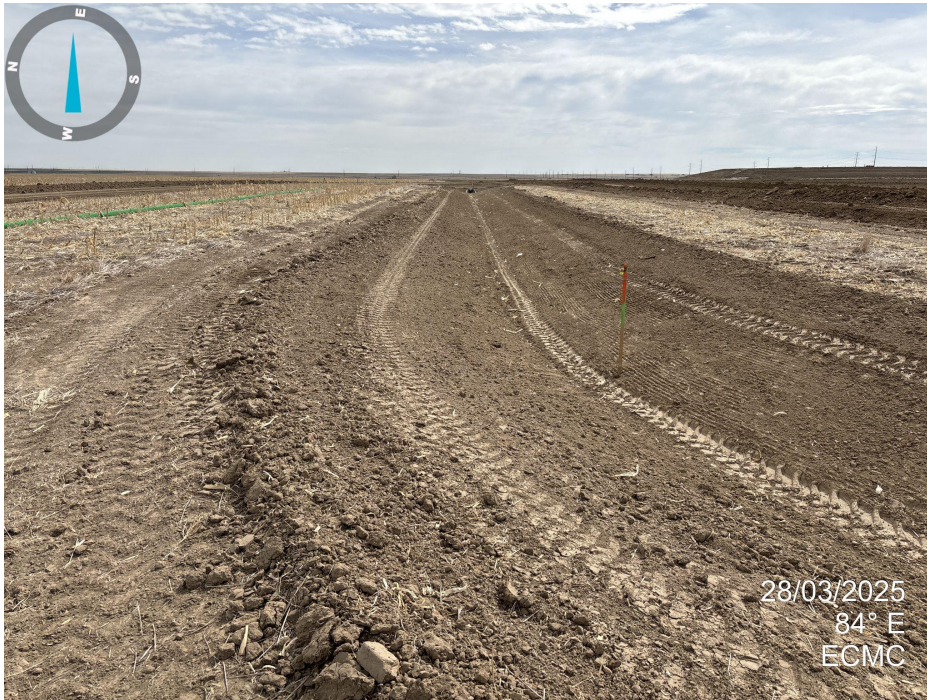
**Photo 7.** Looking east down the northern pad perimeter ditch. Ditch appears to have been compacted and tracked.

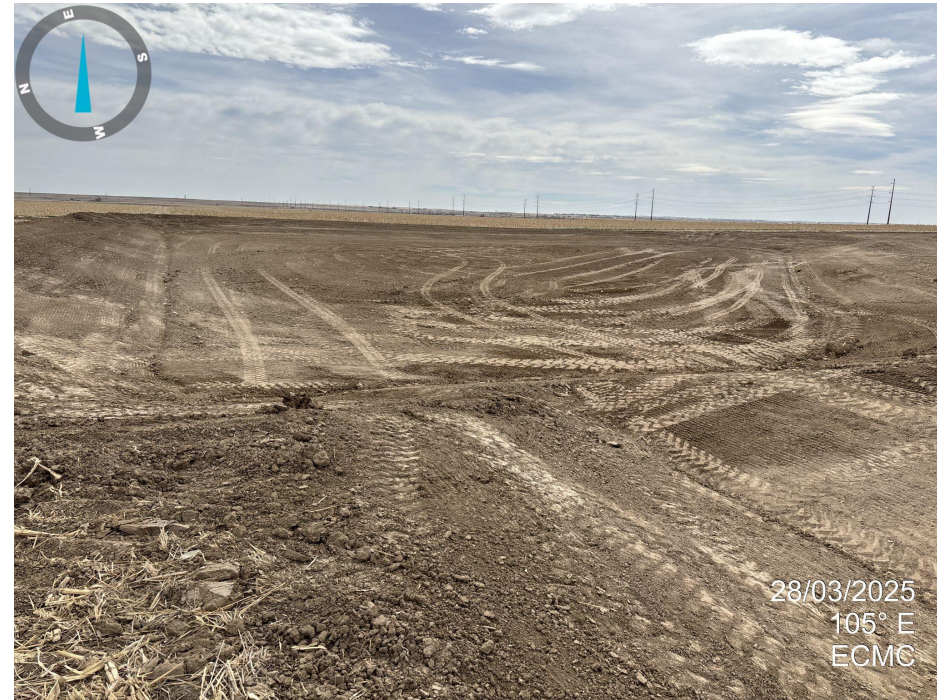
**Photo 8.** Retention pond located in the northeast corner.

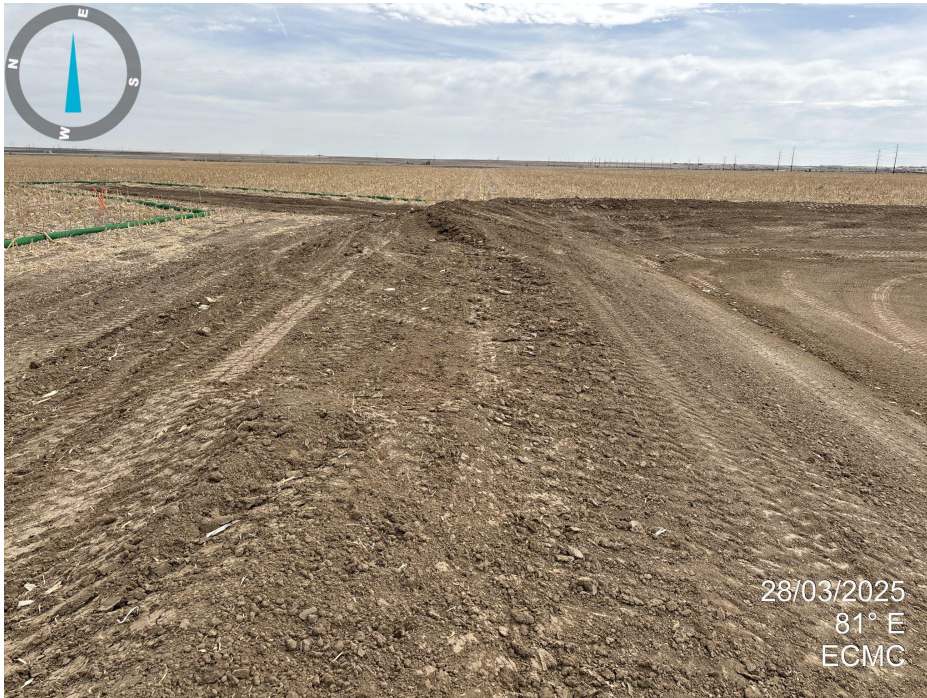
**Photo 9.** Retention pond outflow area, leading to perimeter ditch.

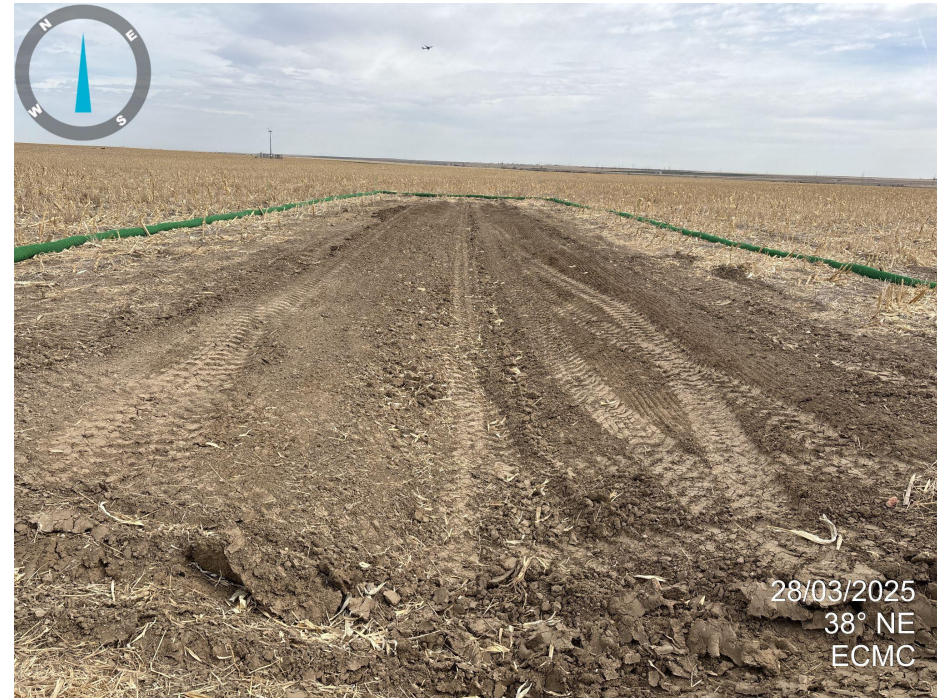
**Photo 10.** Looking northeast away from location. Perimeter ditch/ outflow.

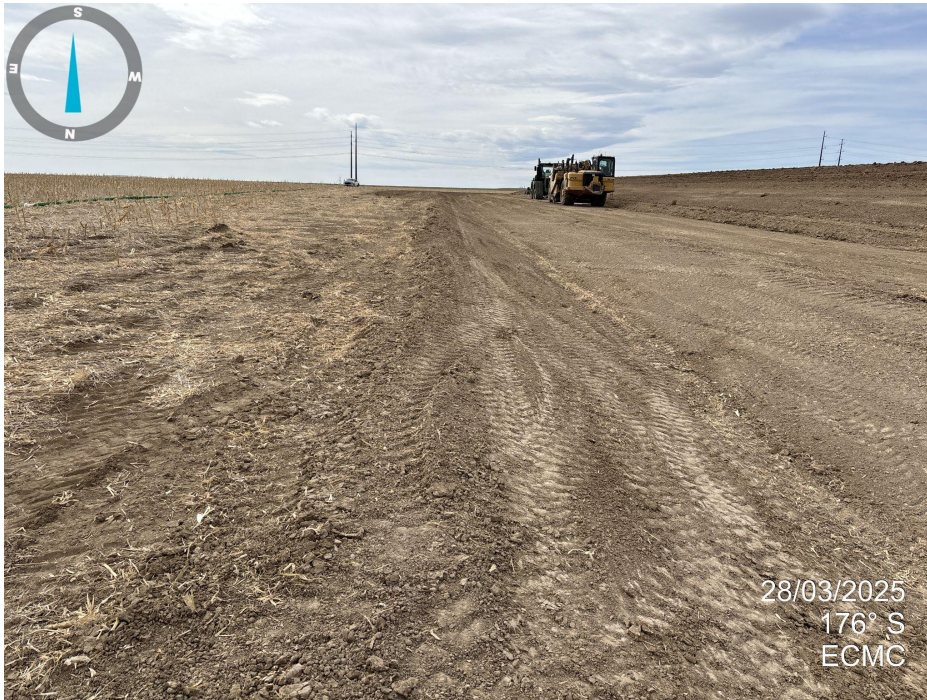
**Photo 11.** Looking south along the east side of location. The ditch is along the perimeter of disturbance area to the east of the topsoil stockpile. The area between the ditch and topsoil stockpile does not indicate topsoil was salvaged in the topsoil plan. Reference photo 19.

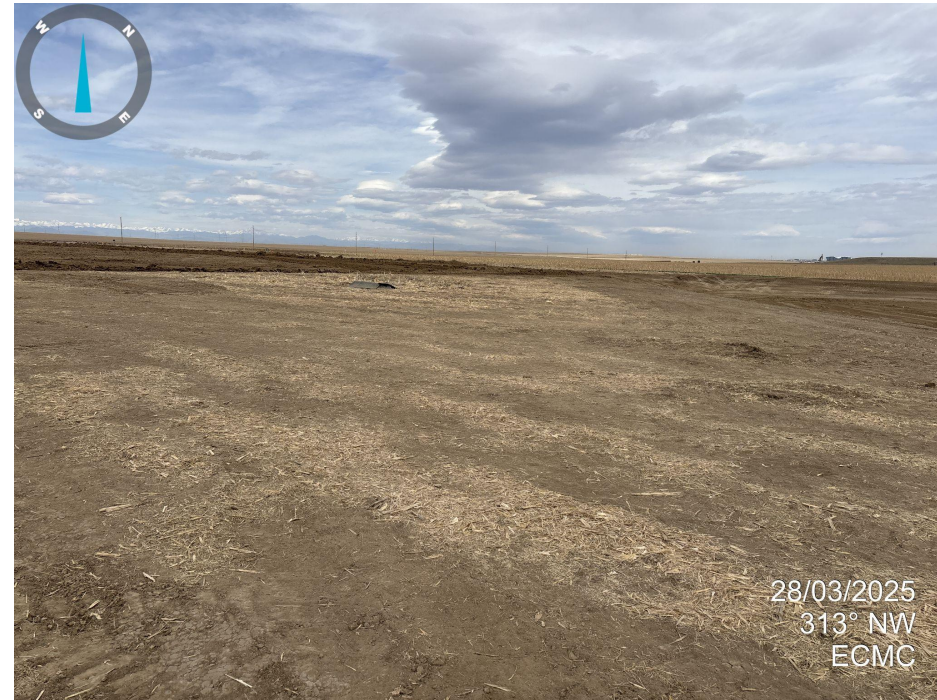
**Photo 12.** Picture taken in the northeast corner looking northwest near the retention basin. Topsoil does not appear to have been salvaged in this area and it appears that there is vehicle traffic in this area. Reference photo 19.

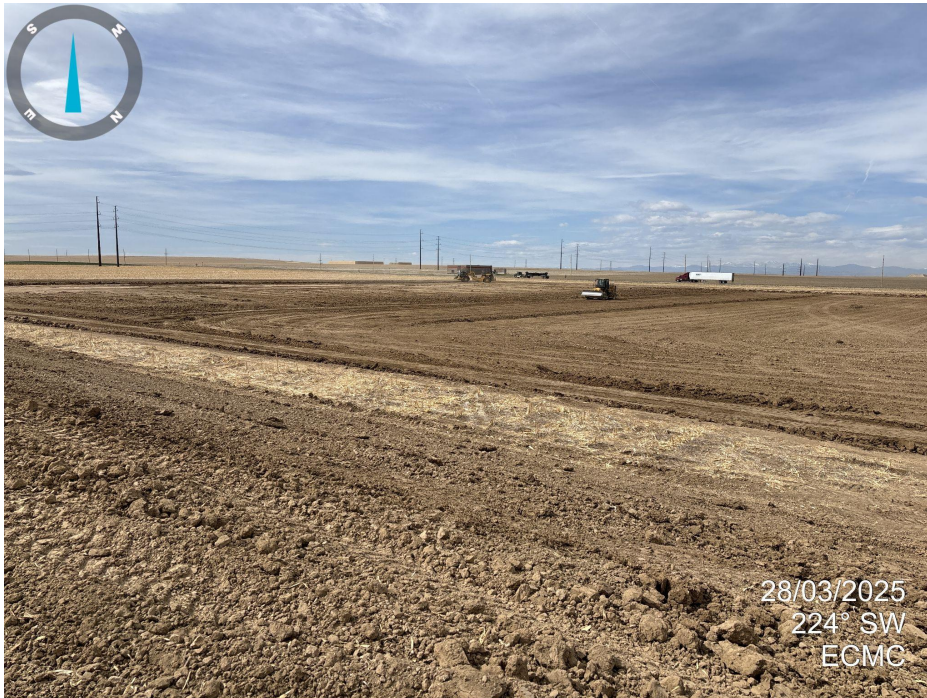
**Photo 13.** Looking southwest across location from the topsoil stockpile. At time of inspection it appears that topsoil had been salvaged from pad and the pad was being graded.

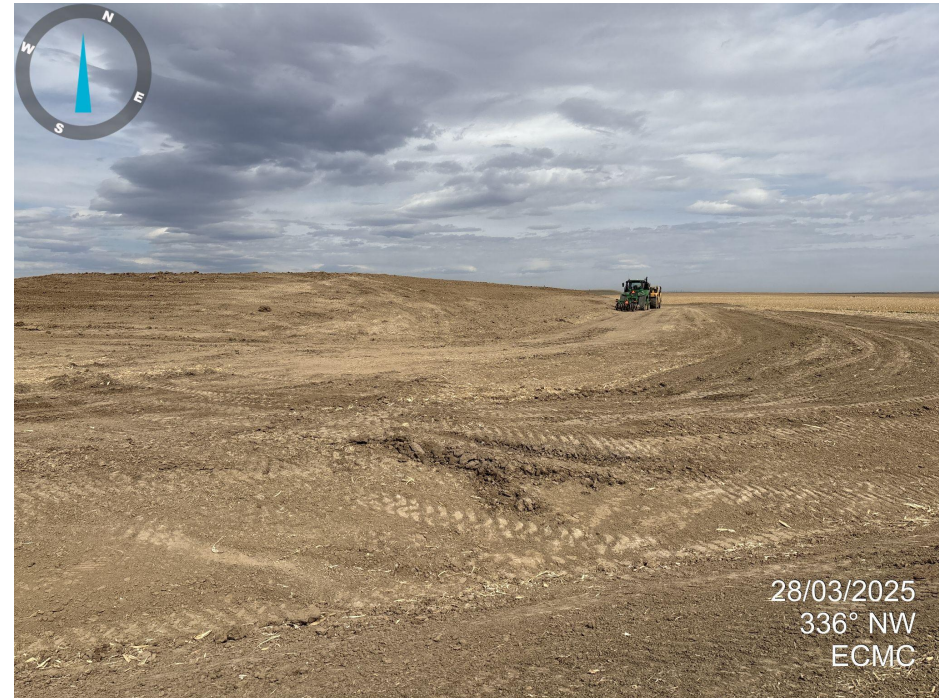
**Photo 14.** Looking north down east side of location. Illustrating topsoil stockpile.

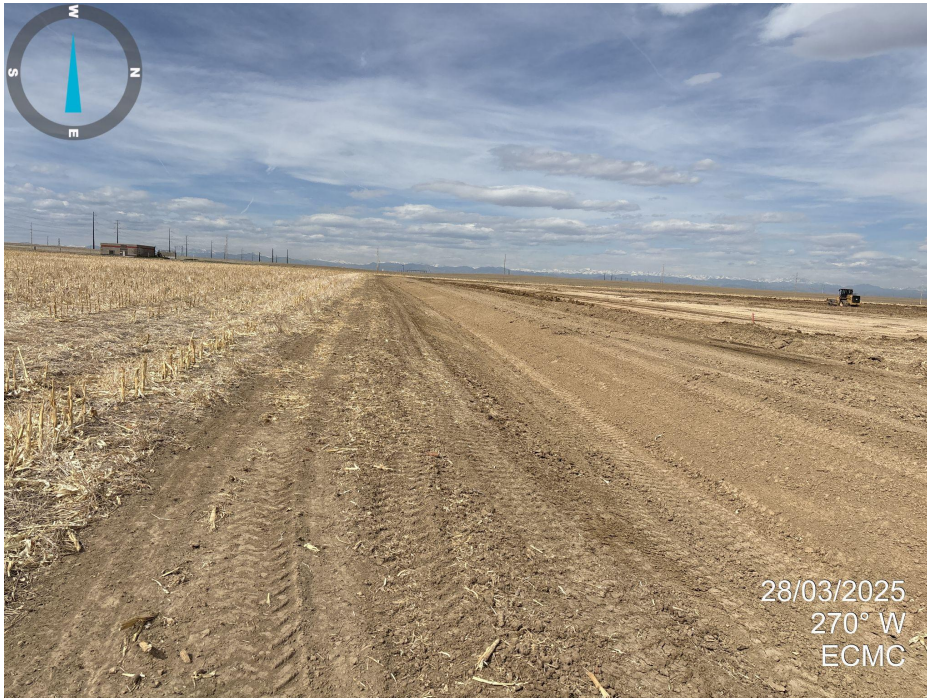
**Photo 15.** Looking west down south side perimeter ditch.

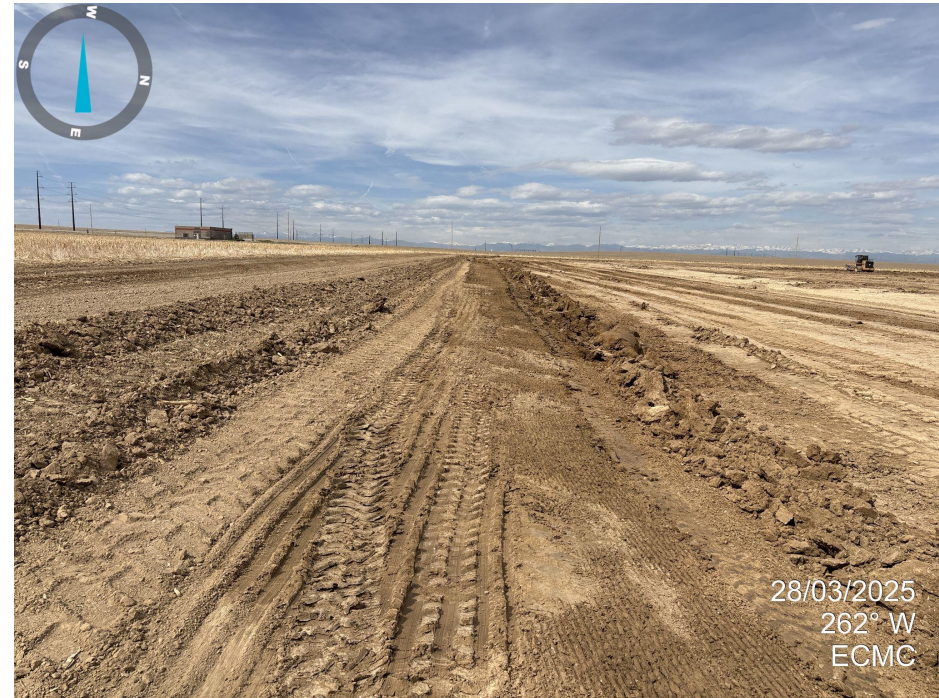
**Photo 16.** Looking west down the area between perimeter ditch and pad. It appears approximately 11 inches of topsoil was salvaged.

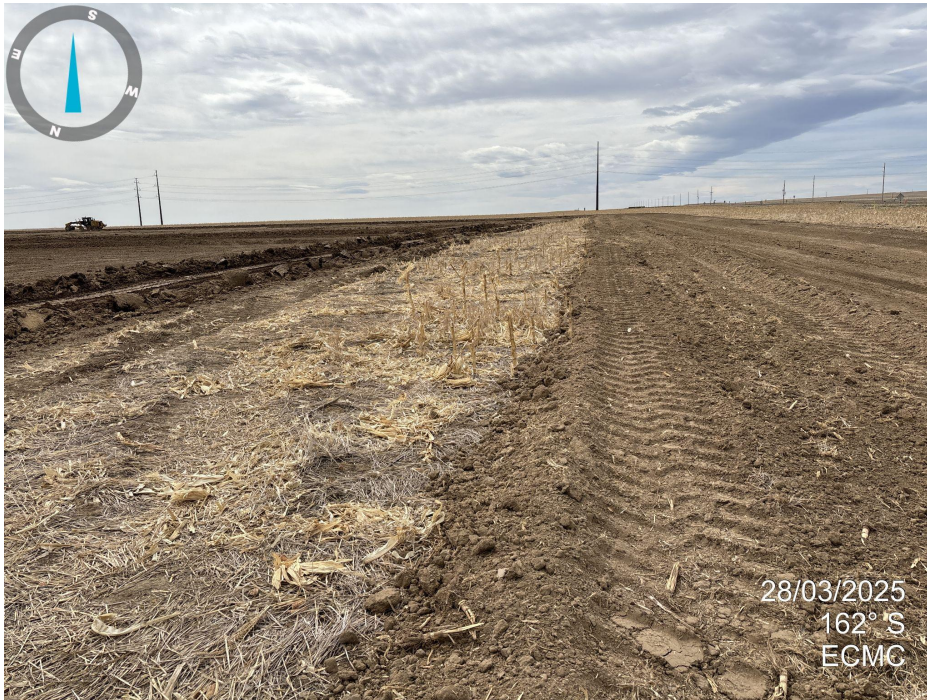
**Photo 17.** Looking south down the west side of location. Perimeter ditch has been constructed. Topsoil remains in the area between the perimeter ditch and pad edge.

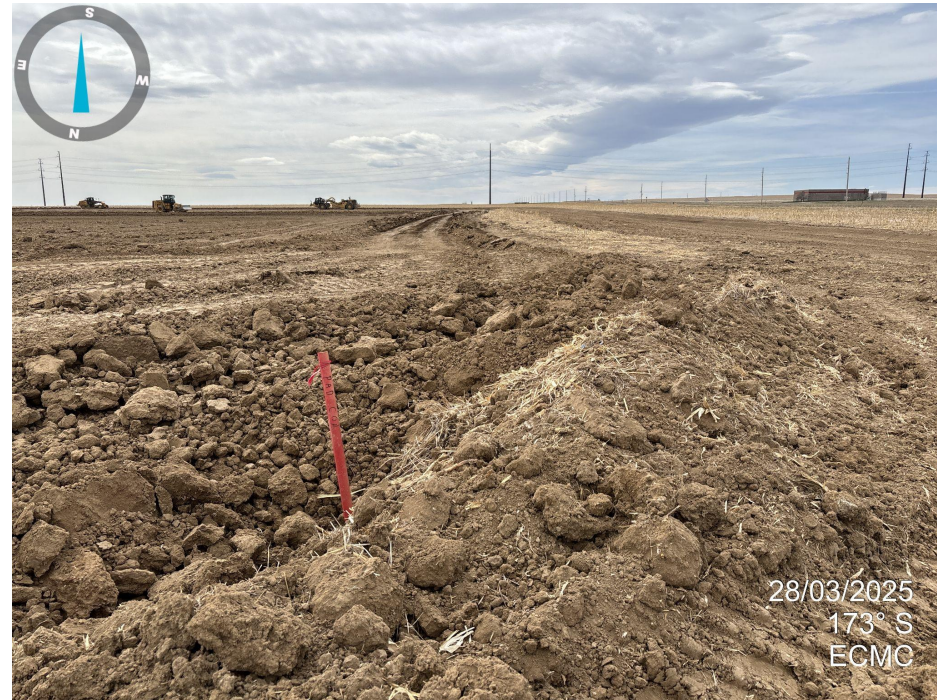
**Photo 18.** Looking south along the west side of pad.

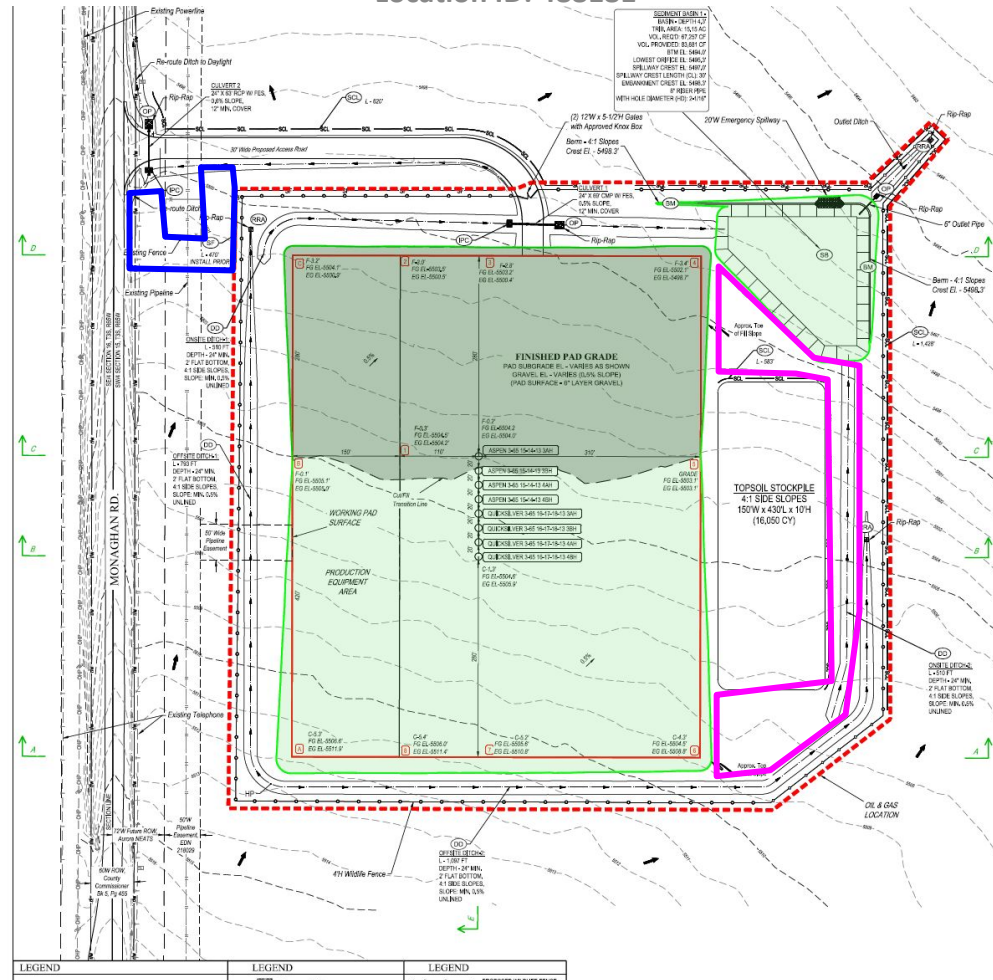
**Photo 19.** Unapproved south access road (blue). Area where topsoil was not salvaged and vehicle traffic/ disturbance is present (pink).
