Interim Reclamation and Stormwater Inspection

Date: 04/01/2025

Operator: MDS ENERGY DEVELOPMENT LLC - 10814

Location ID: 477495

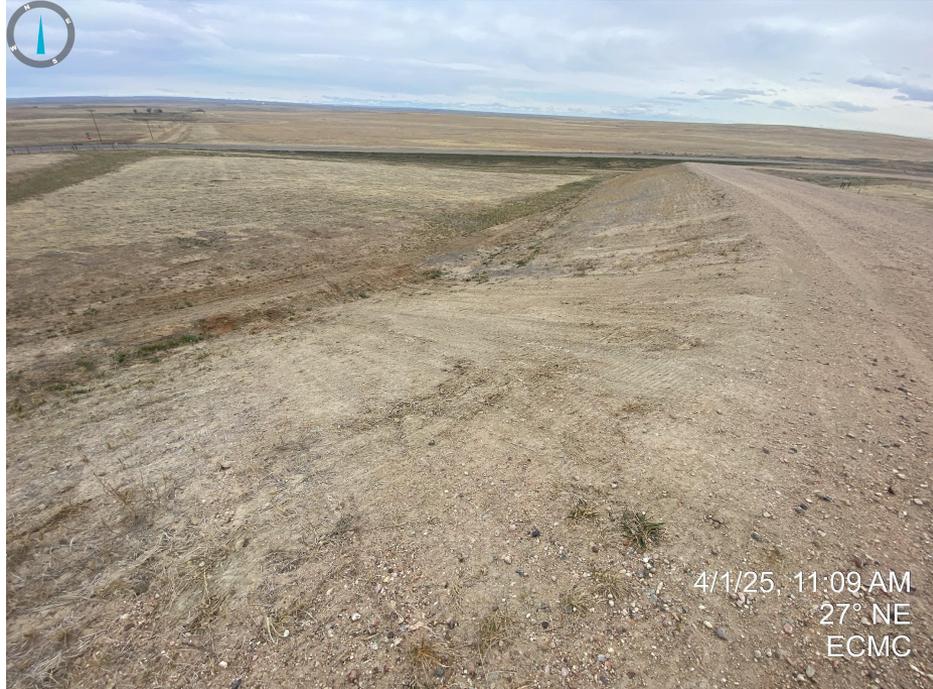
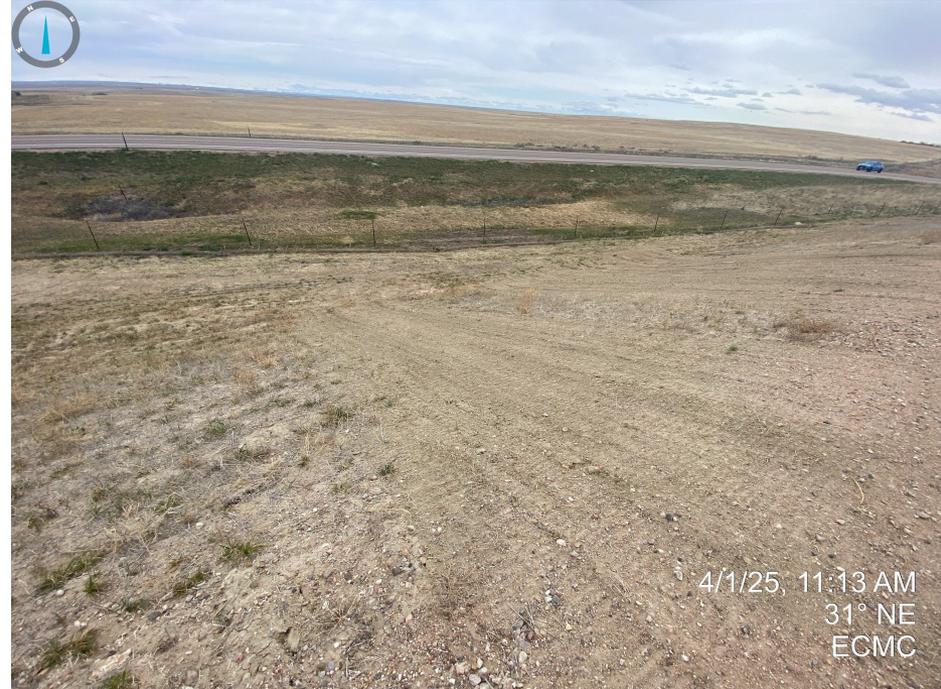
Photos 1 & 2. Erosion degradation previously observed along the access road appears to have been repaired.

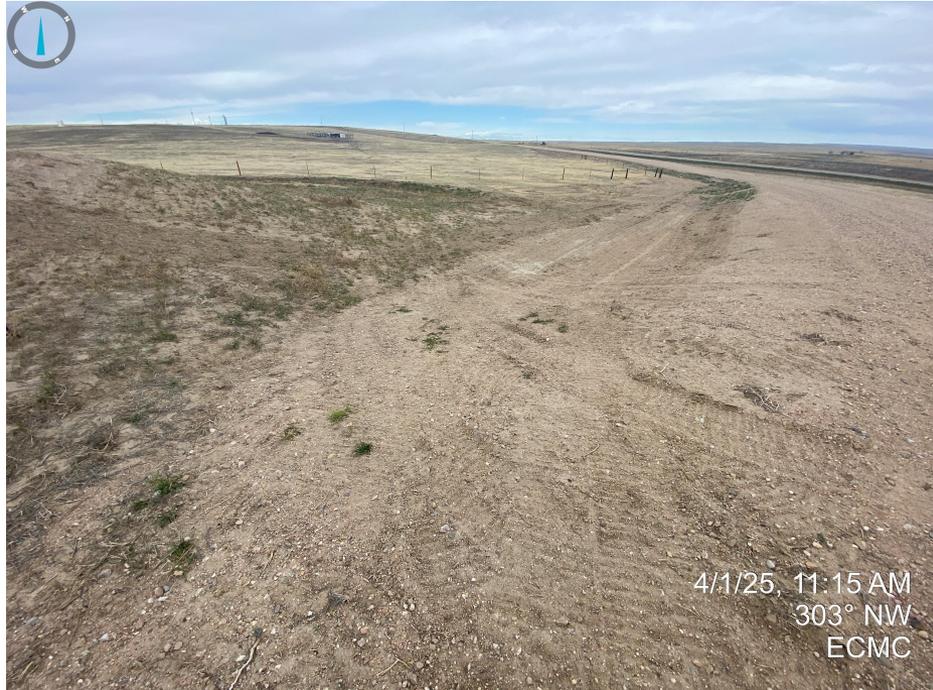
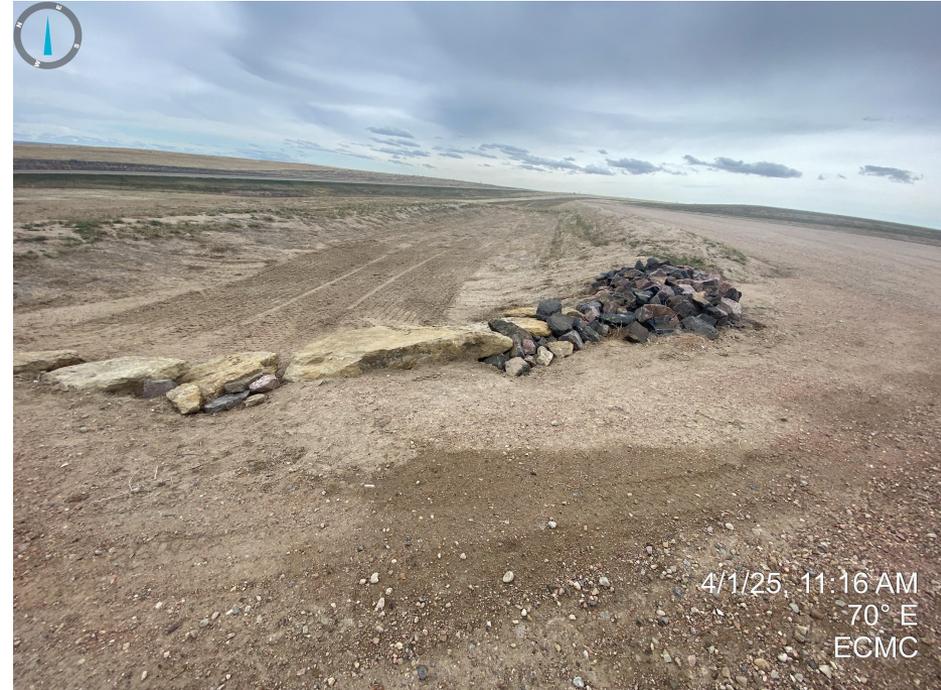
Photos 3 & 4. Erosion degradation previously observed near the drilling pad entrance appears to have been repaired.

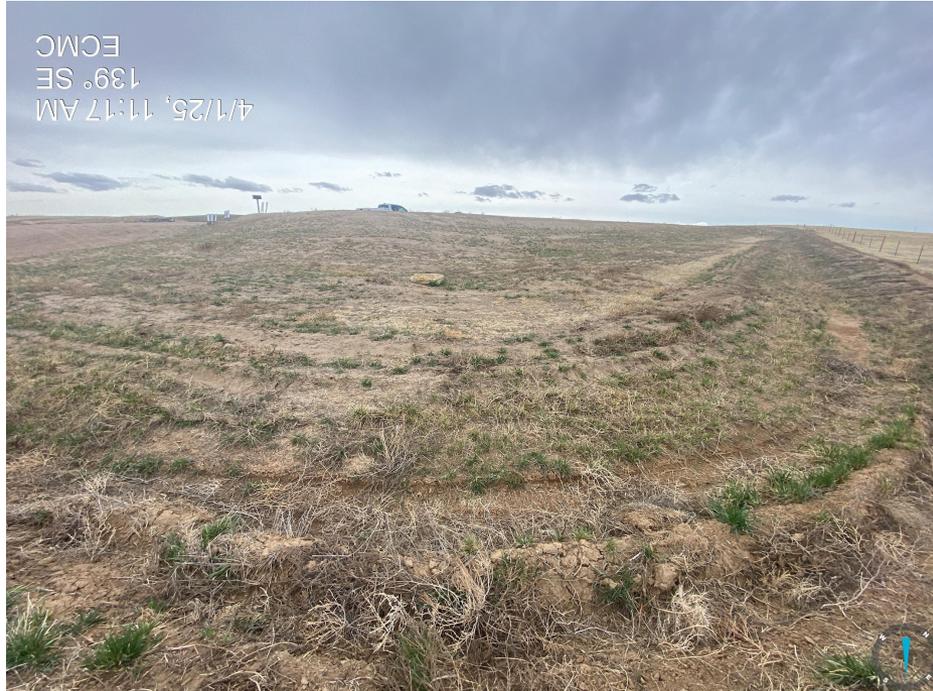
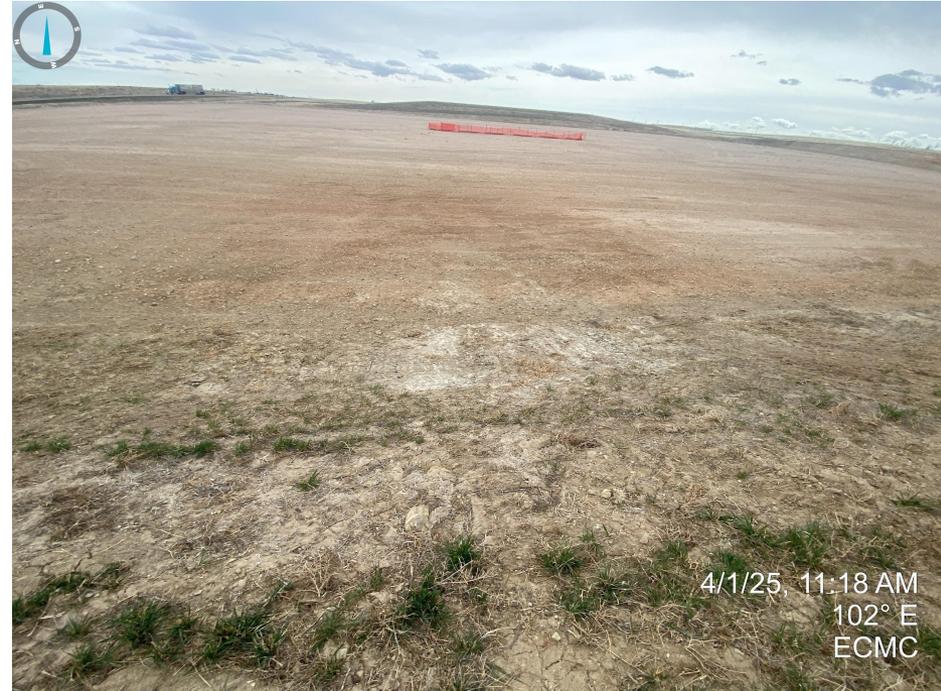
Photos 5 & 6. Photo 5 (left) taken from the northwest corner of the location, illustrating that undesirable vegetation previously observed, appears to have been managed for (e.g. mowed). Photo 6 (right) illustrates that concrete debris has been removed.

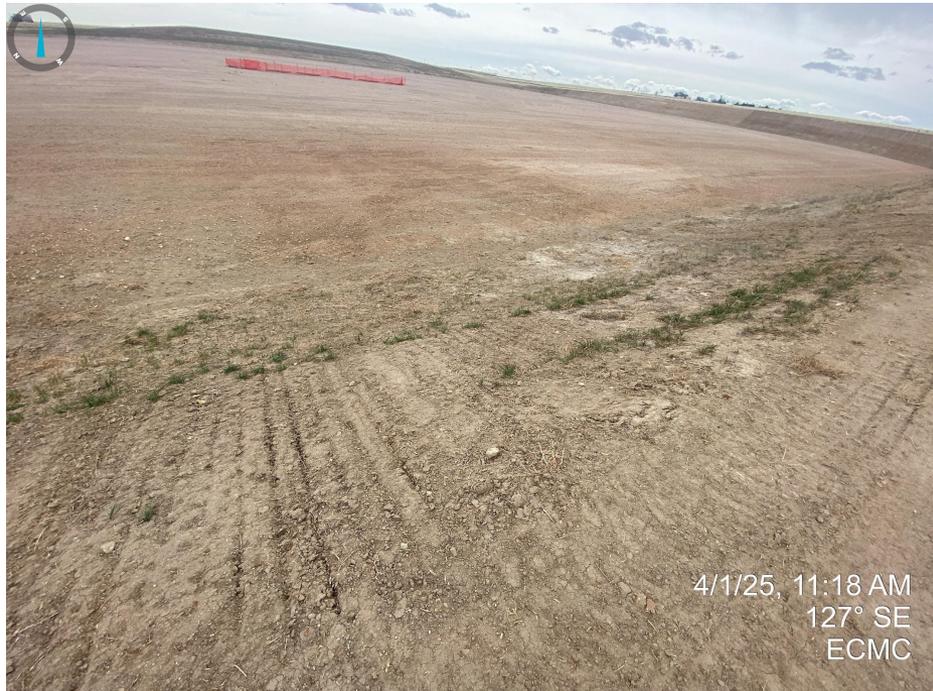
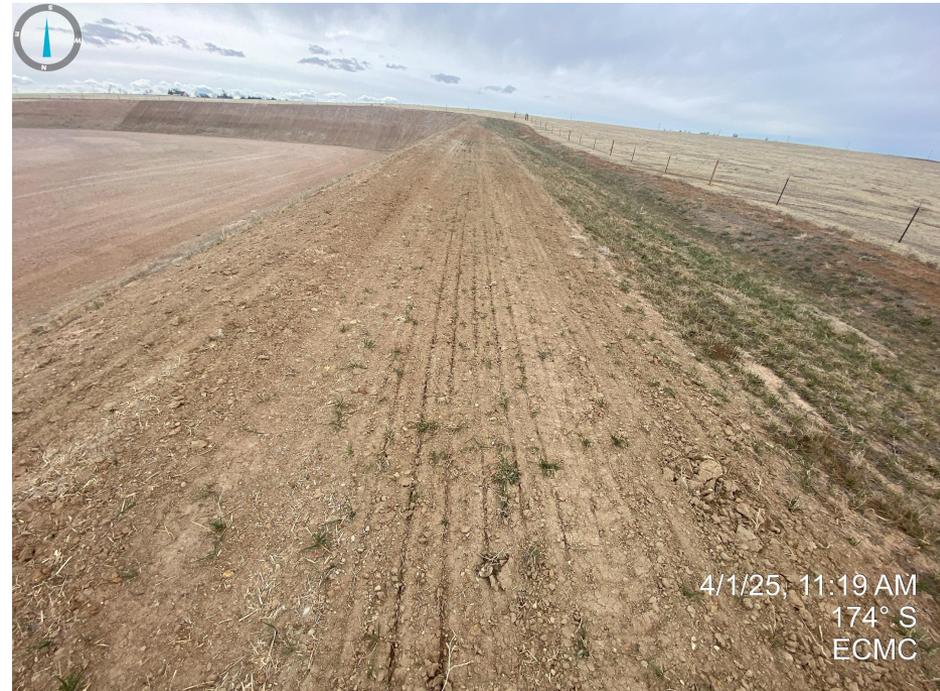
Photos 7 & 8. Taken from the western portion of the drilling pad. Photos illustrate that bare soils appeared to have been seeded for stabilization.

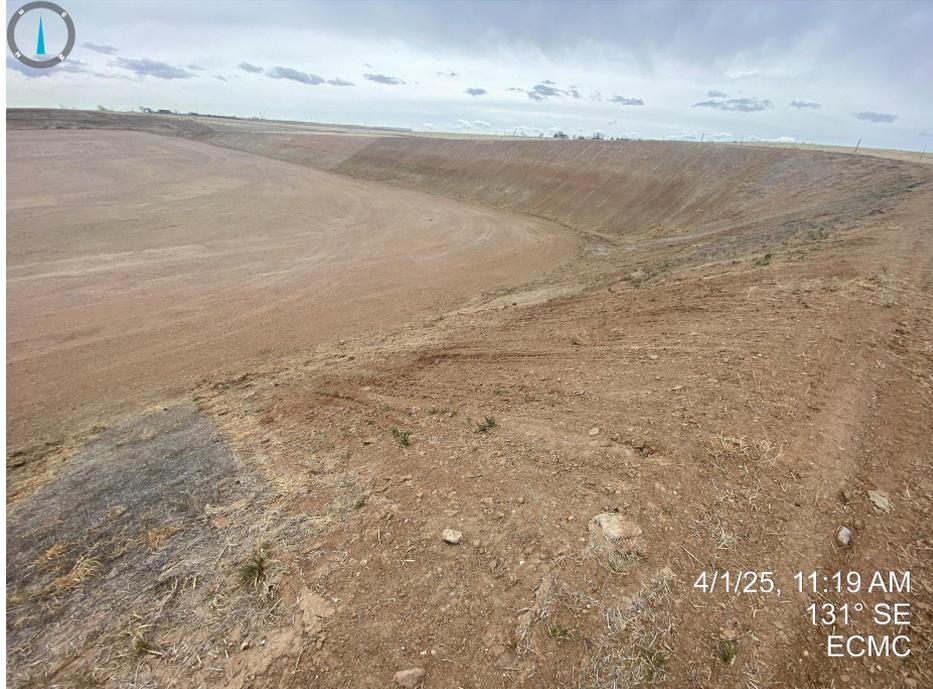
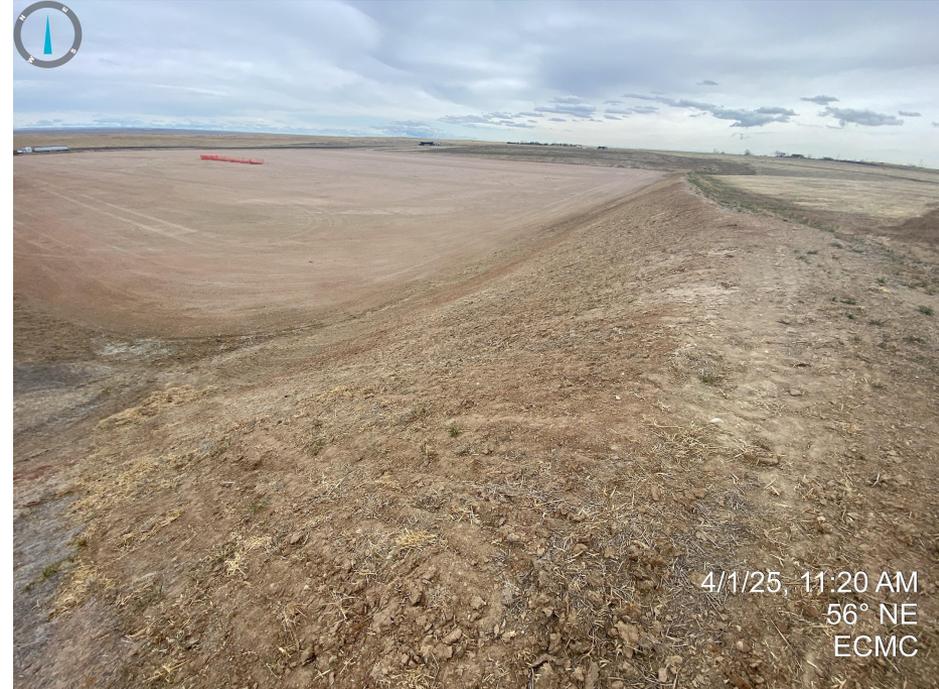
Photos 9 & 10. Taken from the southwest corner of the drilling pad. It appears that erosion degradation previously observed, appears to have been repaired.

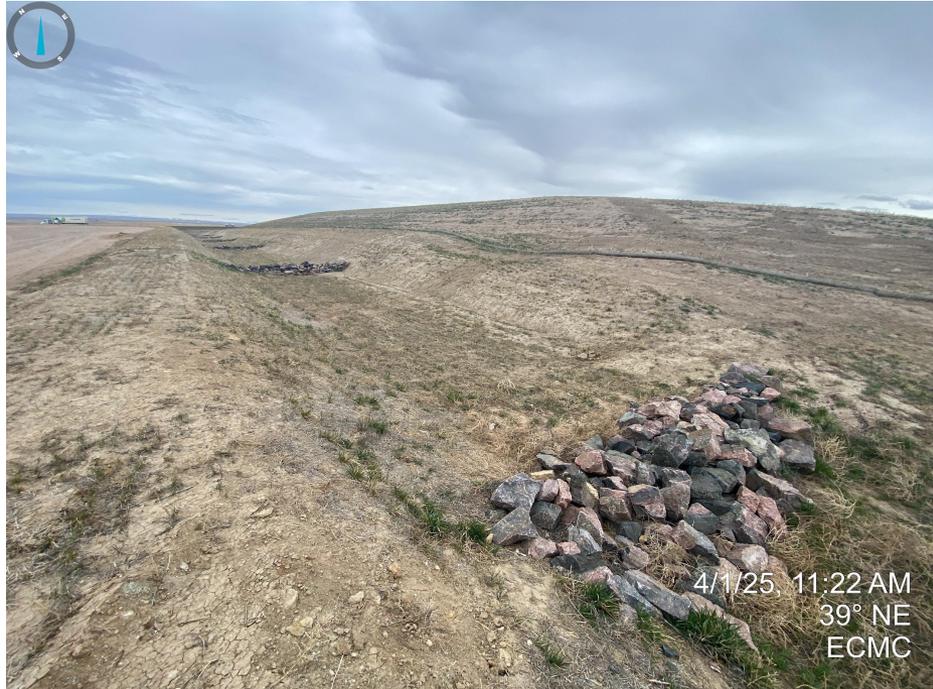
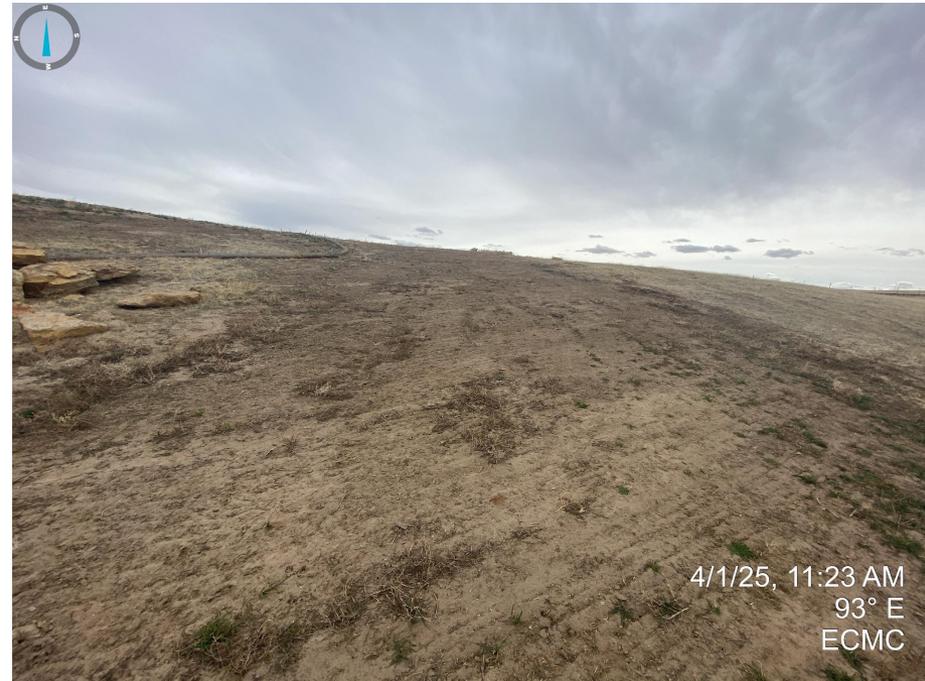
Photos 11 & 12. Taken from the southeast corner of the drilling pad. Photo 11 (left) illustrates that undesirable vegetation appears to have been managed for in the stormwater ditch and topsoil stockpile. Photo 12 (right) illustrates that unstabilized soils south of the topsoil stockpile appear to have been seeded; trash and debris also removed.

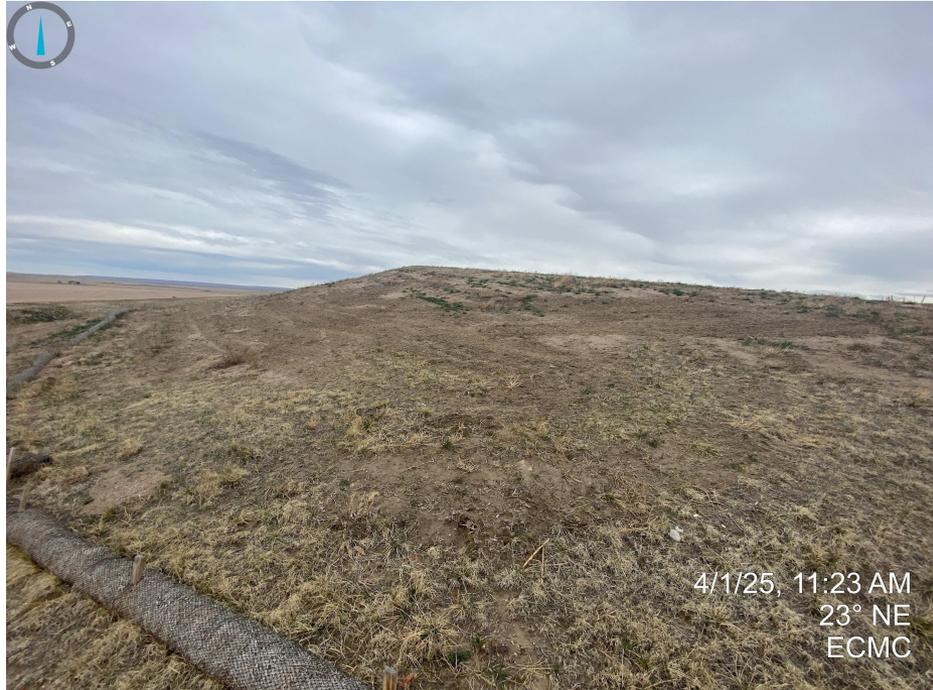
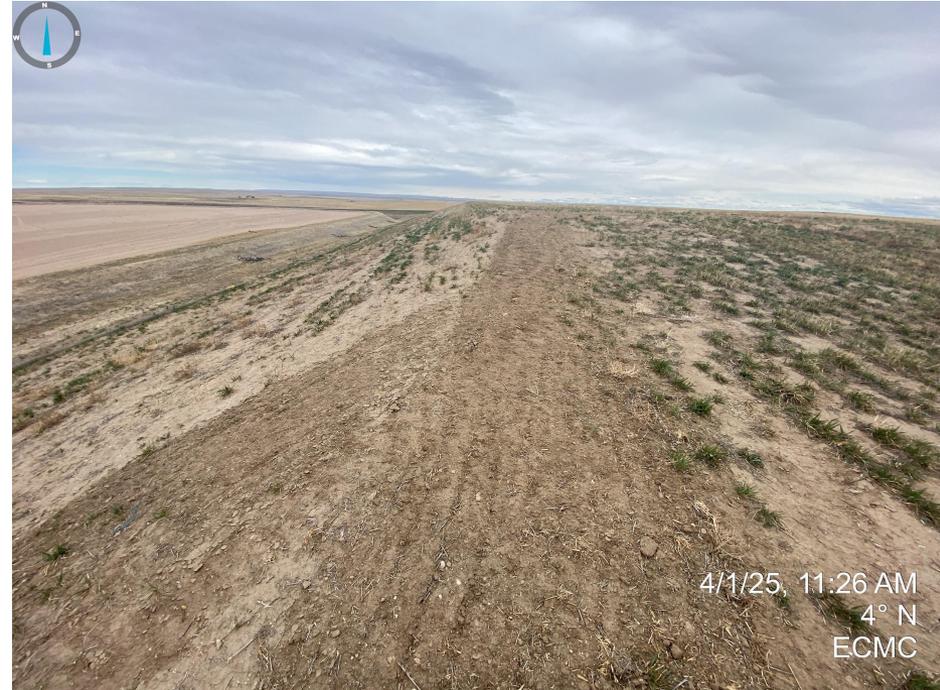
Photos 13 & 14. South side of topsoil stockpile. Undesirable vegetation appears to have been removed and bare soil stabilized with seeding.

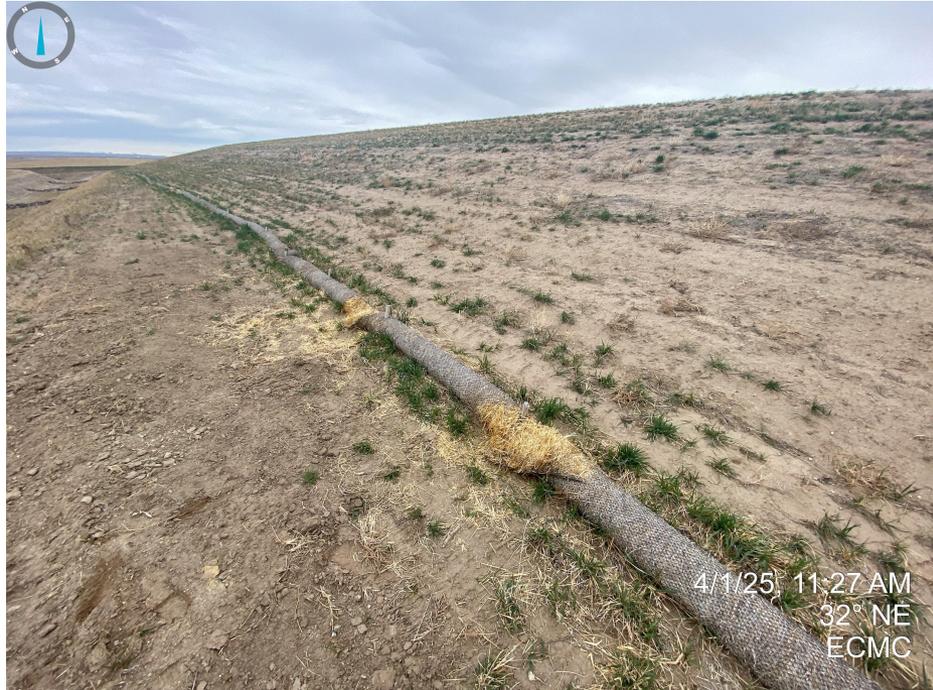
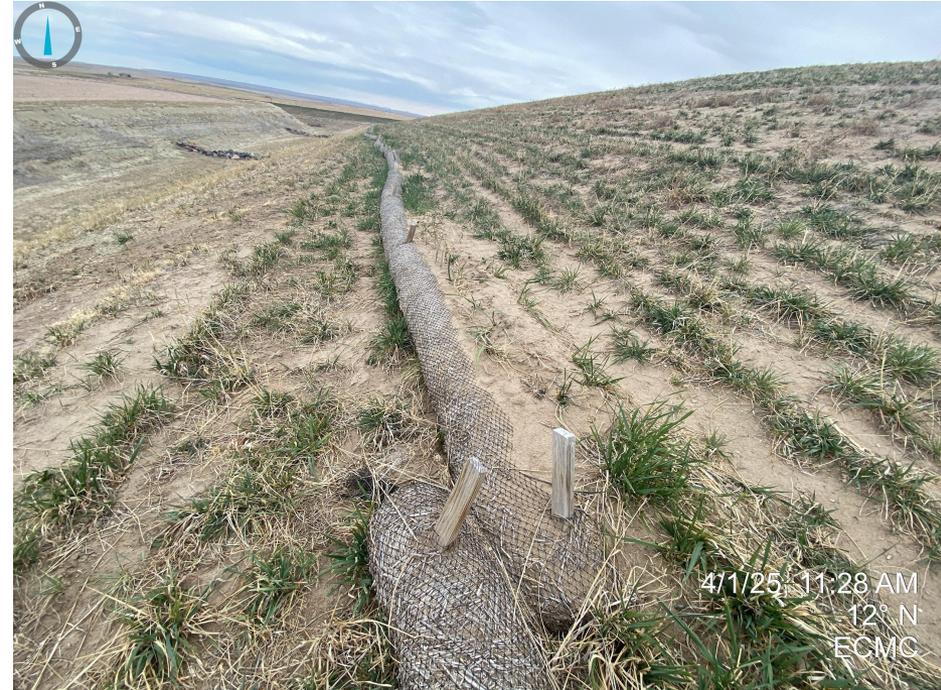
Photos 15 & 16. Stormwater control measures do not appear to be adequate as degradation is evident and straw wattles are beginning to fill with sediment.

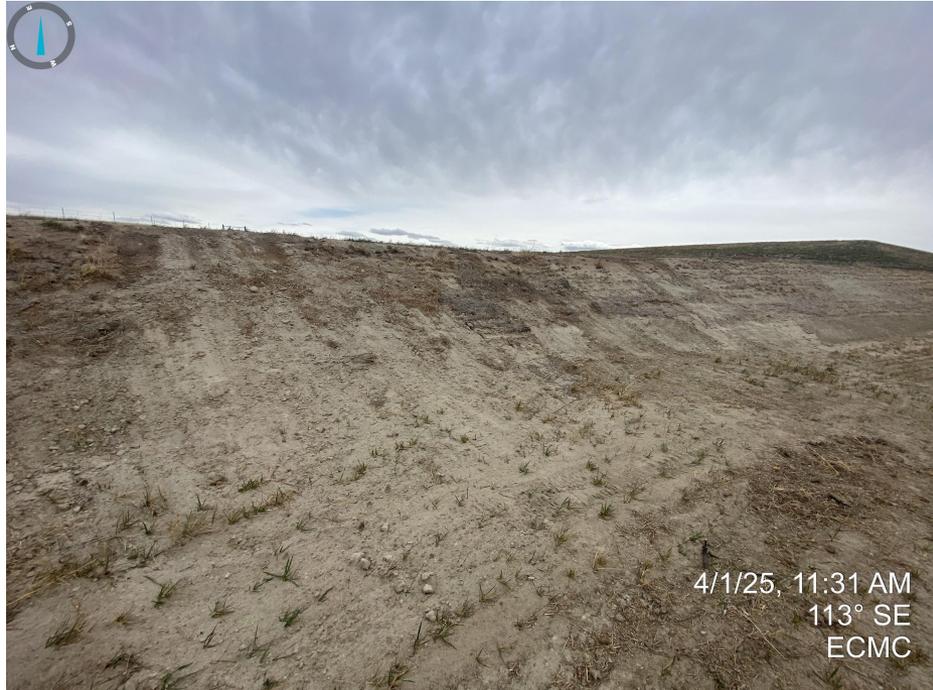
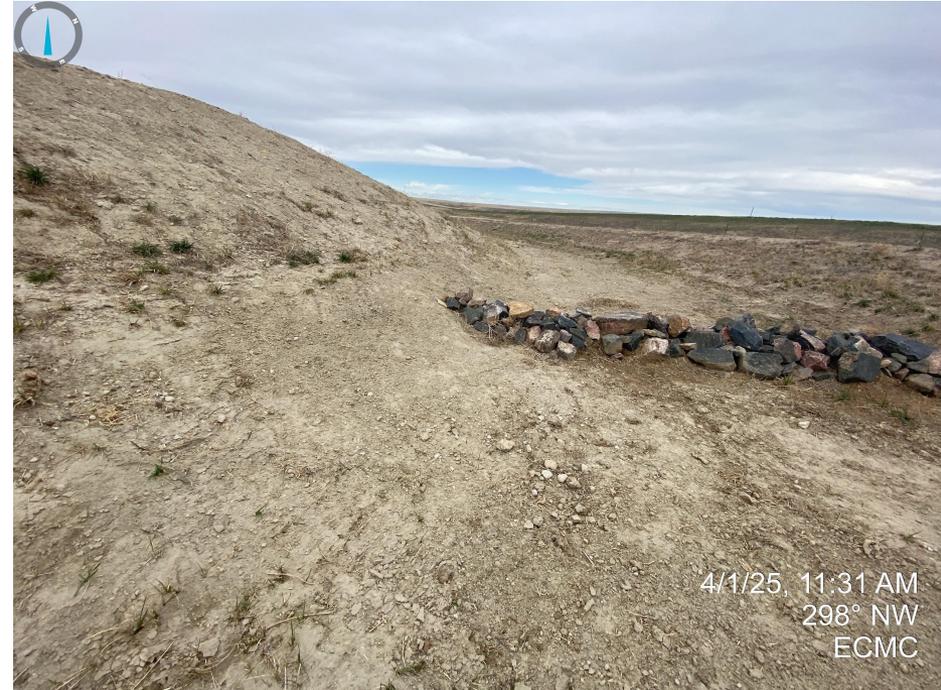
Photos 17 & 18. Erosion degradation within the stormwater ditch (northwest corner of location) appear to have been repaired.

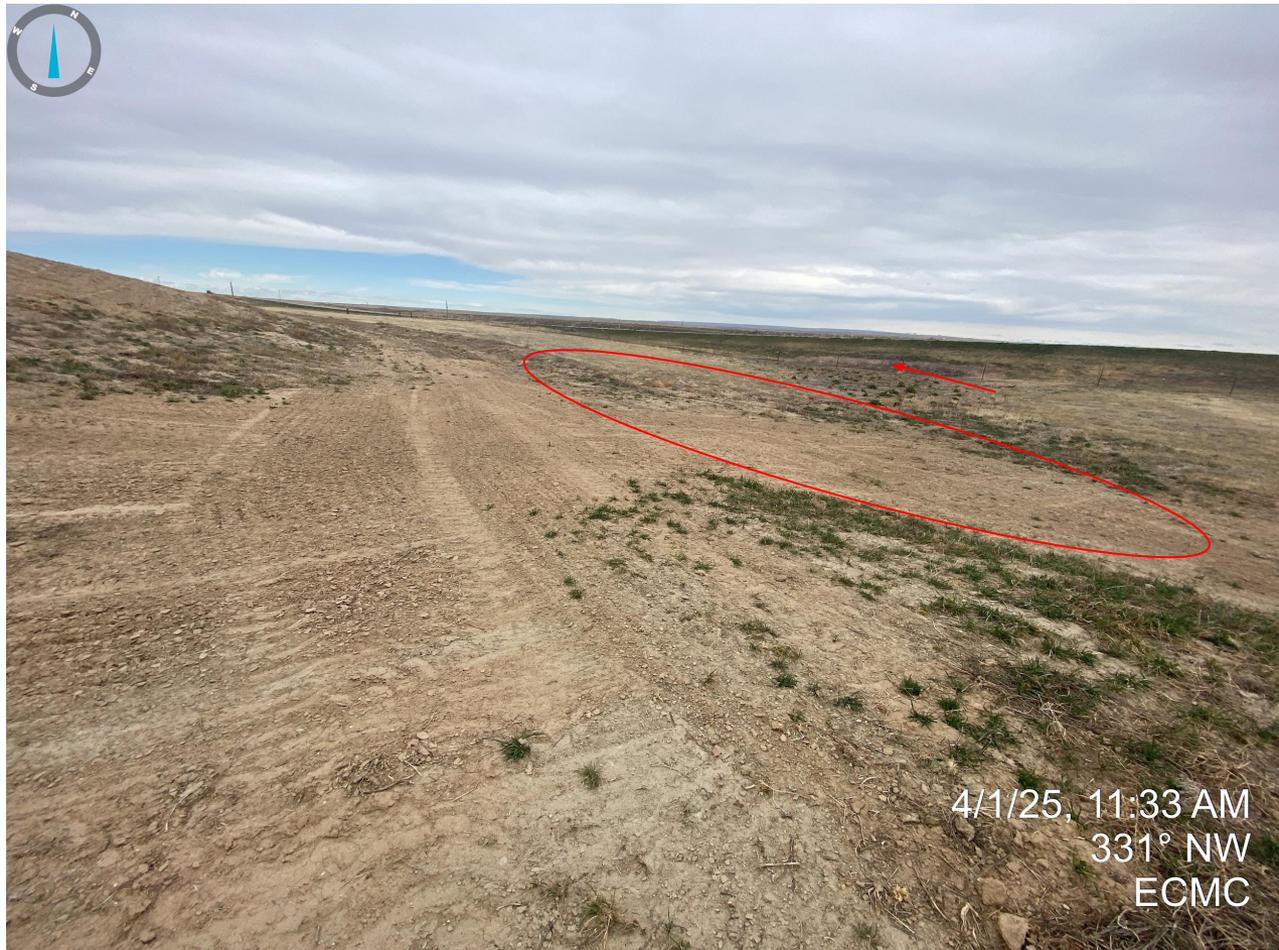
Photo 19. No apparent stormwater control measures observed on the north end of the location that would prevent sediment laden stormwater from exiting off location, into the culvert underneath CO HWY 14 (indicated by red arrow).

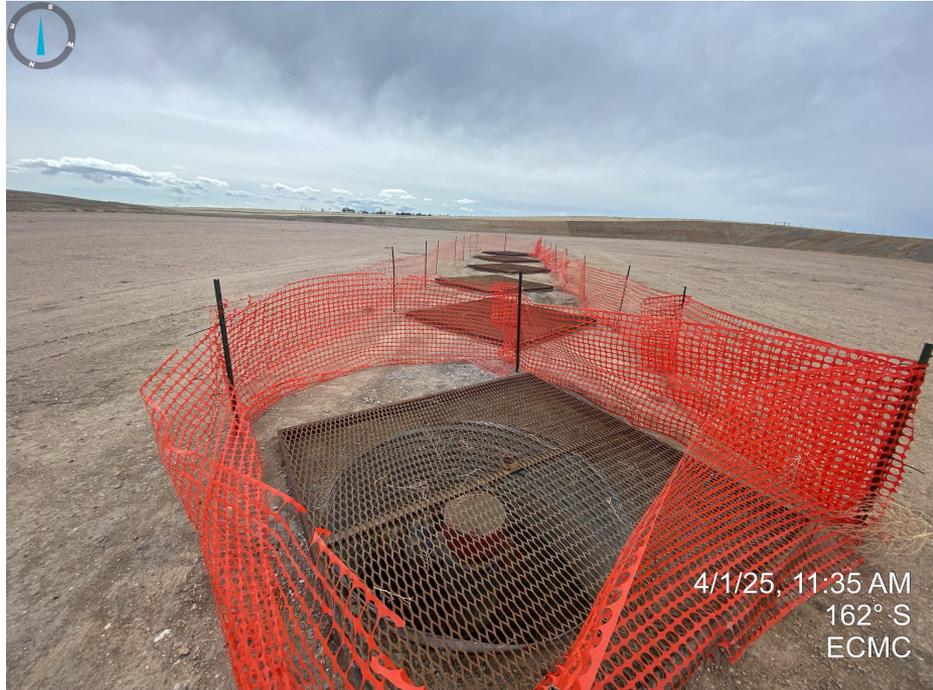
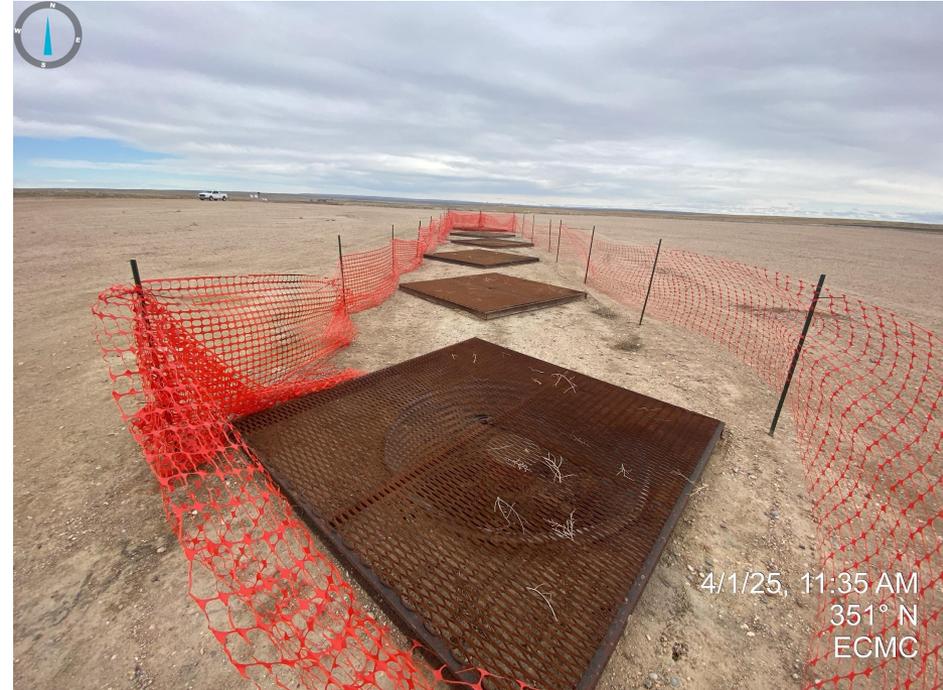
Photos 20 & 21. Cellar covers appear to have been installed around each well location.
